**NEW GOLD RAINY RIVER MINE
APPENDIX K
EXCEEDANCE LETTERS
SUBMITTED TO MECP**

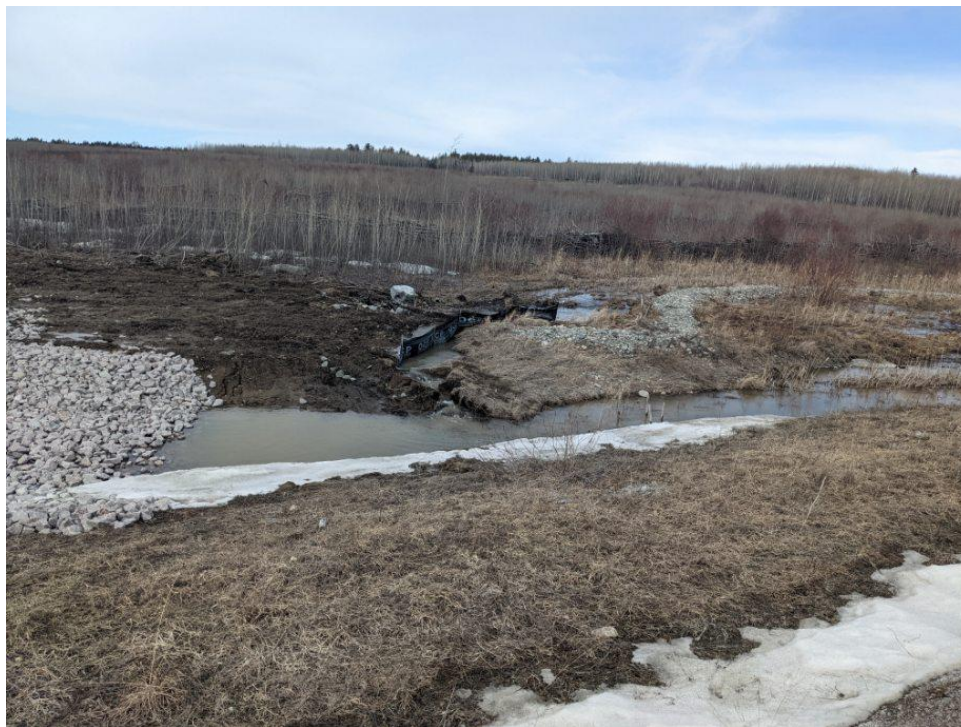
Figure 3 Inadequate sediment and erosion control measures at recently constructed TMA seepage pond.

Rapid snow melt from the open field directly north of the TMA seepage collection sump contributed to the influx of water experienced during the duration of the incident. As this TMA seepage collection sump was recently rebuilt last year, it is expected to be limited contaminants contained in it other than total suspended solids. A full sample was collected, and results will be provided once received. To mitigate this from happening in the future, the following actions are being taken.

1. Erosion and sediment control measures will be upgraded around the newly constructed sump to include a combination of coir logs, erosion blanket, and seeding.
2. A hardline pipe will be installed from the TMA seepage collection sump over the TMA South Dam and will discharge directly into Cell 3.
3. An electric pump will be installed in the TMA seepage collection sump with a float switch that will pump excess water into Cell 3 with the hardline pipe. This pump will be sized accordingly

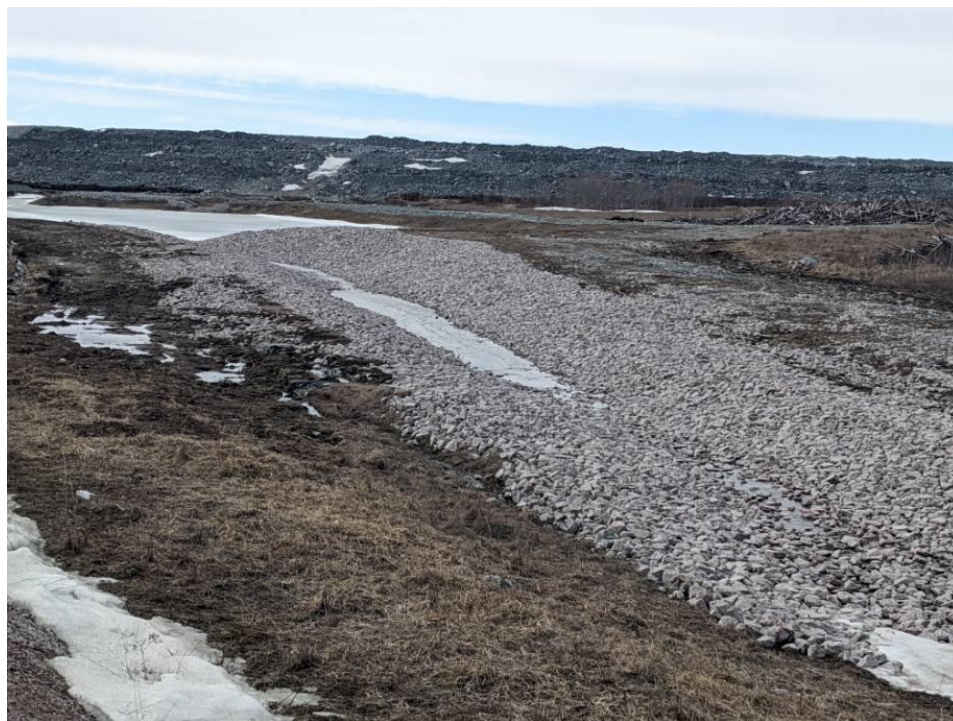
Figure 4 TMA seepage pond spillway activated.

Once it was observed that the recently constructed TMA seepage sump spillway had been activated, a discharge monitoring sample kit was used to collect a sample at Marr Diversion and West Creek Diversion confluence.

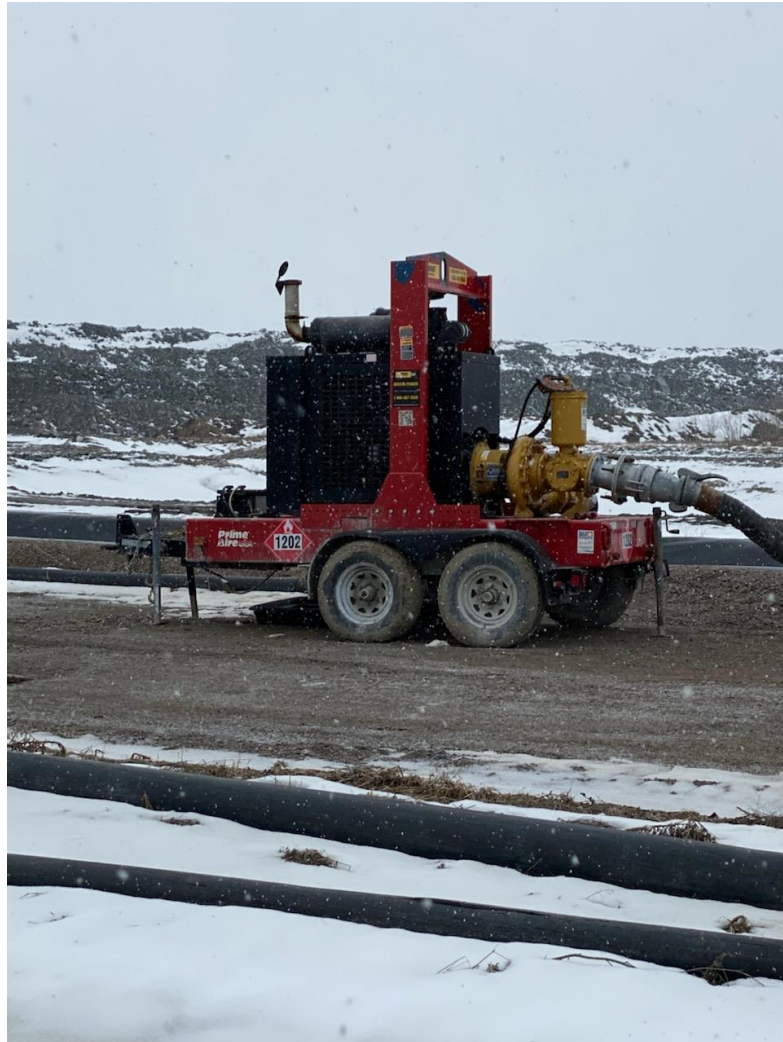
Figure 6 High-Volume pump installed to discharge water straight into tailings line and into the TMA.

to deal with the excess water experienced during this incident. High-Volume pump used during the incident will remain in place until second electric pump is installed.

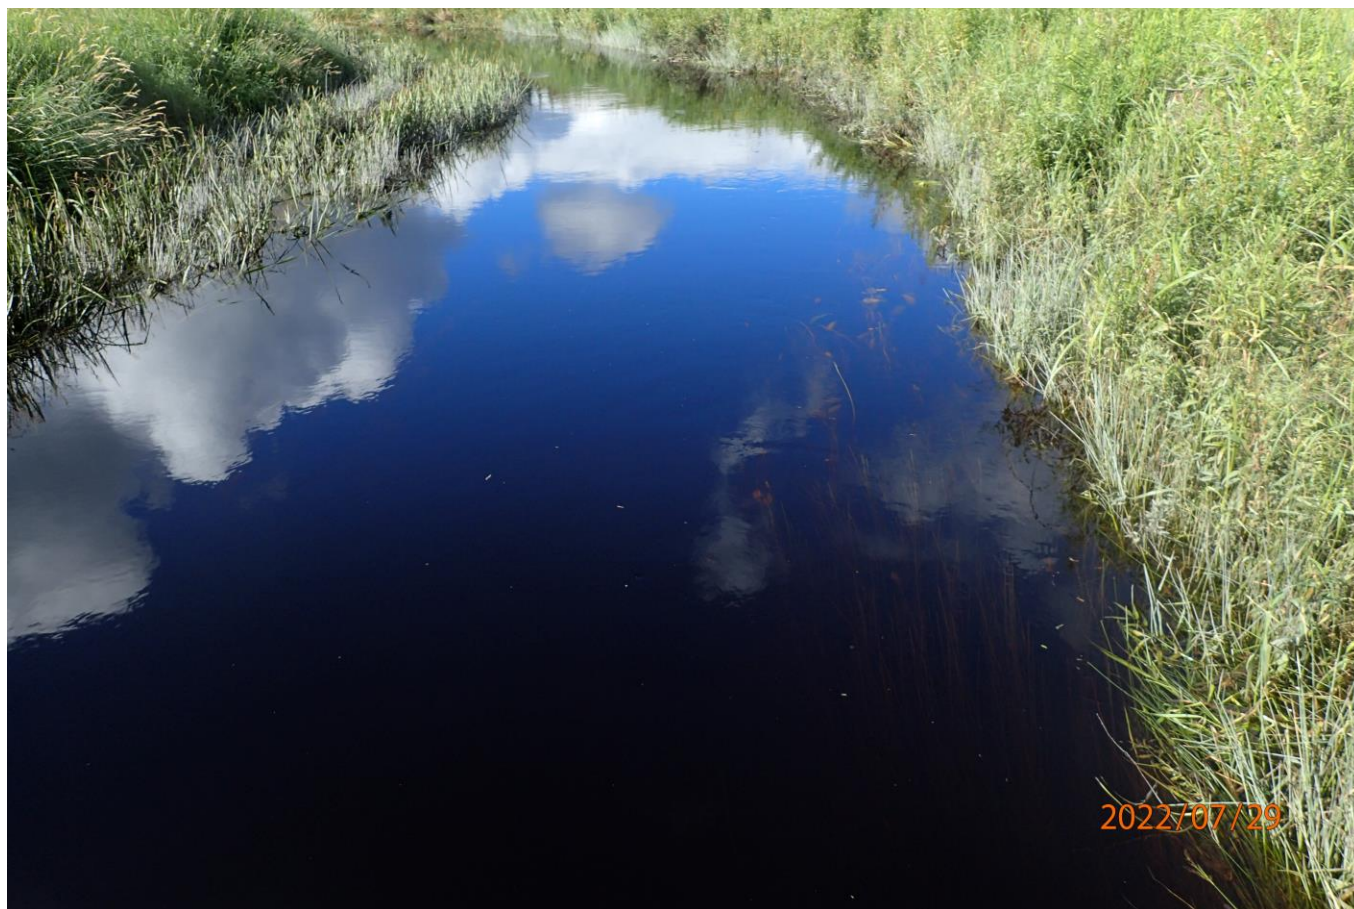
Photo 1: Pinewood River downstream of EDL2 at Surface Water location 22a.

Preliminary water quality results indicate one daily discharge criteria was exceeded. Total Zinc was found to be 0.484 mg/L which is over the daily limit of 0.348 mg/L. Acute toxicity testing showed no mortality confirming no significant adverse effects to the environment.

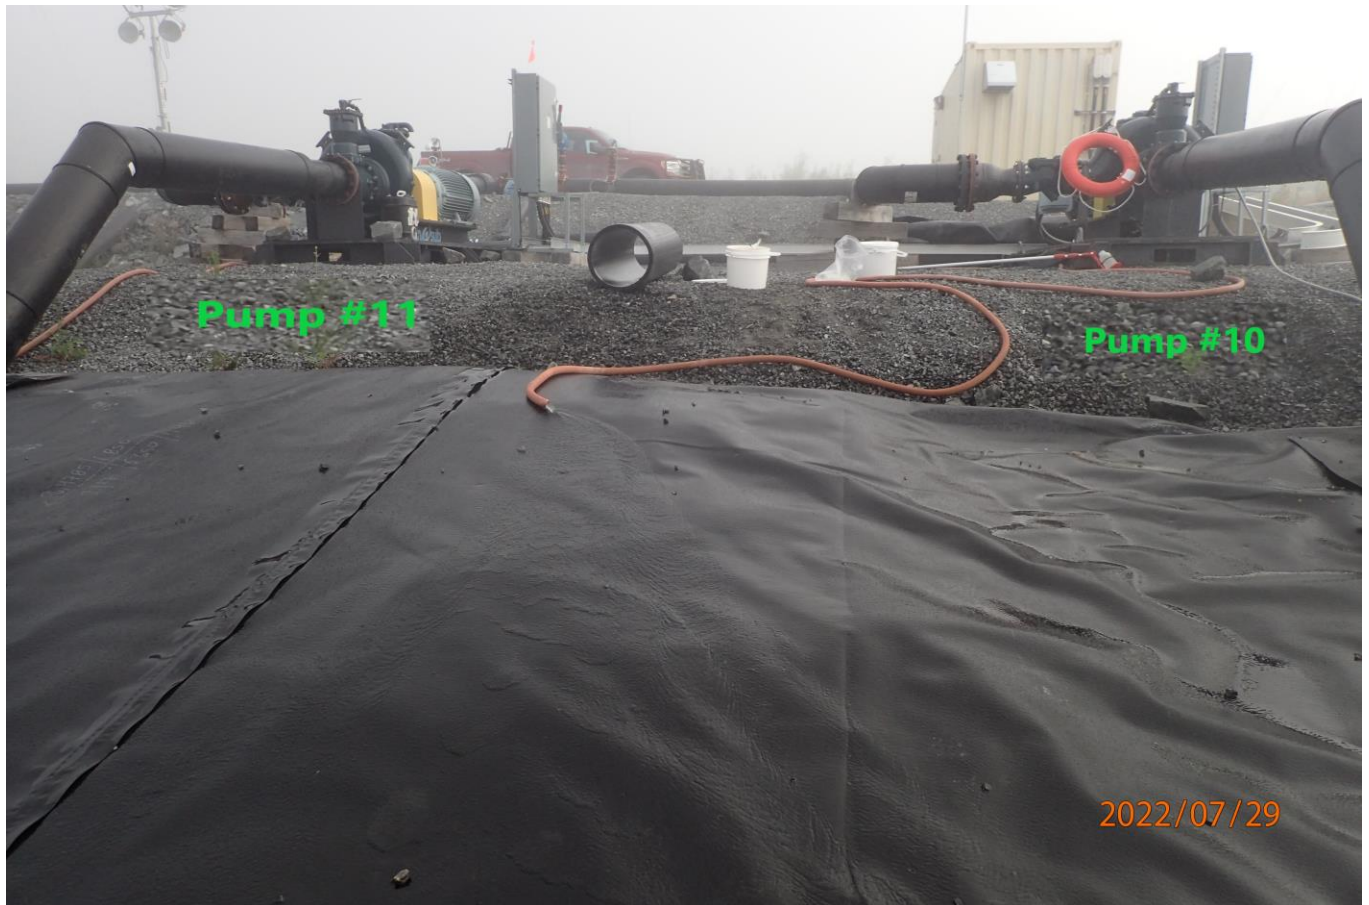
Photo 2: Outflow Basin Pumps

The decision was made on 2022-07-28 to resume discharge of water from Sediment Pond 2 and EDL1. (see attached email) After shift change Mill Nightshift operations staff turned on Pump #11 believing this pump reported to EDL1 not EDL2. Pump #11 is in the Outflow Basin and beside Pump #10 which can report to EDL1, Pump #10 was in use pumping Outflow Basin to TMA as part of a trial to treat Mine Rock Pond water with Biochemical Reactor #2 and Outflow Basin. Since Pump #10 was in use Pump #11 was turned on.

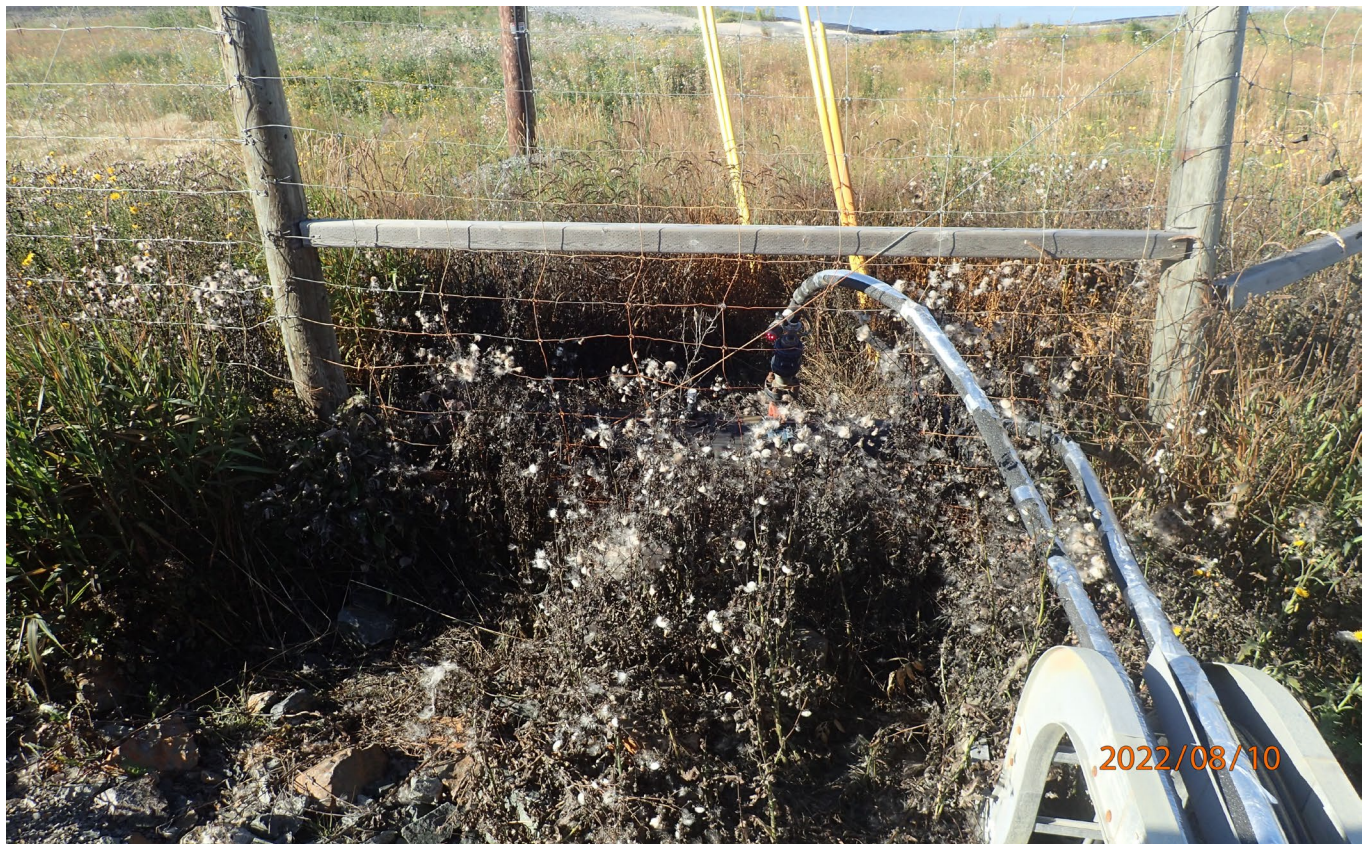
At 1620 on August 9th, the New Gold Environmental Department was made aware that 3 spills of Ferric Chloride had occurred once a day on August 3rd, 4th, and 6th totaling an estimated 165 liters of the substance being spilled. Estimate of volume lost was based on dosing rate of the line and amount of time between one line inspection to the next, which means 165L is a worst-case scenario estimate. The main cause of these spills was a change in product which caused the metal fittings of the dosing line to corrode.

Photo 1: Location and impact of spill.

These spills did not enter a water way and stayed localized as can be seen in the above as evidence by the damage to vegetation, no water or soil samples were collected. A Hydrovac truck was employed to clean up the area and was instructed to remove the impacted material until a change was seen in the color of the material and then remove another 30 cm depth of material. No significant rainfall was observed before cleanup was done.

After the 3rd fitting leak, plastic fittings were installed instead of metal fittings on the dosing line. Ferrous chloride is what the dosing line was designed to use but due to supply chain issues ferric chloride was employed and the result to the fittings was unexpected.

Options for secondary containment are being explored such as a catchment with a liner should this event happen again. Plastic fittings greatly reduce the chance of corrosion, but further protections will be added to reduce risk to the environment.

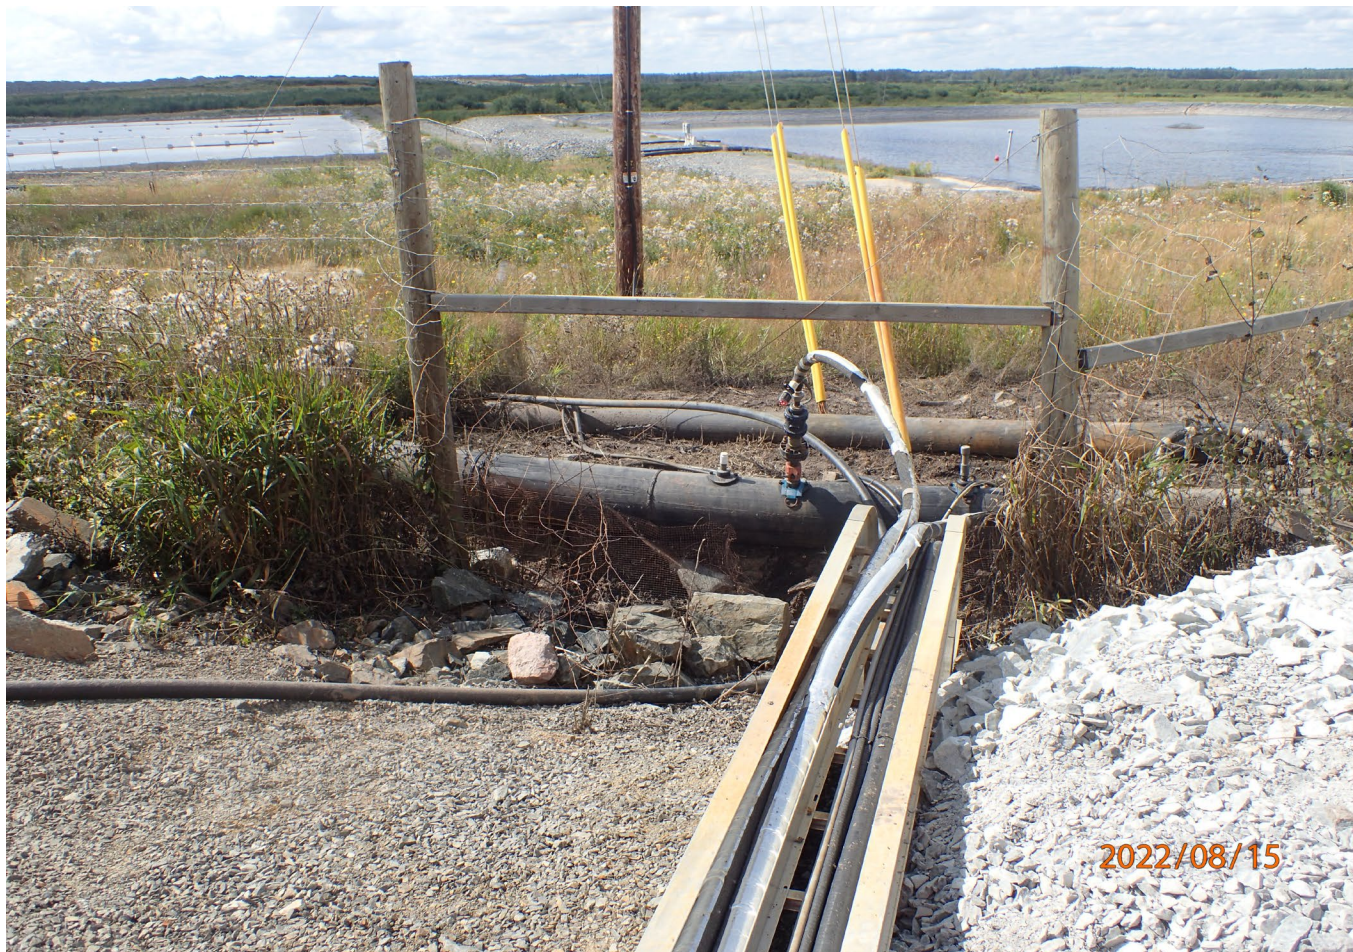
Photo 2: Spill location after clean up

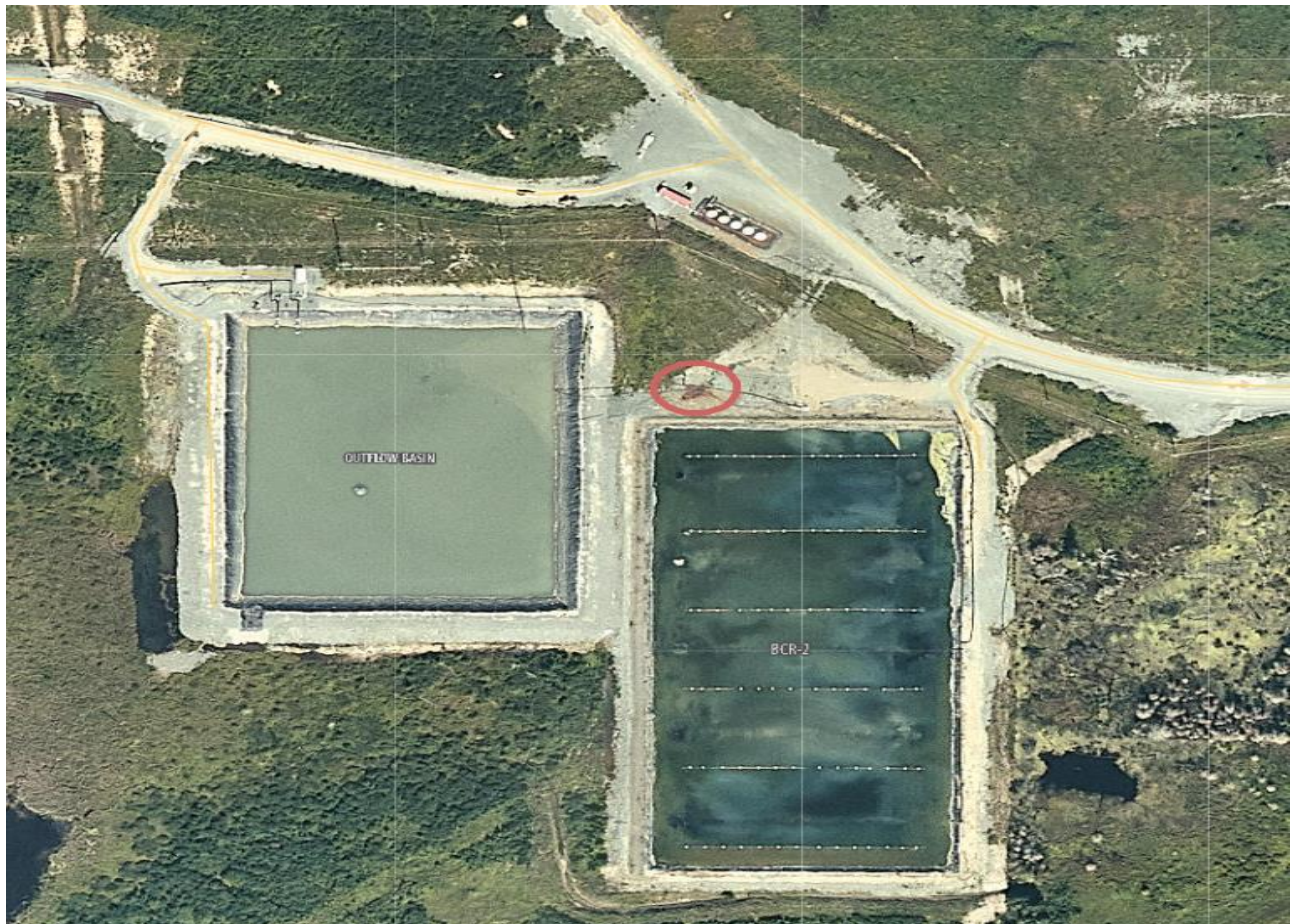
On September 20th, a new GIS image was posted on the New Gold GIS viewer for the Rainy River Mine Site. During a review of this image by Environmental Department staff, a discoloration was noted on the ground north of Biochemical Reactor 2 (BCR2).

Photo 1: location of spill.

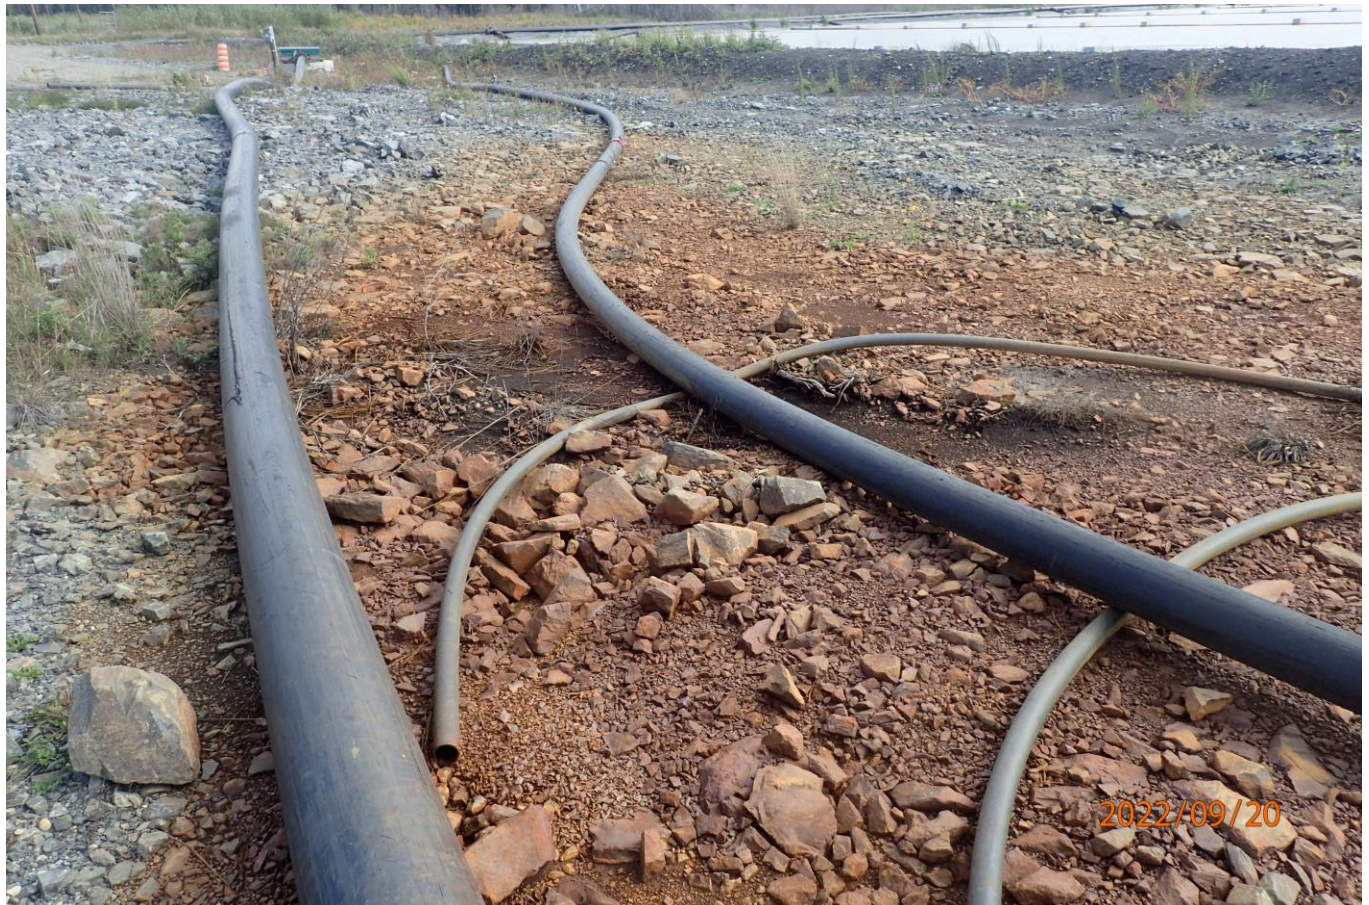
Upon field inspection this was found to be caused by a drain line misplaced for the BCR2 reagent tank secondary containment. There is a drain line that is intended to be placed directly into to BCR2 from this secondary containment so that any leaks or water captured by the containment can be pumped out.

Photo 2: spill impact

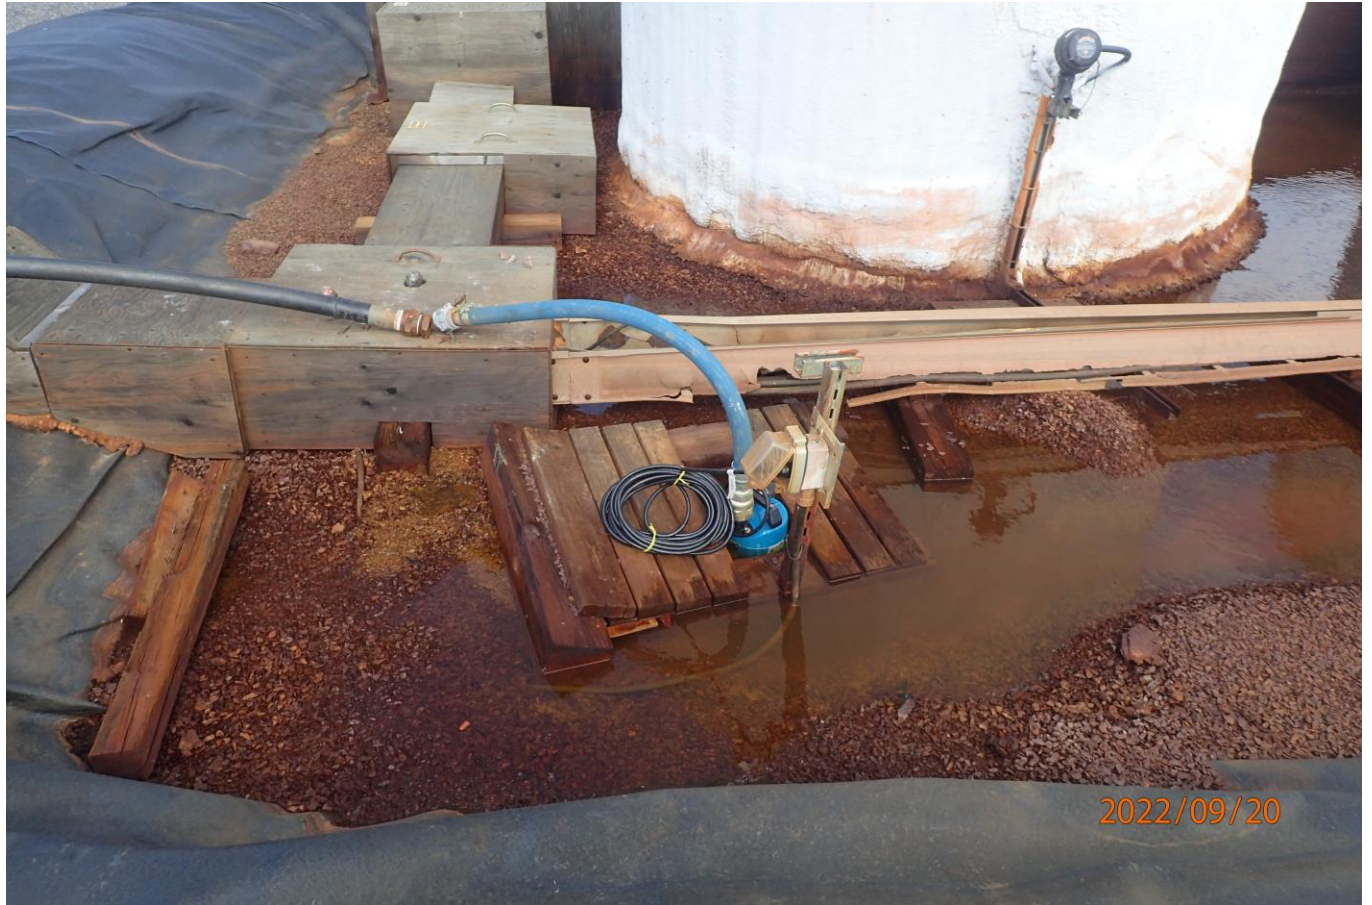
Photo 3: pump found dismantled at time of inspection

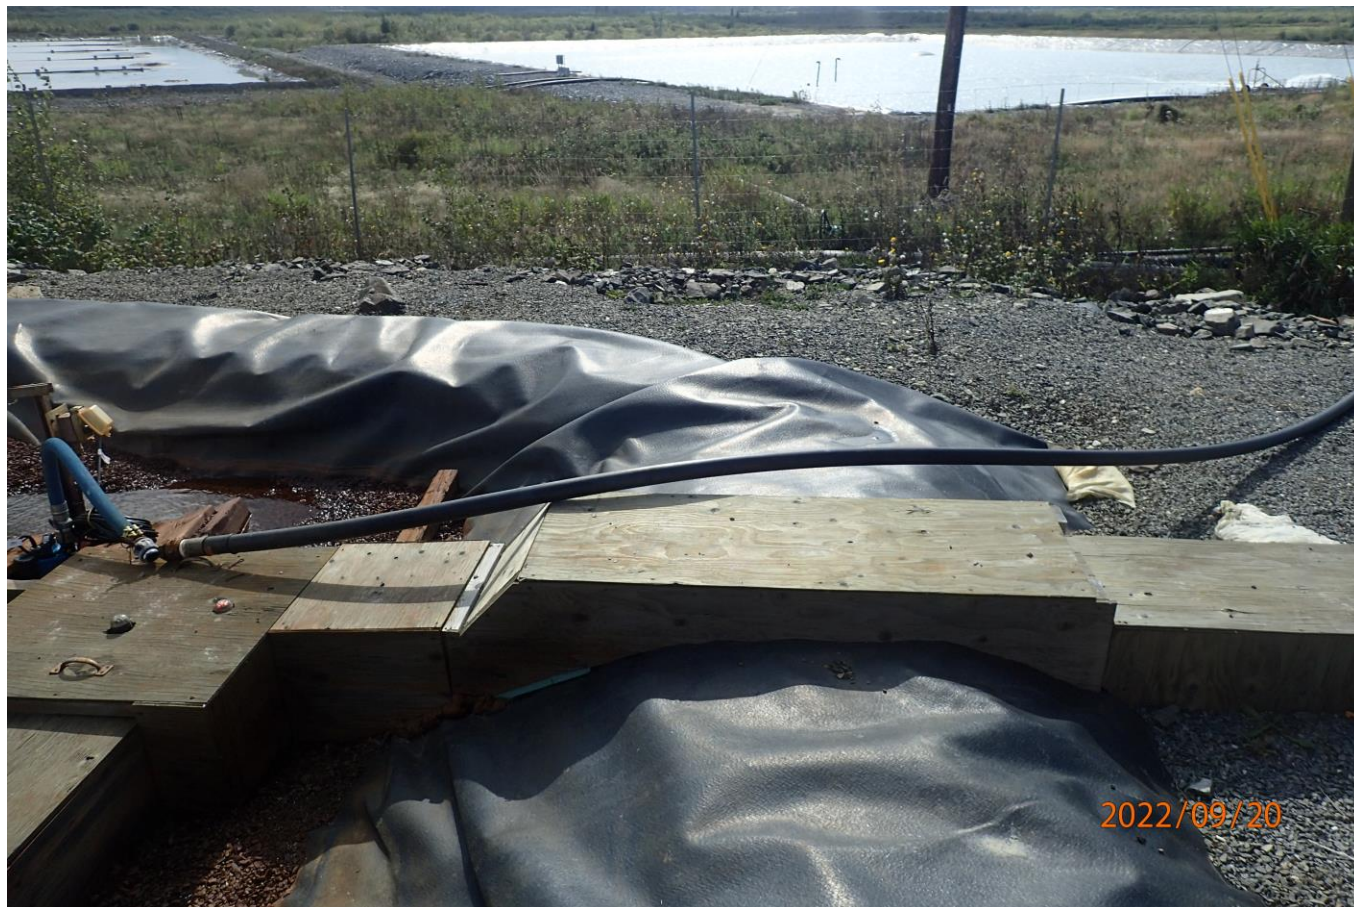
Though this spill was evident in aerial imagery it remained undetected for an unknown length of time due to the topography of the area in which the spill occurred. Vegetation blocks it from line of sight from the reagent tanks and topography blocks it from the well of BCR2.

Photo 3: view of spill location from reagent tanks (BCR2 upper lefthand corner)

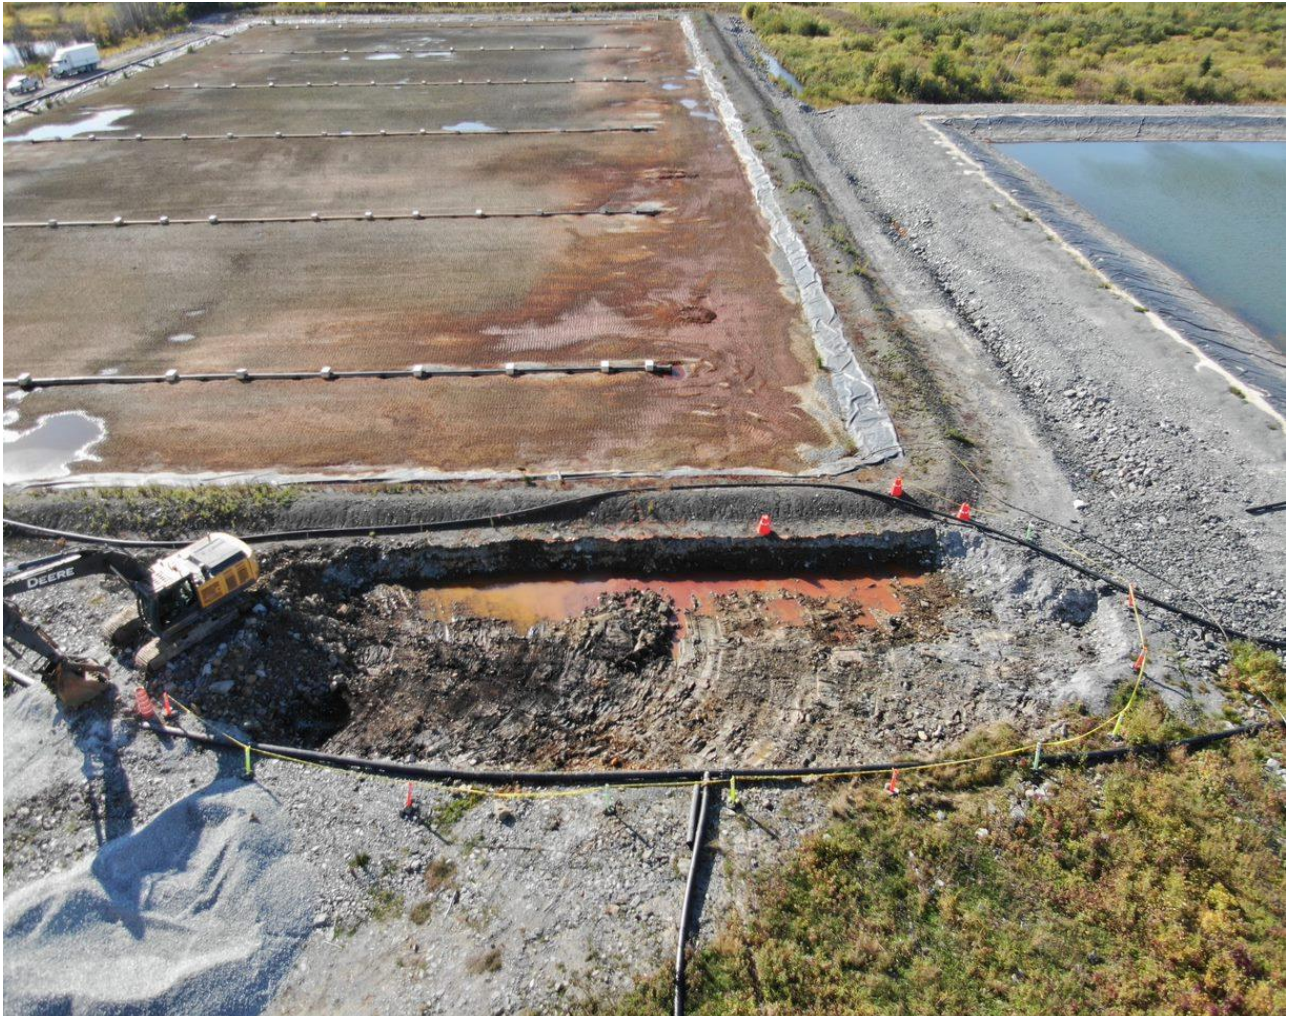
Clean up remains ongoing for this event as staining appears to have mobilized down the ditch between the Outflow Basin and BCR2. Options for containing this entire area with a pump back system are being explored and will be implemented once identified.

Photo 4: current state of clean up as of 2022-09-29.

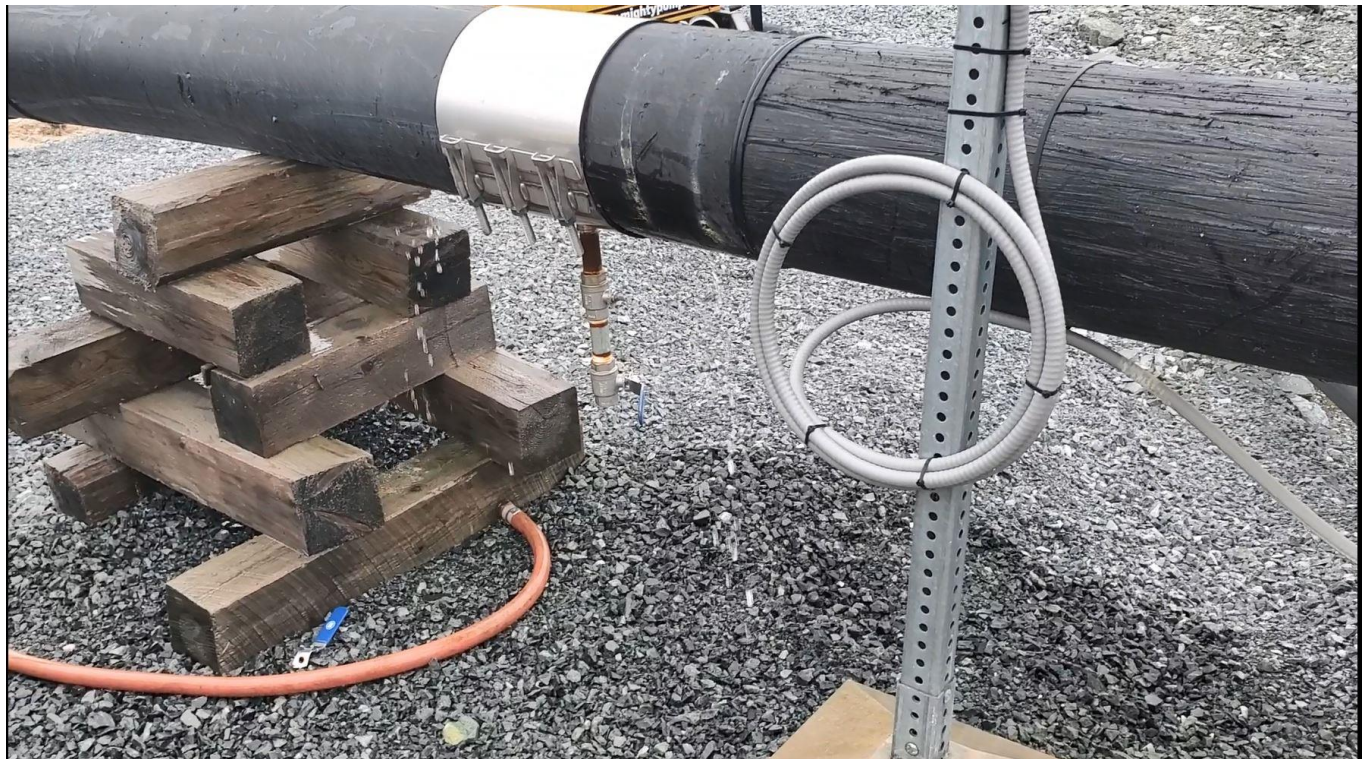
At 1600 on October 26th, the New Gold Environment Department was made aware that a spill had occurred at Outflow Basin (OB), a hugger clamp for a drain valve was found leaking. The pump that supplies water to this pipeline was not running but the line was pressurized due to discharge pumping from Water Management Pond (WMP) to EDL2. Water samples including acute toxicity were collected, but a bucket test could not be performed as the operators that discovered the leaking valve fixed it as soon as possible. Pumping from WMP had only been active for a short time and based on the image captured below by the persons that found the leak, they estimated the volume lost to be approximately 100L.

Photo 1: Leaking hugger clamp.

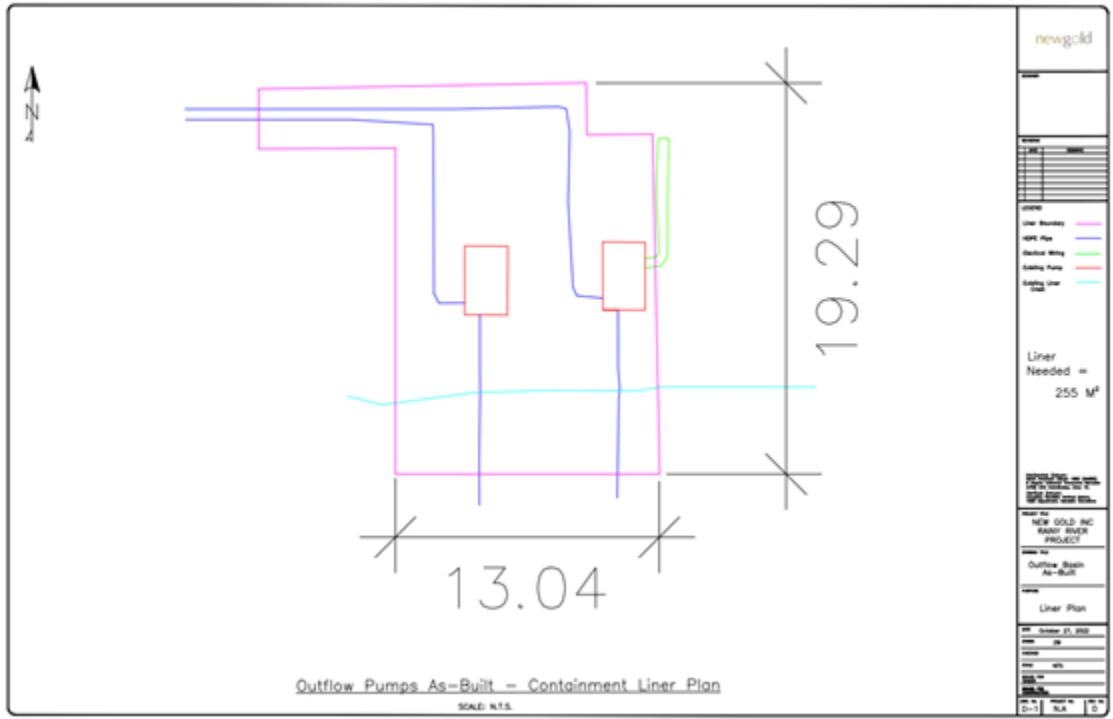
Photo 2; Liner design.

The image above shows a design plan for a liner to be installed that will encompass all potential points of failure with this infrastructure and all spills would report to OB. During winter of 2022-23 this will be installed.

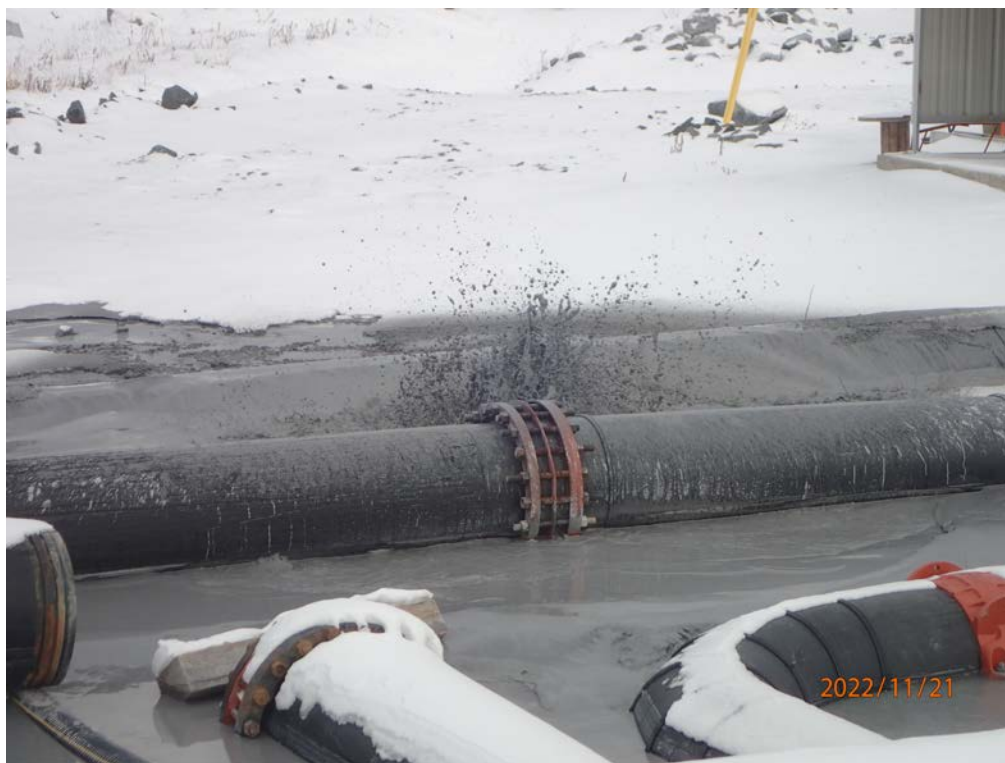
At 11:18 on November 21st, the New Gold Environment Department was made aware of a connection failure along the tailings pipeline just west of the Marr gate. As soon as the event was reported the mill shut down and tailings continued to exit out of the connection as the pressure was reduced. The majority of the material was captured inside the liner and traveled east into the sump as designed. A pump and secondary line were then utilized by site services to pump from the sump to the tailings pond to avoid an increase of water level within the sump.

Photo 1: Leak at pipe connection

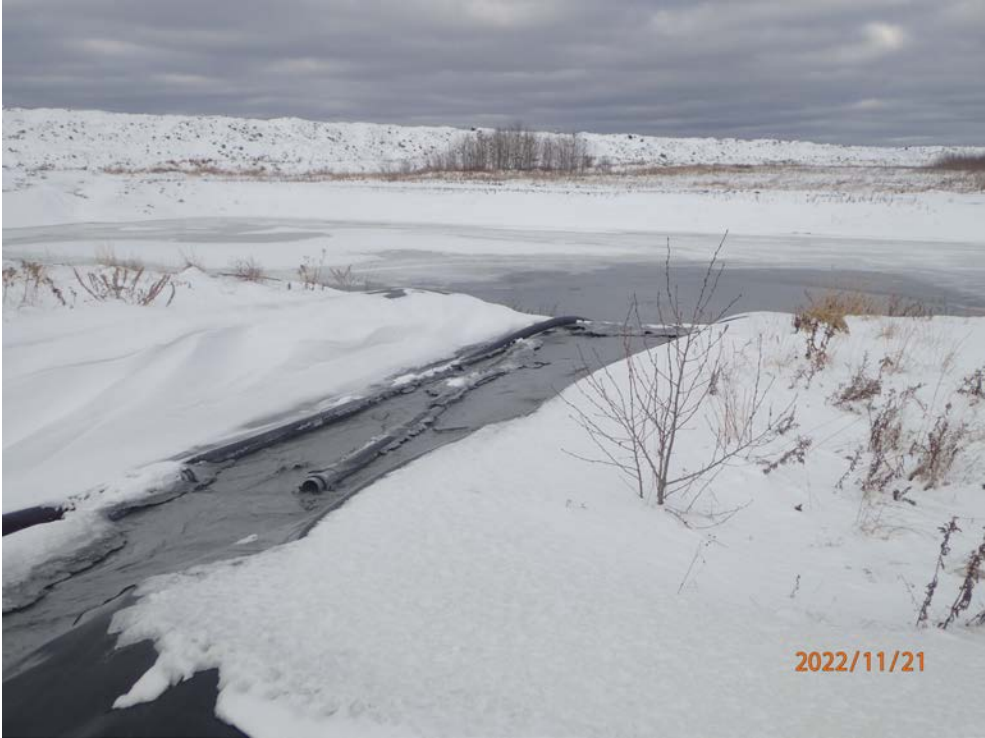
An estimated 60 to 100 liters of tailings was expelled past containment and onto natural ground at the initial point of failure, while the pressure was at its peak. The area of the spill past the liner is still within a hard barricade from reaching the West Creek Diversion and any seepage will be captured further south-west in the TMA Seepage Collection Sump. As a result, there is no evidence of this spill making it to fish bearing waters.

Photo 2: Tailings captured in sump

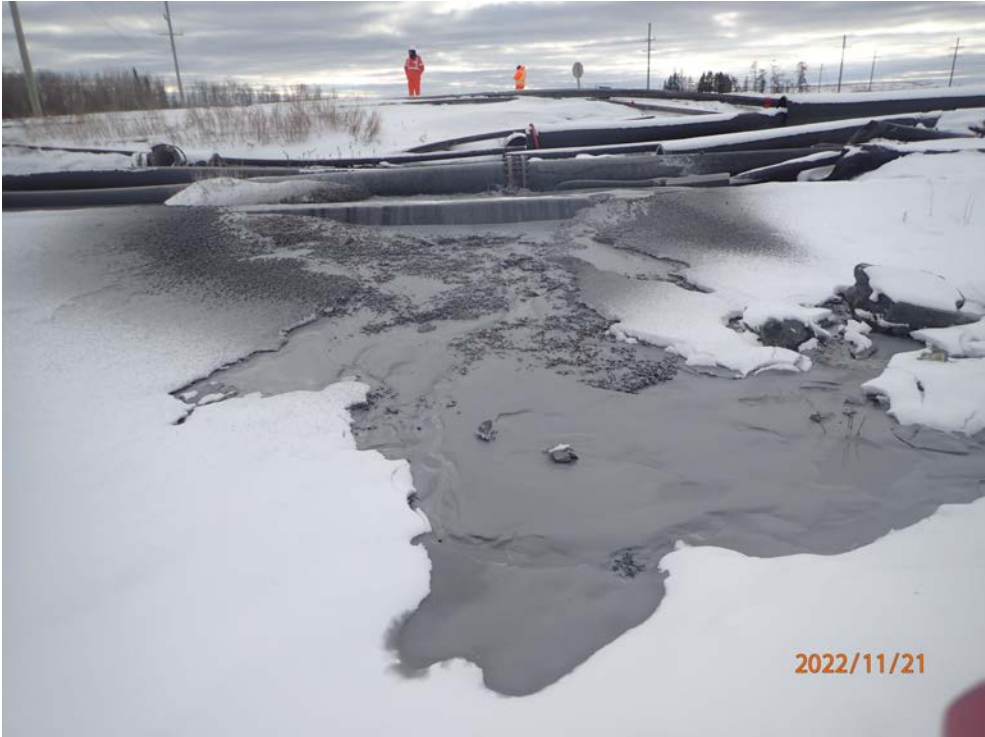
Photo 3: Tailings north of liner

No sampling was completed due to the consistency of the tailings outside of containment. All tailings that did not report to containment were collected with a HydroVac truck..

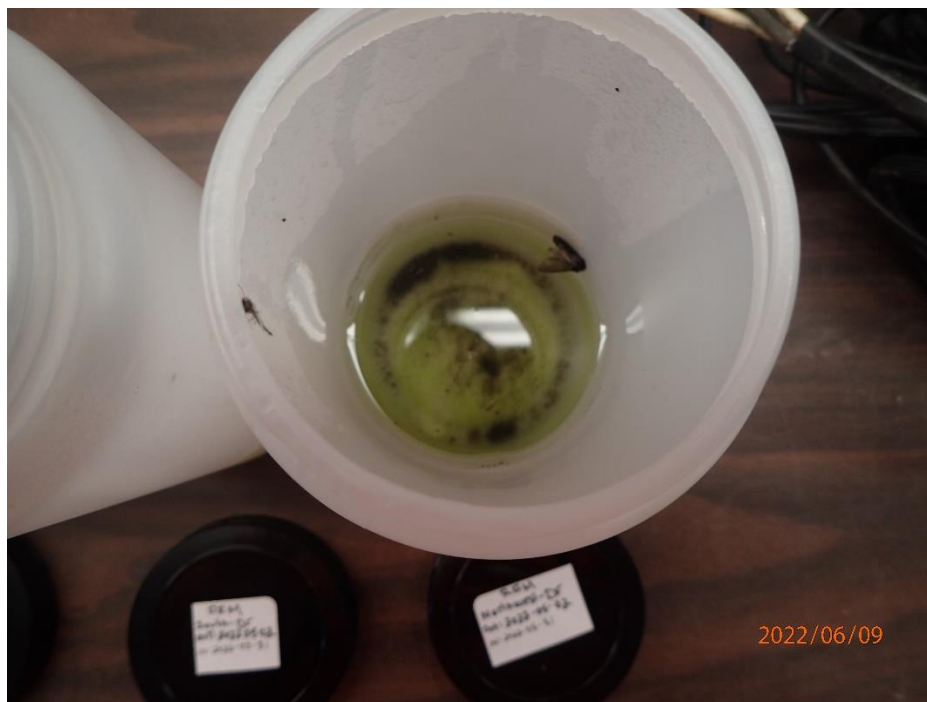
Figure 3 shows May 2022 Northwest Air Quality Station dustfall canister before shipment to certified laboratory.

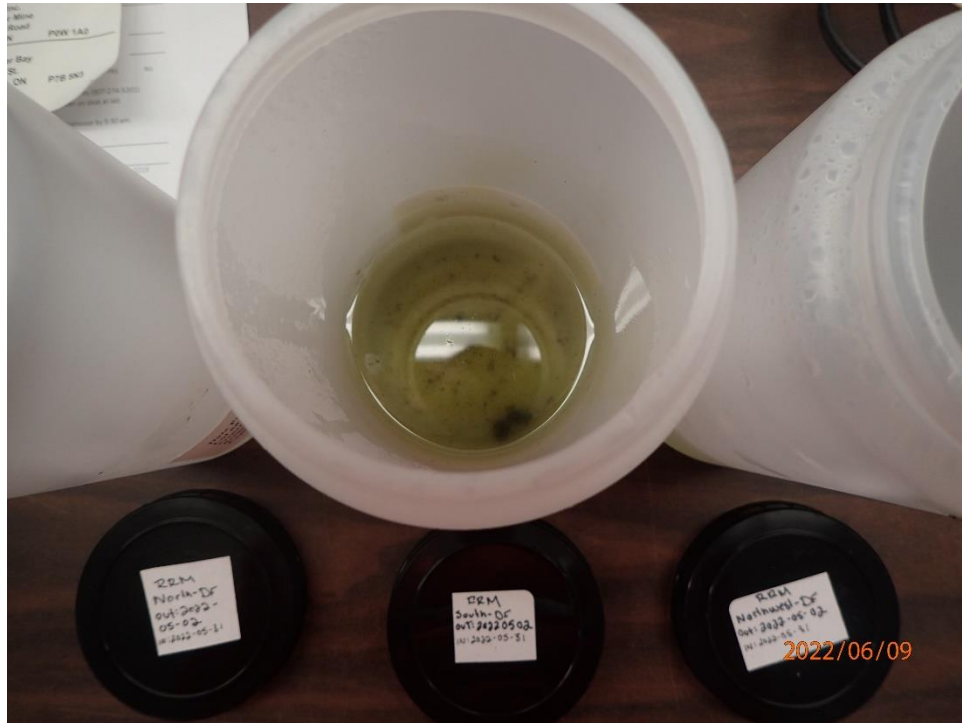
The dustfall exceedance from South Air Quality Station in May 2022 and dustfall exceedances in June 2022 from both North and Northwest Air Quality Stations were due to high organics in the dustfall canister.

Figure 4 shows May 2022 South Air Quality Station dustfall canister before shipment to certified laboratory.
