Date:	May 20,2022	Owner/Client:	New Gold Inc.
Day:	Friday	OKC Project #:	1003-19
Prepared by:	Keith Naumann	Project Location:	Rainy River - Ontario

Date:	May 23,2022	Owner/Client:	New Gold Inc.
Day:	Monday	OKC Project #:	1003-19
Prepared by:	Keith Naumann	Project Location:	Rainy River - Ontario

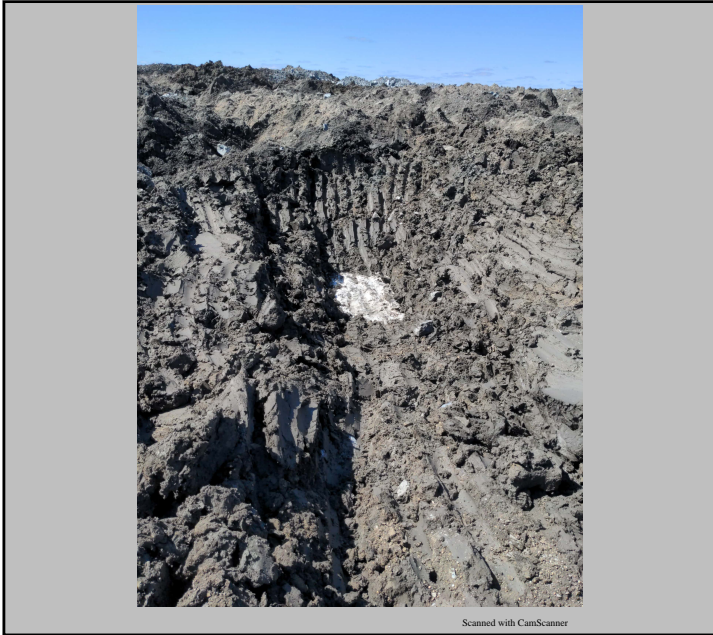
Photo #: 1

Obtained EMRS22_SP_S008_220503.

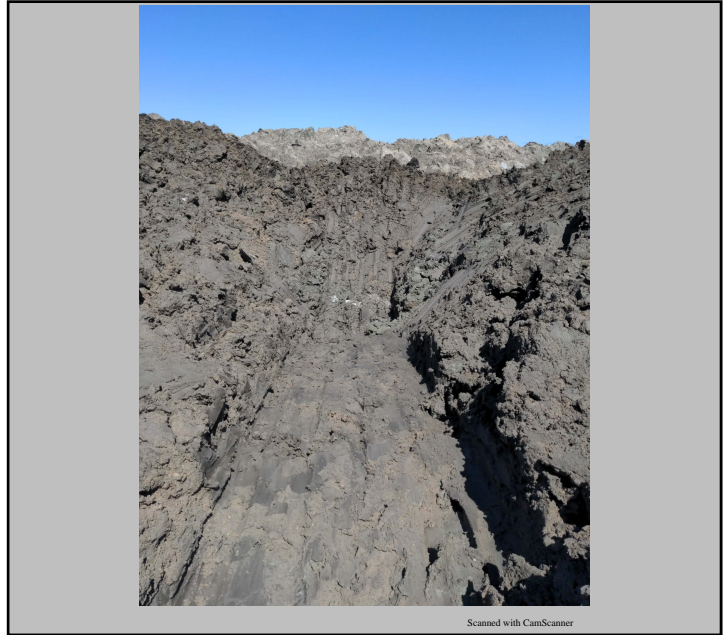
Photo #: 2

Obtained EMRS22_SP_S009_220503.

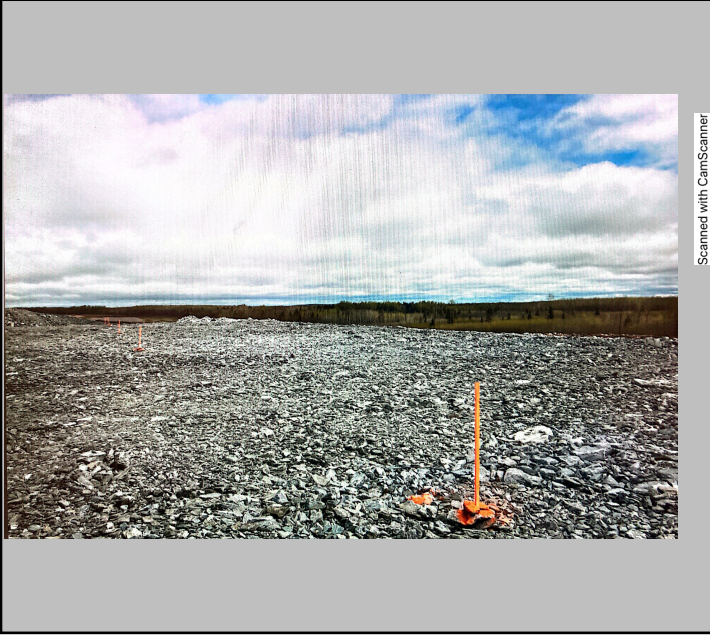
Photo #: 1

Staked line 20m Back from crest.

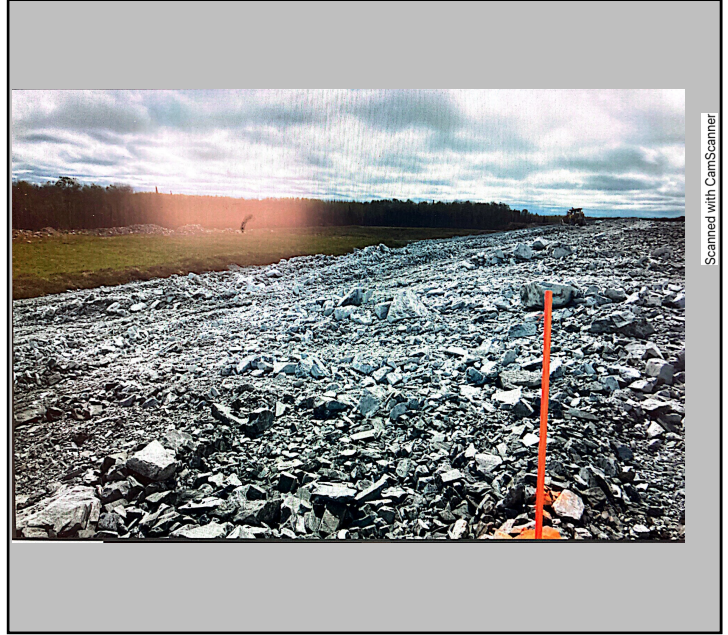
Photo #: 2

418 Dozer preparing slope prior to base survey
from 0+690 - 0+783

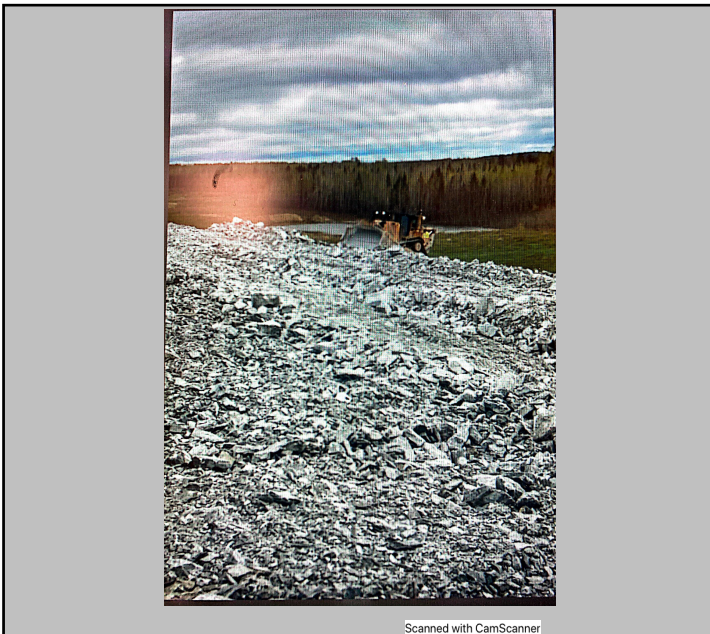
Photo #: 3

418 Dozer preparing slope prior to base survey
from 0+690 - 0+783.

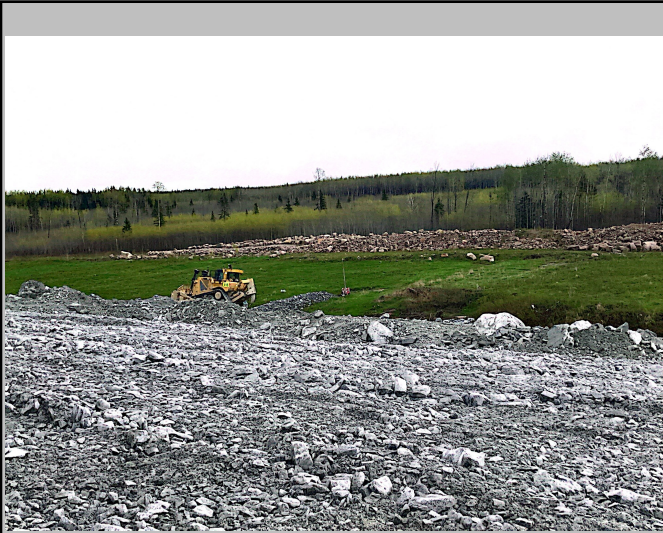
Photo #: 1

418 Dozer preparing slope prior to base survey from 0+690 - 0+783.

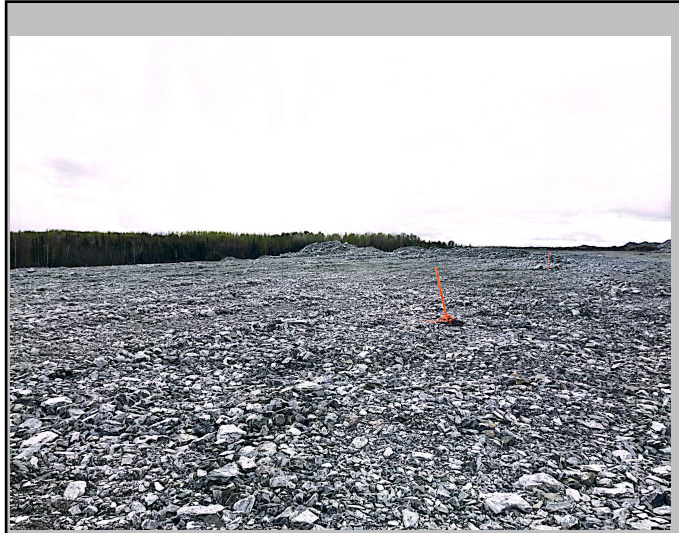
Photo #: 2

Prepared slope ready for base survey.

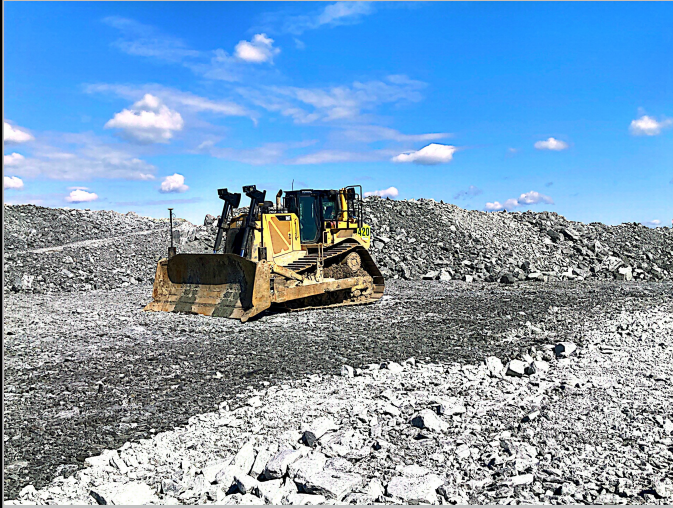
Photo #: 1

420 Dozer arrived at the location

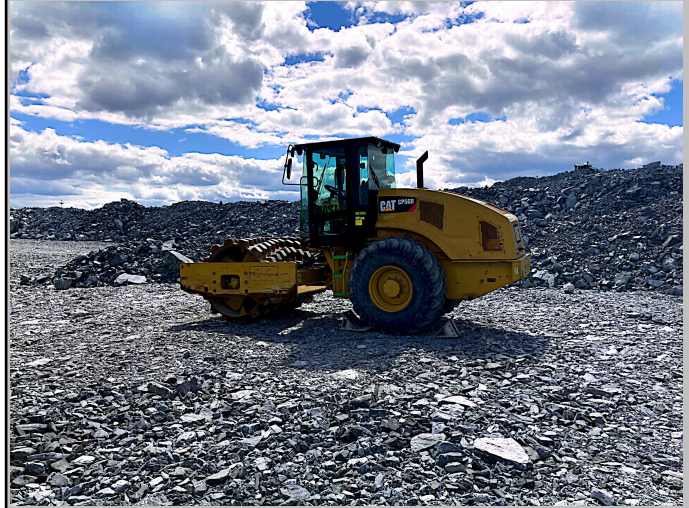
Photo #: 2

Sheep foot roller arrived at location.

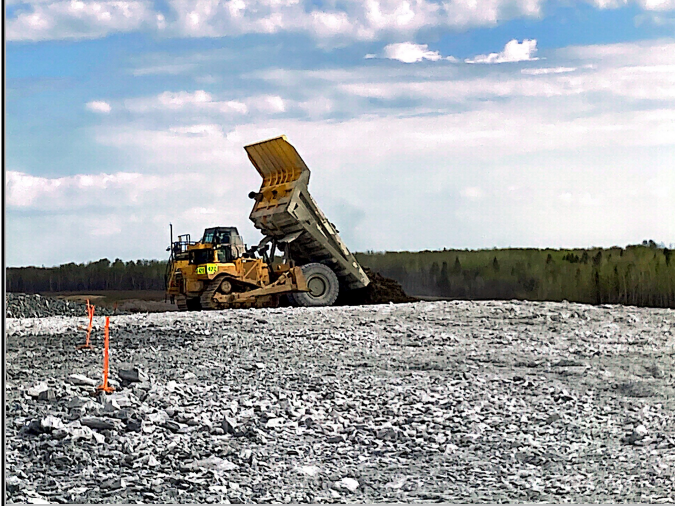
Photo #: 1

Truck 233 dumping CCL panel 30 lift 1. +/-0+700.

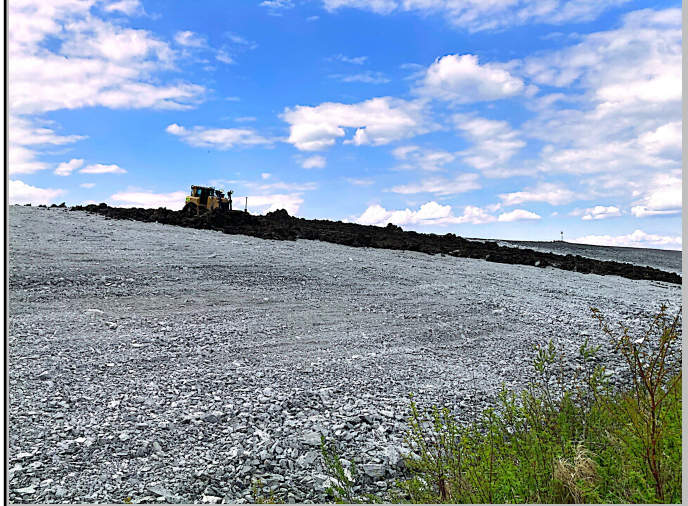
Photo #: 2

Dozer 420 Placing CCL panel 30 lift 1. +/-0+700.

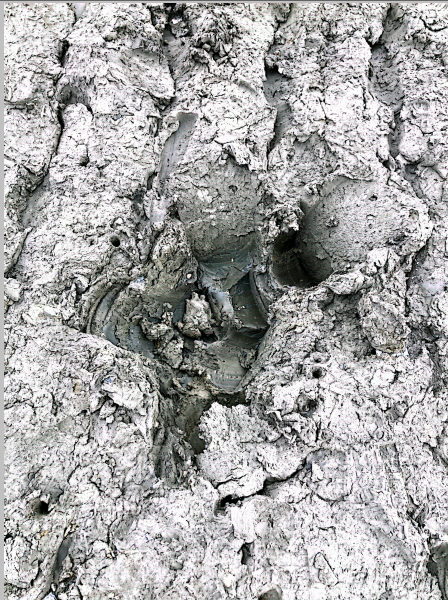
Photo #: 3

Sample:
EMRS22_PR_MC_HY_AT_P30_L1_S509_2200523

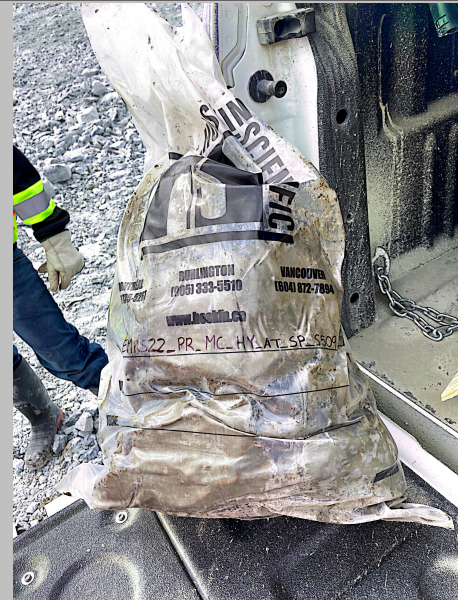
Photo #: 4

Sample ID:
EMRS22_PR_MC_HY_AT_P30_L1_S509_2200523

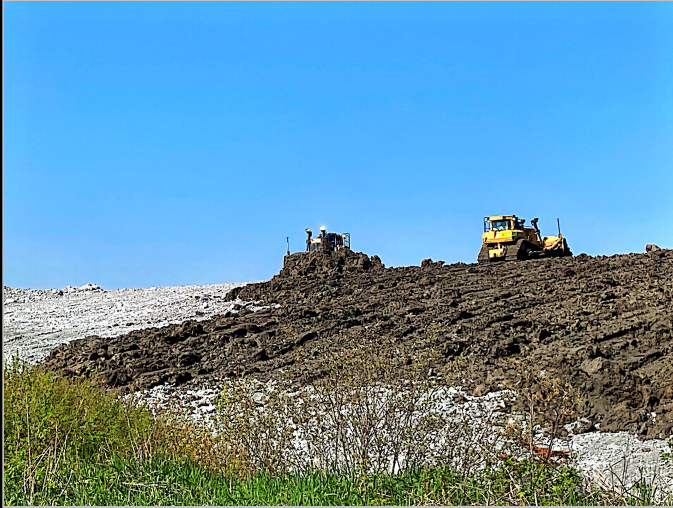
Photo #: 1

Dozer 420 and 421 Placing CCL lift 1 in panel 30

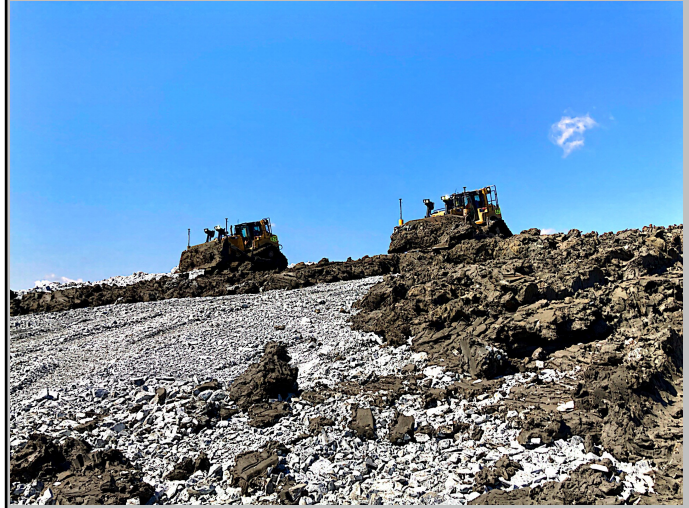
Photo #: 2

Dozer 420 and 421 Placing CCL lift 1 in panel 30

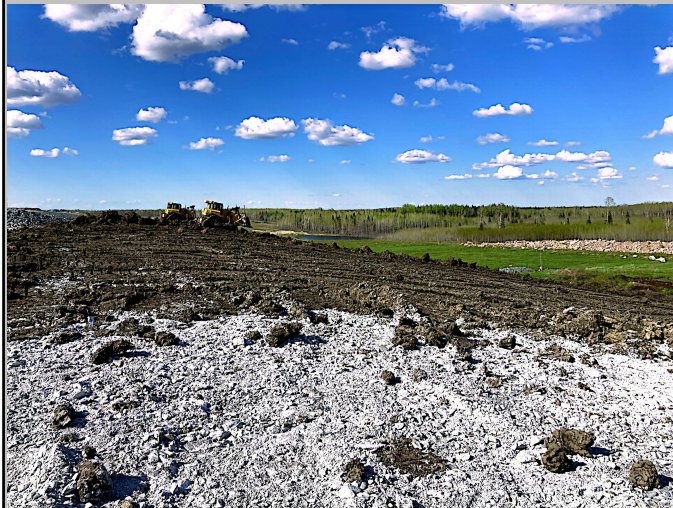
Photo #: 3

Panel 30 Lift 1 mostly placed.

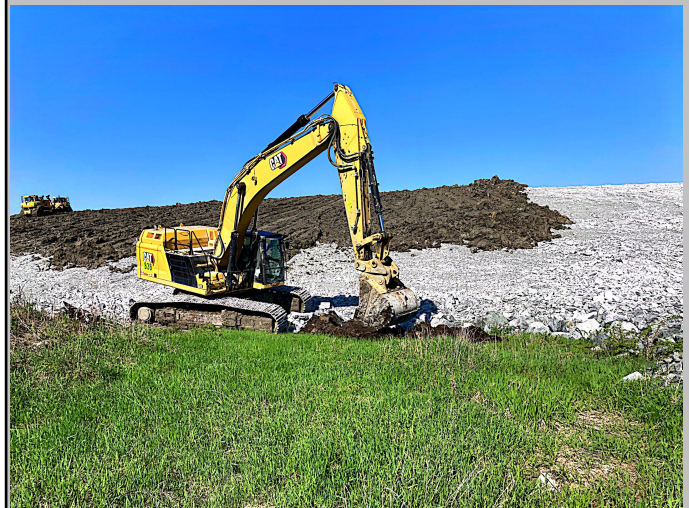
Photo #: 4

Excavator 836 key trench.
