Date:	May 22, 2022	Owner/Client:	New Gold Inc.
Day:	Sunday	Okane Project #:	1003-027
Prepared by:	Brady Hay	Project Location:	Ontario

Date:	May 23, 2022	Owner/Client:	New Gold Inc.
Day:	Monday	Okane Project #:	1003-027
Prepared by:	Brady Hay	Project Location:	Ontario

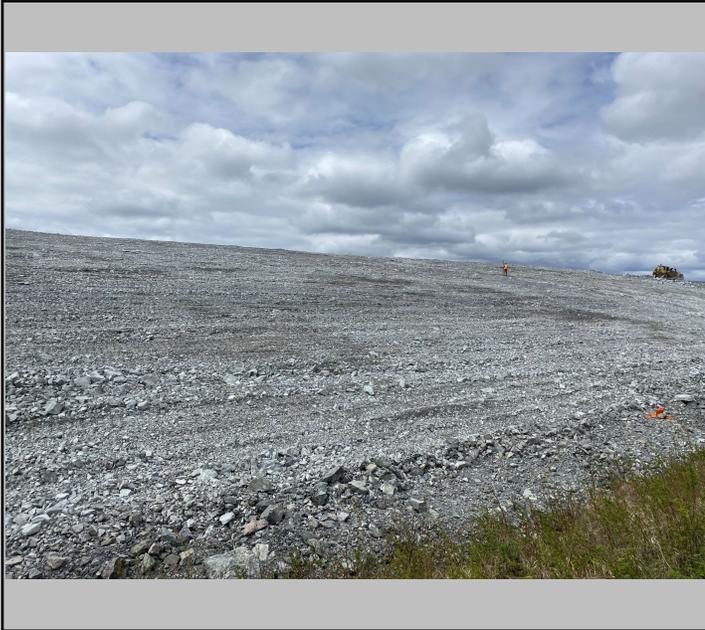
Photo #: 1

Slope preparation in progress (0+690 - 0+783)

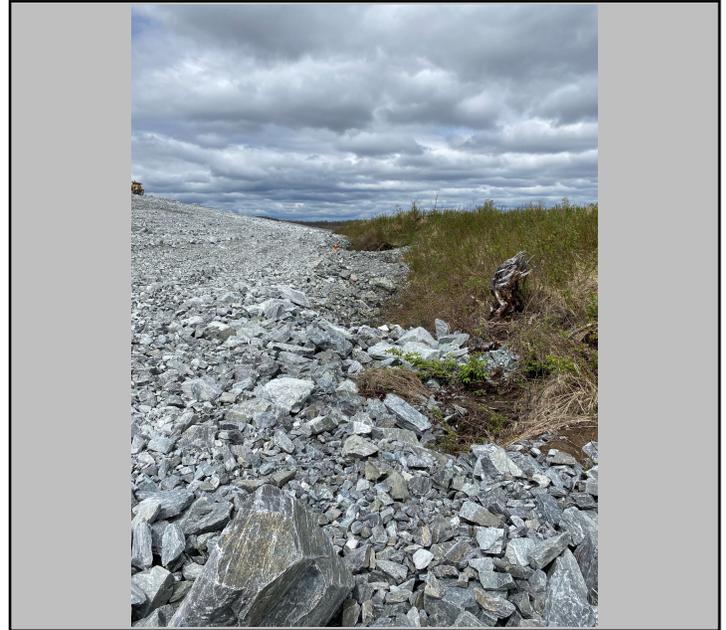
Photo #: 2

0+690 - 0+783 toe

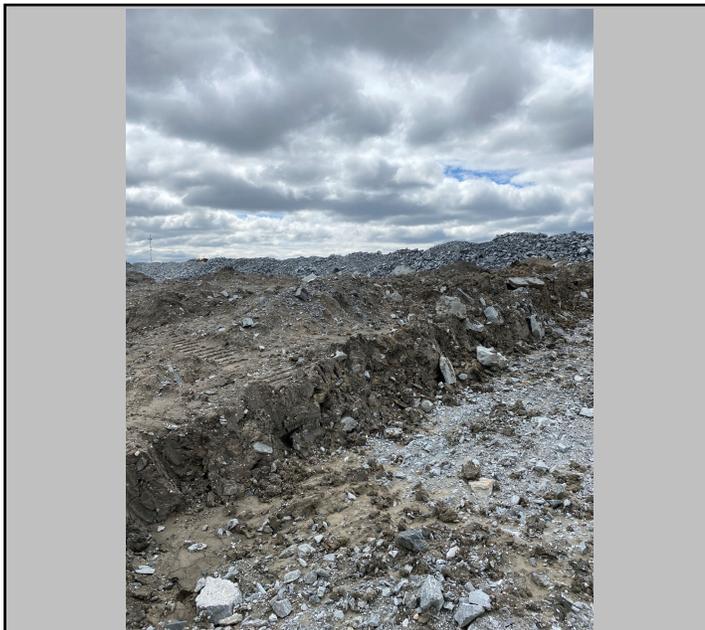
Photo #: 3

Southern borrow area (S504-S505)

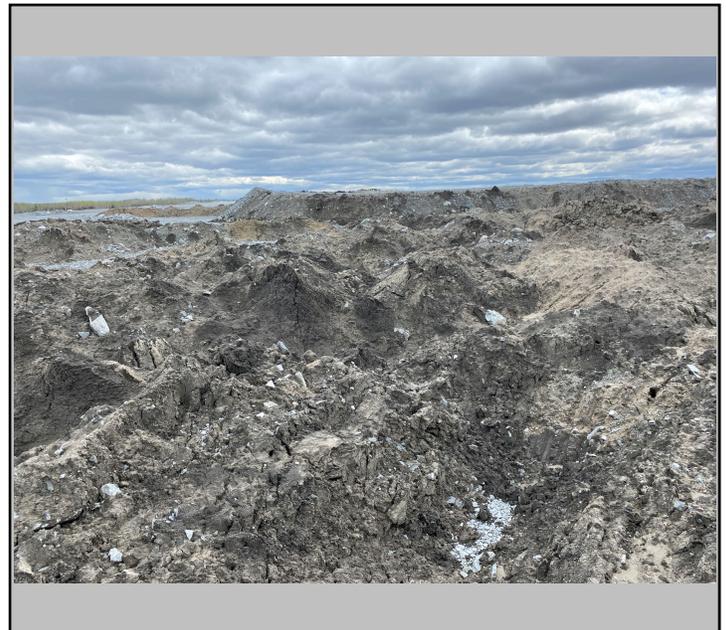
Photo #: 4

Northern borrow area (S499-S503 & S506-S507)

- Slope preparation and survey for 0+690 - 0+783 complete and pending material placement.
- CQA Informed that the previously identified northern borrow area (S499-S503 & S506-S507) will likely not be available for use in cover system construction. Current plan is to utilize material from the southern borrow area for the start of construction. Pockets of material in this area were previously deemed unsuitable for CCL use during the 2021 construction season.
- Met with Travis Alexander to view the southern borrow area and discuss the current material conditions. Okane cautioned that in its current state the southern borrow area contains areas with large quantities of rock that could impact the hydraulic conductivity of CCL lifts. New Gold is aware and plans to sort through the area to obtain material for CCL placement during the hauling process.

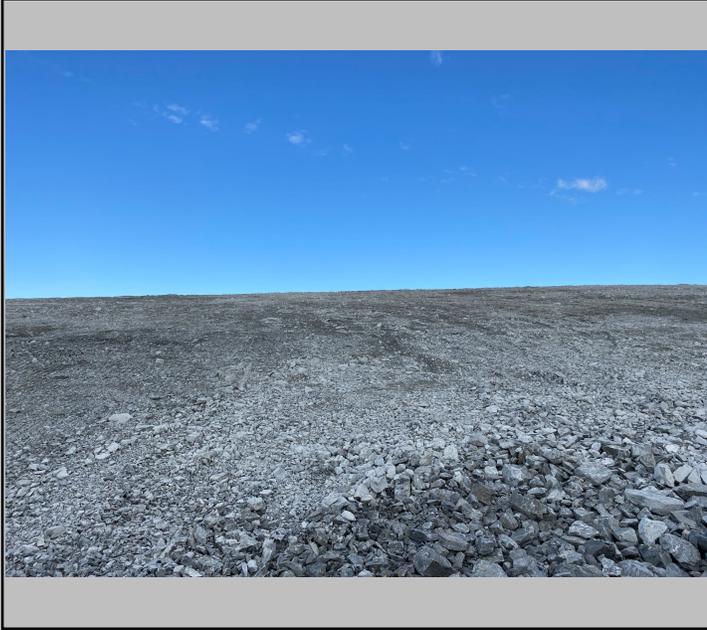
Photo #: 1

0+690 - 0+783 completed WR surface

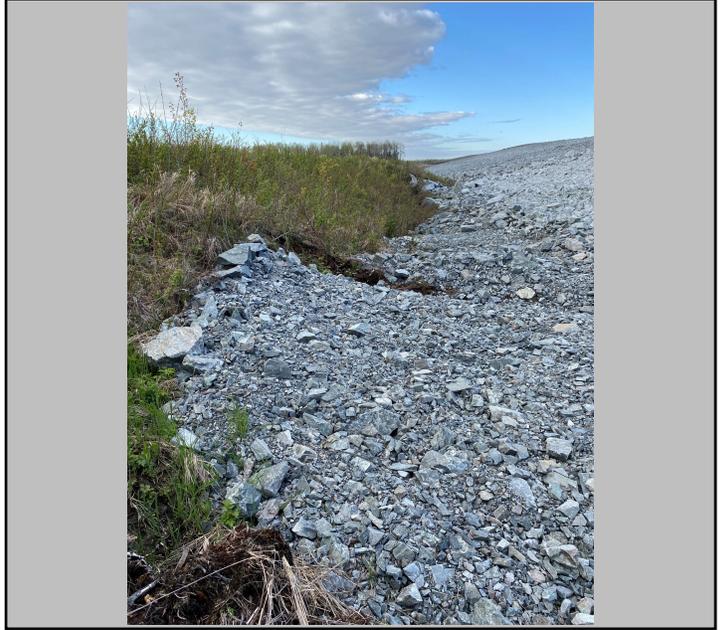
Photo #: 2

WR at toe of slope

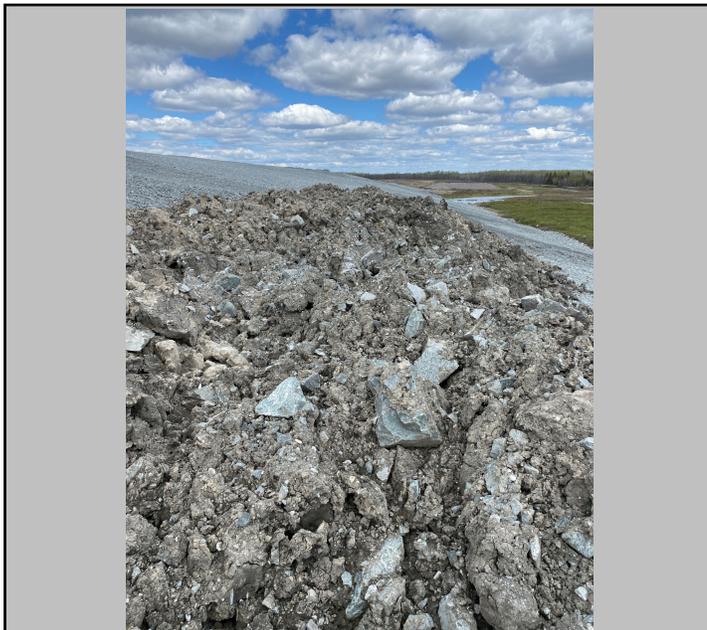
Photo #: 3

Stockpiled material (S508)

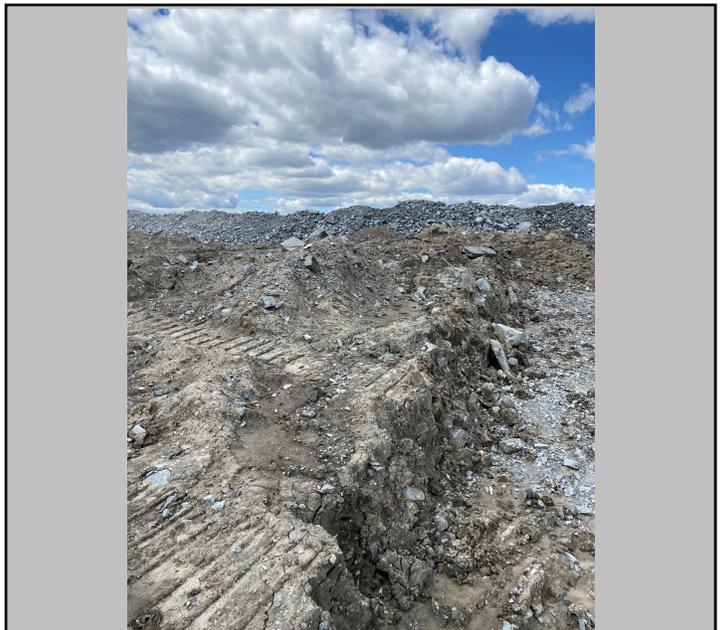
Photo #: 4

Southern borrow area face

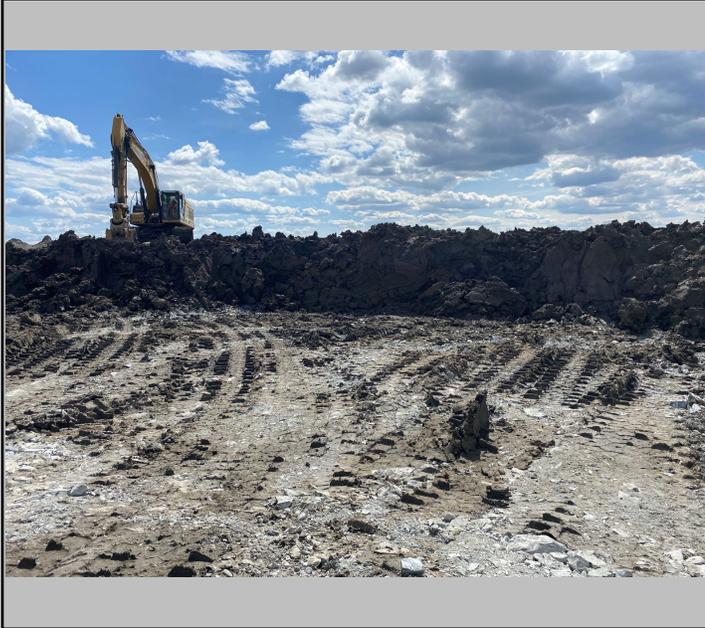
Photo #: 1

Central borrow area used for P30

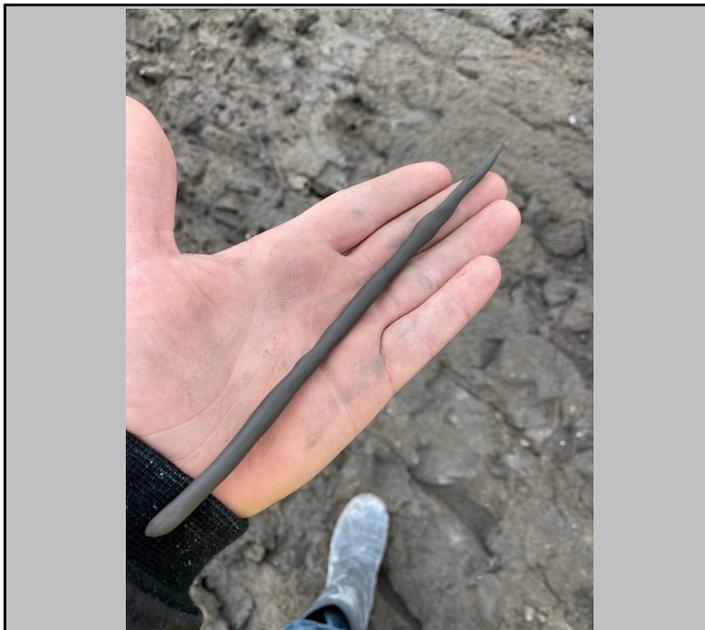
Photo #: 3

P30, L1 material

- Material sourced from the same central borrow source used to complete L1. Material appeared dark brown with lighter streaks, moist, and pliable. Small areas of frozen material still present, but thawing occurred quickly during the placement process in the current conditions.

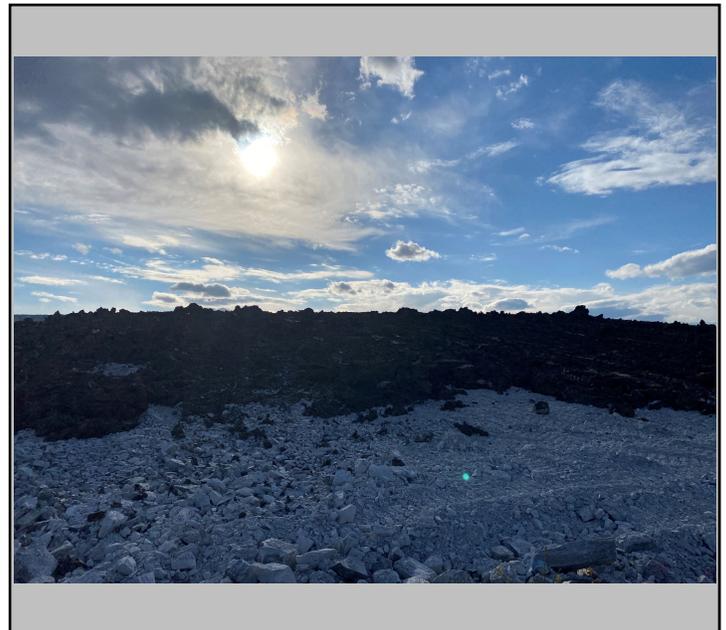
Photo #: 4

P30, L1 placement at end of day

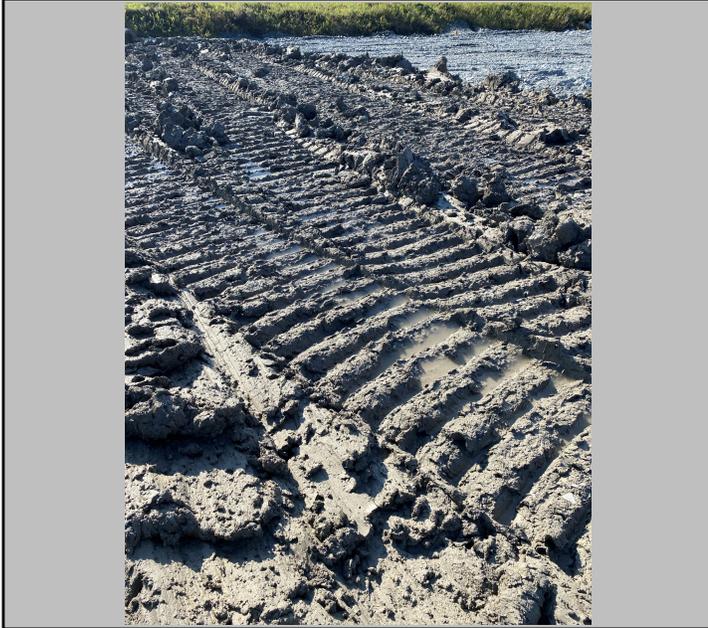
Photo #: 1

- Standing water visible throughout previously placed L1 following evening showers. The material was track packed to remove the standing water and the material was given time to dry.

Standing water on P30, L1 following overnight showers

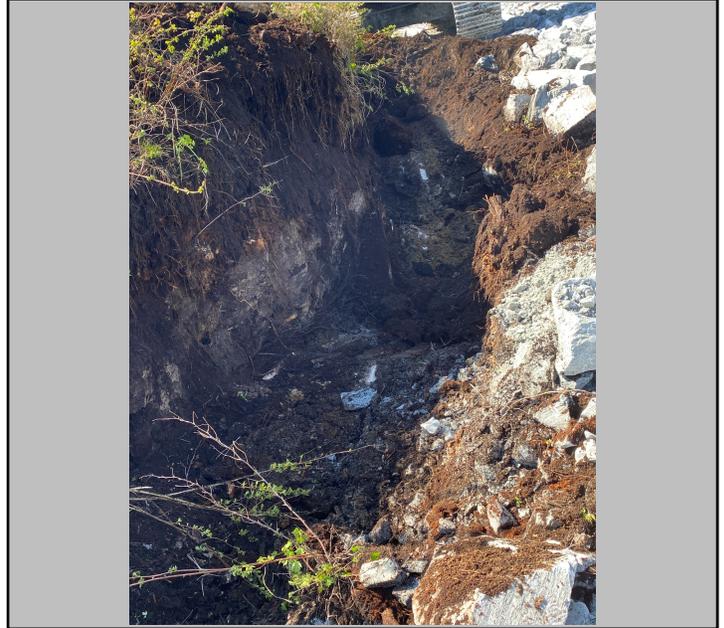
Photo #: 2

- Key trench dug to bedrock at varying depths at the North end of the key trench.
- As bedrock tapered out the trench was dug to approximately 2.0m where suitable tie in material was reached.
- Bedrock was reached again at the South end of the trench where it was terminated (approximately 0 +685).

P30 key trench dug to varying depths to bedrock at North end

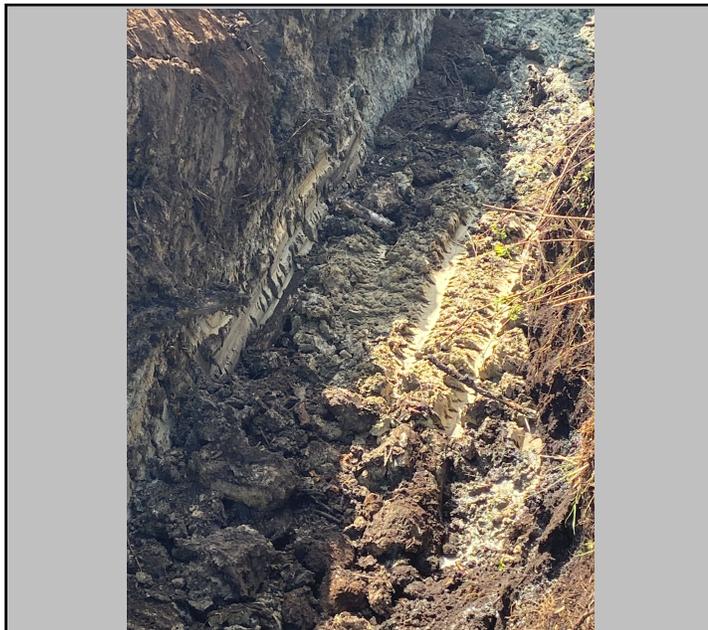
Photo #: 3

Suitable tie in material reached at approximately 2.0m

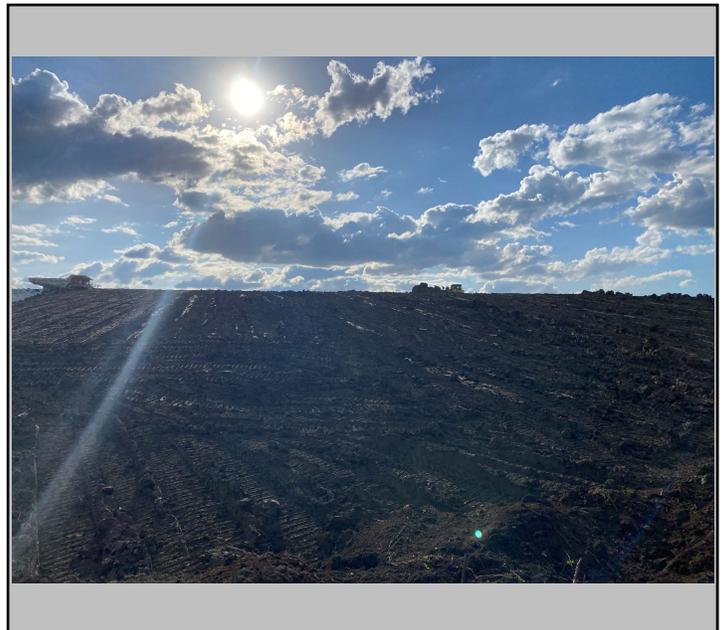
Photo #: 4

P30, L1 at end of day

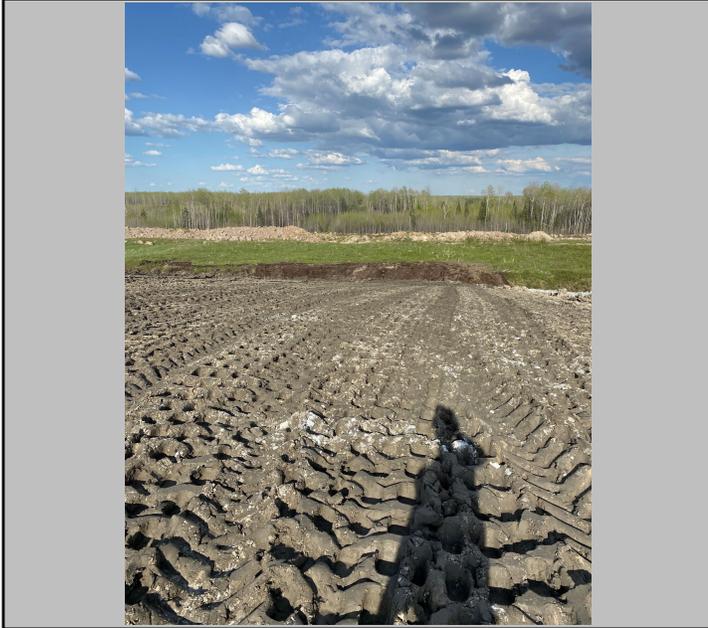
Photo #: 5

- Compaction started on the South half of P30 following Tulloch survey. The bottom quarter of the lift was track packed but not rolled due to material in the area being too wet.

Compacted area of P30, L1

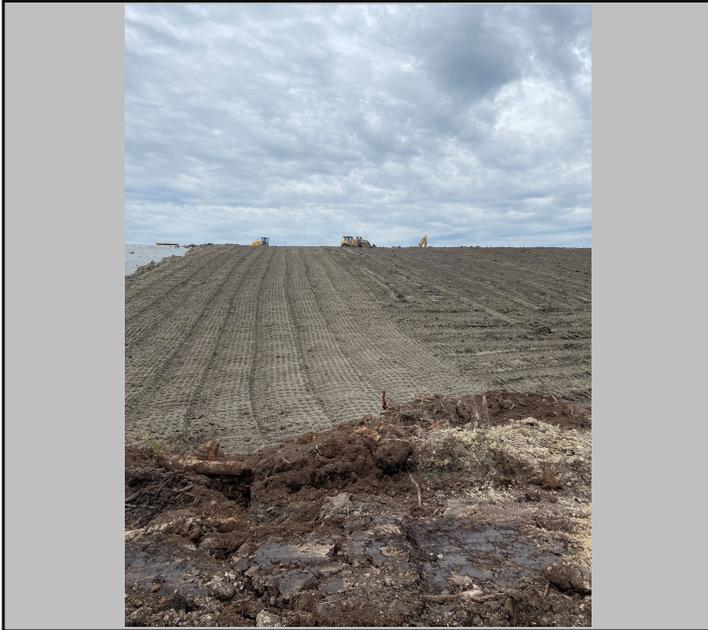
Photo #: 1

- Nuclear density gauge results on South half of P30, L1 showed moisture contents greater than 30 percent in some areas, resulting compaction below 95%. Upon further investigation into these locations the material appeared dark brown/grey, moist, and pliable. Secondary nuclear density gauge results next to high moisture content locations resulted in lower moisture contents and adequate compaction results.

P30, L1 compaction

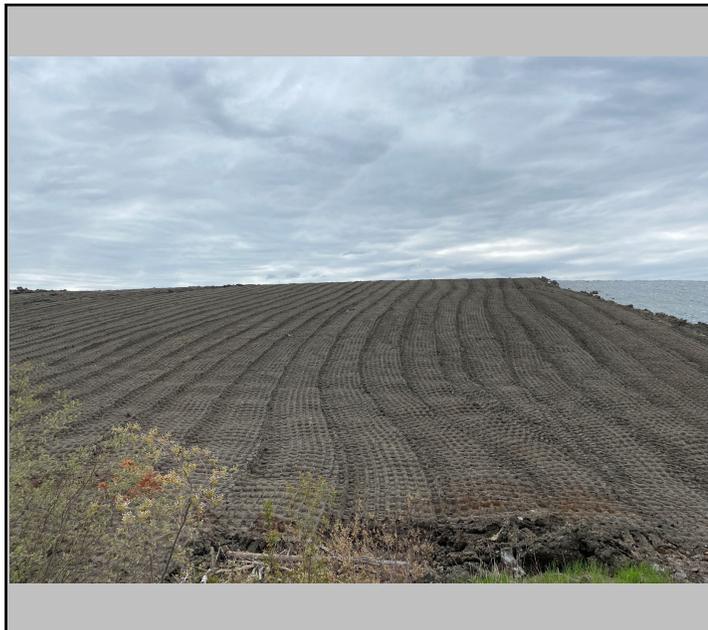
Photo #: 3

- South half of P30, L1 passed based on nuclear density results and in-situ material inspection by CQA.
- Four passes with sheepsfoot roller utilized for the entirety of L1.

P30, L1 compaction completed

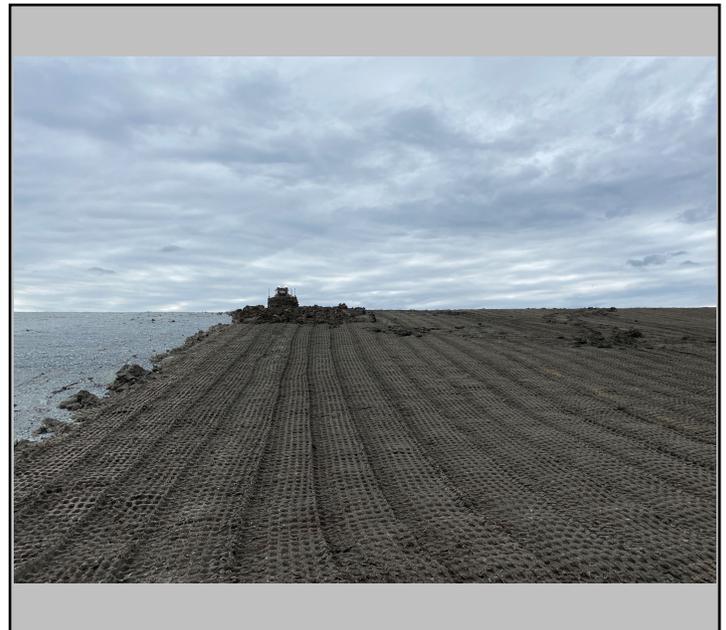
Photo #: 4

- Lift two placement started following the approval of the South half of P30, L1.
- Material from the same central borrow area utilized for L2. Material appeared dark brown, moist, and pliable.

P30, L2 placement started on South half

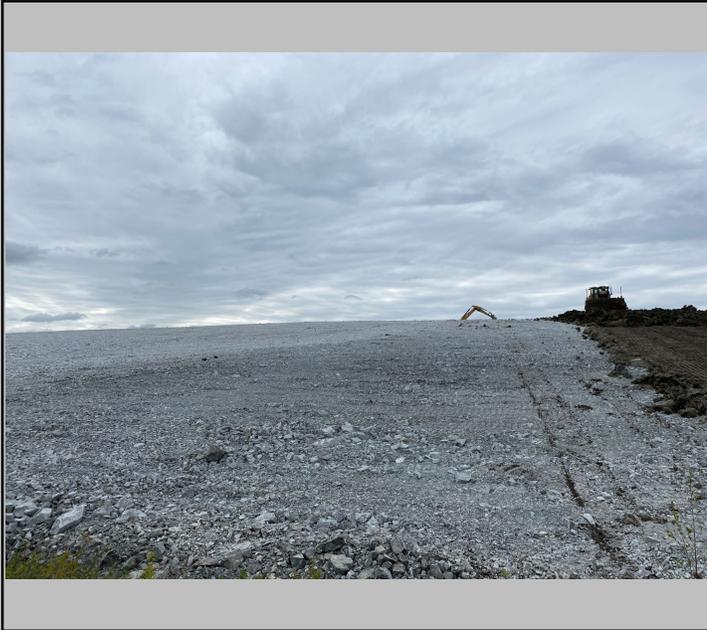
Photo #: 5

- Dozer and excavator smoothed the waste rock surface South of P30 in preparation for future panels.

WR surface smoothed South of P30

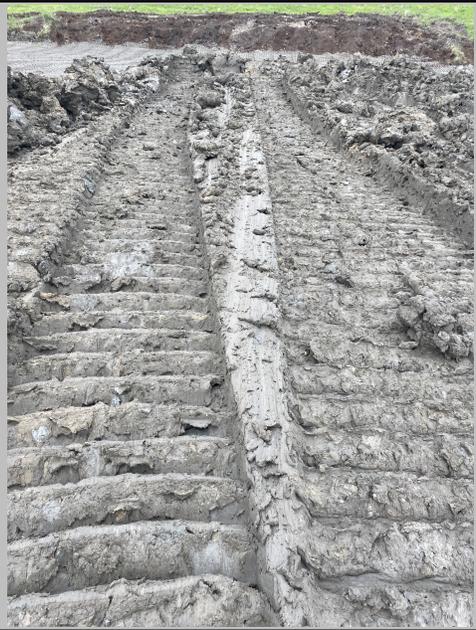
Photo #: 6

P30, L2 material

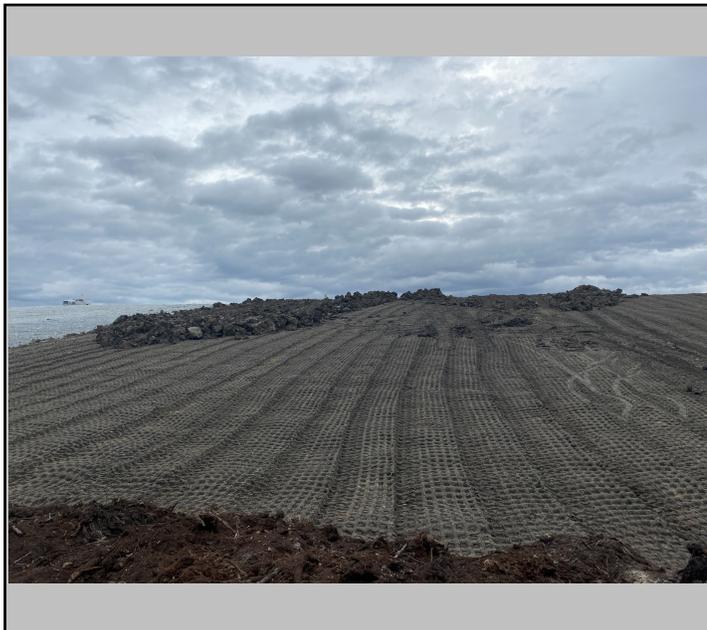
Photo #: 7

P30 at end of day

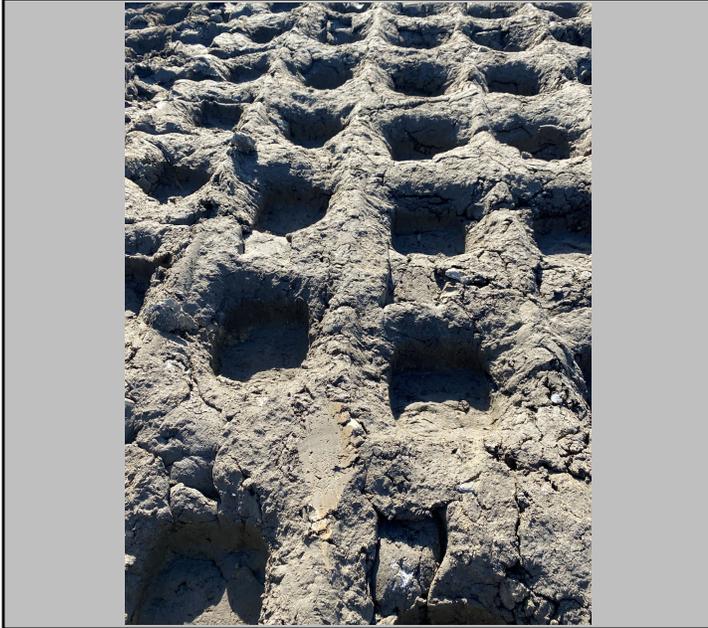
Photo #: 1

- No desiccation visible on exposed areas of L1 upon morning inspection.
- Excavator able to remove two pieces of oversize from L1 during the testing process. Little to no stone noted in the material from the current borrow source.
- Testing on North half of L1 completed in the morning and adequate thickness of L1 confirmed by CQC. The entirety of P30, L1 approved based on nuclear density testing results.

P30, L1 upon morning inspection

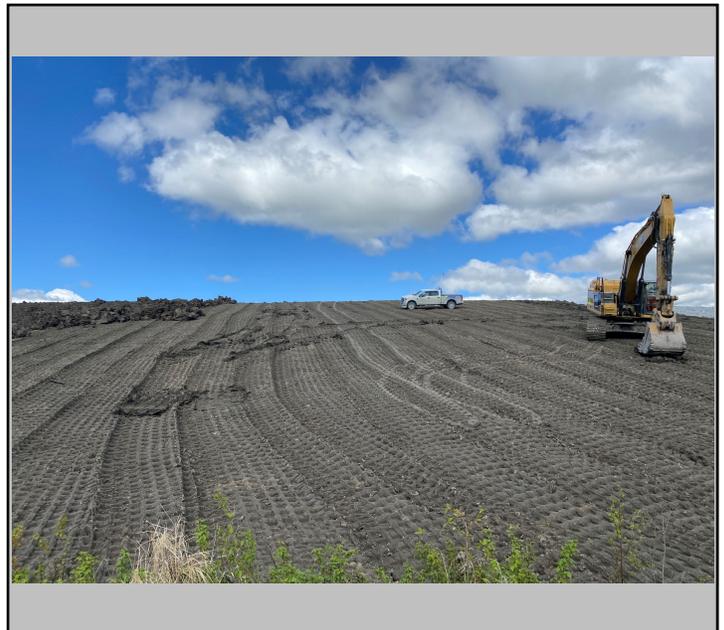
Photo #: 4

P30, L2 testing completed

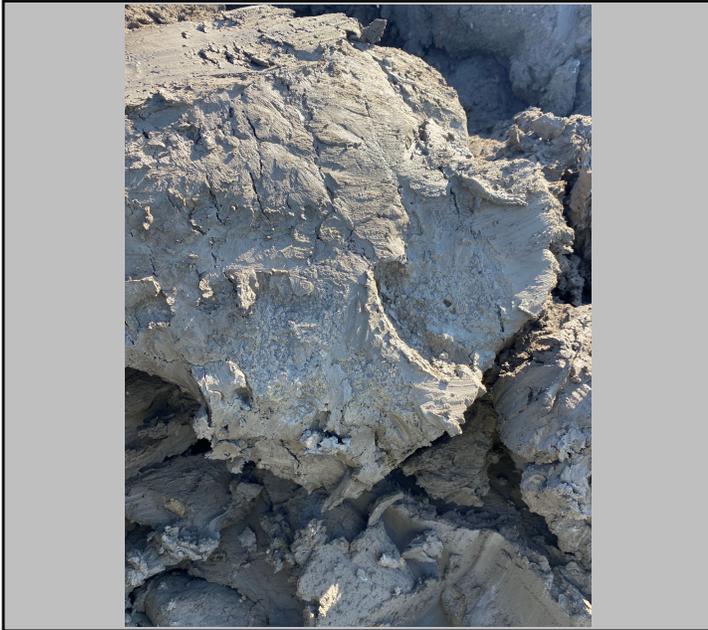
Photo #: 5

Chunk of frozen material in P30, L2

- L2 placement continued for the entirety of P30 following approval of the North half of L1.
- Material from the same central borrow area utilized for L2. Material appeared dark brown, moist, and pliable. Some small areas of frozen material were still noted during placement.
- Recommendation made by CQA to cover the entirety of P30, L1 with a reduced lift of material if L2 could not be completed to grade prior to end of day. This recommendation was made to avoid desiccation on the surface of L1 and aid in the melting of frozen locations in L2.
- P30, L2 placed to cover the entirety of L1.

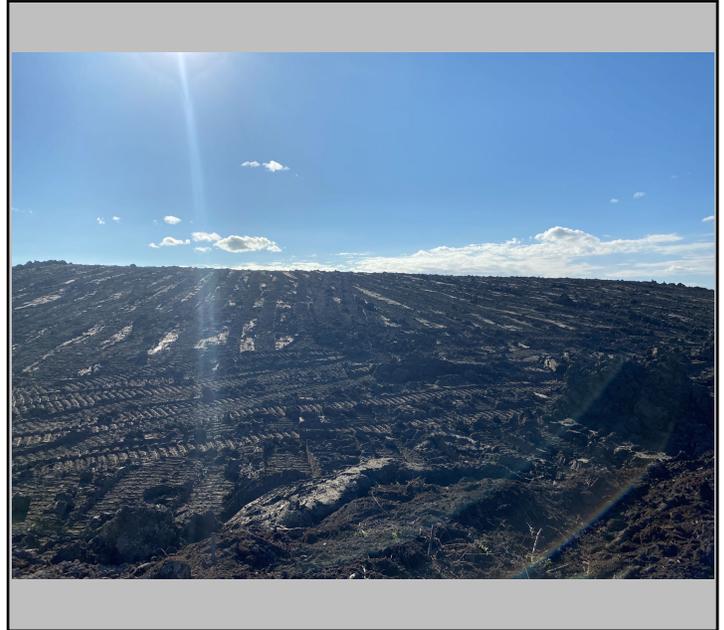
Photo #: 6

P30, L2 placed to cover the entirety of L1

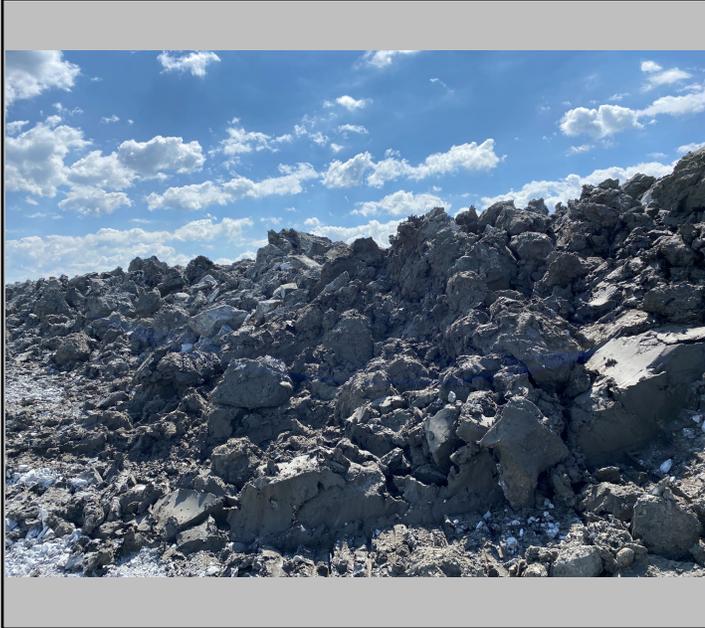
Photo #: 1

- Met with Garry Noga to discuss using live haul material for P30, L3. CQA inspected previously dumped loads and determined the material was suitable for NCL use.
- Tulloch informed CQA that New Gold planned to designate one truck to stockpile NCL material for quicker L3 placement on May 28th.

Live haul dump area

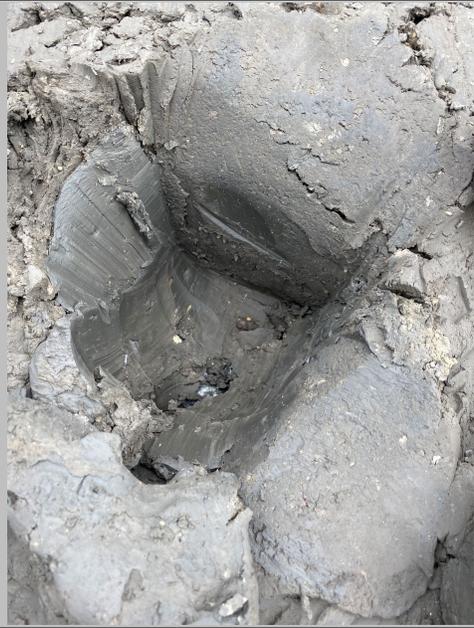
Photo #: 2

- Moisture results of 33.1% and 40.5% for densities D477 & D478 obtained in a small area while testing the South half of L2. Upon investigation the material wasn't wet and appeared consistent with other areas within the lift. A reduced moisture content is expected for D478 once lab results are available and the location has been flagged for hydraulic conductivity testing.

D478 material

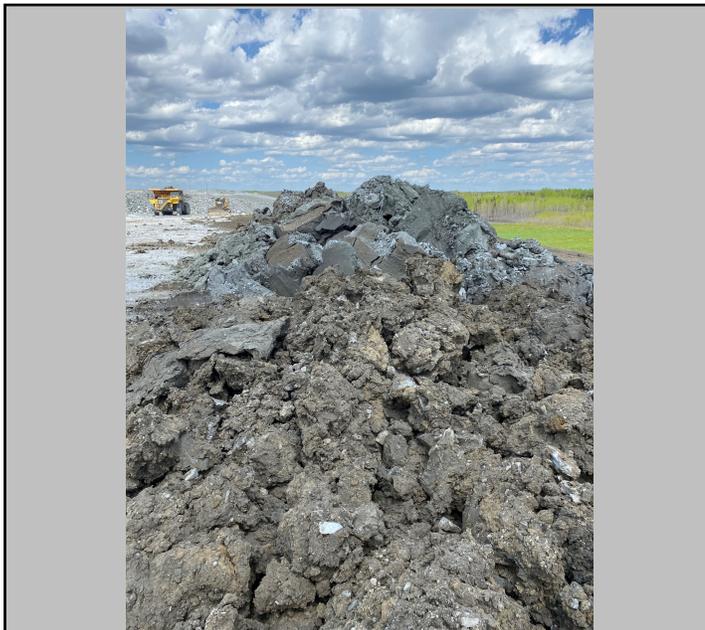
Photo #: 3

- Actively hauled material was stockpiled on the south half bench of P30, L2 for use in L3. Once the South half of L2 was approved the material was placed down the slope.
- Once the stockpiles of actively hauled material was used, material from the previously identified southern borrow area was used to continue with L3 placement.
- All material placed deemed suitable for NCL use.
- L3 still in progress.

P30, L3 material

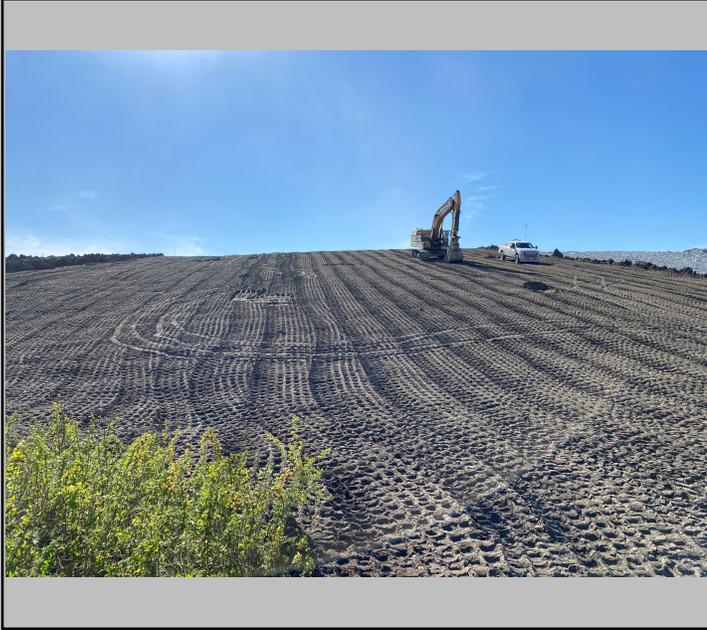
Photo #: 5

- North half of L2 given an hour for the surface to dry before testing to avoid deep tracks being made by the excavator while making testing surfaces.
- Adequate depth of L2 confirmed by CQC and P30, L2 approved based on nuclear density results and in-situ inspections.

North half of P30, L2 tested and approved

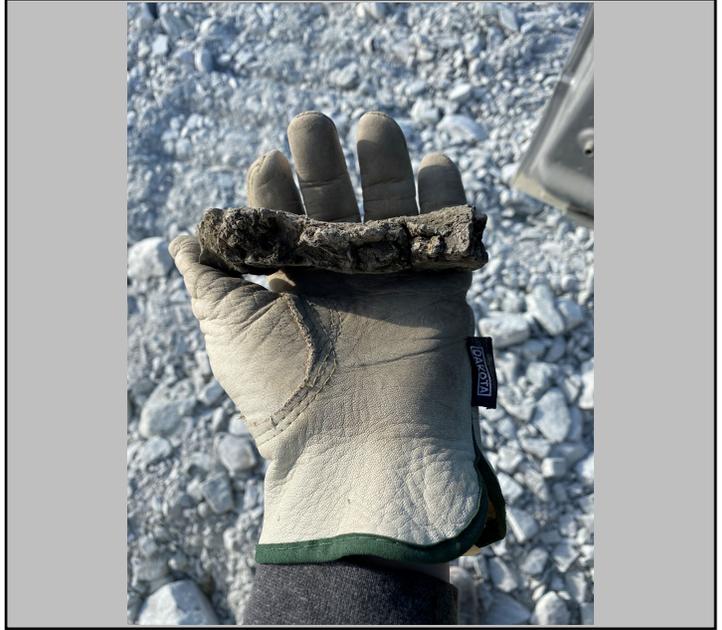
Photo #: 6

P30, L2 desiccation depth at end of day

- L2 desiccation not yet at point of concern upon morning inspection.
- At approximately 16:00 the uncovered areas of L2 on the south half of P30 appeared to reach a level of desiccation which warranted concern. At this point the material had been exposed for approximately 26.5 hours after approval, resulting in the depth of the crust to reach the inside of the sheepsfoot marks in areas. L2 material on the north side of P30 was placed more recently than the south and desiccation was not yet at the point of concern.

- At this point CQA met with CQC to discuss the current level of desiccation. With no capacity to wet or disc the material it was determined the best course of action was to continue covering L2 with the current NCL material which was visually moist and pliable.

- The southeast quarter of P30, L2 was flagged for borehole permeameter testing in order to confirm the area still achieves adequate hydraulic conductivity.

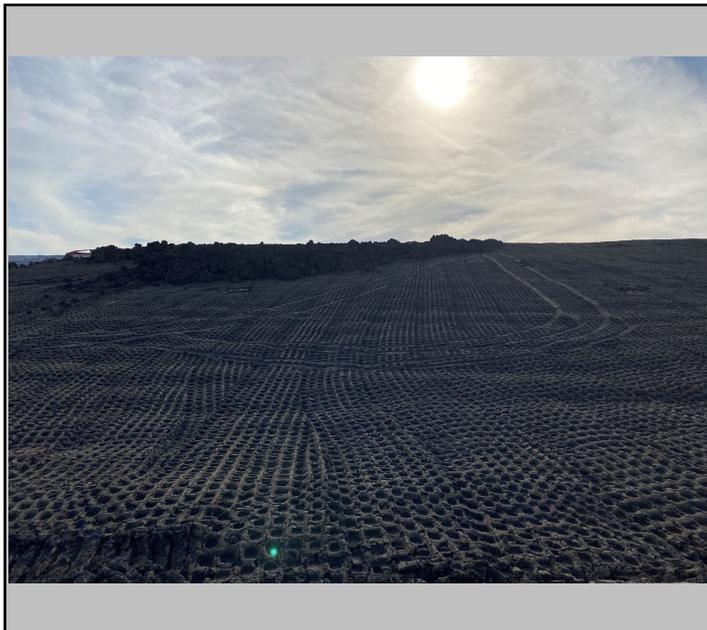
Photo #: 7

P30, L3 placement at end of day
