Date:	July 12, 2022	Owner/Client:	New Gold Inc.
Day:	Tuesday	Okane Project #:	1003-223
Prepared by:	Brady Hay	Project Location:	Ontario

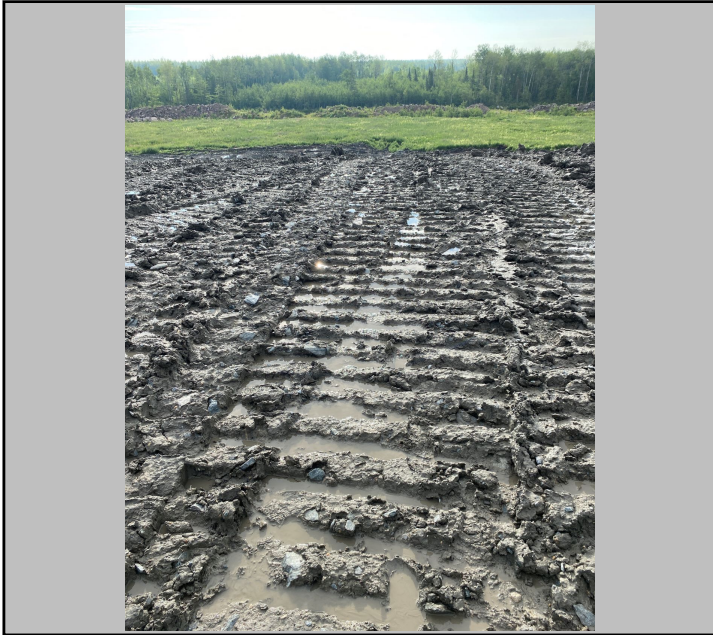
Photo #: 1

P31, L4 morning conditions

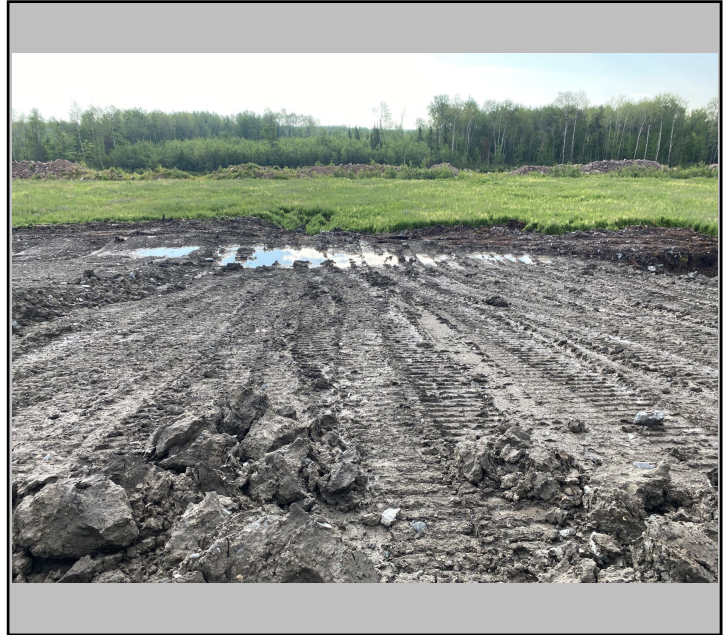
Photo #: 2

P31, L3 morning conditions

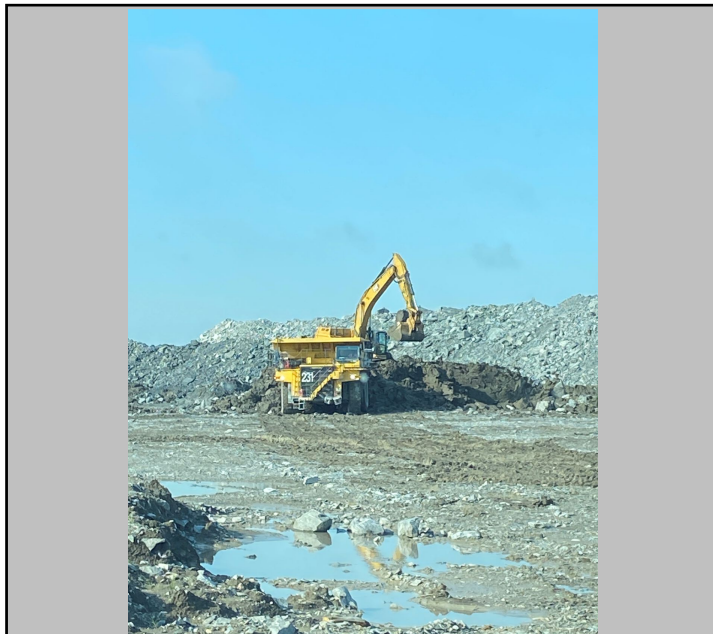
Photo #: 3

Excavator loading haul truck with remaining material from southern borrow area

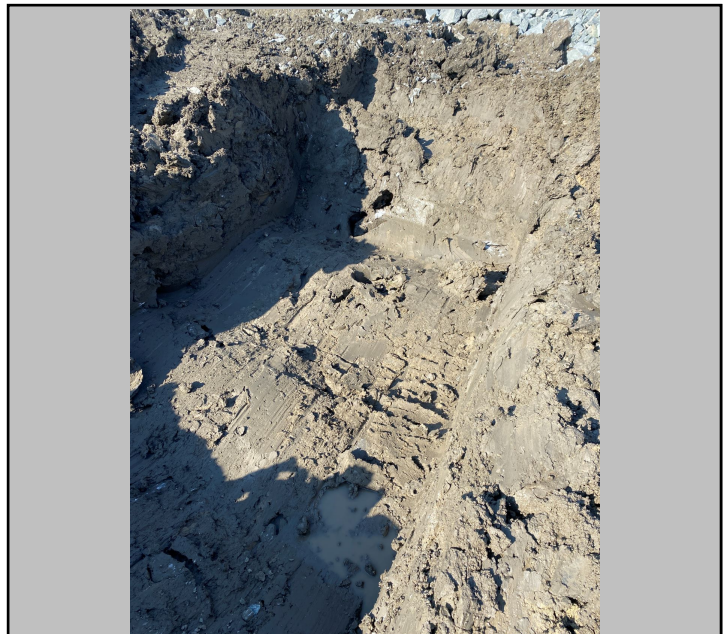
Stockpile S558

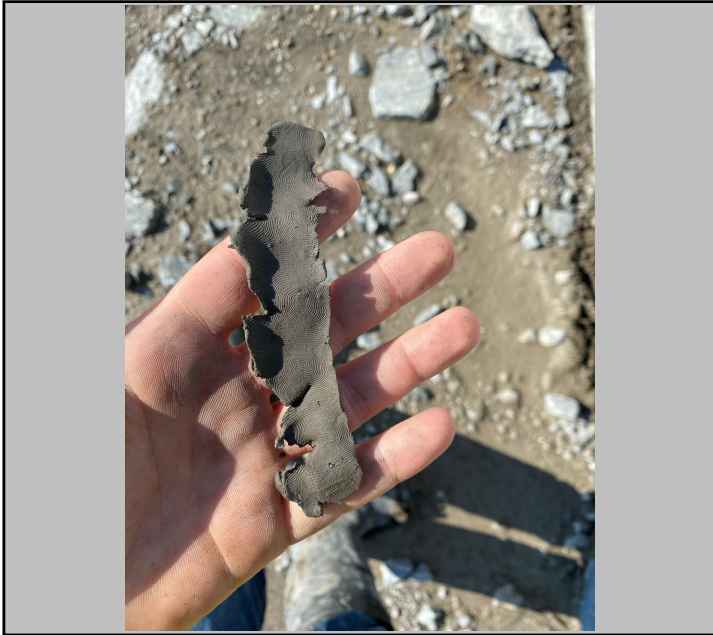
Photo #: 5

S558 material

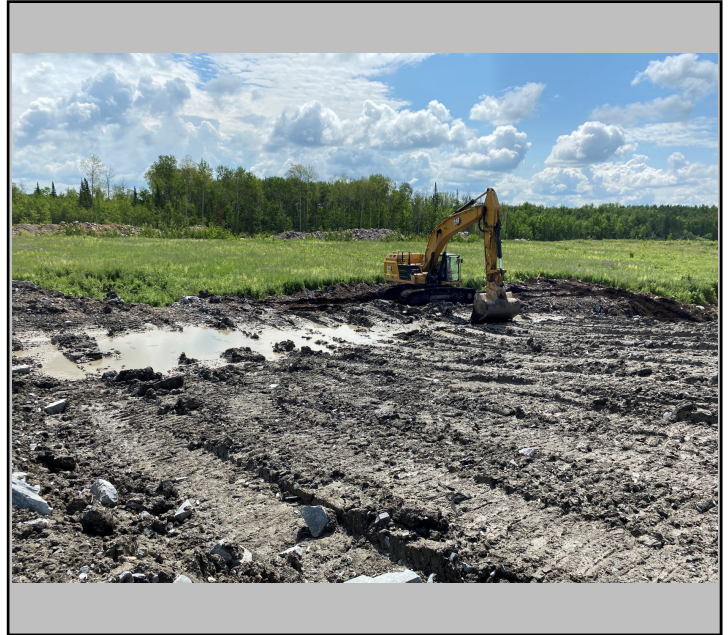
Photo #: 6

Excavator draining standing water from P31, L3 toe

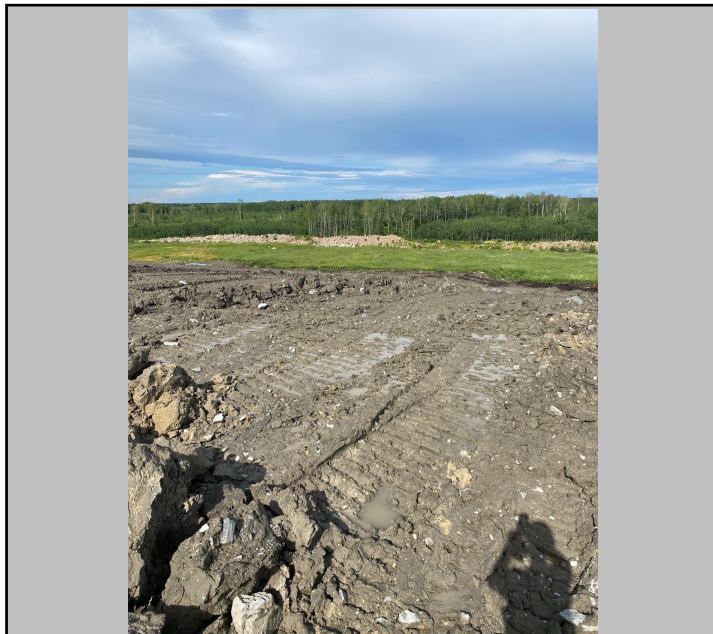
Photo #: 7

P31, L4 end of day conditions

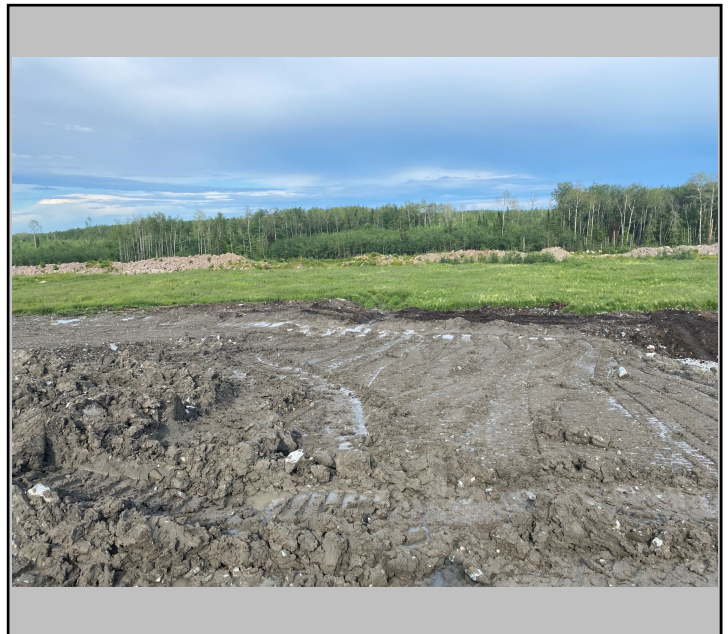
Photo #: 8

P31, L3 end of day conditions

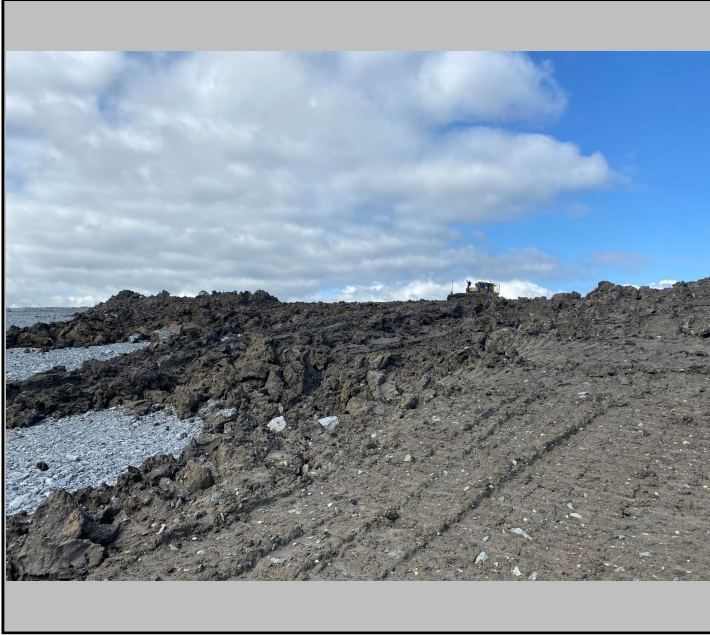
Photo #: 1

P32, L1 initiated

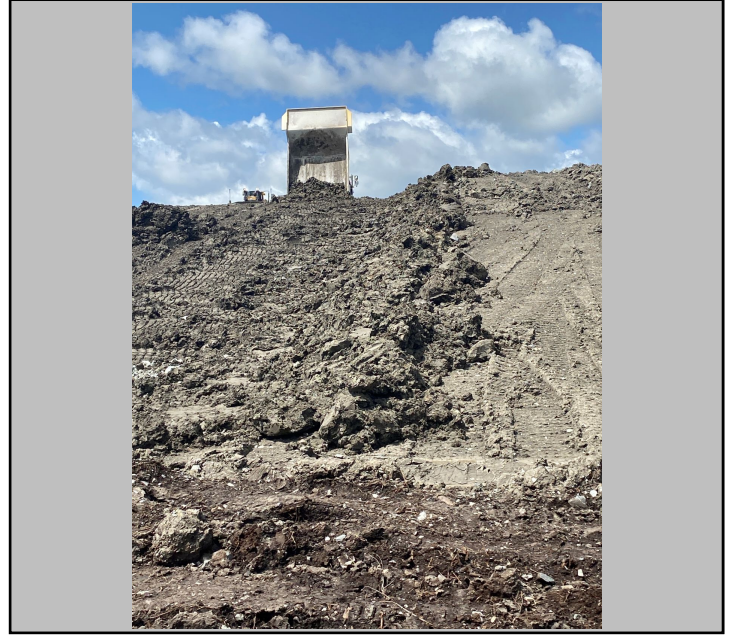
Photo #: 2

P32, L1 tied into P31

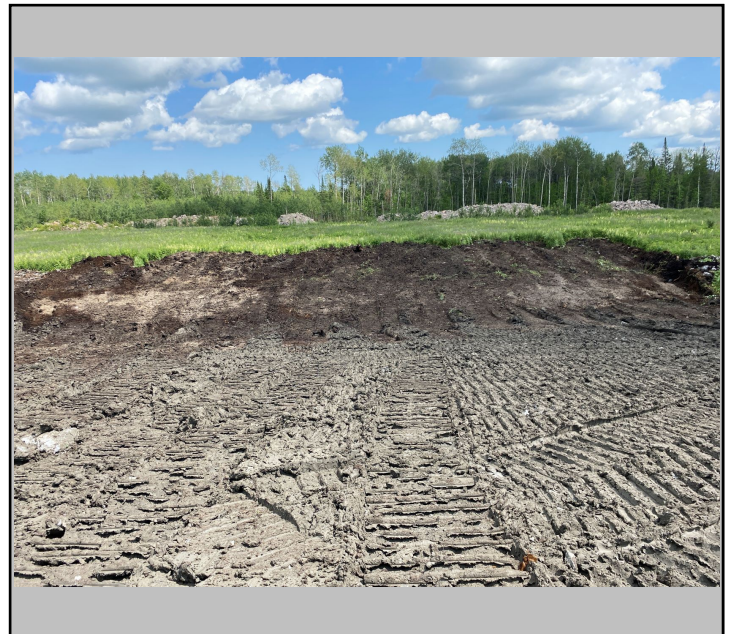
Photo #: 4

Topsoil berm pushed back with dozers

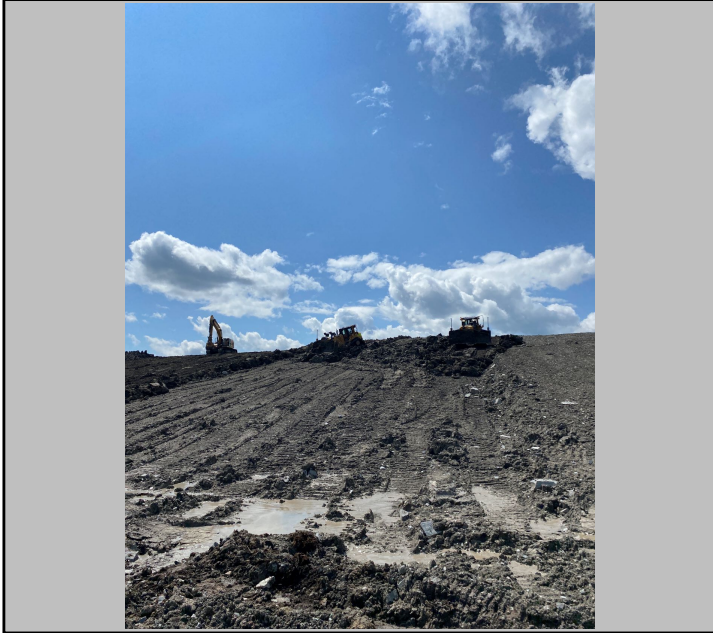
Photo #: 5

P31, L4 placement

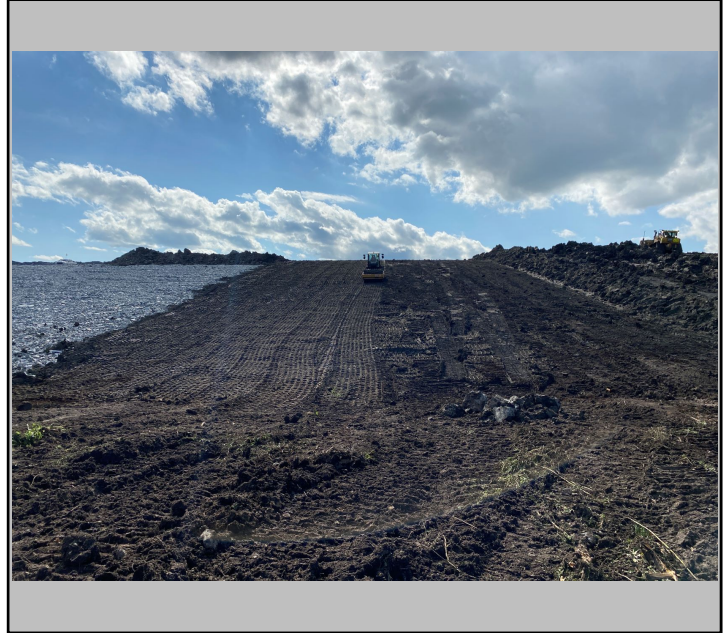
Photo #: 6

P32, L1 compaction

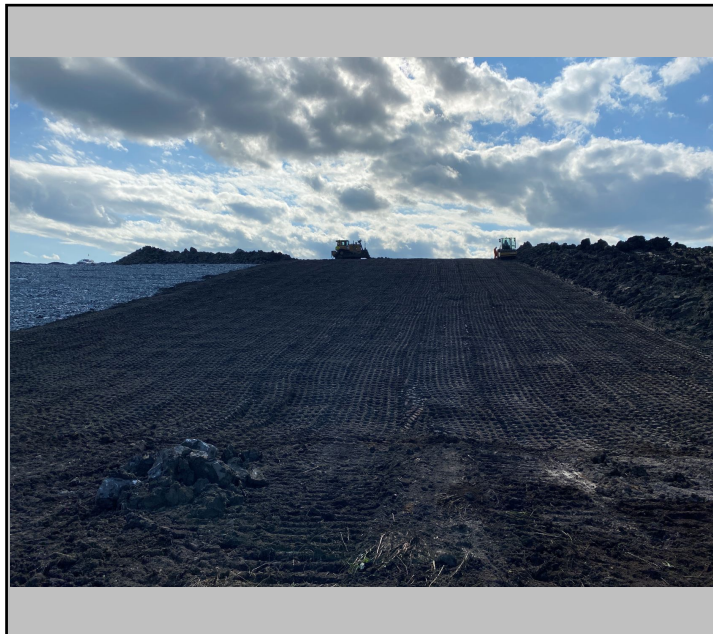
Photo #: 7

P32 at end of day

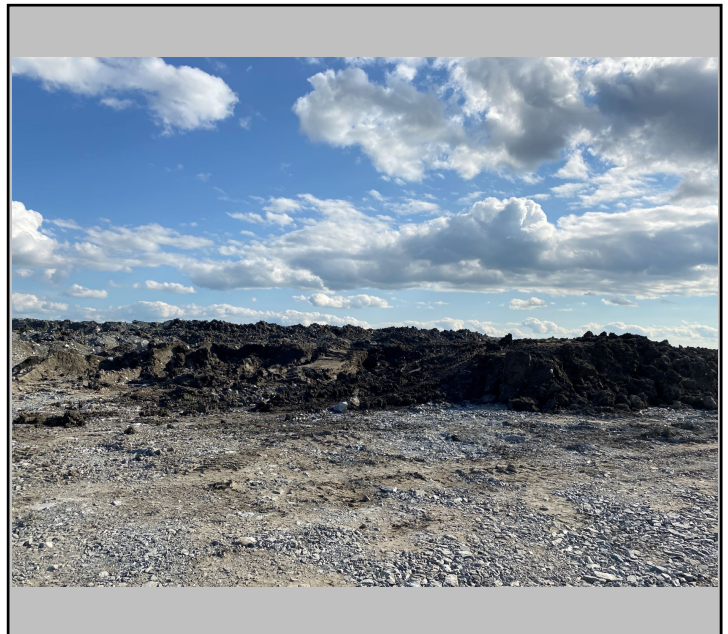
Photo #: 8

P32 borrow area

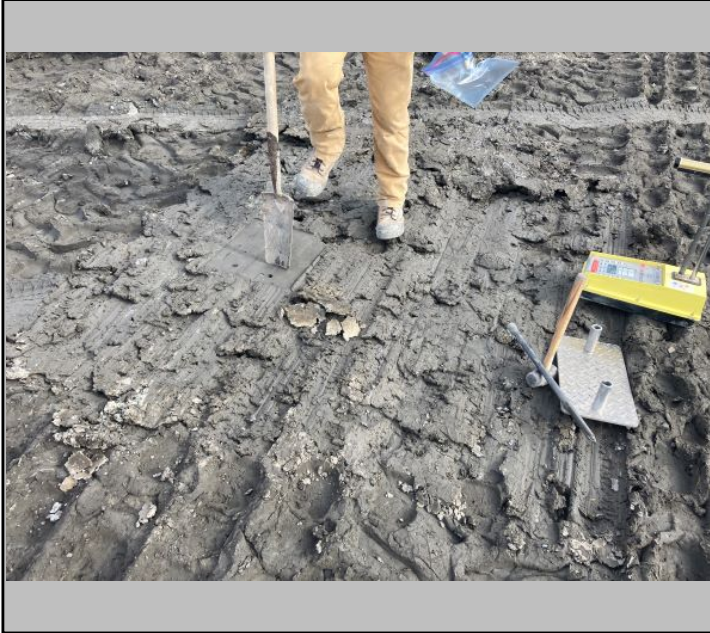
Photo #: 1

P32, L1 density testing

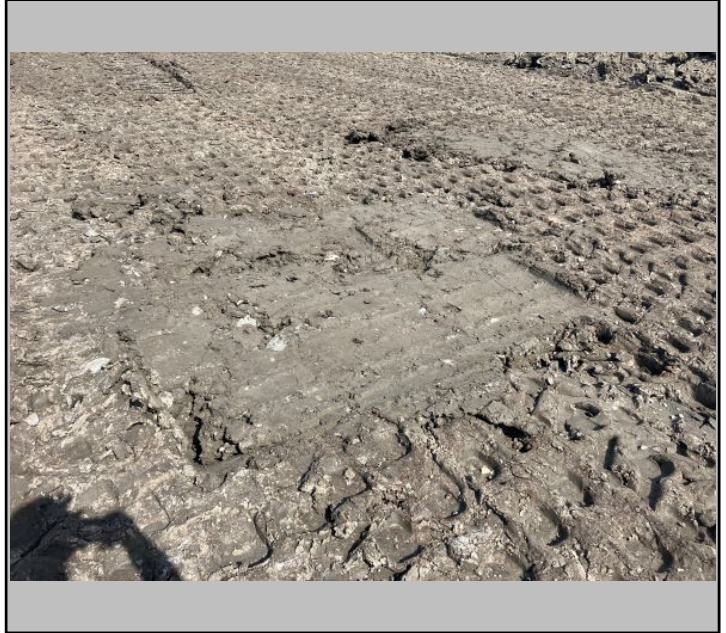
Photo #: 2

Repair following oversize rock removal from P32,
L1

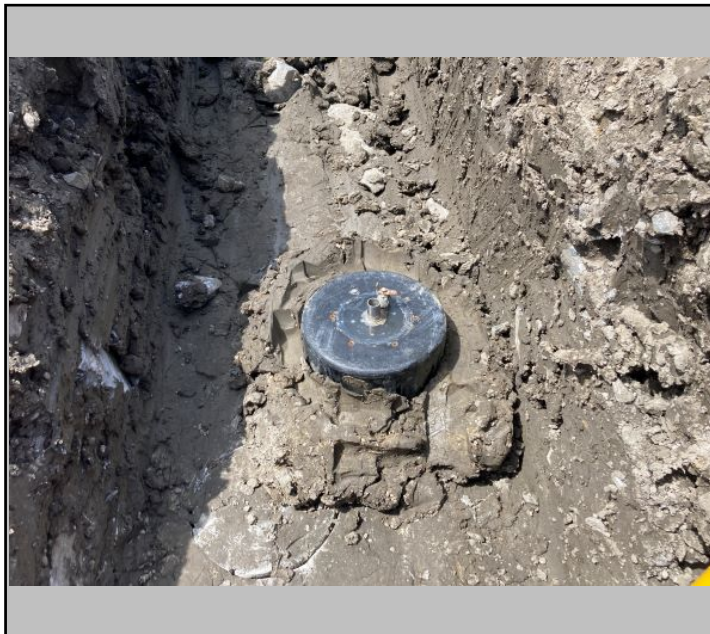
Photo #: 3

EMRS22_BP_P30_L2_B27_220714 casing
installed

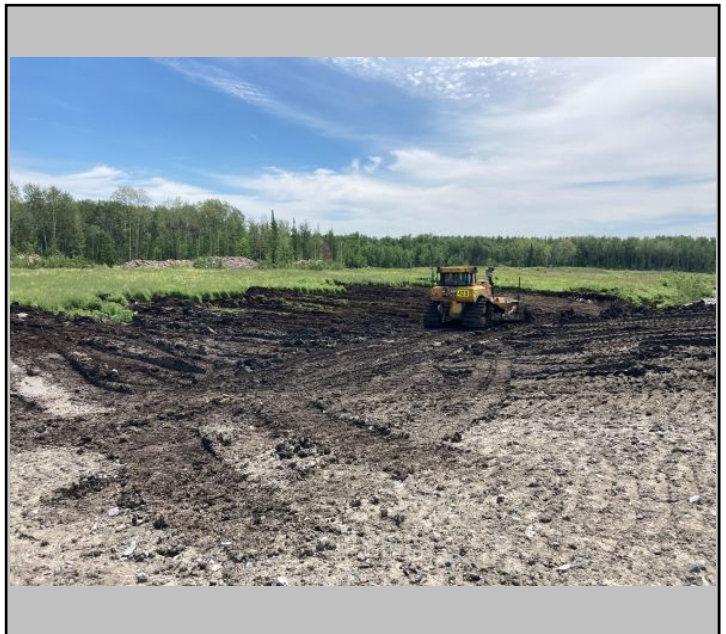
Photo #: 4

P31, L4 toe grading

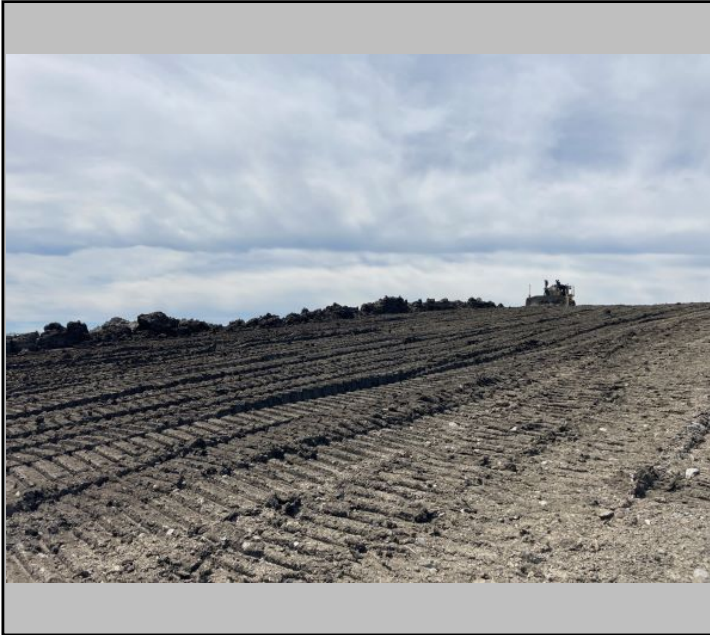
Photo #: 5

P31, L4 nearing completion

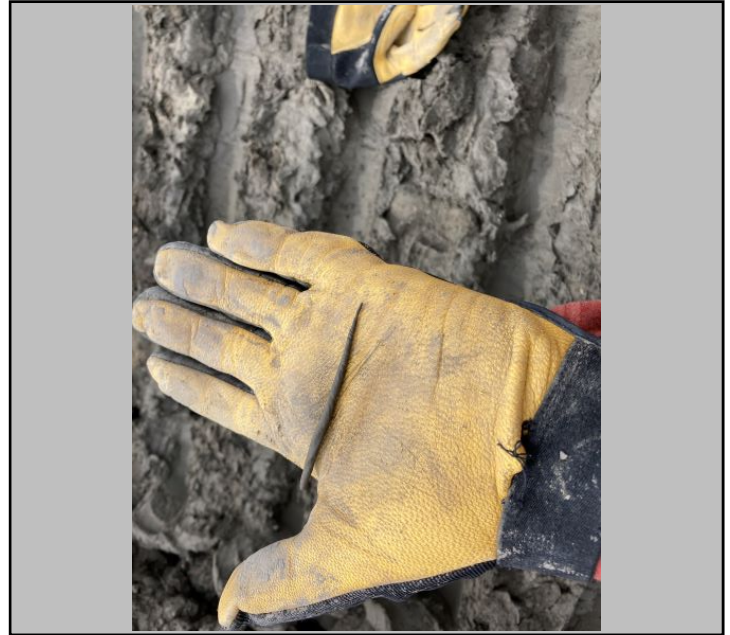
Photo #: 6

Material used in P32, L2 very pliable

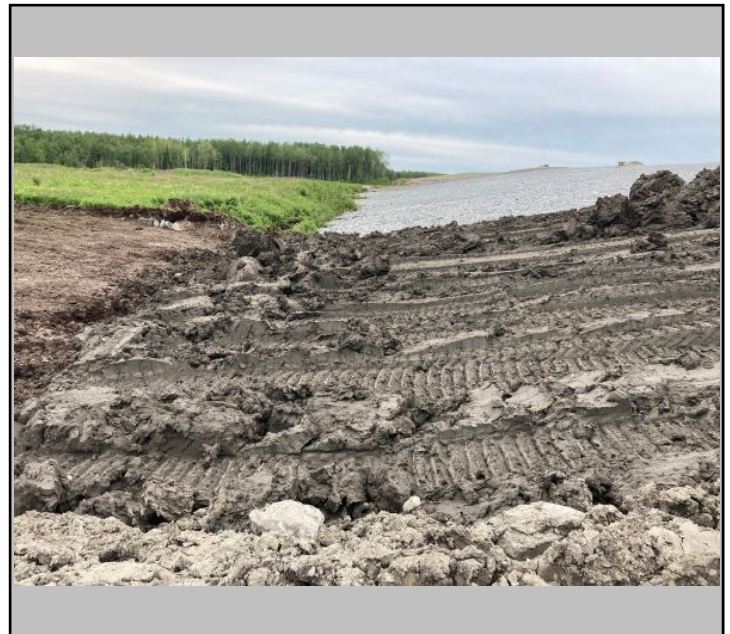
Photo #: 8

P32, L2 fully covering L32, L1 by EOD

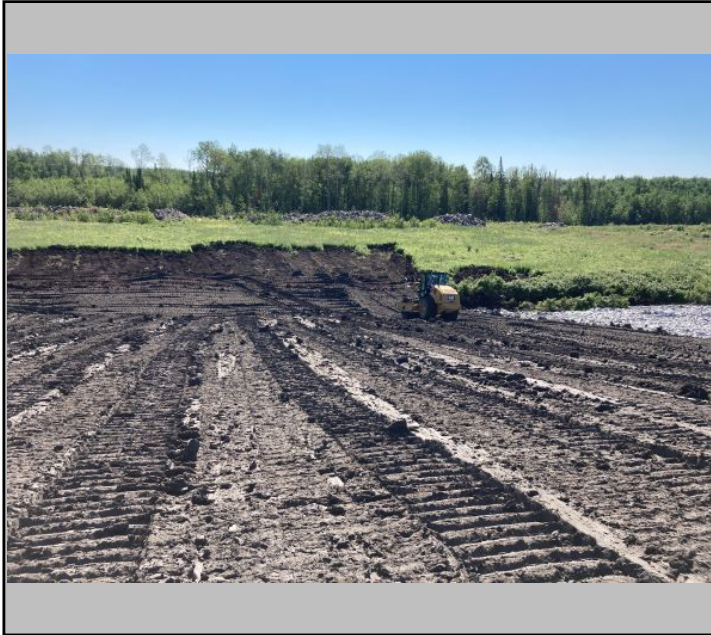
Photo #: 1

P32, L2 compaction

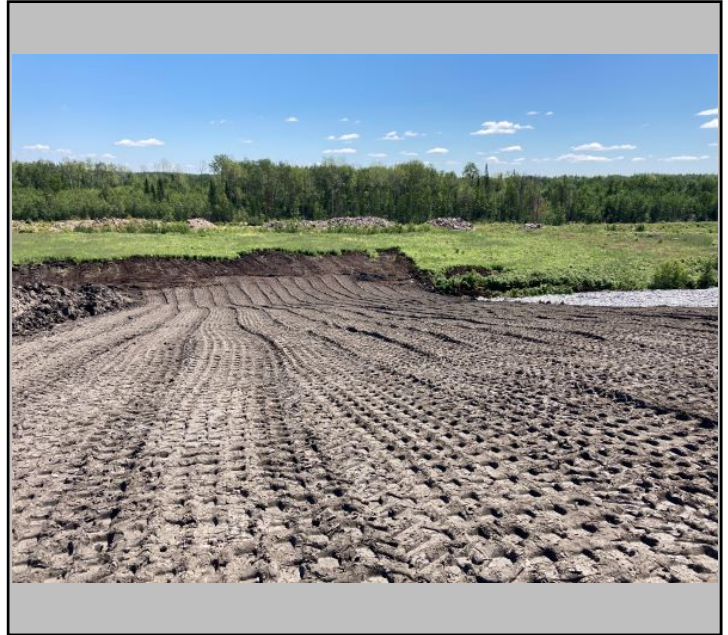
Photo #: 2

P32, L2, post-compaction

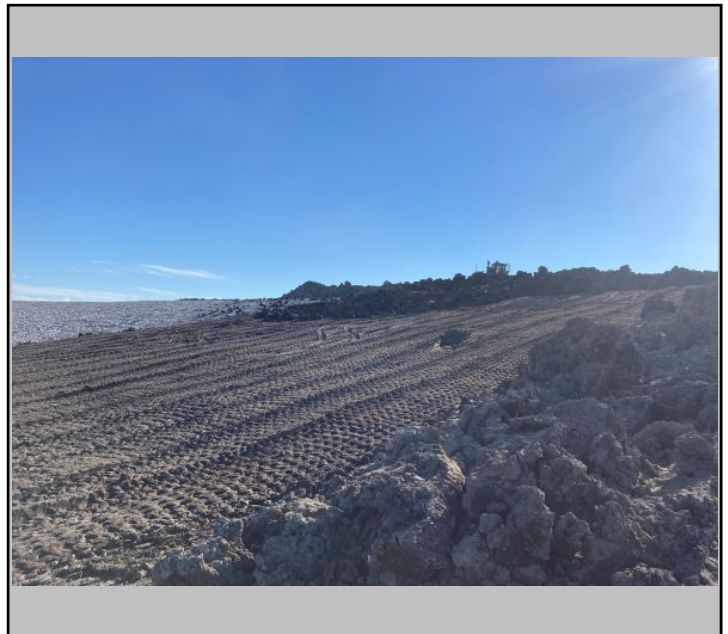
Photo #: 4

P32, L3 covering approximately half of P32, L2
by EOD

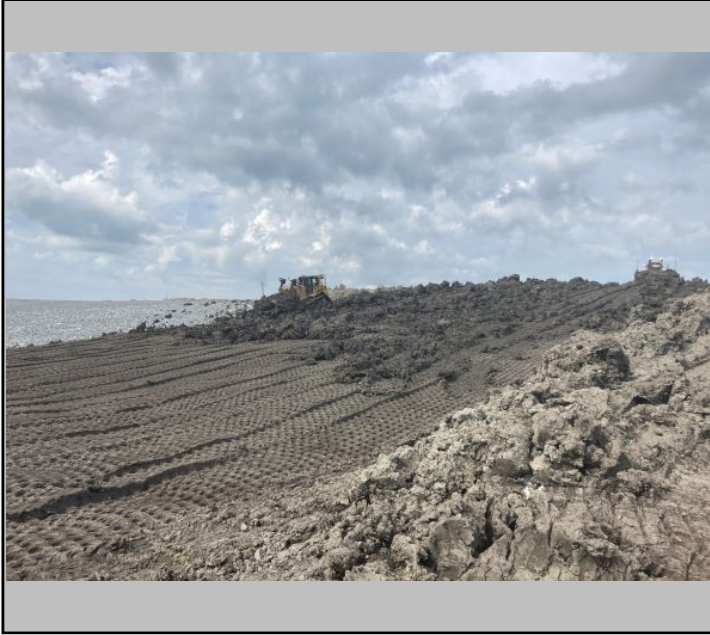
Photo #: 1

P32, L3 placement

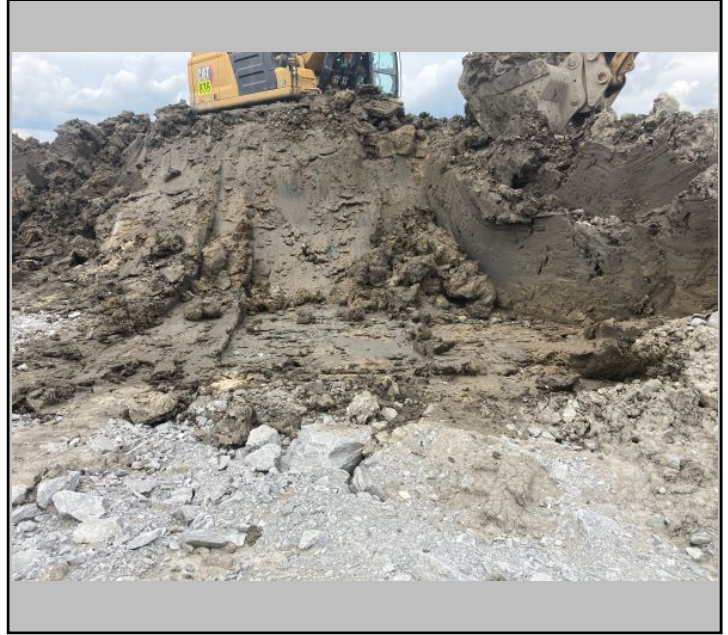
Photo #: 2

Central Stockpile material used for part of P32,
L3 and all of P33, L1

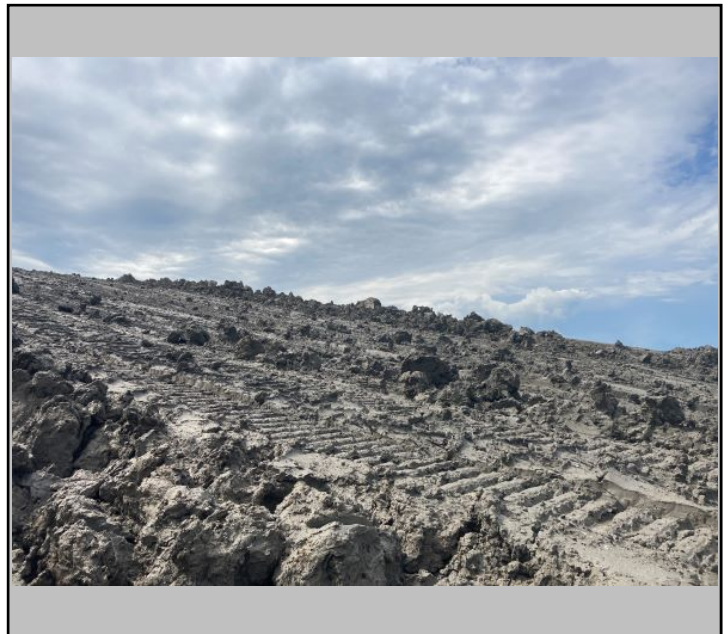
Photo #: 4

P32, L3 material following rainfall

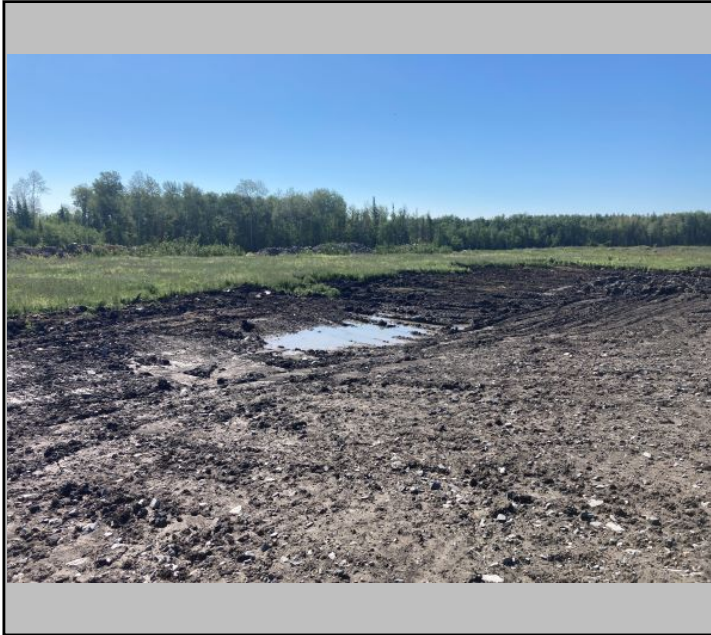
Photo #: 1

Standing water at toe of P30

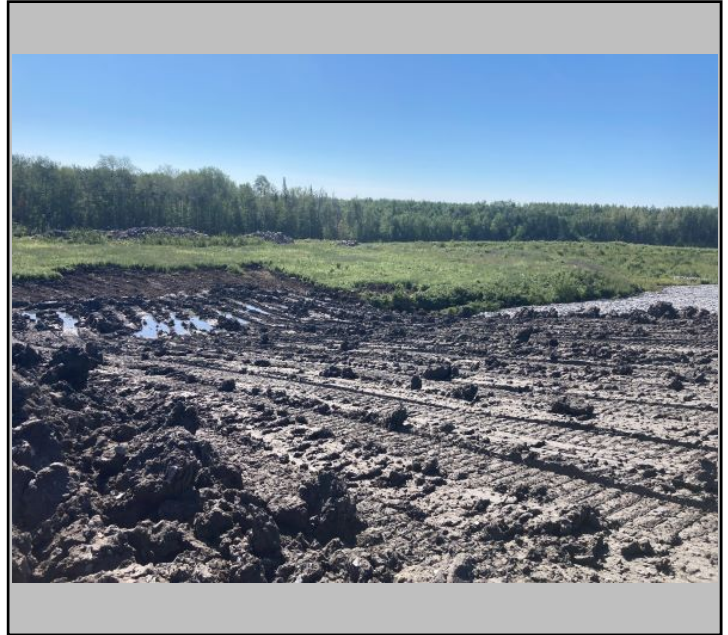
Photo #: 2

Standing water at toe of P32, L3

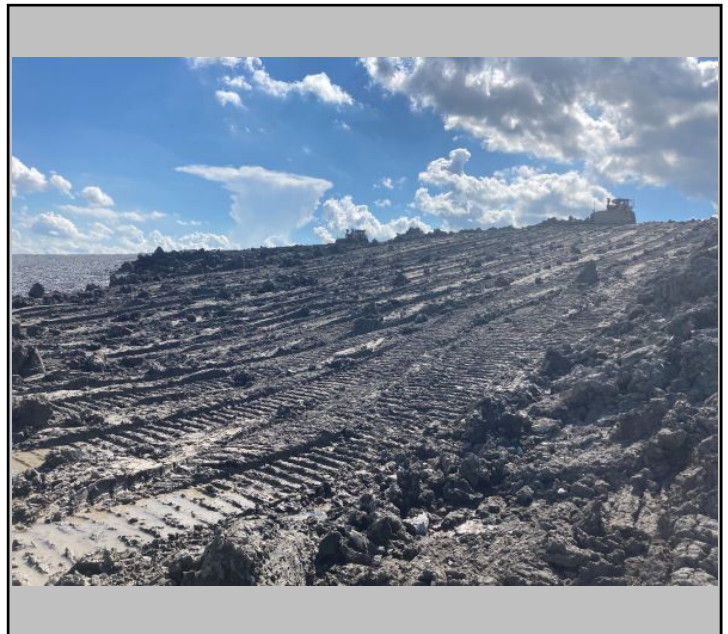
Photo #: 4

P32, L3

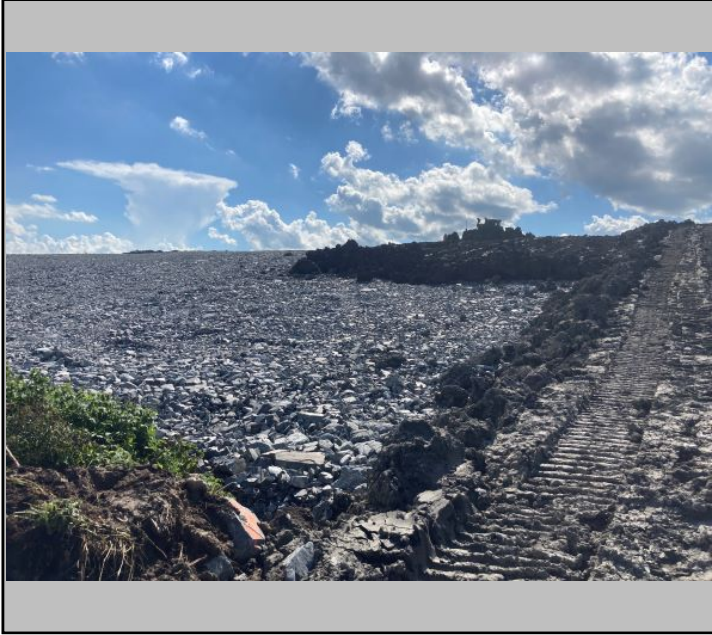
Photo #: 5

P33, L1 placement

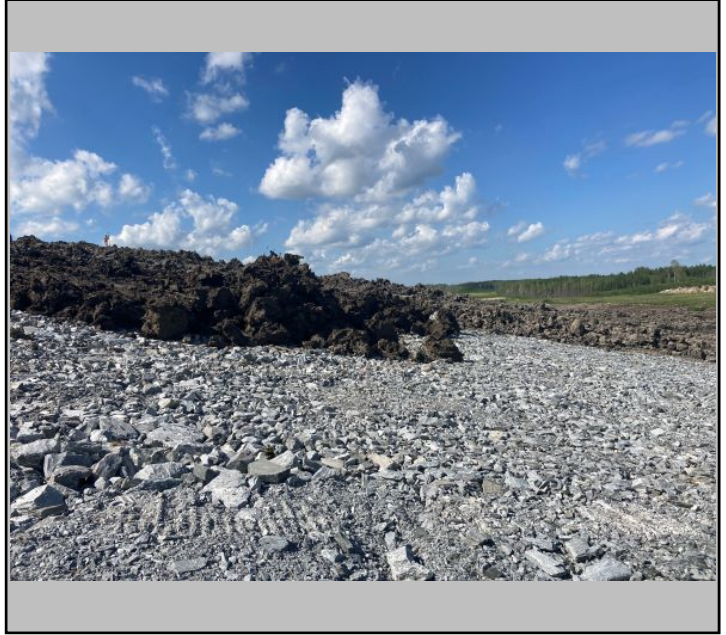
Photo #: 6

P33, L1 placement

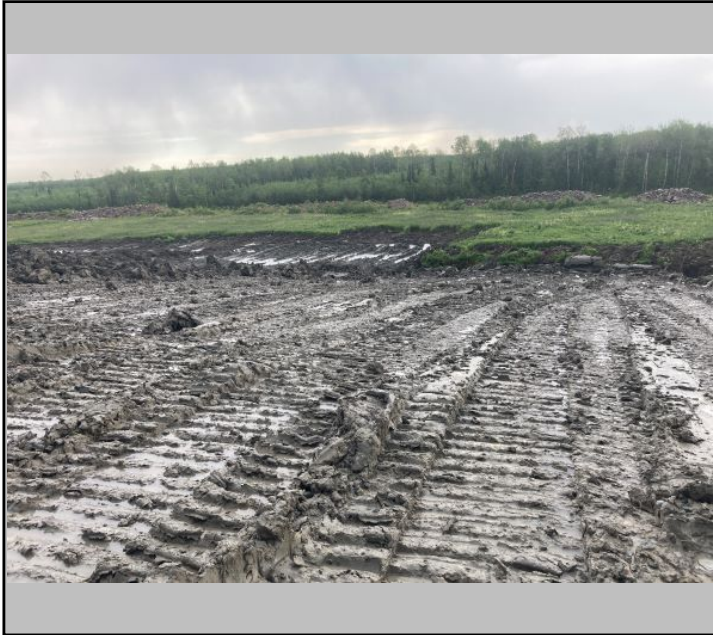
Photo #: 1

Very wet P33, L1 material, with standing water at toe of P32, L3

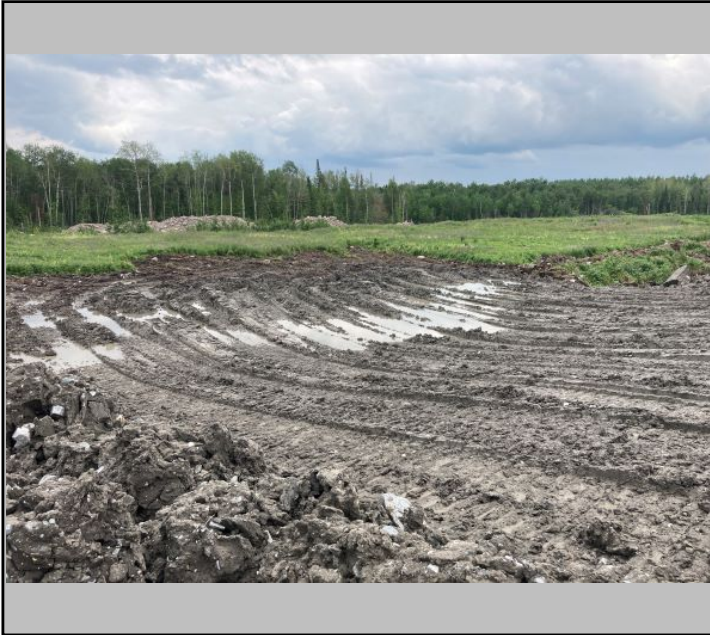
Photo #: 1

Standing water at toe of P32, L3

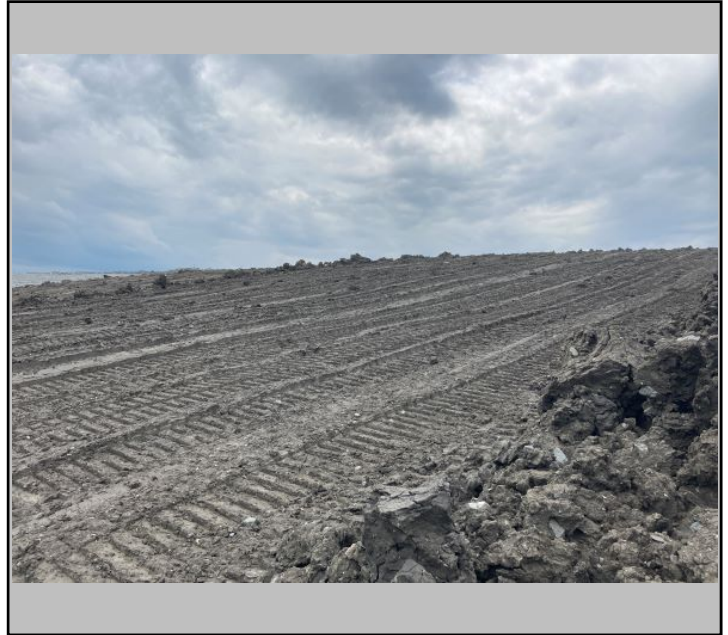
Photo #: 2

P32, L3 material very wet

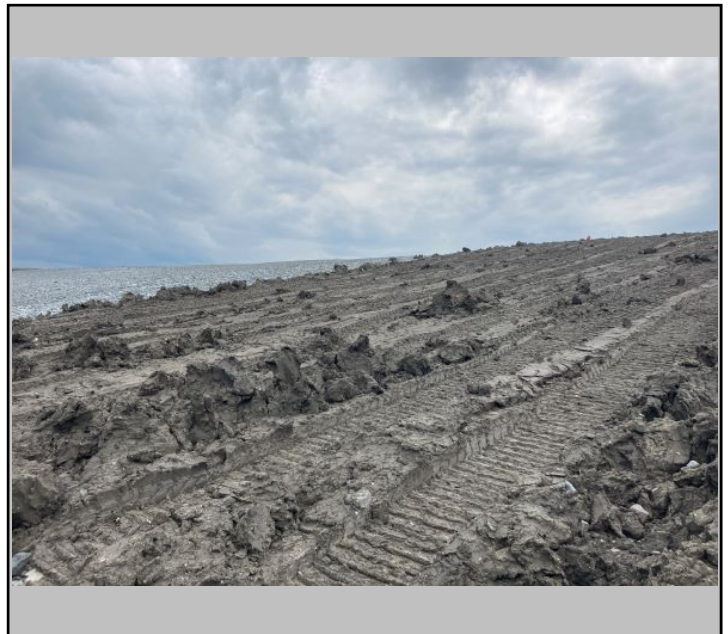
Photo #: 4

P33, L1 material

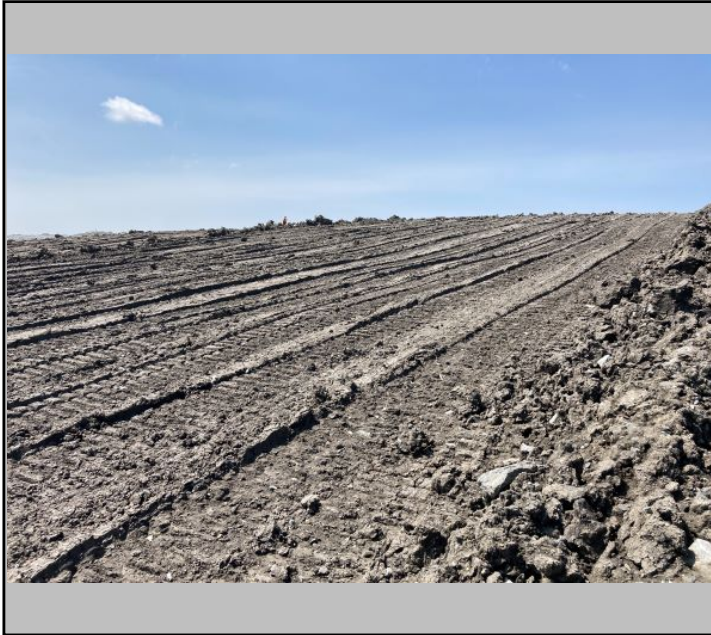
Photo #: 1

P32, L3 material

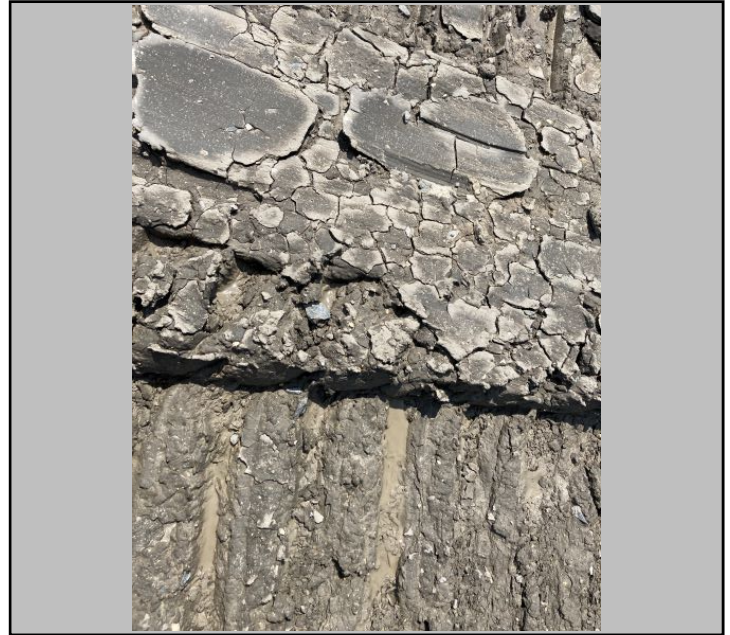
Photo #: 2

P33, L1 material.

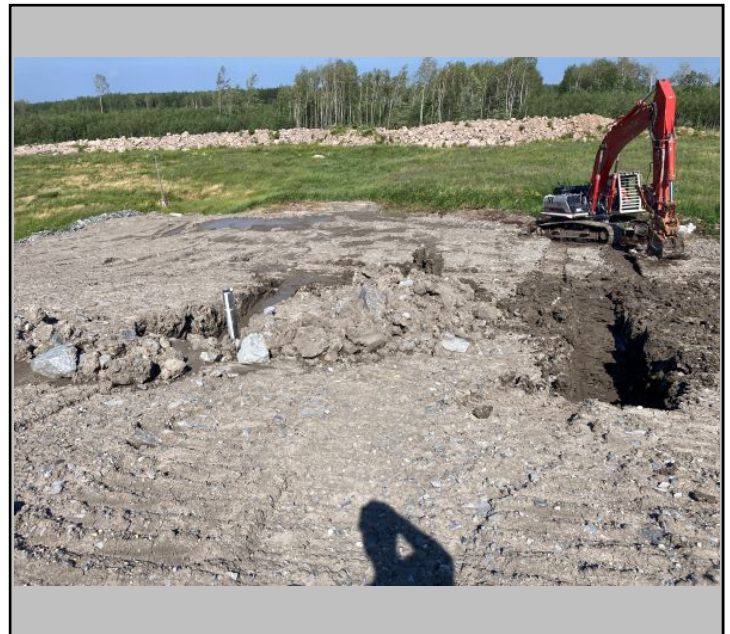
Photo #: 4

New test pit dug beside
EMRS22_BP_P30_L2_B28_220714

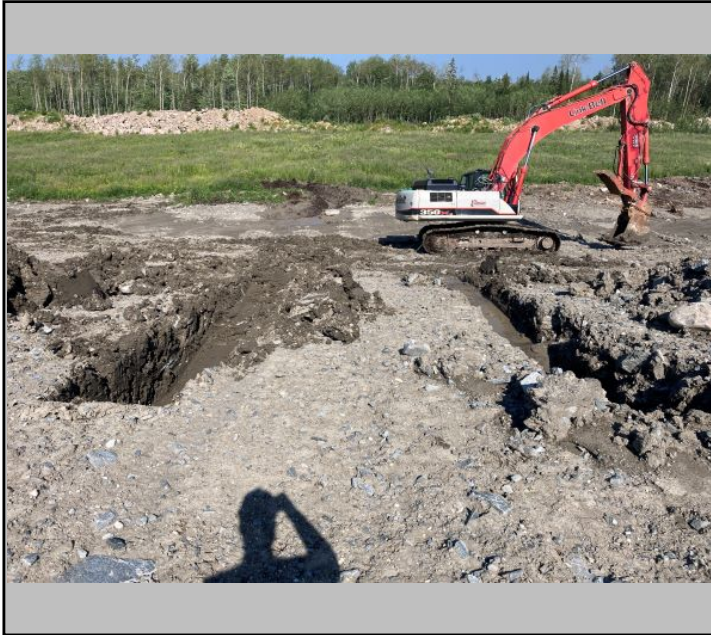
Photo #: 5

New test pit dug beside
EMRS22_BP_P30_L2_B27_220714

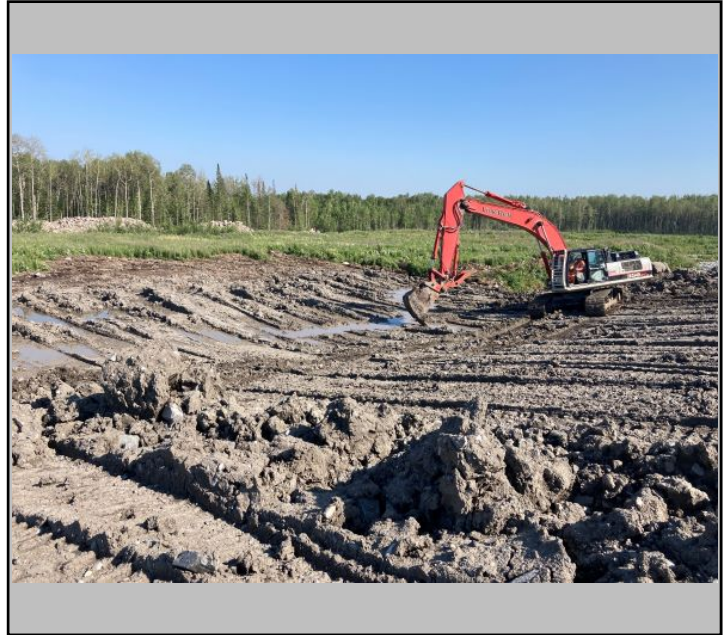
Photo #: 6

P32, L3 drainage

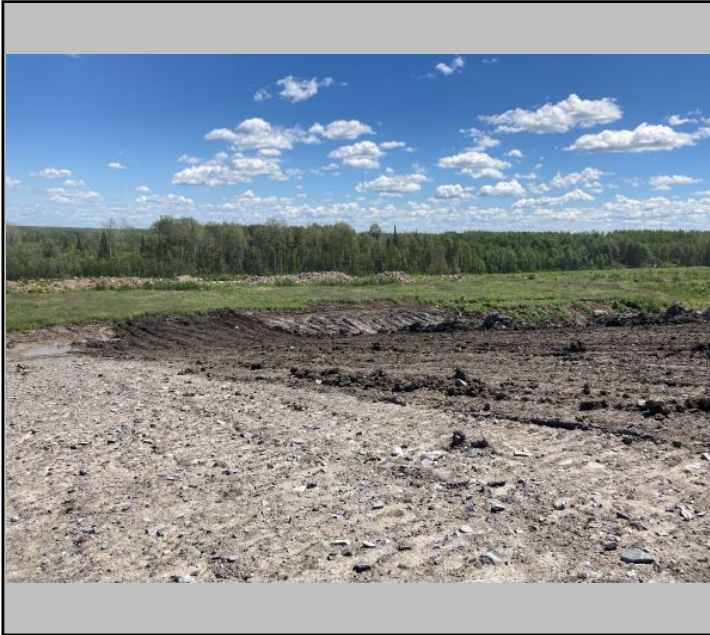
Photo #: 1

P31, L4 toe grading

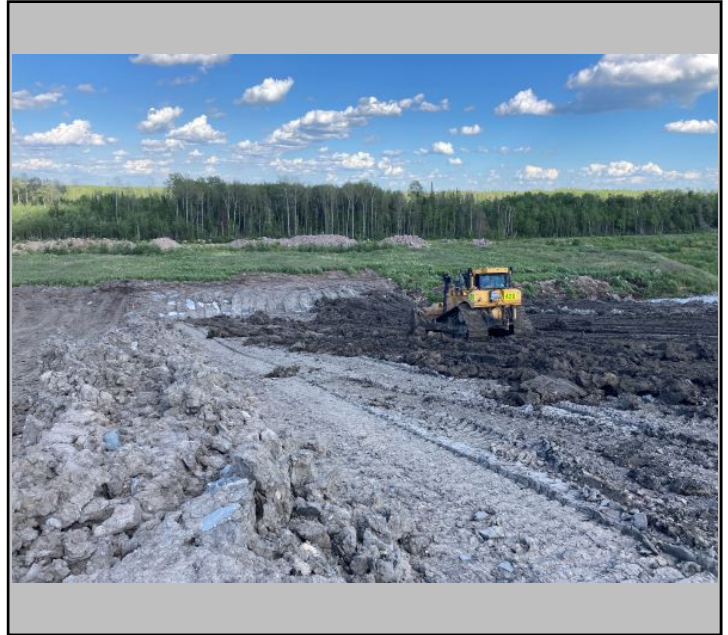
Photo #: 2

P32, L3 placement

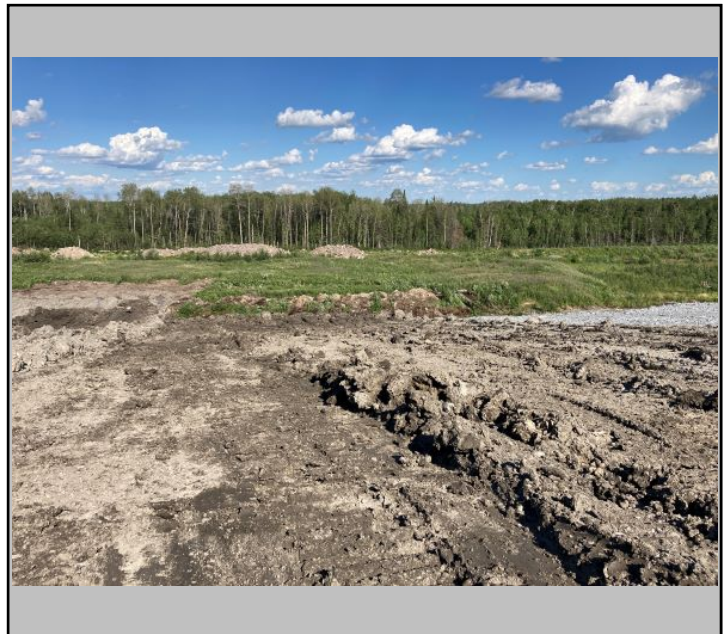
Photo #: 4

P33, L1 placement

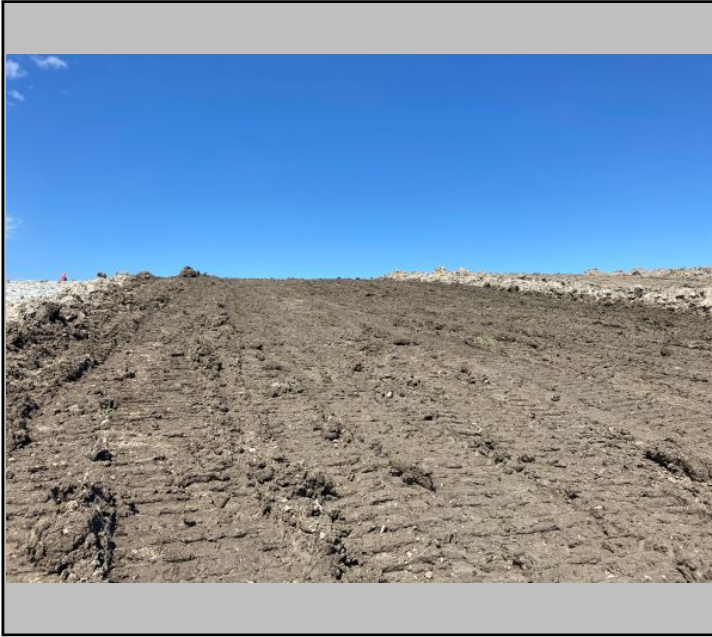
Photo #: 1

P33, L1 placement

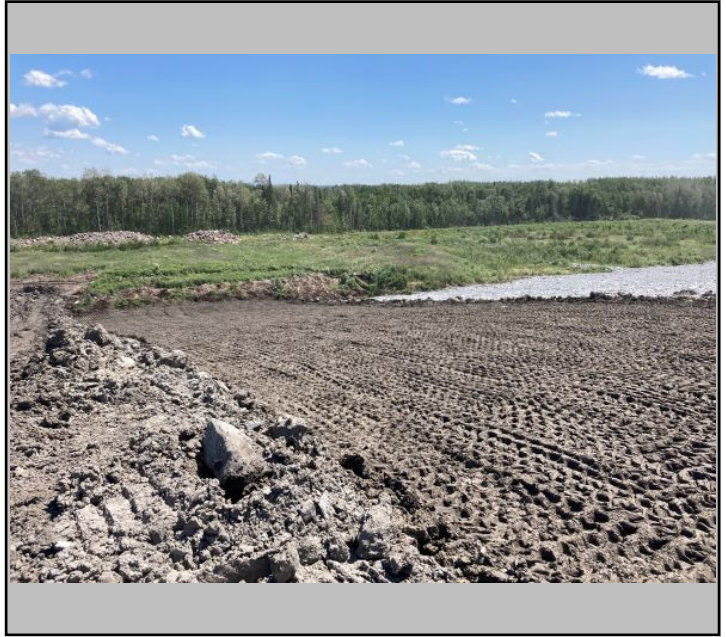
Photo #: 2

P33, L3 compacted

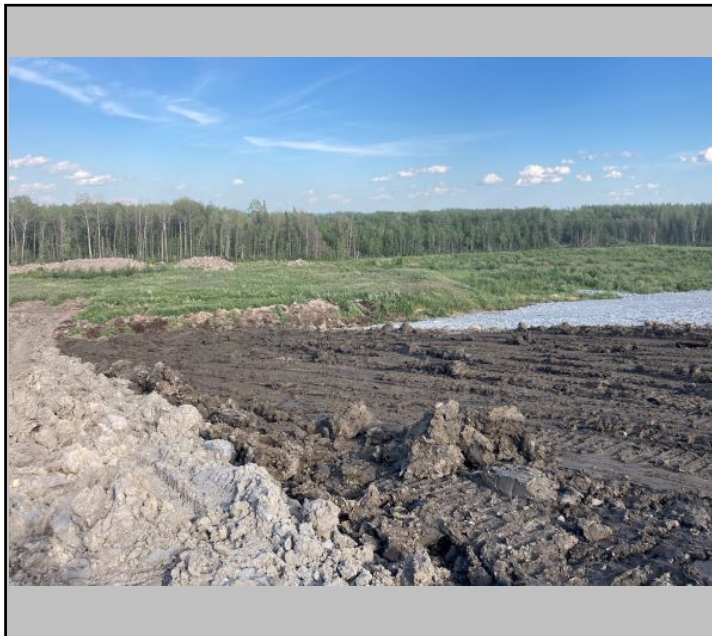
Photo #: 3

P33, L2 placement at reduced thickness

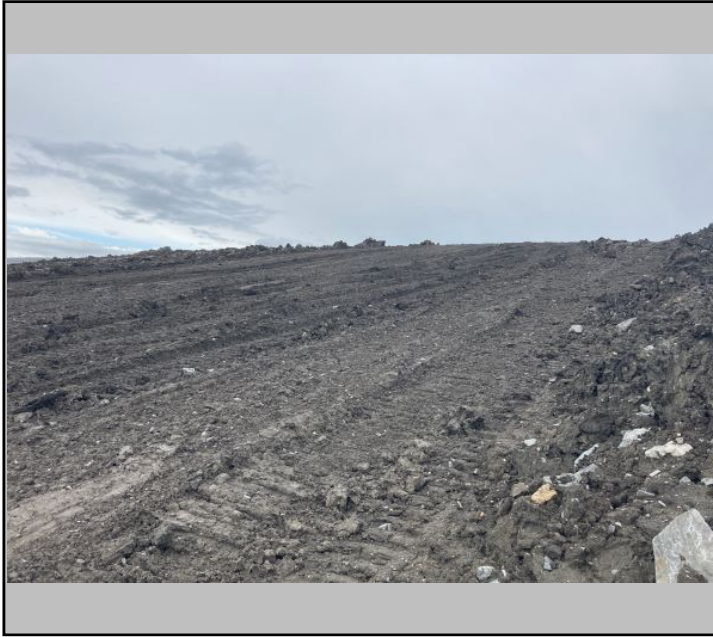
Photo #: 1

P32, L3 slope
