Date:	July 12, 2022	Owner/Client:	New Gold Inc.
Day:	Tuesday	Okane Project #:	1003-223
Prepared by:	Brady Hay	Project Location:	Ontario

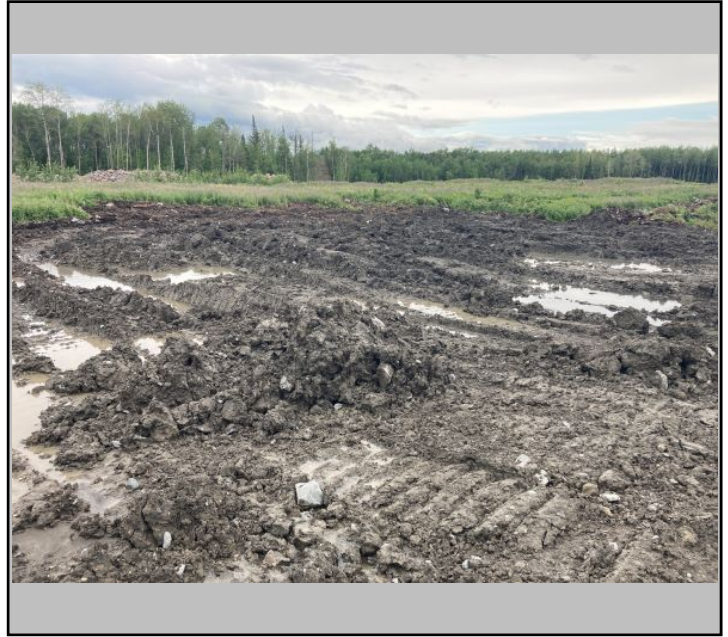
Photo #: 2

P32, L3 toe

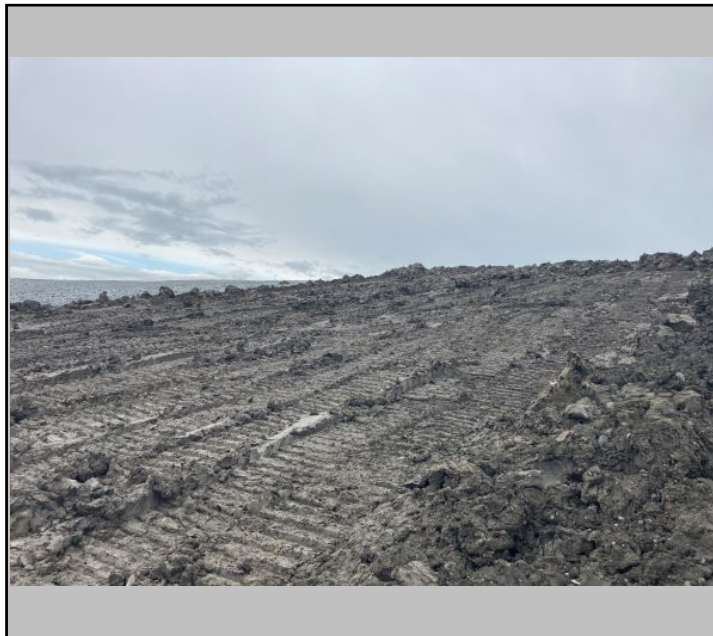
Photo #: 3

P33, L2 slope

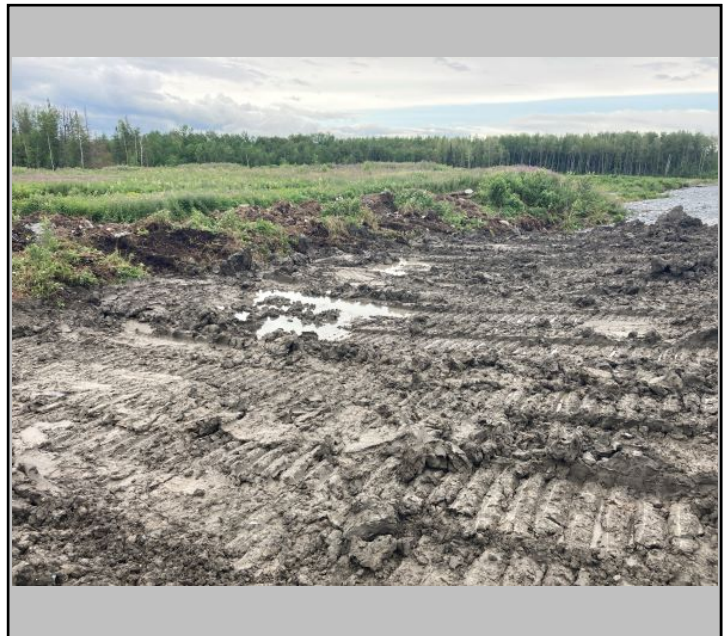
Photo #: 4

P33, L2 toe

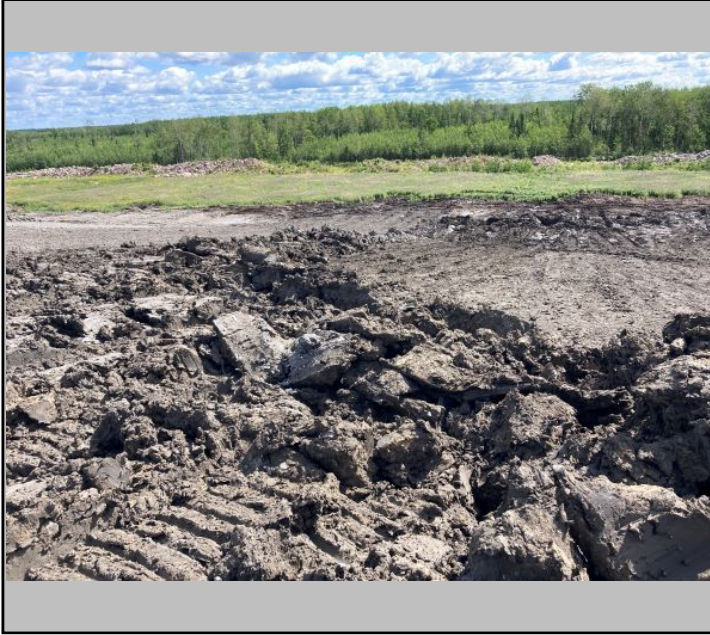
Photo #: 1

P32, L4 placement

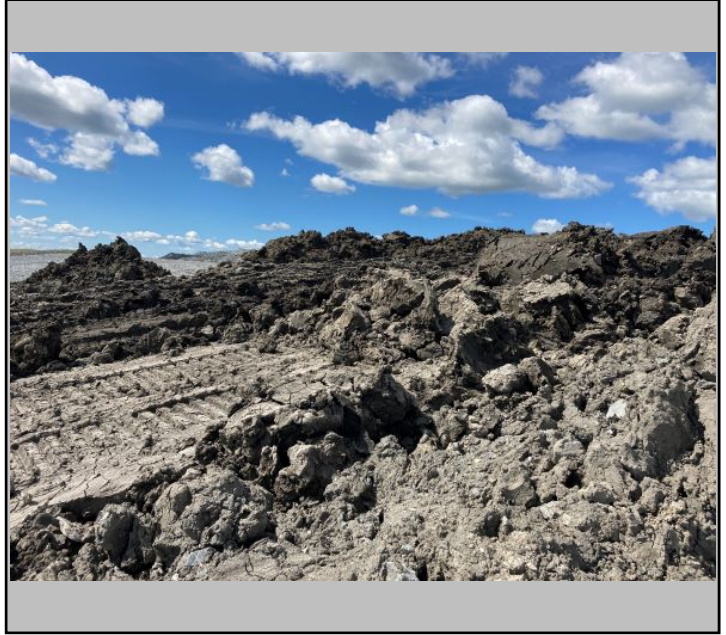
Photo #: 2

P33, L2 placement

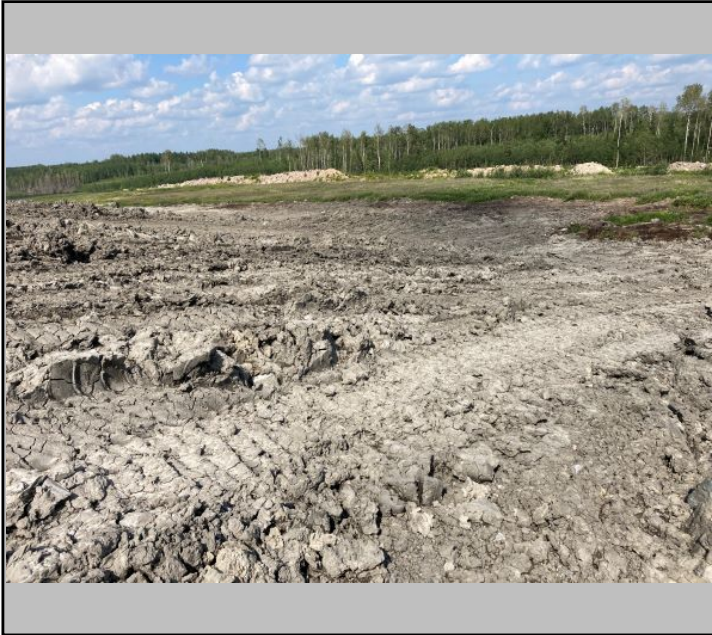
Photo #: 1

P33, L2 placement
