**RE: COPPER SULFATE 40KG SPILL - SAC REFERENCE # 1661-B8VTYV**

New Gold Rainy River

RE: KOMATSU EXCAVATOR 450L HYDRAULIC FLUID SPILL - SAC REFERENCE #6704-B9C2VG

**RE: COPPER SULPHATE 30KG SPILL - SAC REFERENCE # 2828-B9SKZ5:**

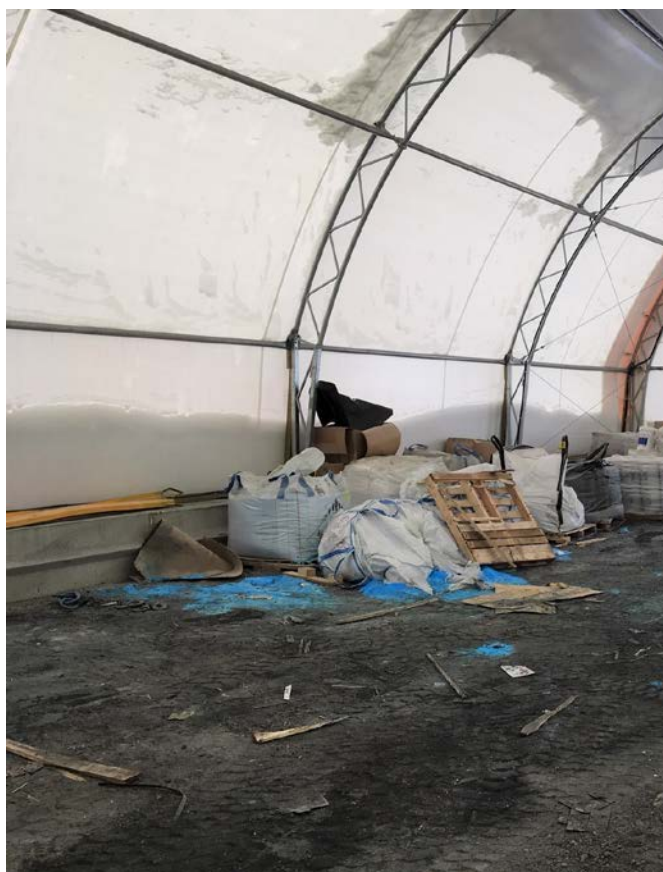
Further to the notification to the Spills Action Center (SAC) Reference # 1661-B8VTYV, on January 29, 2019 at 16:09, a copper sulfate spill was noted on the earthen floor of the covered chemical cold storage area east of the Mill on January 29, 2019 at 13:10. The original volume estimate was 25kg, but it has since been corrected to approximately 40kg.

Figure 1: Location of copper sulfate spill inside the covered chemical cold storage building east of the Mill

To prevent future occurrences, shelving has been ordered for the covered chemical cold storage building to be installed in the spring, which will eliminate the practice of stacking copper sulfate totes. It is also planned to pour a concrete pad for the building to be placed on, which will provide spill containment.

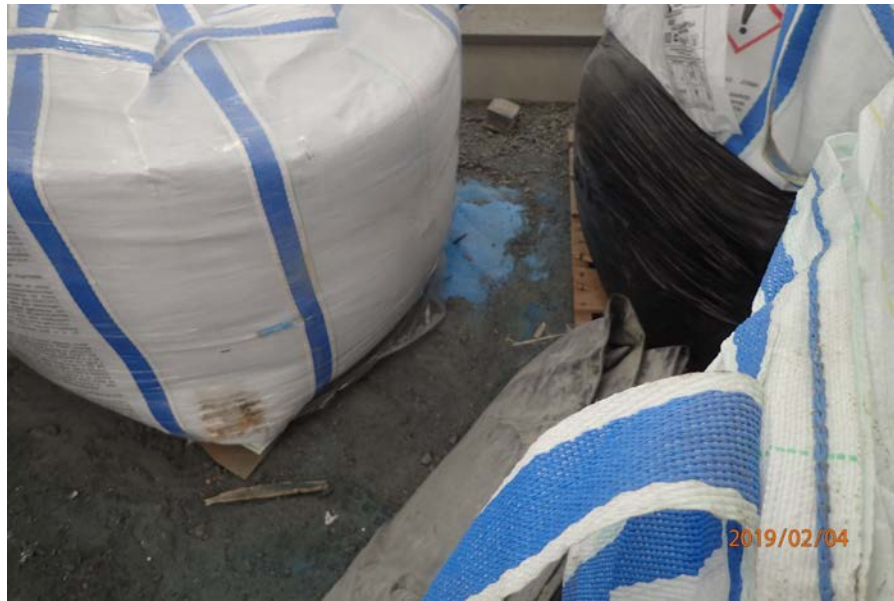
During the cleanup, it was discovered that other totes of copper sulfate were damaged and required cleanup as well, which increased the reported estimated spill volume from 25kg to 40kg. Attempts were made to repair/wrap the damaged totes so they could be moved to complete the cleanup however they were unsuccessful. The spill cleanup was completed at end of day February 7, 2019. Fold out spill containment has been utilized to contain the damaged totes until they can be placed in other totes. Photographs of the location of the spill before and after cleanup have been provided as Figures 1 through 3.

Figure 1: Example of additional damaged totes and spilled copper sulfate discovered during initial clean up.

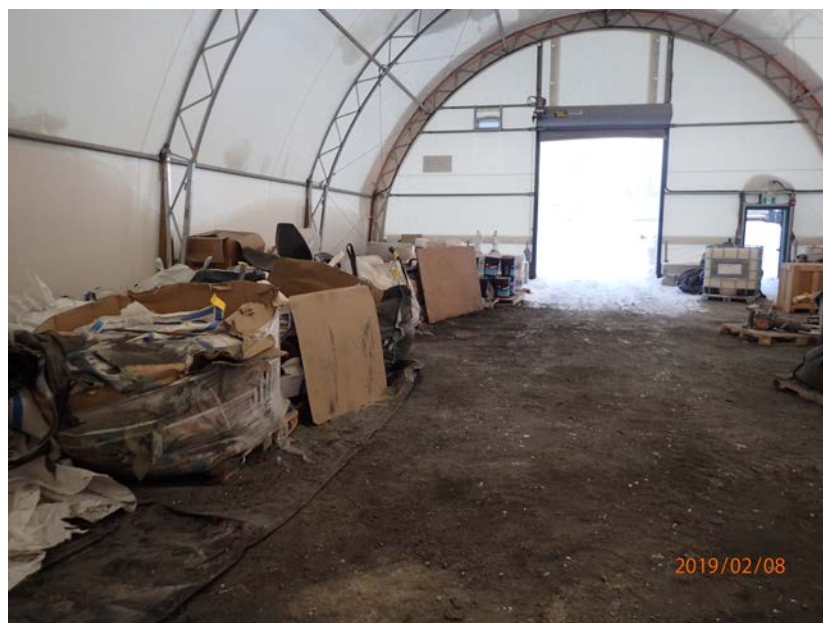
Figure 3: Cleaned up copper sulfate spill inside the covered chemical cold storage building east of the Mill. Damaged totes placed on fold out spill containment.

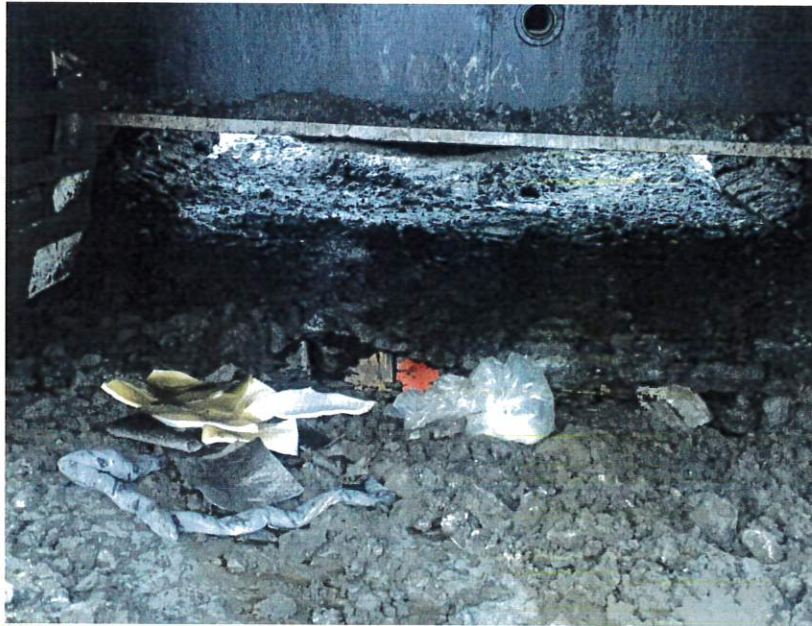
Leaking hydraulic fluid was noticed by the operator who immediately began to shut down the shovel. During the shutdown process approximately 450 L of hydraulic fluid escaped from the fractured hose line and spilled onto the pit floor. The leak was stopped, and cleanup of the spill began. (Photo 2).

Photo 2. Spill cleanup pads, coils and trays used to contain and clean up hydraulic fluid spill.

Corrective actions include continuing with a regular preventative maintenance program, which is designed to identify and replace defective equipment before failures occur.

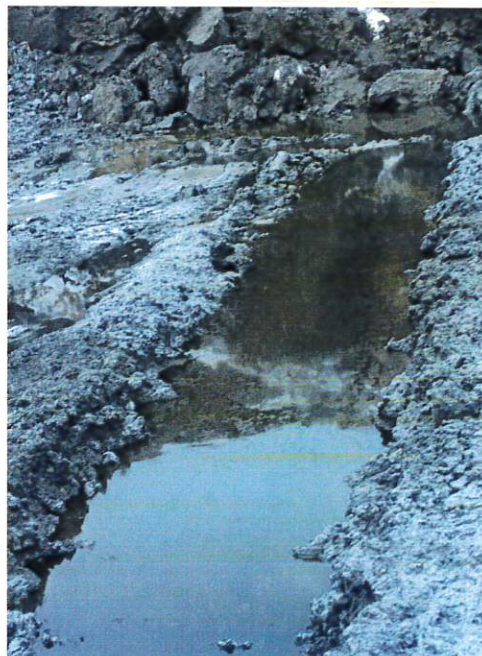
Ponding hydraulic fluid was contained within a berm area (Photo 3). Mine Maintenance used a lubricant and service truck to collect the pooled hydraulic fluid and disposed of it in a used oil tank located on the plant site.

Photo 3. Hydraulic fluid collected in a berm area on floor of 300 bench.

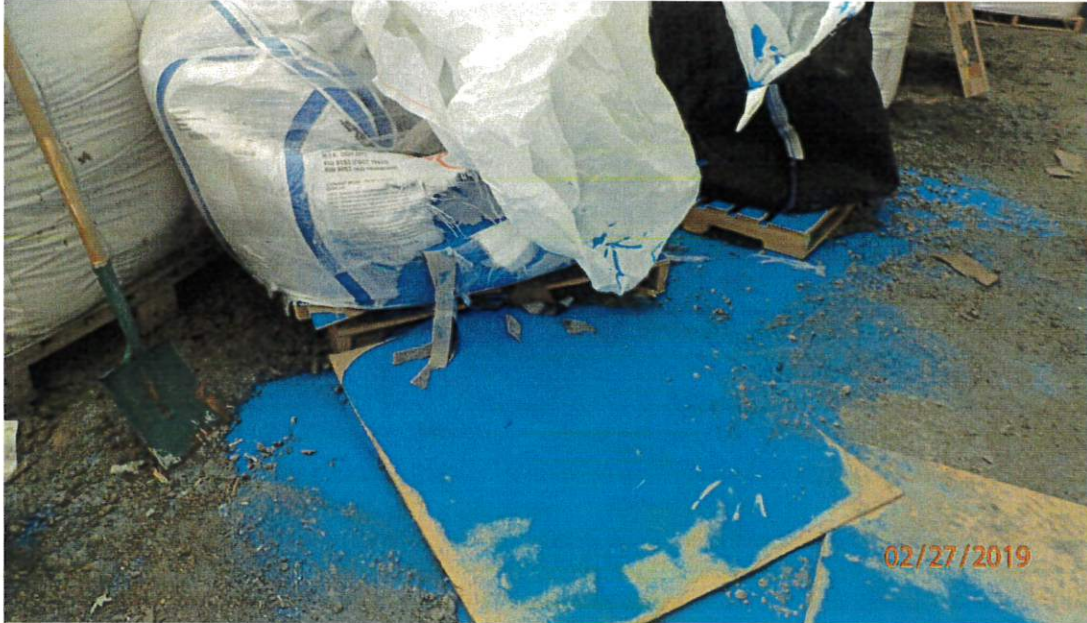
It was determined that during movement of a tote bag of copper sulphate, a forklift contacted an adjacent bag, and tore it open (Figure 2). The spilled copper sulphate was collected and placed into another tote. Granular copper sulphate did not migrate from the spillage area and was contained inside the covered building.

Figure 2. Copper sulphate tote bag with tear and spillage onto cold storage tent floor.

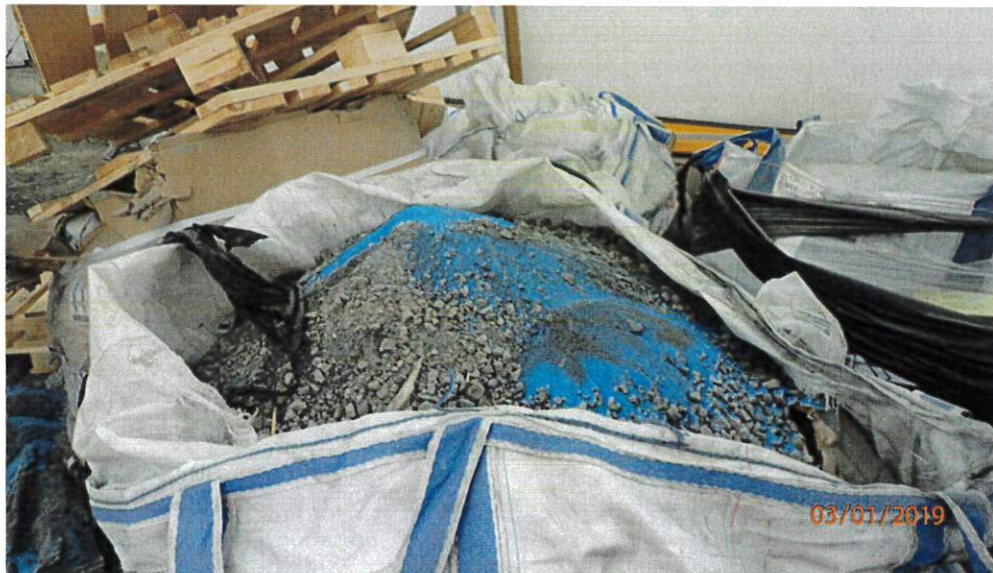
The mill was contacted, and spill cleanup completed by the end of the next day. Gravel, clay and wood particles mixed in with the spillage, prevented the mill from using the copper sulphate in the process. The contaminated mixture will be added into the Cyanide Destruction (CND) circuit and consumed. Disposal is planned for the spring of 2019.

Figure 3. Spillage bag containing materials removed from the cold storage tent floor. Bag contains mixture of granular copper sulphate, gravel, clays and wood.

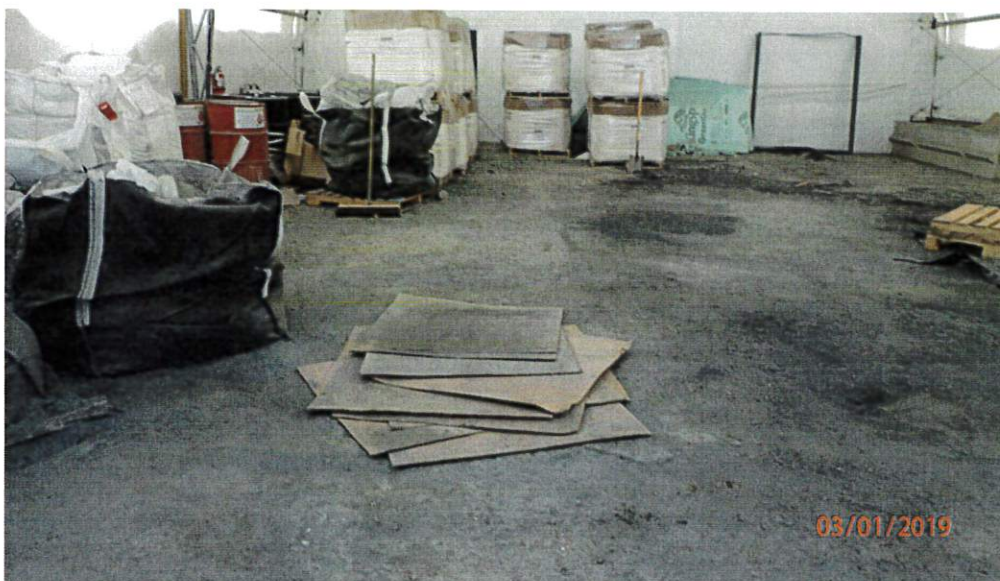
Figure 5. Floor of cold storage tent showing successful clean-up of copper sulphate spillage.

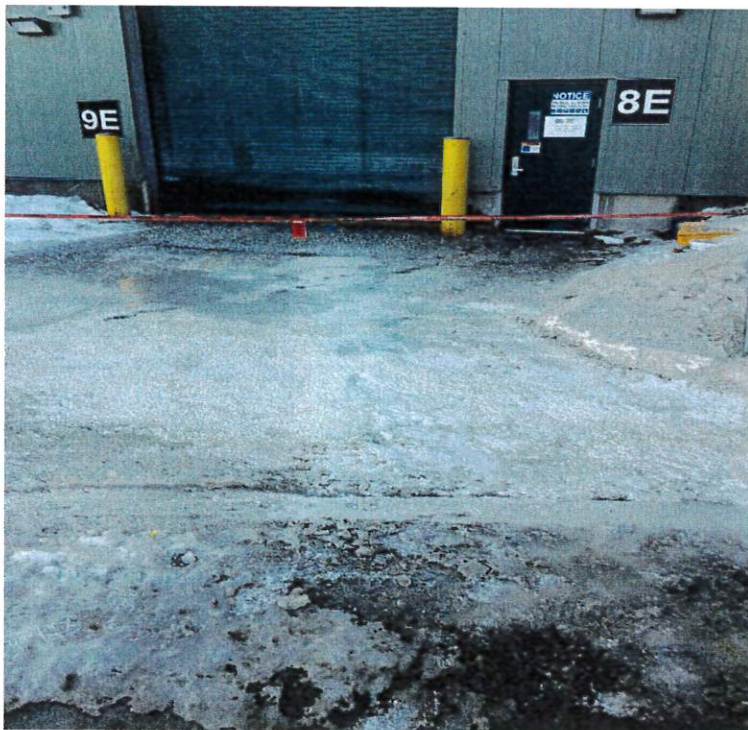
At 17:30 hours on March 12th the mill was receiving a shipment of high calcium quick lime from a transport truck directly into the lime silo. The transfer hose became obstructed due to damp conditions and kinking. When the transport truck operator uncoupled the transfer hose pressure had built up in the line causing approximately 25 kilograms of lime to be spilled. See photo below (lighter areas are snow).

The mill shift supervisor was informed of the situation and contained the area until clean up could begin. The area was cleaned up by collecting as much of the contaminated snow and gravel as possible, then placing it in within the mill sumps. All collected material will be consumed in the mill process.

To prevent another similar event from occurring in future, modifications will be made to the lime silo. The loading pipe will be raised to prevent kinks from forming in the transfer hose which is suspected to have contributed to the blockage.

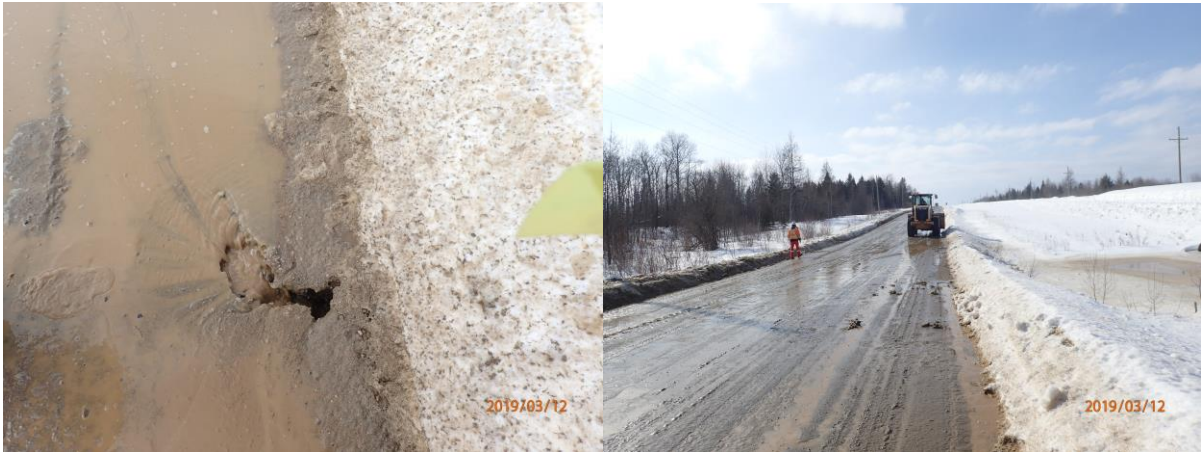
The water flowing through the culvert appeared to be picking up sediment from road material that had thawed, eroded holes through the road bed and entered the watercourse at the upstream end of the culvert. Upon discovery of the turbid water, an in-field turbidity analyses was completed which determined the turbidity to be 77.9 NTU. Another sample was collected that was sent to a licensed external laboratory for total suspended solids and turbidity analyses which were determined to be 24.0 mg/L and 78.3 NTU, respectively.

Figure 2. Eroded hole in Roen Road allowing turbid water from road to enter West Creek (left). Condition of road when mitigation measures were being installed by loader (right).

Water Management General Foreman was contacted and dispatched a loader and supervisor to install mitigation measures. Clean crushed rock was dumped and packed into the eroded holes by hand. This was then reinforced with sand and packed in with the loader. The loader continued to clean up the road by creating three punch outs on the north side and three punch outs on the south side of Roen Road. Small swales were built with shovels to promote water relay to ditches.

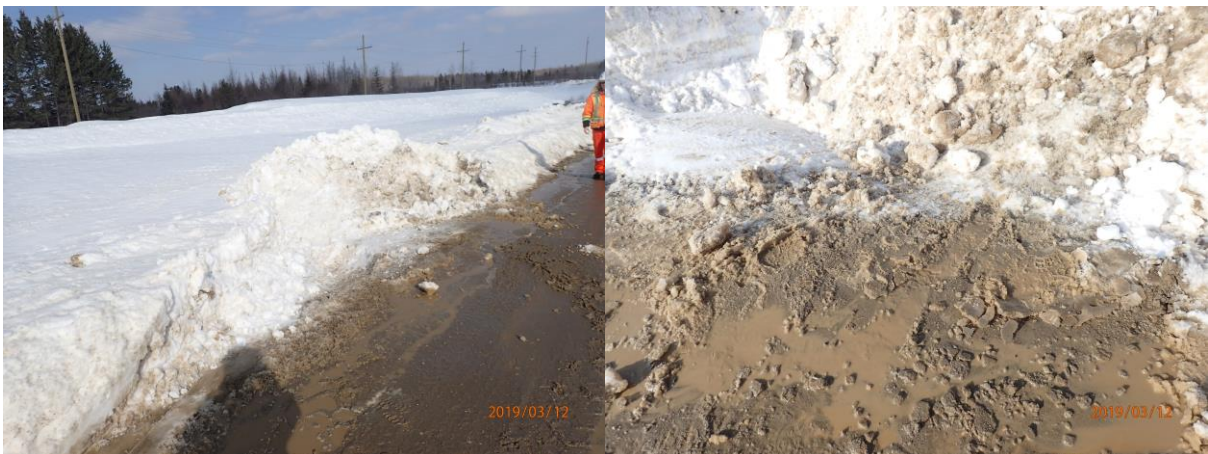
Figure 3. Punch out created on north side of Roen Road (left). Small swale made with shovel to help promote water-shedding from Roen Road (right).

The punch-outs created during this event will be inspected and maintained through the freshet. A site wide inspection will also occur to identify other locations that may require punch-outs to be installed. This will help mitigate any future total suspended solid exceedances from site roadways.

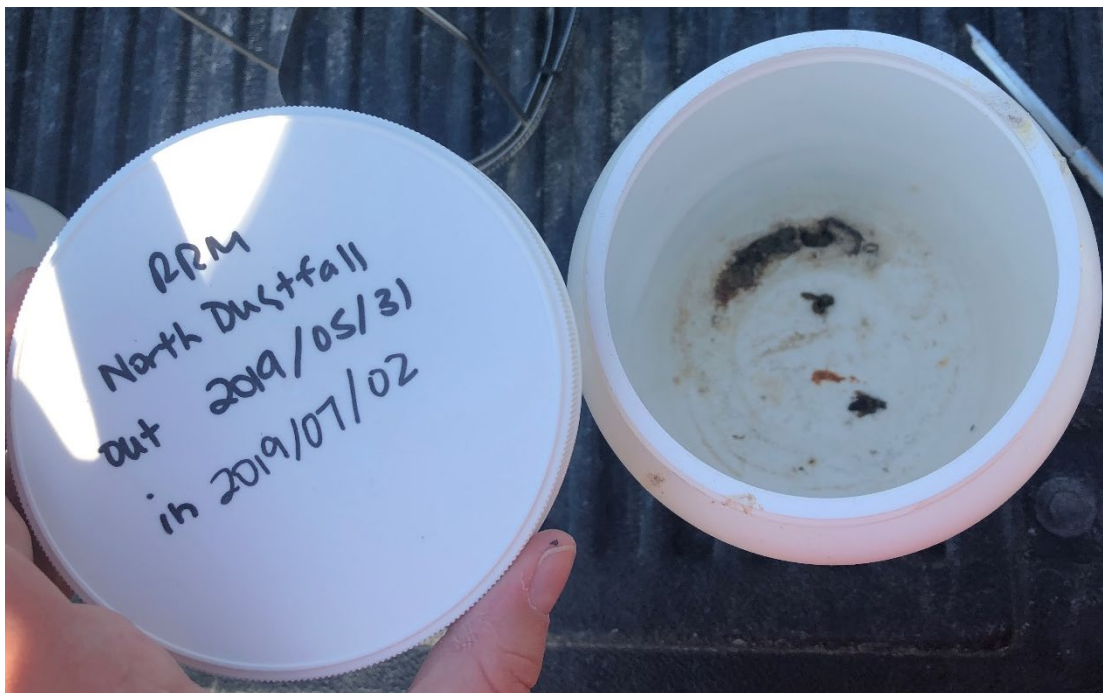
Upon further analysis of the laboratory results, I determined that 9.99 g/m<sup>2</sup>/30-day of the total dustfall was volatile (organic) matter. Tables 1, 2 & 3 outline the laboratory results for this sample. As you can see in Figure 1, the dustfall jar for the month of June collected at least two insects, as well as bird droppings. The elevated total dustfall result is likely cause by these organic sources.

**Figure 1. June Dustfall Jar illustrating organic influences.**

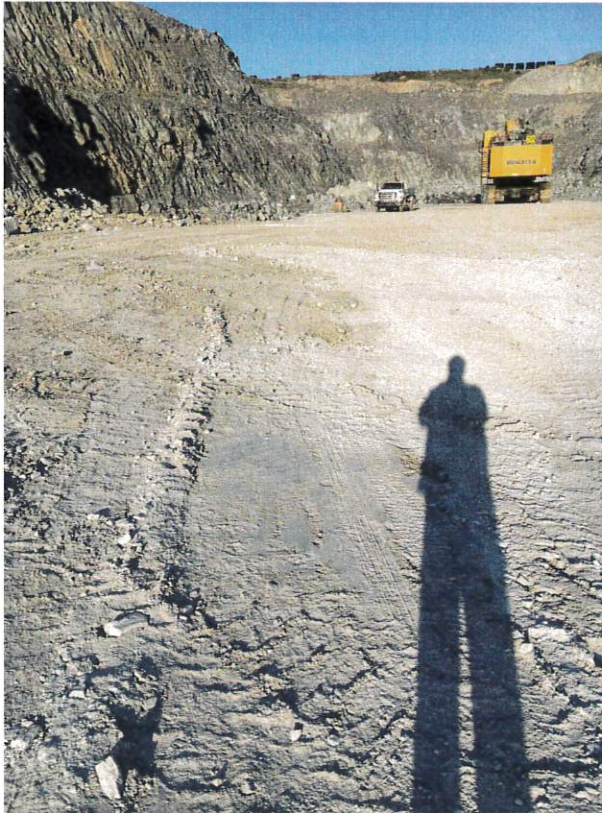
Approximately 5 yards of contaminated gravel was collected and placed in a contaminated soil bin for removal offsite by a certified hazardous waste hauler. See below photos of the spill area cleaned up. The area was returned to the original grade.

Figure 2. Location of spill after cleanup.

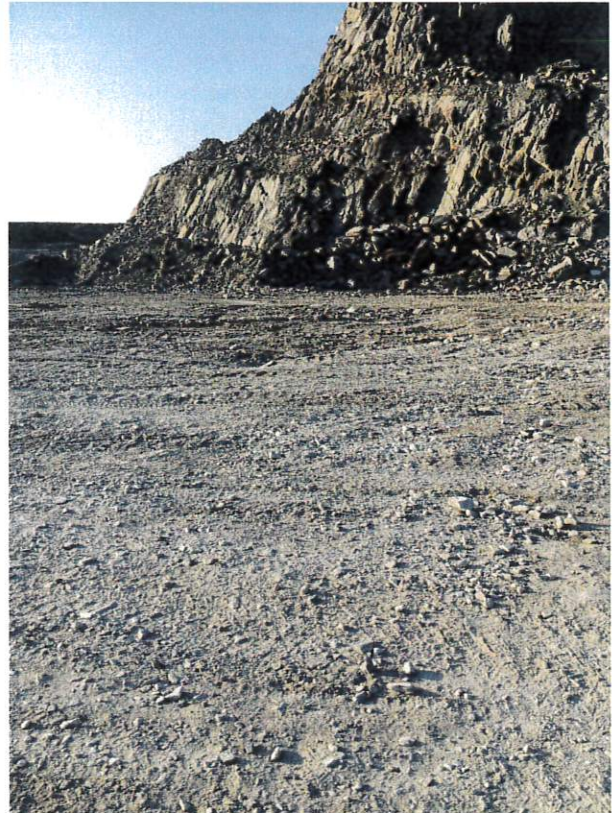
Figure 3. Location of spill after cleanup.

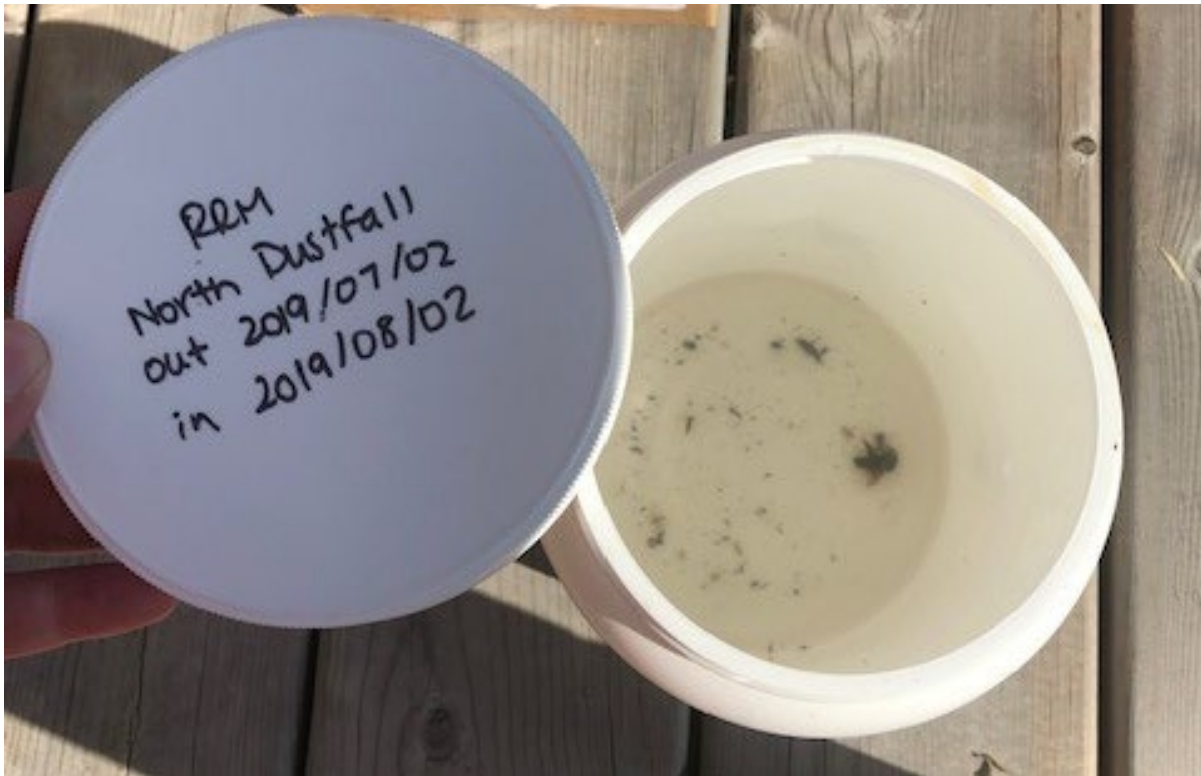
Upon further analysis of the laboratory results, it was determined that 7.05 g/m<sup>2</sup>/30-day of the total dustfall was volatile (organic) matter. Tables 1, 2 & 3 outline the laboratory results for this sample. As seen in Figure 1, the dustfall jar for the month of July collected at least one large intact insect as well as other organic influences. As a result, the elevated total dustfall is likely cause by these organic sources.

**Figure 1. July Dustfall Jar illustrating organic influences.**

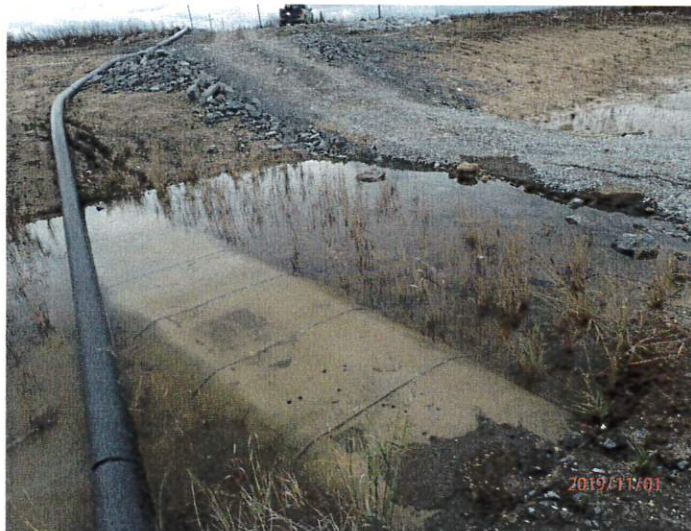
Further to the notification to the Spills Action Center (SAC) Reference # 0476-BHHRKC, on November 1, 2019 at 11:30 am, it was noticed that the spillway at the Water Discharge Pond (WDP) had been triggered, resulting in an unplanned effluent release from the Water Discharge Pond into Lower Loslo Creek via land (Figure 1).

Figure 1 shows water flowing over sill in WDP Spillway and headed to remnant Loslo Creek.

The spillway was triggered at the WDP due to an error in operational conditions.

Mitigation measures to prevent this type of error in the future include daily survey of water levels when water level is close to the maximum operating water level (MOWL) and weekly surveying of water levels thereafter.

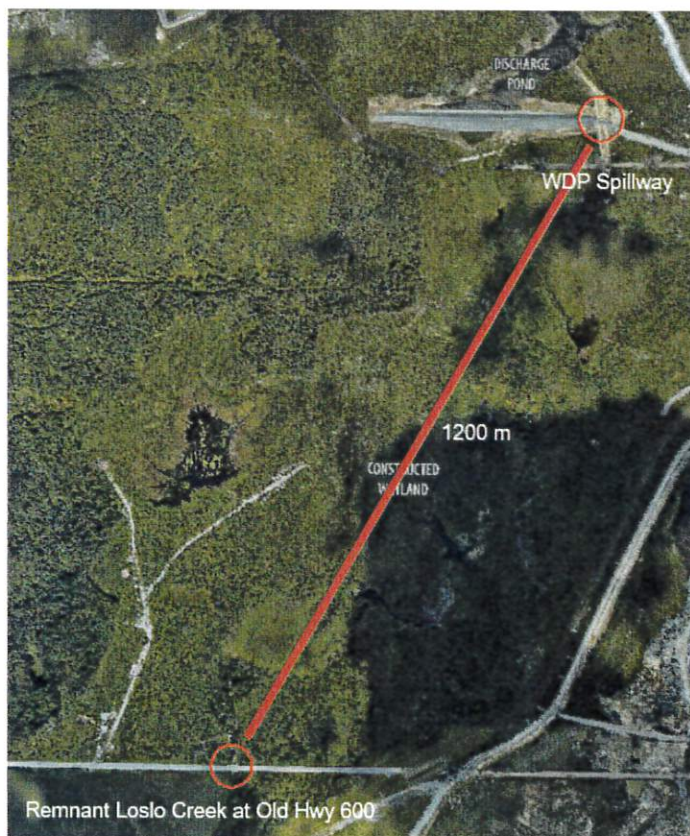
Figure 2 Red circles show where samples were collected at WDP Spillway and remnant Loslo Creek at old Hwy 600. Water travelled approximately 1200 m through the remnant creek with multiple beaver dams and thick vegetation.

The water level in the WDP decreased significantly by Friday, November 1. Water flowing over the sill froze. However, a 25 cm section of the 3 m wide sill remained open. The pond level reduced further over the course of the day causing water to stop flowing over the sill by 2 pm on Saturday, November 2<sup>nd</sup>. Water travelled through heavily vegetated undulatory remnant creek bed with numerous beaver dams before reaching Loslo Creek below Hwy 600 (Figure 2).
