July 2, 2019

**RE: Deceased Sandhill Crane**

**New Gold Inc.**

Rainy River Mine

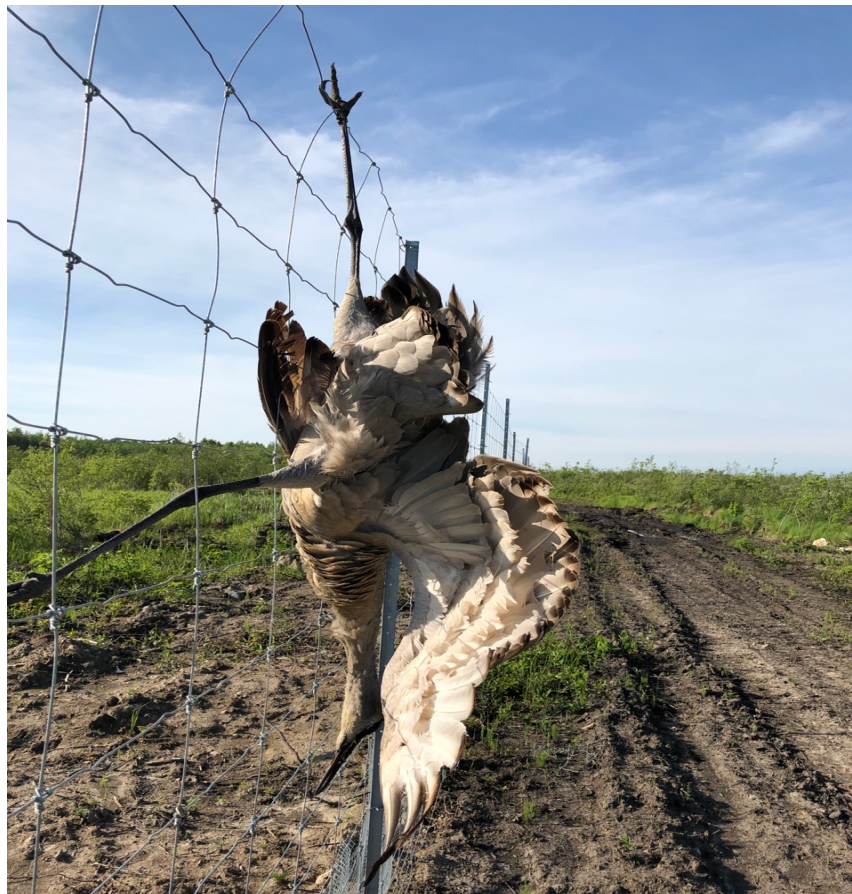
On June 21, 2019 at 0815 a Sandhill Crane was discovered deceased and entangled in the Wildlife Exclusion Fence (See photo 1).

Photo 1. Deceased Sandhill Crane entangled in fencing.

3.1. Location	Wildlife Exclusion Fence		UTMs	E:	N:
3.2. Species	Sandhill Crane		Number of Animals: 1		
3.3. Description of Incident and Outcome	A Sandhill Crane was discovered entangled in the Wildlife Exclusion Fence some time				
	Between June 7 <sup>th</sup> and June 21 <sup>st</sup> and likely died of exhaustion.

To summarize, a Sandhill Crane was found entangled and deceased in the Wildlife Exclusion Fence. It is unknown how this happened as Sandhill Cranes are not often observed attempting to roost on a fence, possibly wind was a factor.

4. Additional Comments					
The Wildlife Exclusion Fence is basically an 8 foot high page wire fence and is patrolled at least twice a month.					
If further incidents occur mitigation efforts will be made, such as the installation of reflective tape on long the top of the fence.

We will continue to patrol the fence and if other similar incidents occur, mitigation efforts will be explored.
