Building Condition Assessment In-situ Decommissioning of Whiteshell Reactor 1 (WR-1)

WLDP-26000-REPT-011

Building Condition Assessment

In-situ Decommissioning of Whiteshell Reactor 1 (WR-1)

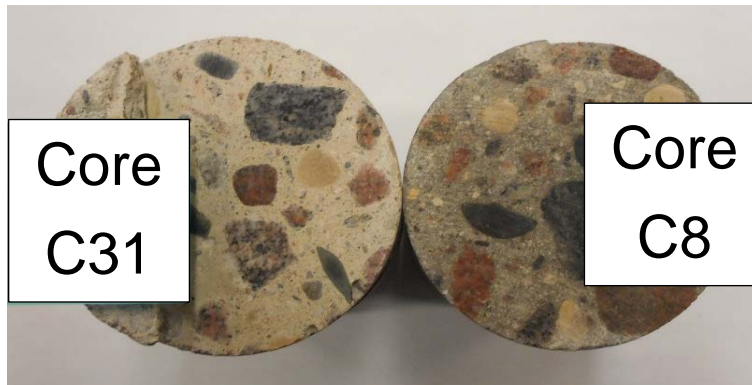
Some of the extracted cores had a slight difference in colour in comparison to most of the samples. The mortar fraction (cement paste + sand) of concrete in Cores C5, C18, C19, C20, and C31 was visually lighter and had a beige tint in contrast to the grayish colour of the other cores (see Figure 1). The colour difference became very noticeable after the fracturing of the samples during compressive strength testing (Figure 4); however, there was no visual difference in coarse aggregate appearance between cores. It should be noted that all beige coloured cores (C5, C18, C19, C20, and C31) were obtained from the foundation walls at the top of the underground level (Level 500) of Building 100.

Figure 1: Sections of Cores C31 (Room 538, South Wall) and C8 (Room 203, West Wall) showing paste colour difference.

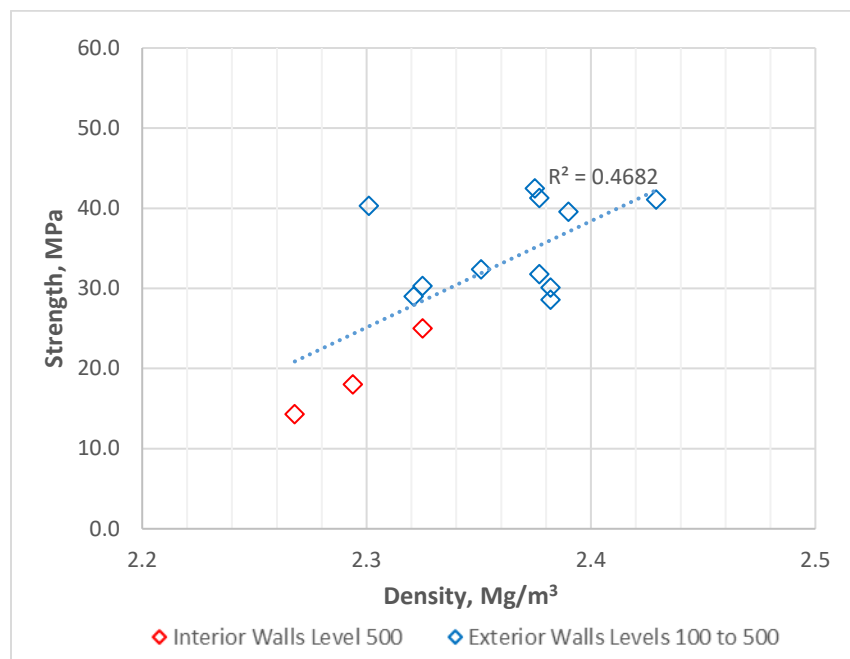
Figure 2: Relationship between Compressive Strength and Density of the tested cores.

The relationship between concrete core density and compressive strength was evaluated (see Figure 2). The R-squared value ($R^2=0.468$) based on the linear trend-line reflects a clear relationship between the two parameters.

During analysis of strength and density values of the tested cores It was noted that most of the low density/strength results (shown in red in Figure 2) were obtained on samples from locations on Level 500 of Building 100.

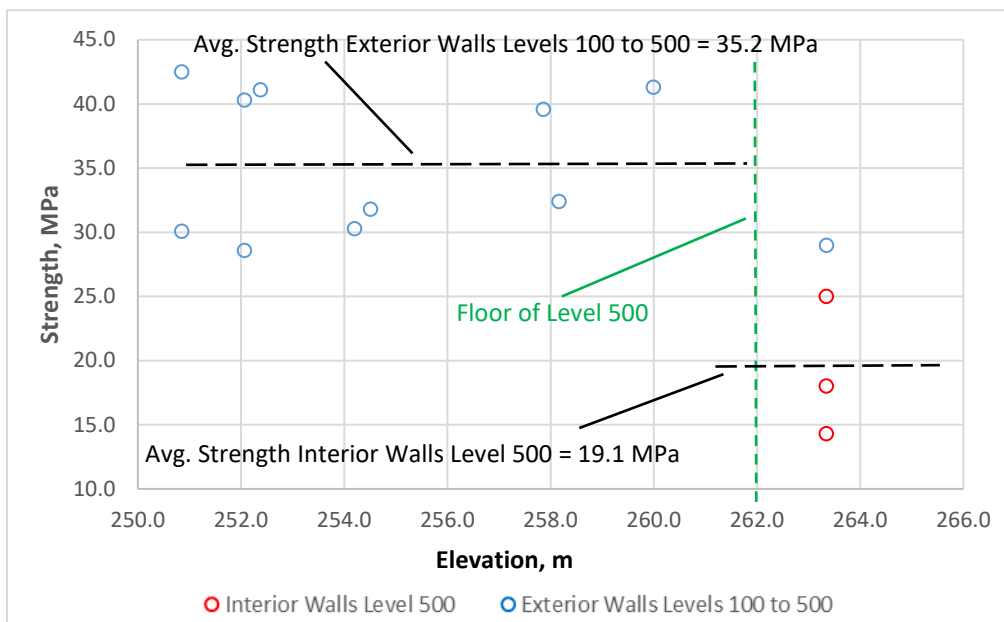
Figure 3: Relationship between Compressive Strength and Elevation of the tested cores.

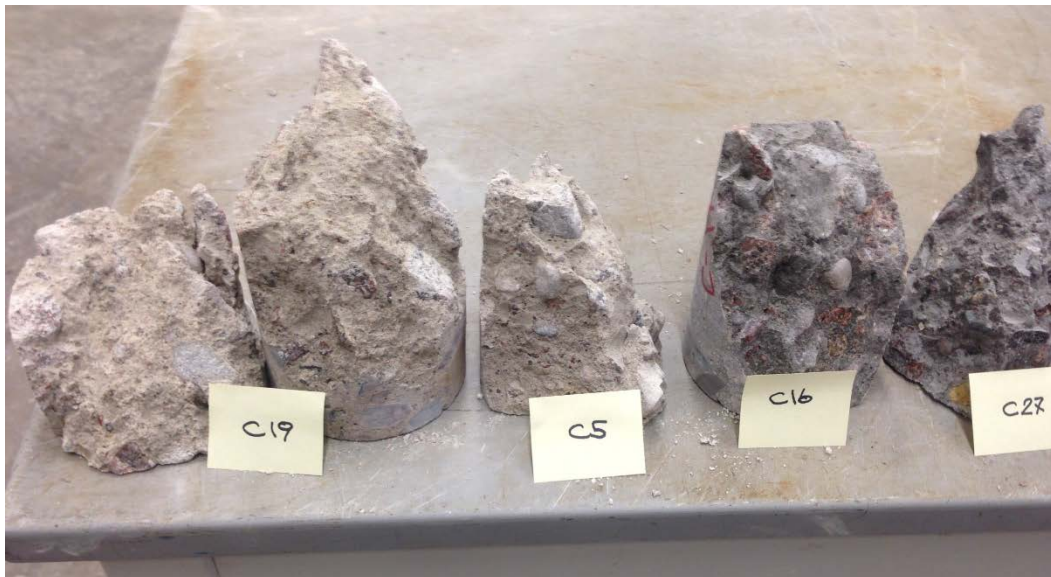
Based on the core visual examination and the compressive strength results, it can be concluded that the concrete of the interior foundation walls of the upper Level 500 (the north, south and west walls) has a different appearance and lower strength than the concrete in the floor slab and Levels 100 to 500 of the exterior foundation walls, confirming that different concrete mixes were used for the interior and exterior structure components.

Figure 4: Cores C19 (West Wall, Room 505), C5 (South Wall, Room 538), C16 (West Wall, Stairs 2), and C27 (Floor slab, Room 111). Note: The different concrete colour between Cores C19/C5 and Cores C16/C27.

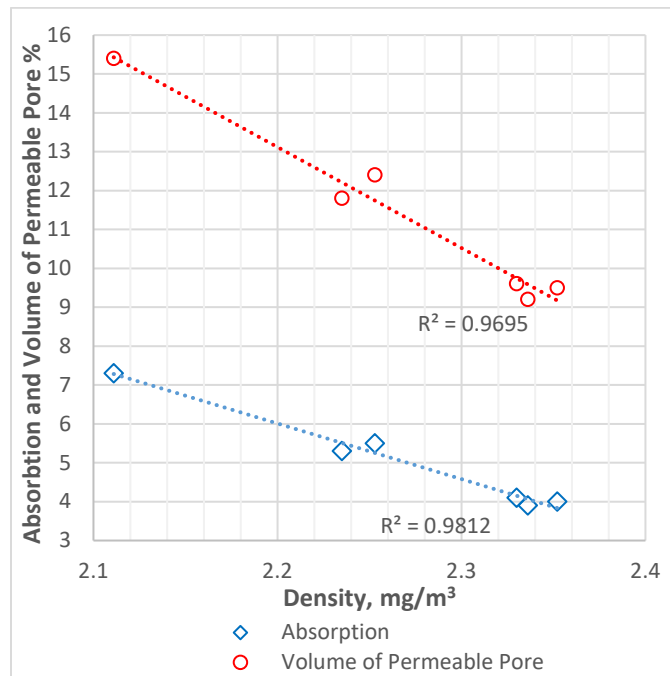
The absorption and volume of permeable pore values for tested cores ranges from 3.9% to 7.9% and 9.2% to 15.4%, respectively, having generally an inverse relationship with bulk dry density: an increase in density led to lower absorption and lower volume of voids values (Figure 5).

The values and ranges obtained for absorption after immersion and boiling and volume of permeable pore space are considered to be typical values for air entrained ordinary heavy concrete with a compressive strength of about 30 MPa.

Figure 5: Relationships between Absorption (blue symbols) and Volume of Permeable Pores (red symbols) and Dry Bulk Density.

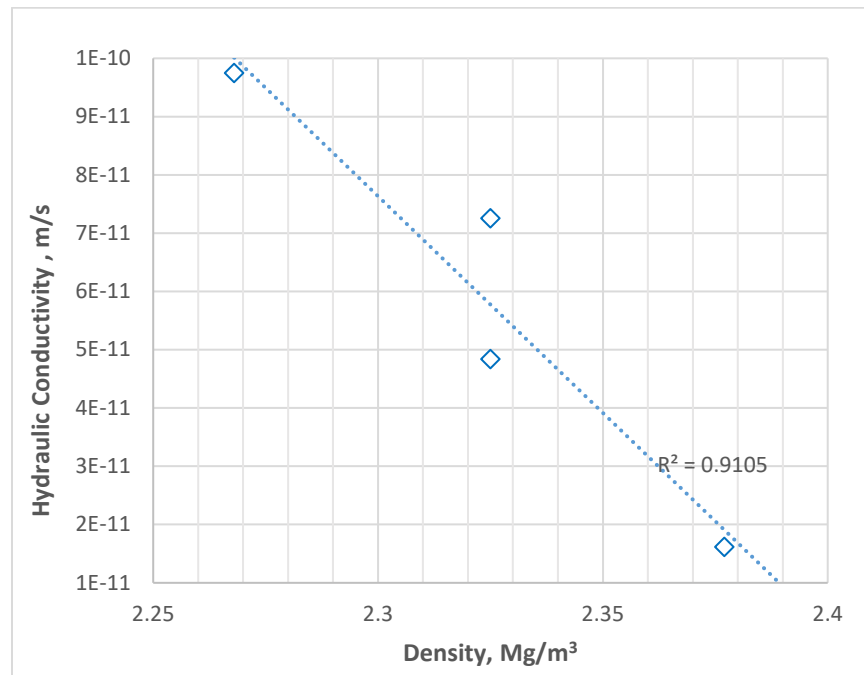
Figure 6: Relationship between hydraulic conductivity and density.

Hydraulic conductivity plotted against compressive strength and density showed inverse relationships between these parameters. Core C18 with the lowest density and, as a result, with the lowest compressive strength had the highest value of hydraulic conductivity, i.e. had the highest permeability among all cores. On the other hand, the densest microstructure of concrete (found in Core C28 which had the lowest porosity) provided the highest compressive strength and the lowest hydraulic conductivity.

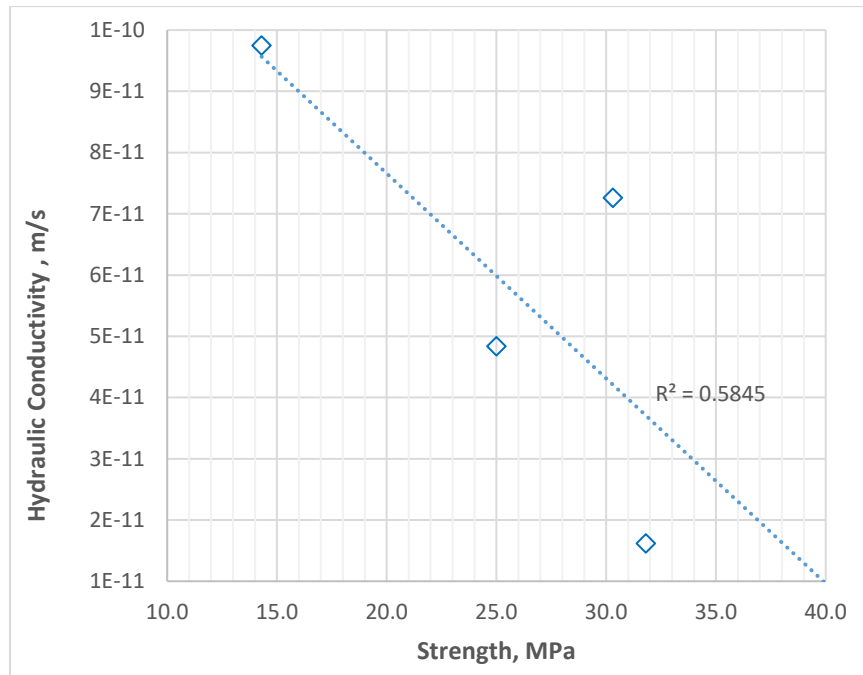
Figure 7: Relationship between hydraulic conductivity and compressive strength.

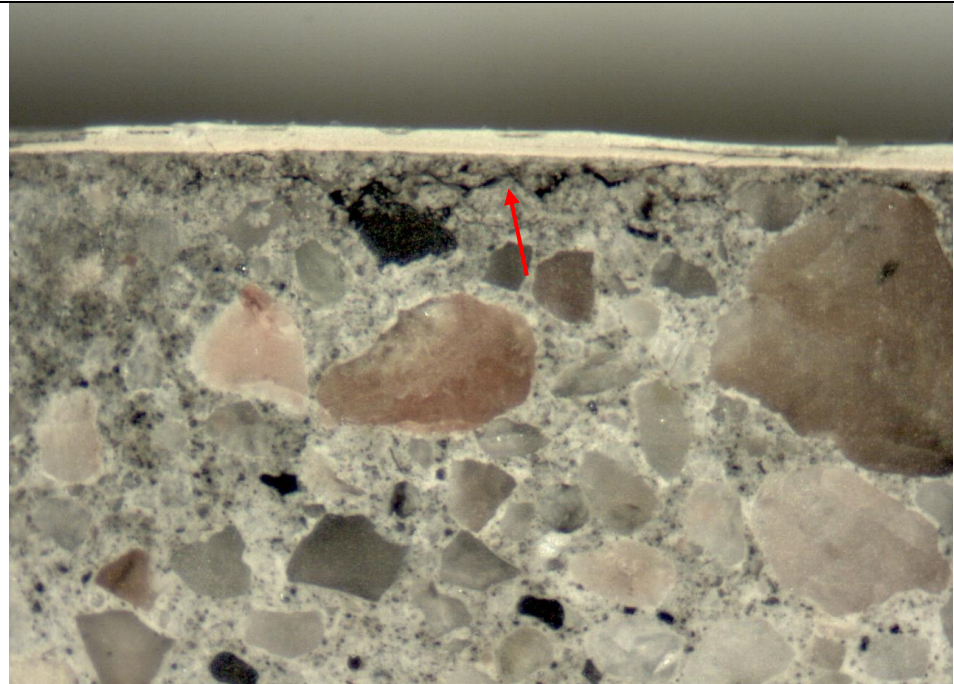
4. View at upper edge of core showing painted surface with minor matrix disturbance (arrow) immediately below the paint coating. Magnification 15x, FOV = 6 mm.

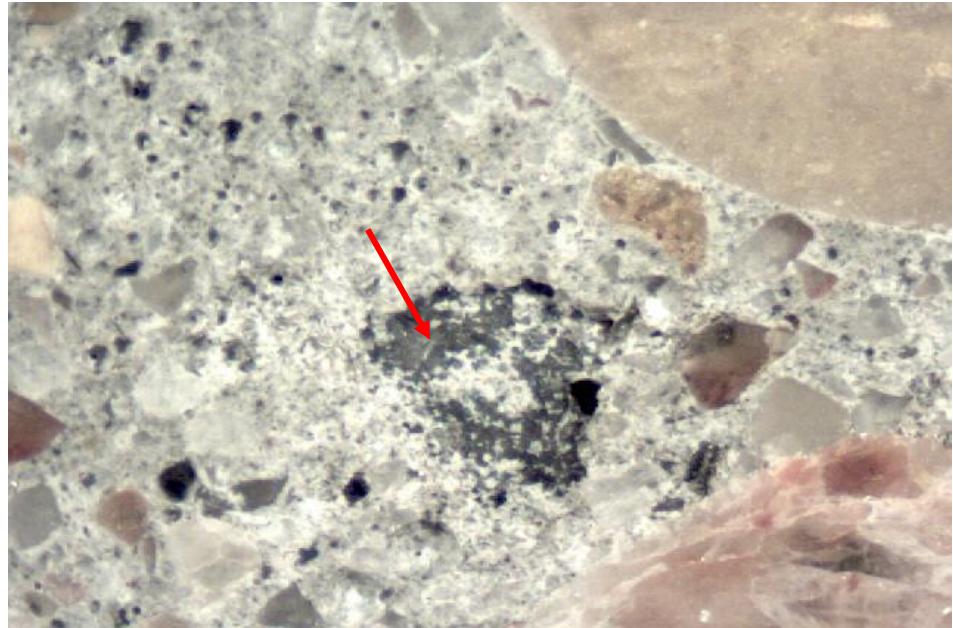
5. View showing disturbed paste having debonded over coarse aggregate; magnification 15 x, field of view 6.5 mm.

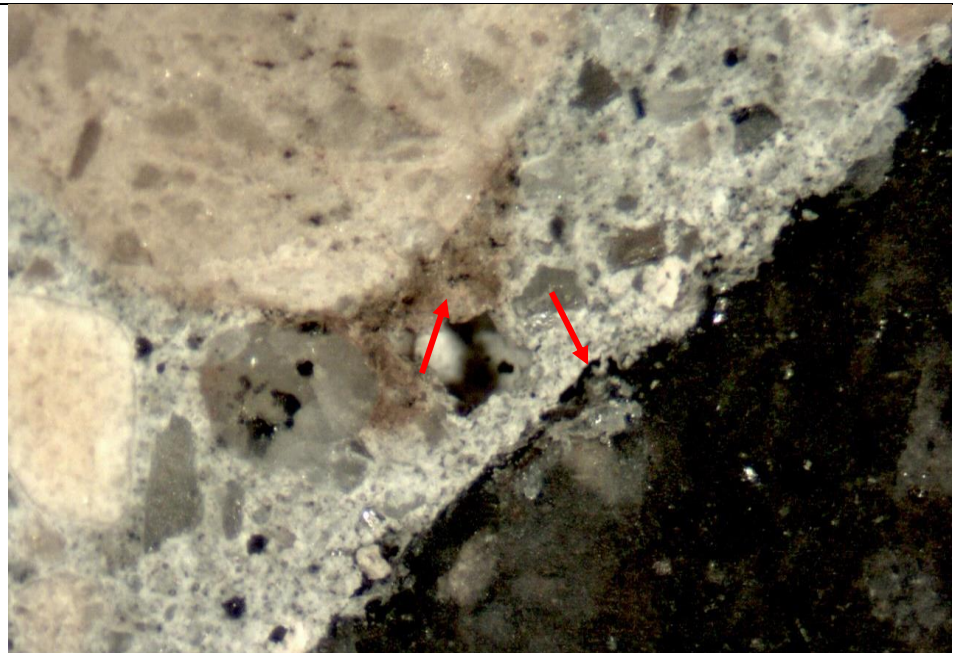
6. View of two aggregate particles with soft/porous paste. Magnification 20x, field of view 4.5 mm.

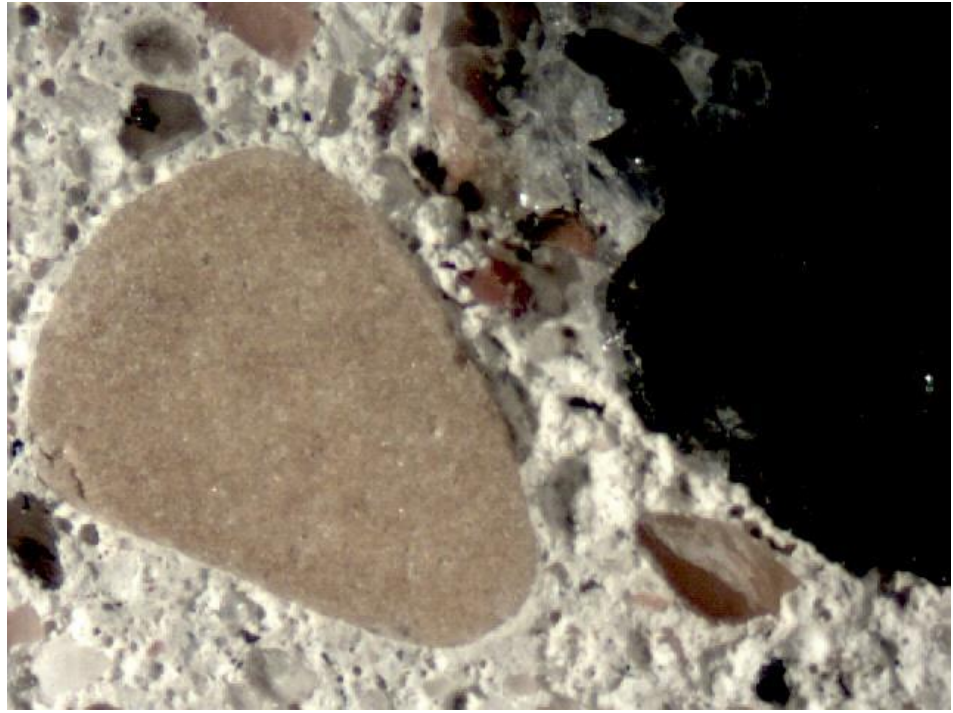
3. Detail of sample showing weak interface zones adjacent two aggregate particles. On the left particle, debonding appears to be underway. 10x magnification, field of view 8.5 mm.

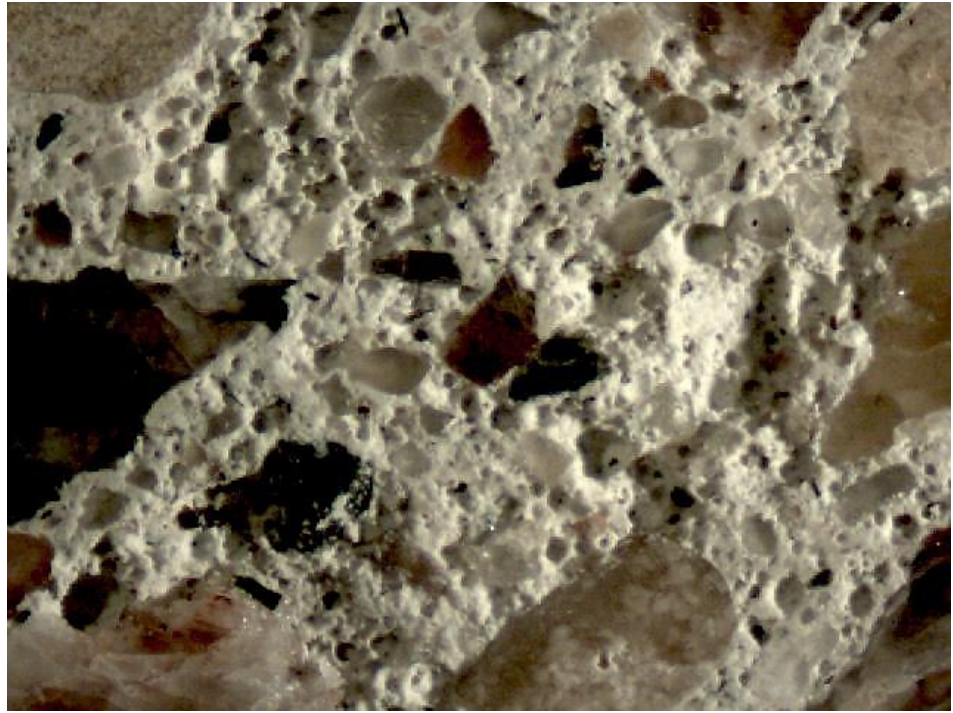
4. View of paste matrix illustrating porosity and poor quality of paste. Numerous voids characterize the paste in this view. Absorption is fast. Enclosure of fine and coarse aggregate is moderate at best. Magnification 10x, FOV = 8.5 mm.

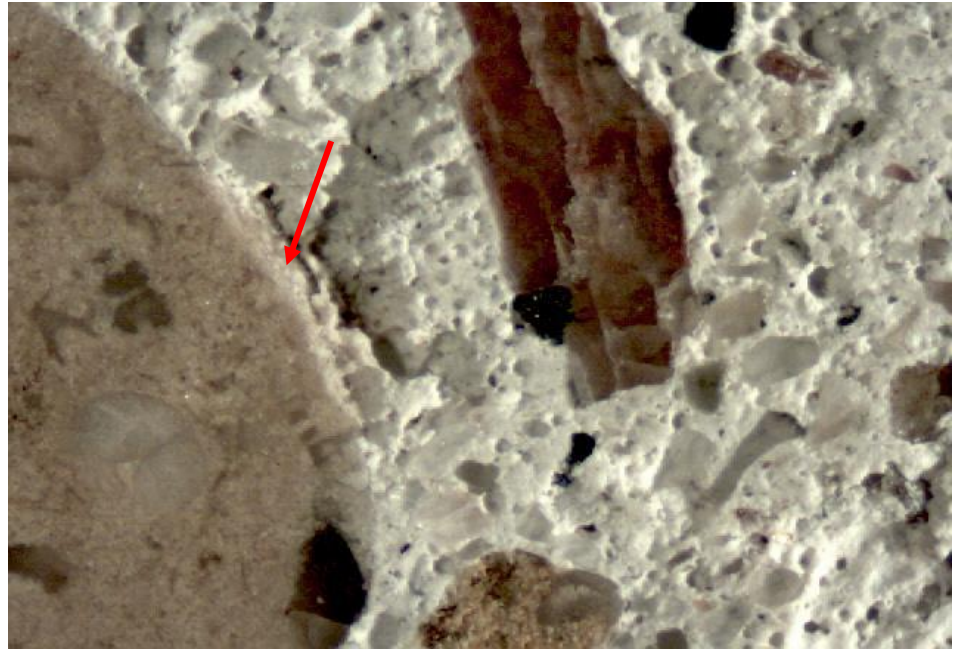
5. View showing weak paste adjacent the limestone coarse aggregate particle at left of view: a portion of the particle's surface is visible (arrow); magnification 15x, field of view 6.5 mm.

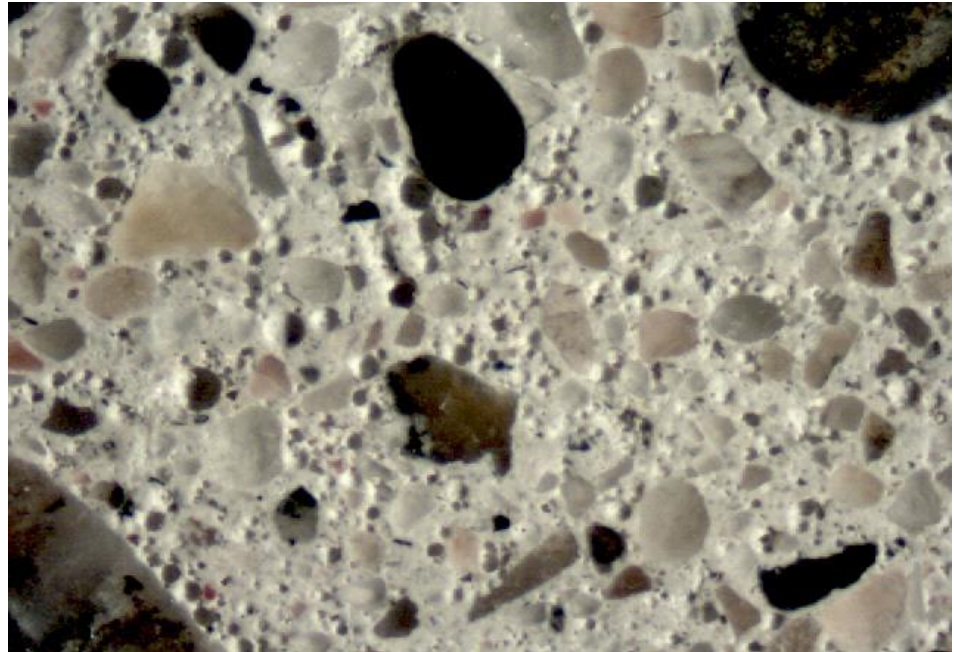
In general, the concrete samples were found to be dense and well consolidated. The concrete was air entrained. The core C18 concrete had an excessive entrained air content (estimated at up to 10%).

6. View of air voids in a paste-dominated portion of the sample. Magnification 10x, field of view 8.5 mm.
