Lake St. Martin Emergency Outlet Channel
Assessment of Effects and Development of Offsetting

Physical Environment Supporting Volume (PESV)

May 2015

A report prepared for
Manitoba Infrastructure and Transportation
by
North/South Consultants Inc. and KGS Group

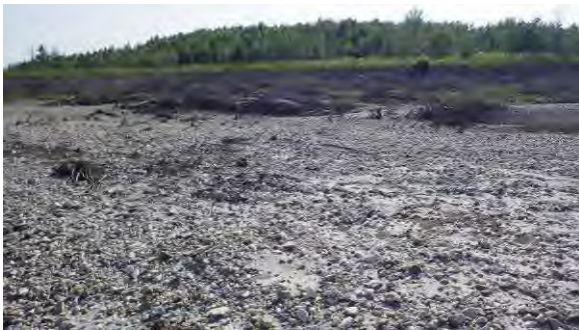
Photo 1. “Bare” substrate observed at 18+000.

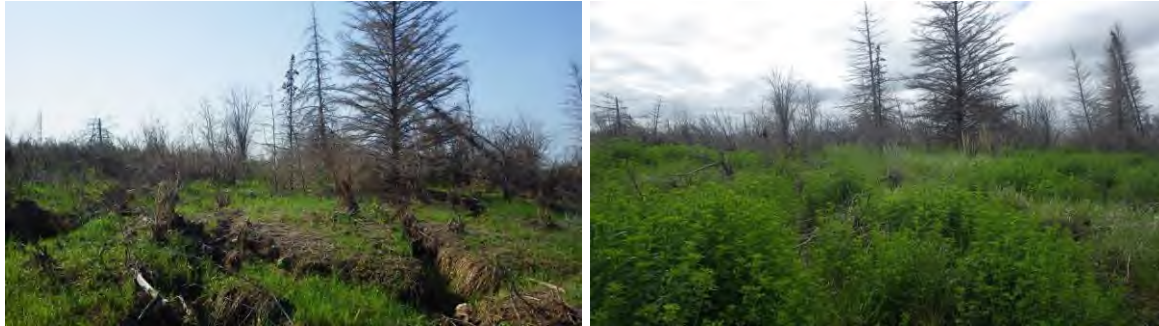
shrubs appeared to have recovered. The flooded area on the right transect appeared to be larger and deeper in 2014 than in 2013, possibly as a result of recent beaver activity. Organic soils were present at the surface on both sides of the creek with depths of at least 2 cm. Beneath the organic soils, a mixture of till, silty clay and gravel were observed.

13+500-Right: Transect from creek in 2013 (left) and 2014 (right).

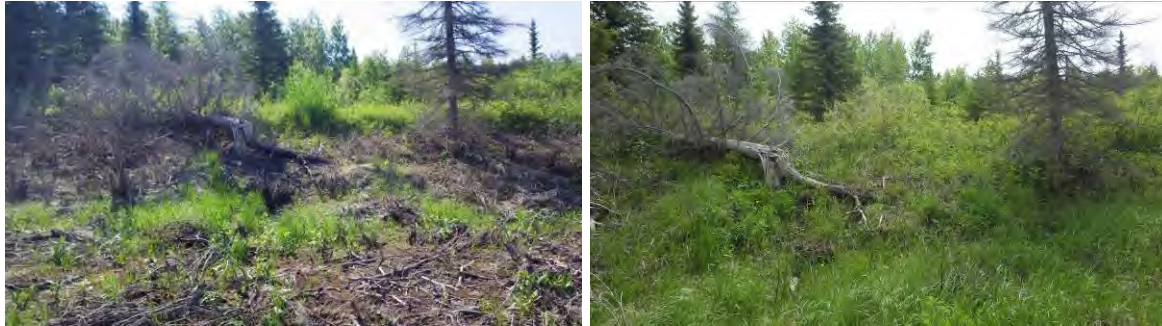
of beaver presence at that location. Similar to 2013, organic soil was present at the surface in 2014 (1-4 cm). Beneath the organic soil was a mixture of silty and sandy clays. An area with gravel deposition was noted approximately 100 m upstream from 14+000 and an area with erosion on left and deposition on right was noted 75 m downstream from 14+000 (photos below).

14+000-Right. Transect from creek in 2013 (left) and 2014 (right).

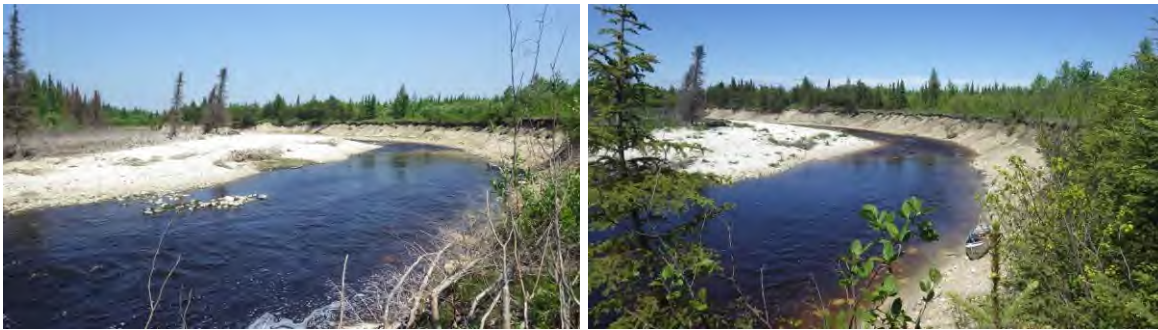
expansive bare area of cobble deposition, and beyond that was a large area of dead shrubs with bare understory. In 2014, little appears to have changed. The right transect still had a steep unvegetated slope with exposed silt, while the left side of the creek still had large areas of exposed cobble. The area with dead shrubs further along the left transect had developed a thick layer of vegetation beneath it which has begun to grow through the dead shrubs. As the high water levels do not appear to have reached above the bank on the right, the vegetative composition appears to be the same between years. The slope on the left side is very gentle and the bank is much further away from the creek. Above the slope, the vegetative composition of short shrubs and young trees followed by larger trees remained the same. Organic soils were present further away from the creek up the slopes. Exposed cobble and silt covered the areas closer to the creek channel. Several areas of significant erosion and deposition were seen both upstream and downstream from transect 15+000 (photos below).

15+000: On right side of creek, looking downstream in 2013 (left) and 2014 (right).

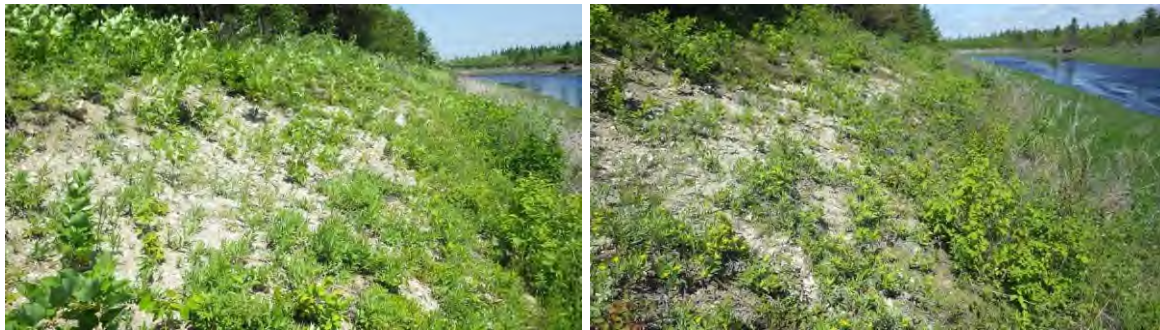
the slopes on each side was outside of the impact zone from the elevated water levels and little change was observed. A mixture of jack pine, black spruce, aspen and willow were observed. Organic soils from 3 to 18 cm deep were observed at the surface in both 2013 and 2014 at most locations on both sides of the creek with clayey silt and silty clay beneath. The slope on the left side had negligible organics and was primarily clayey silt. There doesn't appear to any significant erosion or deposition at this transect.

15+500: Looking downstream on left side of creek in 2013 (left) and 2014 (right).

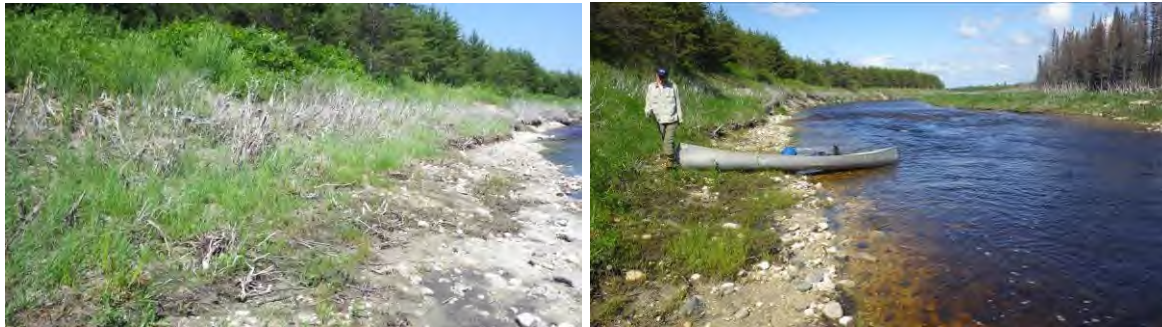
channel, a dense mixture of shrubs and trees which was above the high water level was unchanged between years. Both ends of the transect ended in sphagnum bog. Where bare inorganic soils were not present, 4-5 cm of organic soils overlaid a clayey soil within the flooded portion of the transect. The ends of the transect were in sphagnum and therefore had a thick organic layer which was unchanged between years. An extended area of erosion was present on the left side approximately 50 m downstream from the transect (photos below).

16+000: Left bank, looking downstream in 2013 (left) and 2014 (right).

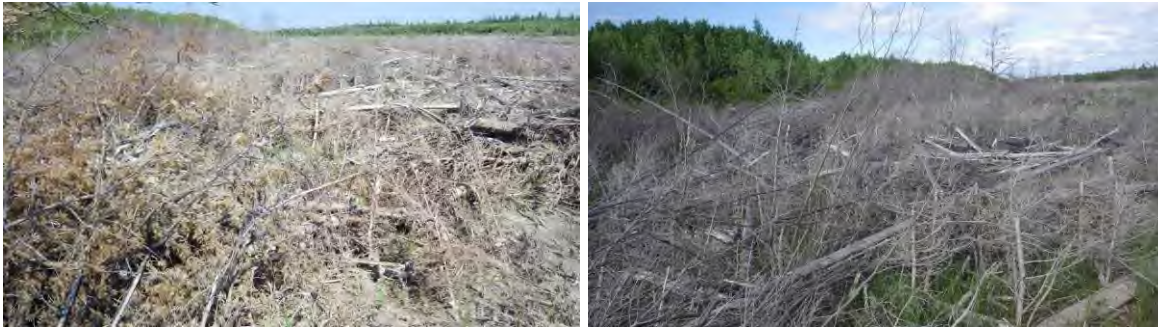
16+500: On left side of creek, looking downstream in 2013 (left) and 2014 (right).

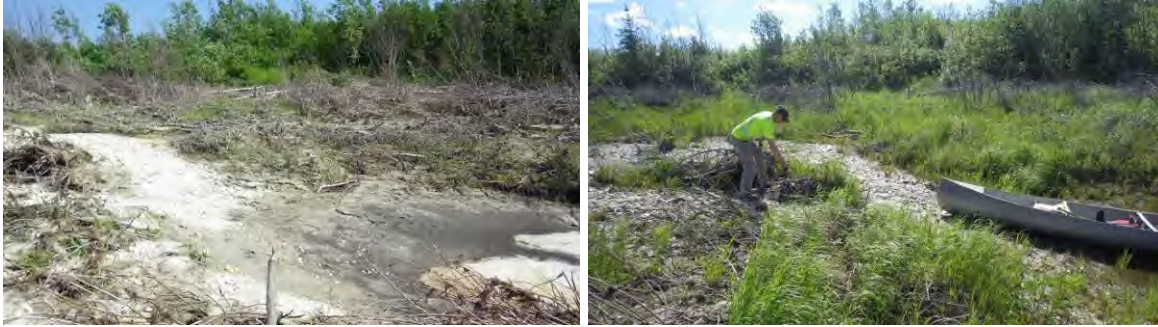
This transect runs in a northwest-southeast orientation and is situated immediately upstream of the beginning of Reach 3. In 2013, both sides of the creek showed a mix of bare cover, grass and dead shrubs extending 10 to 15 m from the creek banks. Bare areas were much reduced in 2014 compared to 2013 as most areas are now covered with a thick grass layer. Larger bare areas consisting of deposited cobbles and sand were still present on the right side of the creek. Dead shrubs observed in 2013 did not recover in 2014, but have become less obvious as they fall to the ground and the grass grows up and around it. Up the slope on the left side of the river is an area of herbaceous plants and very young poplar trees which transitions into a mixture of trees and shrubs comprised of poplar, willow and alder. This area is above the high water mark and did not change between years. A similar mixture of taller shrubs was observed on the right side of the river. The transect on the right side ended in wet peaty bush. Soils near the creek show signs of deposition of inorganic clayey silt, coarse sand, and gravel above the organic soils (1-5 cm). Above the creek banks, organic soils were observed at the surface at depths of 10 to >15 cm.

17+000: Right transect from near creek bank in 2013 (left) and 2014 (right).

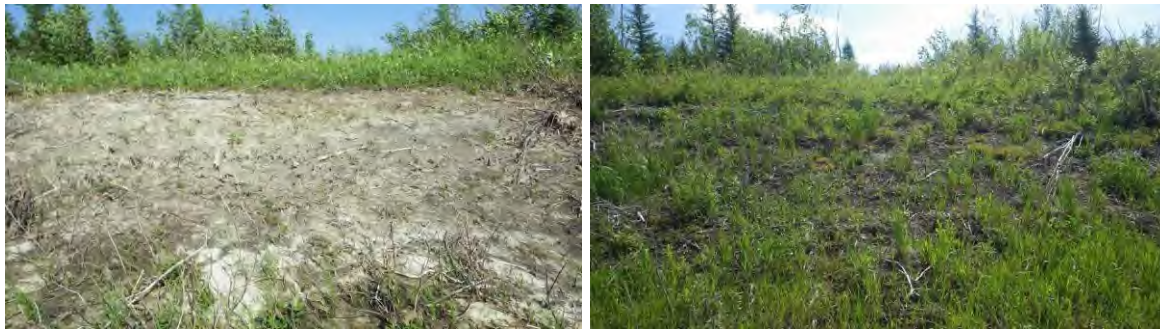
appear to have breached the bank, and the vegetative community noted above the bank did not change between years. The left side had a gentler slope as this was the inside bend of river. Beyond the large area with dead shrubs and inorganic deposition, was an area with live shrubs where it appears high water levels did not reach. Inorganic soils overlay organic soils at most locations sampled along this transect. Soils on the left side were mainly sand near the creek and silt further away from the creek. On the right side was a mixture of silts and clays. Areas with sand were 3 to 15 cm deep, while silty soils ranged from 1 to 5 cm deep. Peat was observed at the end of the right transect

17+500: Right bank seen from creek bank in 2013 (left) and 2014 (right).

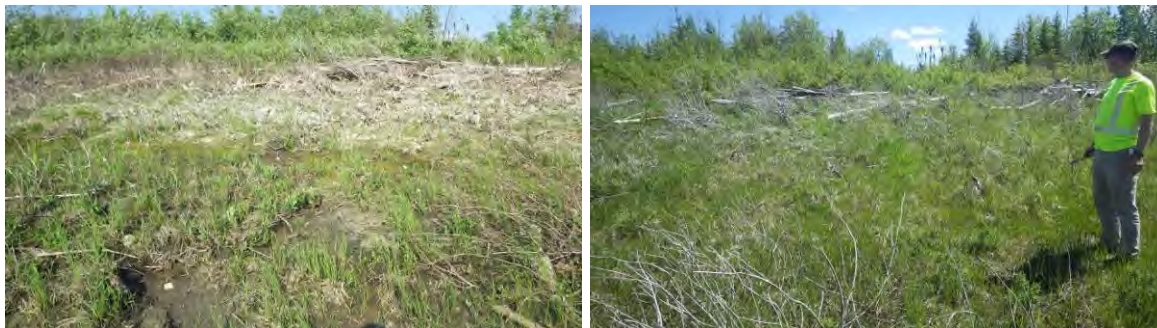
This transect runs in a northeast-southwest direction at a relatively strait section of the creek. A large bare area (20 m) of cobble and gravel was observed on the left side of the creek in 2013. In 2014, this area looked very similar as only a small area was revegetated. Beyond the bare exposed area on the left side in 2013 was a band of dead shrubs (17 m) which was also bare beneath. When visited in 2014, much of this area was now covered by grass, but up to 40% of some areas remained bare. The dead shrubs and trees did not recover. Beyond this, as the slope increased, an area of short shrubs (herbaceous and young poplar) transitioned to taller shrubs (alder) and then to trees. This area appears to be outside of the impacts of high water and was unchanged between years. On the right side of the river, the first 18 m were largely bare soil with grass and some dead shrubs in 2013. In 2014, this area was entirely covered by grass, but dead shrubs still protruded above. Up the slope and beyond the impact area of high water, shrubs transitioned to trees with a largely sphagnum understory which was unchanged between years. Depositional inorganic soils were noted at most sites along this transect, but particularly on the left side. On the left side, large areas of sand, gravel and cobble were observed closer to the creek, while further from creek, organic soils are overlain with 0.5 to 5 cm of silt. On the right side of the creek, a thin layer of organic soil overlaid silt which was above the organic soil.

18+000: Right transect seen from creek bank in 2013 (left) and 2014 (right).

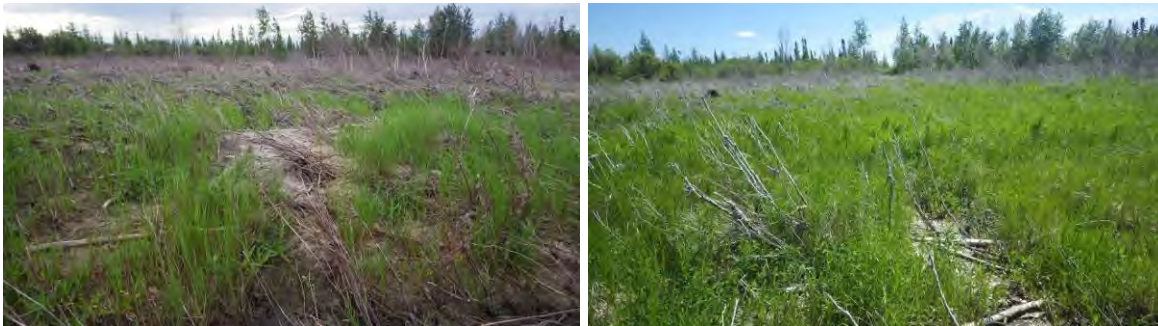
This transect runs in a northwest-southeast orientation. In 2013, bare areas with dead shrubs and grass were observed on both sides of the river, however most extensively on the right side. In 2014, the bare areas were much smaller (5%) as most of the area was covered with thick grass. The dead shrubs and trees did not recover, but new vegetation was beginning to grow beneath and through the dead shrubs and trees. Above the slope on the left side, and beyond the high water impact zone, the understory was largely sphagnum beneath shrubs with a small percentage of trees in both 2013 and 2014. On the right side, beyond the dead shrub area, vegetation transitioned to shrubs, then largely trees before ending in a grassy marsh area with standing water. This area was unchanged between 2013 and 2014. In 2013, inorganic soils were observed at the surface adjacent to the creek on the right side, while elsewhere 2-7 cm of organic soils were measured at the surface. On the right side in 2014, sand was noted near the creek, and deposited silt was noted throughout the area where dead shrubs and trees were seen. On the left side in 2014, a small amount of silt deposition was present above the organic soils. Peat was present at both ends of the transects in both 2013 and 2014. During the 2011 survey, this area was inundated by a beaver dam which flooded areas near the channel. No beaver dam was observed in 2013 in 2014 whoever a beaver lodge was present.

18+500: Right transect seen from creek bank in 2013 (left) and 2014 (right).

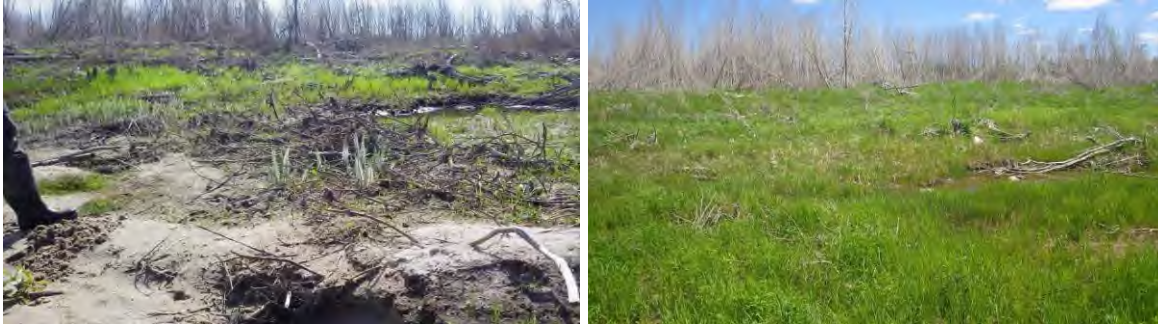
sand (5 cm) were measured. On the left side in 2014, a mixture of deposited silty clay, silt and sandy silt was observed for the majority of the transect.

19+500: Right transect seen from near creek bank in 2013 (left) and 2014 (right).

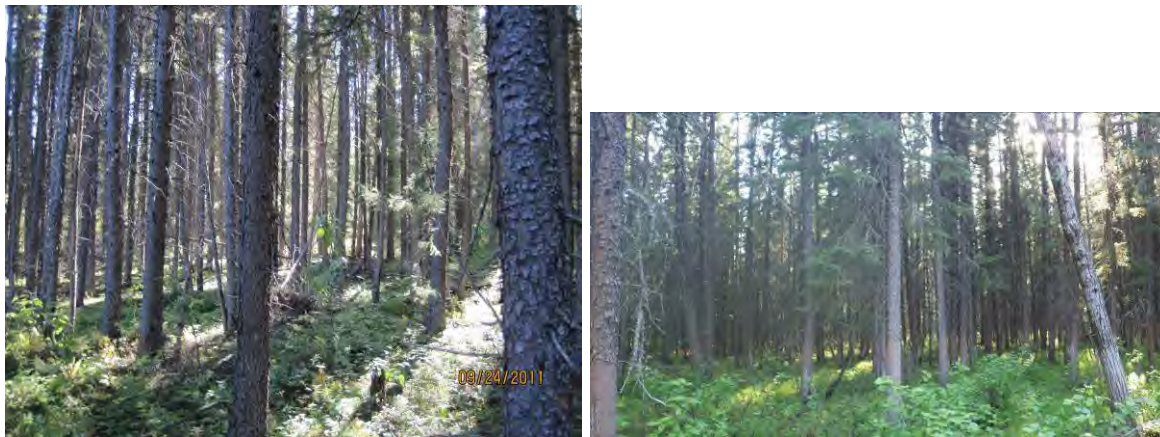
22+500: Mature spruce trees and herbaceous understory in 2011 (left) and 2014 (right). Note high water mark in 2014. (Photos not from exact same location)

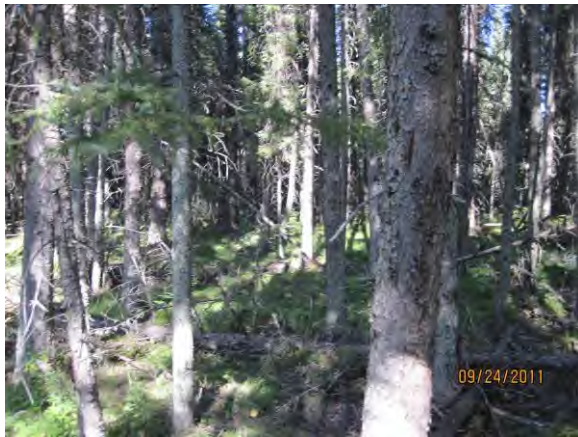
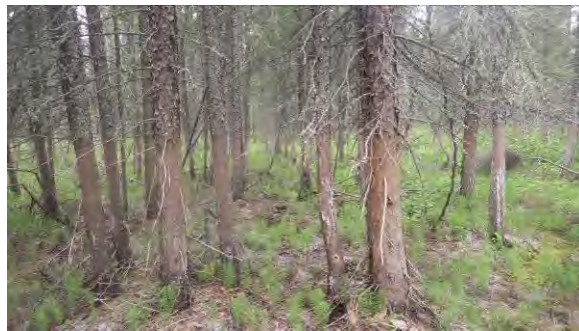
23+000: Mature spruce trees and herbaceous understory in 2011 (left) and 2014 (right). Note high water mark in 2014. (Photos not from exact same location)

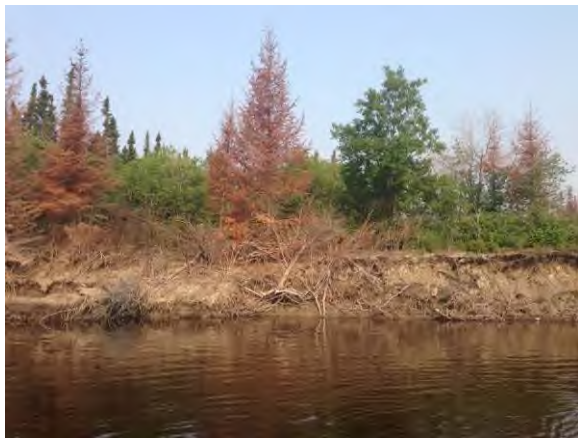
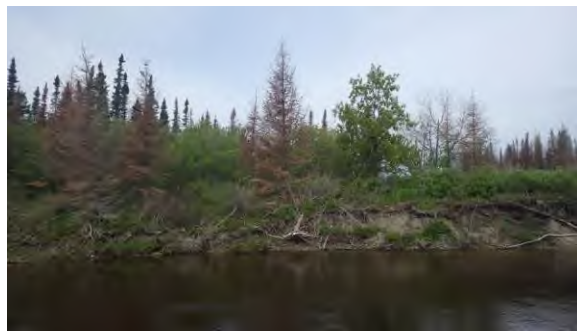
High water levels forged new creek channels immediately downstream from the transect, essentially short-cutting the previous meandering route. While water continues to pass through the previous channel, it appears the majority of water now goes through the new channels, particularly during low water conditions.

24+000: Looking across creek at left transect from right bank in 2013 (left) and 2014 (right).

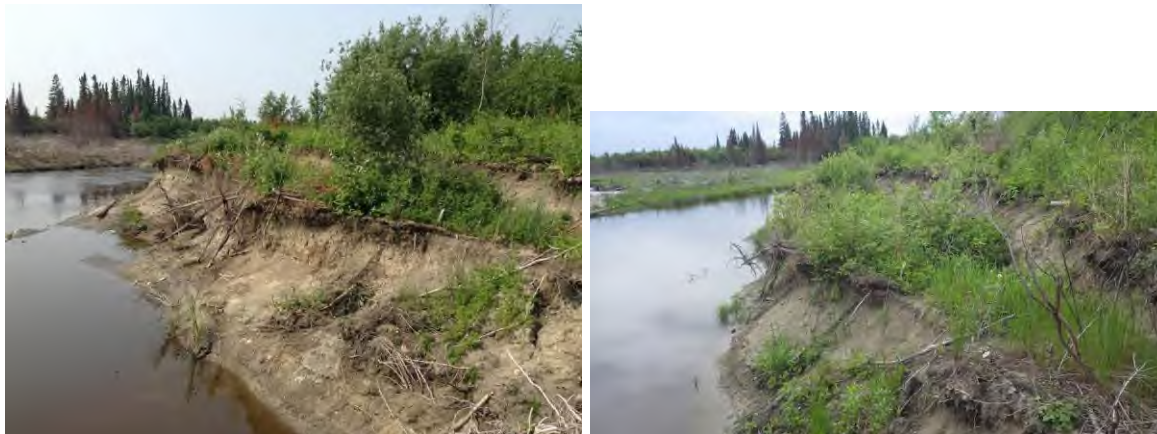
bank which appears to have slumped (see photo below). At the top of the slope were shrubs which were followed by deciduous trees and then coniferous trees. The right side in 2013 was less steep and had dead shrubs and a bare understory until 36 m. Much of the area consisted of exposed cobbles, gravel and sand. Beyond this was a mixture of live trees and shrubs. In 2014, the slumped bank was still present and had minimally more vegetation on it. Above the slope, a similar composition of shrubs and trees was observed. The right side in 2014 still had a bare cobble area adjacent to the creek although patches of grass had grown in a few locations. Beyond the cobble, thick grass was growing within the dead shrubs until near the end of the transect where the transect leaves the dead zone and live trees and shrubs are encountered. A fair bit of debris (logs, branches) was deposited within the dead shrub area. In 2013, 1 to 4 cm of inorganic soil overlaid organic soils near the creek, except for the large areas of cobble which were deeper. Organic soils were present on the surface further from the creek on both sides. In 2014, the bank slump on the left side was identified as being mainly silt. Above the bank, trace silt was present above organic soils. On the right side in 2014, 10 cm of silty organic soil was observed above silt within the grassy area with dead shrubs. Peat was present at the end of the right transect. An area with cobble and gravel deposition was observed approximately 200 m upstream from the transect at a sharp bend in the creek (photo below).

25+000: Bank slump on left side of creek, looking upstream in 2013 (left) and 2014 (right).

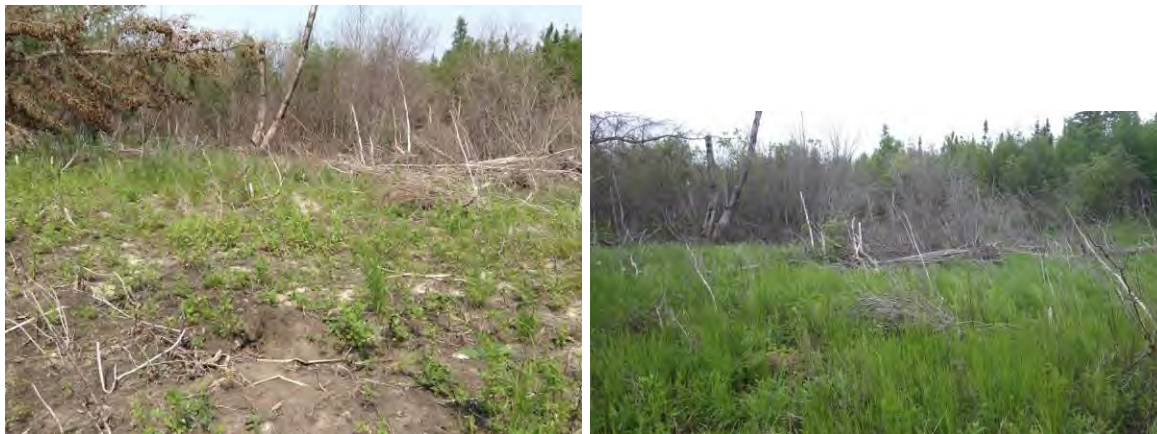
m where the transect entered 100% live trees. In 2014, none of the dead shrubs or trees recovered. The first half of the left transect was fully grassed over while a more herbaceous layer was present further along the transect closer to the dead trees. The right side in 2014 was fully grass-covered near the creek with a more herbaceous groundcover seen within the dead shrubs. Some accumulated debris (branches) was also noted on the right side. Soils in 2013 had 2-5 cm of inorganic deposition above organic soils near the creek, and throughout the left transect. Organic soils were observed on the surface on the right side after the first 20 m. In 2014, 15 cm of sandy silt was measured above organic soils near the creek on the left side, while organic soil was noted on the right side of the creek. An area of erosion was noted on the on right side approximately 175 m downstream from transect (photo below).

26+500: Right transect from shore in 2013 (left) and 2014 (right).

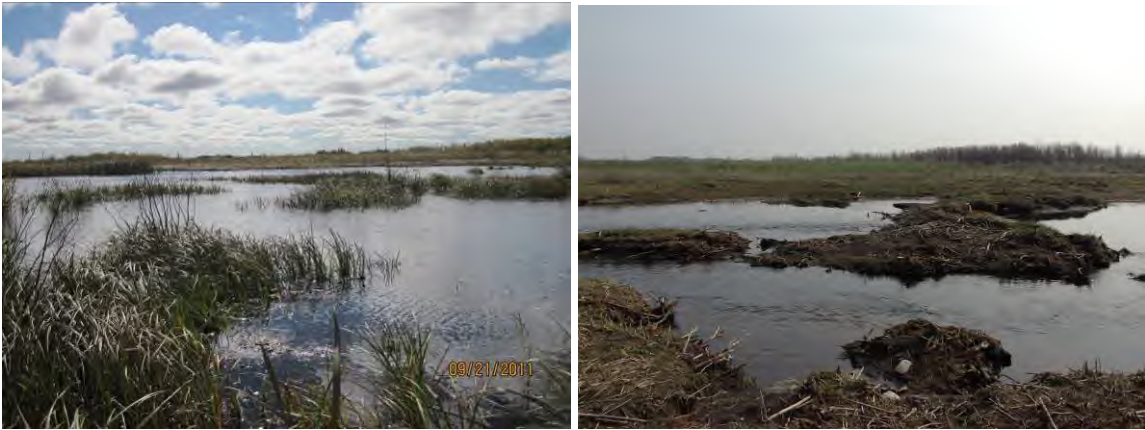
Photo 5. Buffalo Creek at transect 13+000 (left photo: 2011 ; right photo: 2013)
