Revised Phase 1 Environmental Site Assessment  
- Fifteen Mile Stream Project,  
Stantec Consulting Ltd.

**FINAL -  
Revised Phase I Environmental Site Assessment**

Fifteen Mile Stream  
Route 374, Trafalgar, NS

September 27, 2019

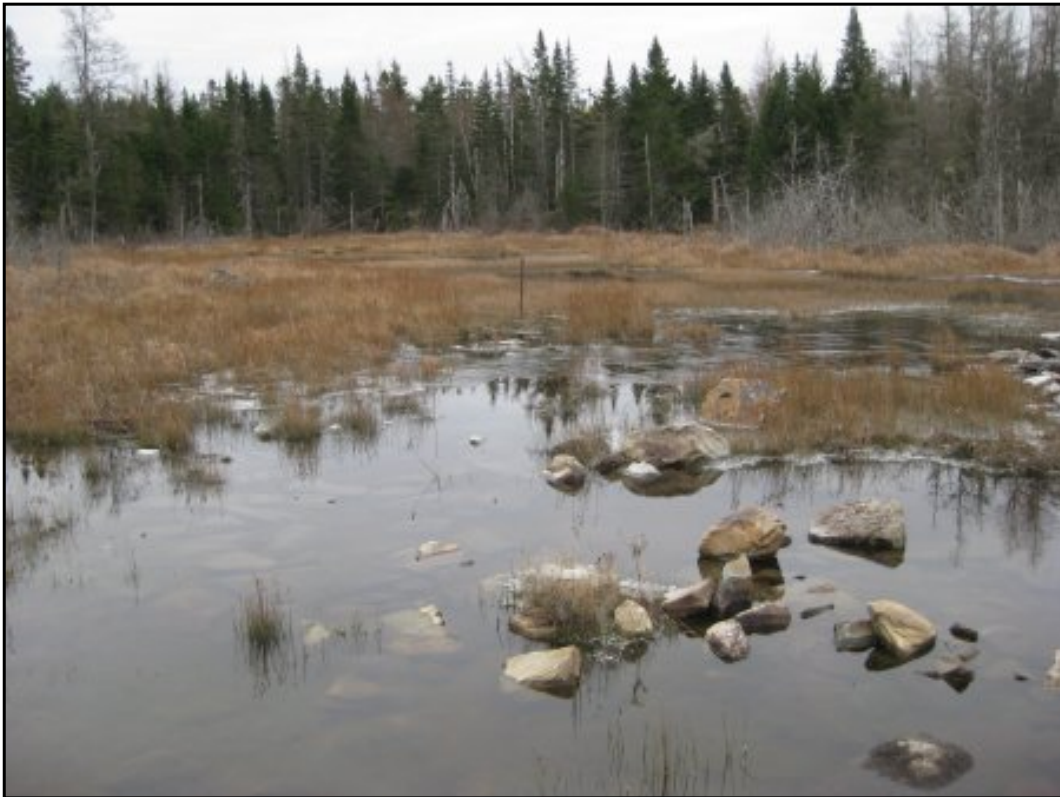
Wetland in the central area of the proposed pit location - apparent tailings along the edges

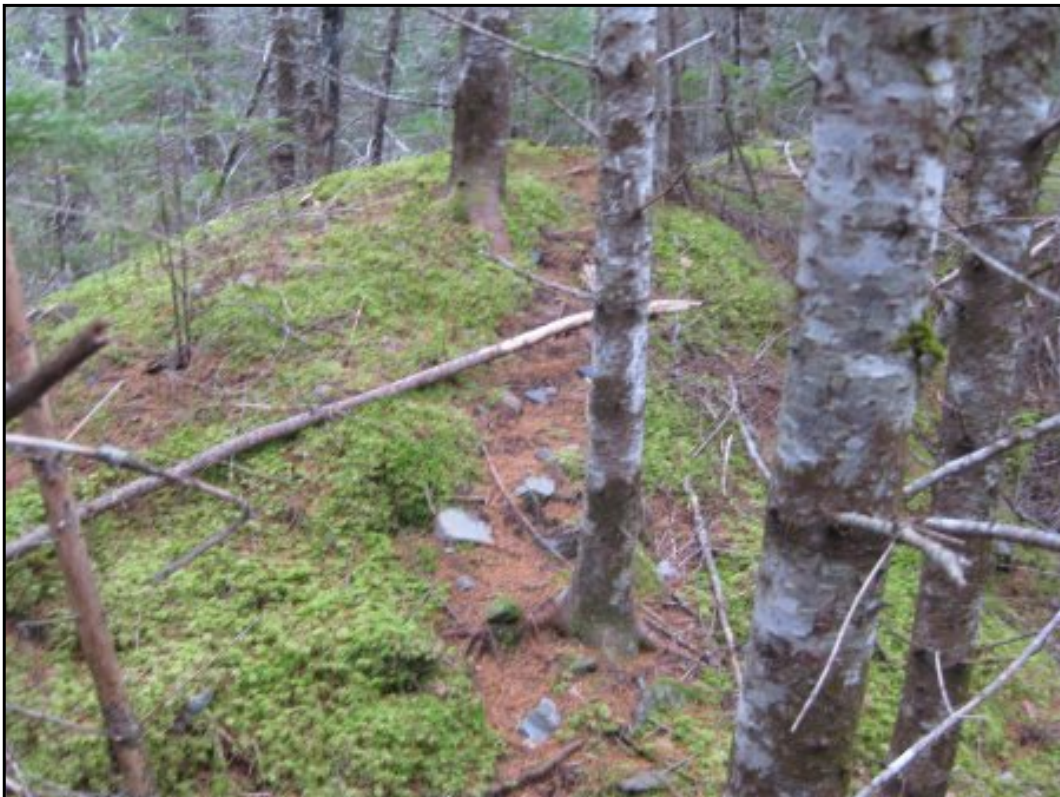
Typical moss covered waste rock piles on the Site

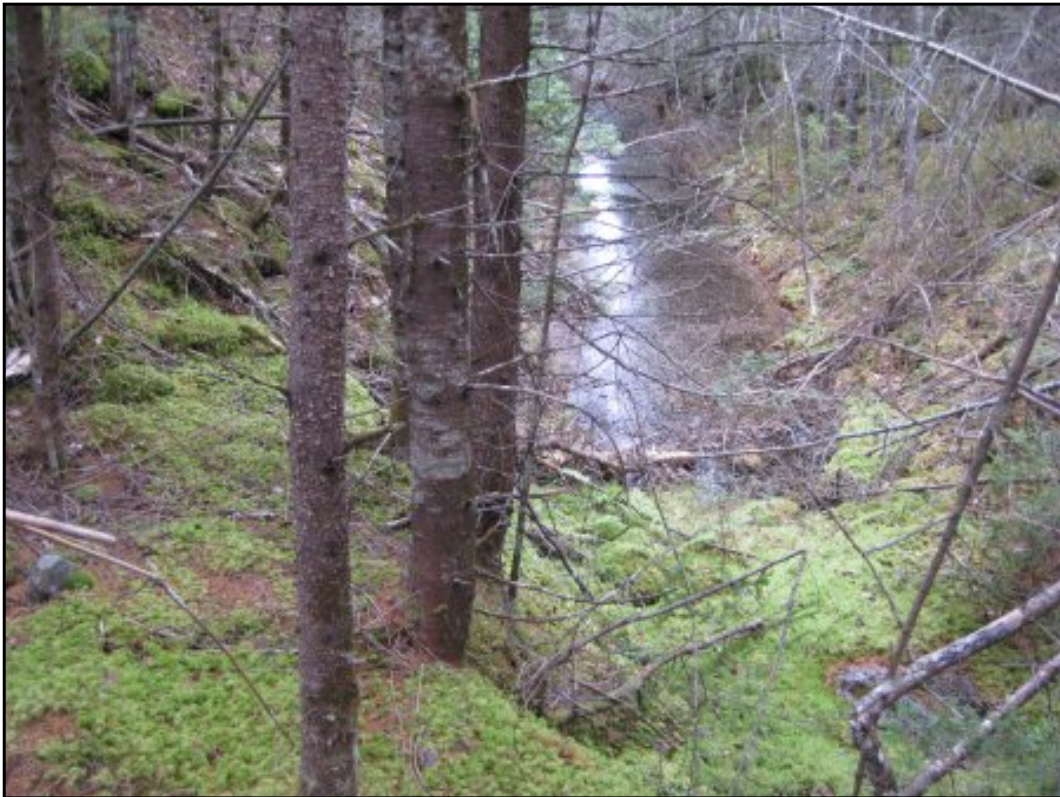
Typical historical mine working / trench with moss covered waste rock

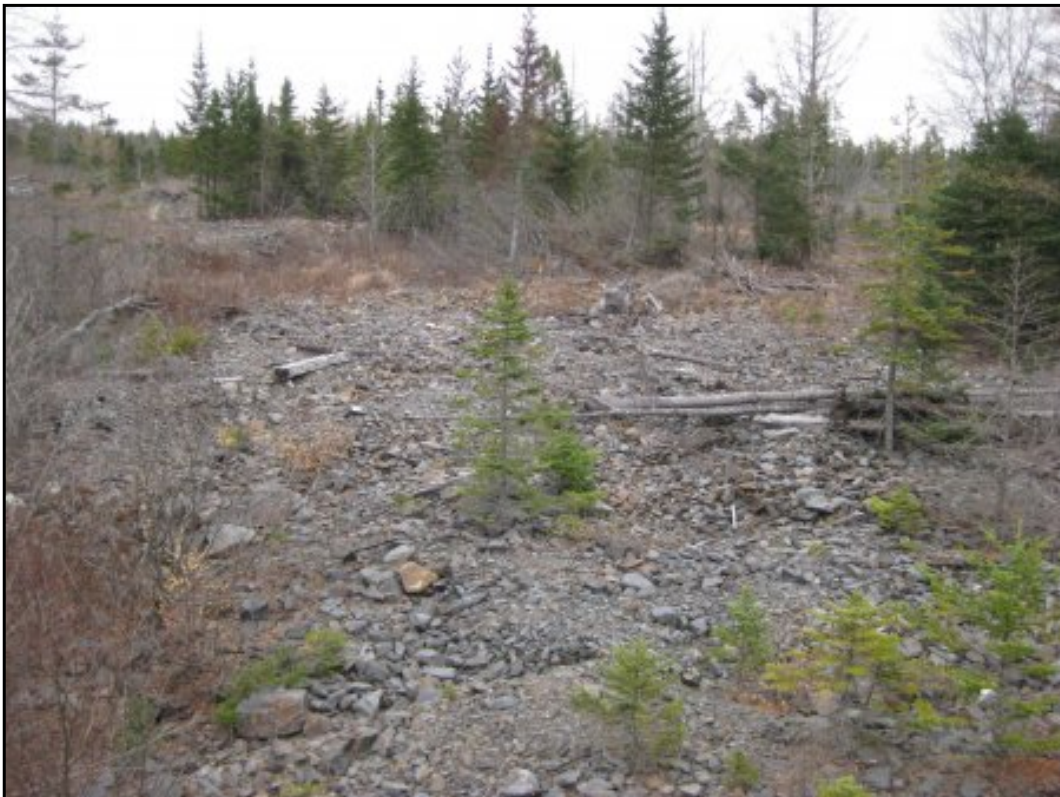
Exposed waste rock in the area of the proposed Pit

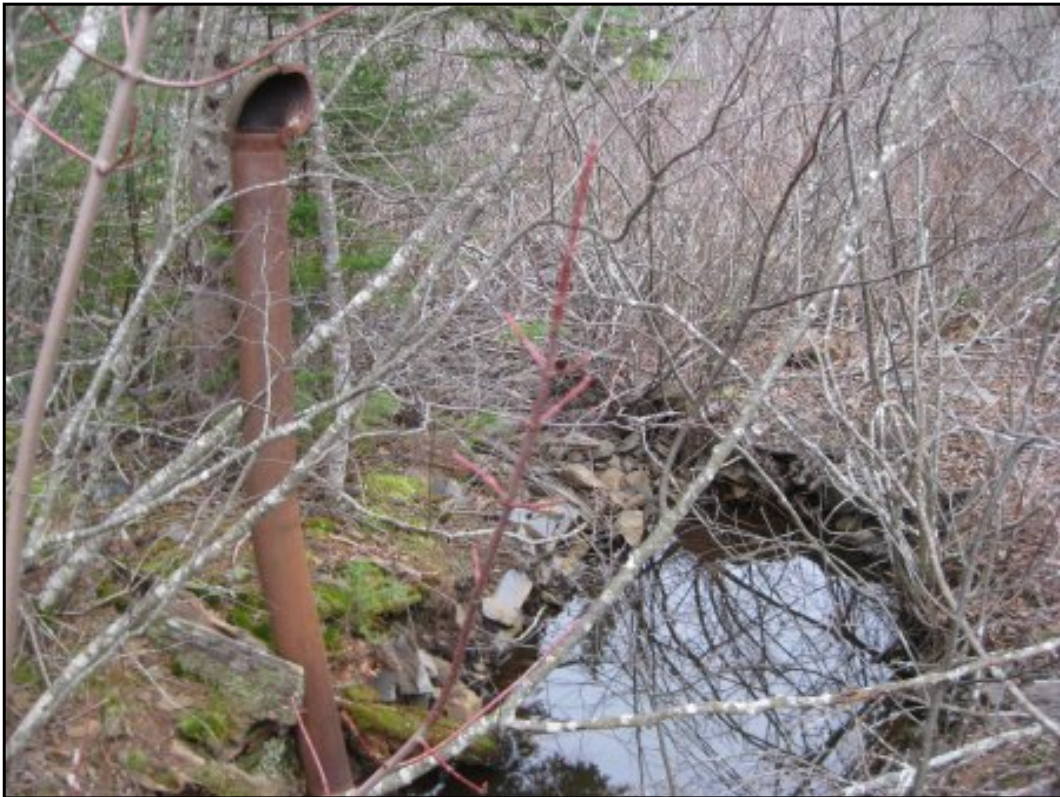
Typical water filled excavation, potential shaft

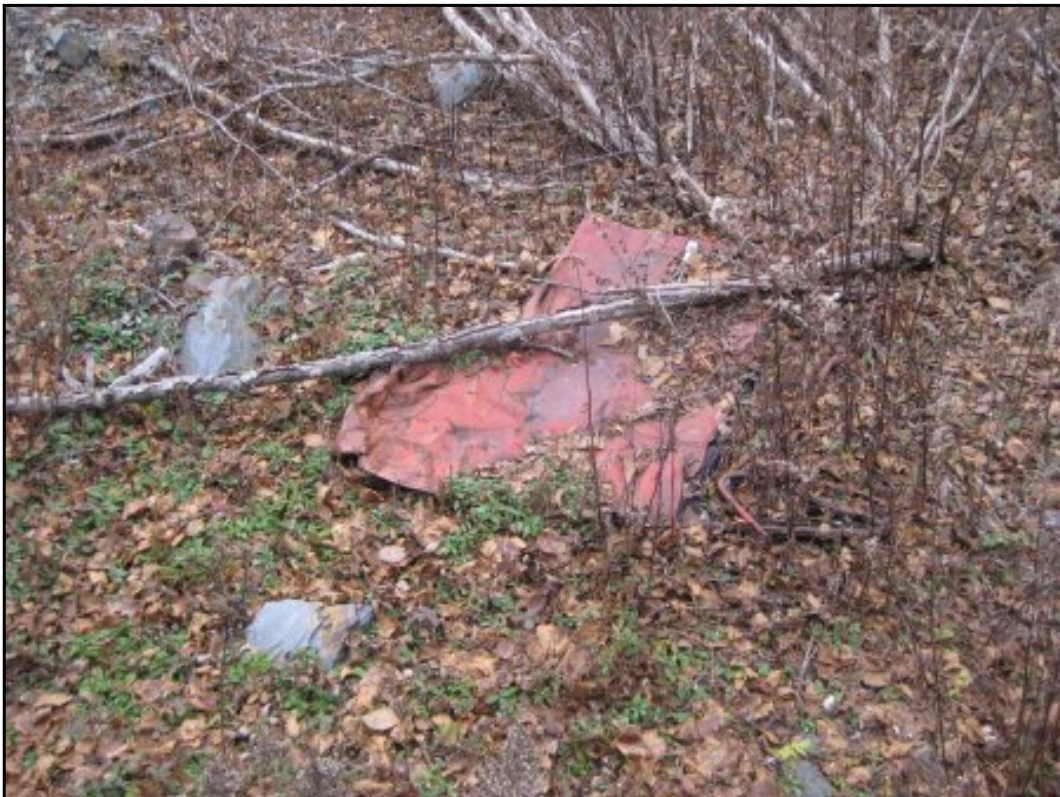
Typical metal debris present on the Site

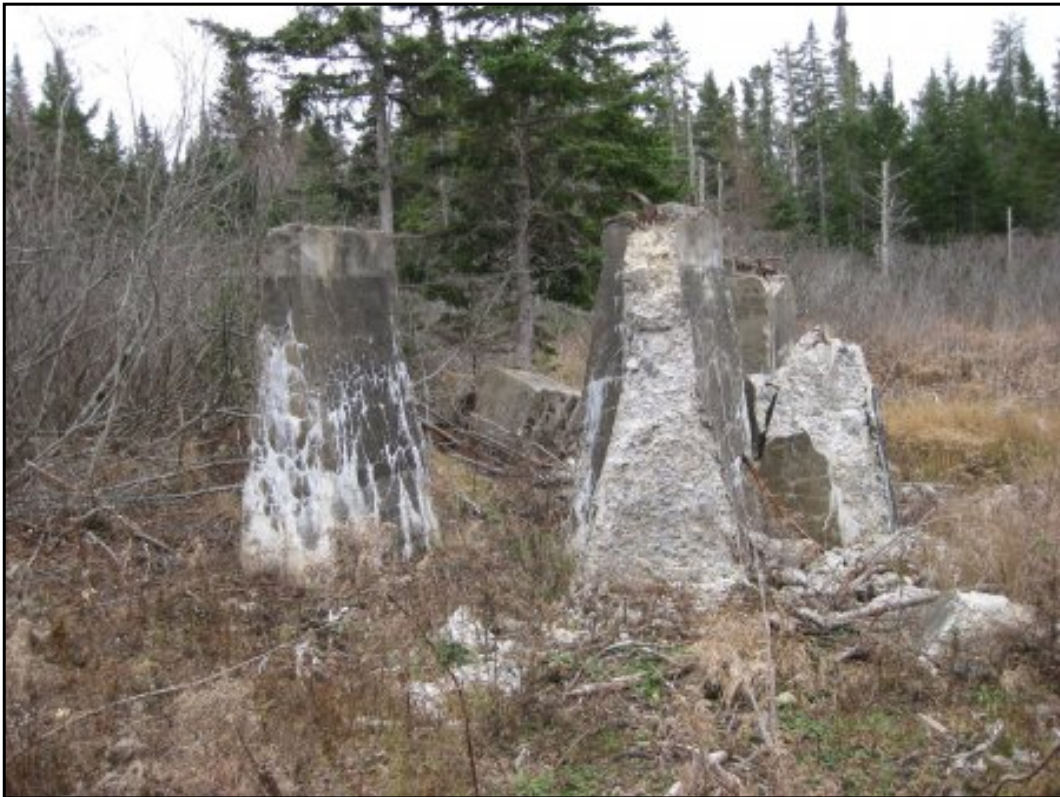
Concrete foundation to the south of the gravel access road

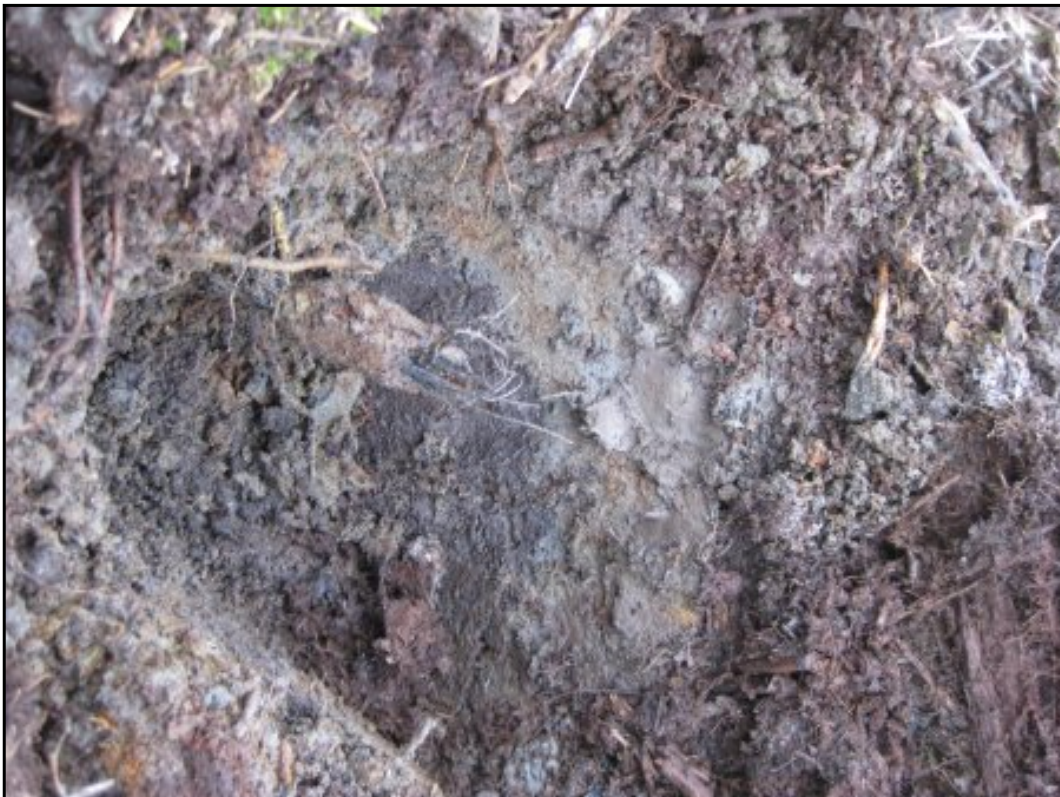
Typical grey / dark grey sand apparent tailings under a layer of organic material

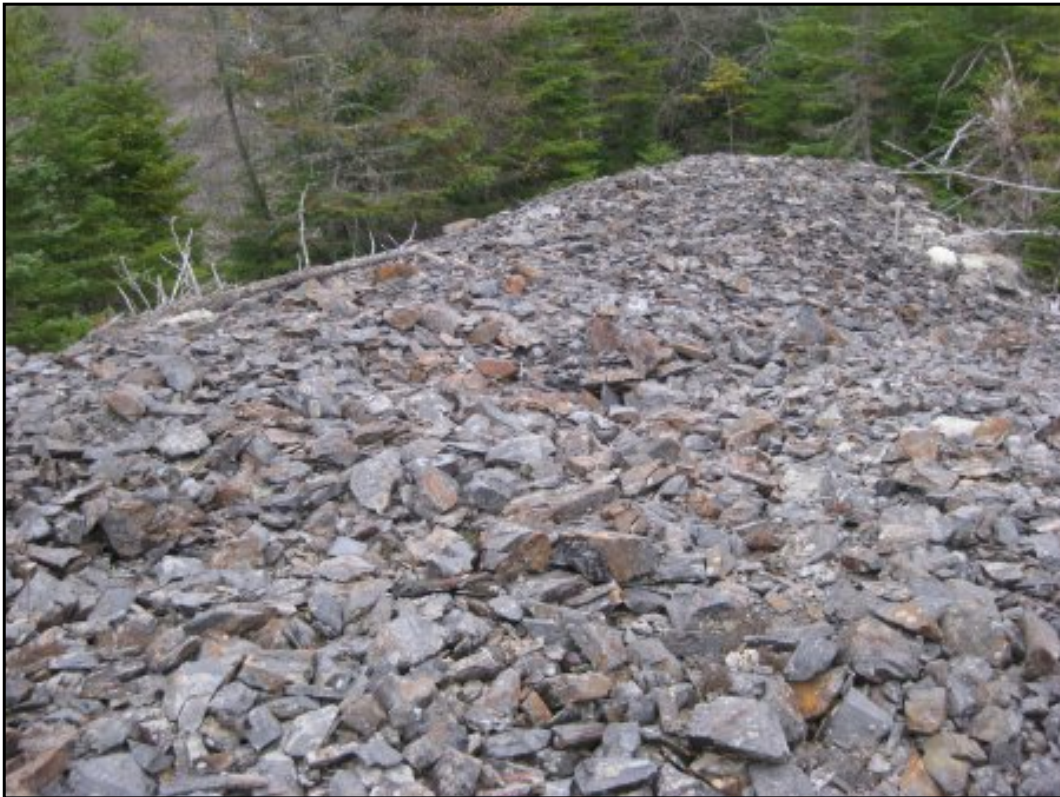
Exposed waste rock pile several metres high to the south of the gravel access road

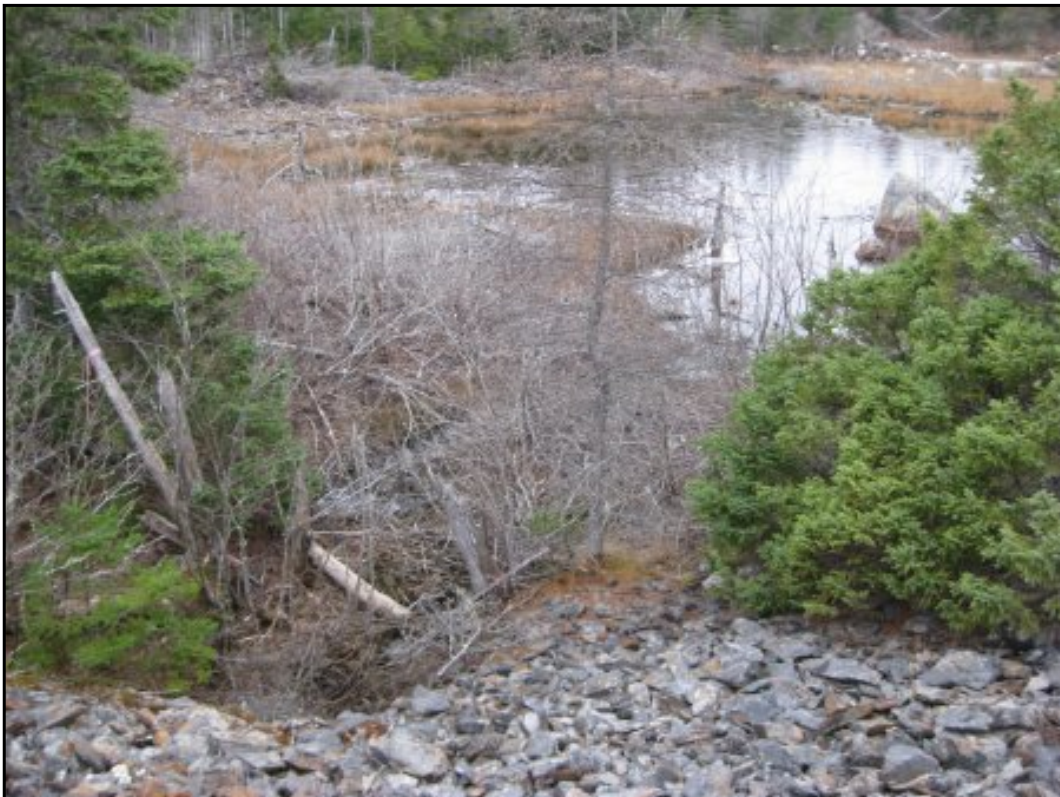
Stressed vegetation (dead trees) adjacent to the waste rock pile and wetland

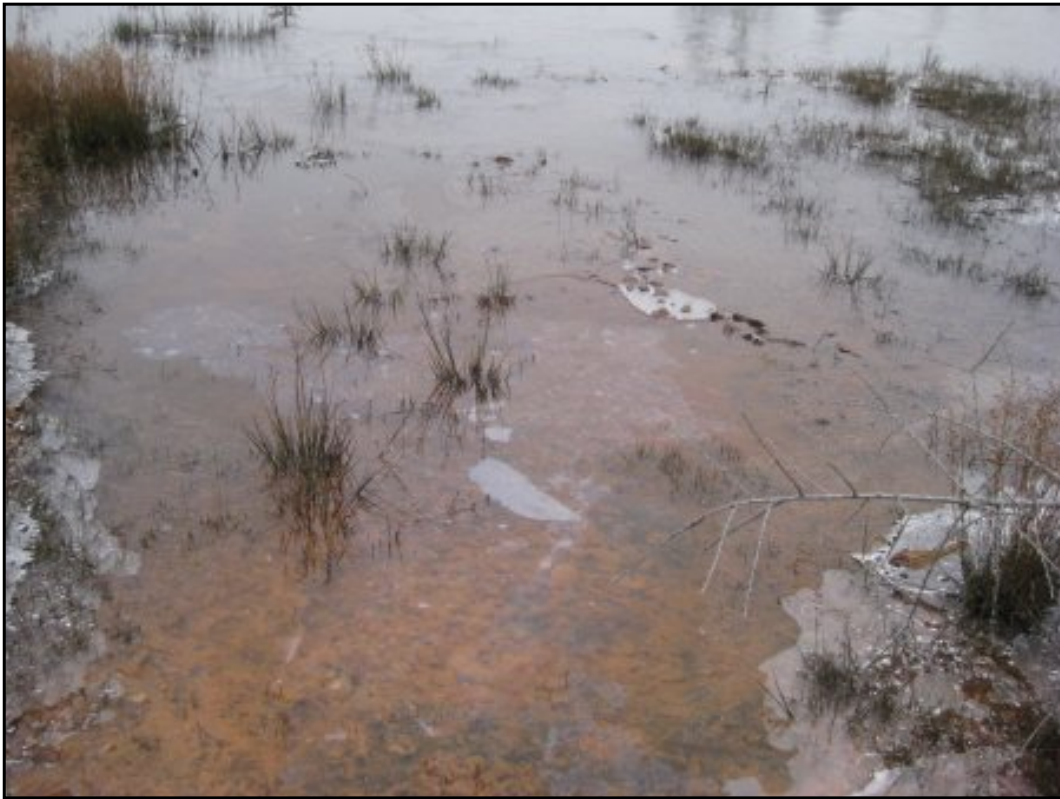
Iron staining in the pond adjacent to the waste rock pile

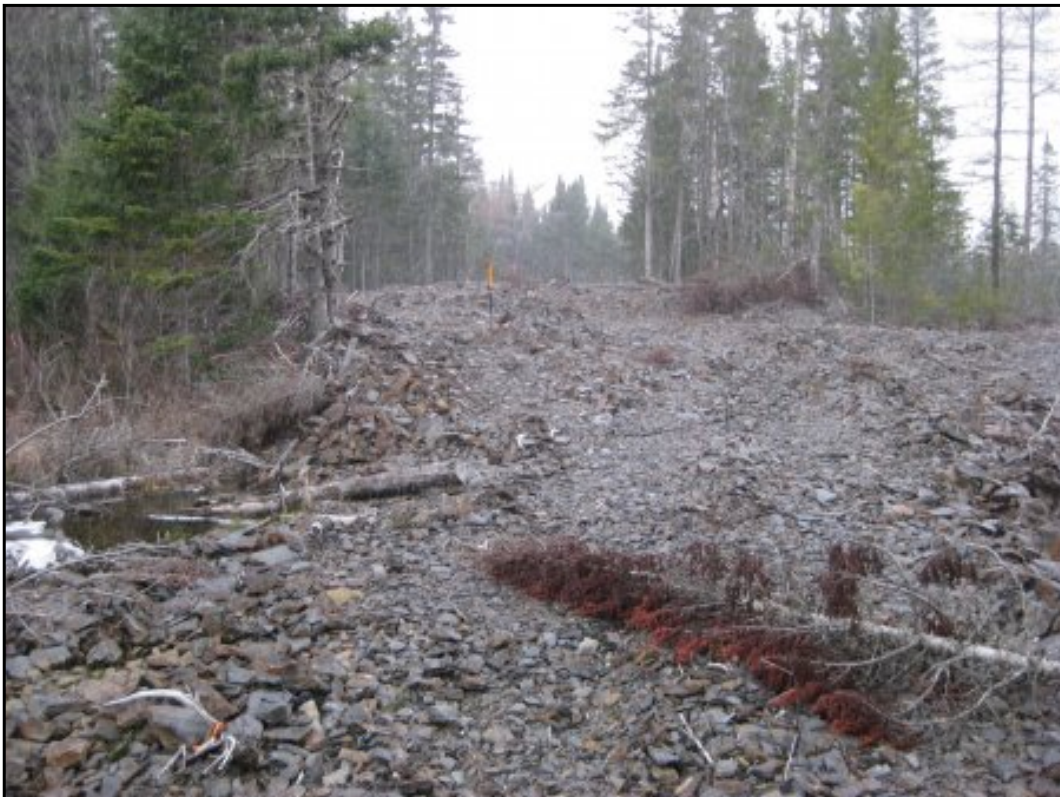
Graded waste rock along the western edge of the proposed pit

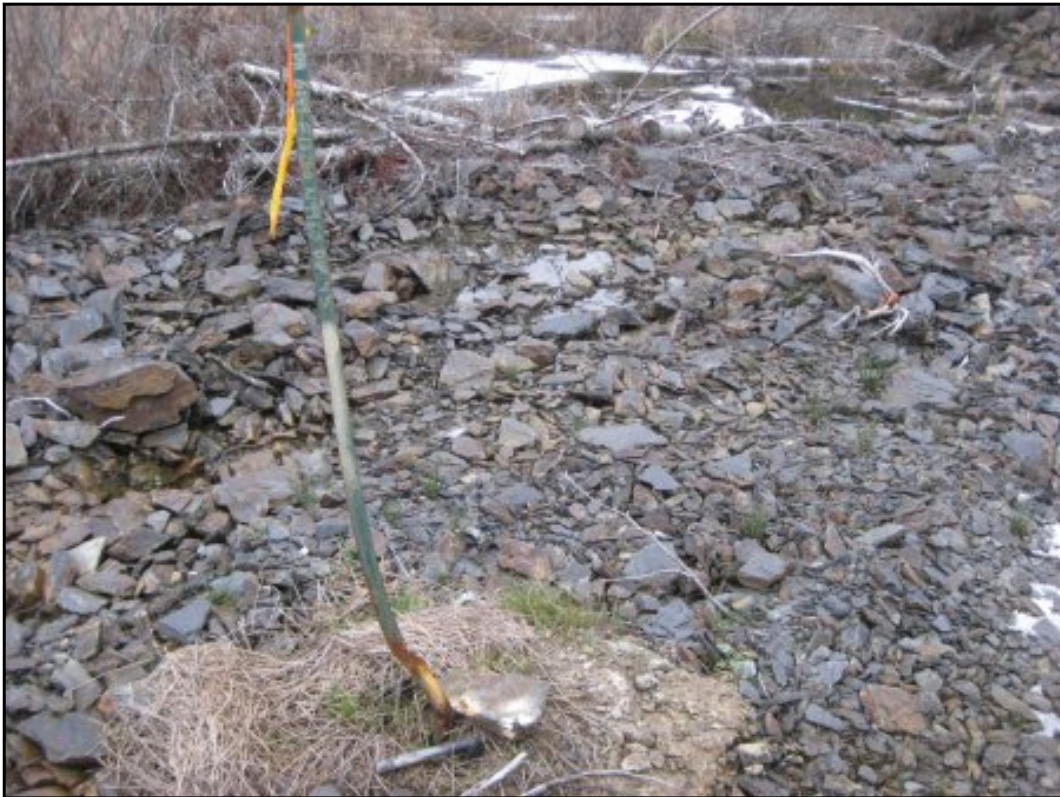
Typical exploration borehole location from the 1980s

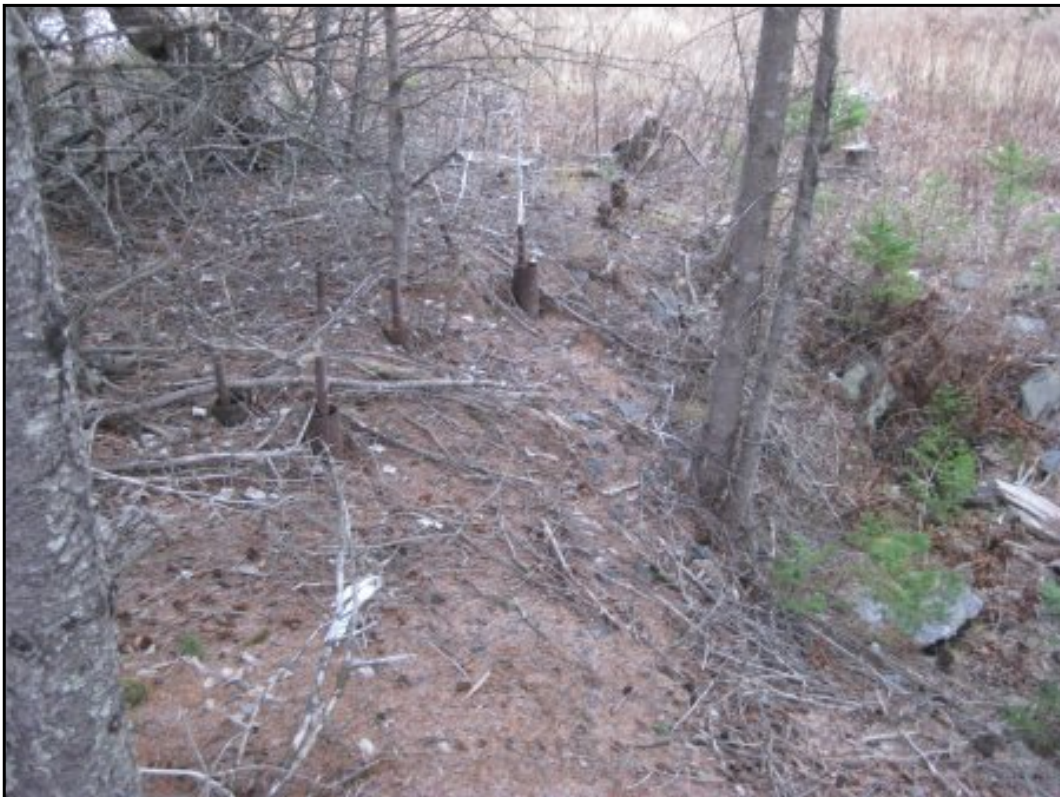
Foundation remains adjacent to the gravel road next to Seloam Brook and exposed apparent tailings
