Taseko Prosperity Gold-Copper Project

Appendix 3-8-C

**AN ASSESSMENT OF THE HANCEVILLE HATCHERY AS A RAINBOW
TROUT FRY PRODUCTION FACILITY**

June 20, 2008

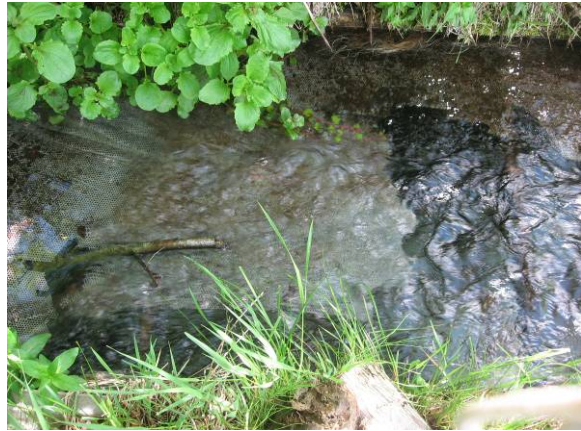
- Livestock can also access the ditch and waterline potentially resulting in bank erosion and/or damage to the waterline.
- Spring water collection box damaged and unsuitable for future use.
- Hatchery waterline is broken in at least one location and may be subject to further breakages.
- Exposed access to spring pond and water in ditch and hatchery settling pond poses significant risk of contamination and disease from all forms of wildlife.
- Several mature rainbow trout were observed in ditch and settling pond adjacent to and upstream of hatchery. Potential vector for fish disease.
- At least 2 other waterlines are connected to the spring water supply and ditch so presumably neighbours are accessing some of this water for their needs.

Photo 4. Damaged water intake box

- Install full fencing of spring to exclude all livestock and other wildlife.
- Replace existing intake box with an aluminum and screened water intake box.
- Replace and bury waterline and associated valves and fittings to avoid future damage from livestock, vandals and weather.
- Incorporate a screening and aeration system in any future buried waterline to ensure no debris fouls hatchery plumbing and hatchery water supply is fully saturated with oxygen.
- Cover the spring and pond to exclude leaves, debris and all wildlife.
- Remove all fish, dry and fill existing ditch leading from the spring to the hatchery to exclude any future fish and other disease vectors.
- Any legal water users must connect to new water intake box at spring pond.

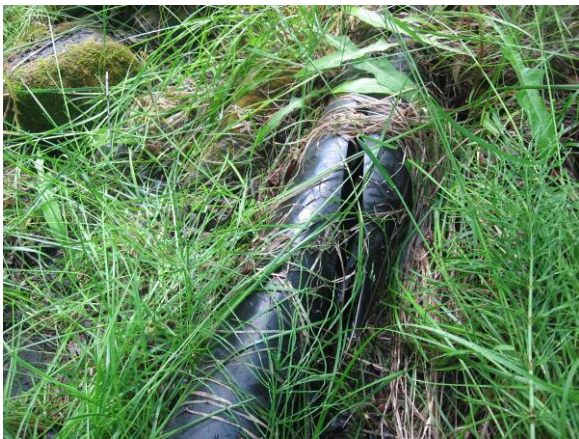
Photo 5. Broken water supply pipe

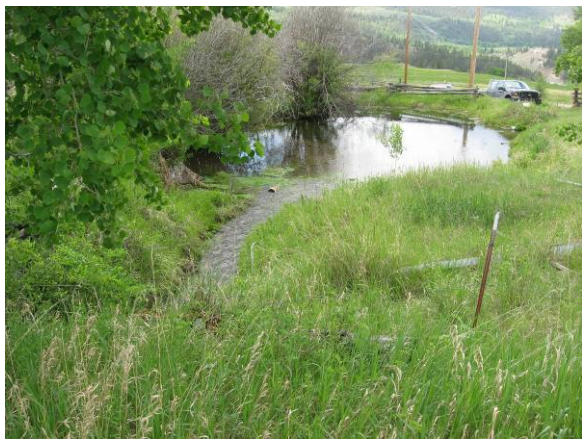
- The hatchery water distribution head tank is made of aged wood and is unsuitable as a safe water supply.
- The hatchery discharge pipe is made from a half-round 14" galvanized steel culvert.
- The discharge pond is functional although shallow with numerous live fish inhabiting it.

Photo 9. Settling pond

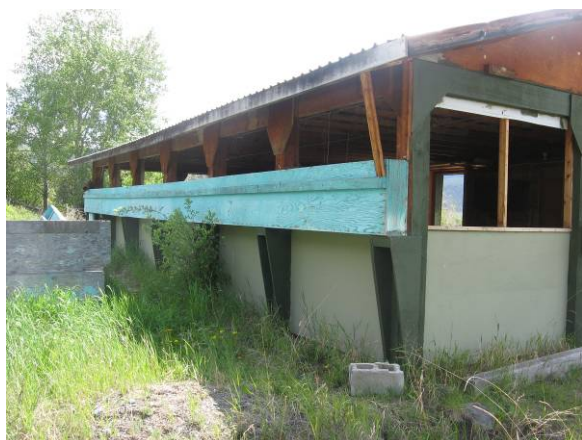
Photo 17. Water supply wood header box (exterior)

- Fabricate a new aluminum or plastic header pipe and new water valves and piping to all hatchery containers.
- Replace the culvert discharge pipe with a more easily cleaned concrete discharge channel with grating, screening and pipe system leading to the settling pond. This channel along with a connecting incubation discharge channel would be integrally formed into a new concrete floor slab.
- Add three levels of discharge screening (legal requirement) to prevent any fish from escaping downstream from hatchery facilities.
- Replace the aged thermograph and level control system.
- Dredge the effluent pond to obtain further depth and settling ability. In addition, any fish that might accidentally escape from hatchery containers and into the settling pond must be prevented from migrating either upstream or downstream through effective screening and/or other barrier systems.

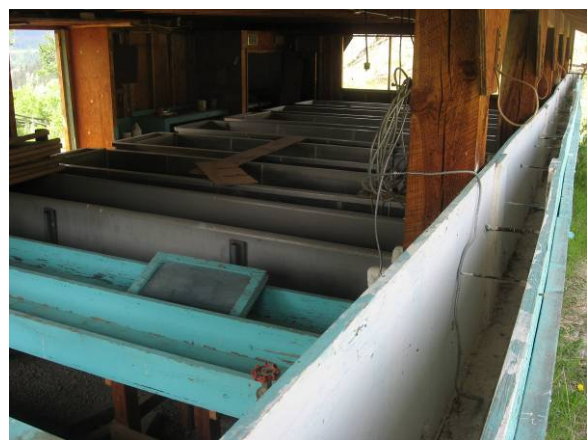
Photo 18. Water supply wood header box (interior) plus troughs

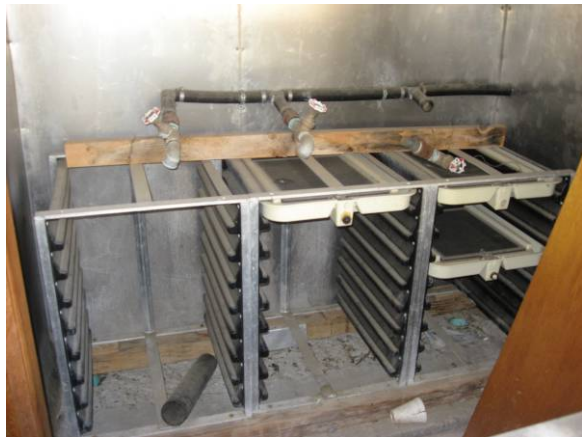
- Three vertical tray (Heath brand) incubation systems are located in the hatchery. Trays appear to be in satisfactory condition and suitable for future use.
- Six – 16' X 2.5' X 2' aluminum jumbo flat-bottomed rearing troughs are located at the hatchery. They are all in satisfactory condition and suitable for future use.
- One 16' X 2' X 2' plastic trough is located at the hatchery. It too is in satisfactory condition and suitable for future use.
- An aged EWOS fish feeding system is installed at the hatchery. It is unsuitable for present fish culture needs.

Photo 19. Vertical tray incubators

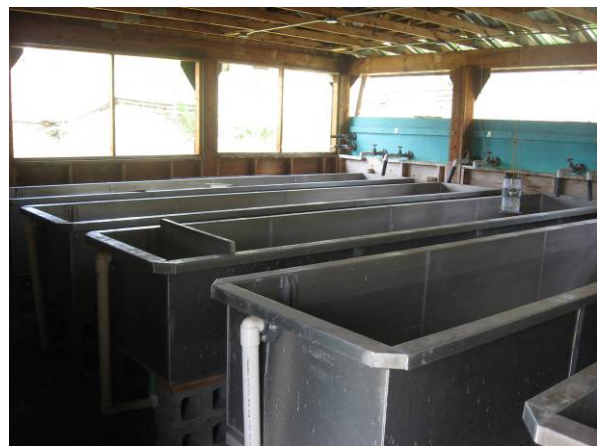
Photo 22. Aluminum jumbo troughs

- Purchase of 10 – 6” upwelling incubators for initial egg incubating needs and to help minimize fungus problems.
- Fabricate new outlet and intermediate mesh screens for all existing troughs.
- Fabricate mesh shade/predator covers for all existing troughs.
- Purchase a series of belt or other suitable trough feeders.

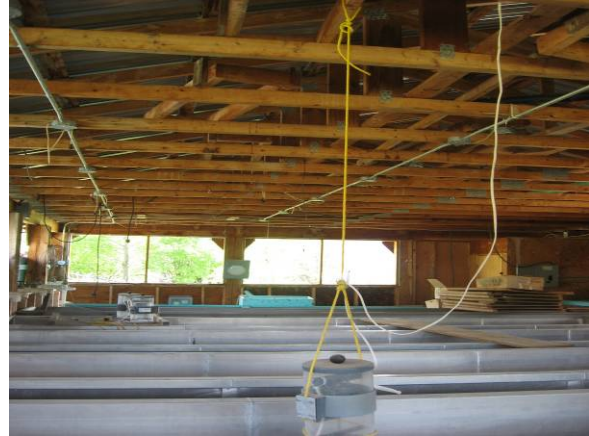
Photo 26. EWOS trough feeders

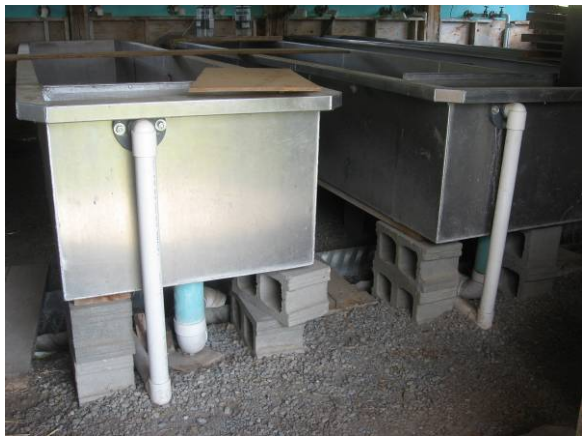
- Rats and mice have infested all areas of the hatchery.
- Hatchery floor is gravel and unsuitable for biosecurity needs of cultured fish.
- Tin roof on wood trusses appears in satisfactory condition although it may leak during certain weather conditions.
- The electrical service does not appear to be consistent with present day electrical standards. The electrical supply has been disconnected at the hatchery power pole. The inside electrical service appears to be a 60 amp 120 volt 1-phase service. This is inadequate for most modern small electrical needs. No 3-phase electrical power was observed in the immediate area although it is not required for this small hatchery facility.
- Environmental controls and alarms systems are aged and inadequate for safe culturing of fish.

Photo 27. Trough outlet and gravel floor

- A full concrete floor be constructed with discharge drain and floor drain system incorporated into floor slab.
- A roofing company assess the condition of the existing roof and replace as needed.

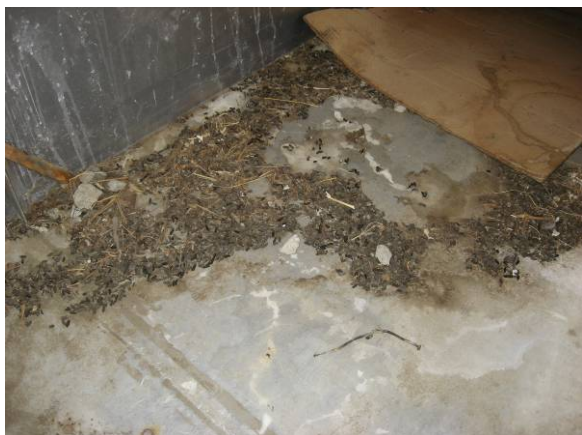
Photo 29. Rat droppings in trough

- All access points for rodents, birds and other wildlife must be blocked. This is critical for fish biosecurity purposes and also for human health (e.g., Hantavirus) reasons.

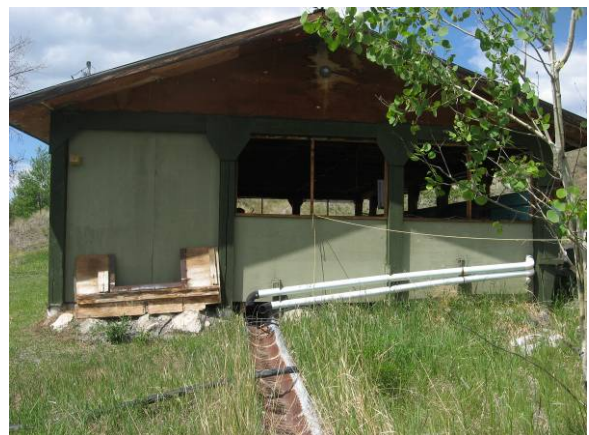
Photo 30. Hatchery discharge pipe outside building

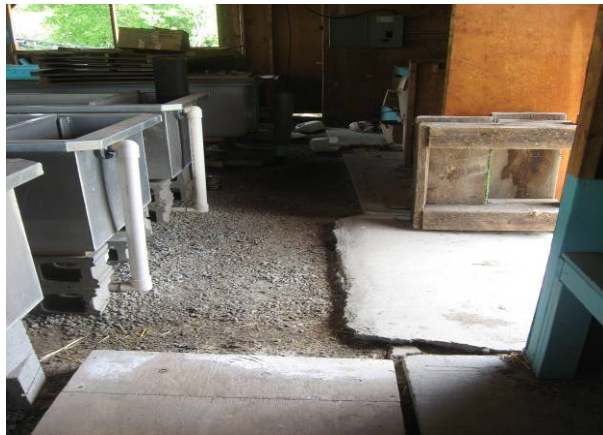
Photo 31. Gravel floor at entrance

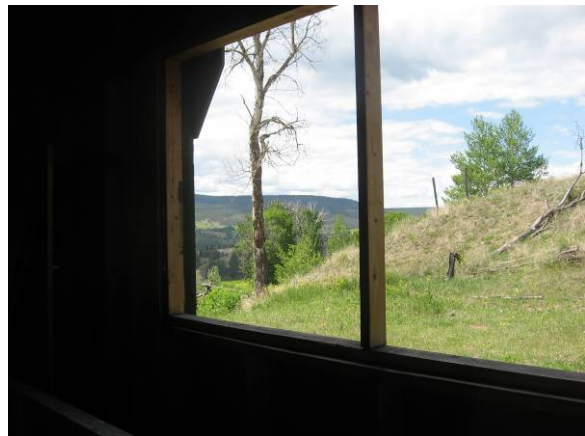
- No glass or security screens are attached to the building's windows.
- No appropriate toilet facilities. An old composting toilet is located in the hatchery building.

Photo 34. Open window frames

- An electrical contractor to develop a lighting and electrical distribution system to bring the building in line with the electrical code.
- Hinged glass and metal mesh screens be added to three sides of the existing building to allow for outside light and breezes to enter building but exclude wildlife, vandals and inclement weather as necessary.

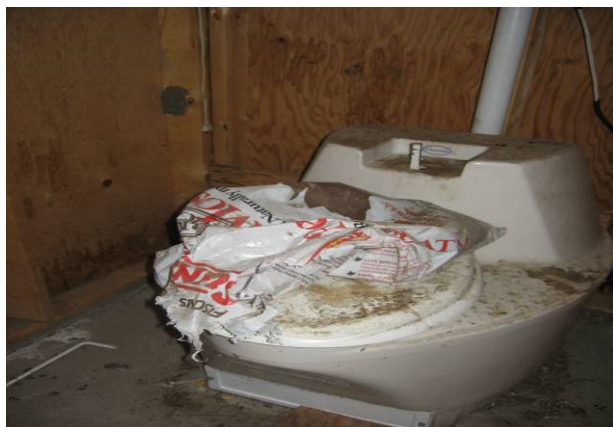
Photo 35. Composting toilet inside hatchery building

- A portable toilet to be provided or a small washroom facility connected to a seasonally pumped septic holding tank or septic discharge system be constructed depending on health and building code requirements.

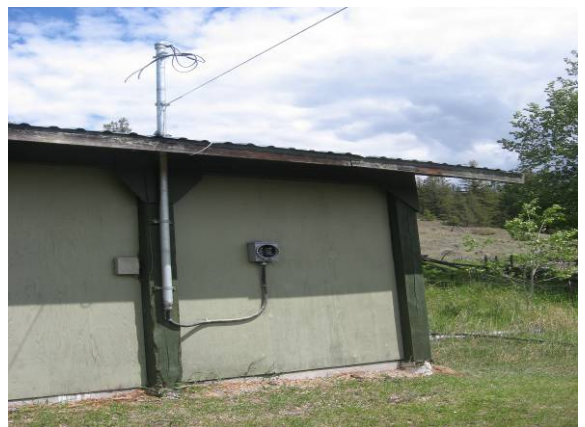
Photo 36. Disconnected electrical service
