**Direct Shipping Ore Project Phase I
Reconnaissance of Potentially Affected Fish Habitat
Western Labrador and Eastern Quebec**

**TF8165901
July 2008**

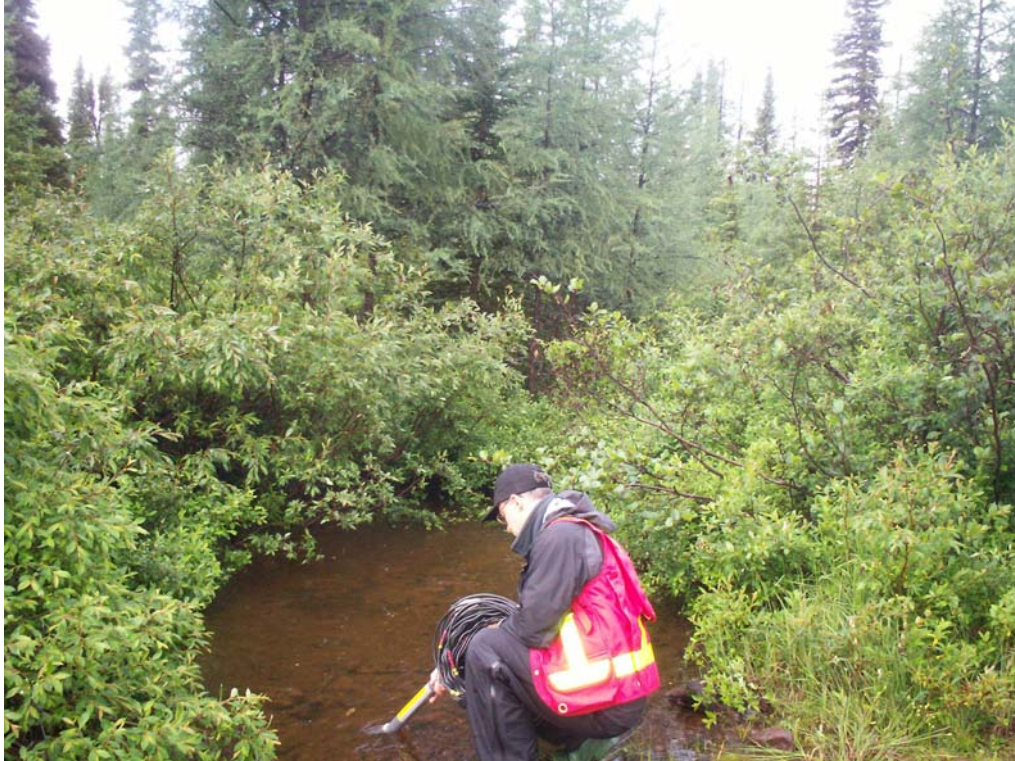
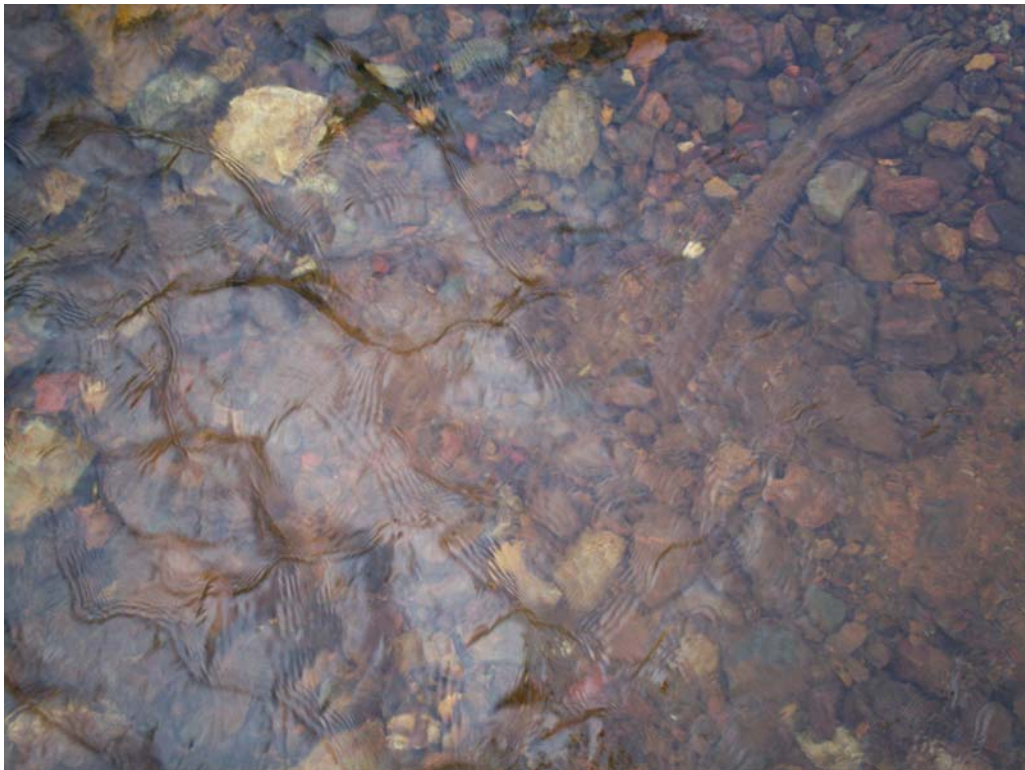
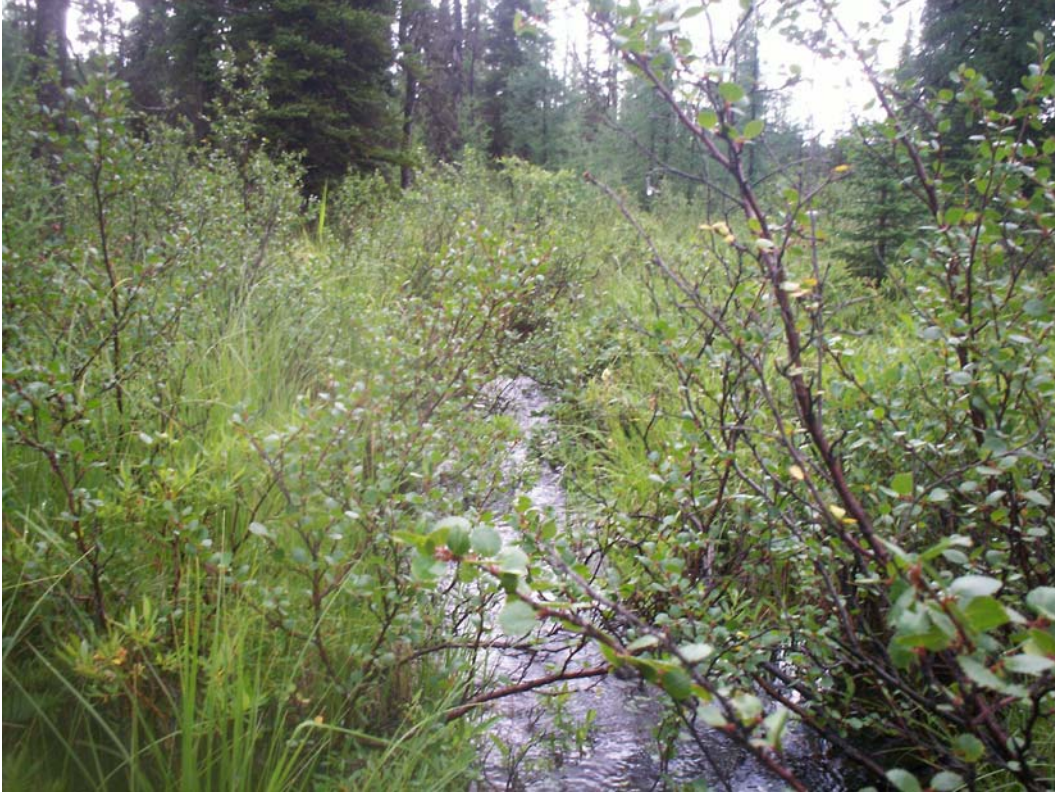
Approximately 370 m of stream was surveyed with most of the habitat being classified as riffle/run. The average stream wet width was 1.45m. Mean water depth was 0.54m with an average velocity of 0.17m/s. Substrate consisted predominantly of cobble and rubble with sand and gravel intermixed. One pool was identified and measured at 3m long by 6 m wide, had an average depth of 0.55m and an average flow of 0.06. The pool contained substrate dominated by medium and fine substrate-types. See Photos B-1 to B-3, Appendix B.

Photo B-1. DSO2-01 looking upstream (pool)

Photo B-2. DSO2-01 substrate (pool)

Photo B-3. DSO2-01 upstream (riffle)

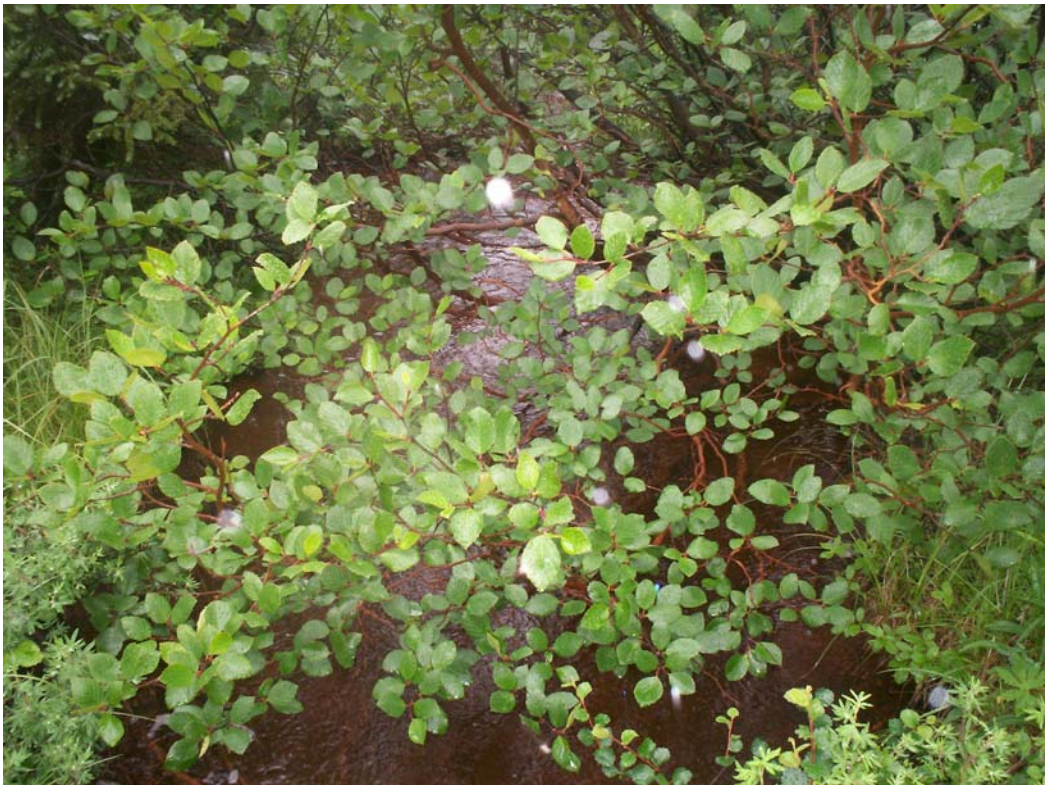
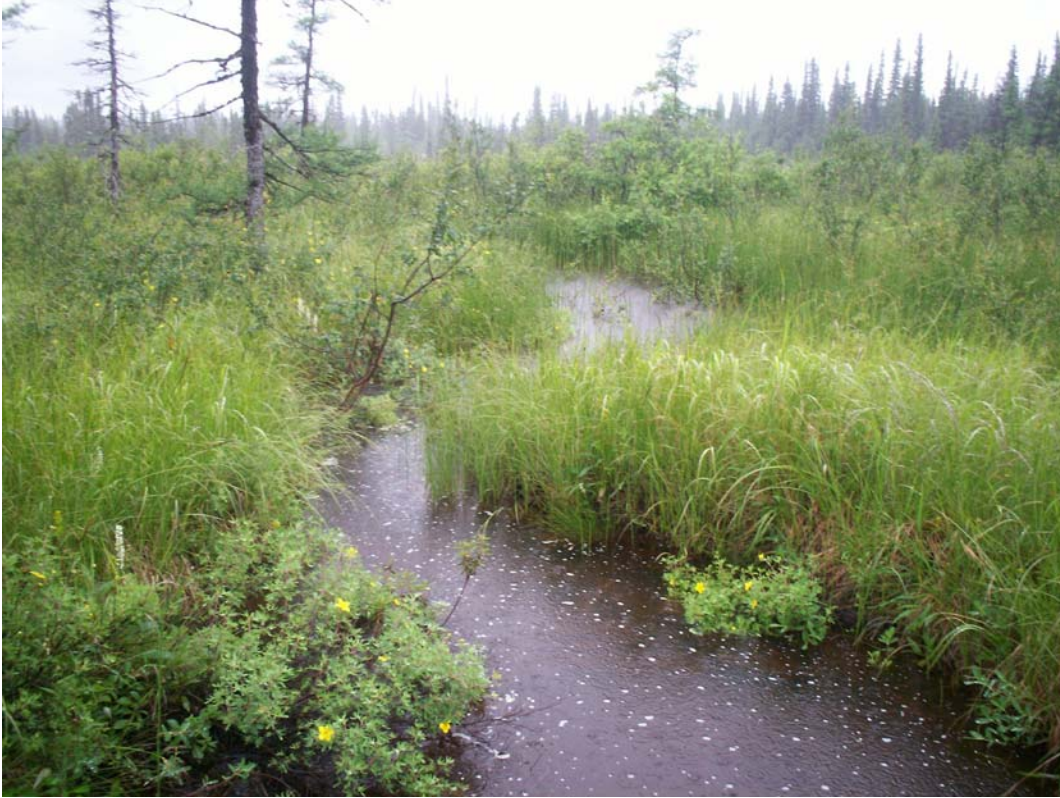
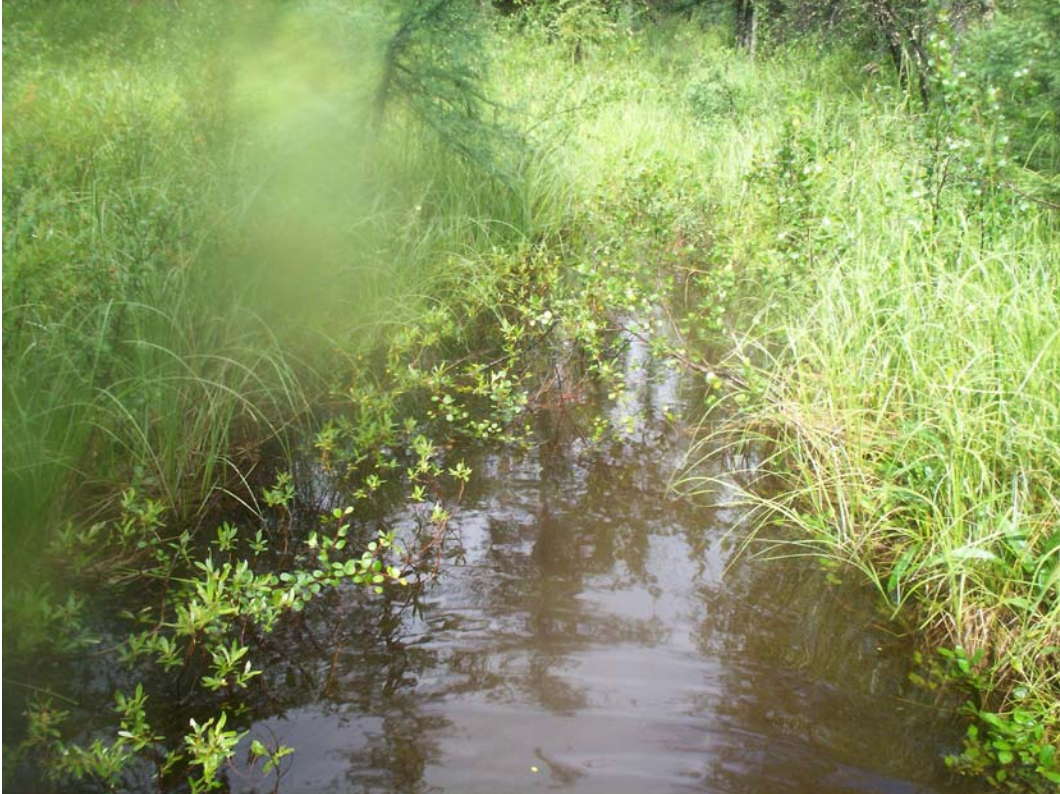
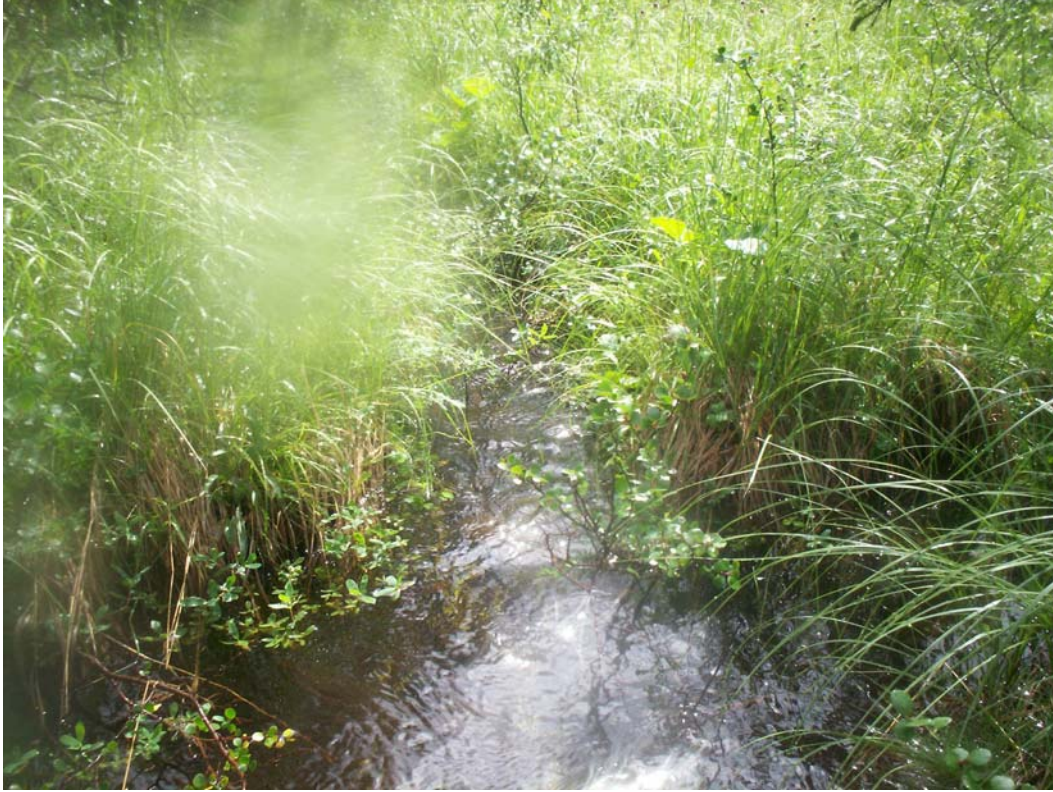
Approximately 500m of stream was surveyed and classified as comprising a majority of run/riffle habitat. The average stream wet width was 0.9 m. Mean water depth was 0.39m with an average velocity of 0.10m/s. Substrate consisted of medium and fine substrates. One pool was identified and measured at 2.8m long and 6m wide, had an average depth of 0.54 m with no measurable velocity. The pool contained substrate consisting of medium and fine substrate. See Photos B-4 to B-7 in Appendix B.

Photo B-4. DSO2-02 upstream

Photo B-5. DSO2-02 downstream

Photo B-6. DSO2-02 upstream

Photo B-7. DSO2-02 downstream

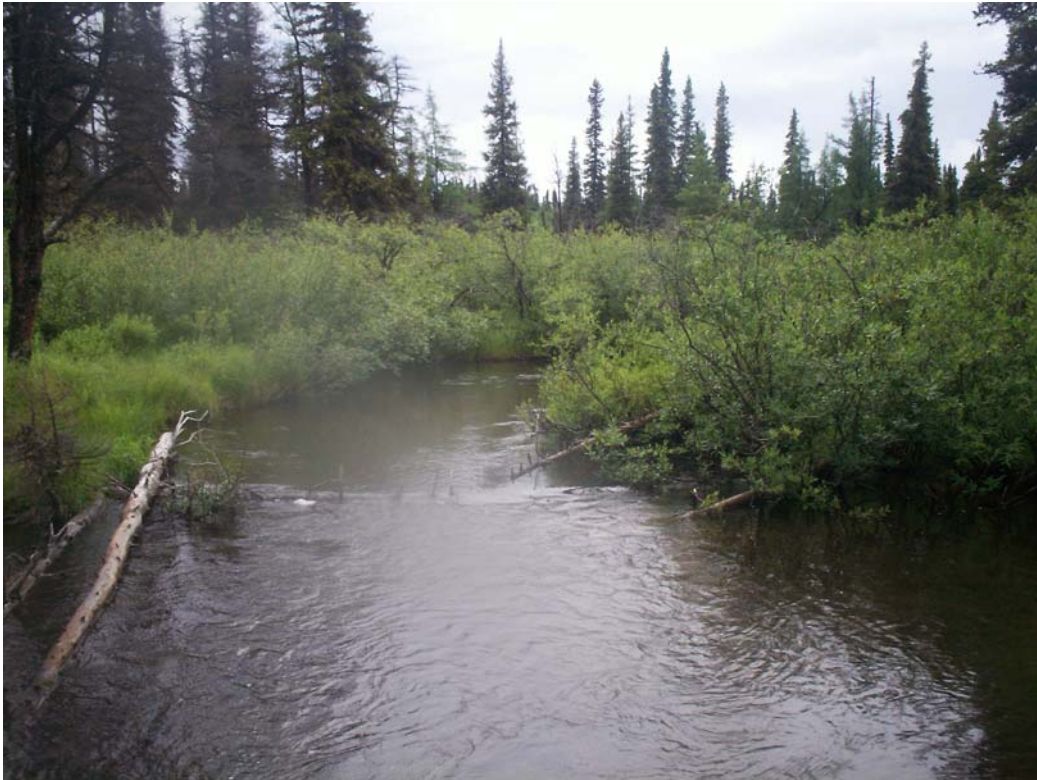
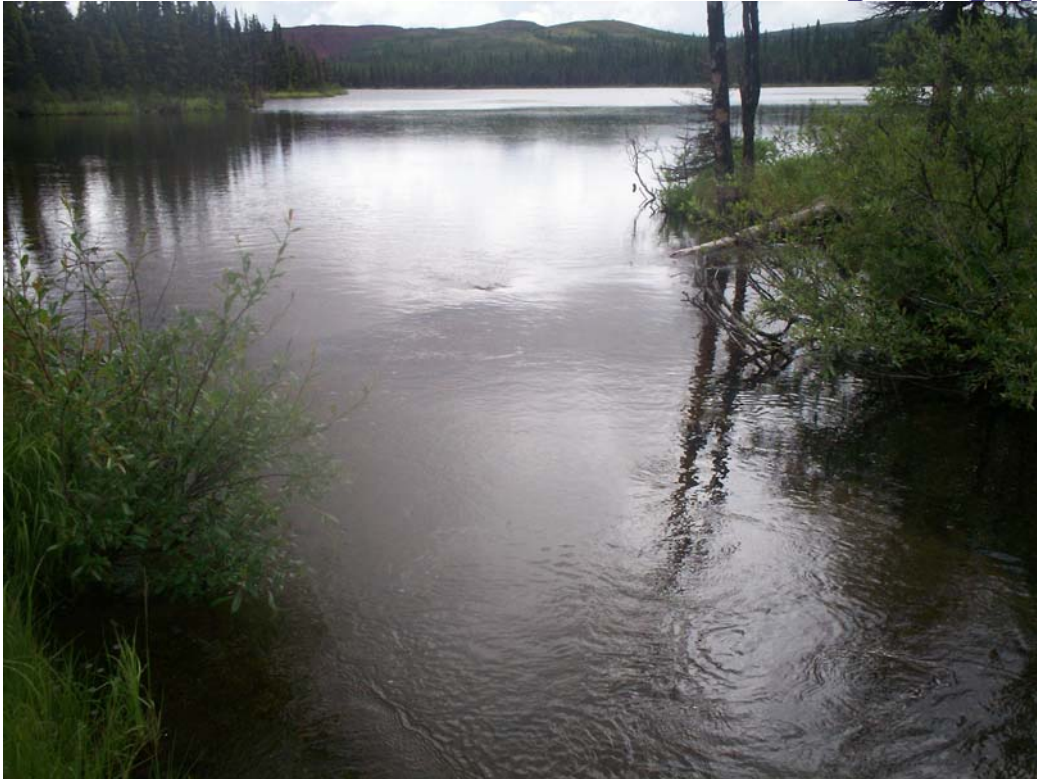
Approximately 300m of stream was surveyed and classified as predominantly run/riffle habitat. The average stream wet width was 3.12 m. Mean water depth was 0.28m with an average velocity of 0.37m/s. Substrate consisted of medium and fine substrates. One pool that was identified at the inflow to Lac Star and measured at 5.0m long by 8.0m wide, had an average depth of 1.0 m. Velocity could not be measured due to the pools depth. The pool contained substrate consisting of a majority of medium substrates with fines settled along the sides of the pool. See Photos B-8 and B-9 in Appendix B.

Photo B-8. DSO2-03 pool upstream

Photo B-9. DSO2-03 pool downstream

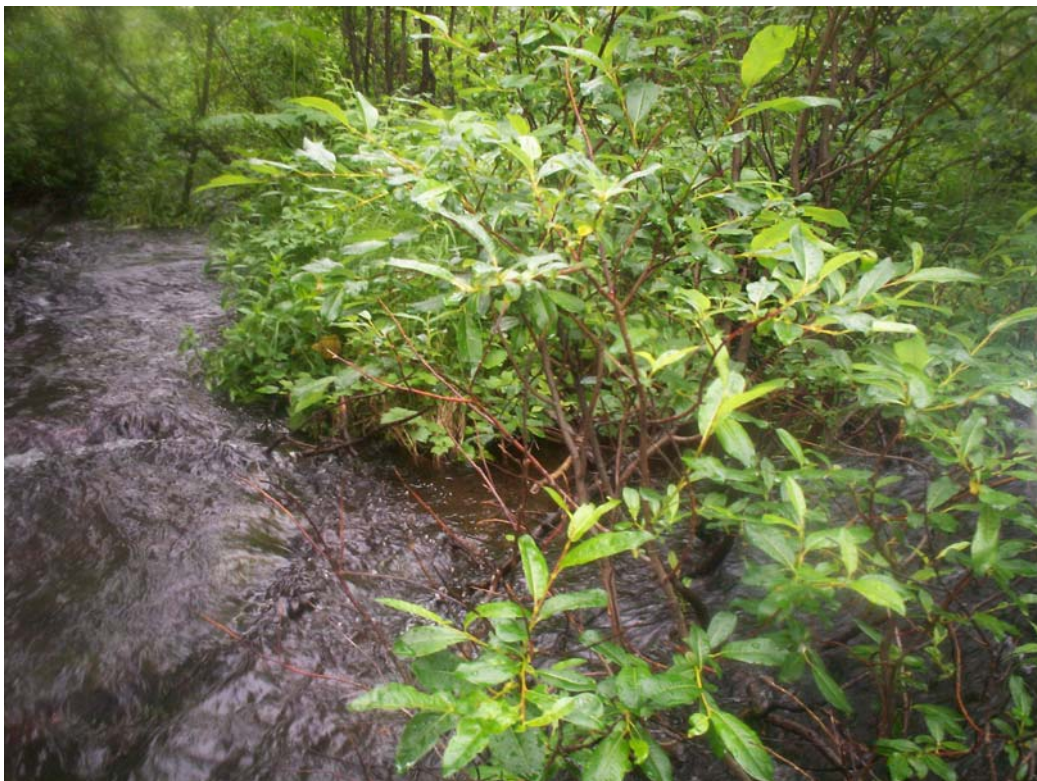
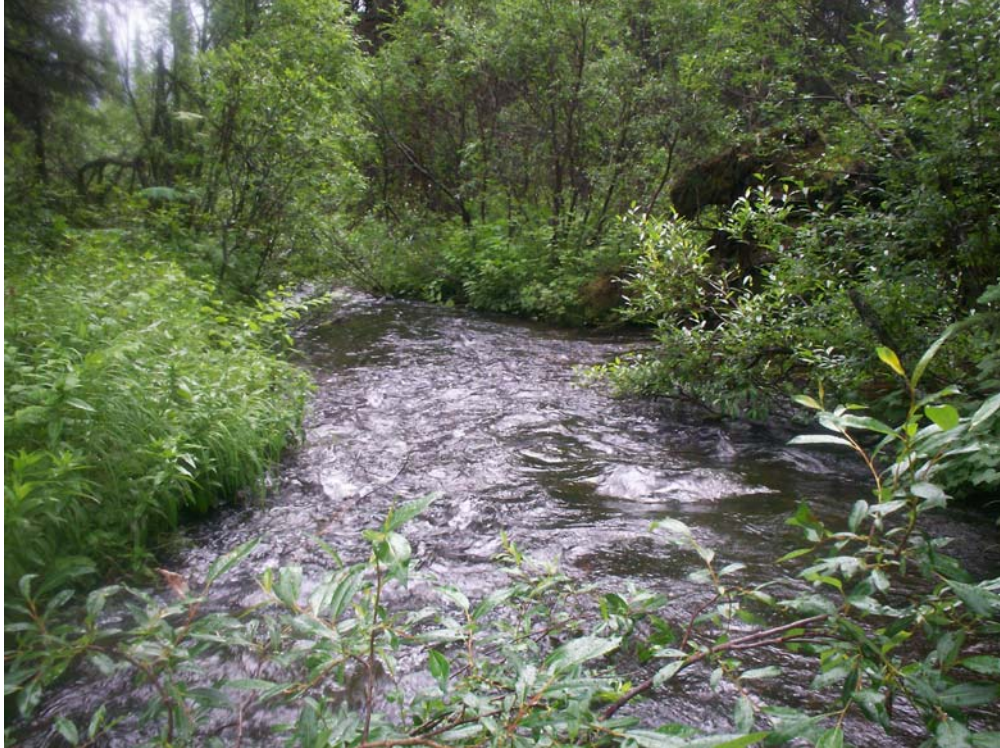
Approximately 120m of stream was surveyed and classified as comprising a majority of run/riffle habitat. The average stream wet width was 5.1m. Mean water depth was 0.39 m with an average velocity of 0.34m/s. Substrate consisted of medium substrate with fines intermixed. See Photos B-10 and B-11, Appendix B.

Photo B-10. DSO2-04 upstream

Photo B-11. DSO2-04 downstream

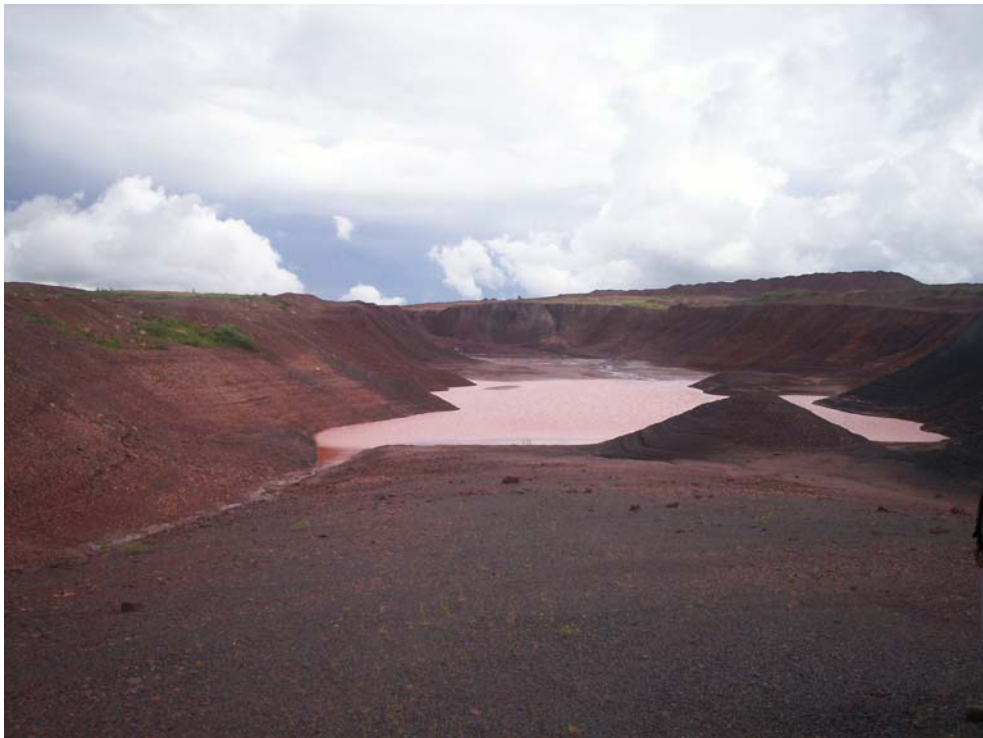
This site is Timmins Pit 3N. No habitat survey of the pit was conducted due to its depth and size; however water quality samples were collected and measured. See Photo B-12, Appendix B.

Photo B-12. Timmins 3N looking SE

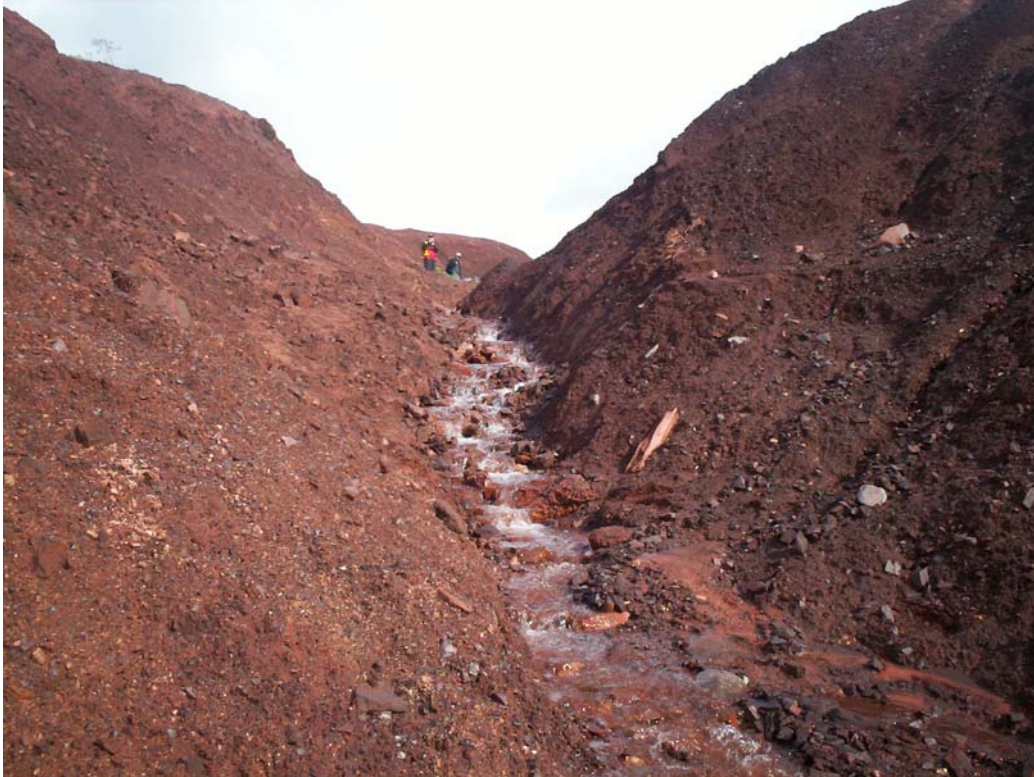
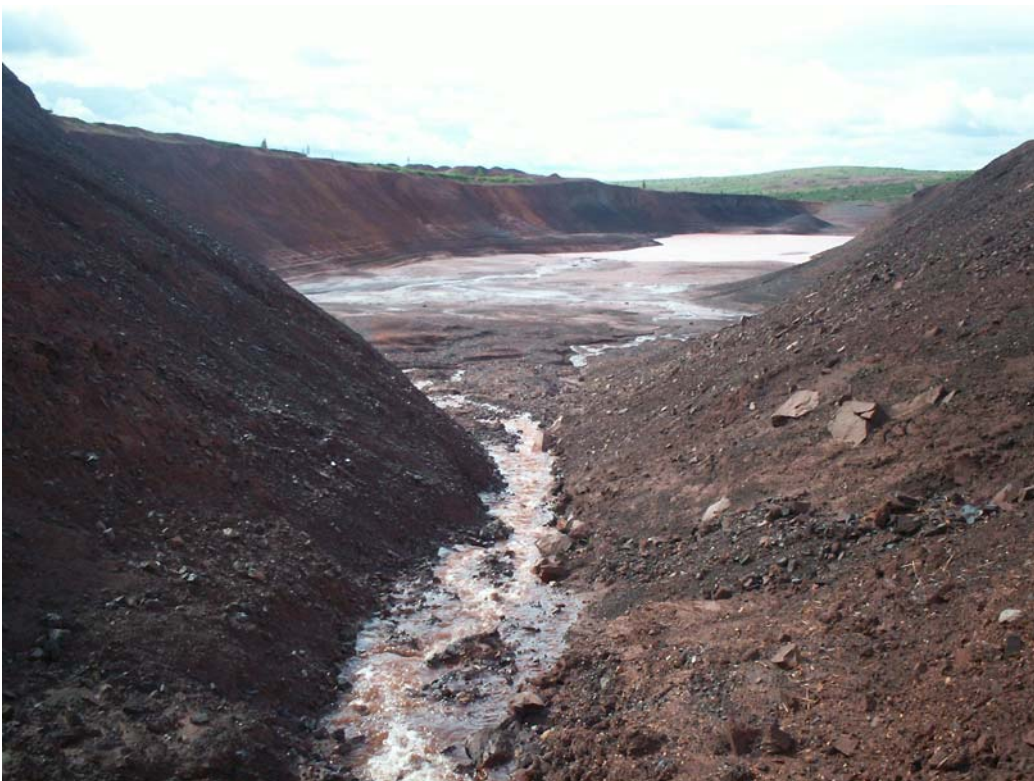
Approximately 200m of stream was surveyed and classified as predominantly run/riffle habitat. This stream flows between three existing mine pits (Timmins 3A, 3B, and 3C) with the stream terminating at pit 3C. The average stream wet width was 1.5m. Mean water depth was 0.1m with an average velocity of 0.24m/s. Substrate consisted mostly of medium substrate with fines intermixed. See Photos B-13 and B-14, Appendix B.

Photo B-13. DSO3-2, Stream flowing into pit 3A

Photo B-14. DSO3-2, Stream flowing into pit 3A

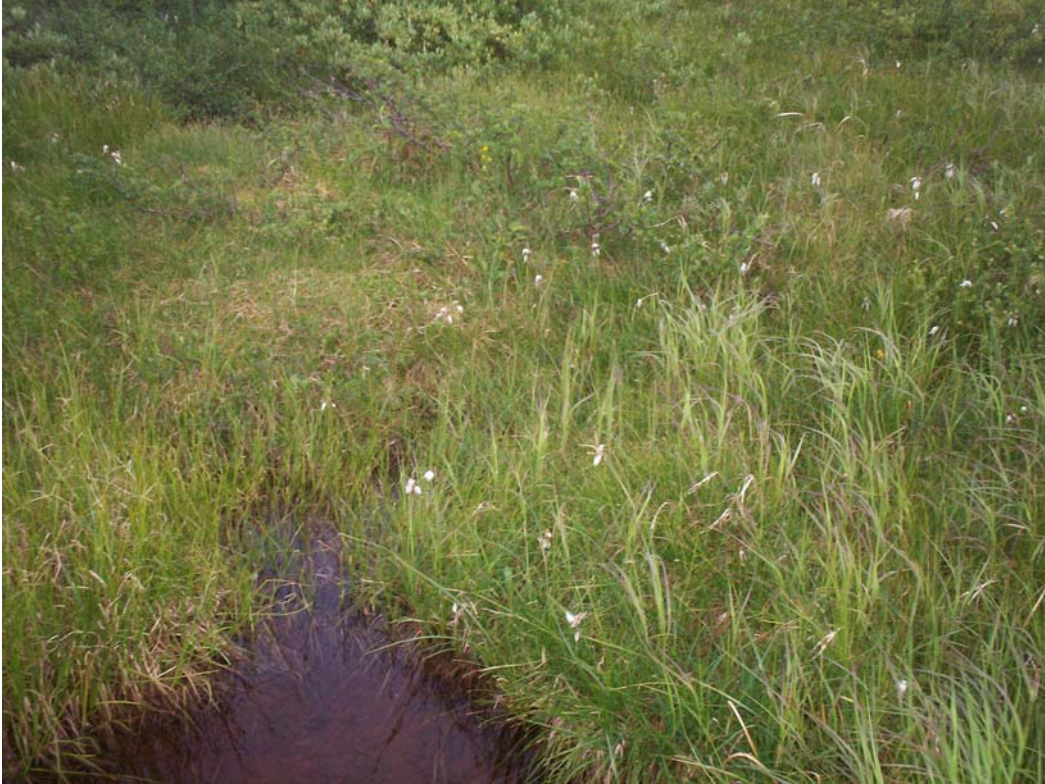
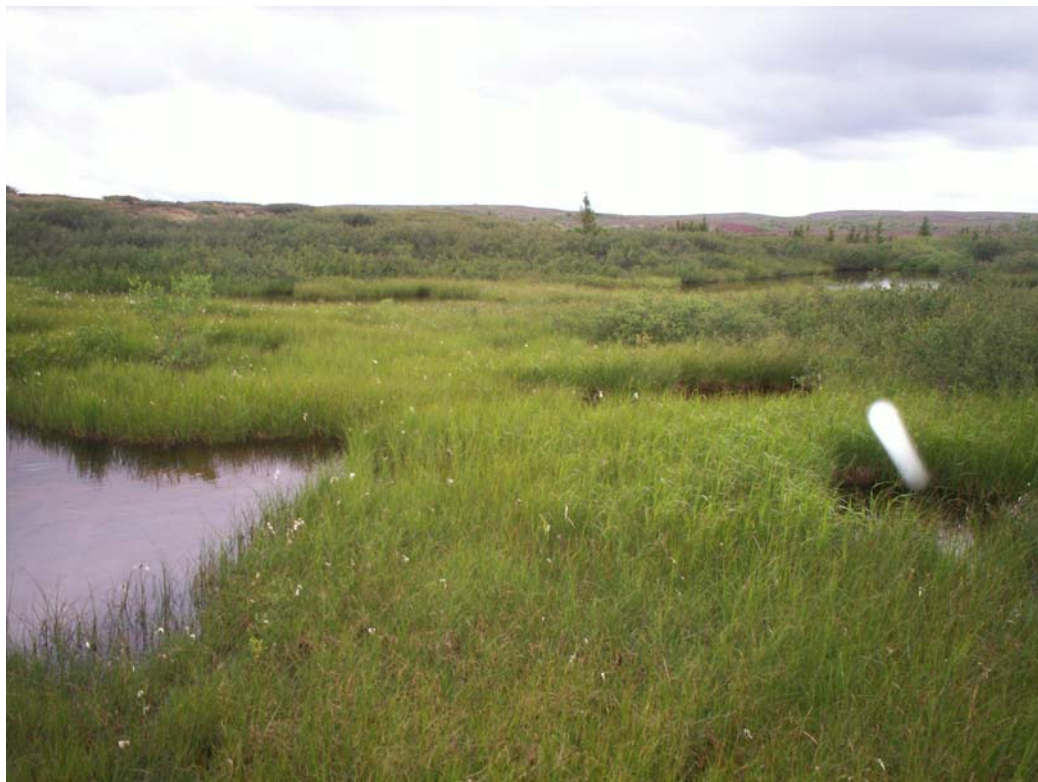
Approximately 320m of stream was surveyed and classified as comprising a majority of steady with a portion of run/riffle habitat. The average stream wet width of the steadies was 2.3m with a mean depth of 0.27m and an average velocity of 0.01m/s. Substrate consisted primarily of organics. The average stream wet width of the run/riffle habitat was 0.58m with a mean water depth of 0.12m and an average velocity of 0.25m/s. Substrate in this habitat type consisted primarily of organics with medium and fine substrates intermixed. See Photos B-15 and B-16, Appendix B.

Photo B-15. DSO3-3 upstream flowing from bog

Photo B-16. DSO3-3 downstream flowing into bog

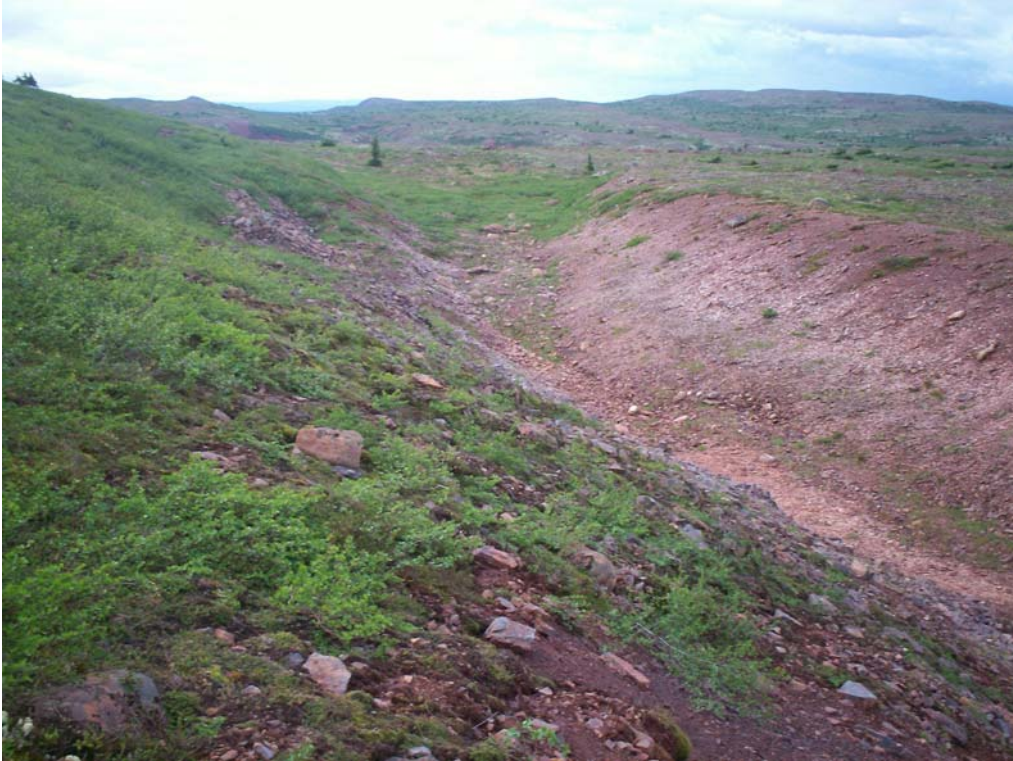
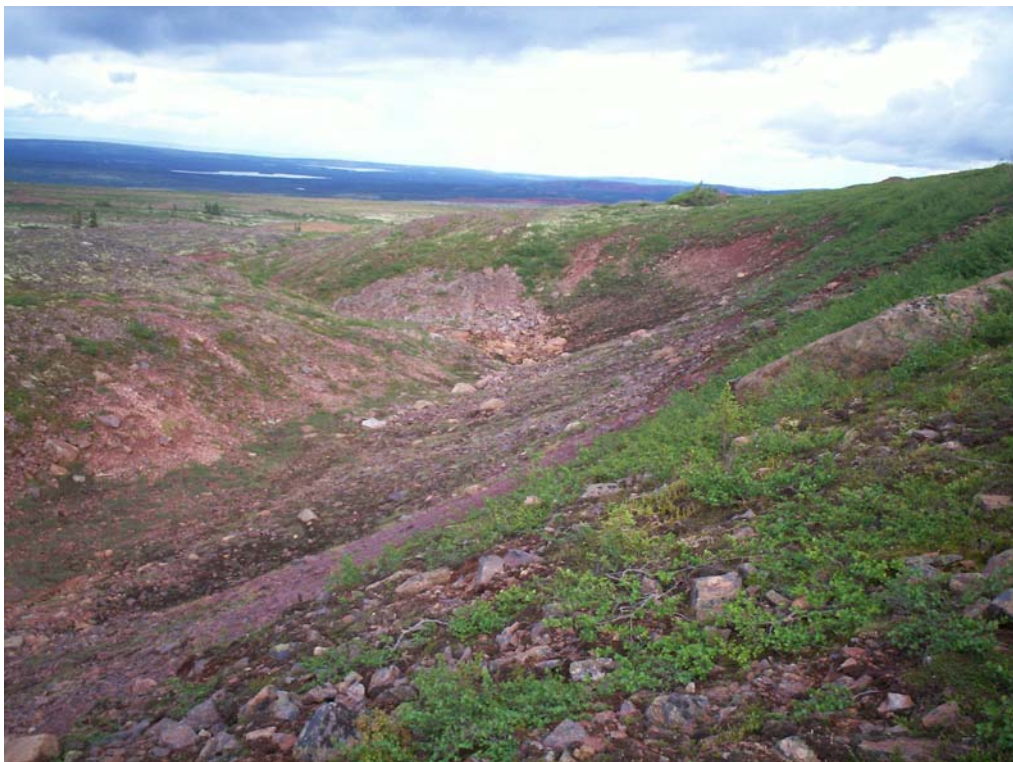
This site consisted of a small body of water located just west of Timmins Pit 1 near the former railway track. The perimeter of the water body was surveyed and no inflows/outflows were located. Geologists working for New Millennium stated that this water body is a result of rain runoff and the spring freshet. See Photos B-17 and B-18, Appendix B.

Photo B-17. Dry streambed along side of DSO3-4

Photo B-18. Dry streambed along side of DSO3-4 (Stagnant body of water)

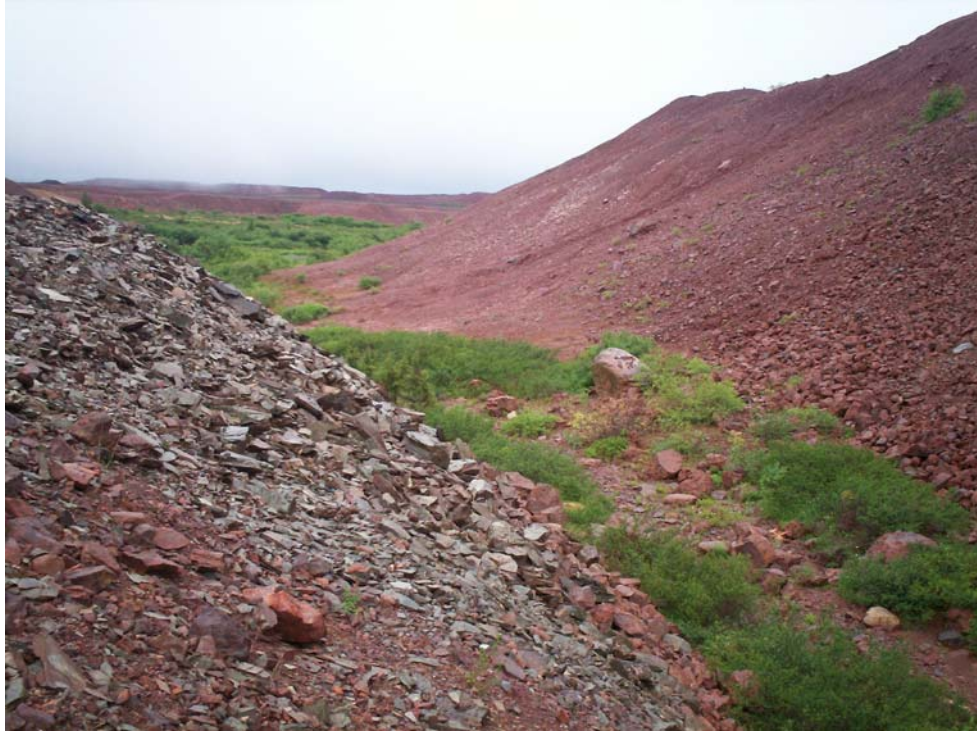
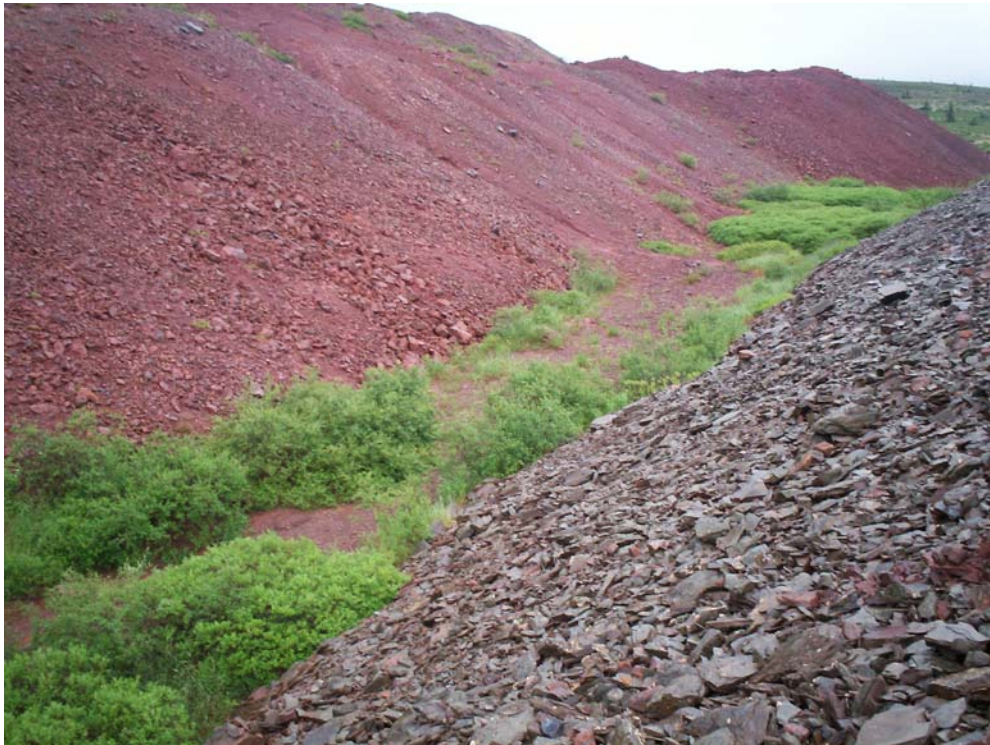
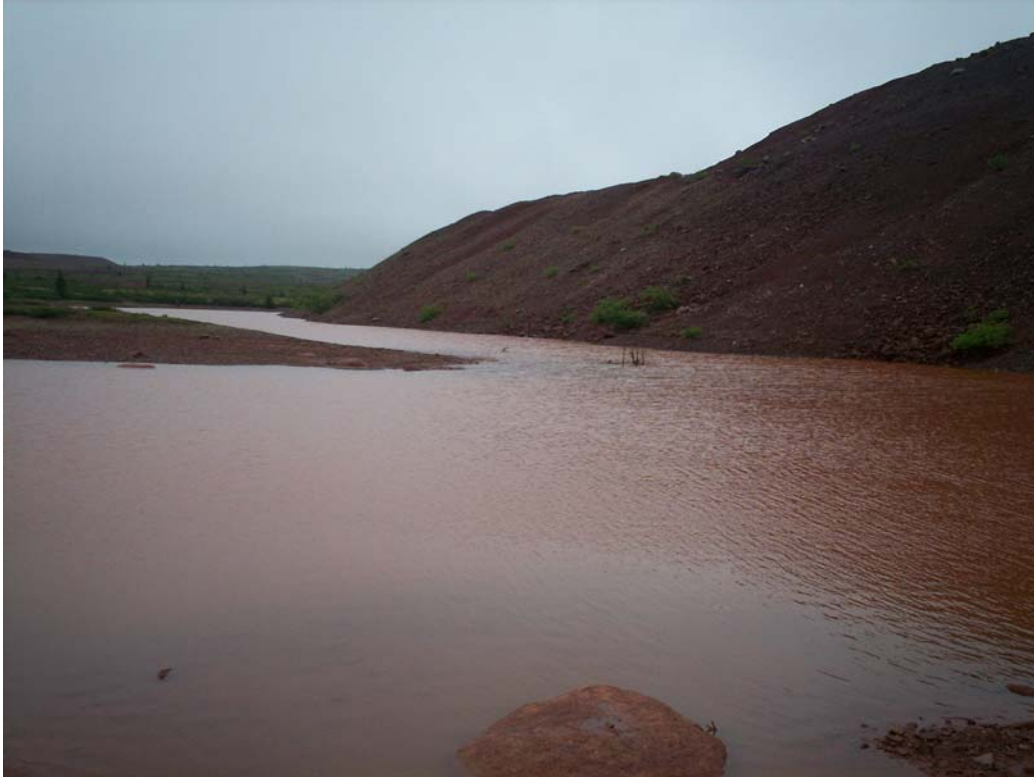
This site also consisted of a small water body located just to the east of DSO3-04. This water body was also surveyed around its entire perimeter with no evidence of an inflow/outflow identified. Geologists again stated that this water body is a result of rain runoff and spring freshet. See Photos B-19 and B-20, Appendix B.

Photo B-19. Dry streambed along side of DSO3-5 (Stagnant body of water)

Photo B-20. Dry streambed along side of DSO3-5 (Stagnant body of water)

Photo B-21. DSO3-5 (Stagnant body of water) with no inflow

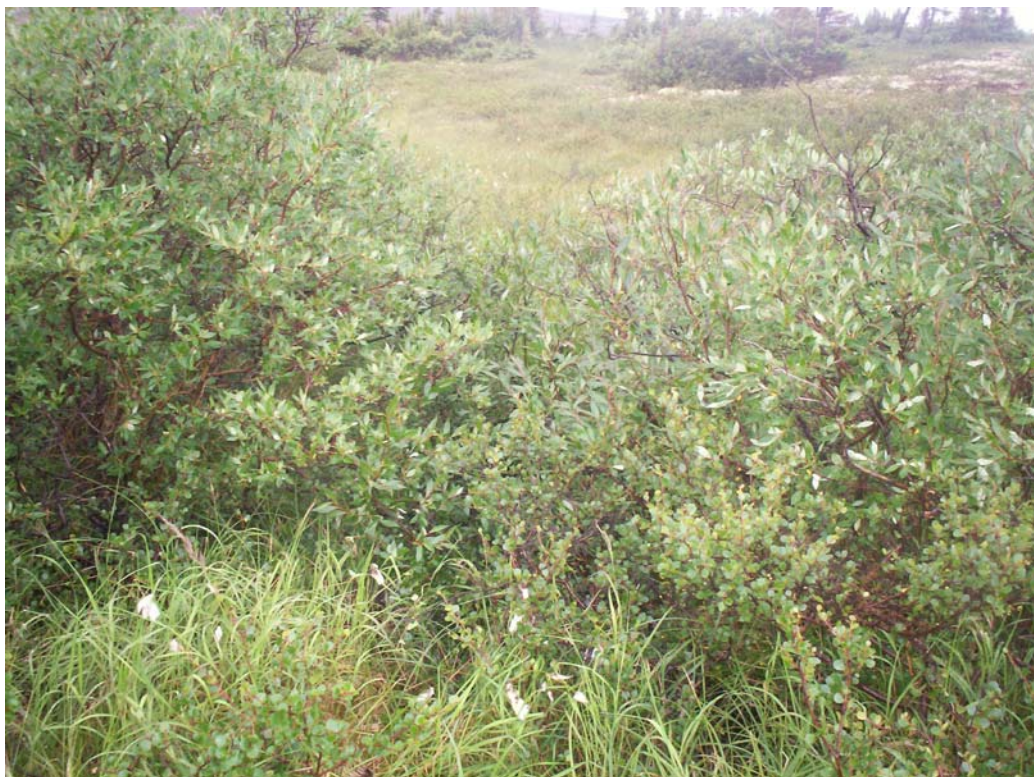
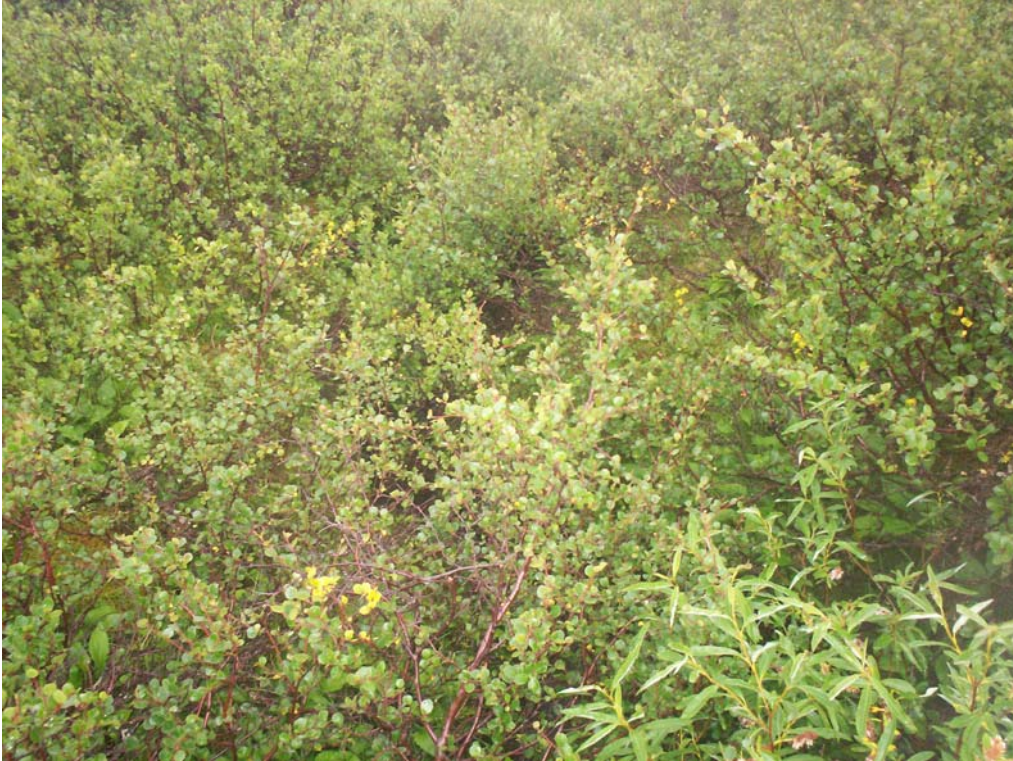
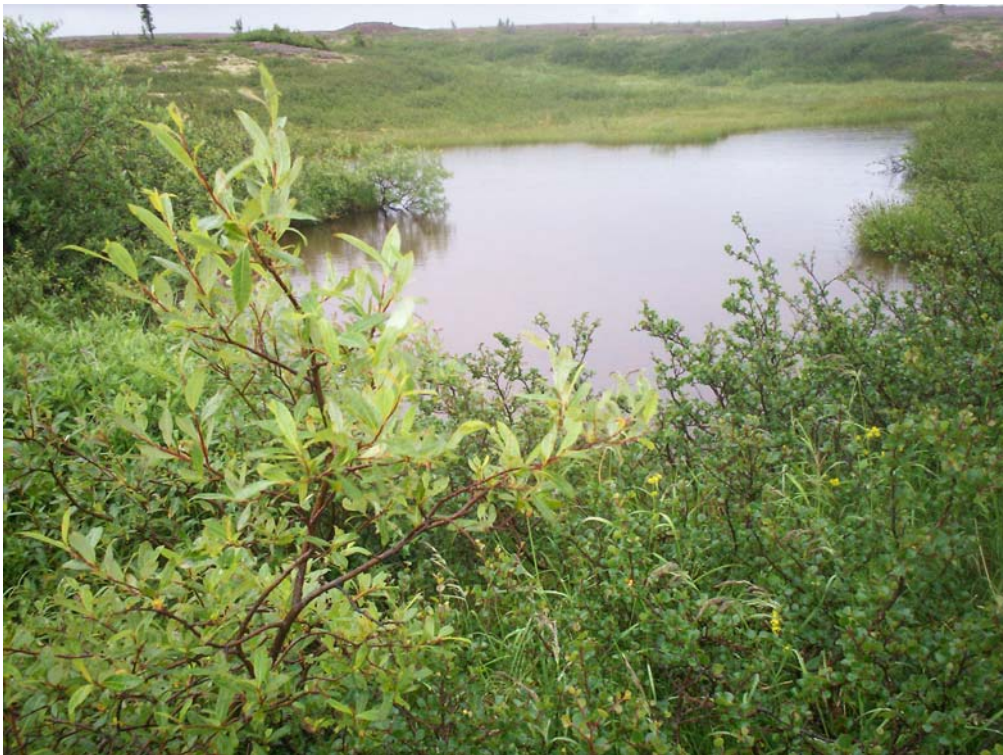
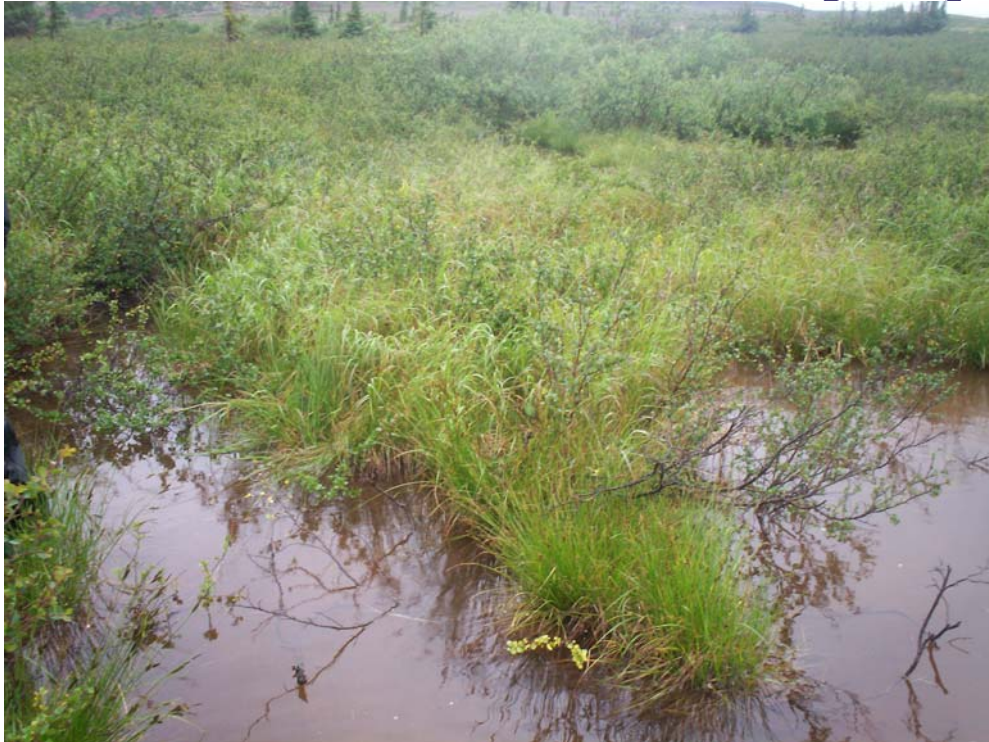
Approximately 500m of stream was surveyed and classified as steady habitat. The average stream wet width was 1.18m. Mean water depth was 0.15 m with an average velocity of 0.02m/s. Substrate consisted primarily of organics with medium and fines intermixed. See Photos B-22 to B-25, Appendix B.

Photo B-22. DSO3-6 downstream view, stream is completely covered by sedge

Photo B-23. DSO3-6 upstream view, stream is completely covered by sedge

Photo B-24. DSO3-6 upstream view, stream outflow from a bog steady

Photo B-25. DSO3-6 downstream view, stream outflow from a bog steady

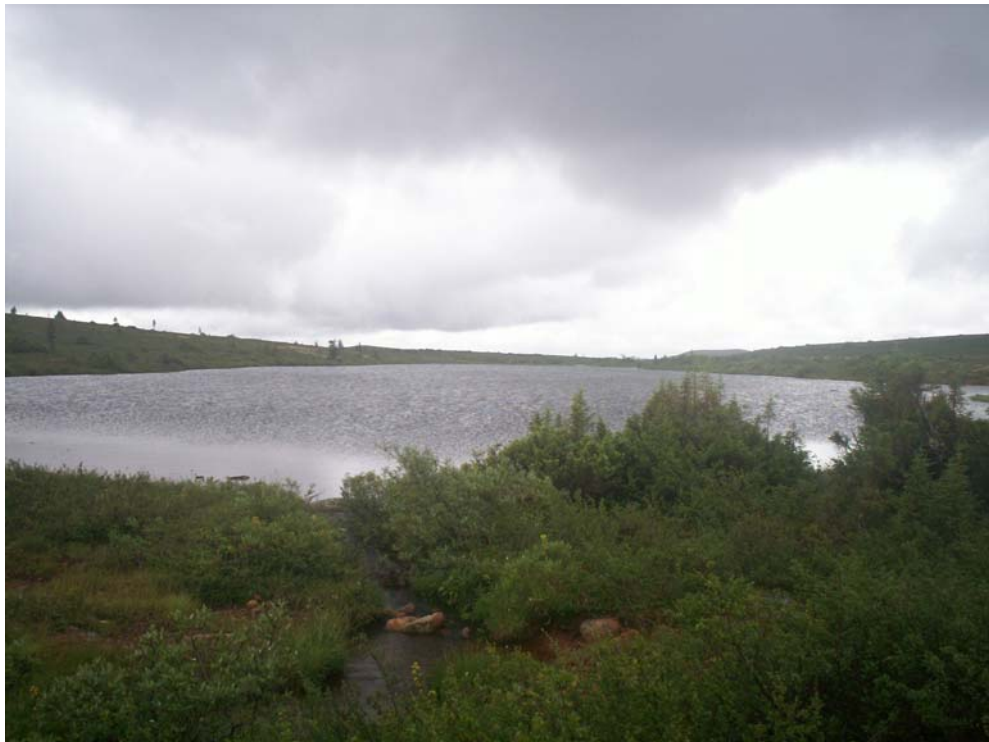
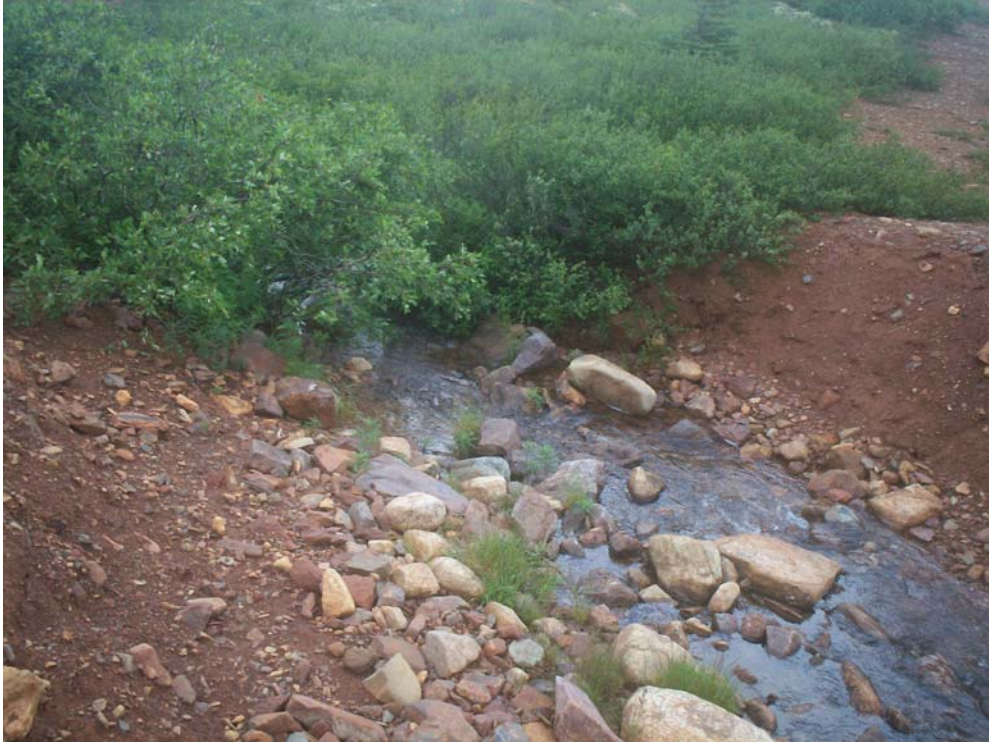
This site consisted of a lake (Inukshuk Lake). No stream surveys were conducted; however water quality samples were collected and measured. This site may be considered as a control or reference site for water quality should development proceed. See Photos B-26 and B-27, Appendix B.

Photo B-26. DSO3-7 Lake Inukshuk

Photo B-27. DSO3-7 Lake Inukshuk outflow
