**Direct Shipping Ore Project Phase I
Reconnaissance of Potentially Affected Fish Habitat
Western Labrador and Eastern Quebec**

**TF8165901
July 2008**

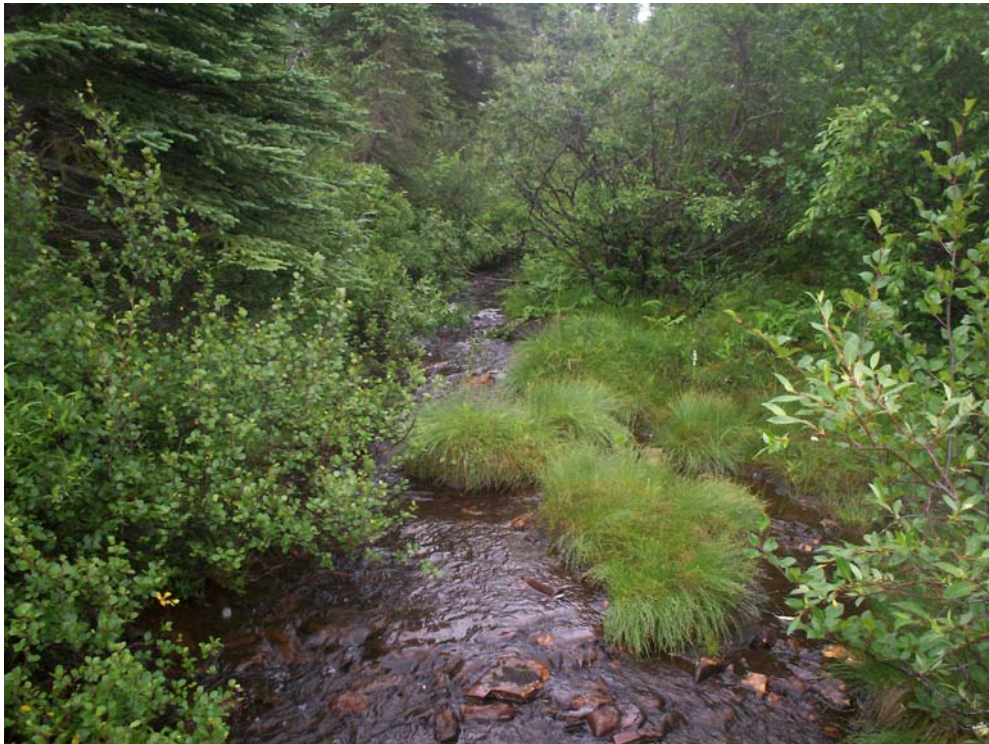
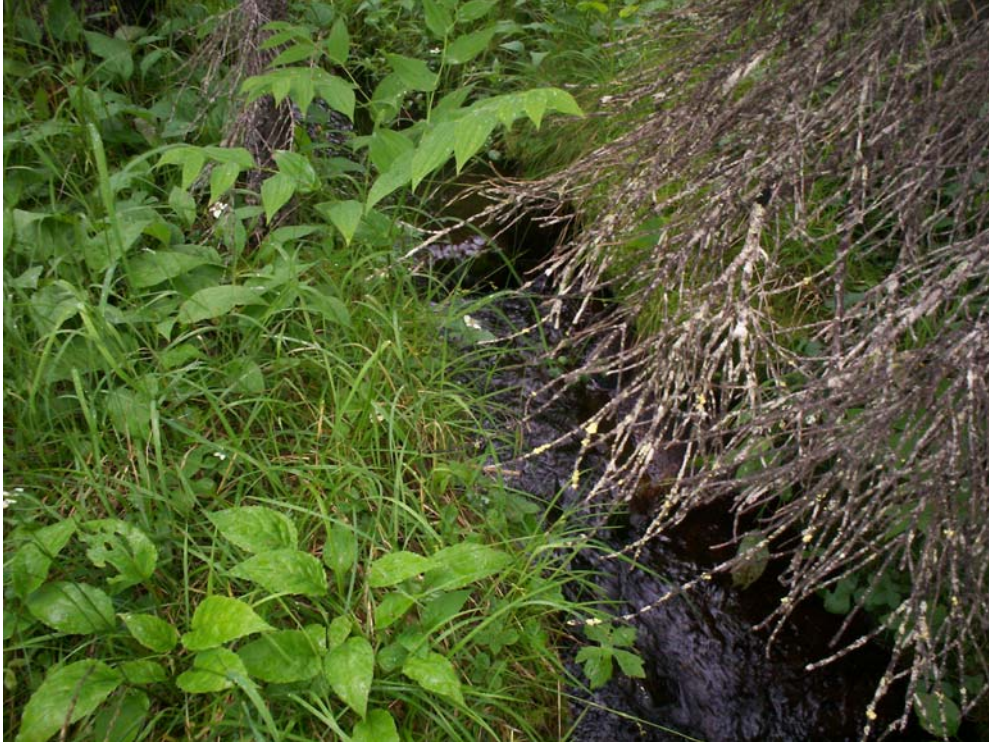
Approximately 60m of stream was surveyed and classified as run/riffle habitat. The average stream wet width was 1.38m. Mean water depth was 0.11 m with an average velocity of 0.19m/s. Substrate consisted predominantly of medium and fines with coarse substrate intermixed. An access road is proposed to cross this stream. See Photos B-28 and B-29, Appendix B.

Photo B-28. DSO3-8 downstream view (proposed road crossing)

Photo B-29. DSO3-8 upstream view (proposed road crossing)

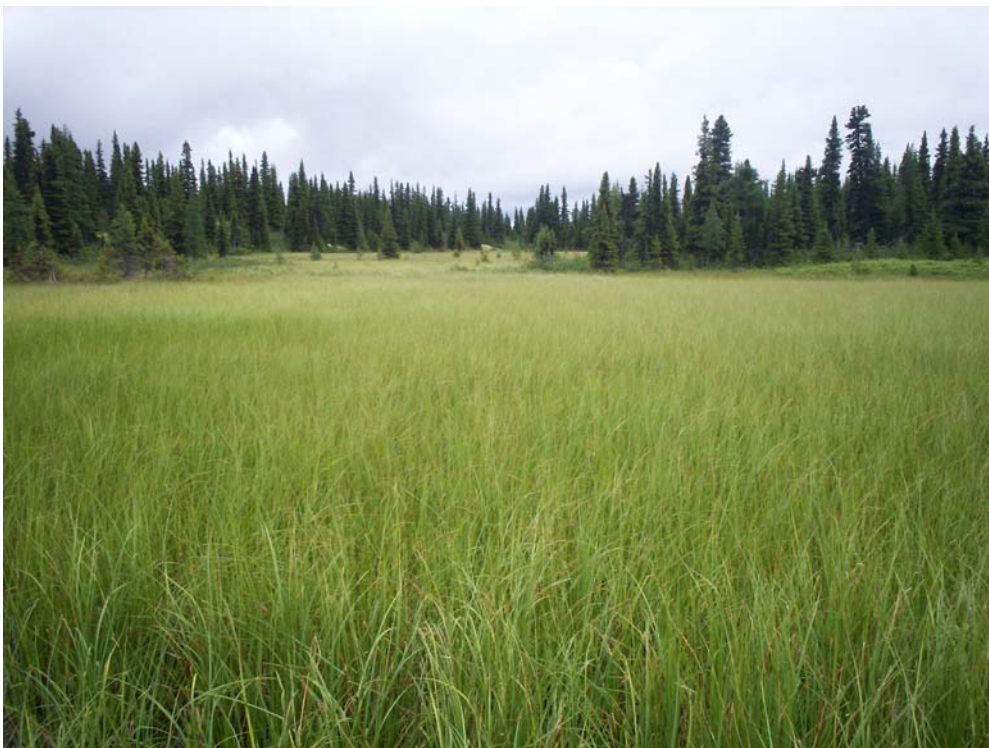
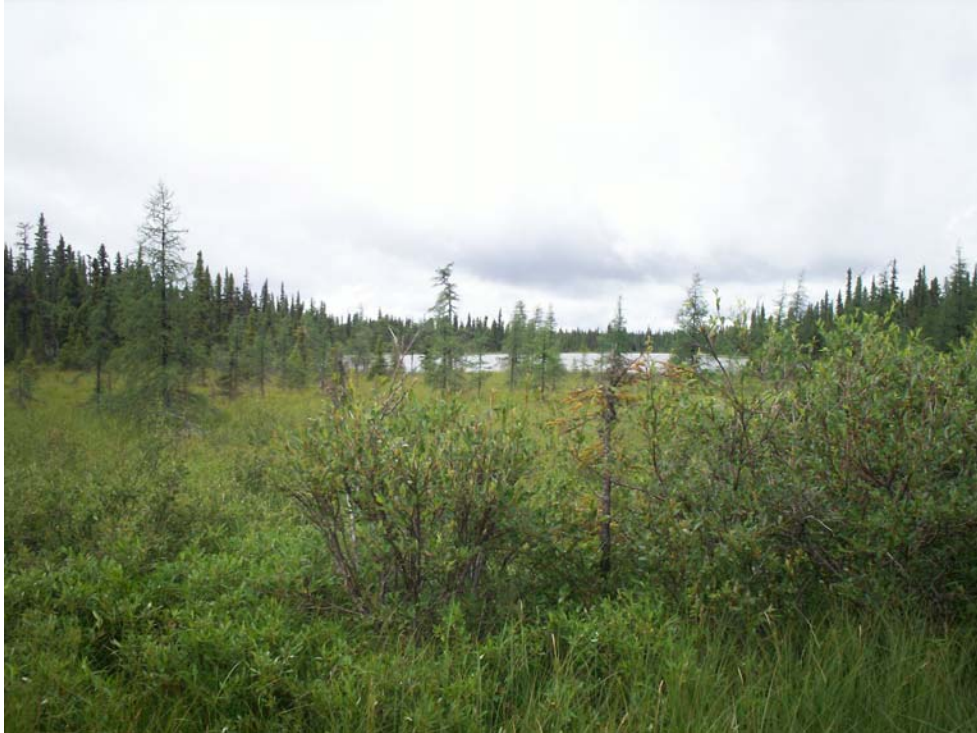
This site has an existing road crossing between a bog and a lake; however no inflow or outflow were identified connecting the two bodies of water therefore no stream surveys were conducted. See Photos B-30 and B-31, Appendix B.

Photo B-30. DSO3-9 road crosses wetland

Photo B-31. DSO3-9 road crosses by waterbody (no stream connection to wetland)

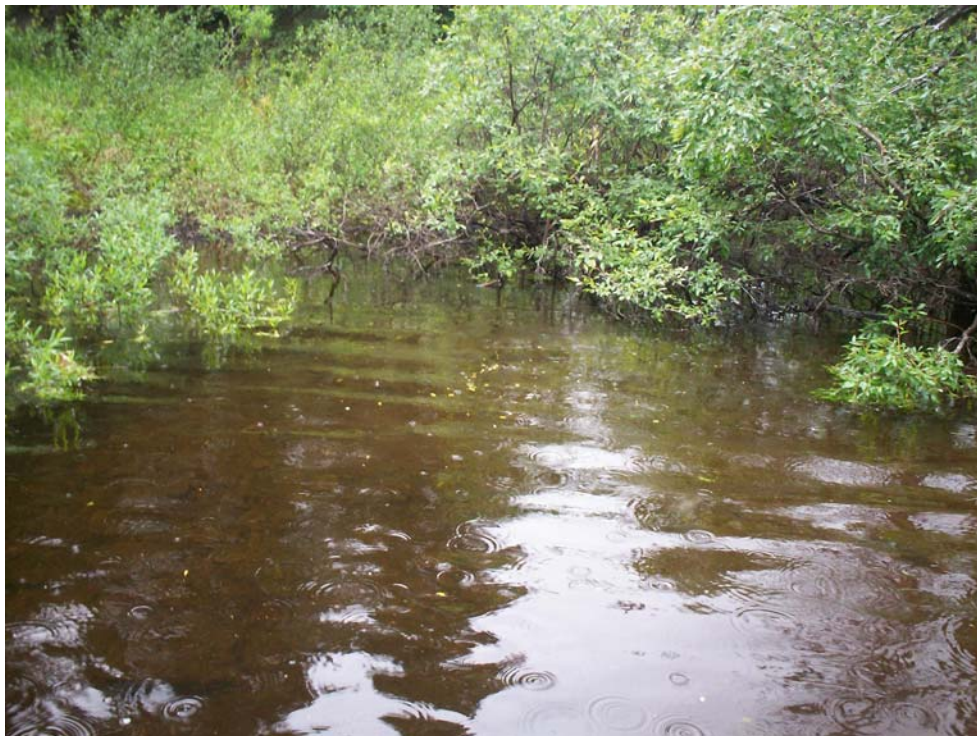
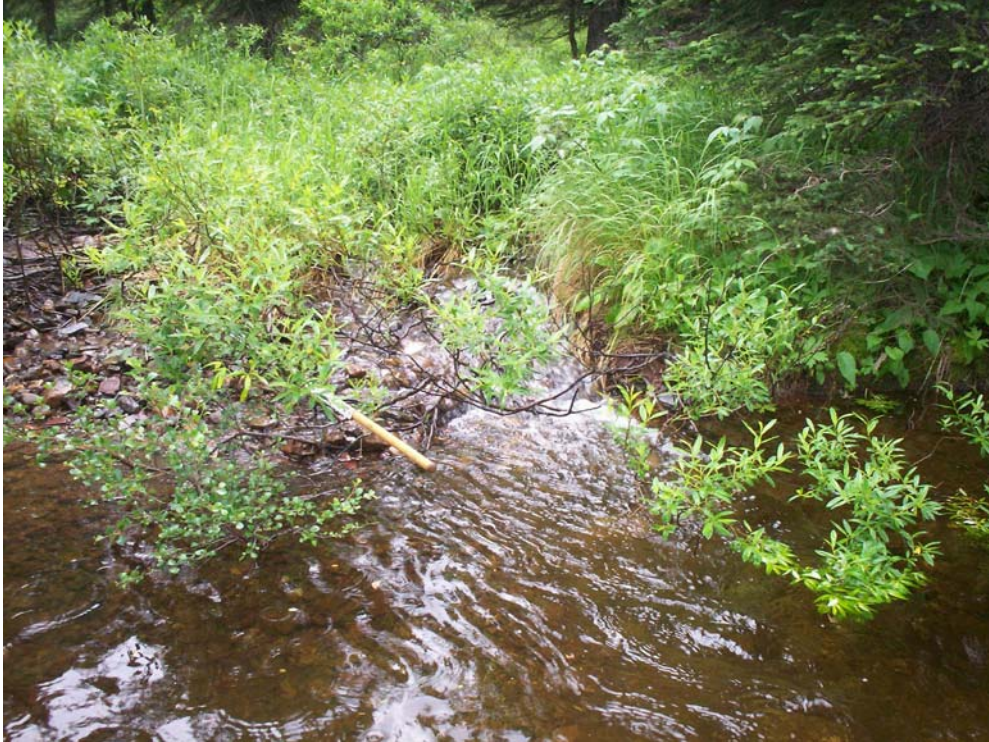
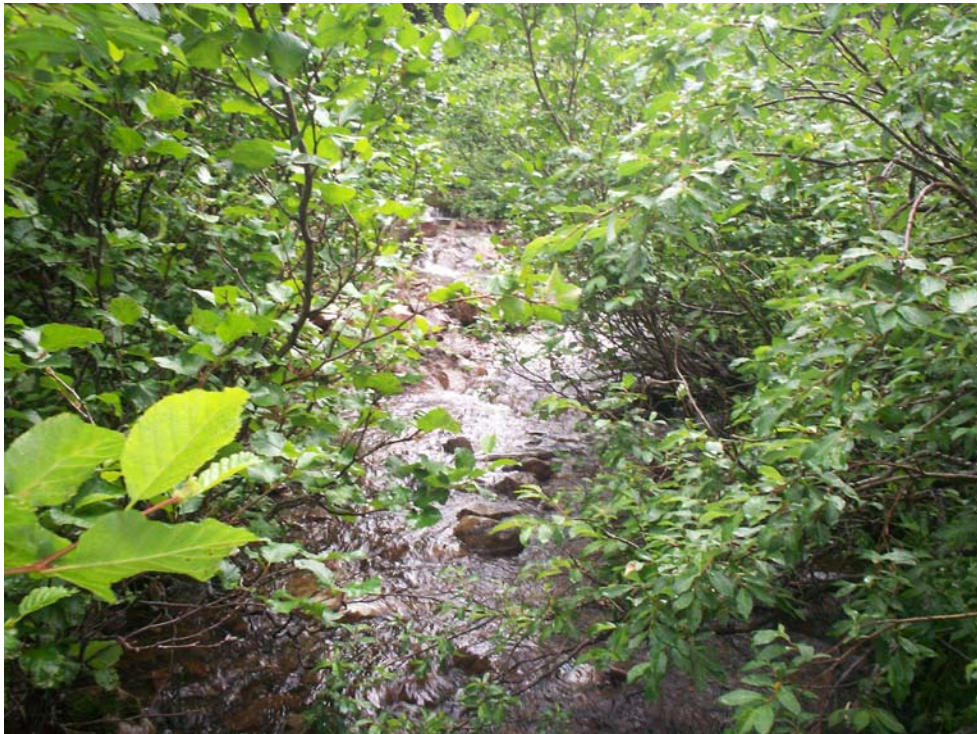
Approximately 60m of stream was surveyed and classified as predominately run/riffle habitat. The average stream wet width was 3.37m. Mean water depth was 0.11m with an average velocity of 0.15m/s. Substrate consisted mostly of medium substrate intermixed with coarse and fines. An access road is proposed to cross this stream. See Photos B-32 to B-34, Appendix B.

Photo B-32. DSO3-10 view of pool upstream of potential road crossing

Photo B-33. DSO3-10 view of pool inflow, upstream of potential road crossing

Photo B-34. DSO3-10 view of riffle, upstream of potential road crossing

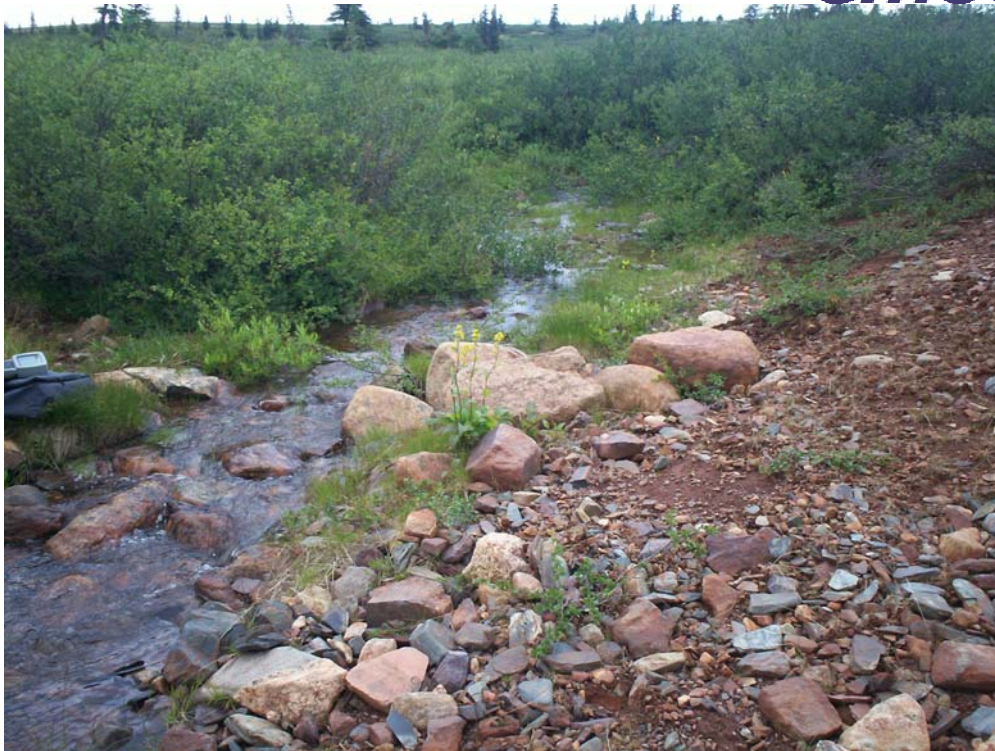
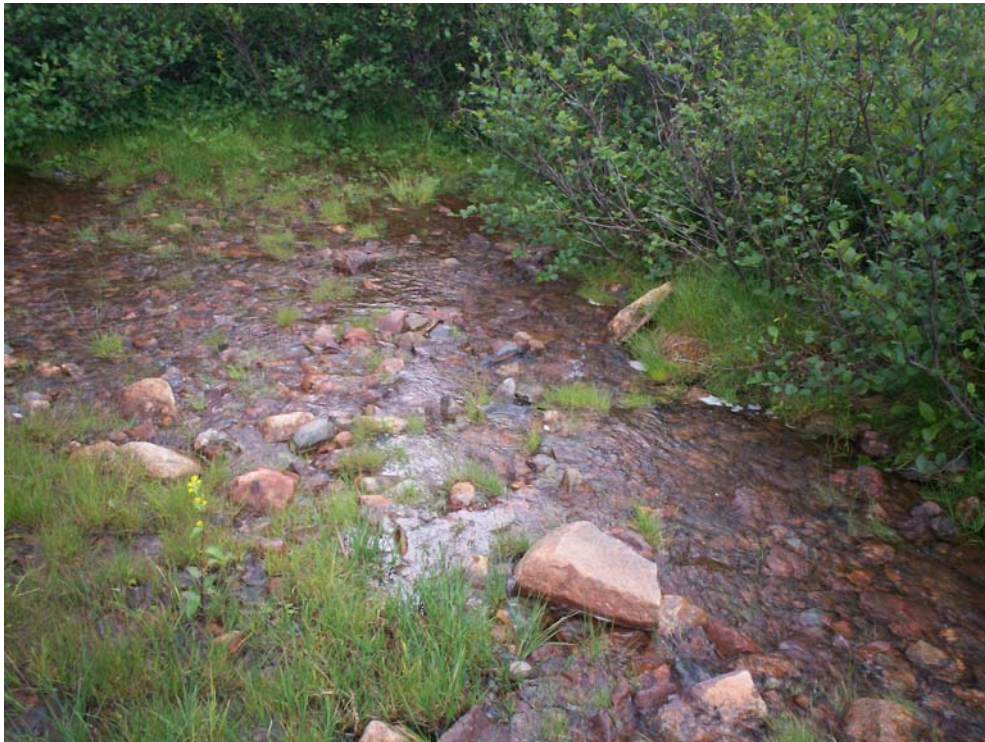
Approximately 60m of stream was surveyed and classified as predominately run/riffle habitat. The average stream wet width was 1.1m. Mean water depth was 0.20m with an average velocity of 0.06m/s. Substrate consisted predominately of medium substrate intermixed with coarse, fines and organics. An access road is proposed to cross this stream. See Photos B-35 and B-36, Appendix B.

Photo B-35. DSO3-11 upstream view of riffle (potential road crossing)

Photo B-36. DSO3-11 downstream view of riffle (potential road crossing)

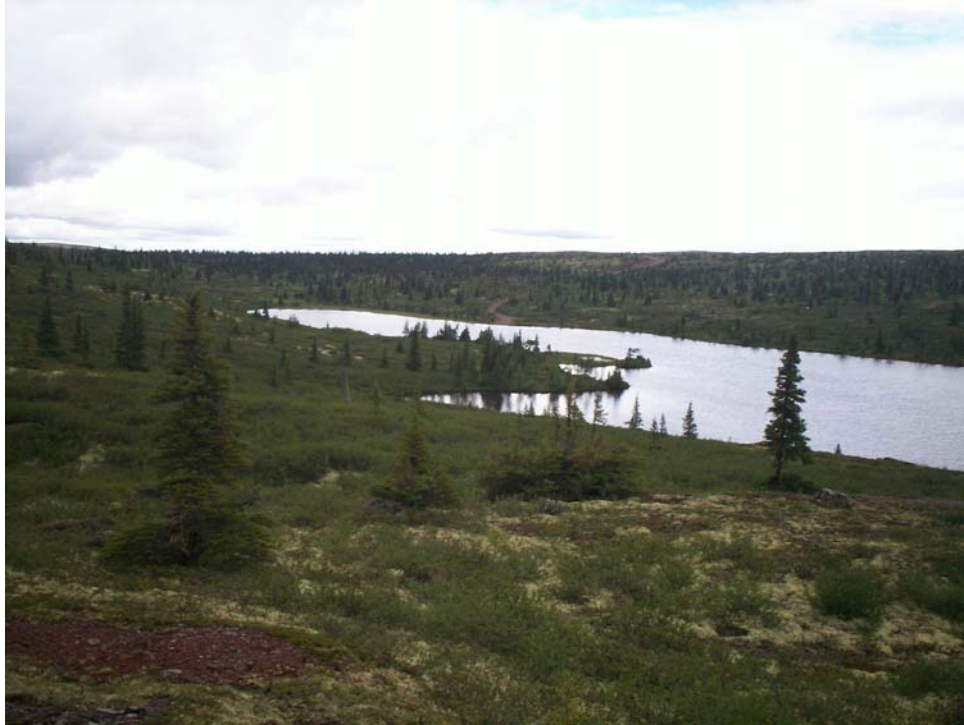
This site consisted of a lake (Lake Pinette). No stream surveys were conducted; however water quality samples were collected and measurements taken. See Photo B-37, Appendix B.

Photo B-37. DSO3-12 Pinette Lake

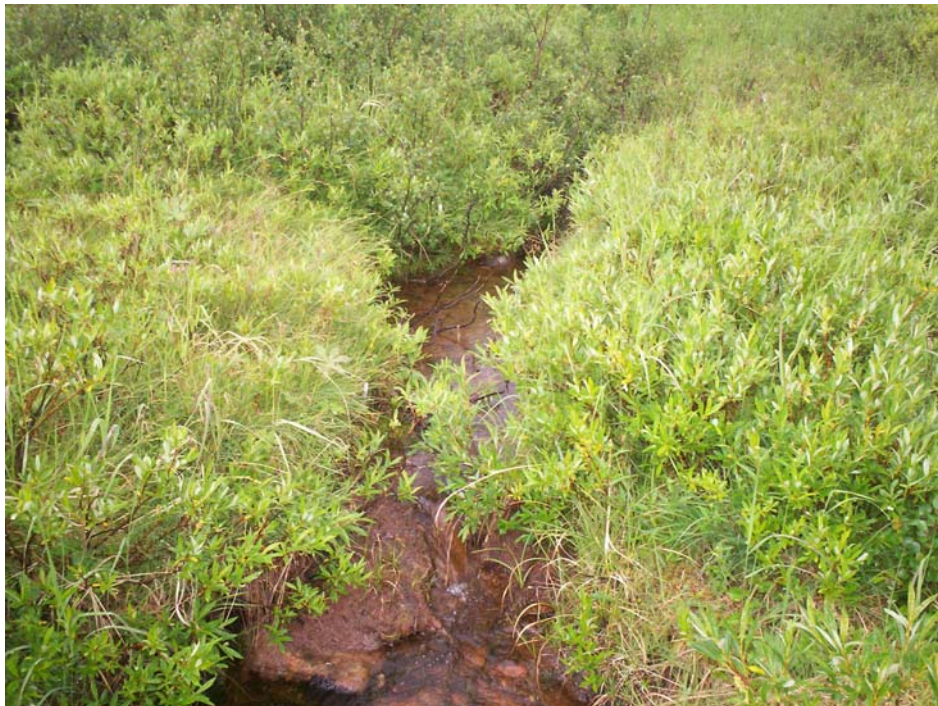
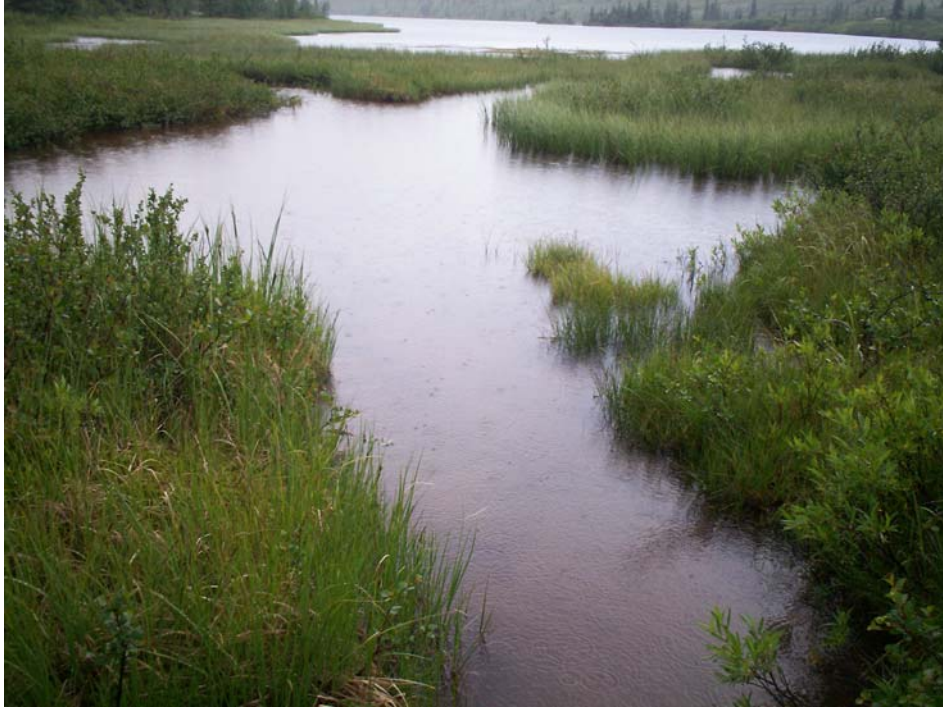
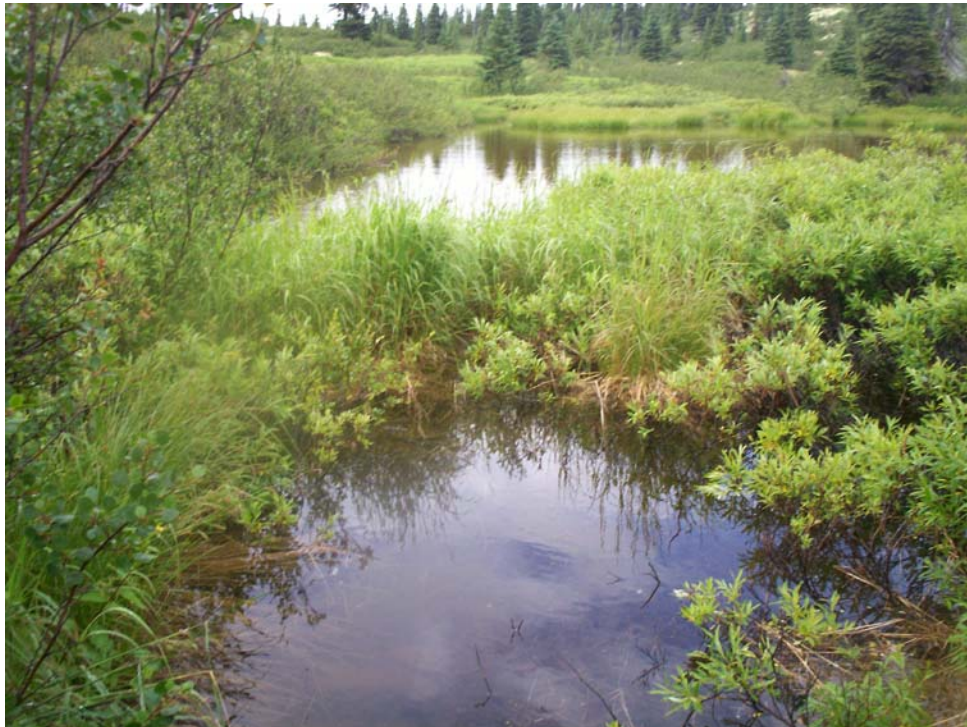
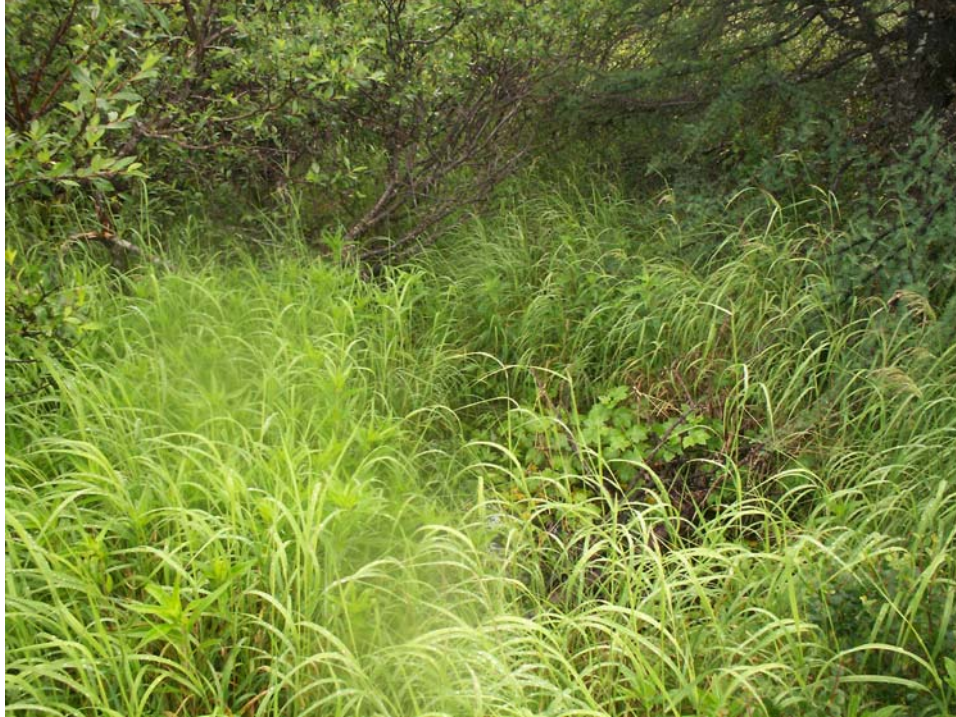
Approximately 150m of stream was surveyed and classified as a combination of run/riffle, steady, and pool habitats. The average stream wet width of the run/riffle habitat was 0.43m with a mean water depth of 0.15m and an average velocity of 0.52m/s. Substrate consisted of a majority of medium substrate intermixed with coarse, fines and organics. The average stream wet width of the identified steady habitat was 2.2m with a mean water depth of 0.26m and an average velocity of 0.0m/s. The average stream wet width of the identified pool habitat was 2.2m with a mean water depth of 0.45m and an average velocity of 0.04m/s. Substrate in the steady and pool habitat consisted mostly of medium substrate intermixed with coarse, fines and organics. See Photos B-38 to B-41, Appendix B.

Photo B-38. DSO3-13, upstream view of inflow to Pinette Lake

Photo B-39. DSO3-13, downstream view of inflow to Pinette Lake

Photo B-40. DSO3-13, upstream view of outflow from steady

Photo B-41. DSO3-13, downstream view of outflow from steady

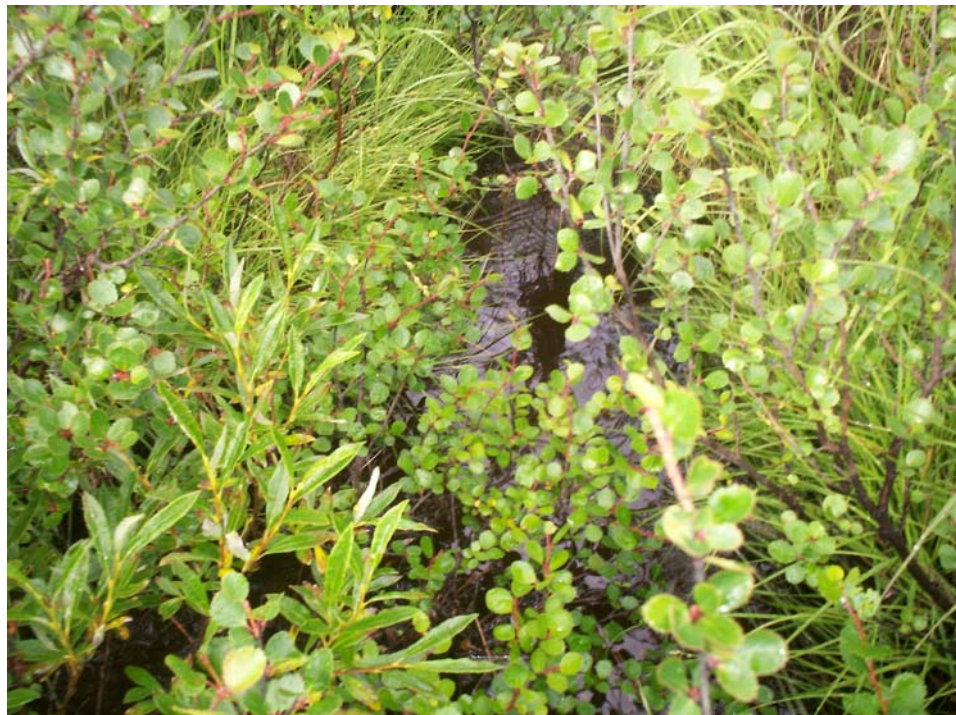
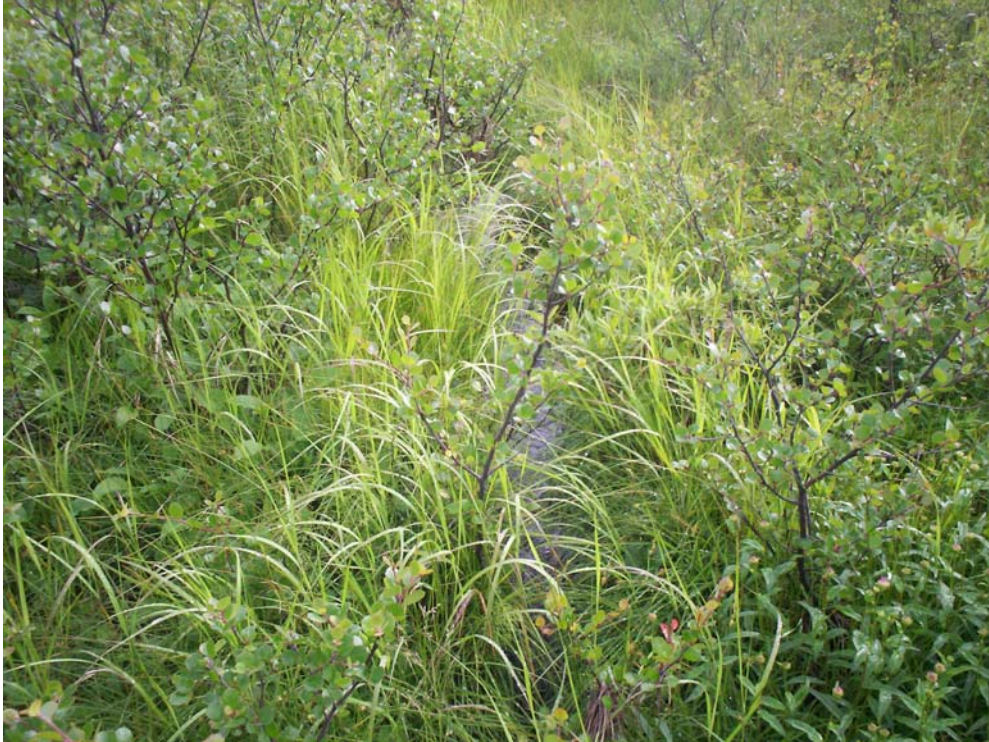
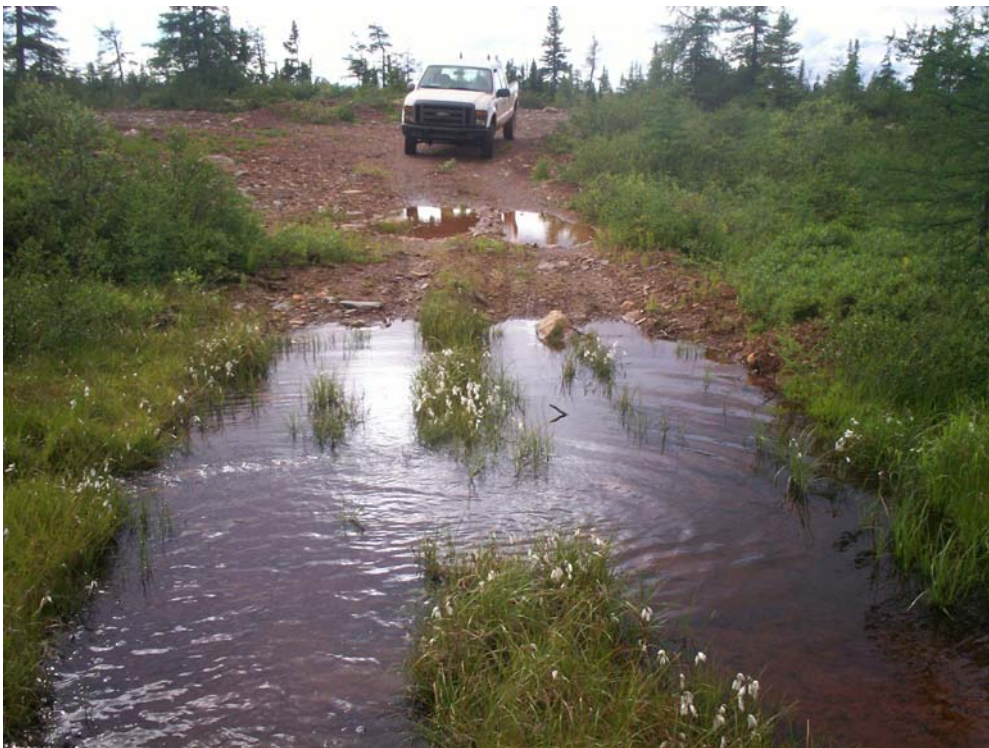
Approximately 60m of stream was surveyed and was classified as steady habitat. The average stream wet width was 0.84m. Mean water depth was 0.22m with an average velocity of 0.13m/s. Substrate consisted predominately of organics intermixed with fine and medium substrate. See Photos B-42 to B-44, Appendix B.

Photo B-42. DSO3-14, upstream view of potential road crossing

Photo B-43. DSO3-14, downstream view of potential road crossing

Photo B-44. DSO3-14, view of potential road crossing

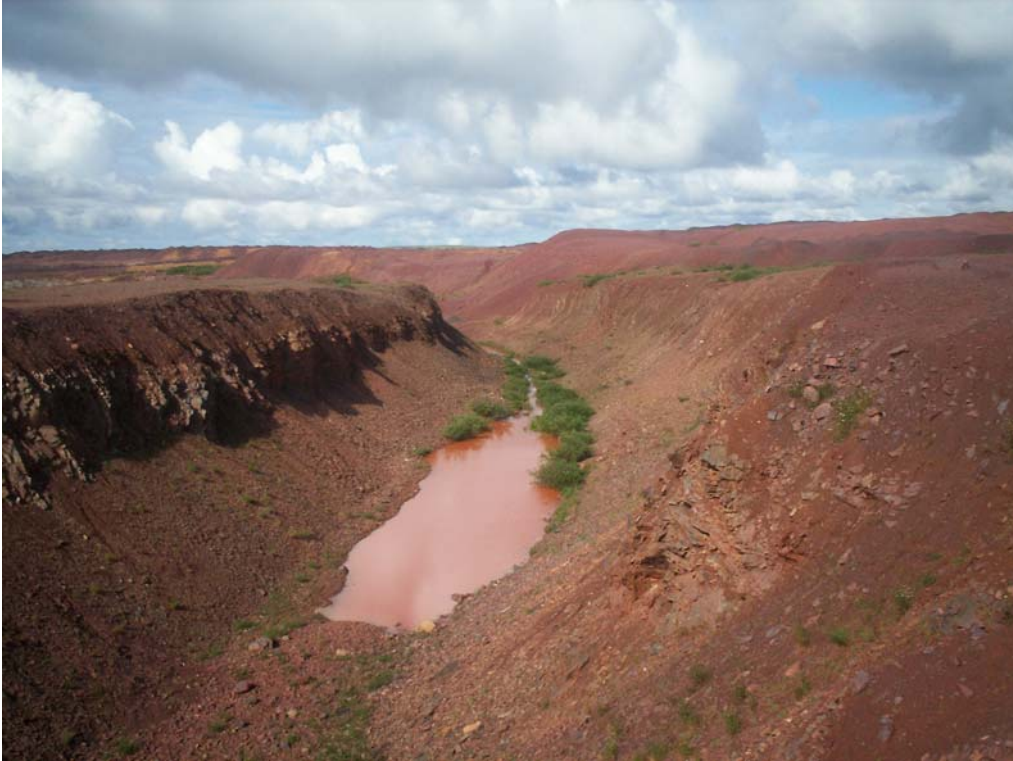
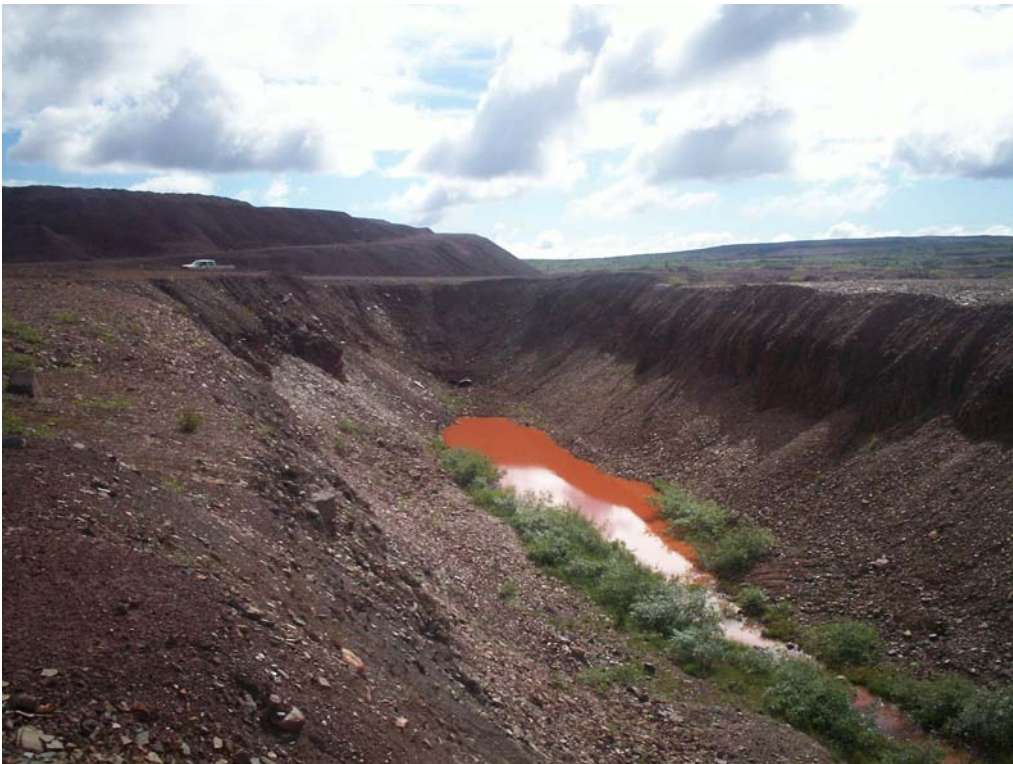
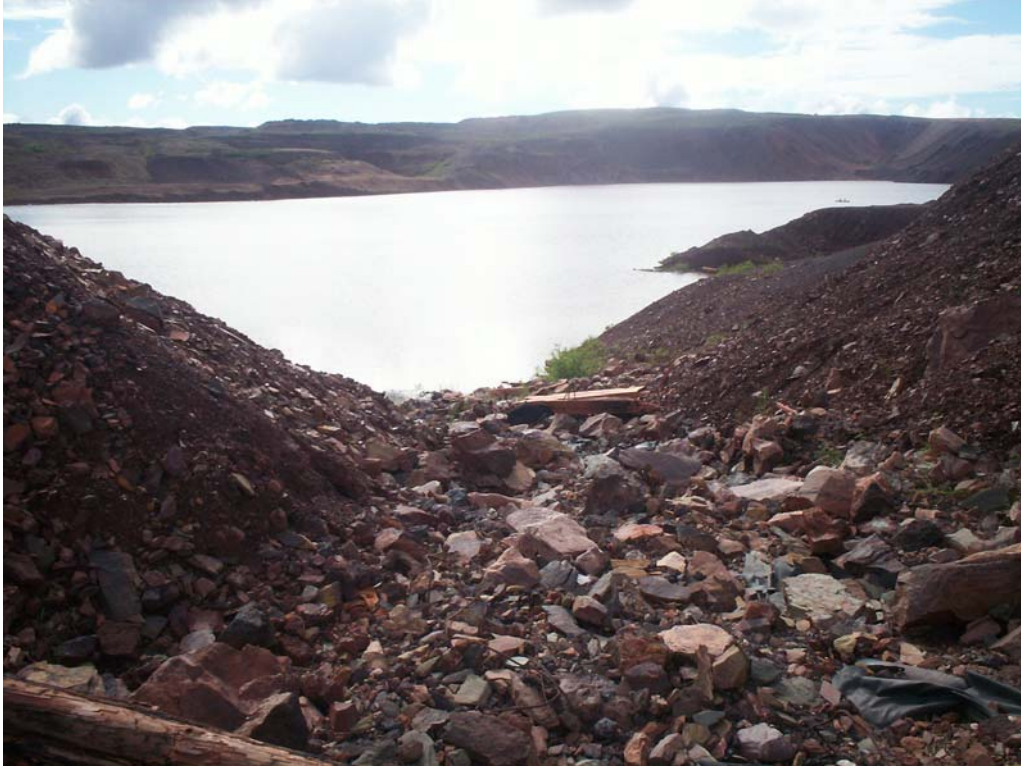
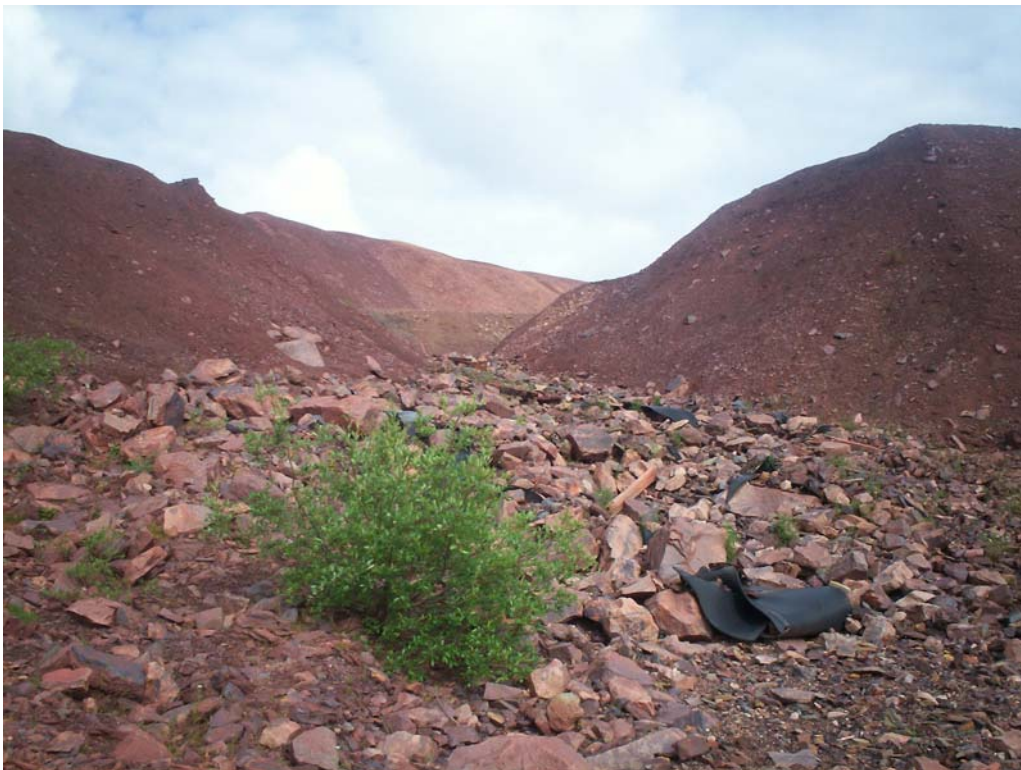
Photo B-45. Timmins 1 Ditch, downstream view from road which runs to Timmins 1

Photo B-46. Timmins 1 Ditch, upstream view from road which runs to Timmins 1 (could not find culvert inflow on other side of road)

Photo B-47. Timmins 1 Ditch, downstream view with Timmins 1 in background

Photo B-48. Timmins 1 Ditch, upstream view (a lot of debris such as wood and rubber conveyor belts in ditch)

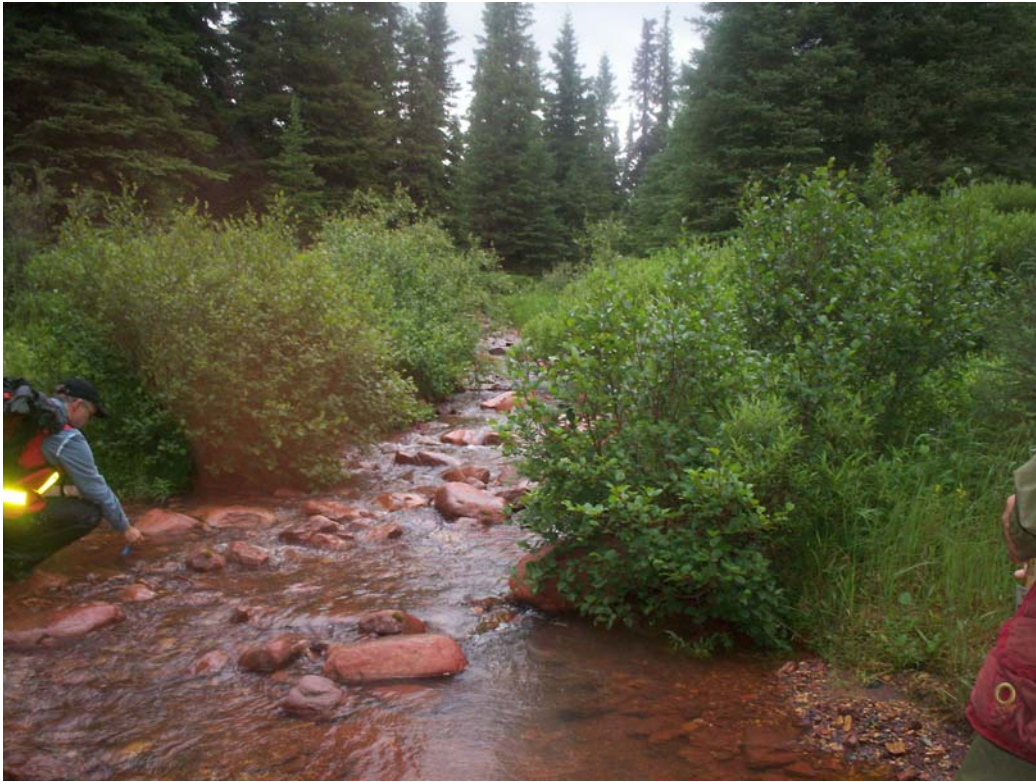
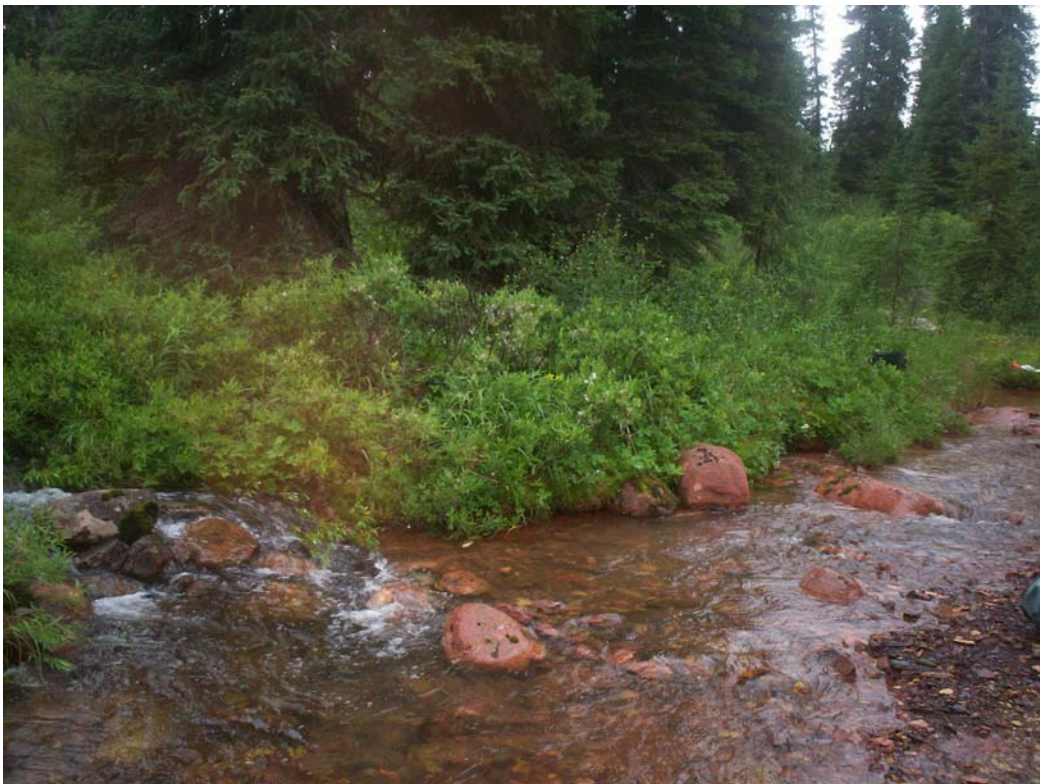
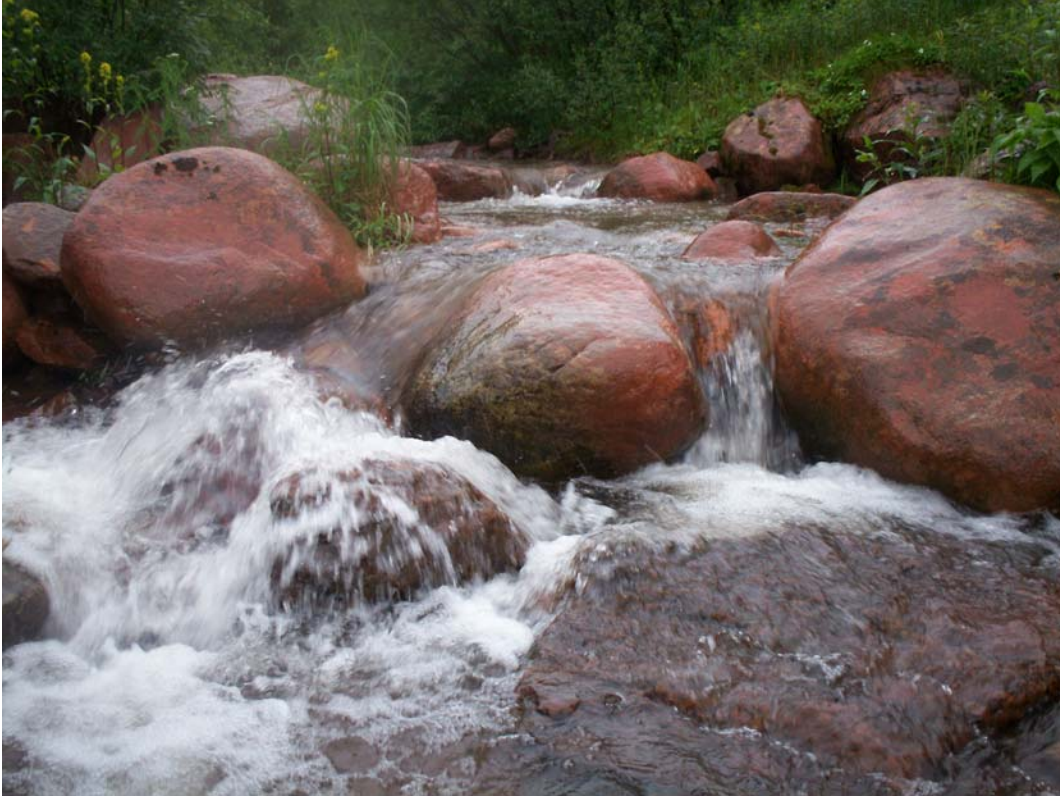
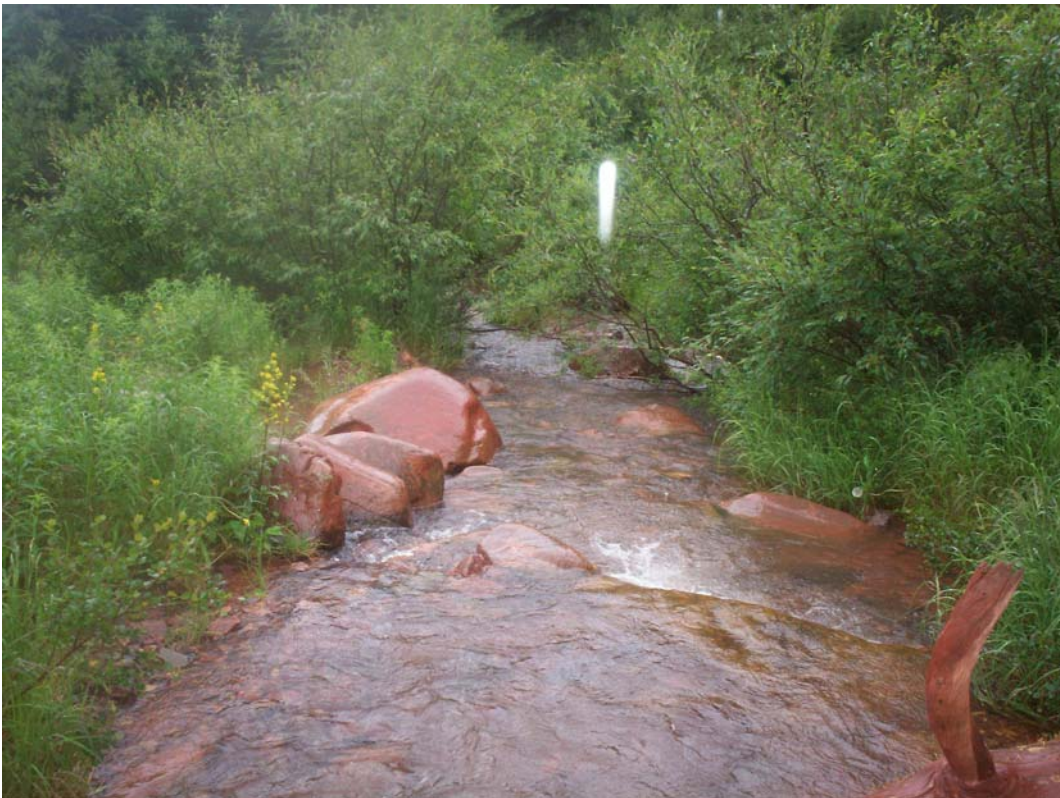
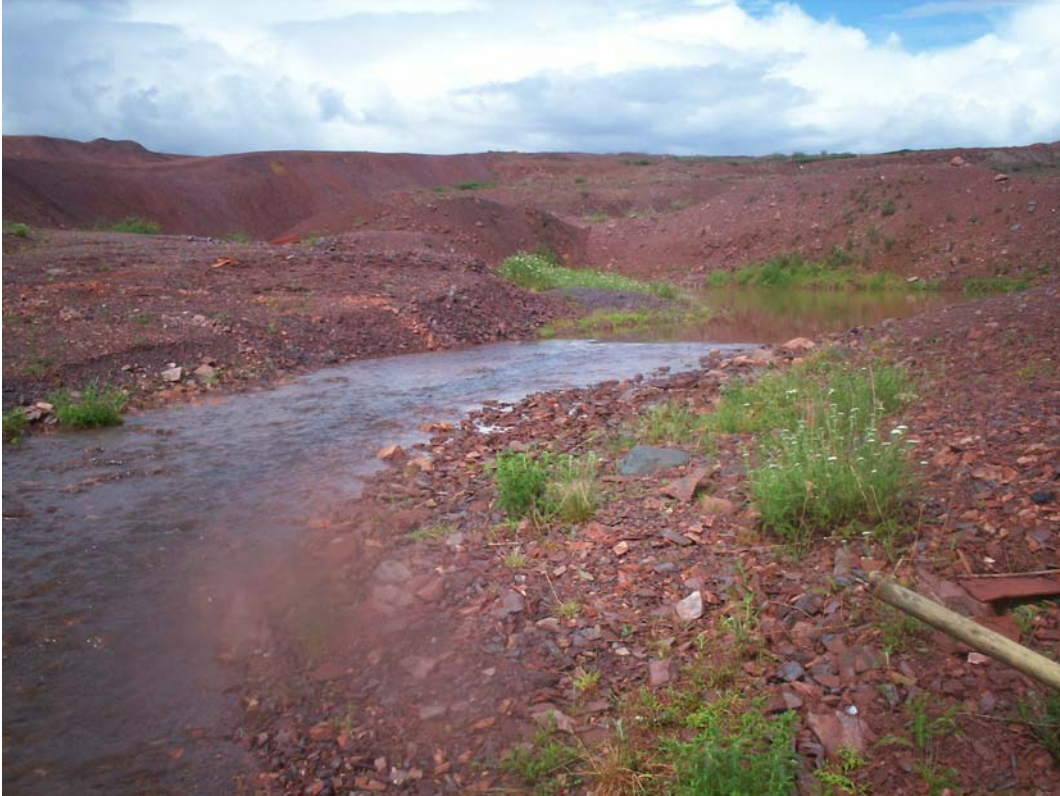
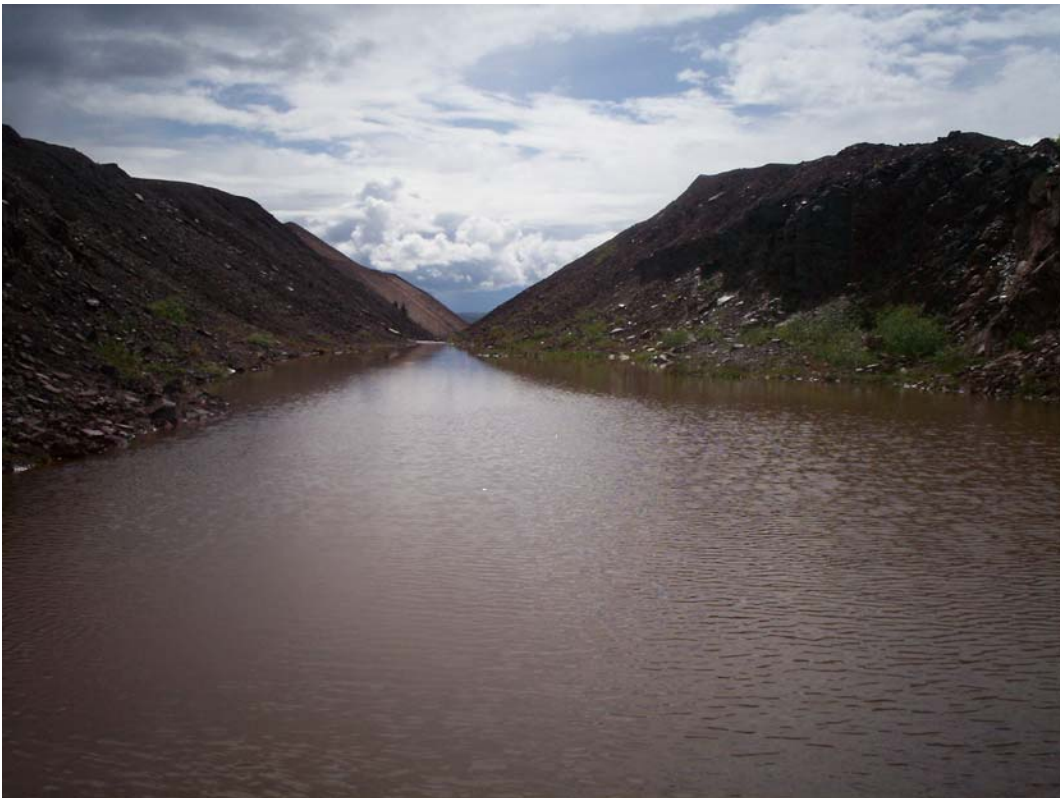
The outflow of Timmins Pit 2 was surveyed between the pit and where it joins the outflow of Lake Pinette (1.5km). The stream was predominately riffle habitat with an average stream wet width of 2.84m. Mean water depth was 0.11m with an average velocity of 0.21m/s. Substrate consisted mostly of medium substrate intermixed with fine and coarse substrate. At the outflow from the pit, there were two steadies (6m x 20m and 15m x 100m). One small pool was also identified while surveying the stream. Its dimensions were 3.79m x 3m with an average depth of 0.32m and an average velocity of 0.06m/s. The substrate was classified as medium with coarse and fine substrates intermixed. See Photos B-49 to B-54, Appendix B.

Photo B-49. DSO3-15 upstream view of riffle

Photo B-50. DSO3-15 upstream view (inflow from Pinette lake on left)

Photo B-51. DSO3-15 upstream view

Photo B-52. DSO3-15 downstream view

Photo B-53. DSO3-15 upstream view of inflow from Timmins 1

Photo B-54. DSO3-15 downstream view of steady (tailing piles on left and right causing heavy siltation)
