KSM Transmission Line: Preliminary Geotechnical Review

KSM PROJECT

TEIGEN CREEK - KSM TRANSMISSION LINE: PRELIMINARY GEOTECHNICAL REVIEW

PROJECT NO: 0638-005 DATE: February 7, 2012 DOCUMENT NO:

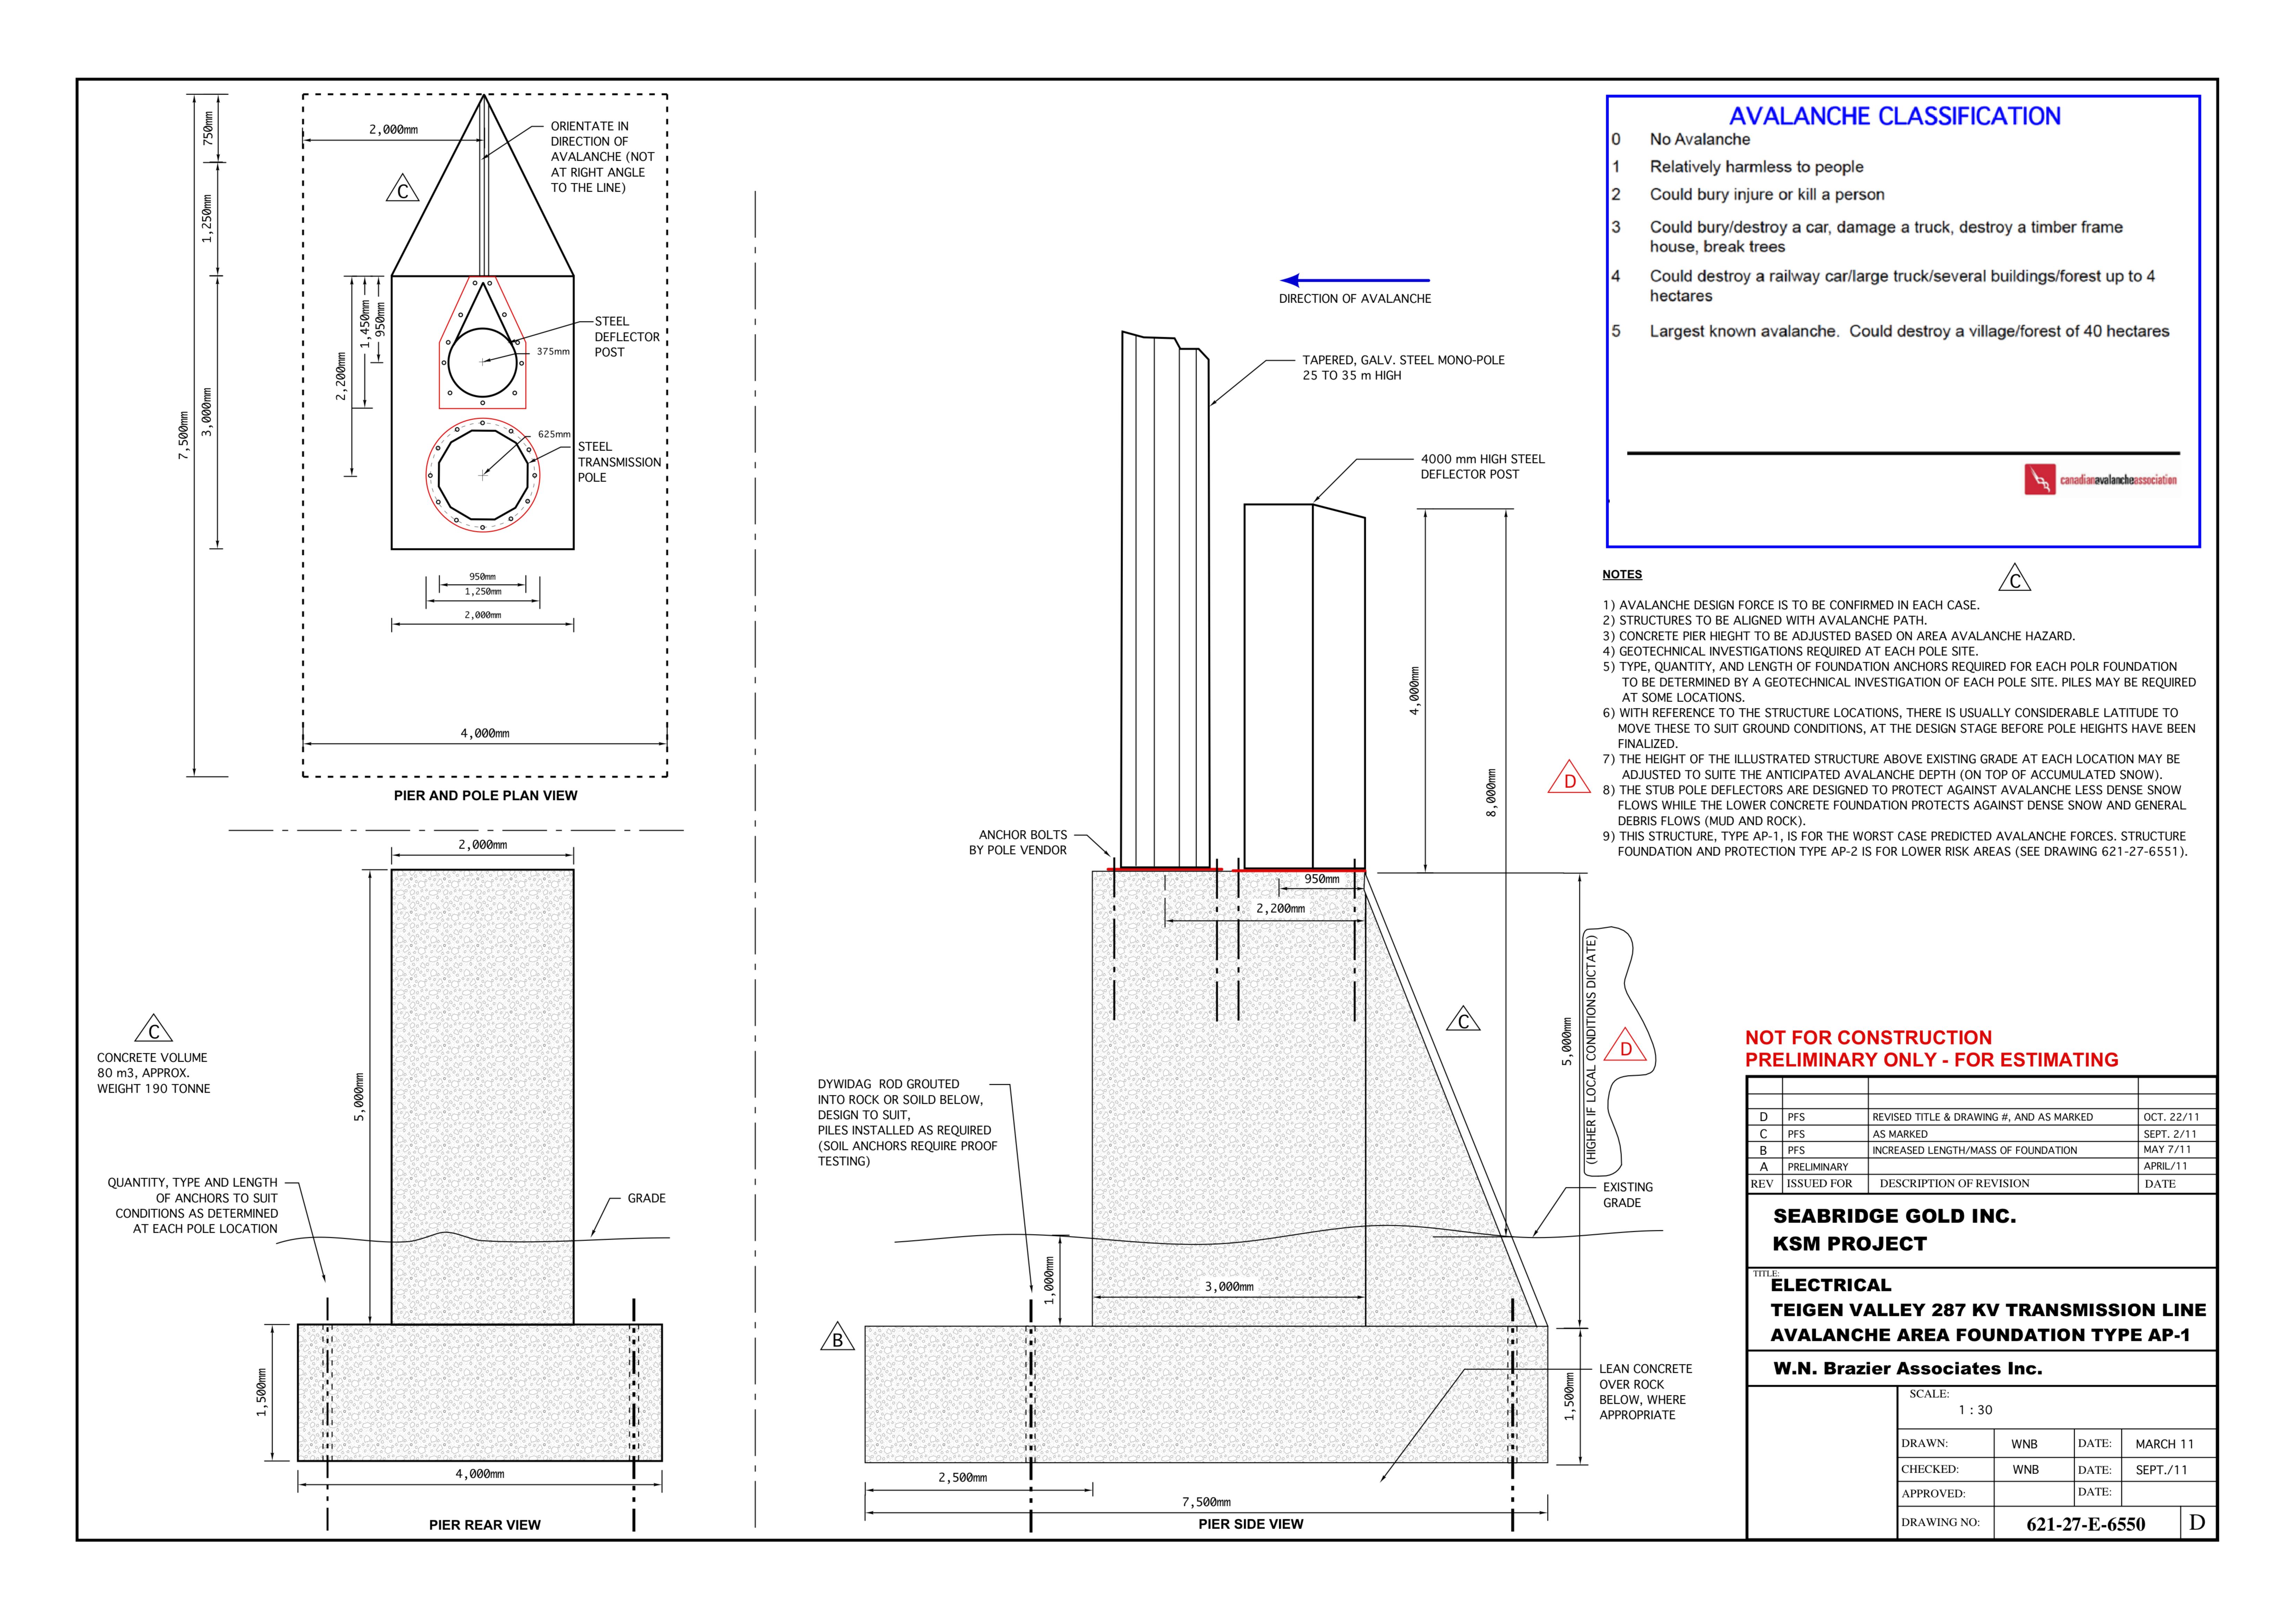
APPENDIX A AVALANCHE AREA FOUNDATION TYPE AP-1

- 9. A TYPICAL DESIGN HAS BEEN ORIGINATED FOR TRANSMISSION LINE STRUCTURES SUBJECT TO SEVERE AVALANCHE HAZARD. REFER TO THE DESIGN SKETCH. THE PRINCIPLE IS TO RAISE THE STEEL POLE BASES ABOVE THE LEVEL OF HAZARDOUS AVALANCHE FLOWS. SMALLER CONCRETE STRUCTURE FOUNDATIONS WOULD BE PROVIDED FOR POLES IN SEMI-HAZARDOUS AREAS.
