**APPENDIX 9-D**  
**KSM PROJECT GEOHAZARD RISK ASSESSMENT OF**  
**UPDATED FACILITY LOCATIONS**

## **SEABRIDGE GOLD INC.**

### **KSM PROJECT**

# **GEOHAZARD RISK ASSESSMENT OF UPDATED FACILITY LOCATIONS**

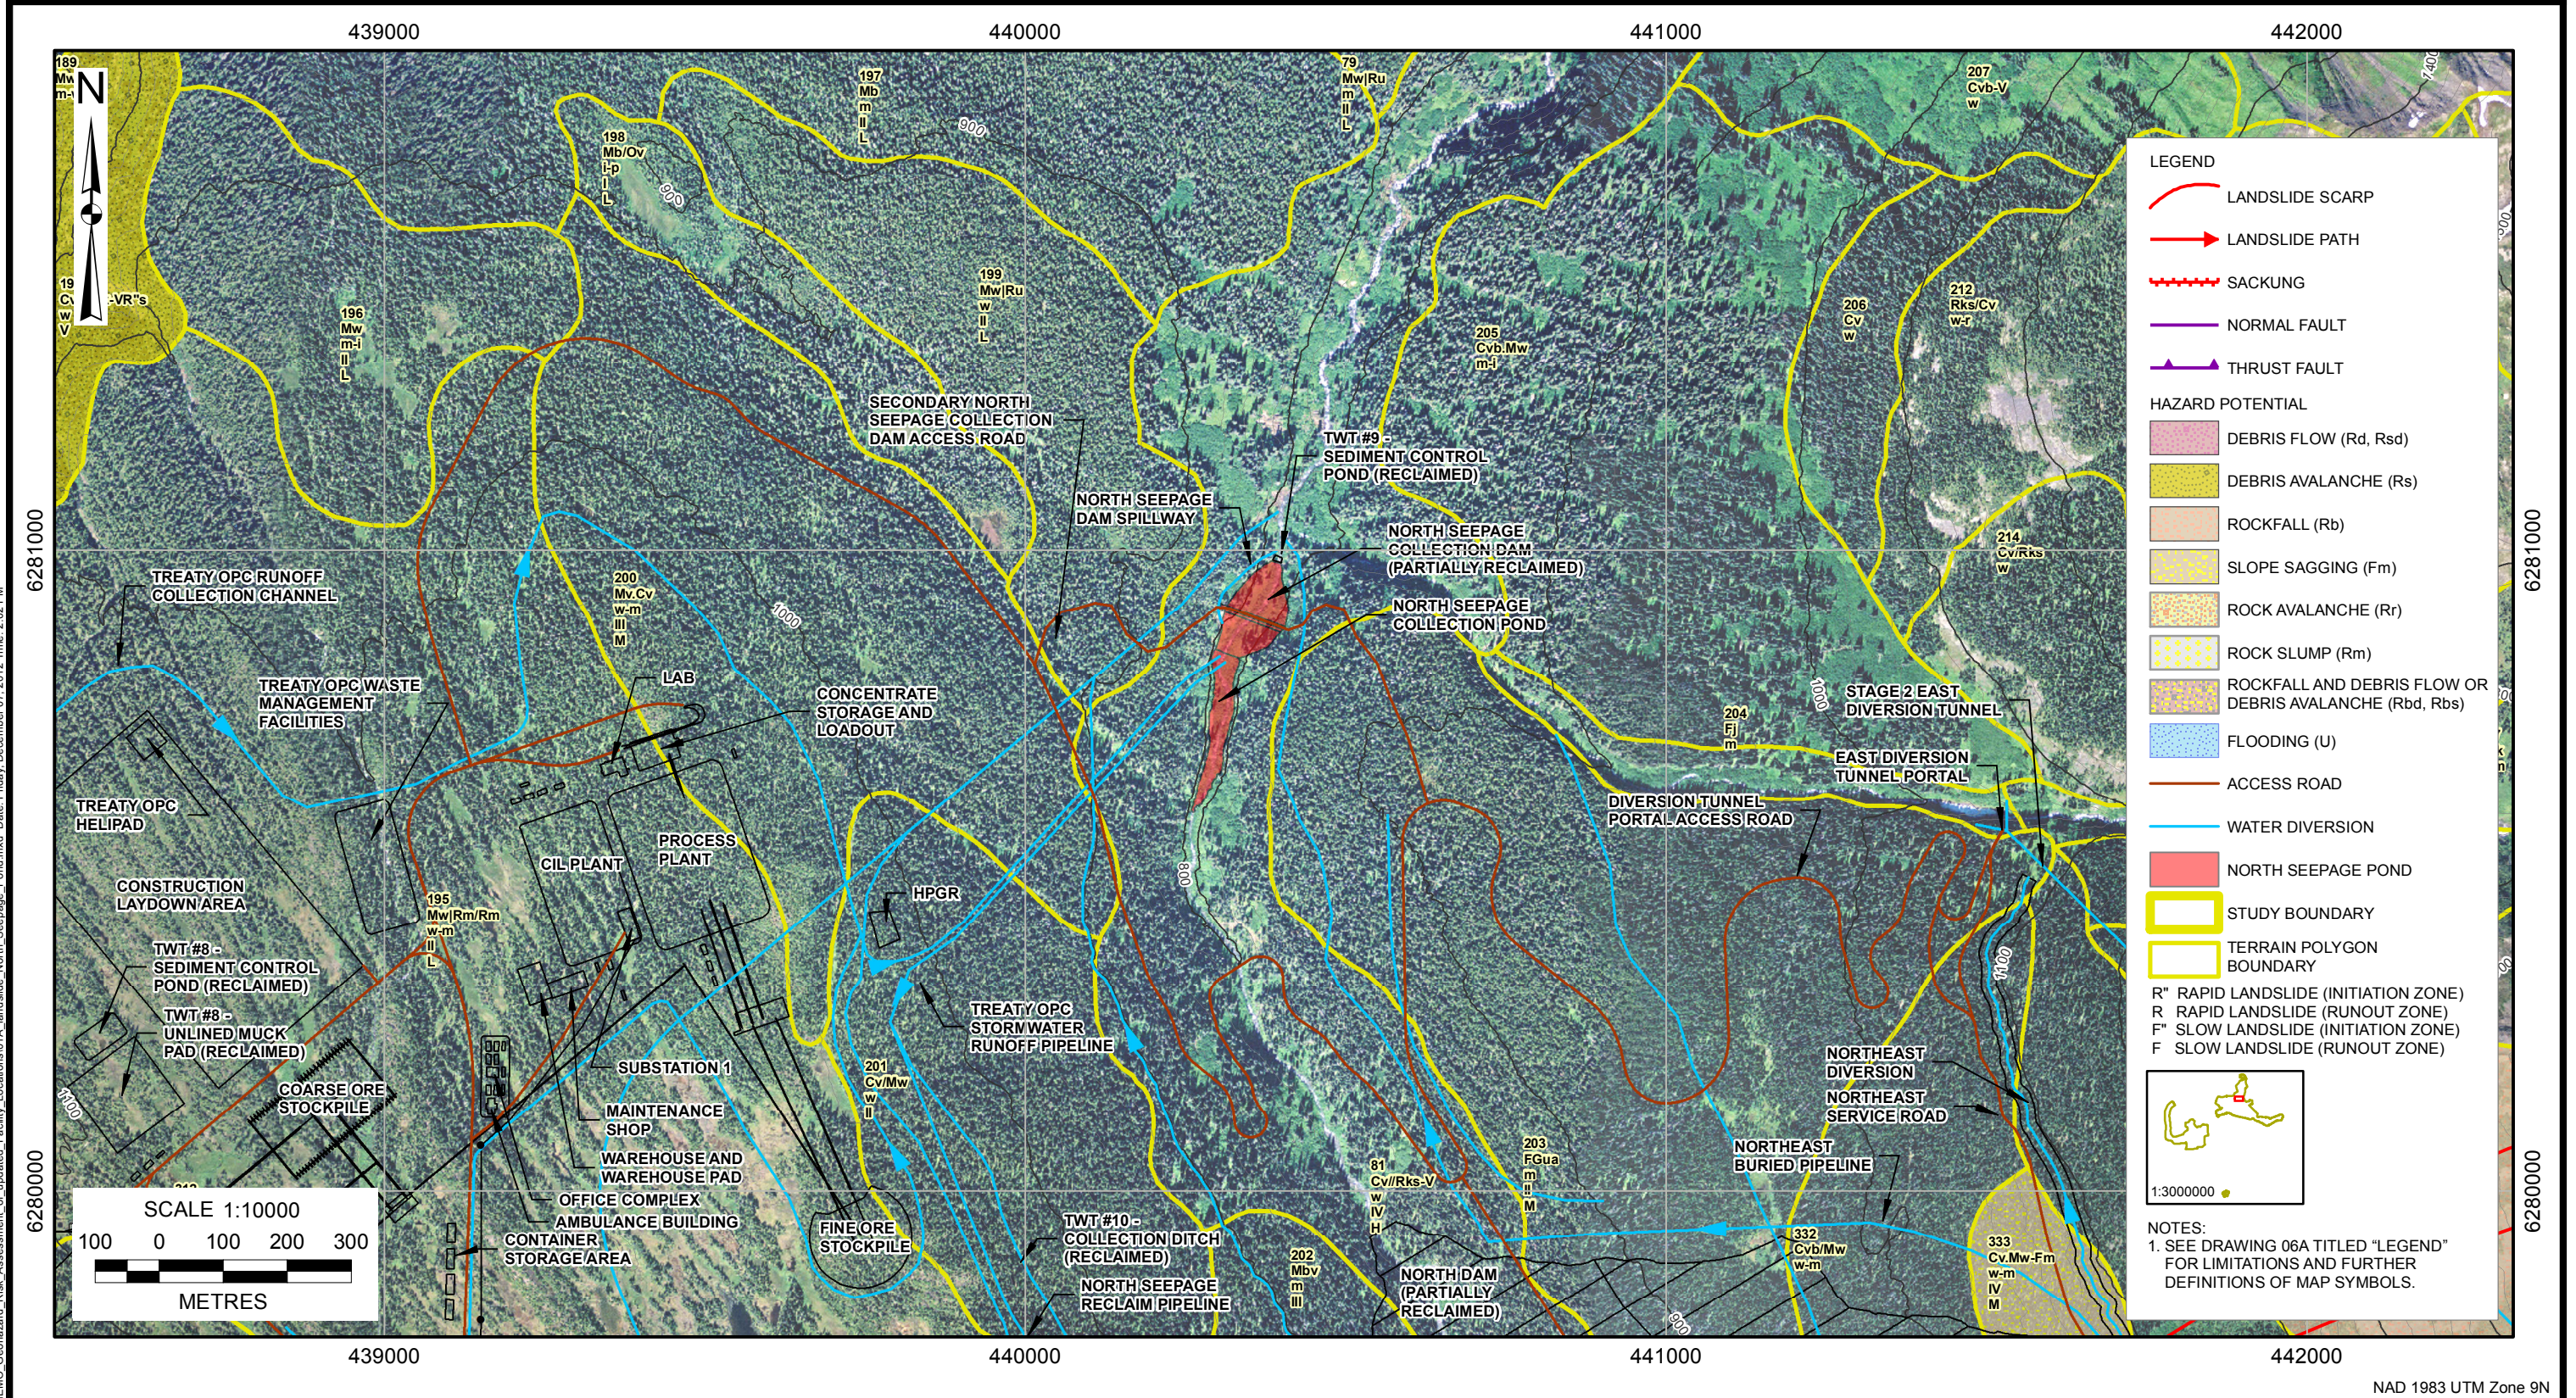
The North Seepage Dam is has been moved 500 m north to a position about 2.0 km north of the North Dam Crest (Drawing 1a and 1b). No avalanche or landslide geohazards were identified at this location. Based on air photo interpretation, the dam footprint extends across a steep, bedrock-controlled, V-shaped valley bottom partially overlain by thin (< 1 m) colluvium. No active landslides were identified on air photos; however slopes in the vicinity of the dam footprint are undercut by gully and fluvial erosion and may be subject to localized instability above the creek channel.

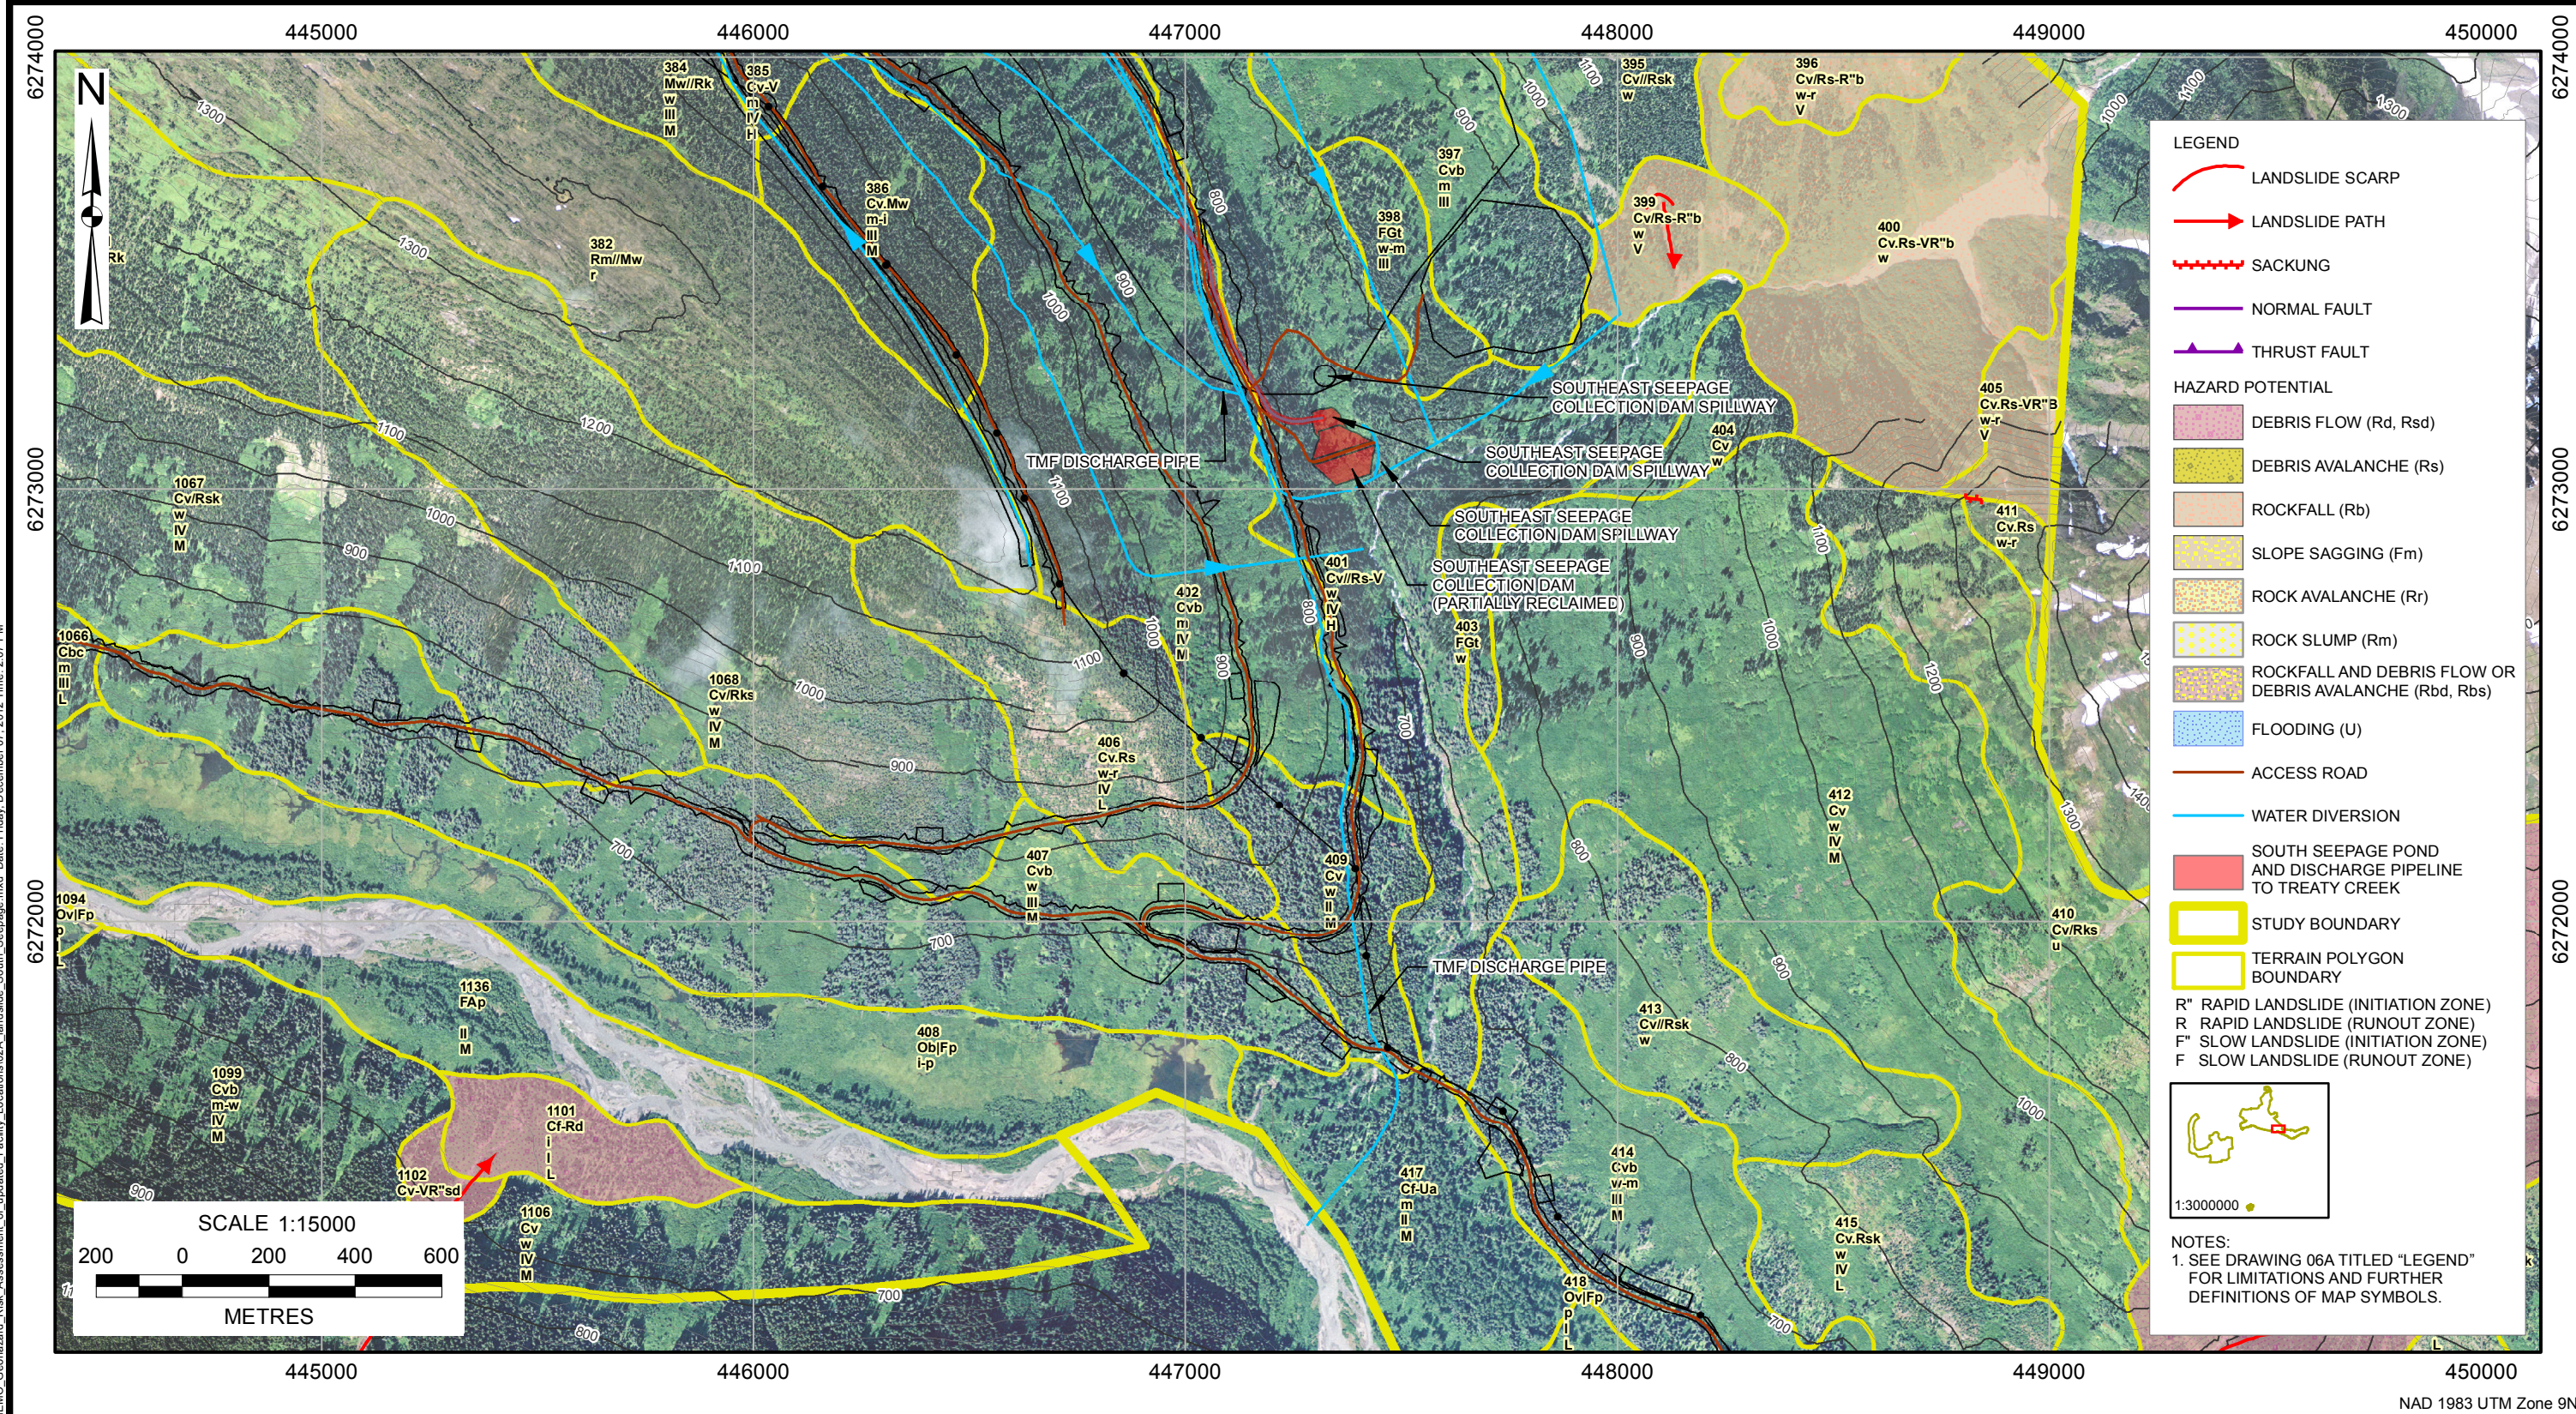
The Southeast Seepage Dam has been moved 500 m south to a position 2.0 km downstream of the South Dam (Drawings 2a and 2b). The southwest boundary of the dam footprint is immediately adjacent to the runout of an avalanche path to the west. Avalanches are not expected to be a hazard to the collection dam or the pond. There is potential for hazard to personnel during construction and serving, depending on the location of worksites. No other avalanche or landslide geohazards have been identified at this location.

The TMF discharge pipe runs from the north cell of the TMF to Treaty Creek. From the north cell to the Southeast Dam the pipe replaces the South Diversion Channel. From the Southeast Dam the pipe parallels the North Treaty road and North Treaty Creek to Treaty Creek (Drawings 2a and 2b). The pipe crosses avalanche paths between the Southeast Dam and Treaty Creek. These could be a hazard during construction or servicing. No geohazards were identified that could impact a buried pipe.

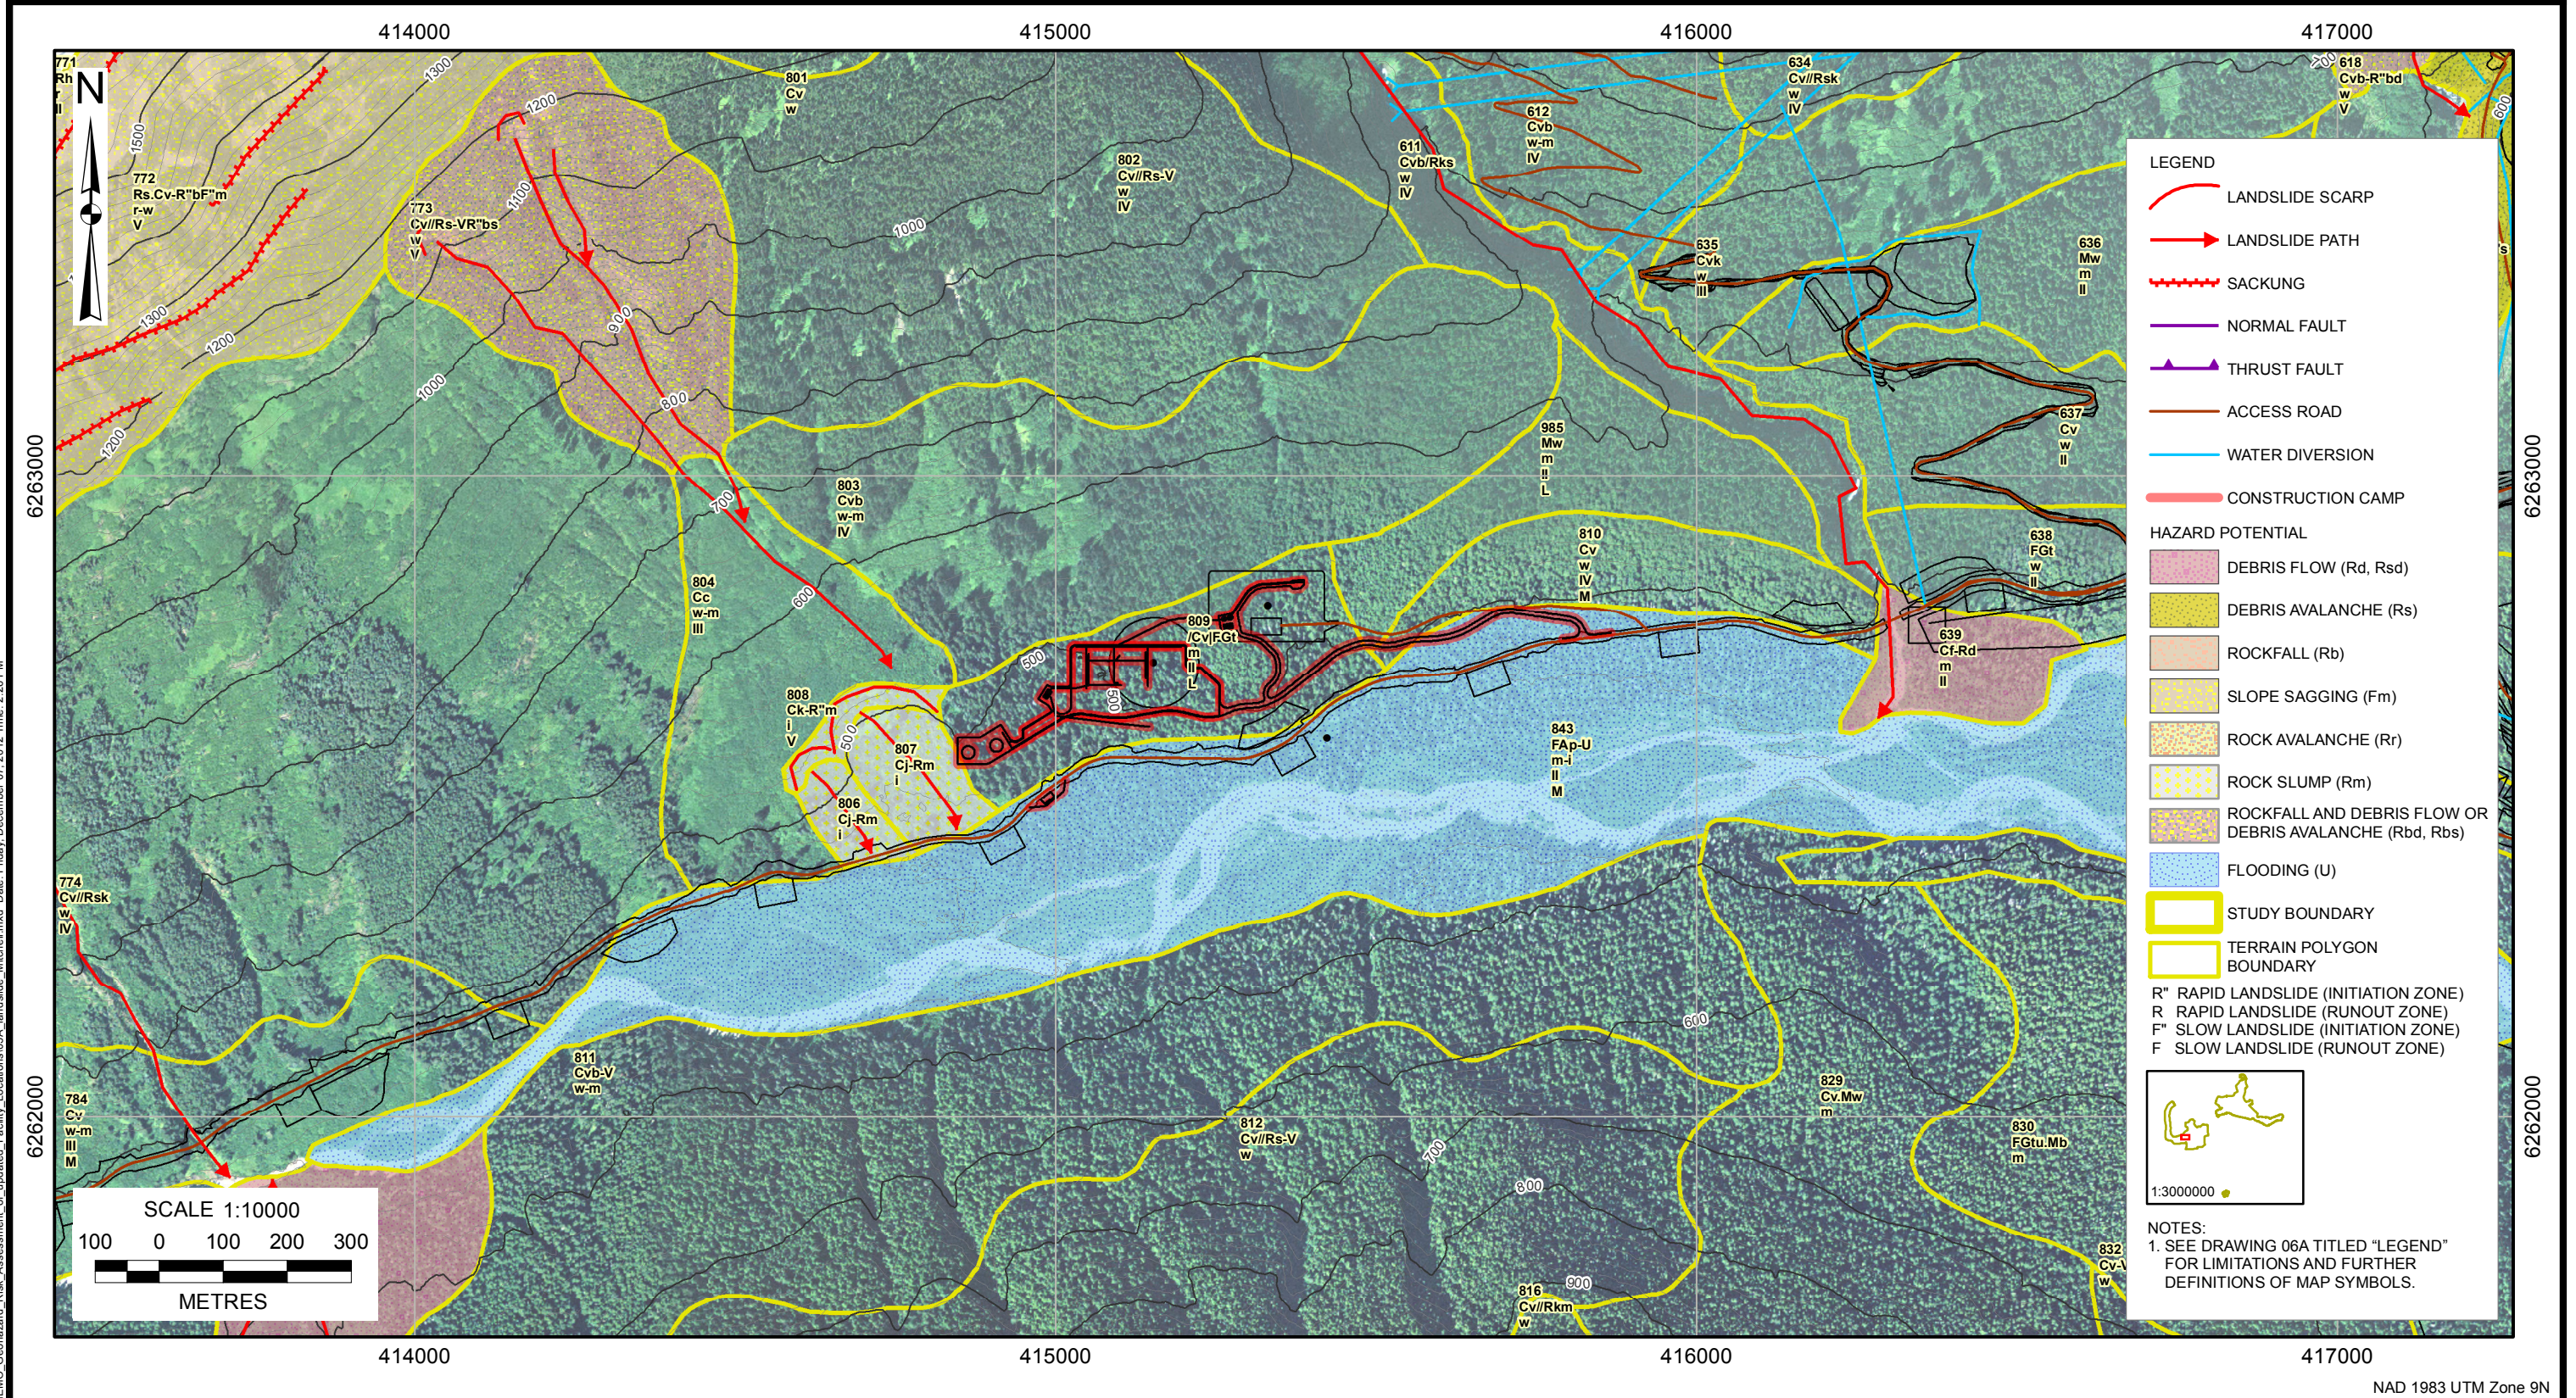
This camp is located on the north side of Sulphurets Creek approximately 600 m west of Gingrass Creek (Drawings 5a and 5b). No landslide geohazards were identified with the potential to impact the camp location. However the structures at the western edge of the camp are adjacent to a slump in thick colluvial material. The western edge of the camp footprint extends near an avalanche path runout area and could be subject to avalanche mass or powder impact. A small gully located to the north is capable of producing wet flowing avalanches. The analysis completed suggests it does not reach the camp footprint, but this is subject to field confirmation.
