**Appendix D. Site C PAG Contact RSEM Surface Water Quality Monitoring Time Series Plots  
– L5 Monthly and 5 in 30-day Data.**

## 2.0 2019 SITE AUDITS OVERVIEW AND SITE CONDITIONS

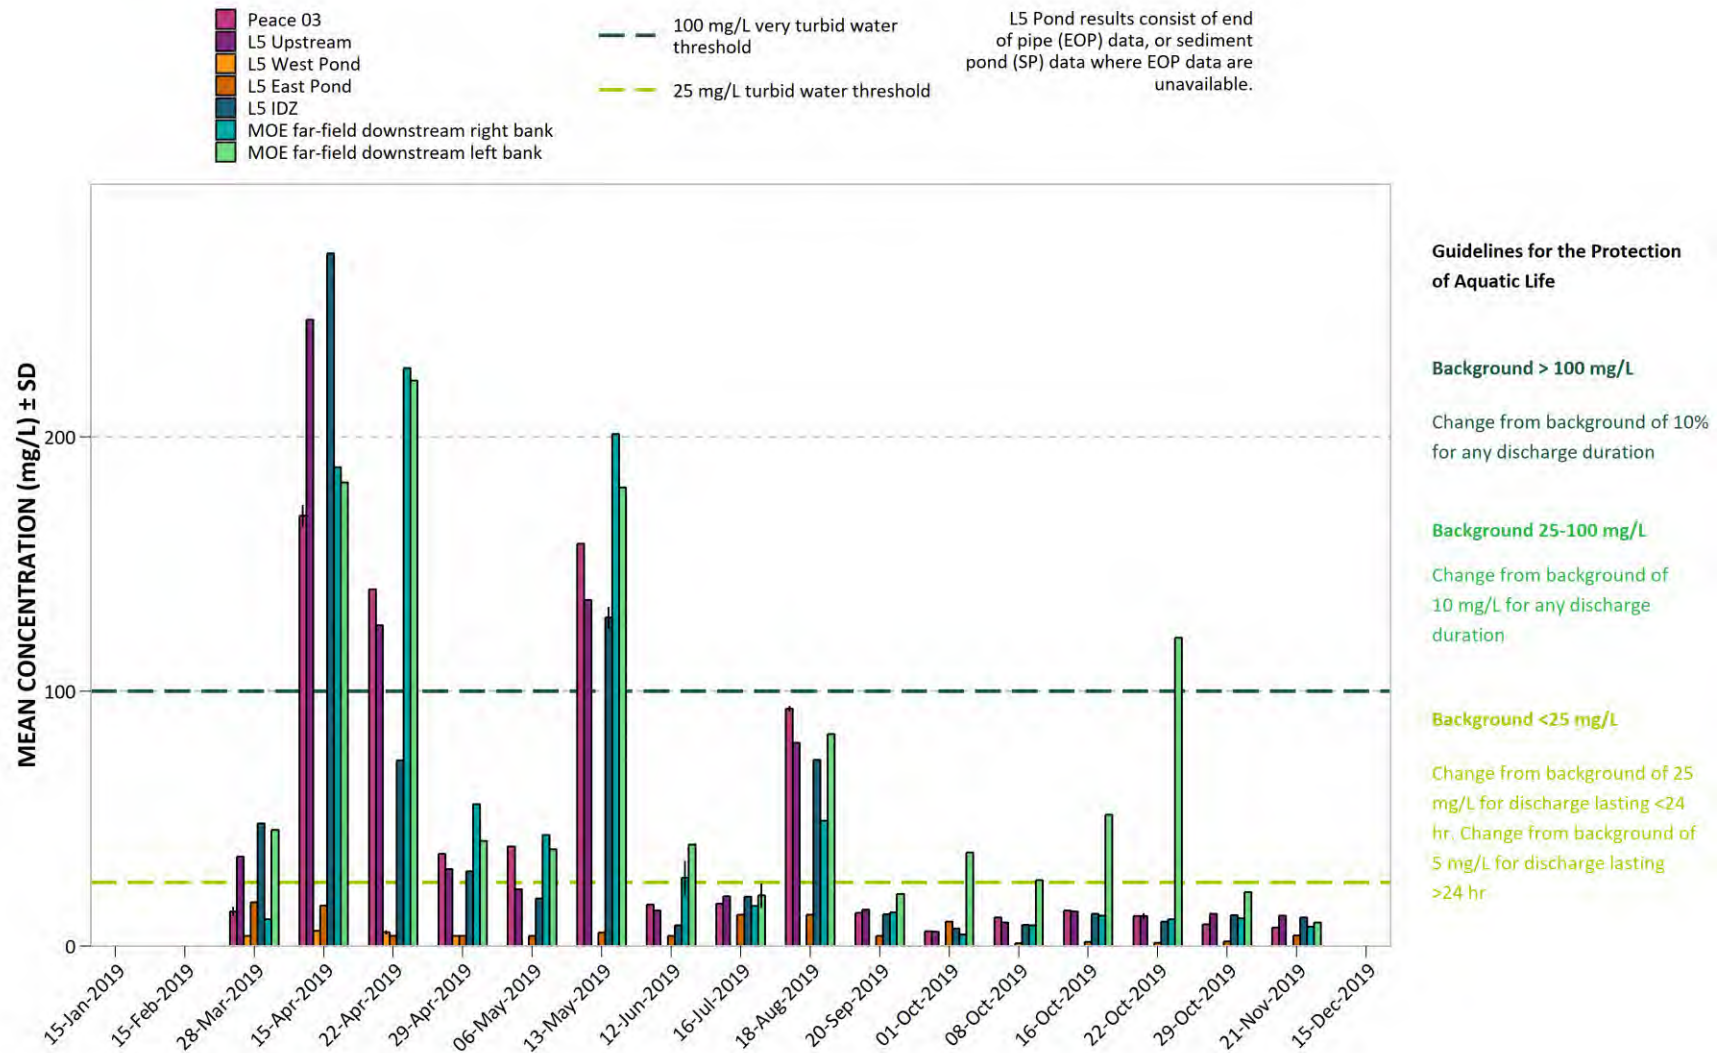
Figure 180. 2019 Peace River and RSEM L5 pond total suspended solids (TSS).

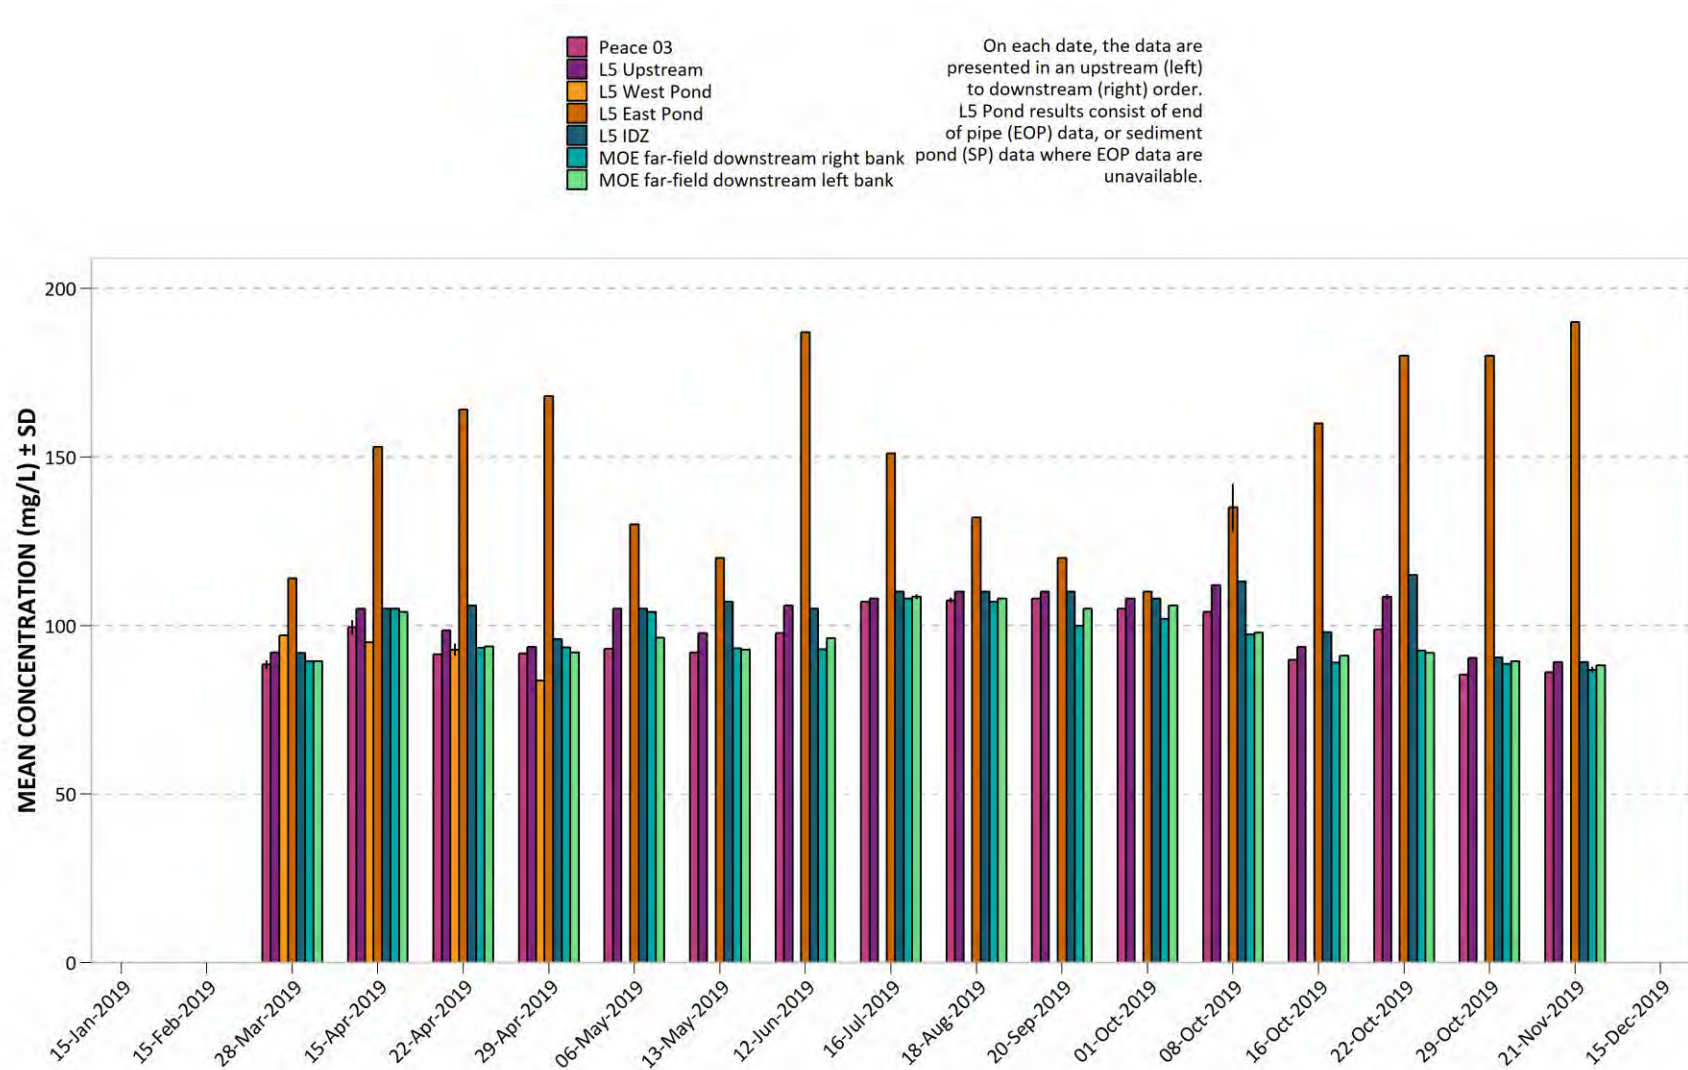
Figure 184. 2019 Peace River and RSEM L5 pond total alkalinity (as CaCO<sub>3</sub>).

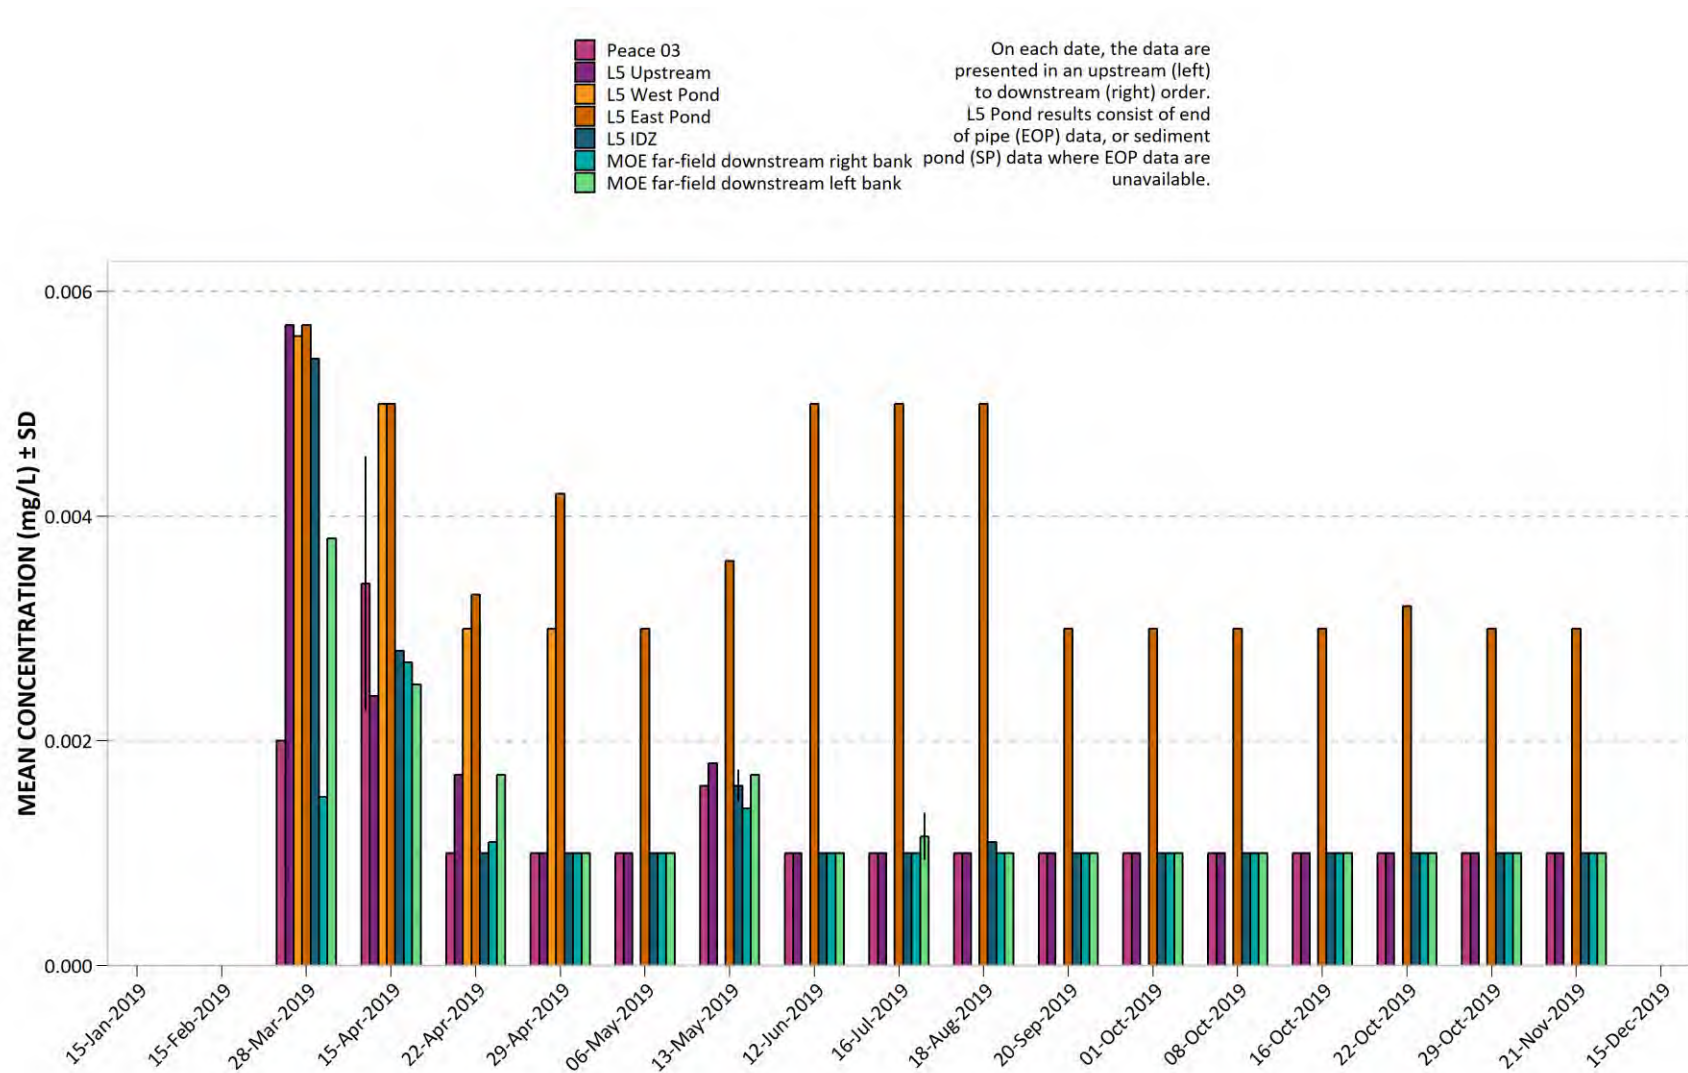
Figure 188. 2019 Peace River and RSEM L5 pond dissolved orthophosphate.

Peace River results less than the MDL were assigned the MDL value 0.001 mg/L. Pond data less than the MDL were assigned the corresponding MDL.

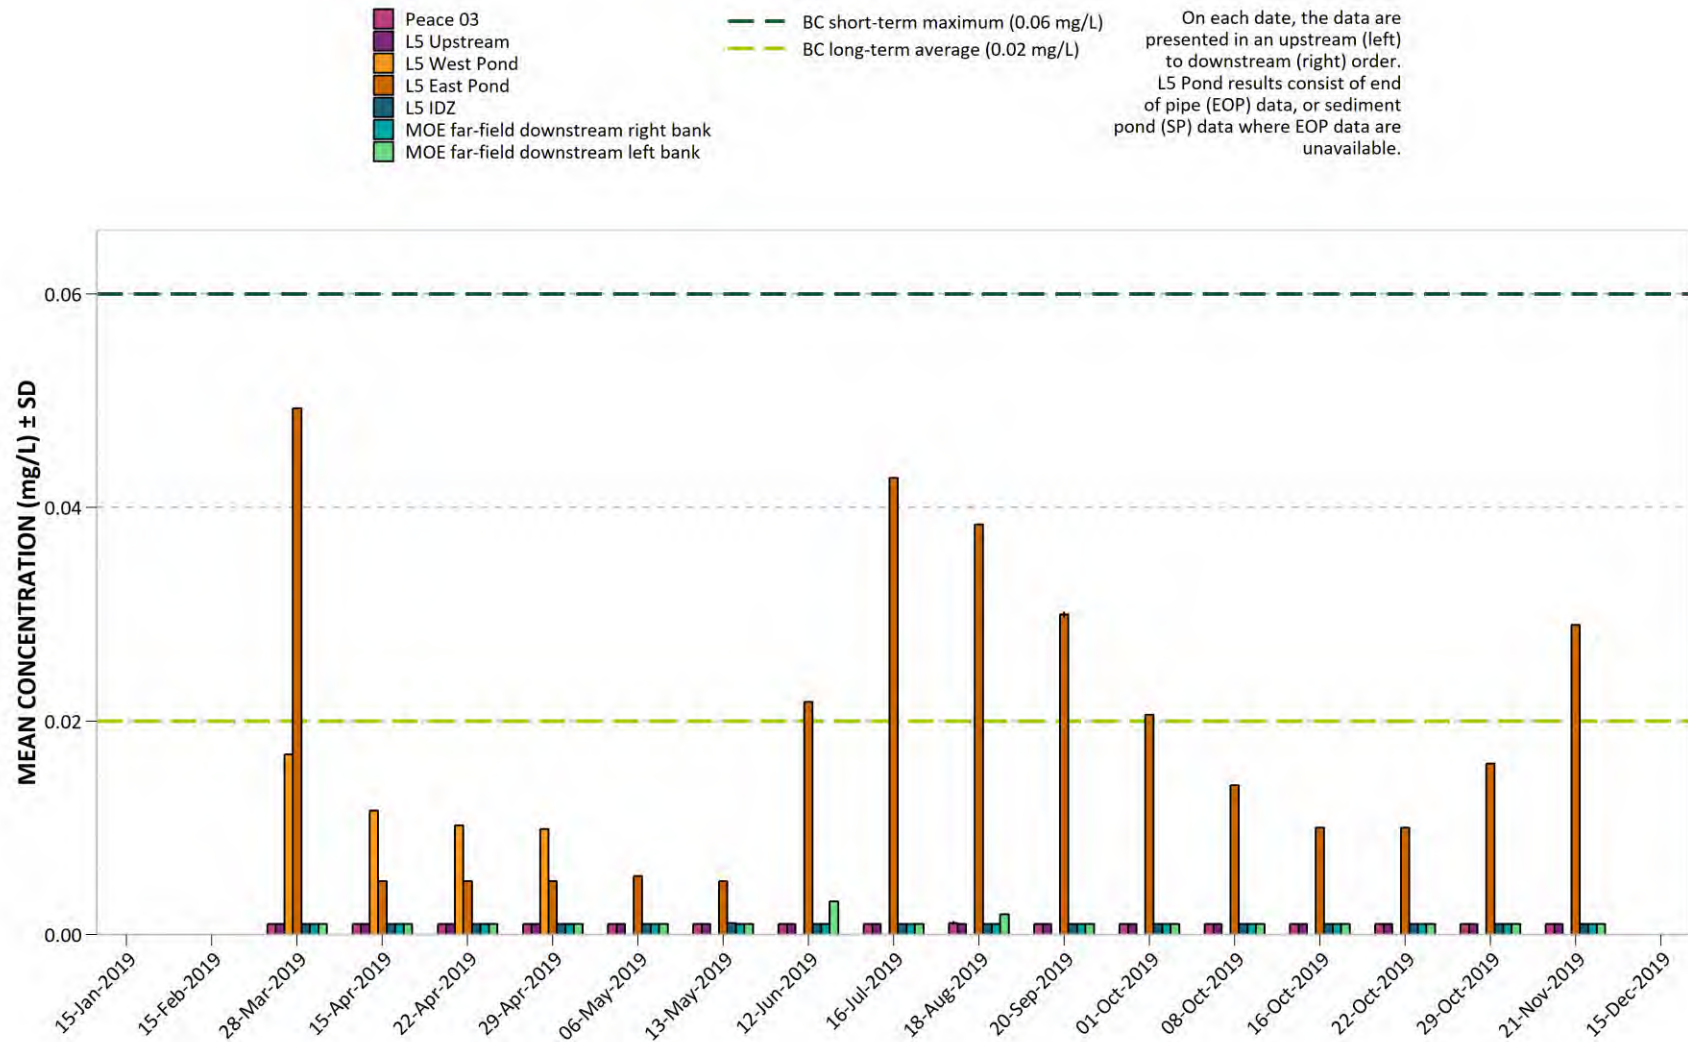
Figure 191. 2019 Peace River and RSEM L5 pond nitrite (as N).

Note: BC WQG for nitrite are chloride dependent, and therefore guidelines depicted in the plot are applicable for Peace River sites only. Based on the range of chloride values observed in the Peace River, the applicable BC Maximum and 30-day guidelines are 0.06 mg/L and 0.02 mg/L, respectively.

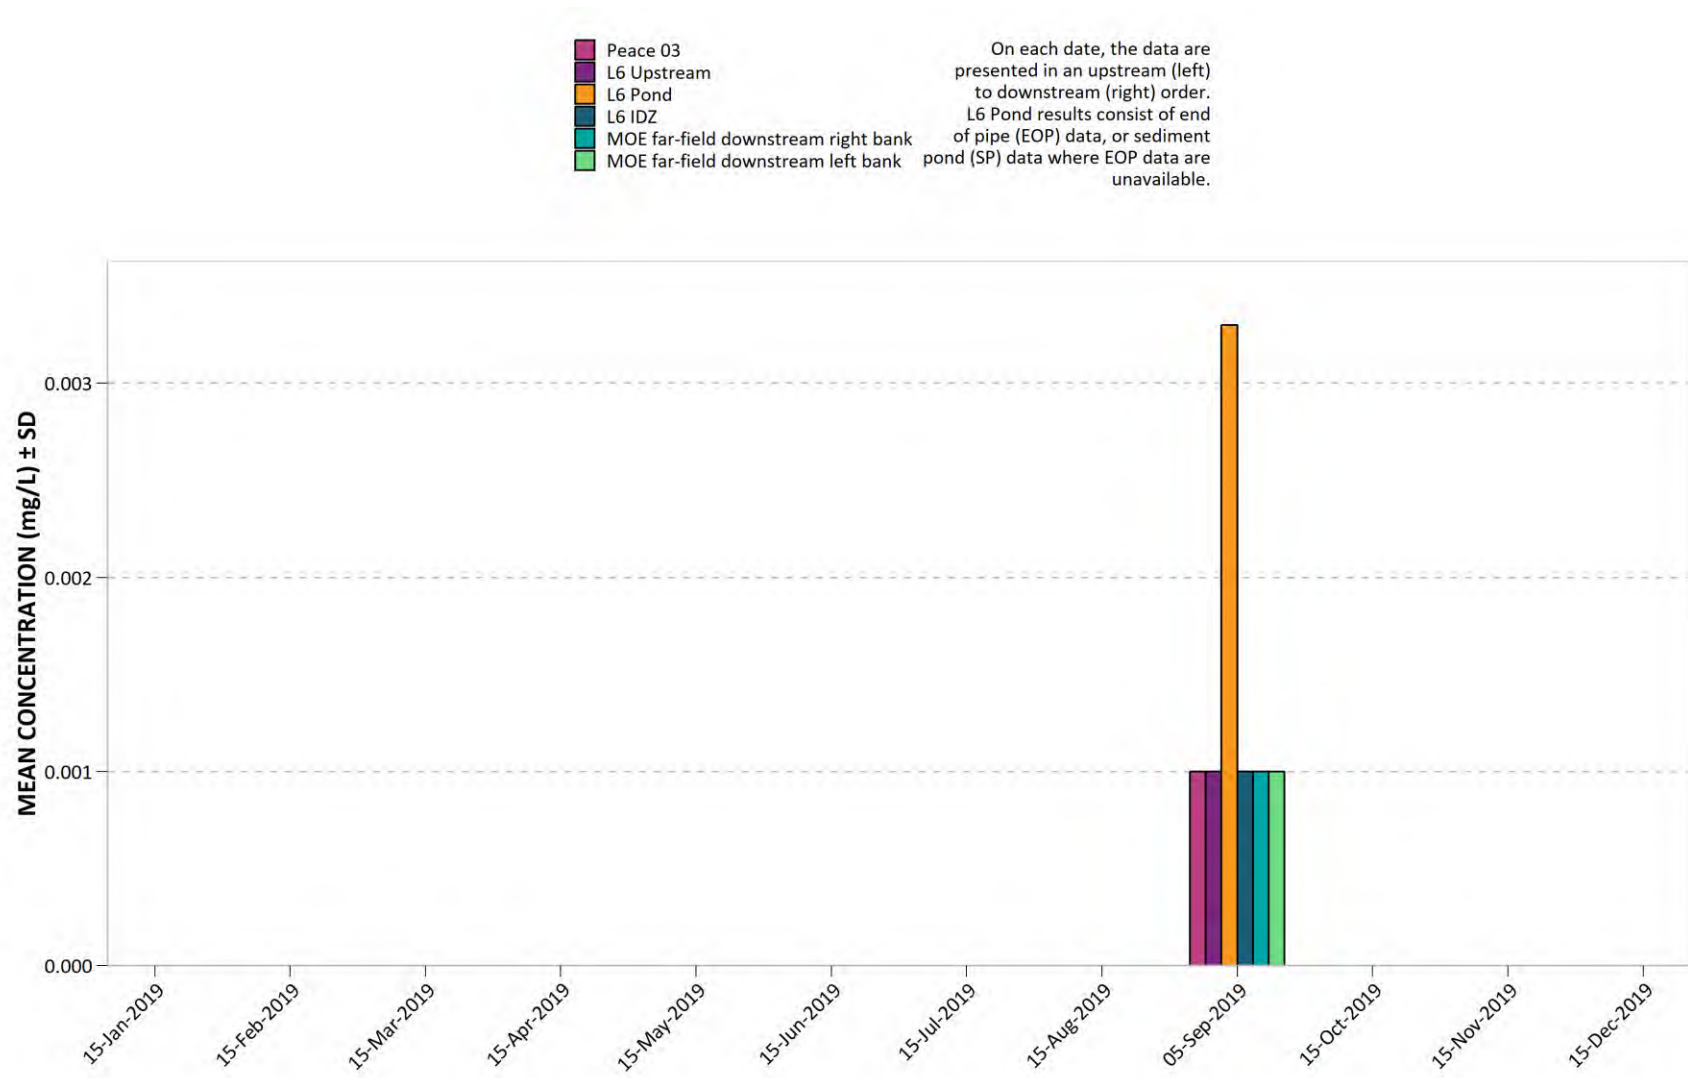
Figure 275. 2019 Peace River and RSEM L6 pond dissolved orthophosphate.

Peace River results less than the MDL were assigned the MDL value 0.001 mg/L. Pond data less than the MDL were assigned the corresponding MDL.

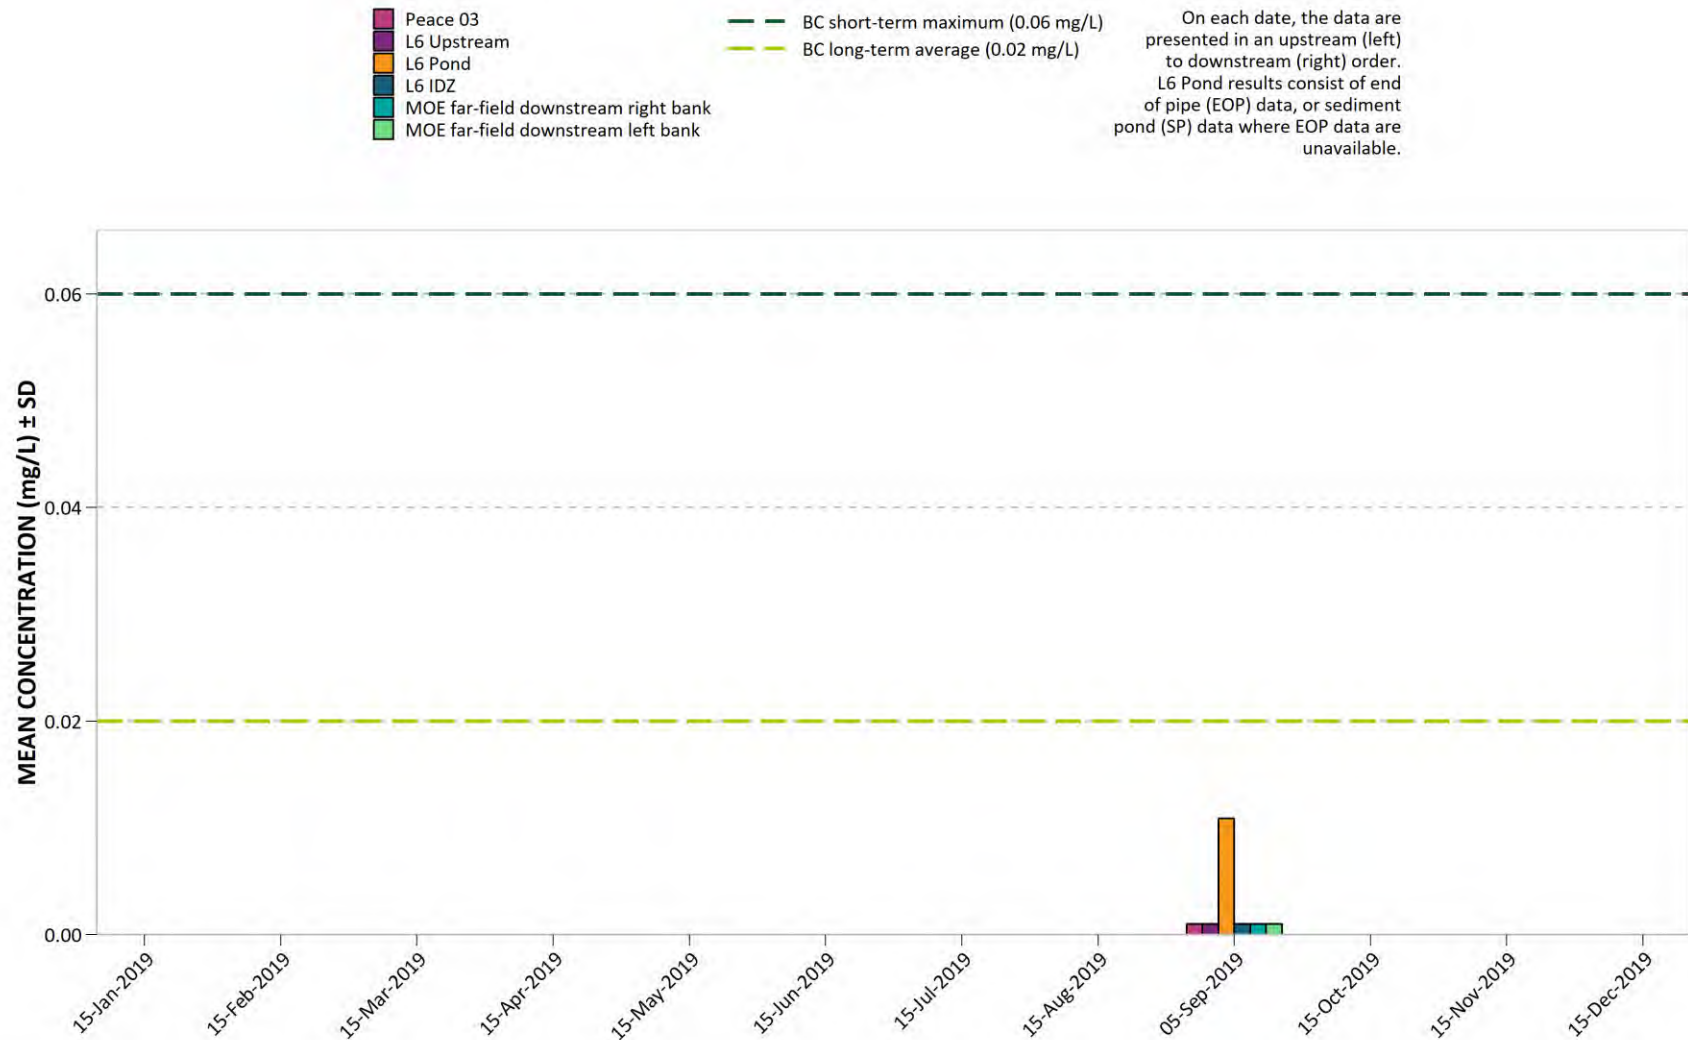
Figure 278. 2019 Peace River and RSEM L6 pond nitrite (as N).

Note: BC WQG for nitrite are chloride dependent, and therefore guidelines depicted in the plot are applicable for Peace River sites only. Based on the range of chloride values observed in the R6 pond, the applicable BC Maximum and 30-day guidelines are 0.6 mg/L and 0.2 mg/L, respectively.
