**NEW GOLD RAINY RIVER MINE
APPENDIX G
VEGETATION PLOT WORK SUMMARY
MEMO**

Memorandum

Re: **Rainy River Mine - 2022 Vegetation Trial Monitoring Summary Rev0**

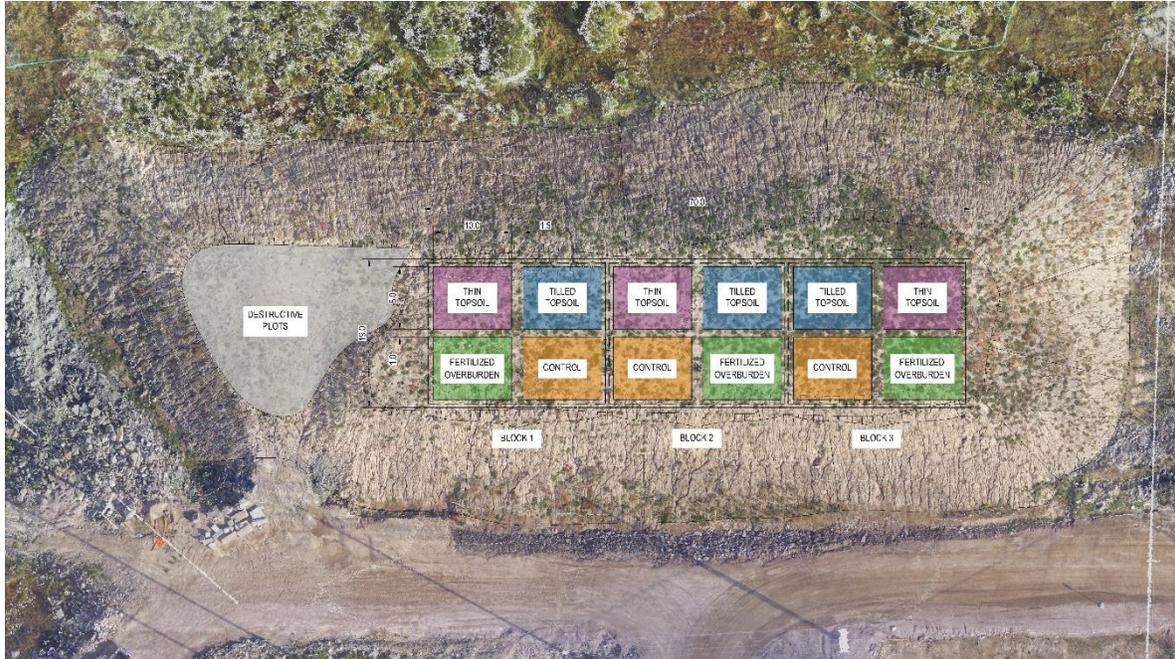
Figure 1: Arrangement of soil treatments in experimental tree plots.

been seeded with various methods and are used to qualitatively evaluate operational seeding techniques, vegetation establishment and erosion. Planned arrangement of the trial area is presented for reference in Figure 1 to 3.

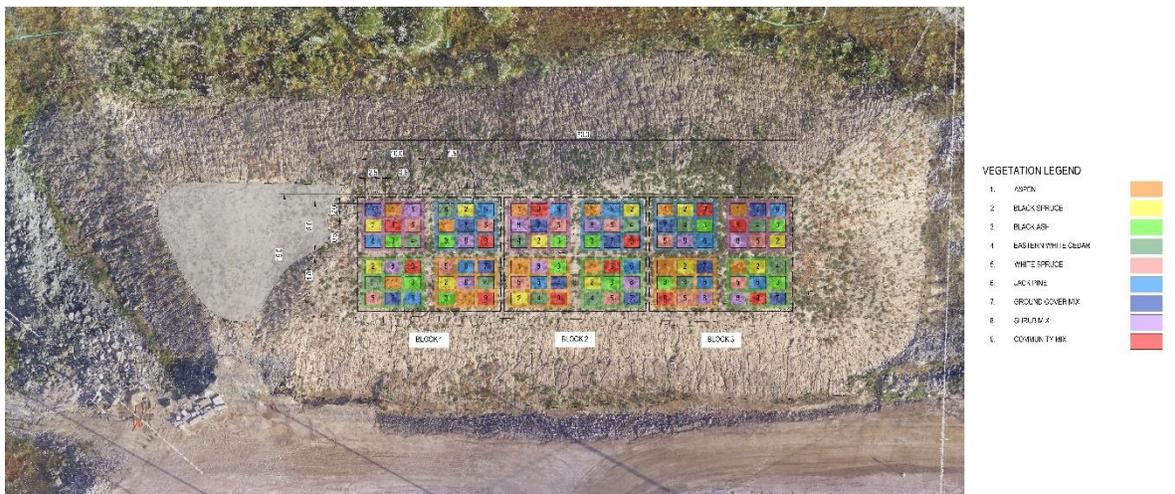
Figure 2: Arrangement of vegetation treatments in experimental tree plots.

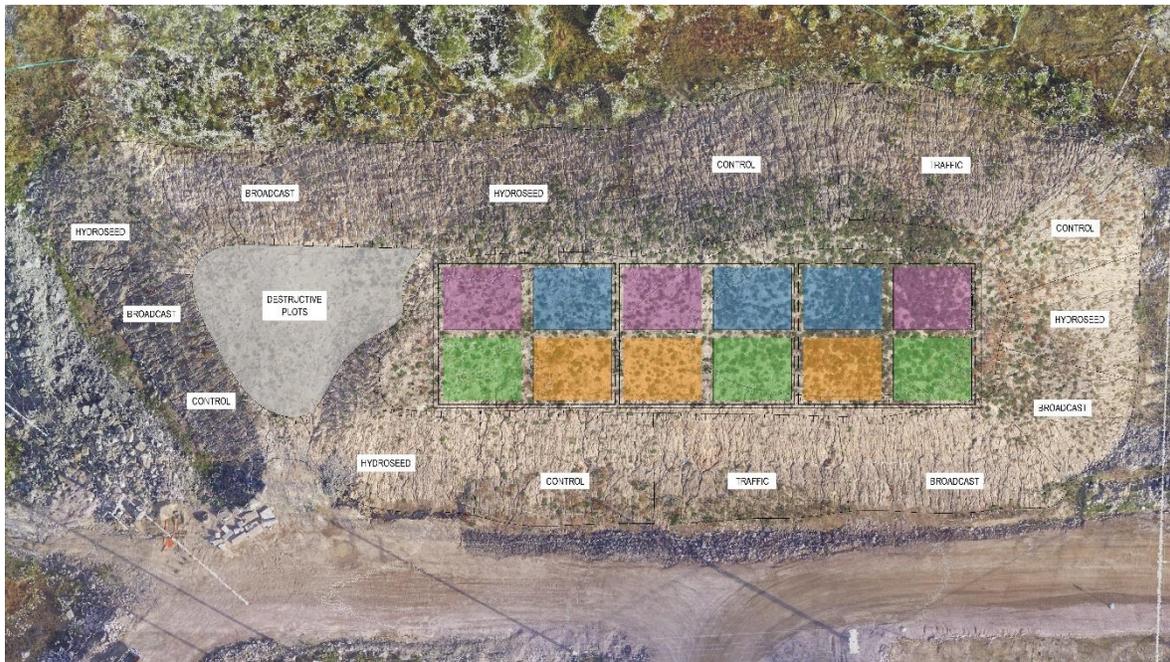
Figure 3: Arrangement of slope treatments

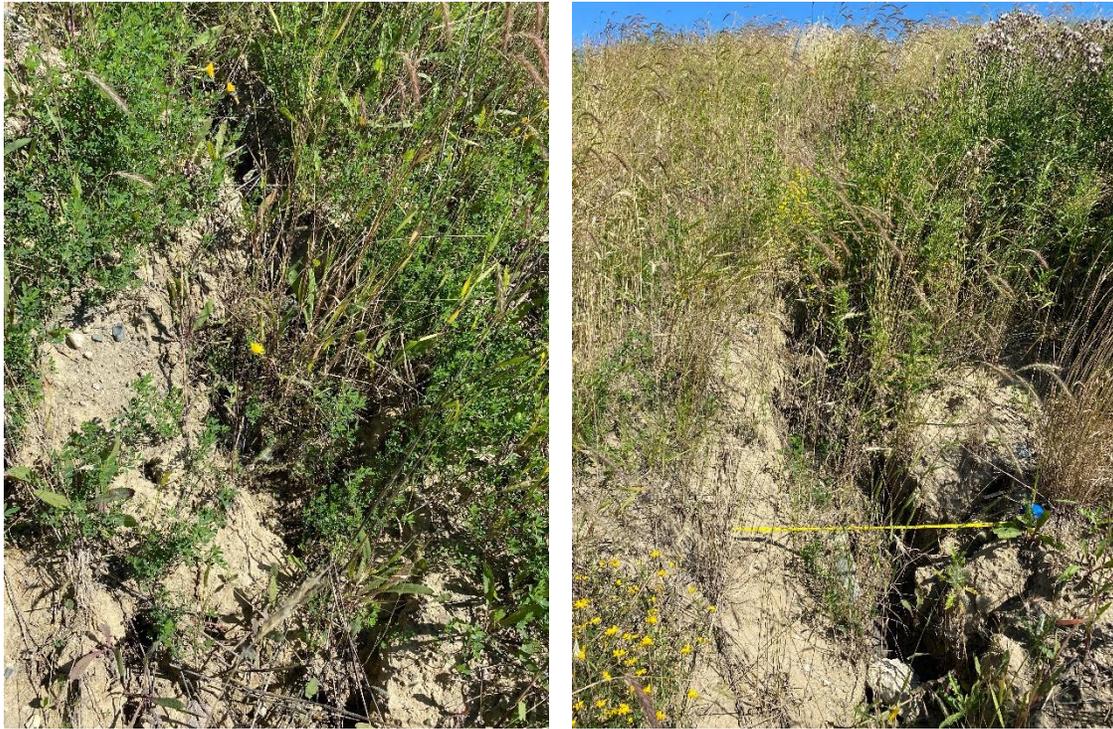
In general, significant erosion was observed on the sloped areas of the trial. Measured erosional features are included in Table 1. Erosion features were difficult to identify on most trial areas due to high vegetative coverage.

Figure 4: South Slope Rill (left) and Gully (right) erosion.

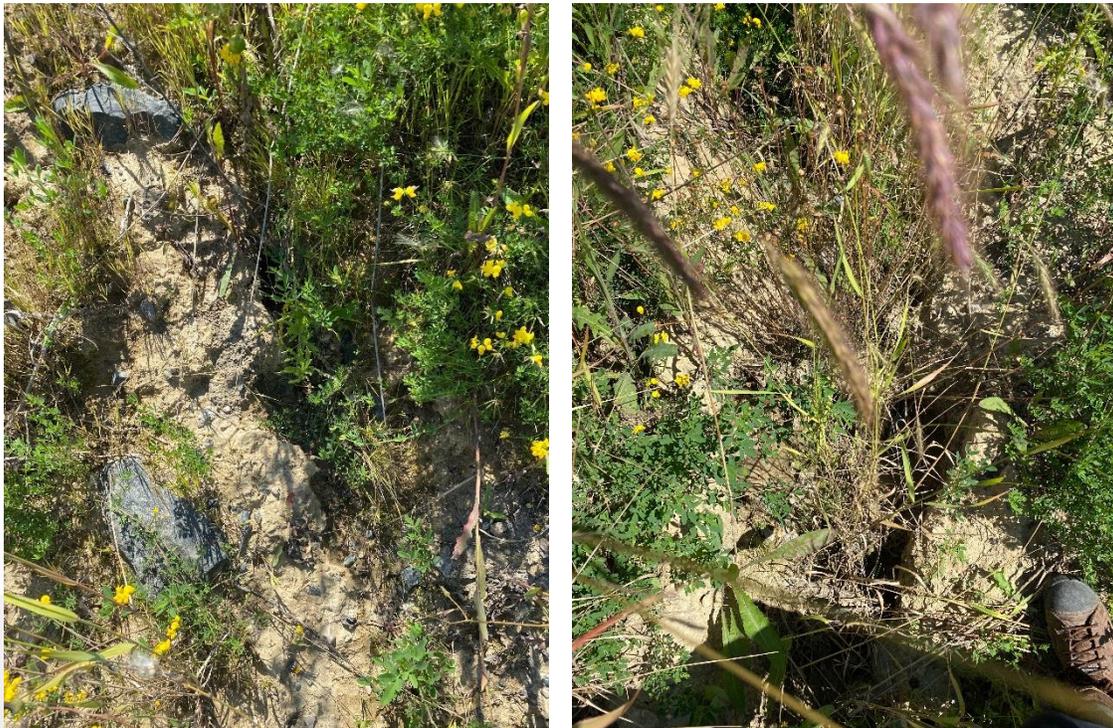
Figure 5: North Slope Rill (left) and Gully (right) erosion.

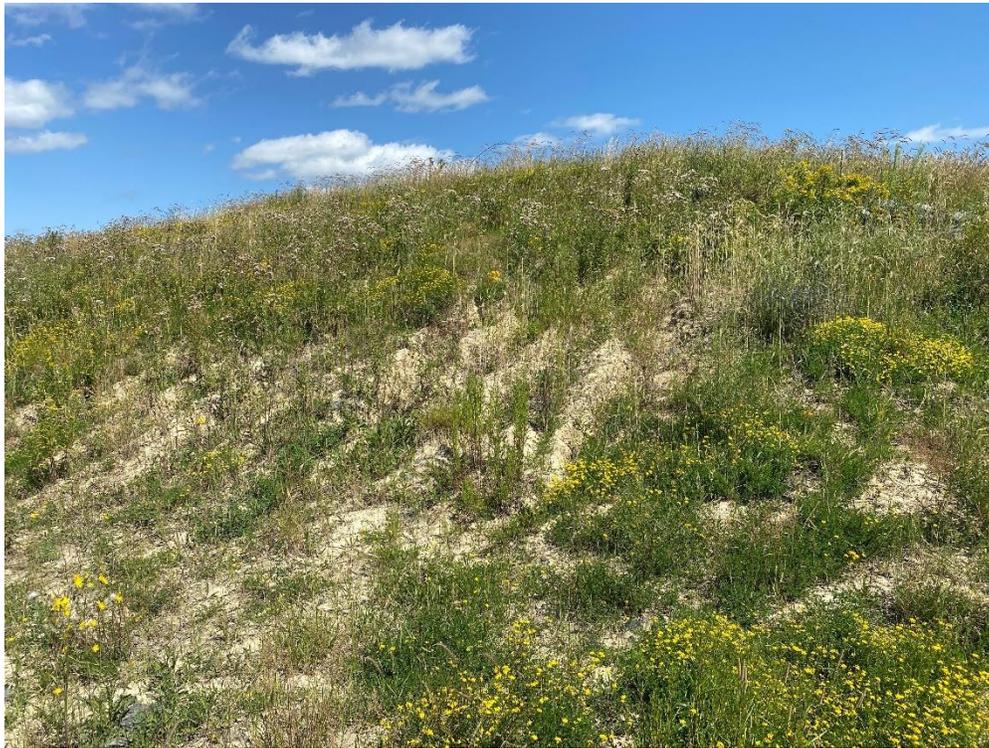
Figure 6: West Slope Rill erosion.

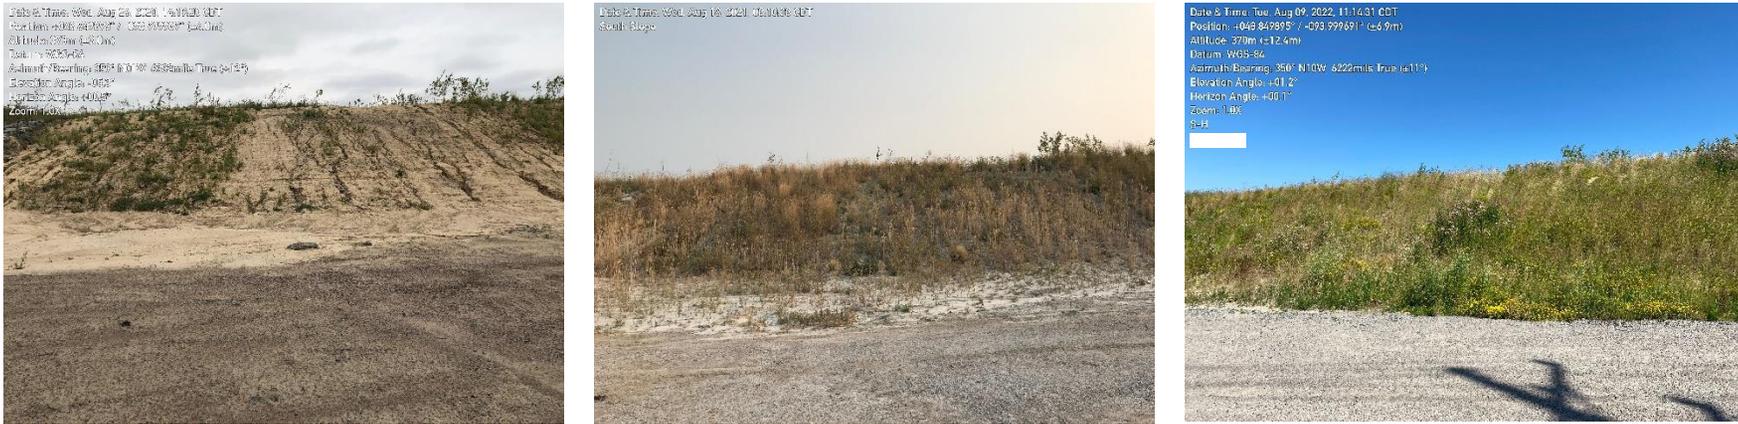
Vegetation ground coverage generally increased, ranging from 50% to 100% over the slopes (Table 2). Of note, all slopes were treated with ProGanics Biotic Soil Media in September 2020 to minimize further erosion. Ground coverage increased from 2021 in which most slope treatment areas had on average 50% coverage to a minimum of 75% coverage in 2022.

Figure 7: South Slope Hydroseed – August 26, 2020 (left), August 18, 2021 (middle), and August 9, 2022 (right).

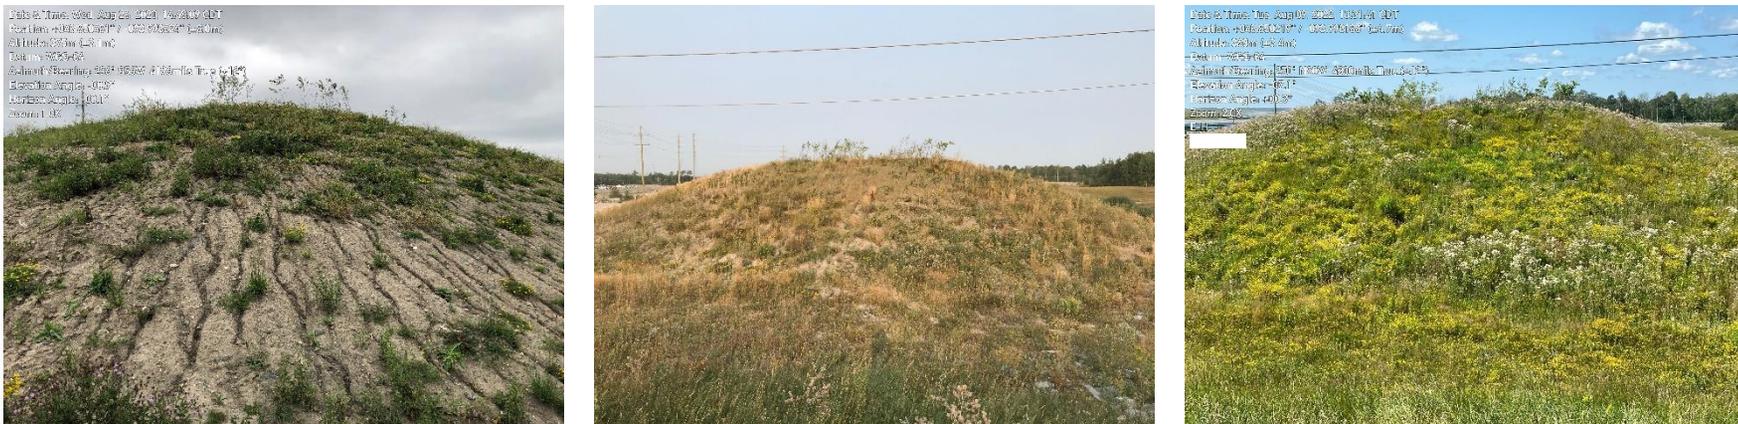
Figure 8: East Slope - August 26, 2020 (left), August 18, 2021 (middle), and August 9, 2022 (right).

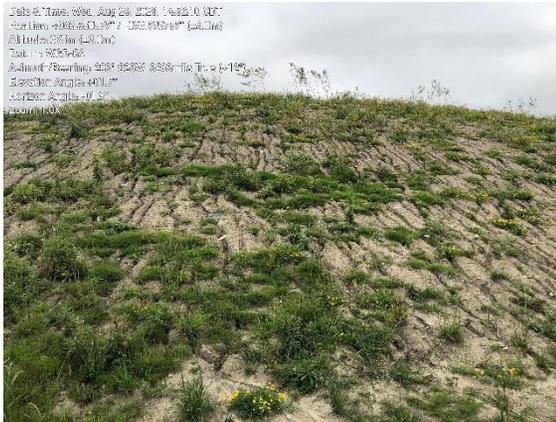
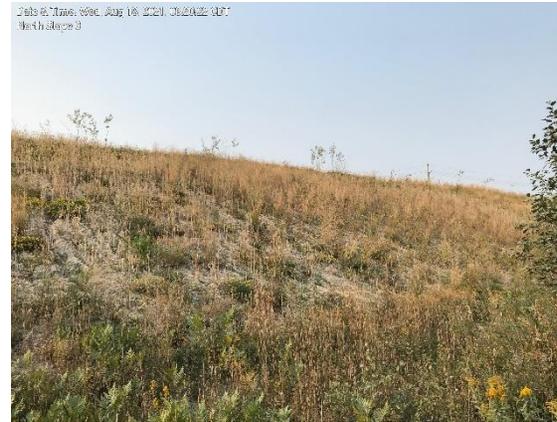
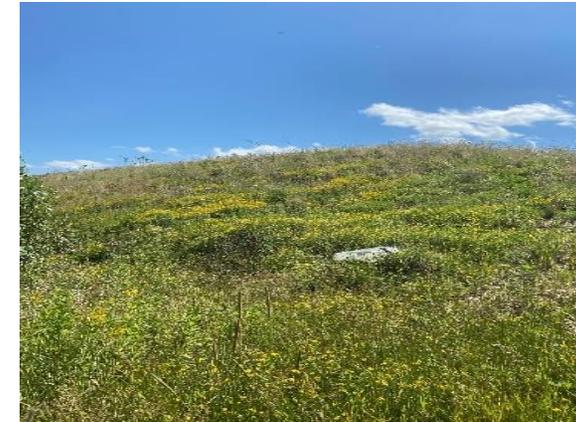
Figure 9: North Slope Control - August 26, 2020 (left), August 18, 2021 (middle), and August 9, 2022 (right).

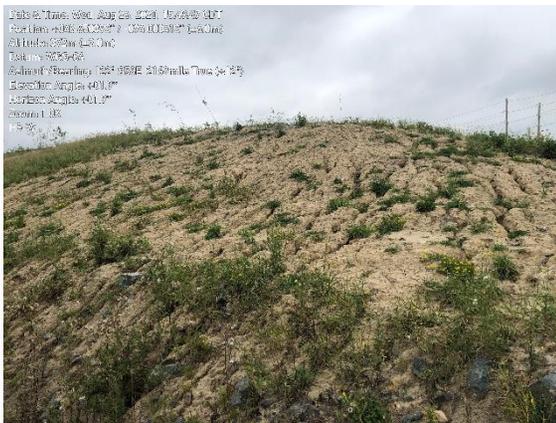
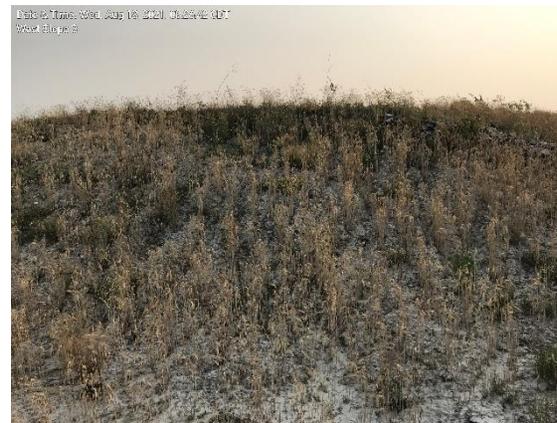
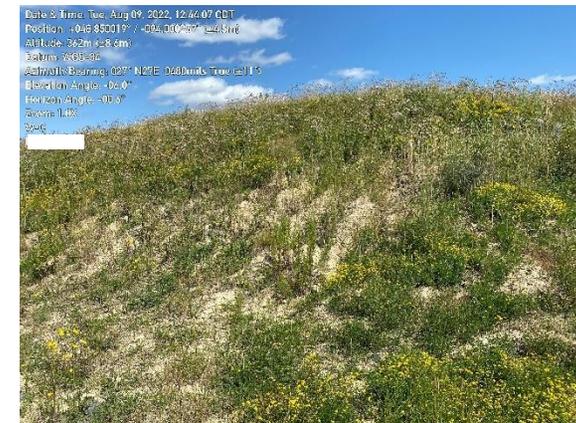
Figure 10: West Slope Broadcast - August 26, 2020 (left), August 18, 2021 (middle), and August 9, 2022 (right).

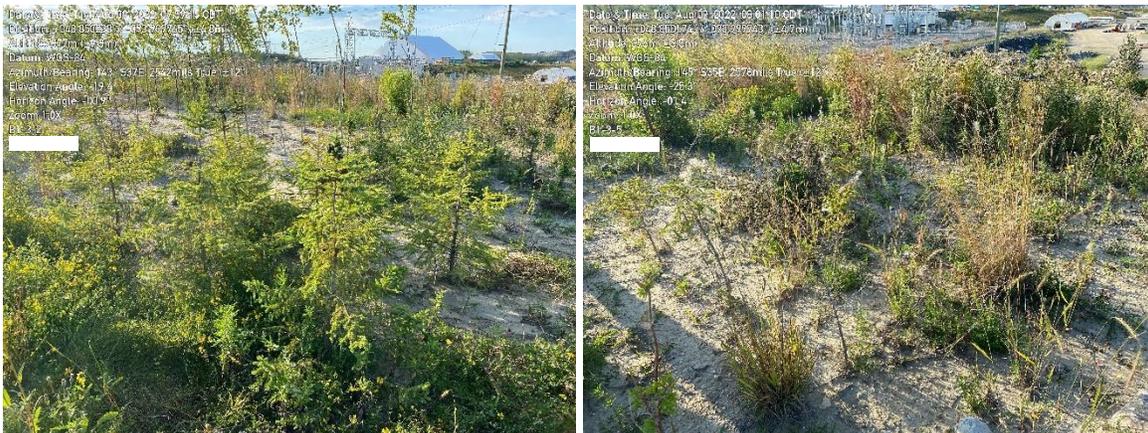
- Aspen and Black Ash – generally appeared to be doing better for the fertilized overburden and control soil treatments.
- Black Spruce – generally appeared to be doing better for the fertilized overburden and control soil treatments.
- White Spruce – appeared to be struggling and/or dead for all four soil treatments.
- Shrub mix – generally appeared to be struggling for all soil treatments however new bottom growth was occurring on some of the shrubs.

Figure 11: Block 1 – Fertilized Overburden - Black Spruce (left) and White Spruce (right).

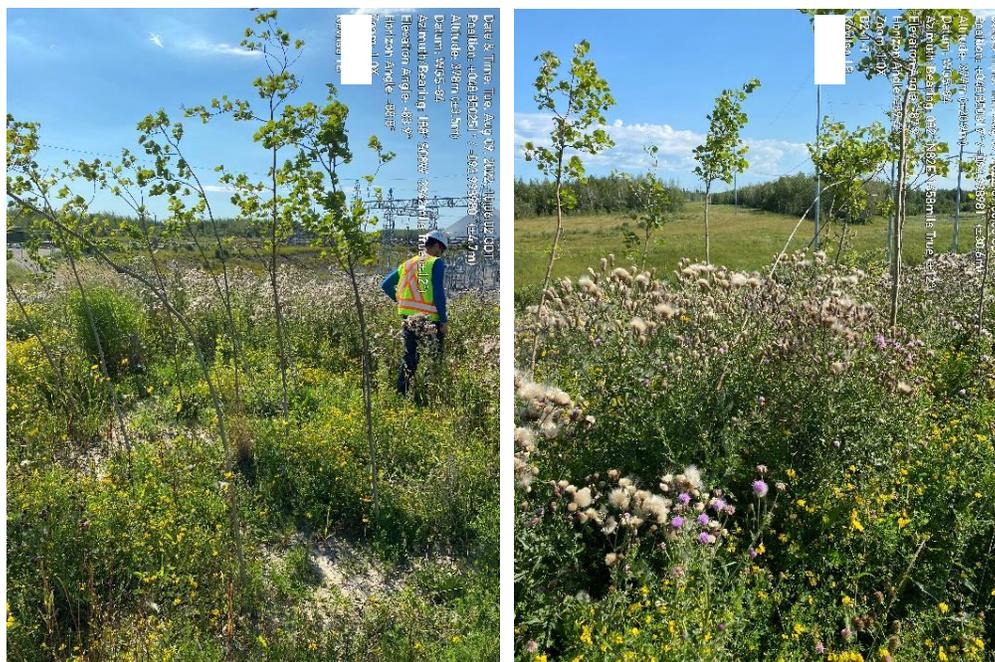
Figure 12: Block 3 –Fertilized Overburden – Aspen (left) and Thin Topsoil – Aspen (right).

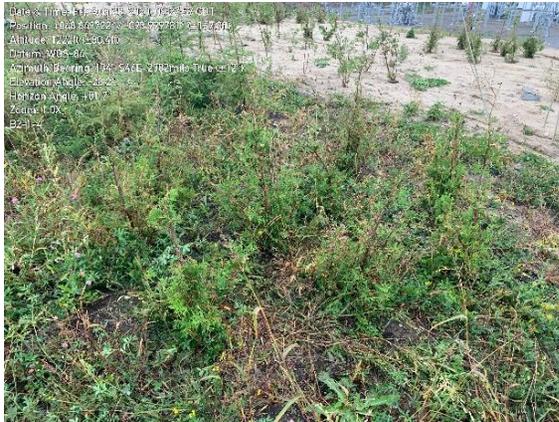
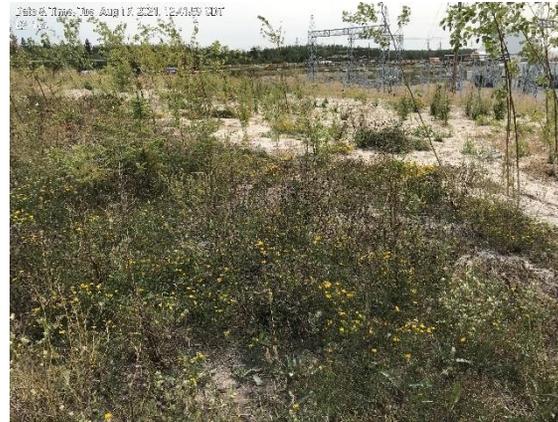
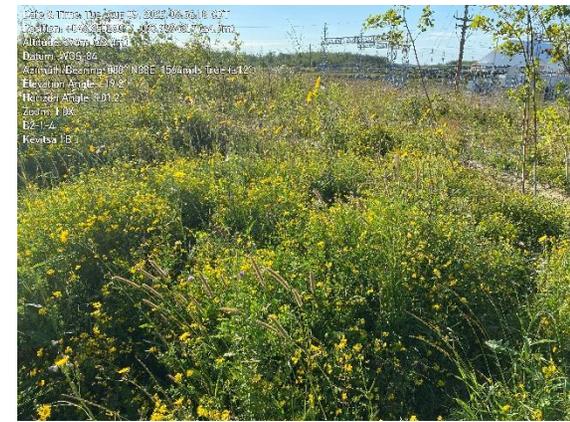
Ground cover was estimated at each plot during the surveys. During the 2022 autumn survey, ground cover increased in all plots, and most notably in some of the control and fertilized overburden plots (Table 5). Figures 13 to 16 compare plots from each soil treatment group as observed during the 2020, 2021 and 2022 surveys.

Figure 13: Block 2 – Thin Topsoil – Eastern white cedar plot as observed on August 28, 2020, (left), August 17, 2021 (middle), and August 9, 2022.

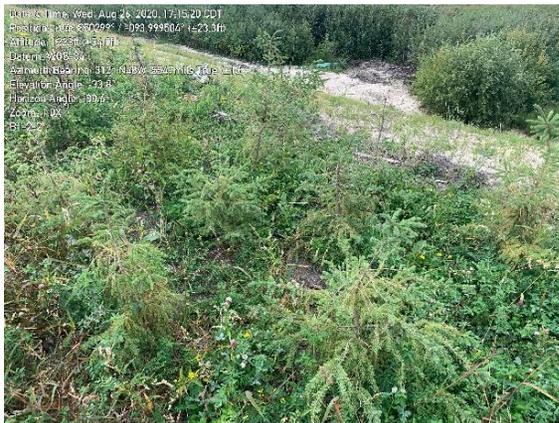
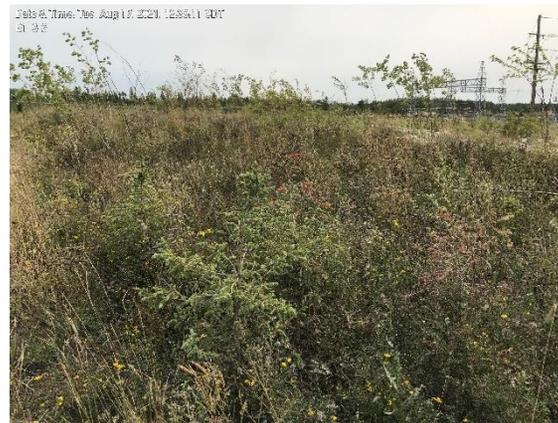
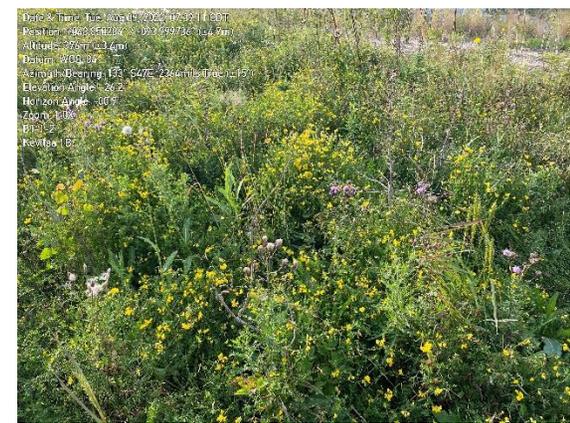
Figure 14: Block 1 – Tilled Topsoil – Black Spruce plot as observed on August 28, 2020, (left), August 17, 2021 (middle), and August 9, 2022.

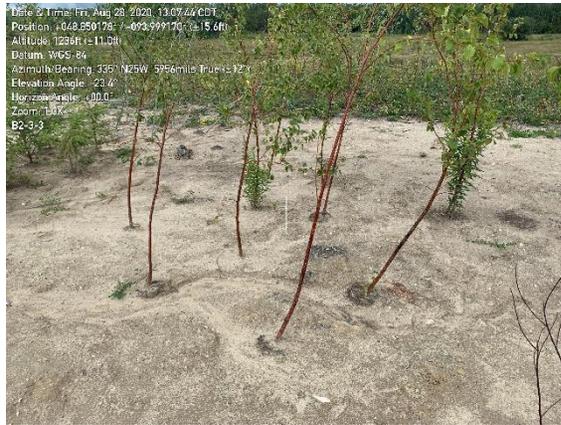
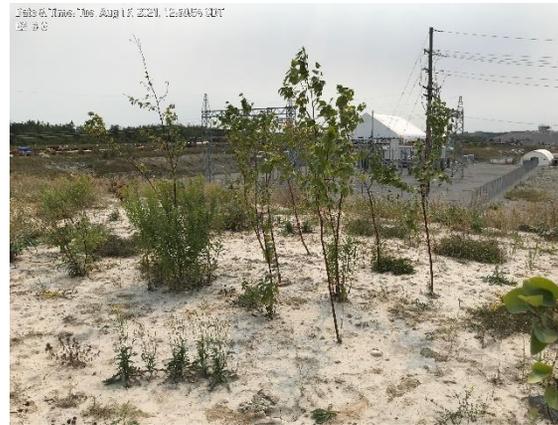
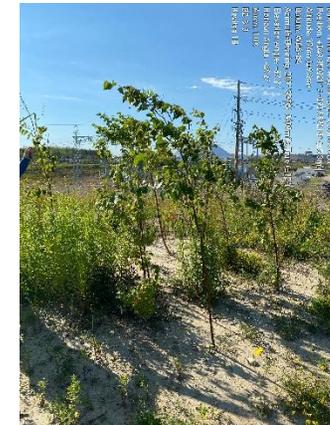
Figure 15: Block 2 – Fertilized Overburden – Black ash plot as observed on August 28, 2020, (left), August 17, 2021 (middle), and August 9, 2022.

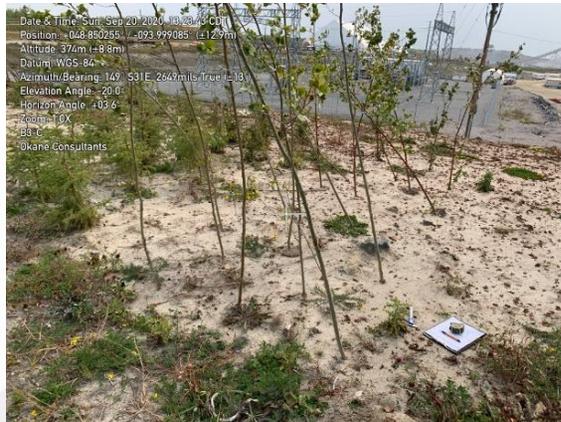
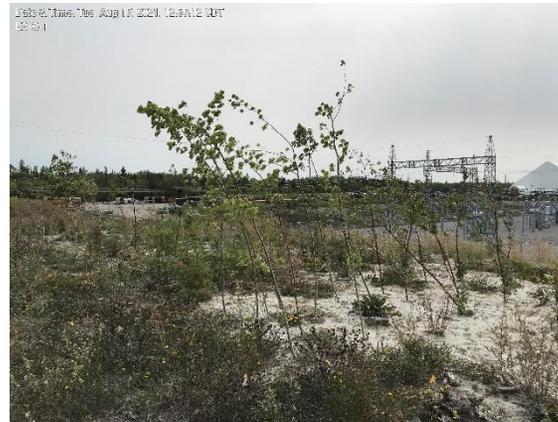
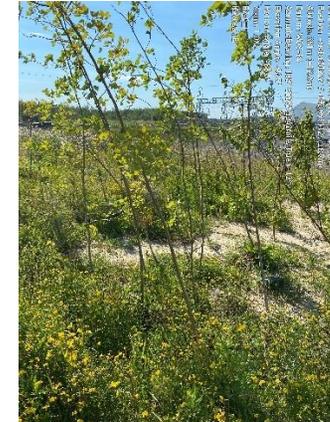
Figure 16: Block 3 – Control – Aspen plot as observed on August 28, 2020, (left), August 17, 2021 (middle), and August 9, 2022.

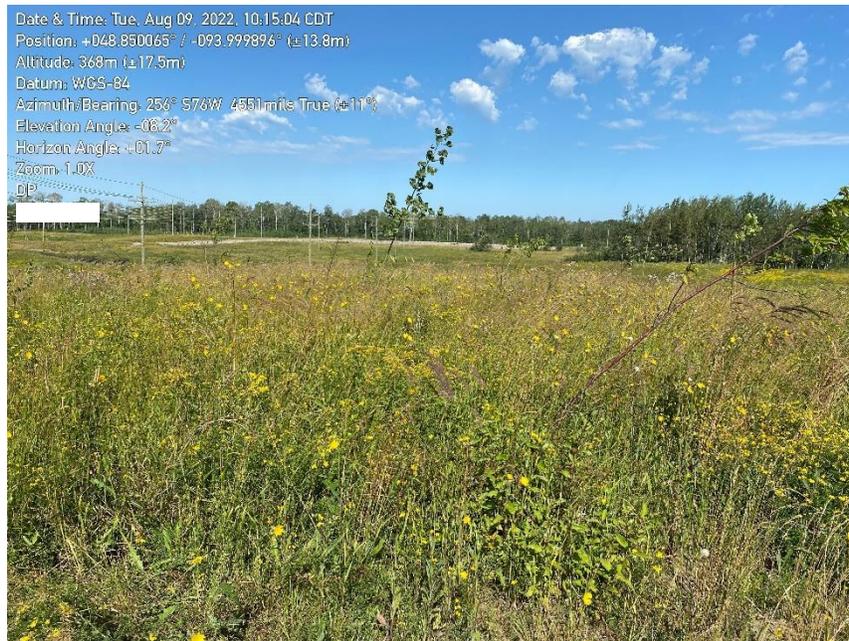
Minimal erosion was observed in the destructive plot, except for some down-slope erosion on the north edge of the plot. Vegetation was generally noted to have established well, and ground cover has increased since the 2021 survey. Estimated percent ground cover during the annual survey in autumn was approximately 75% for 2020 and 2021 but has increase to 90% for 2022. Only general observations of poor health were noted during the autumn visit; Table 6 includes a summary of general health, extrapolating the number of healthy trees from the totals recorded.

Figure 17: Destructive plot ground coverage.
