# Memorandum

**Our ref:** 1003-018-009

**Re:** **Rainy River Mine - 2020 Vegetation Trial Monitoring Summary Rev1**

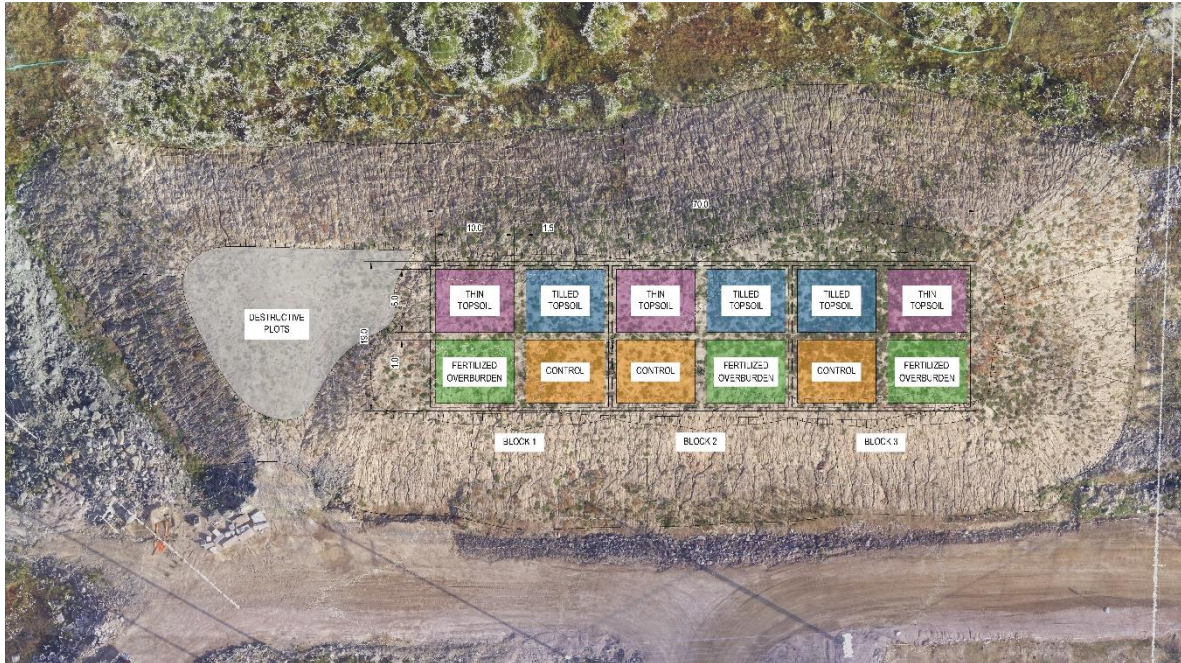
Figure 1: Arrangement of soil treatments in experimental tree plots

are used to qualitatively evaluate operational seeding techniques, vegetation establishment and erosion. Planned arrangement of the trial area is presented for reference in Figure 1-3.

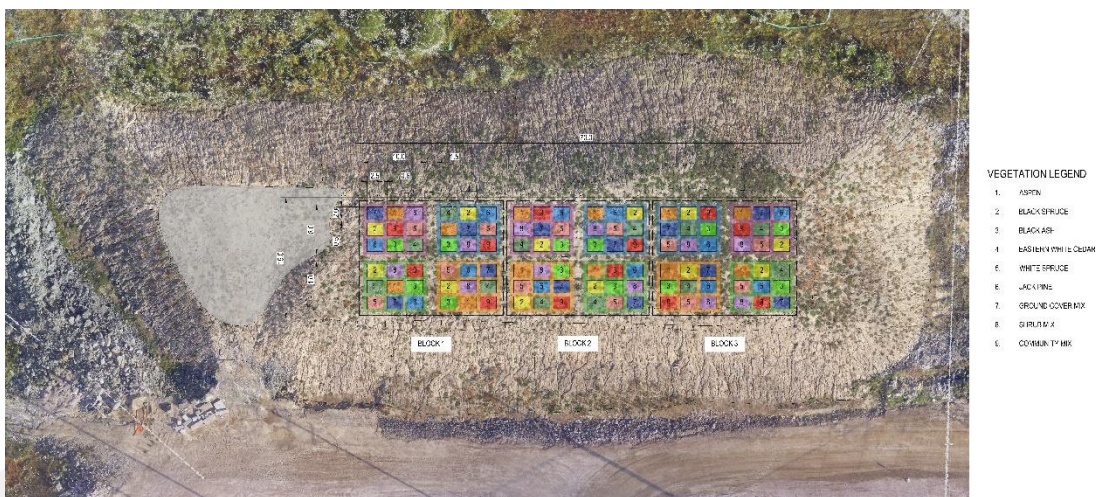
Figure 2: Arrangement of vegetation treatments in experimental tree plots

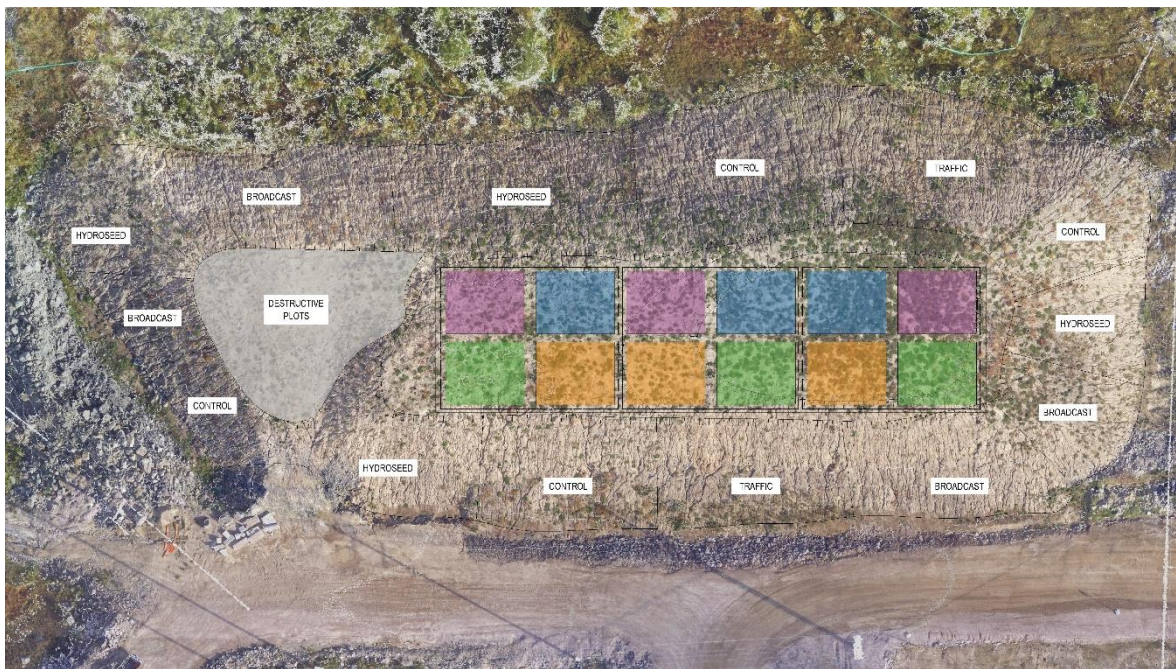
**Figure 3: Arrangement of slope treatments**

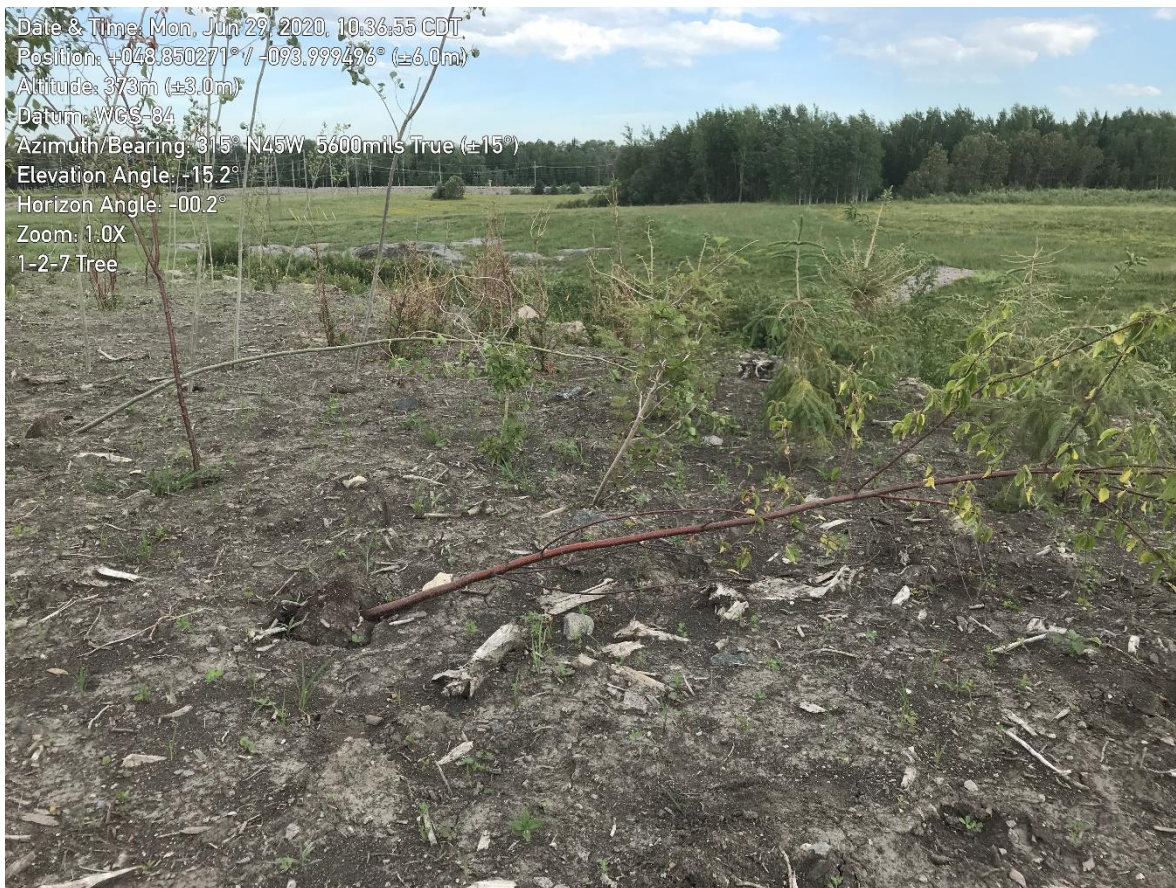
Generally, planted vegetation appeared to be in good health, with the notable exception of eastern white cedar, of which all trees observed were in poor condition. Additionally, although still appearing in good health at the time of the field visit, some trees were leaning severely and partially uprooted (see Figure 4).

**Figure 4: Uprooted tree in Block 1 - Tilled Topsoil - Ground Cover Mix plot**

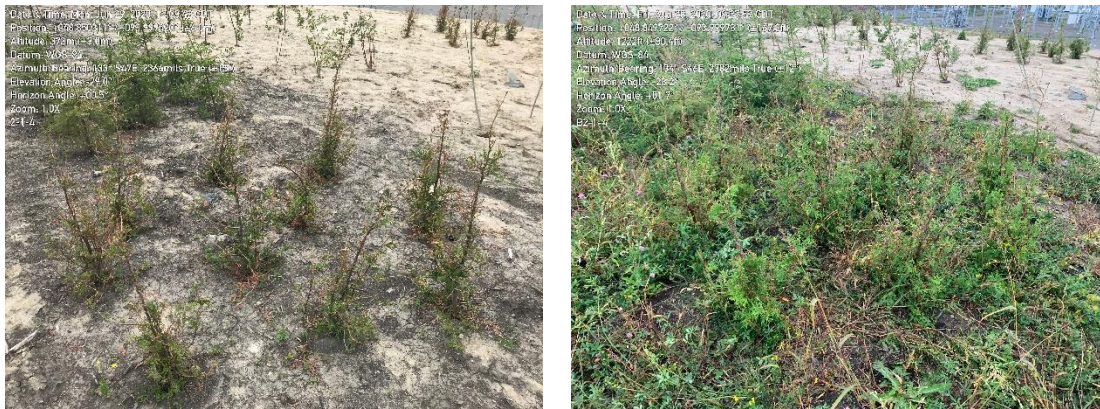
autumn survey, ground cover increased in all plots, and most notably in plots including topsoil (Table 9). Figures 5-8 compare plots from each soil treatment group as observed during the spring and autumn 2020 surveys.

**Figure 5: Block 2 – Thin Topsoil – Eastern white cedar plot as observed on June 29, 2020 (left), and August 28, 2020 (right)**

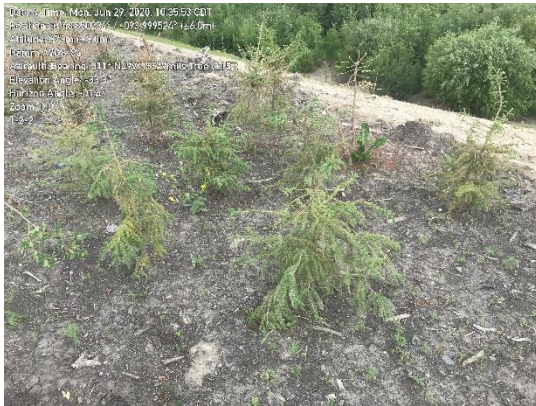
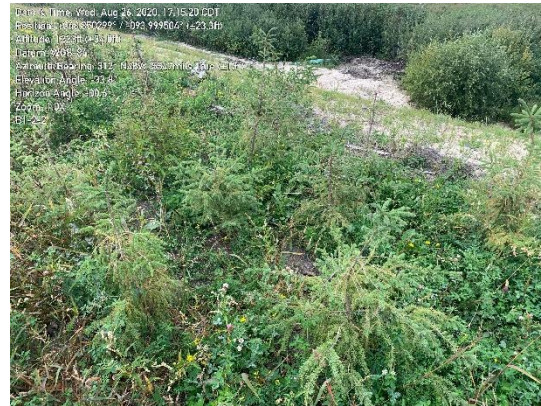
**Figure 6: Block 1 – Tilled Topsoil – Black Spruce plot as observed on June 29, 2020 (left) and August 26, 2020 (right)**

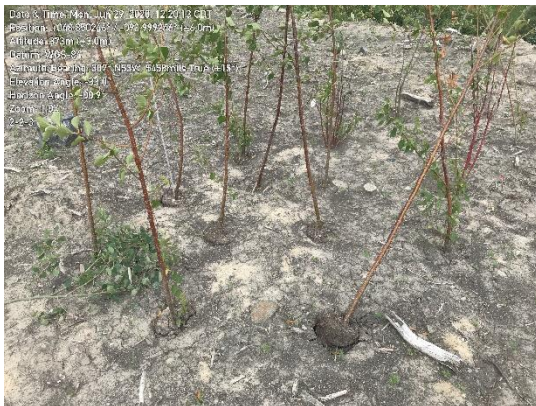
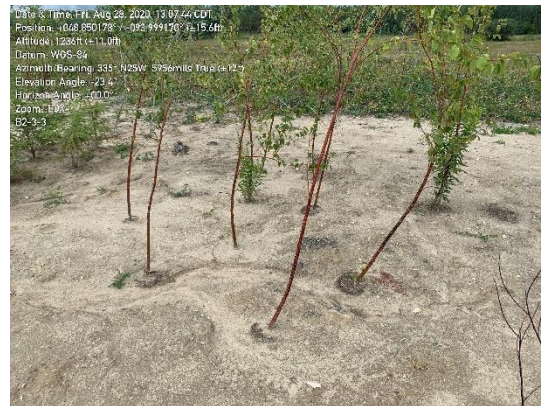
**Figure 7: Block 2 – Fertilized Overburden – Black ash plot as observed on June 29, 2020 (left) and August 28, 2020 (right)**

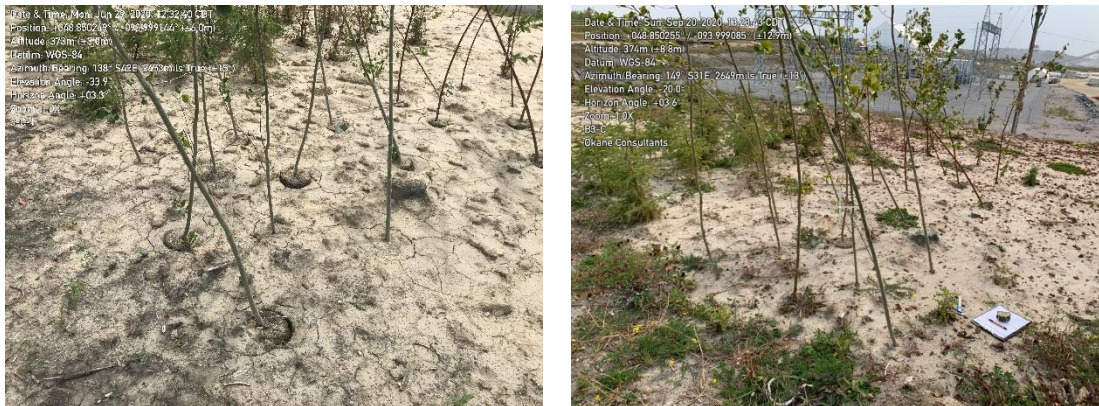
**Figure 8: Block 3 – Control – Aspen plot as observed on June 29, 2020 (left) and September 20, 2020 (right)**
