*Murray River Coal Project: Navigable Waters Assessment 2014*

**Application for an Environmental Assessment Certificate / Environmental Impact Statement**

# MURRAY RIVER COAL PROJECT **Navigable Waters Assessment 2014**

July 2014

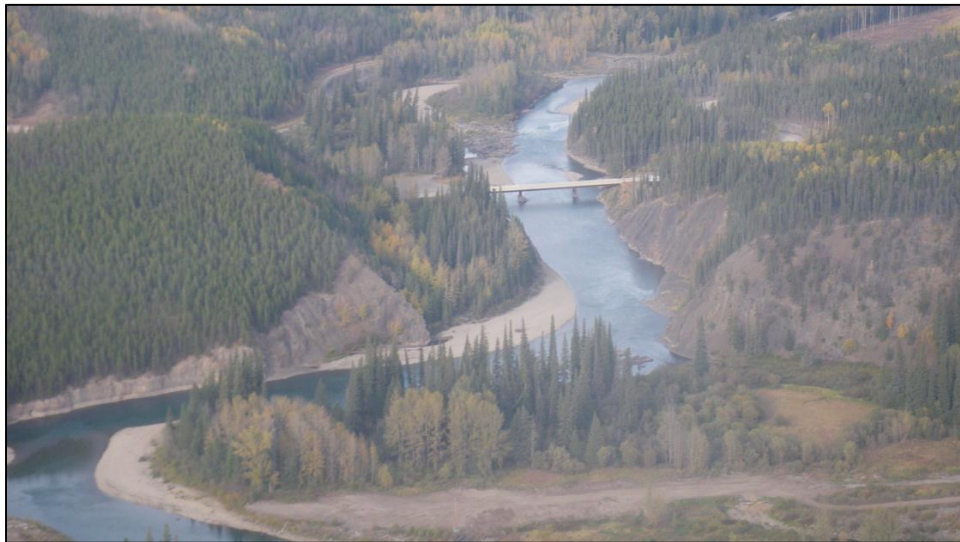
*Plate 7.1-1. Murray River: aerial view looking downstream. Flow rate = 20 m<sup>3</sup>/s. September 26, 2012.*

Murray River (Site ID 16) is clearly navigable. The river has been monitored by HD Mining as part of baseline environmental studies from 2011 through 2014. Recreational boating use has been observed during baseline data collection. A bathymetric survey of a 5 km reach from upstream of the Murray River FSR bridge to below M19 Creek was conducted by ERM Rescan, EDI and McElhanney in May 2013 using a jet boat. Plates 7.1-1 to 7.1-4 illustrate the channel morphology of the river, including the right bank conditions near the proposed water discharge pipeline location.

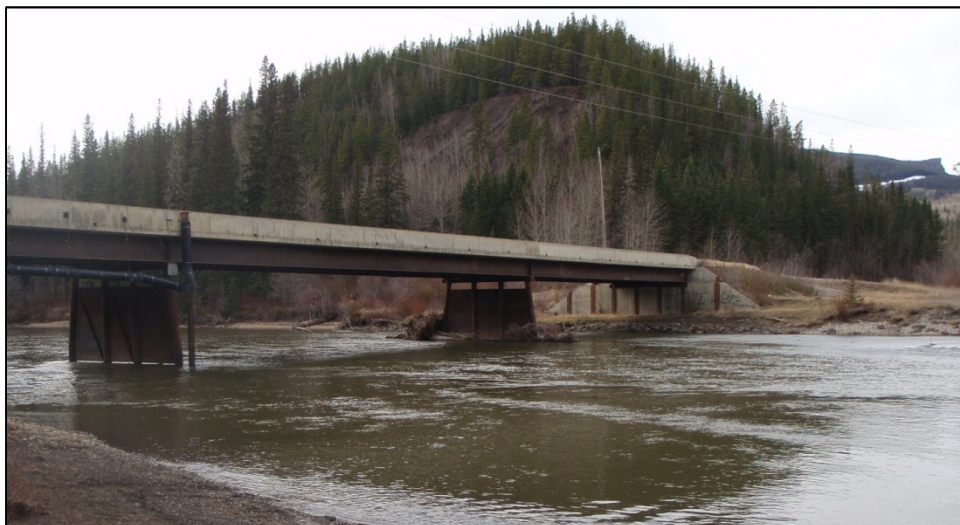
*Plate 7.1-2. Murray River: view upstream at the Murray River FSR Bridge. Flow rate = 53 m<sup>3</sup>/s. A public access boat launch area is located adjacent to the bridge. April 28, 2012.*

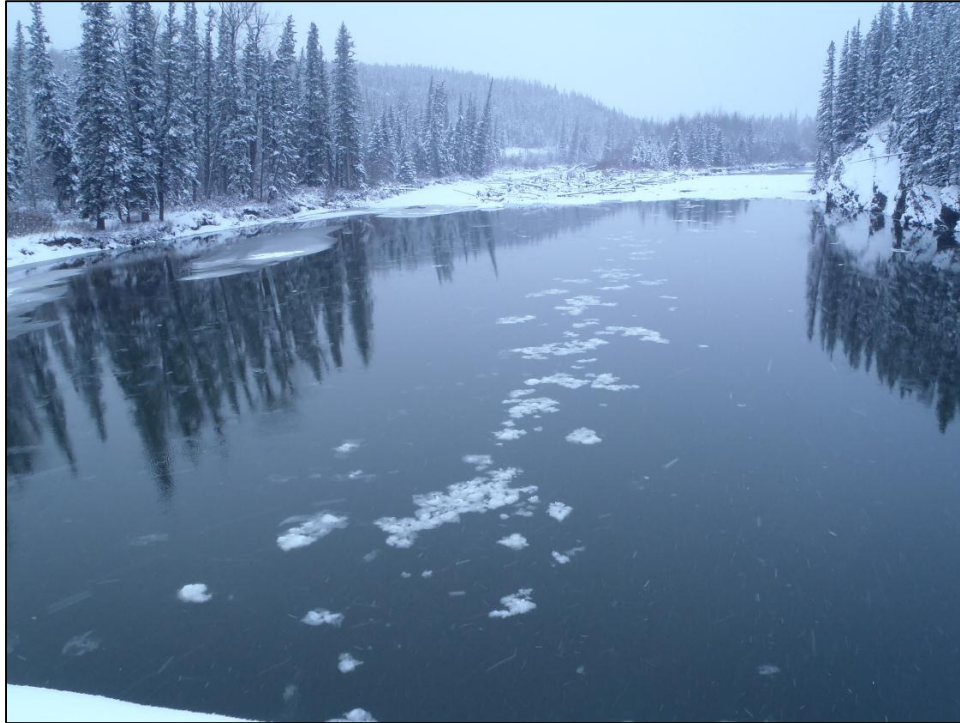
*Plate 7.1-3. Murray River: view downstream from Murray River FSR bridge. Flow rate = approx. 80 m<sup>3</sup>/s. November 7, 2012.*

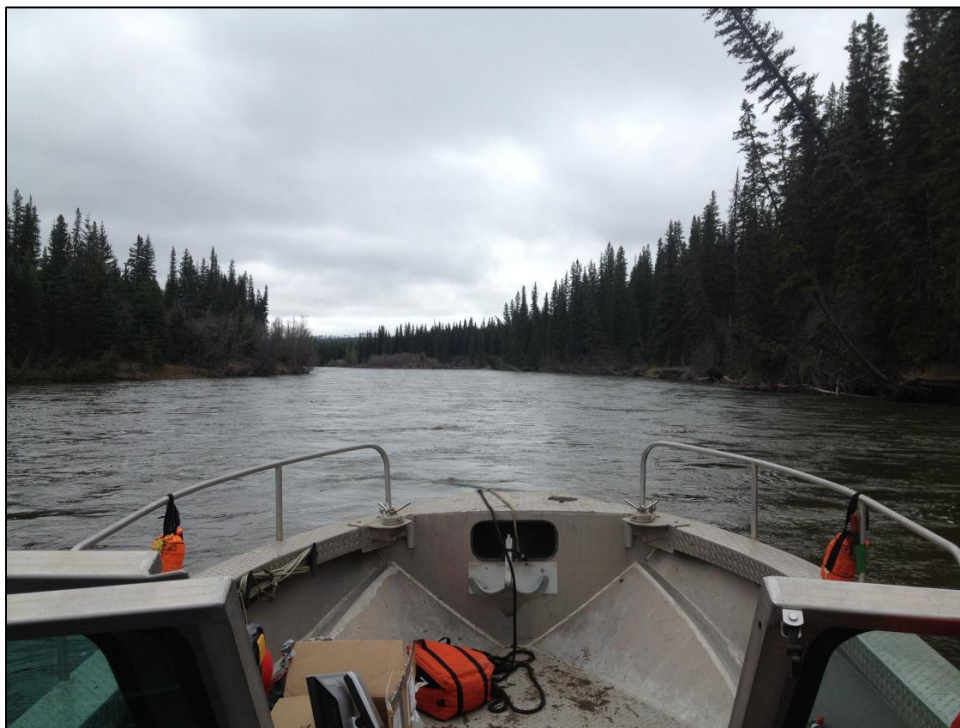
*Plate 7.1-4. Murray River: view downstream toward proposed water pipeline discharge location on right bank. Flow rate = 145 m<sup>3</sup>/s. M19 Creek joins the Murray River on the right bank in the distance. May 23, 2013.*

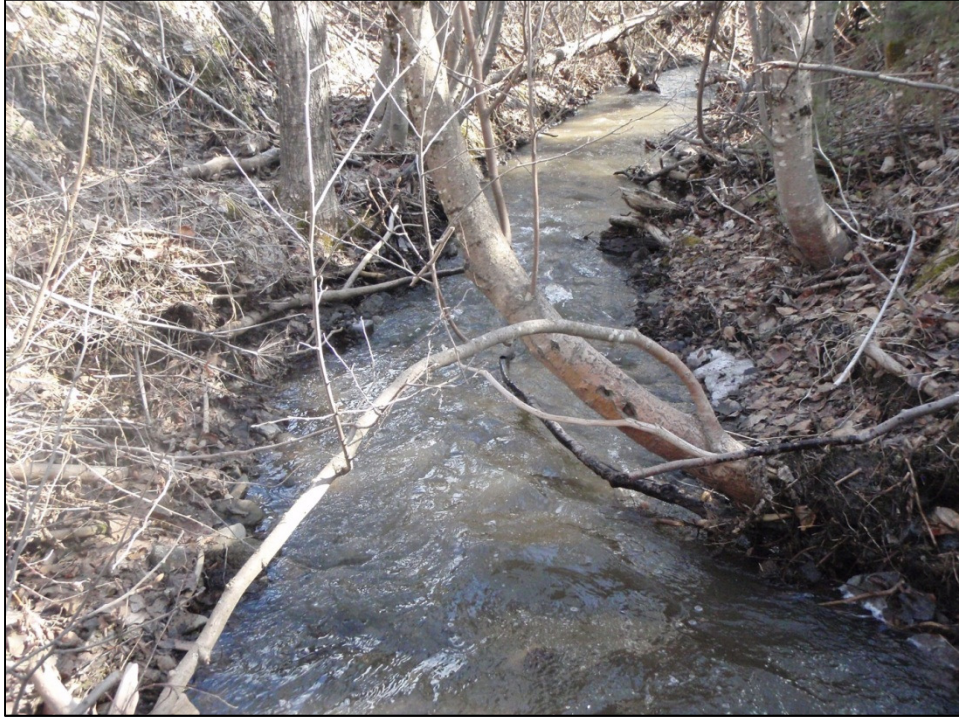
Seven of the stream crossings that were identified in Table 5-1 are associated with the proposed power lines (Site IDs 1 through 7). The largest of these crossings (Twenty Creek), is illustrated in Plate 7.2-1.

*Plate 7.2-1. Twenty Creek: view downstream from hydrometric station MH-3. Several branches create low clearance along the reach. April 27, 2012.*

Potential effects to navigability at these sites can be managed as minor works during construction, and would not be expected to influence navigability after installation. These seven crossings are therefore screened out from further assessment.

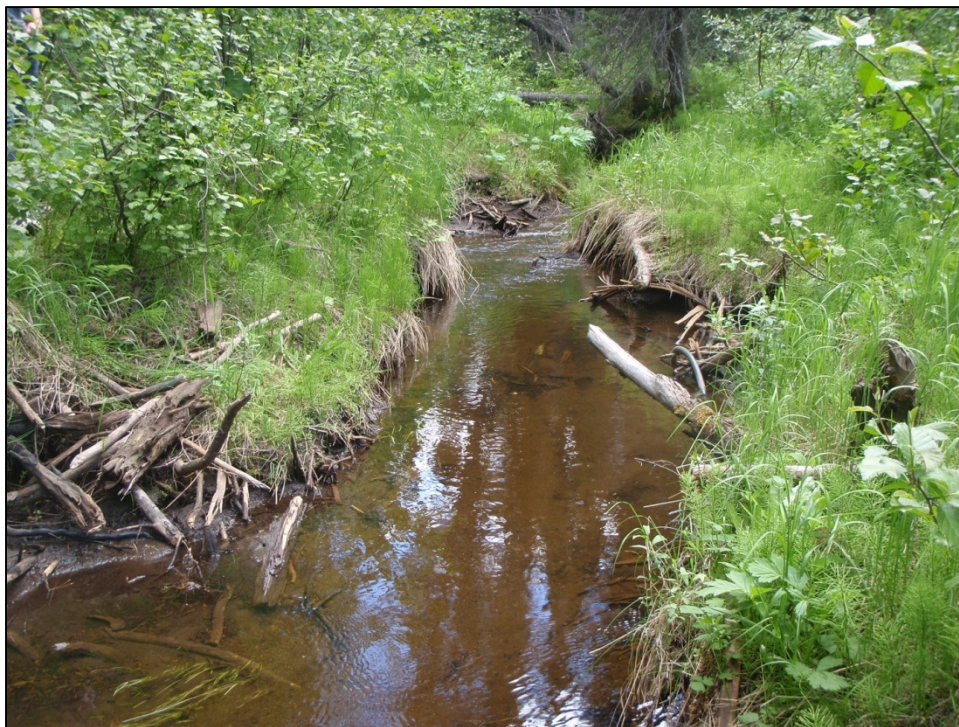
*Plate 7.3-1. Mast Creek: view upstream at hydrometric station MH-5. Large amounts of vegetation establish on the banks each summer. June 25, 2012.*

No obstructions in the tributary interacting with the Secondary Shaft Site have been recorded. In MH-5 some woody debris partially obstructs the channel (Plate 7.3-1). The channel morphology of

the reach around MH-5 has a sinuosity that would limit the length of any vessel attempting to navigate it.

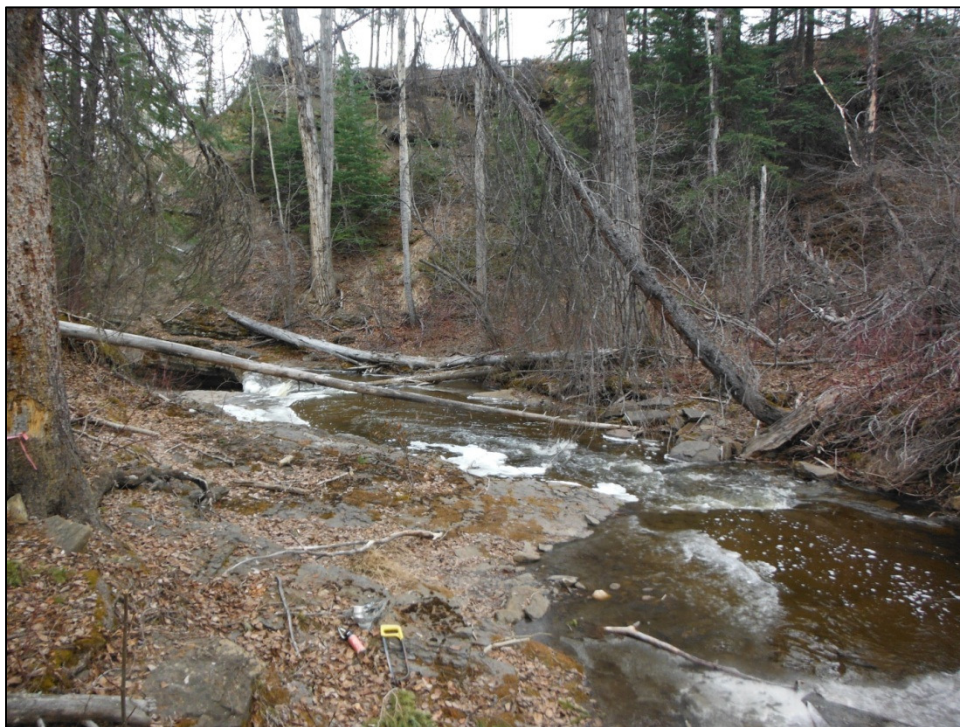
Three crossings of M19 Creek were identified (Site IDs 8, 9 and 13). M19 Creek has been monitored by ERM Rescan since 2012 as part of the hydrometric monitoring network (station MH-7). The channel morphology at the station is bedrock and is located in a deeply incised ravine (Plate 7.4-1).

*Plate 7.4-1. M19 Creek: view downstream from hydrometric station MH-7. Several logs have fallen across the stream and the edge of the waterfall can be seen in the distance. April 17, 2014.*

Approximately 10 m downstream from the station location there is a small waterfall and many logs obstruct navigation at the station location (Plate 7.4-1). From the station location 3 obstructions can be seen; the waterfall, one log upstream and one log downstream.
