FLUVIAL GEOMORPHOLOGY ASSESSMENT  
OF ALEXANDER CREEK

CROWN MOUNTAIN COKING COAL PROJECT

October 21, 2021

Prepared for: NWP Coal Ltd.

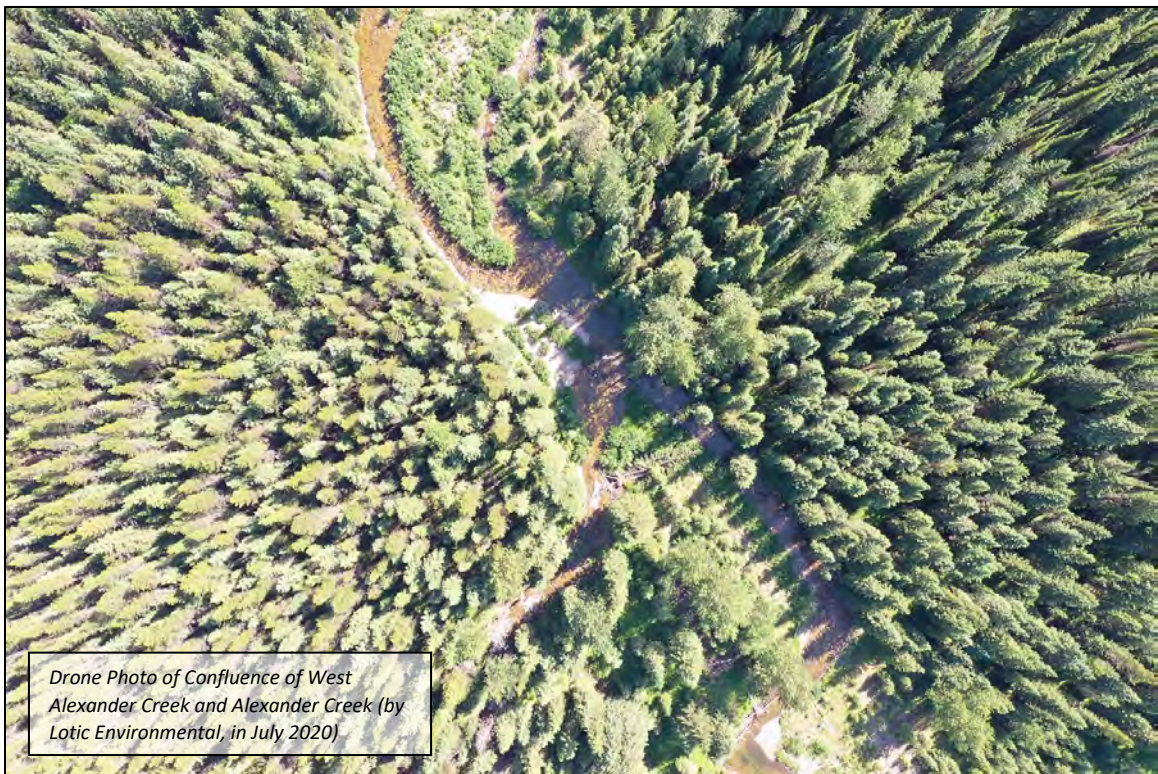
*Drone Photo of Confluence of West  
Alexander Creek and Alexander Creek (by  
Lotic Environmental, in July 2020)*

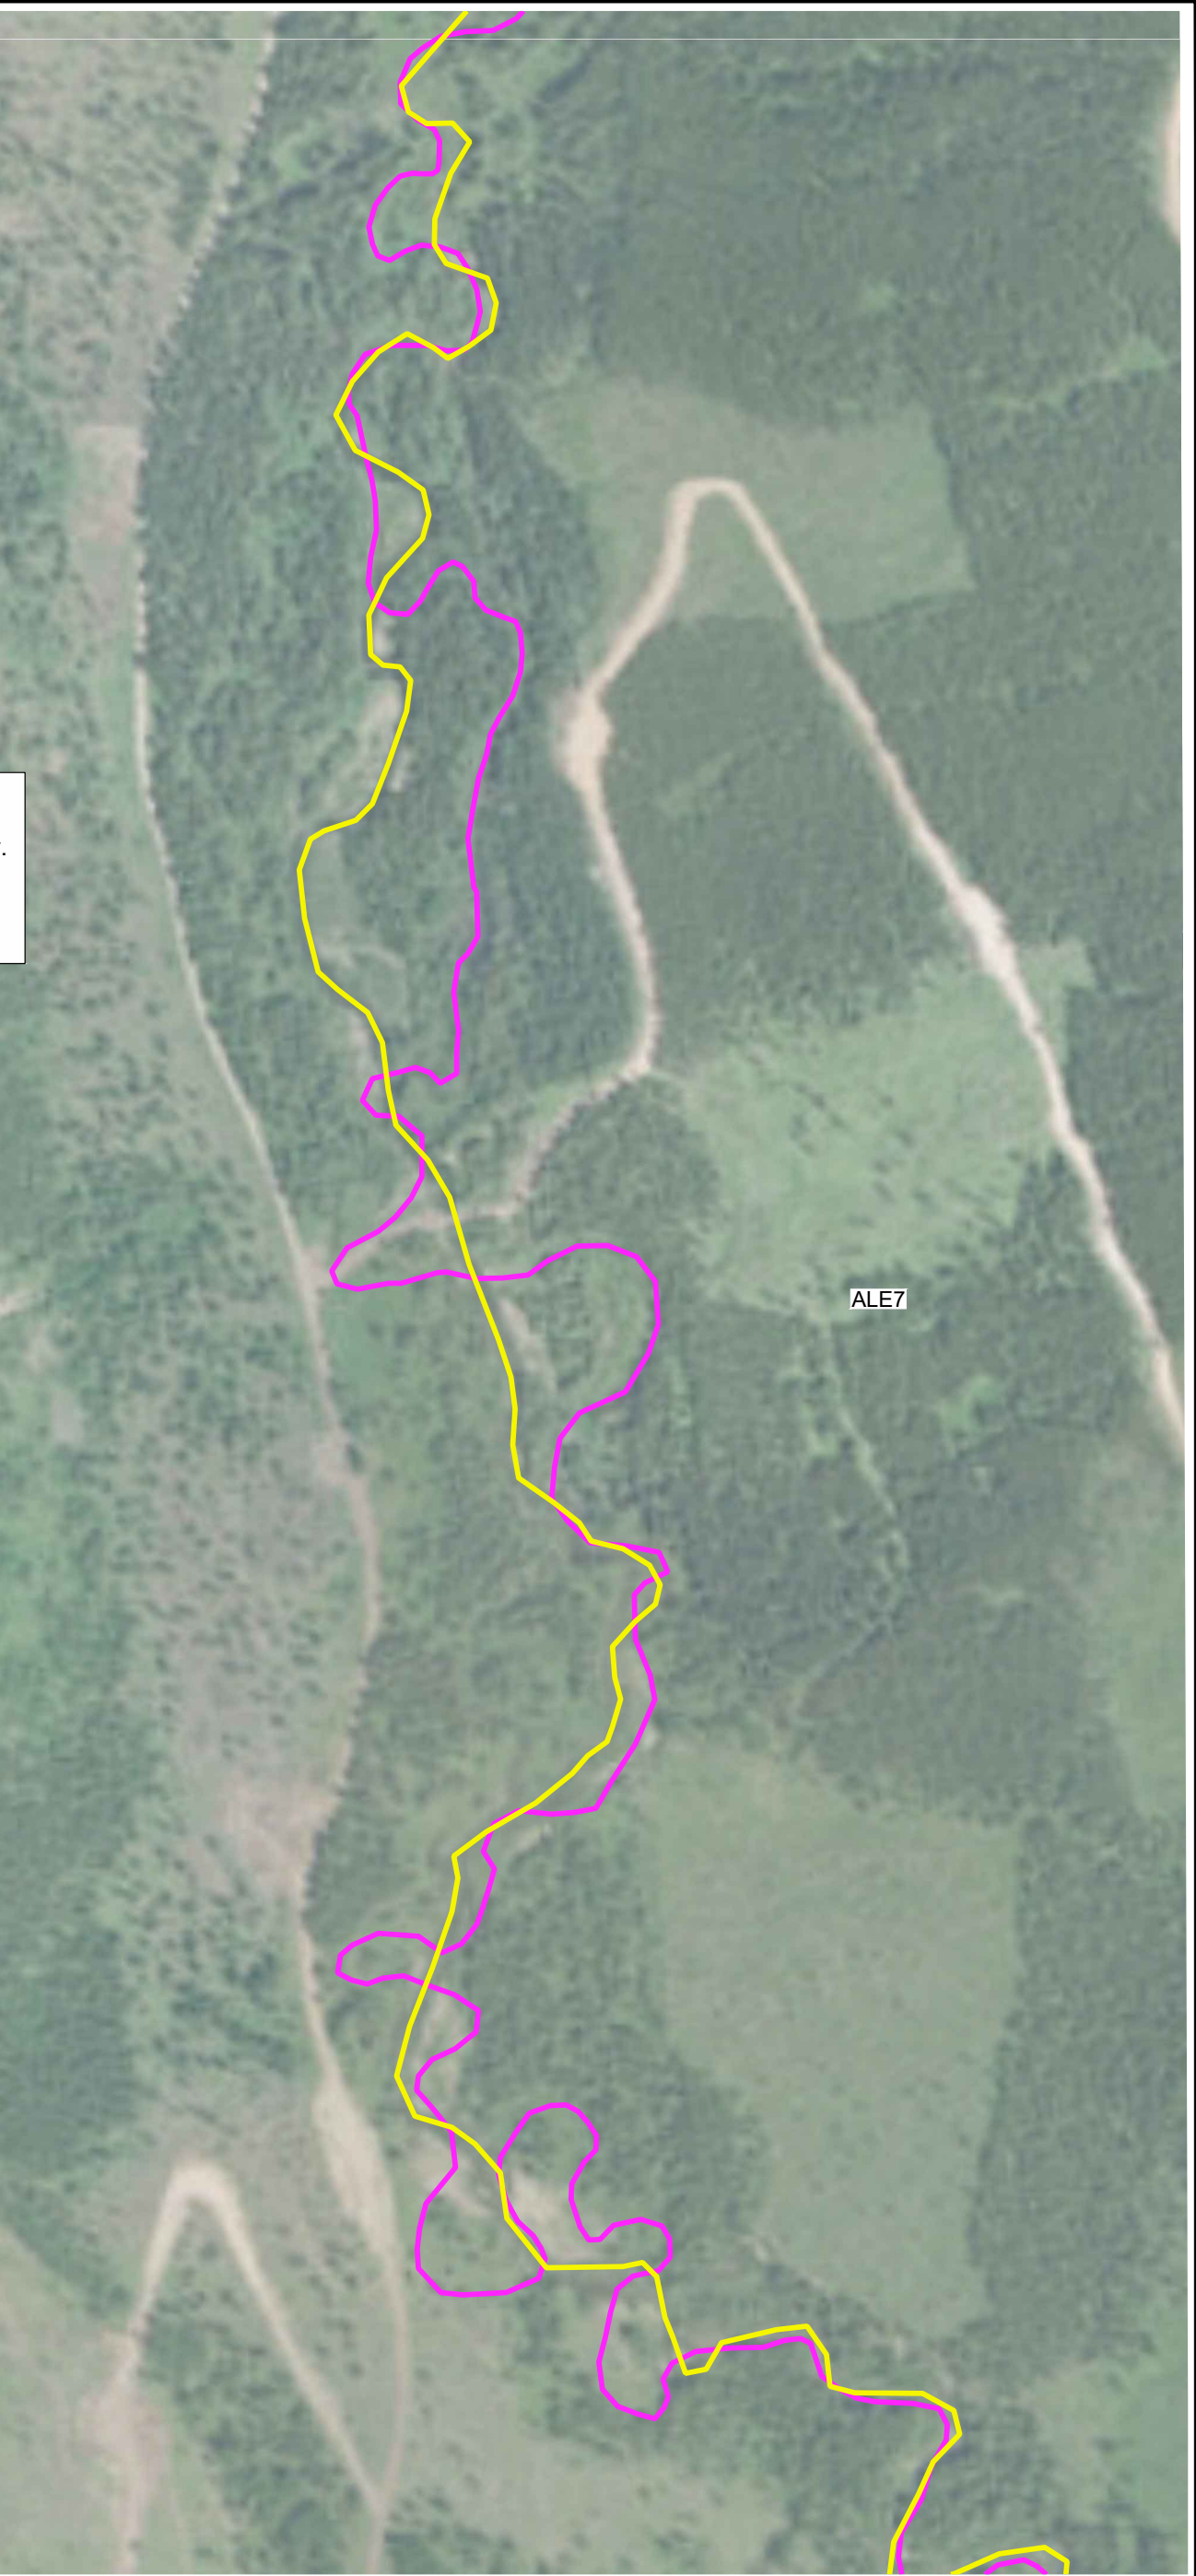
Scale: 1:5,000	NAD 1983 UTM Zone 11 U	Figure No.
Project No: 21-0104	Date: September 30, 2021	<b>4.3</b>

**1962 vs 2017 Comparison**  
 Decreased channel length, increased channel gradient,  
 decreased channel width, significantly decreased sinuosity.  
 The channel has cutoff several meanders, resulting in an  
 increased number of flow splits and side channels, where  
 remnants of the historic channels remain.

Several areas of significant channel change noted along Reach 7 of Alexander Creek, downstream of the confluence with West Alexander Creek were identified. These focused areas of interest are examined in more detail and 2017 imagery are provided in Figures 4.2 to 4.4.

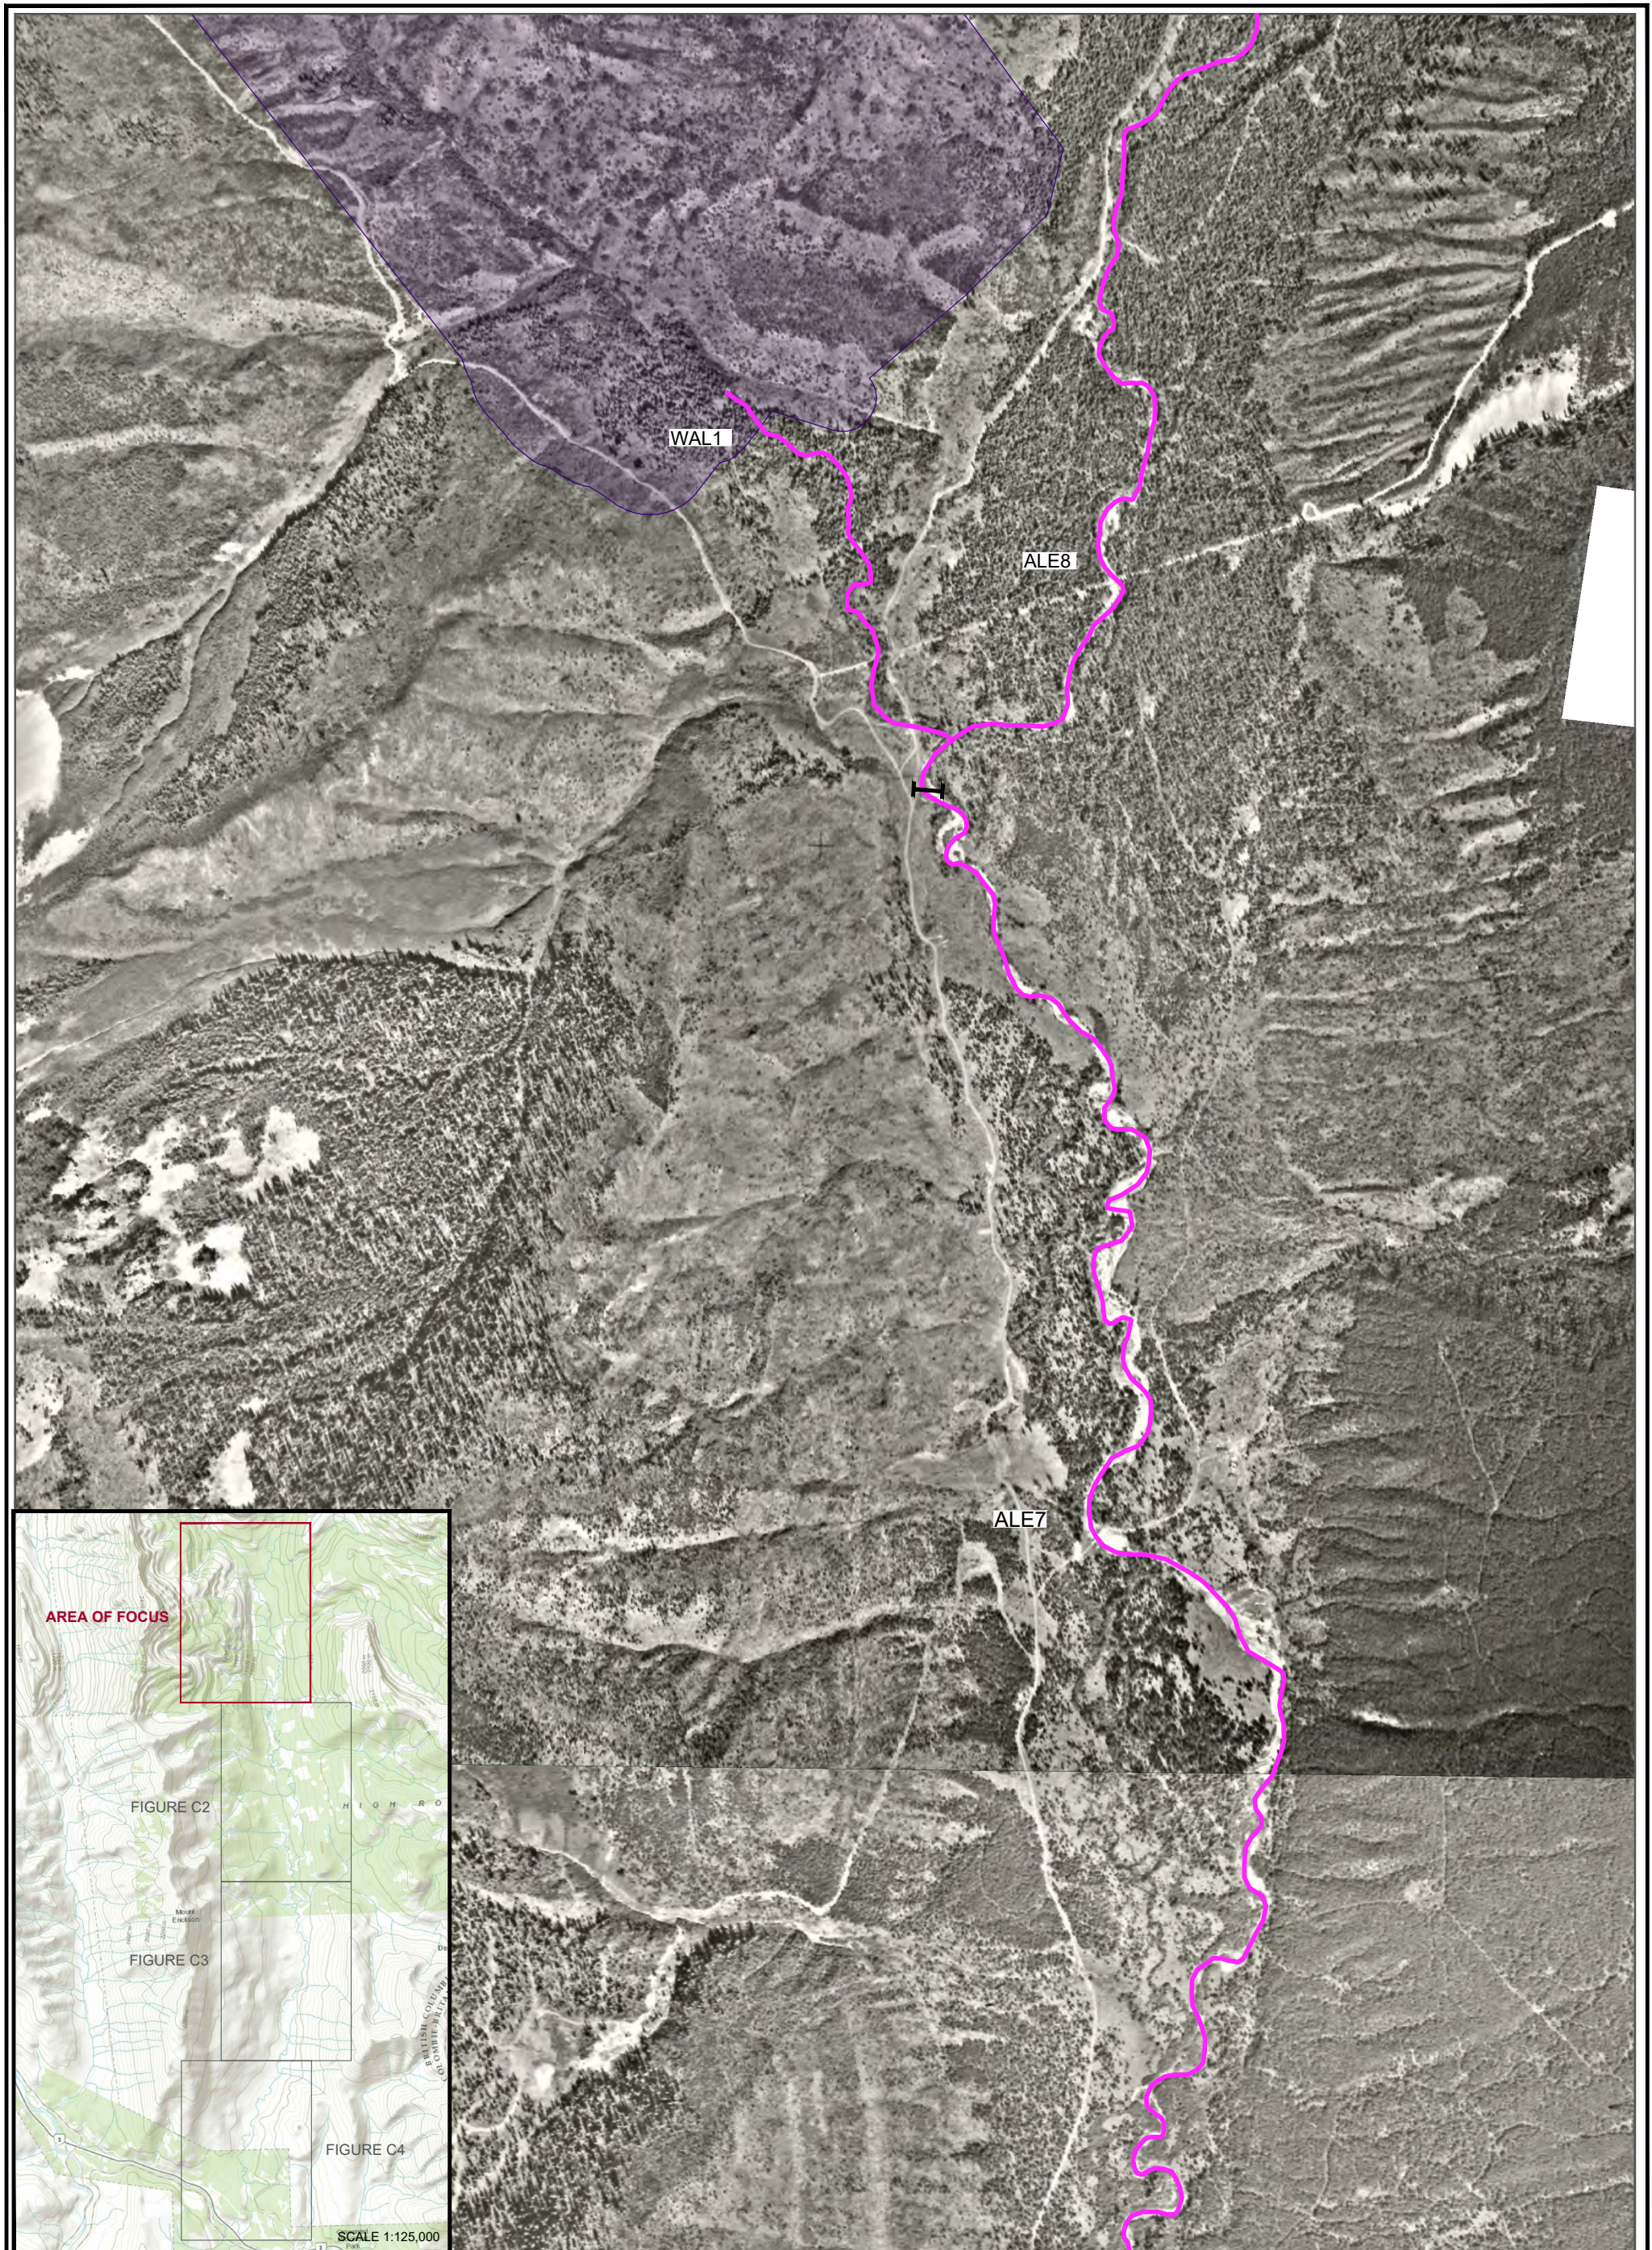
<b>CROWN MOUNTAIN COKING COAL PROJECT</b>	
<b>FLUVIAL GEOMORPHOLOGY ASSESSMENT OF ALEXANDER CREEK</b>	
<b>1962 HISTORICAL AIR PHOTO SHOWING CHANNEL ALIGNMENT</b>	
Scale: 1:10,000	NAD 1983 UTM Zone 11 U
Project No: 21-0104	Date: September 30, 2021
Figure No. <b>C1</b>

Figures C1 to C4      1962 Historical Air Photo showing Channel Alignment
