Appendix IR1-09-A

May 2017 Field Visit Report

Red Mountain Underground Gold Project
IDM Mining Ltd. Responses to
Canadian Environmental Assessment Information Request #1

Re: Red Mountain Field Visit, May 15-18, 2017
Field Report

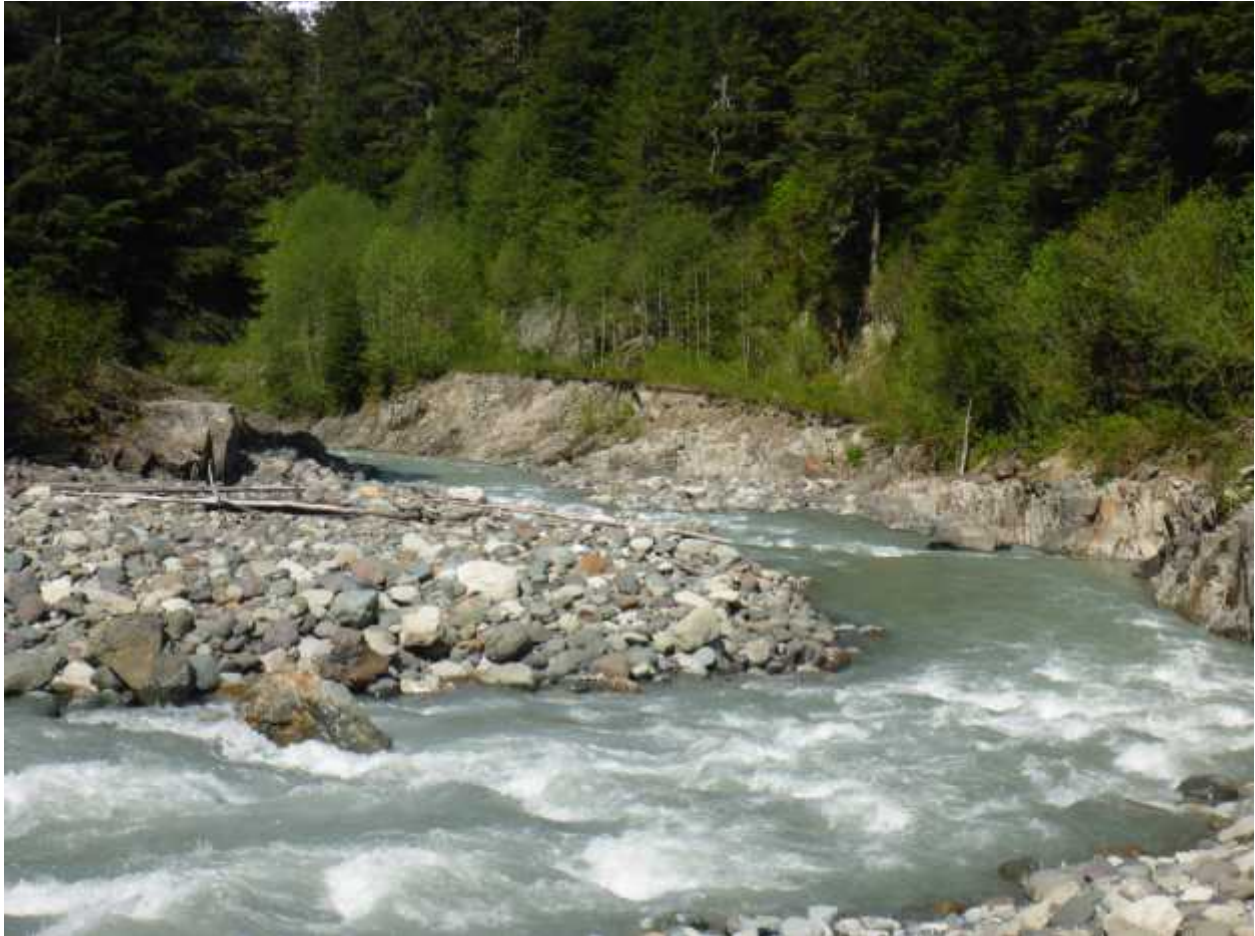
Encroachment of the Access Road into Bitter Creek occurs along the right (north) bank. Some of the encroachment areas are within confined sections of Bitter Creek, where the road is expected to be within the wetted area of the creek. The habitat of Bitter Creek within these areas is typically comprised of riffle and run habitat with some slower moving areas along the river edge (Figure 1 and Figure 2).

Figure 1: Downstream view of road encroachment area in a confined section of Bitter Creek. Date taken: 17-May-2017.

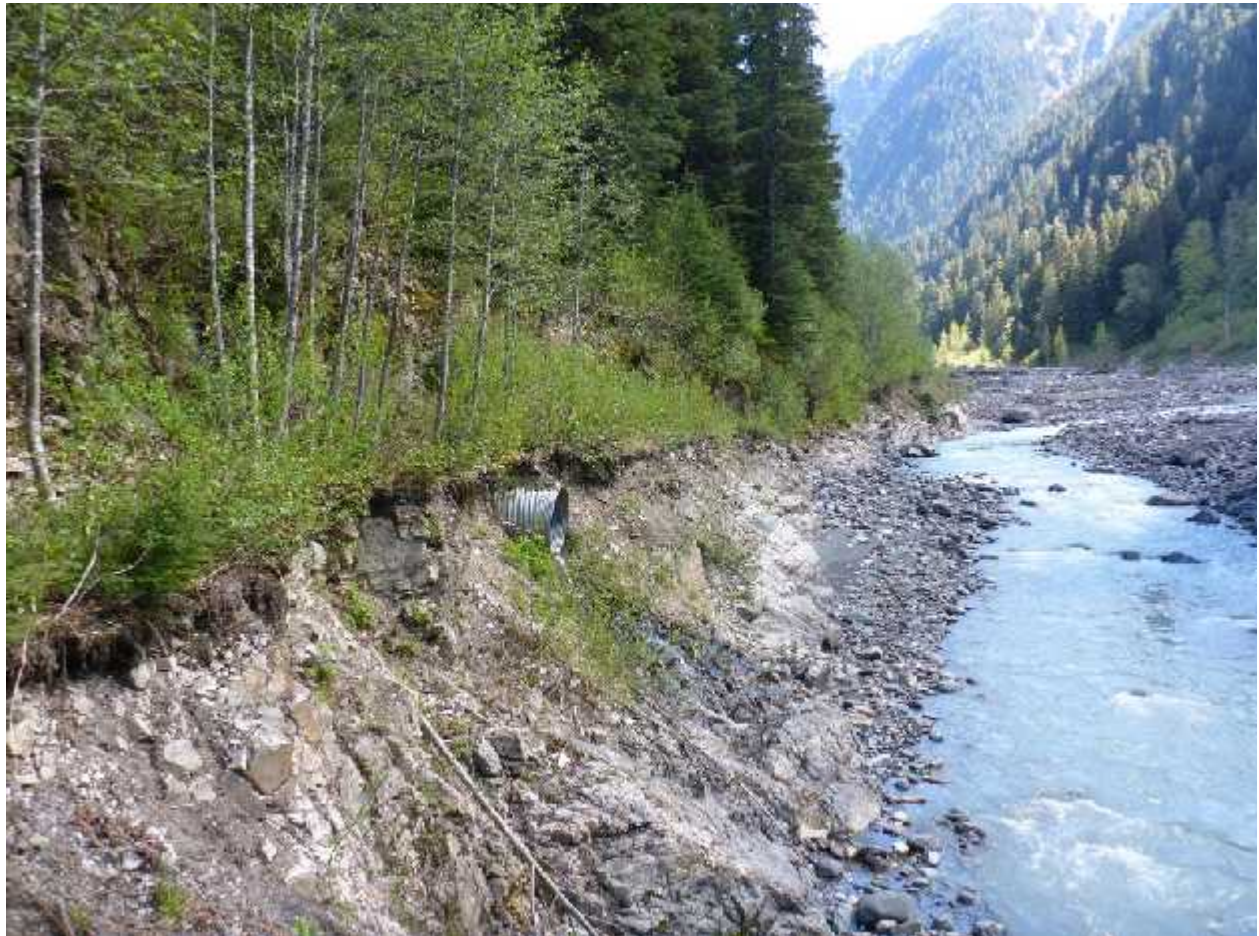
Figure 2: Upstream view at of road encroachment area in a confined section of Bitter Creek. The culvert inflow on river right, conveys a tributary watercourse (*i.e.* road crossing). Date taken: 16-May-2017.

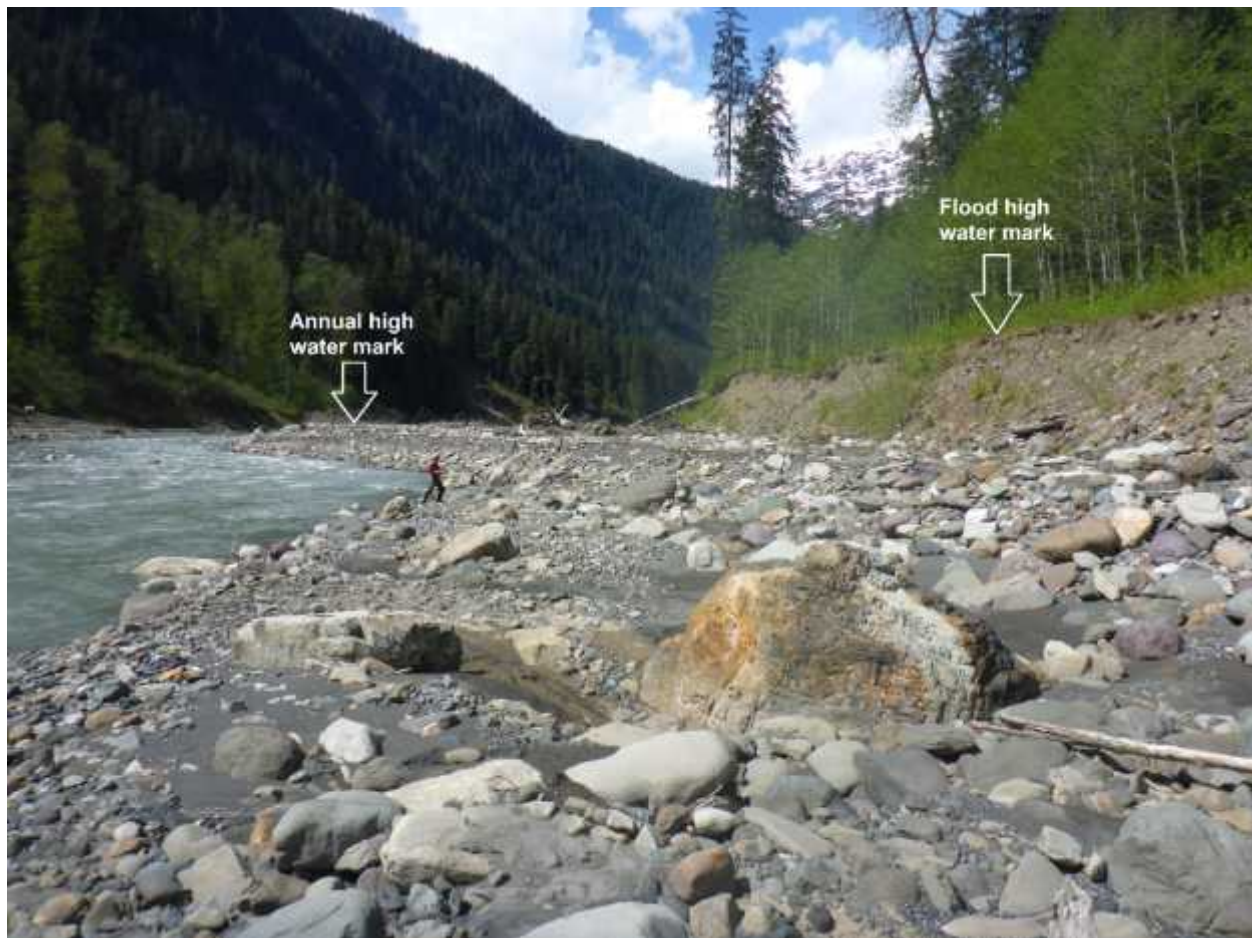
Other encroachment areas are within unconfined sections of Bitter Creek, consisting of floodplain terraces that are rarely wetted. The road is not expected to be within the wetted area of the creek along these sections. Channel morphology throughout these sections of Bitter Creek was altered in 2011 when an extreme flood event widened the channel, and scoured the banks. As such, the proposed road encroachment areas are setback from the annual high-water mark of Bitter Creek. This is evidenced by vegetation (shrubs and saplings) growing in the channel in these areas (Figure 3).

Figure 3: Downstream view of road encroachment area, showing annual high-water mark, and high-water mark from the 2011 flood. Date taken: 17-May-2017

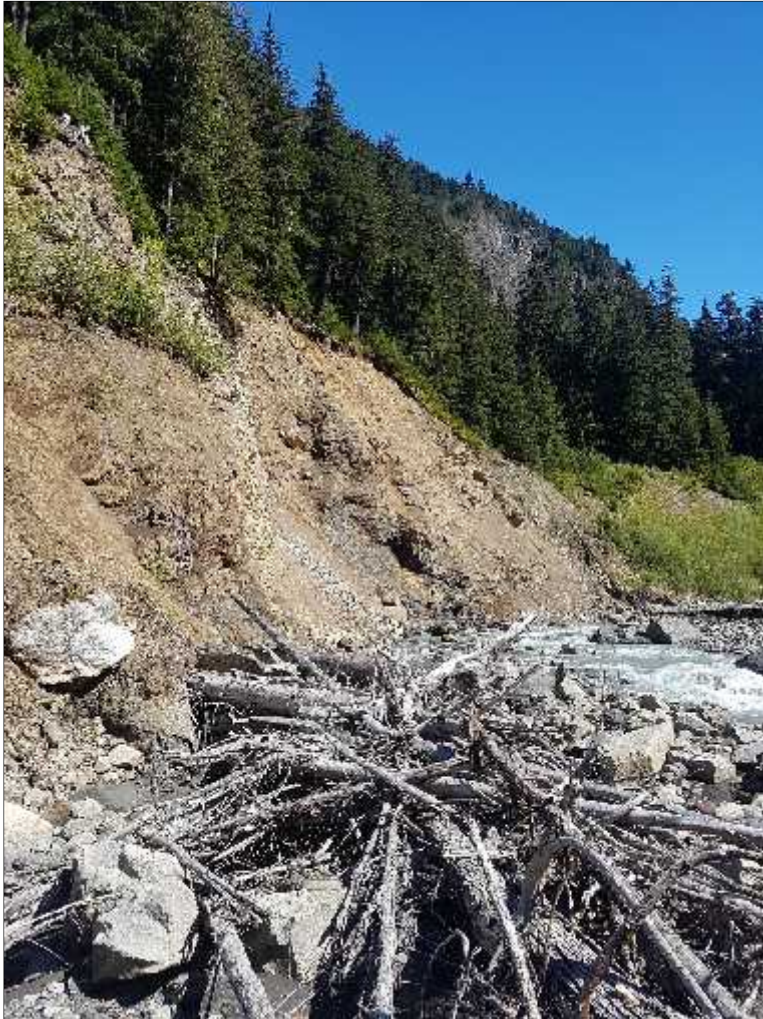
**Figure 4: View of upstream section of road encroachment area.
Date taken: 16-May-2017.**

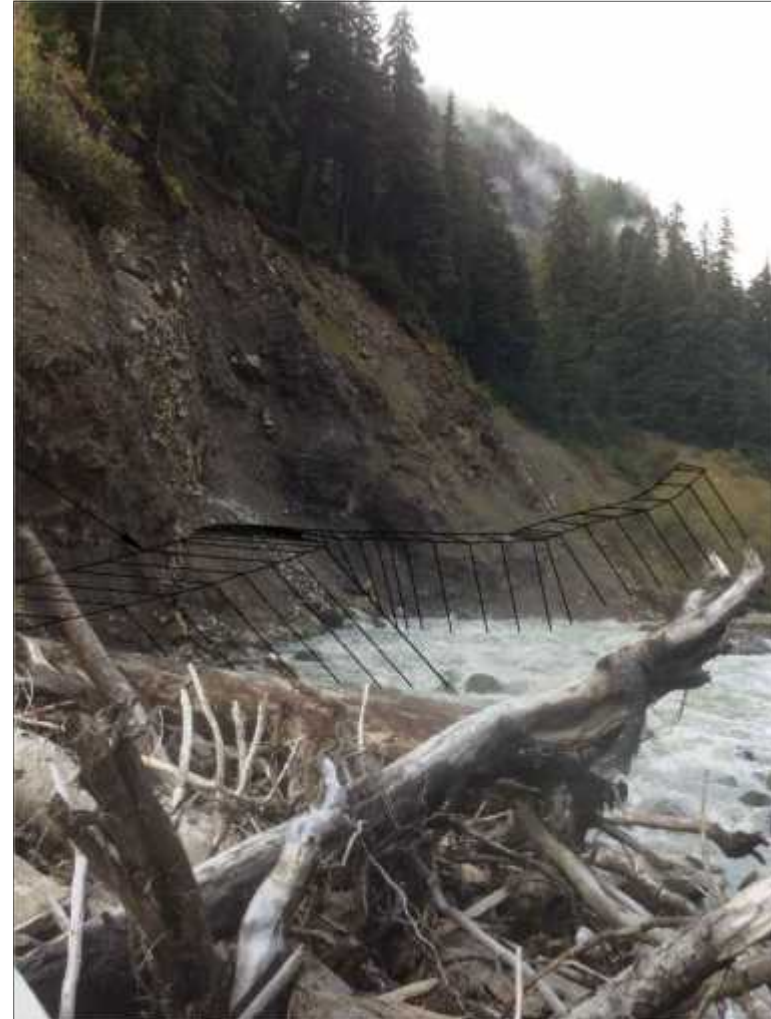
**Figure 5: View of upstream section of road encroachment area.
Source: Onsite Engineering, Drawing # 1464-2-RIVERFILL- 002**

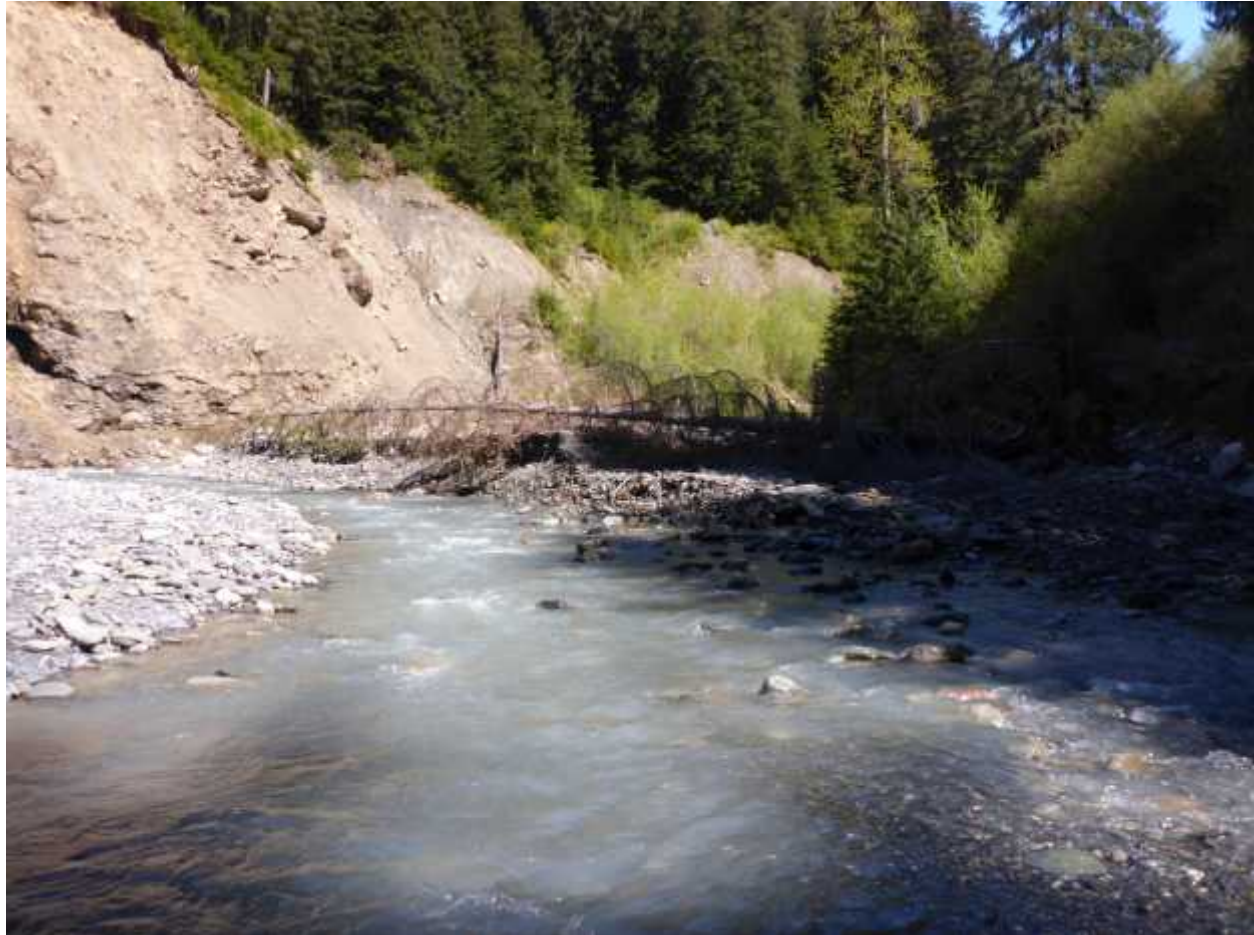
The site of the proposed channel realignment is within a confined section of Bitter Creek. This area contains pocket water habitat between boulders along the right bank which is suitable for juvenile rearing. The proposed works at this location include realignment of the Bitter Creek channel, construction of a road prism along the right bank (Figure 4 and Figure 4), and bank armouring. On river left at this location, a side channel provides additional rearing habitat, and gravel substrate was noted which may be suitable for spawning (Figure 6).

Figure 6: Upstream view of side channel along river left, at creek realignment location. Date taken: 16-May-2017.

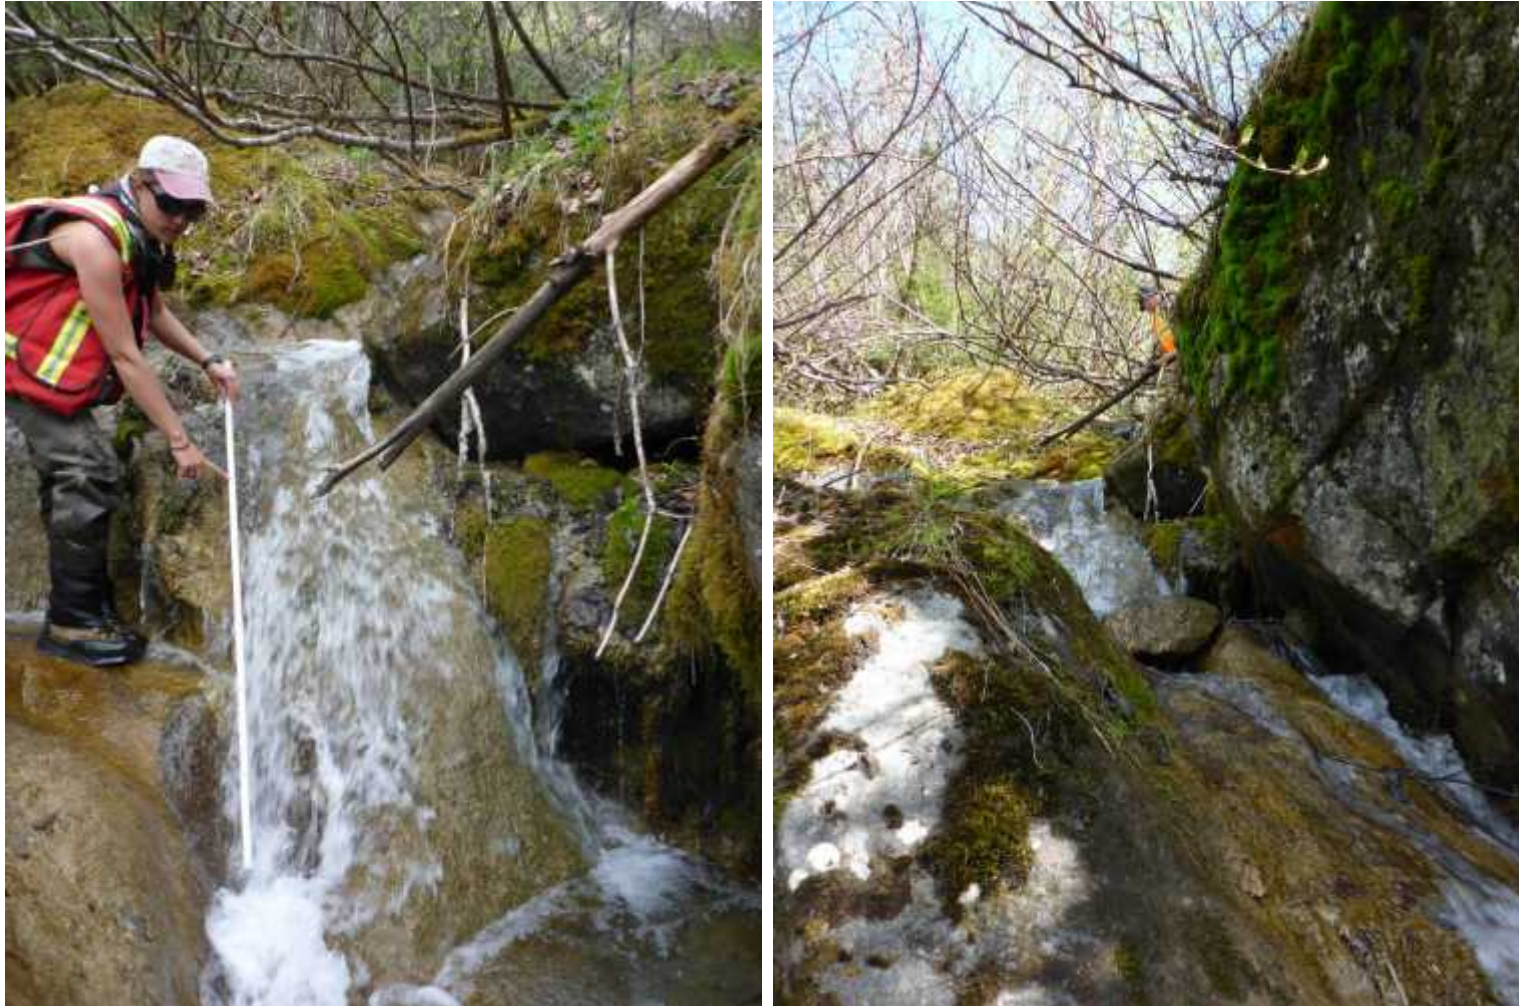
The unnamed tributary was determined to be non-fish bearing owing to a series of chutes and drops within a 200 m section immediately upstream of the confluence with Bitter Creek, which are shown in the figures below, from downstream to upstream (Figure 7, Figure 8 and Figure 9). The section of the tributary below the most downstream drop (close to Bitter Creek), is shallow and lacks channel definition where the creek fans before entering Bitter Creek (Figure 10 and Figure 11).

**Figure 7: Chute on unnamed tributary, crew member's left index finger shows the 1 metre mark on the meter stick. Gradient was 46%.
Date taken: 16-May-2017.**

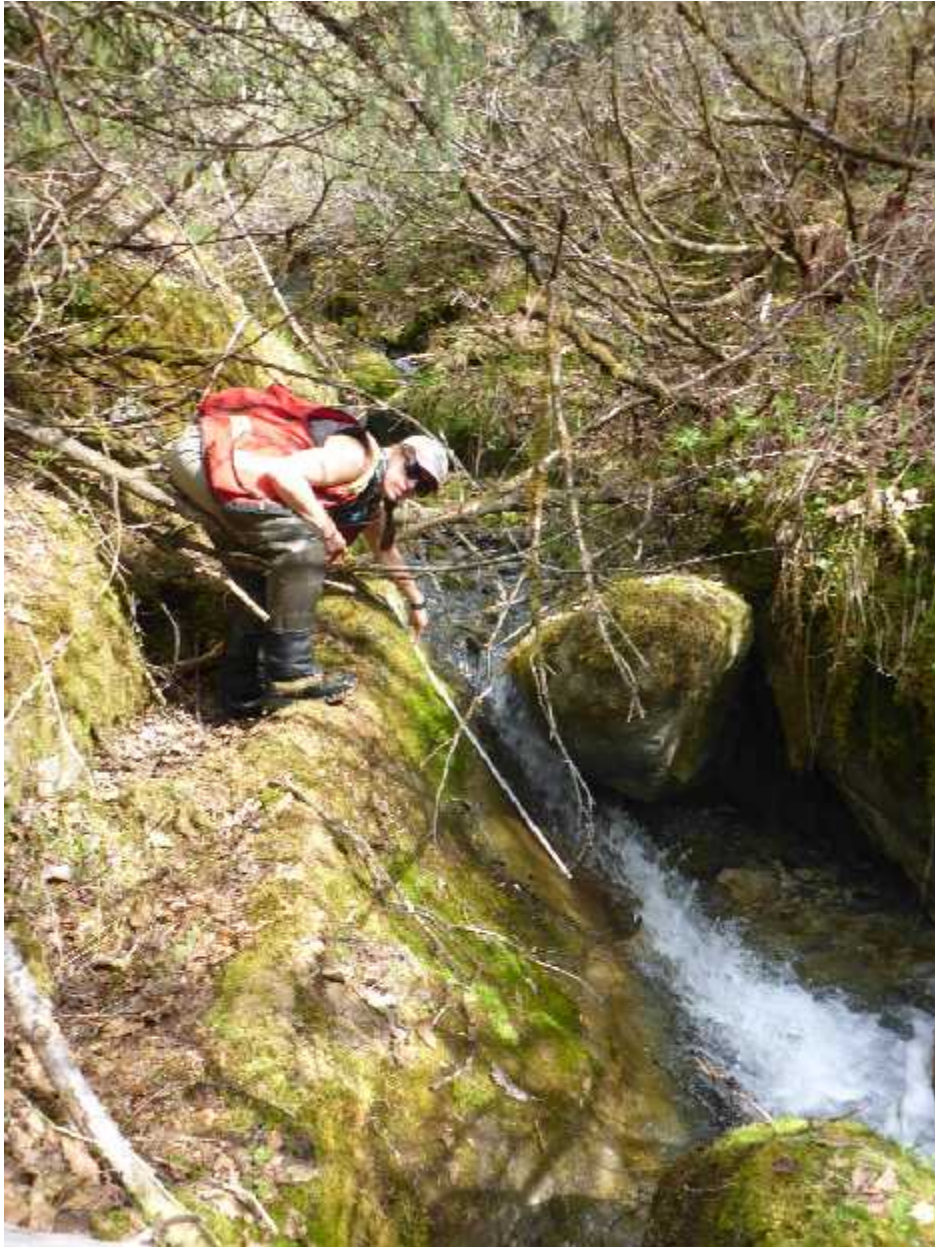
Figure 8: Chute on unnamed tributary, crew member's left index finger shows the 1 metre mark on the meter stick. Date taken: 16-May-2017.

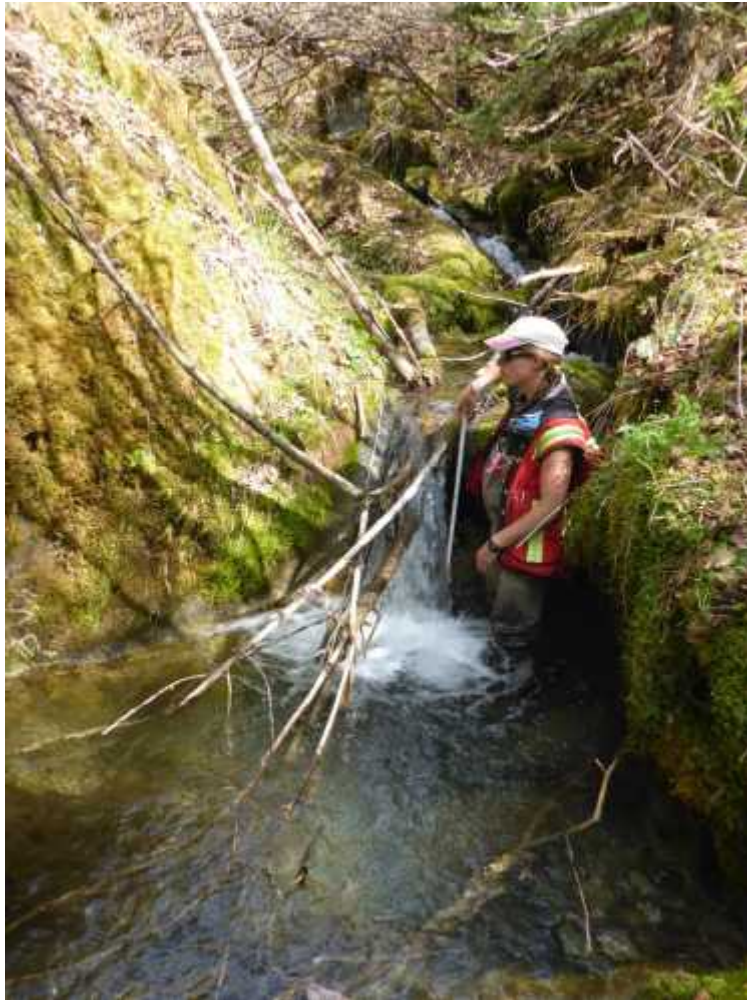
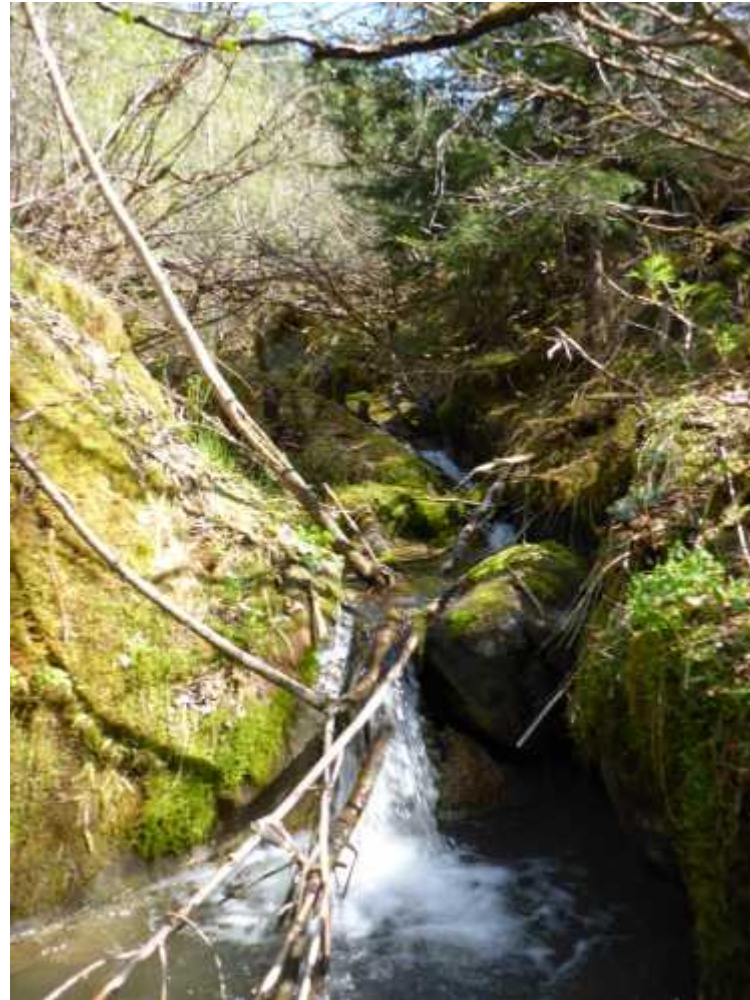
**Figure 9: Drop on unnamed tributary, crew member's right index finger shows the 1 metre mark on the meter stick.
Date taken: 16-May-2017.**

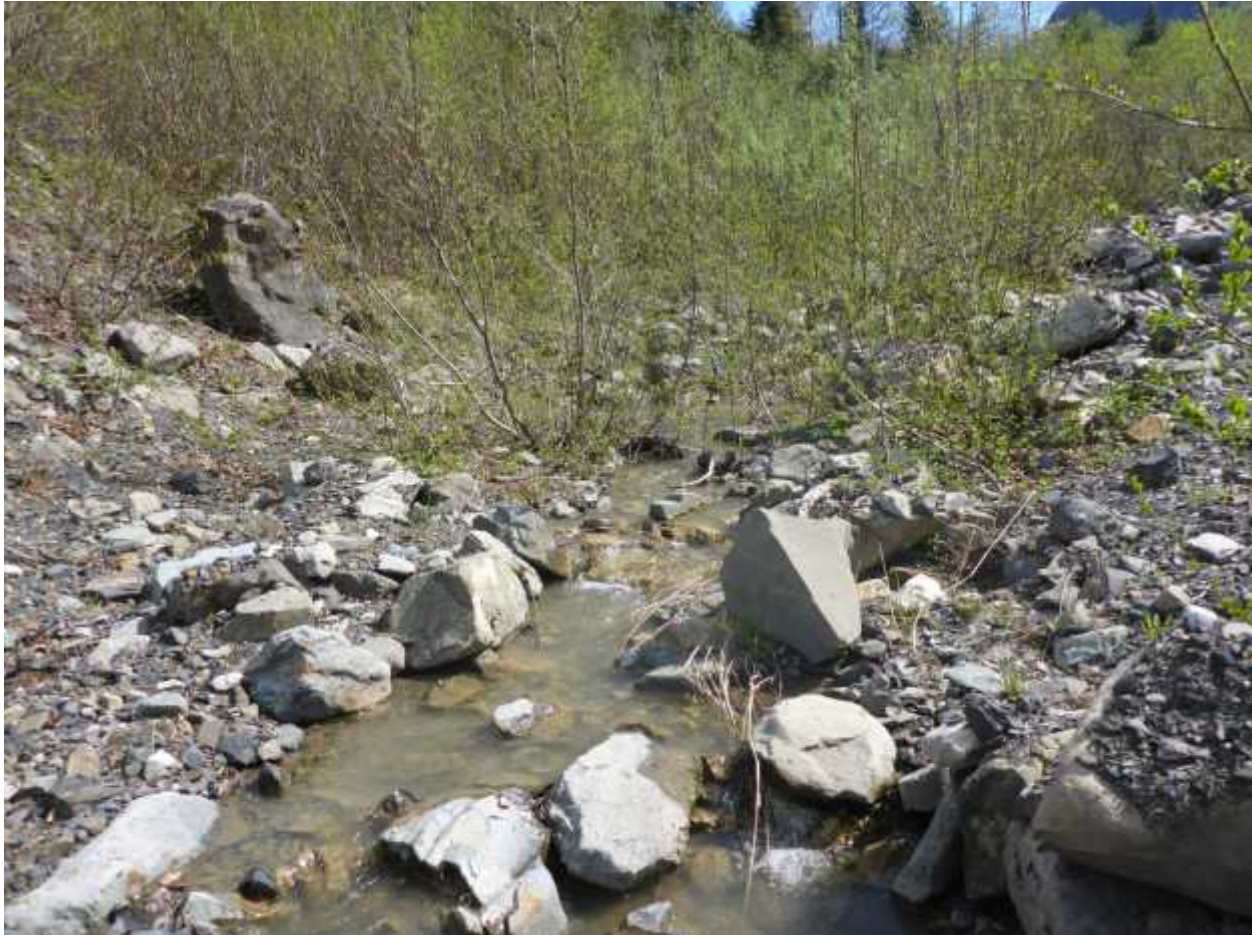
Figure 10: Upstream view of unnamed tributary close to confluence with Bitter Creek. Date taken: 16-May-2017.

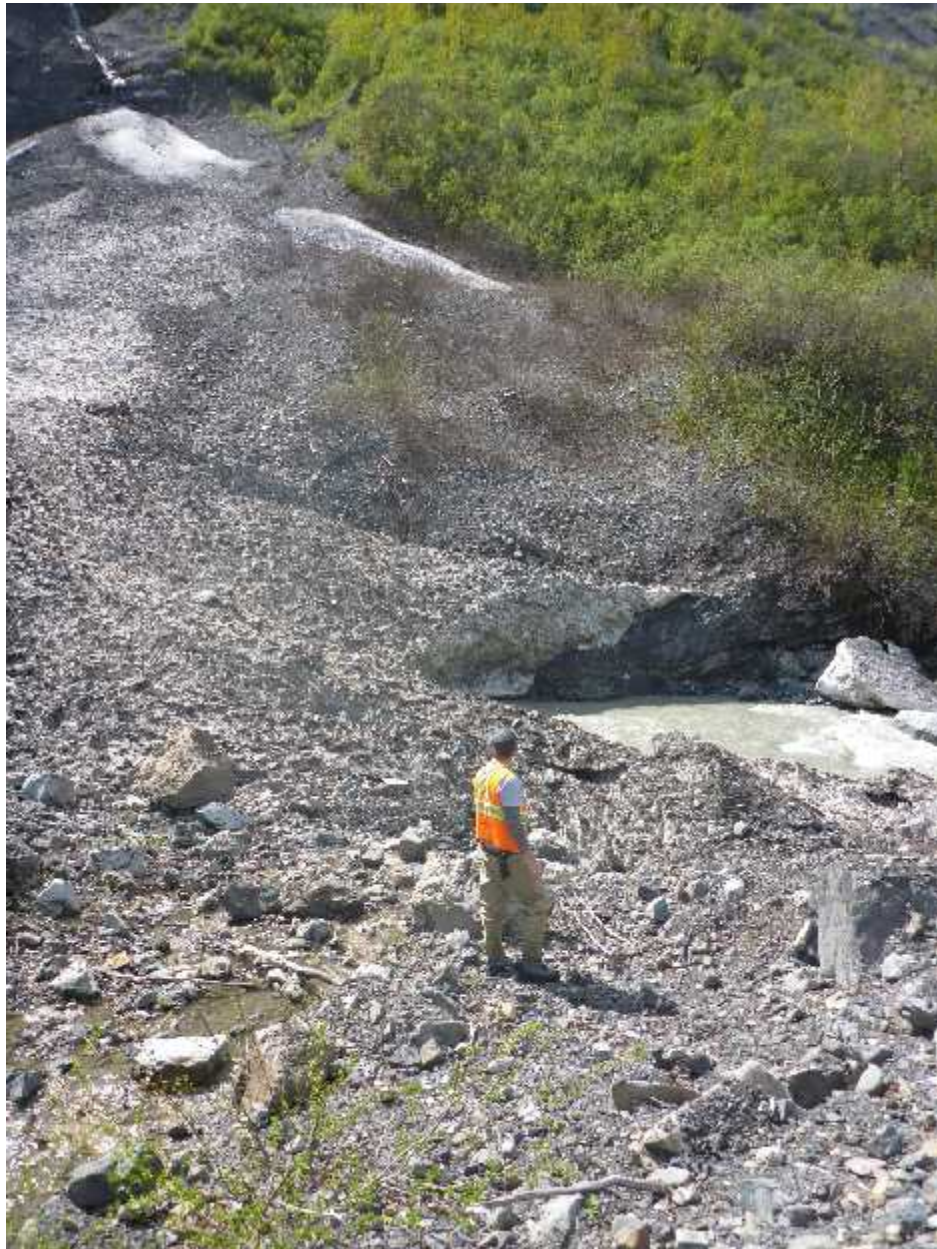
Figure 11: Unnamed tributary confluence with Bitter Creek. Date taken: 16-May-2017.
