Project 4: Berens River First Nation to Poplar River First Nation All Season Road Aquatic Environment Report

Aquatic Environment Report

August 2015

North/South Consultants Inc.
Aquatic Environment Specialists

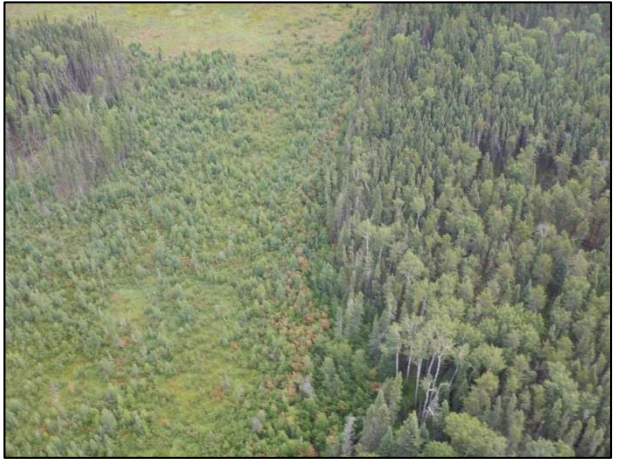
Watercourse	Representative Photograph
<p>Site: P4-X02 - Unnamed Drainage Location: 14U 644288/5798617 CANVEC: Yes Connectivity: No Description: No defined channel at the crossing site.</p>

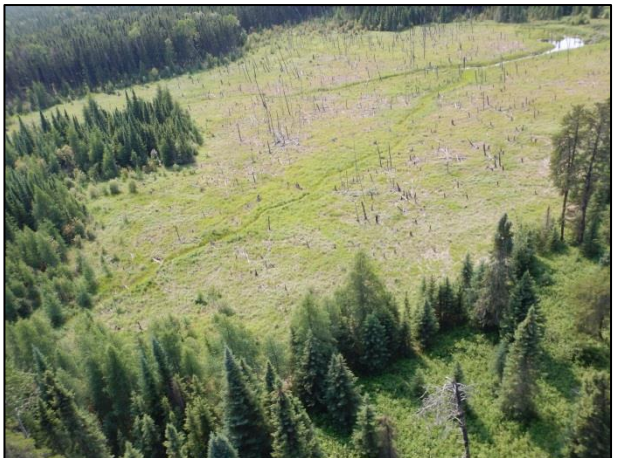
<p>Site: P4-X06 – Unnamed Drainage Location: 14U 648929/5808634 CANVEC: No Connectivity: No Description: small wetland channel with poor connectivity (absence of well-defined channel connection) to Site P4-X05 drainage.</p>

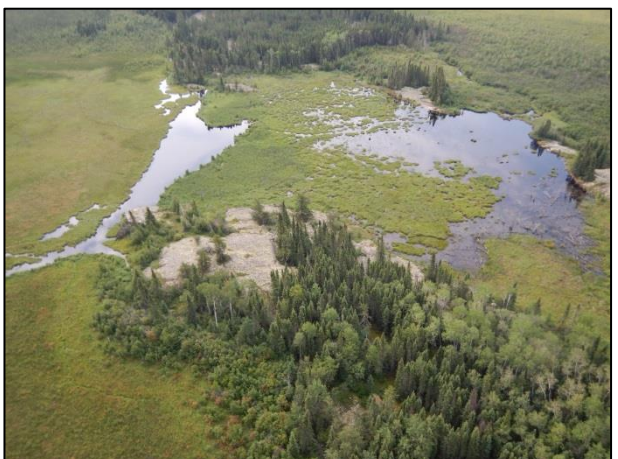
<p>Site: P4-X08 – Unnamed Drainage Location: 14U 648712/5815230 CANVEC: No Connectivity: No Description: Impounded water (beaver dam) within a broad boreal wetland. No defined connection to overwintering habitats.</p>

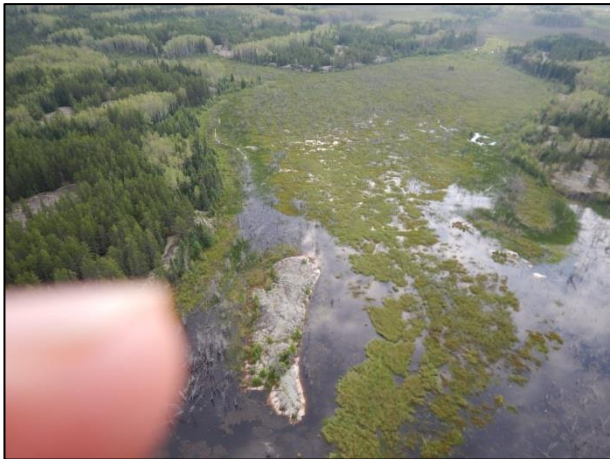
Watercourse	Representative Photograph
<p>Site: P4-X09 – Unnamed Drainage Location: 14U 648495/5815629 CANVEC: No Connectivity: No Description: Small discontinuous channel within broad wetland. No defined connection to overwintering habitats.</p>	
<p>Site: P4-X10 – Unnamed Drainage Location: 14U 648272/5815981 CANVEC: No Connectivity: No Description: Impounded water (beaver dam) within a broad boreal wetland. No defined connection to overwintering habitats. Located on same drainage as and adjacent to Site P4-X11.</p>

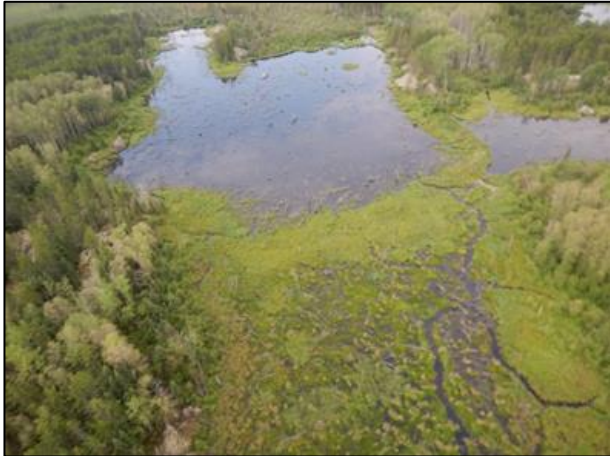
<p>Site: P4-X12 – Unnamed Drainage Location: 14U 647869/5817308 CANVEC: Yes Connectivity: No Description: CANVEC mapped as a small, isolated waterbody. Impounded water (beaver dam) within a broad boreal wetland. No defined connection to overwintering habitats.</p>

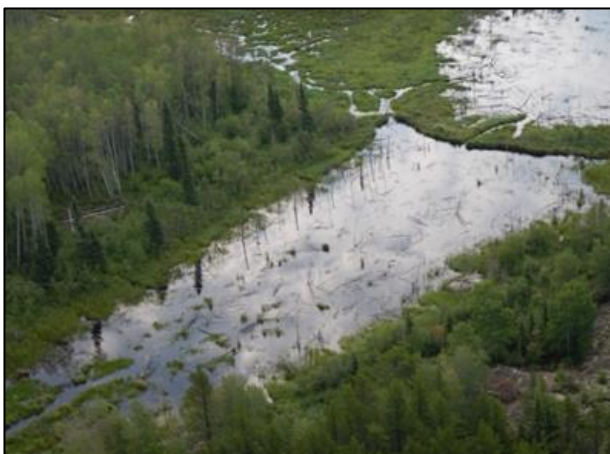
<p>Site: P4-X13 – Unnamed Drainage Location: 14U 647782/5817516 CANVEC: No Connectivity: No Description: Small intermittent channel within boreal wetland; flows to Site P4-X12 impoundment; no downstream connection.</p>

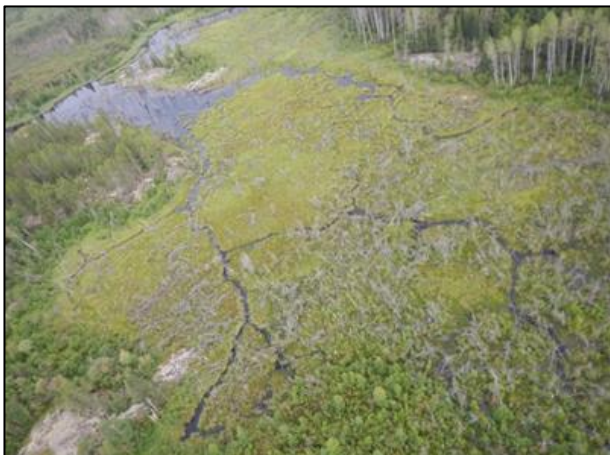
<p>Site: P4-X14 – Unnamed Drainage Location: 14U 647730/5817642 CANVEC: No Connectivity: No Description: Small intermittent channel within boreal wetland; no downstream connection; Located adjacent to and on the same drainage as Site P4-X15.</p>

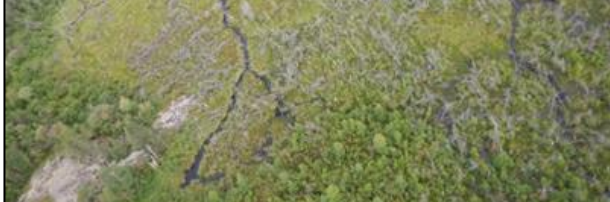
<p>Site: P4-X15 – Unnamed Drainage Location: 14U 647718/5817671 CANVEC: No Connectivity: No Description: Small intermittent channel within boreal wetland; no downstream connection. Located on the same drainage as Site P4-X14.</p>

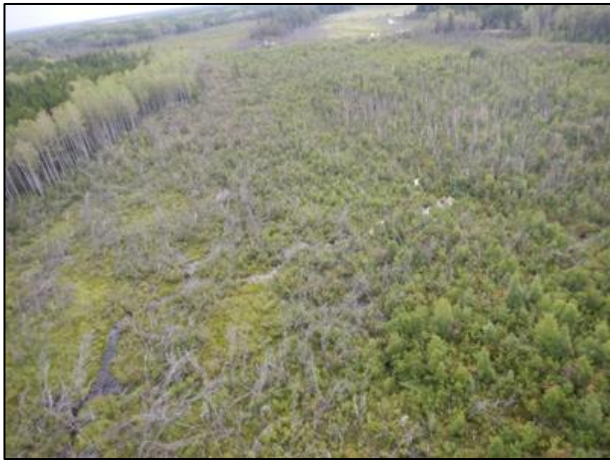
Watercourse	Representative Photograph
<p>Site: P4-X16 – Unnamed Drainage Location: 14U 647690/5817756 CANVEC: No Connectivity: No Description: Small intermittent channel within boreal wetland; no downstream connection.</p>

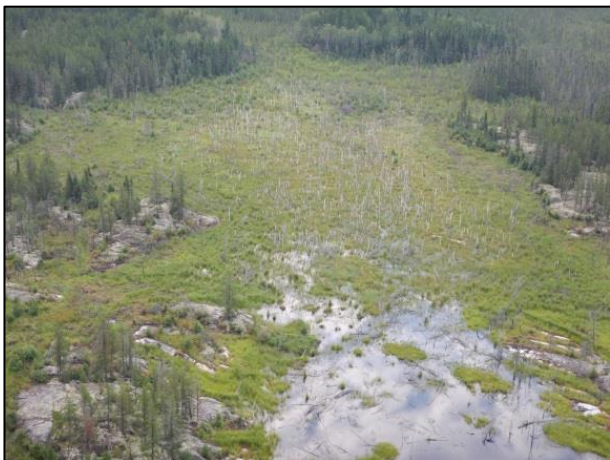
<p>Site: P4-X17 – Unnamed Drainage Location: 14U 647281/5819729 CANVEC: Yes Connectivity: No Description: CANVEC mapped as a small, isolated waterbody. Boreal wetland area with no defined channel. Series of beaver dams and impoundments located downstream but no defined channel connection to overwintering habitats.</p>

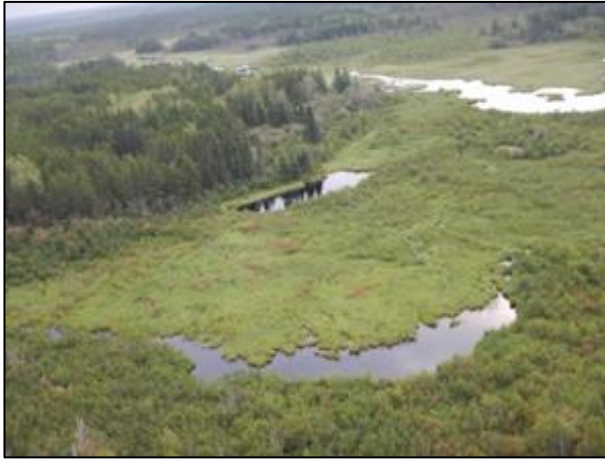
Watercourse	Representative Photograph
<p>Site: P4-X18 – Unnamed Drainage Location: 14U 647170/5820298 CANVEC: No Connectivity: No Description: Impounded water (beaver dam) within a broad boreal wetland. No defined connection to overwintering habitats. Sites P4-X18 and P4-X19 are located on the same impoundment.</p>

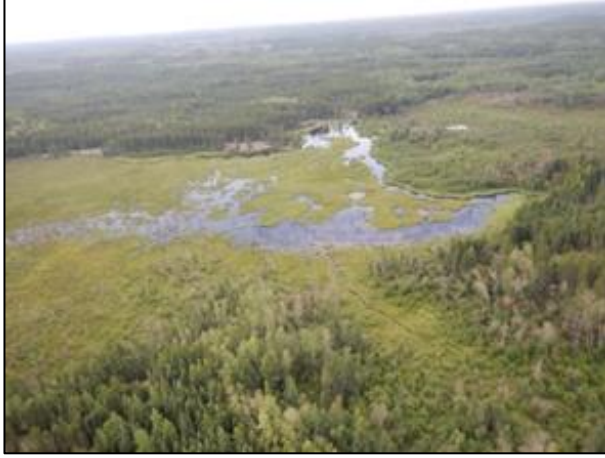
<p>Site: P4-X19 – Unnamed Drainage Location: 14U 647167/5820337 CANVEC: No Connectivity: No Description: Impounded water (beaver dam) within a broad boreal wetland. No defined connection to overwintering habitats. Sites P4-X18 and P4-X19 are located on the same impoundment.</p>	
<p>Site: P4-X20 – Unnamed Drainage Location: 14U 647184/5821742 CANVEC: No Connectivity: No Description: Impounded water (beaver dam) within a broad boreal wetland. No defined channel downstream from impoundment. No connection to overwintering habitats. Located on the same impoundment as Site P4-X21.</p>

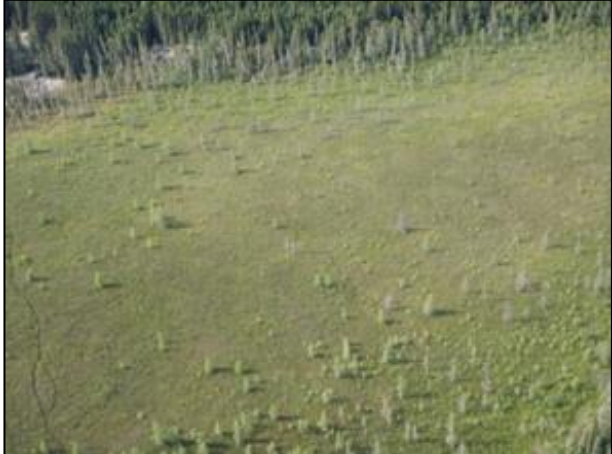
Watercourse	Representative Photograph
<p>Site: P4-X23 – Unnamed Drainage Location: 14U 648249/538188 CANVEC: No Connectivity: No Description: No defined channel at crossing site.</p>

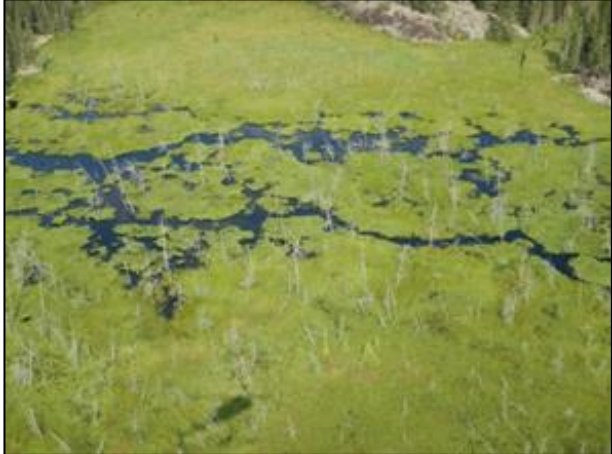
<p>Site: P4-X25 – Unnamed Drainage Location: 14U 647835/5840254 CANVEC: No Connectivity: No Description: Small wetland channel. Beaver dam and impoundment downstream from crossing. No defined channel downstream of dam. No connection to overwintering habitats. Located adjacent to and within the same wetland as Site P4-X26.</p>

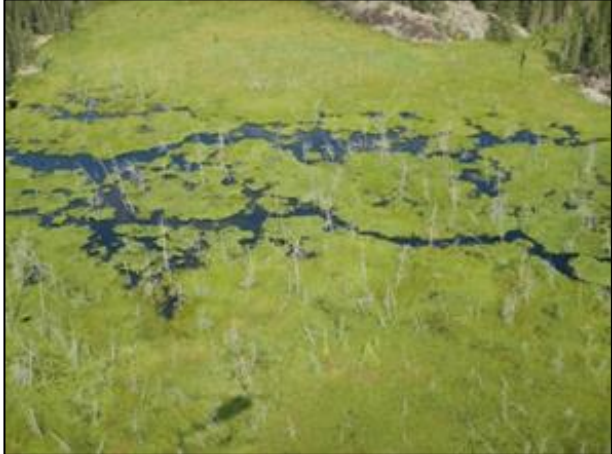
<p>Site: P4-X26 – Unnamed Drainage Location: 14U 647804/5840294 CANVEC: No Connectivity: No Description: Small wetland channel. Beaver dam and impoundment downstream from crossing. No defined channel downstream of dam. No connection to overwintering habitats. Located adjacent to and within the same wetland as Site P4-X25.</p>

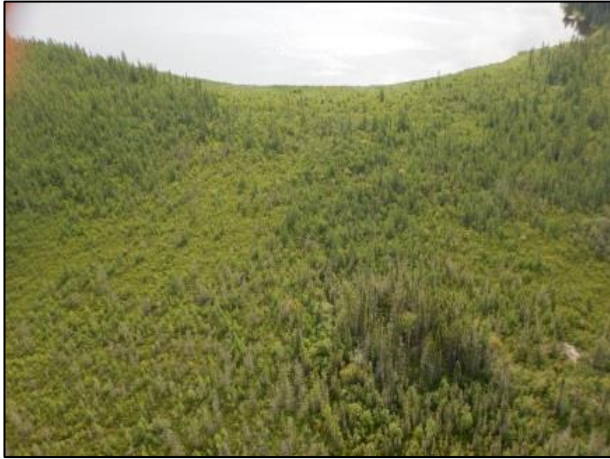
Watercourse	Representative Photograph
<p>Site: P4-X27 – Unnamed Creek Location: 14U 641366/587454 CANVEC: Yes Connectivity: No Description: Broad wetland adjacent to a small, isolated lake; no visible channel at the crossing or defined connection to lake.</p>

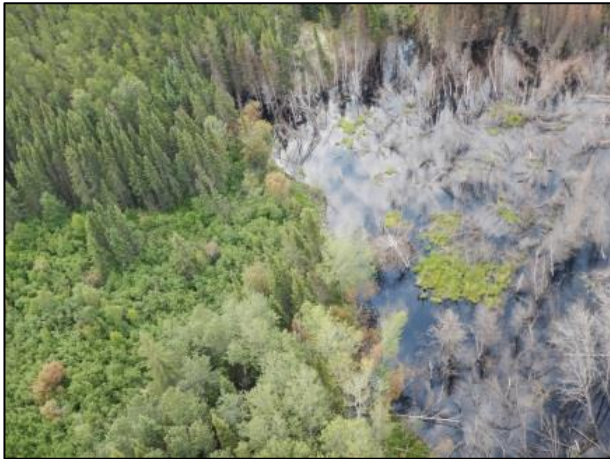
<p>Site: P4-X28 – Unnamed Creek Location: 14U 640598/5849291 CANVEC: Yes Connectivity: No Description: Impounded water (beaver dam) at crossing; no defined connection to downstream receiving tributary.</p>

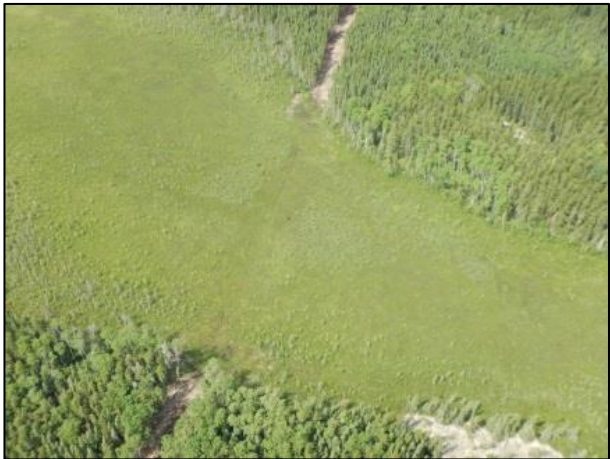
<p>Site: P4-X32 – Unnamed Drainage Location: 14U 624506/5862152 CANVEC: Not at crossing, but further downstream Connectivity: No Description: Broad wetland; no defined channel at crossing site.</p>

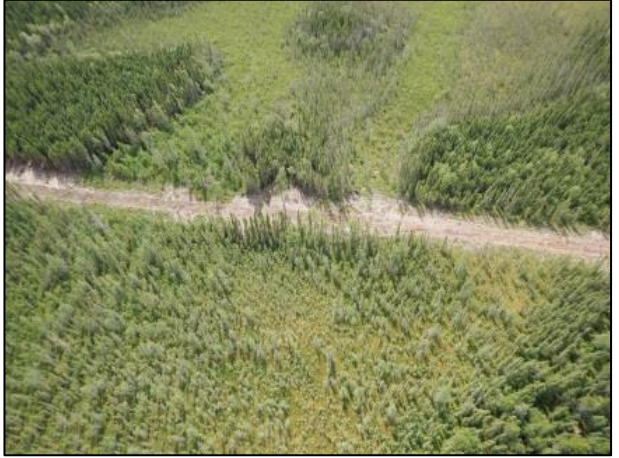
Watercourse	Representative Photograph
<p>Site: P4-X33 – Unnamed Location: 14U 620897/ 5864651 CANVEC: Yes Connectivity: No Description: No defined channel at crossing site.</p>

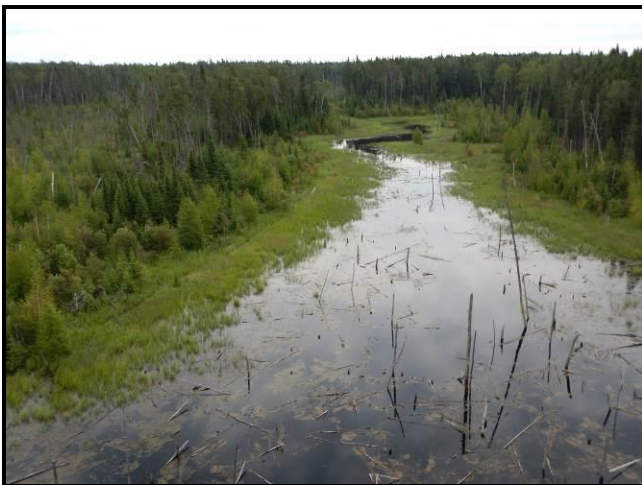
Upstream view of impoundment located downstream from crossing.

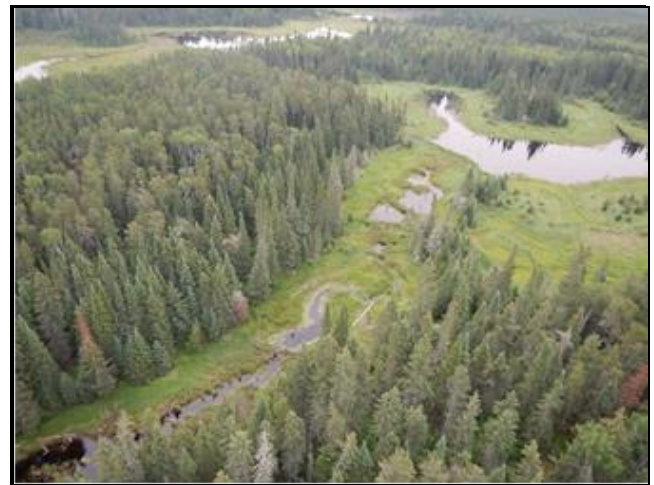
Downstream from the crossing, the channel is heavily impacted by beaver dams.
