Phase I - Environmental Site Assessment (Beaver Dam),
- August 6, 2019
Completed for the Updated 2021 Beaver Dam Mine EIS

**FINAL -
Phase I Environmental Site Assessment**

Beaver Dam Property
181 Beaver Dam Mines Road, Marinette, NS

Prepared by:
Stantec Consulting Ltd.
40 Highfield Park Drive
Dartmouth, NS B3A 0A3

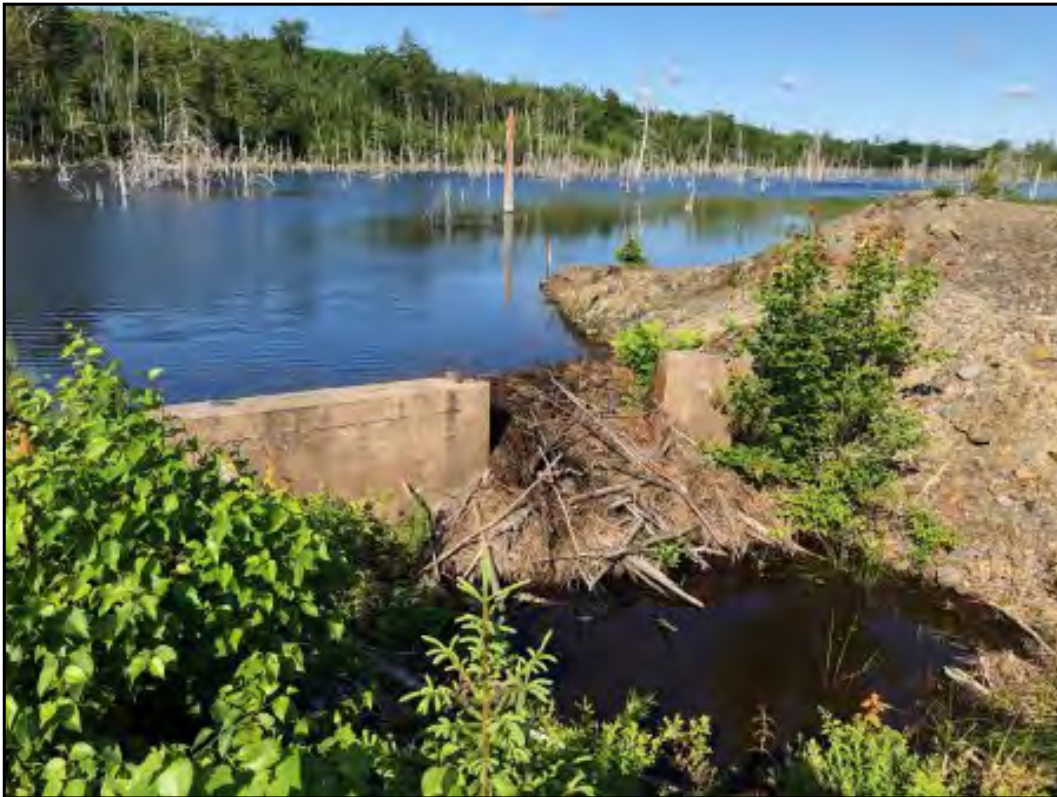
View of earthen dam spillway looking west

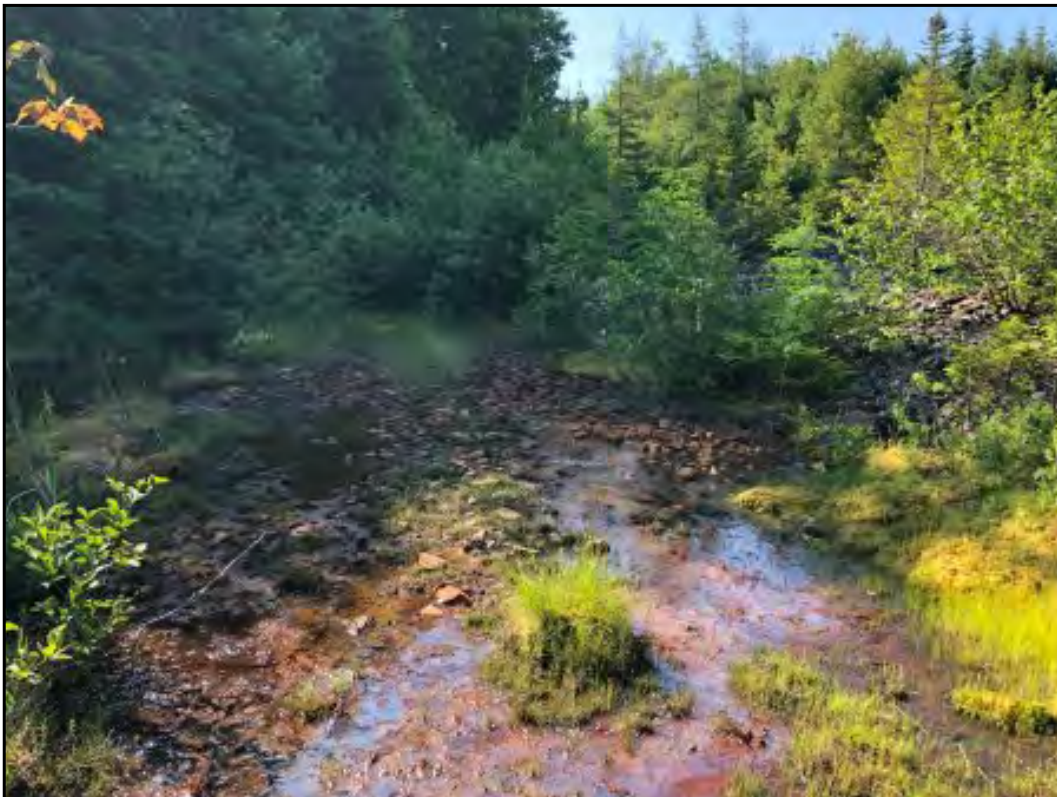
Seepage from the base of the dam stained red looking east

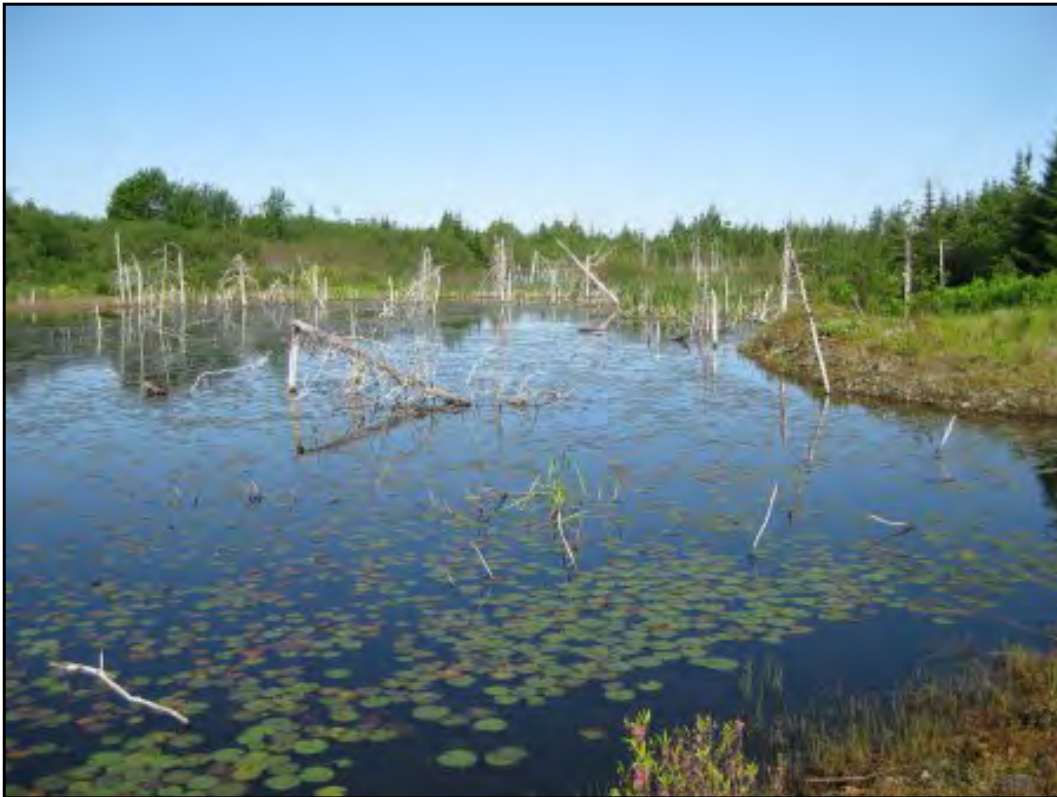
View of settling pond looking west

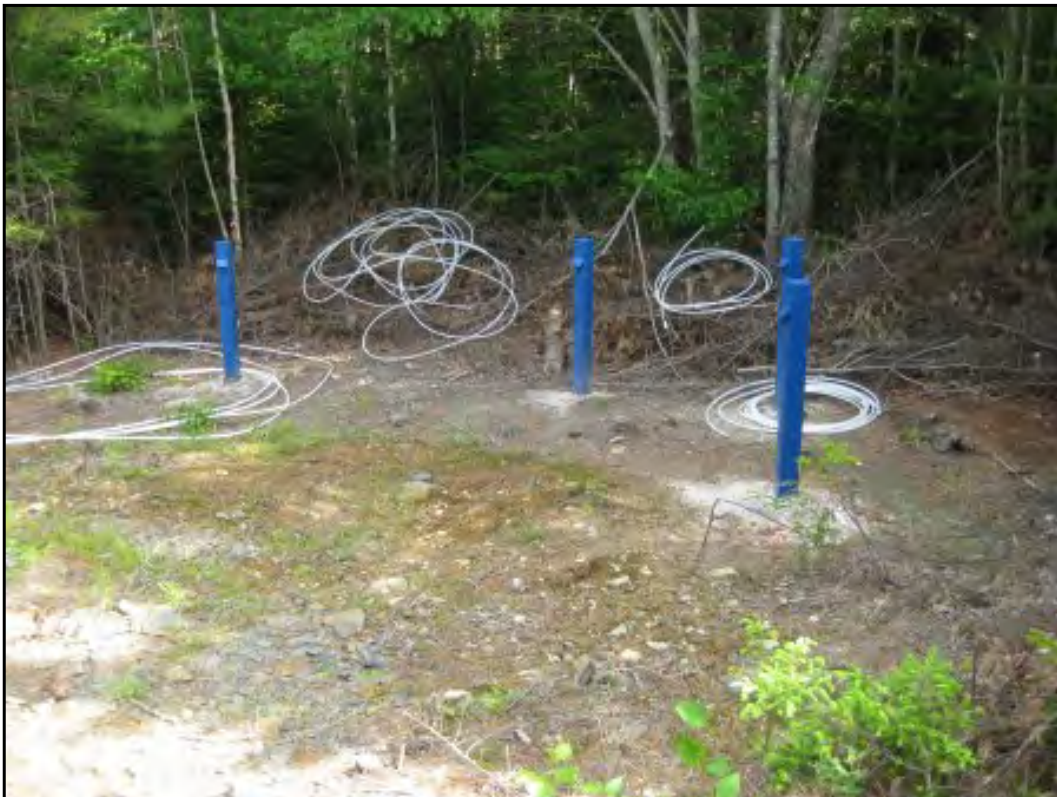
During the site visit various sets of monitoring wells were observed both on-site and on the adjoining properties. No reports for these wells were provided to Stantec. Adjacent to the wells were coils of plastic tubing suggesting that they have been sampled in the past. Since the wells were located in clusters they are likely drilled to different depths. Additionally, historical boreholes with plastic standpipes were also observed in various locations on the Site. There were records for a number of drilled exploration holes as part of the assessment of the area for development of a mine both on the Site and in the surrounding area in a grid pattern. It is unknown how the historical drilled holes, which extended several hundred feet in some cases, were backfilled.

Typical cluster of monitor wells installed in various locations on and around the Site

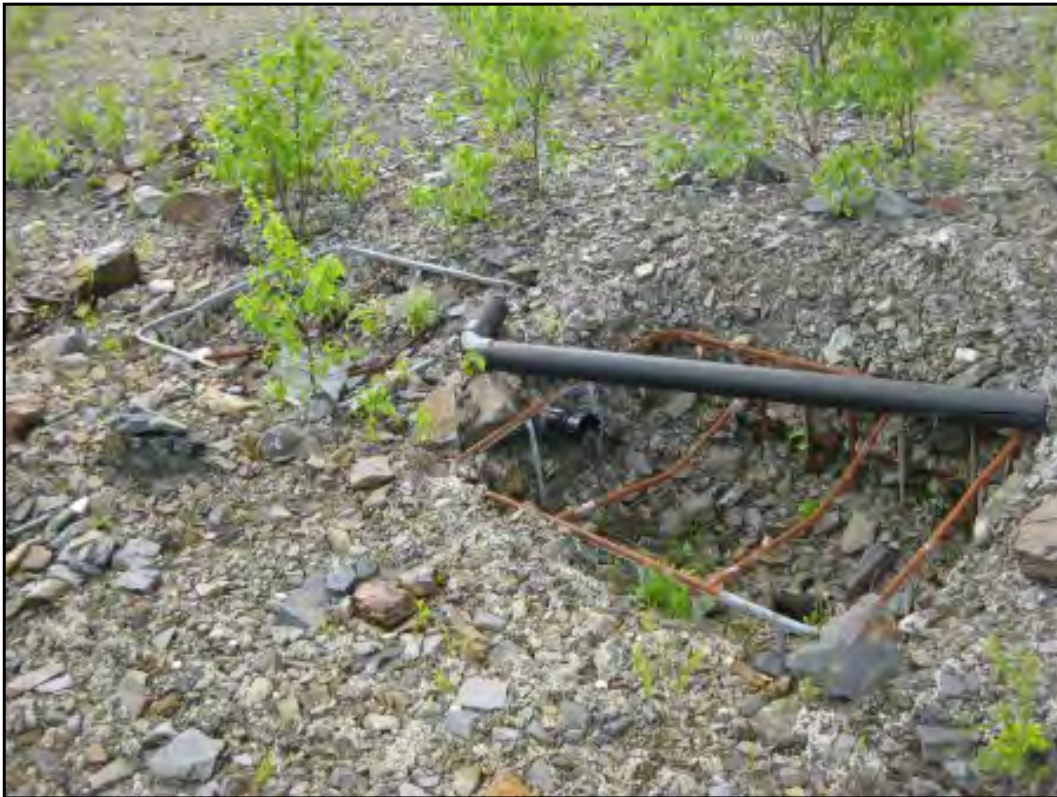
During the site visit no chemical or fuel storage USTs were identified on the Site. Further, no vent or fill pipes indicating the potential presence of an abandoned or decommissioned UST were observed. As noted previously in Section 4.3 there was reported underground fuel storage in the 1980s which represents a potential environmental concern.

View of old 1,000 L totes buried in the former Seabright Operations area

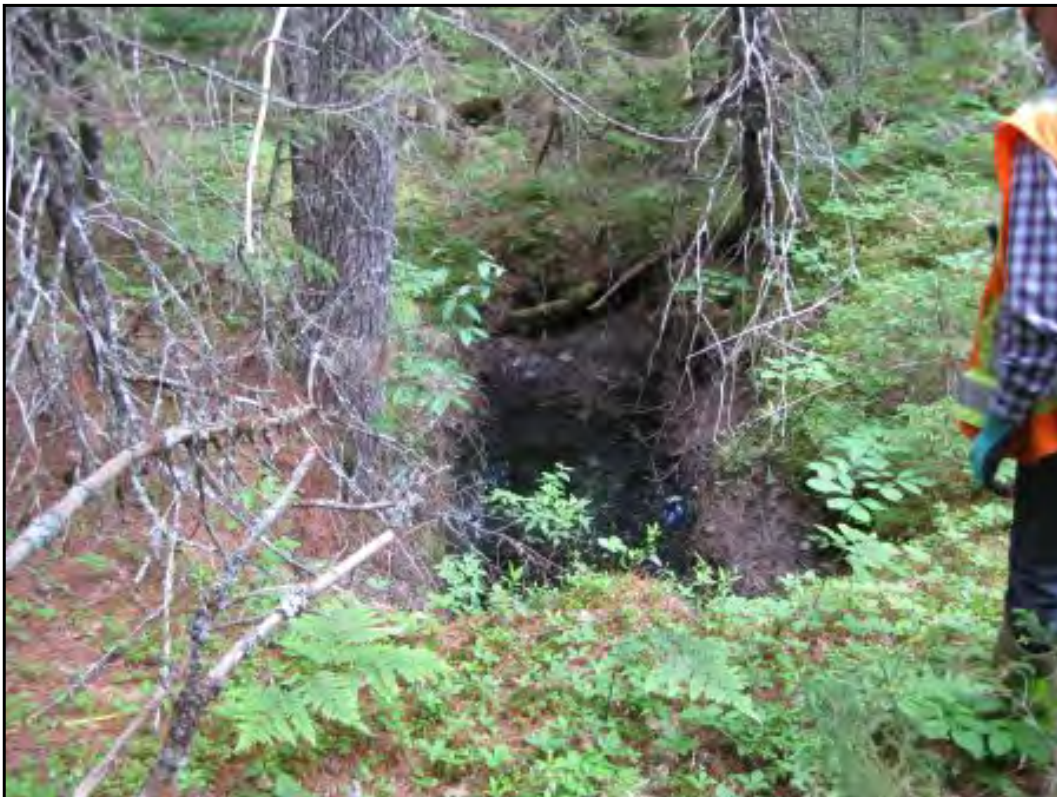
It was noted that in various locations there are exposed suspected waste rock areas that do not support vegetation. During the site visit, several water filled pits and trenches were noted associated with historical mining and exploration activities.

Typical small water filled trench/opening found on-site

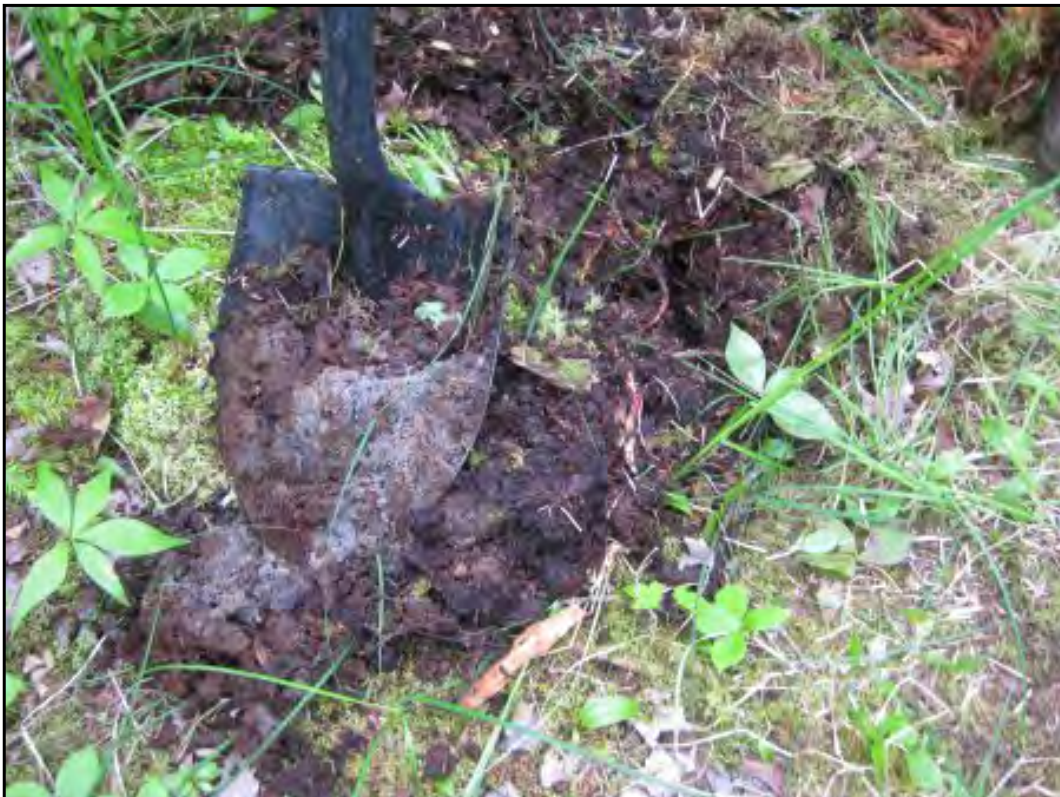
There are areas of exposed suspected historical waste rock at the Site. Based on information obtained during the document review, the Seabright area of mining in the 1980s produced 135,000 tonnes of rock of which 41,000 tonnes was shipped off-site. The remaining rock appears to have been used to regrade the areas disturbed during the operations on-site. Smaller piles of suspected waste rock were noted in the Forge Hill area and along the northern side of Crusher Lake.

Suspected mine tailings found north of Crusher Lake near brook under layer of organics

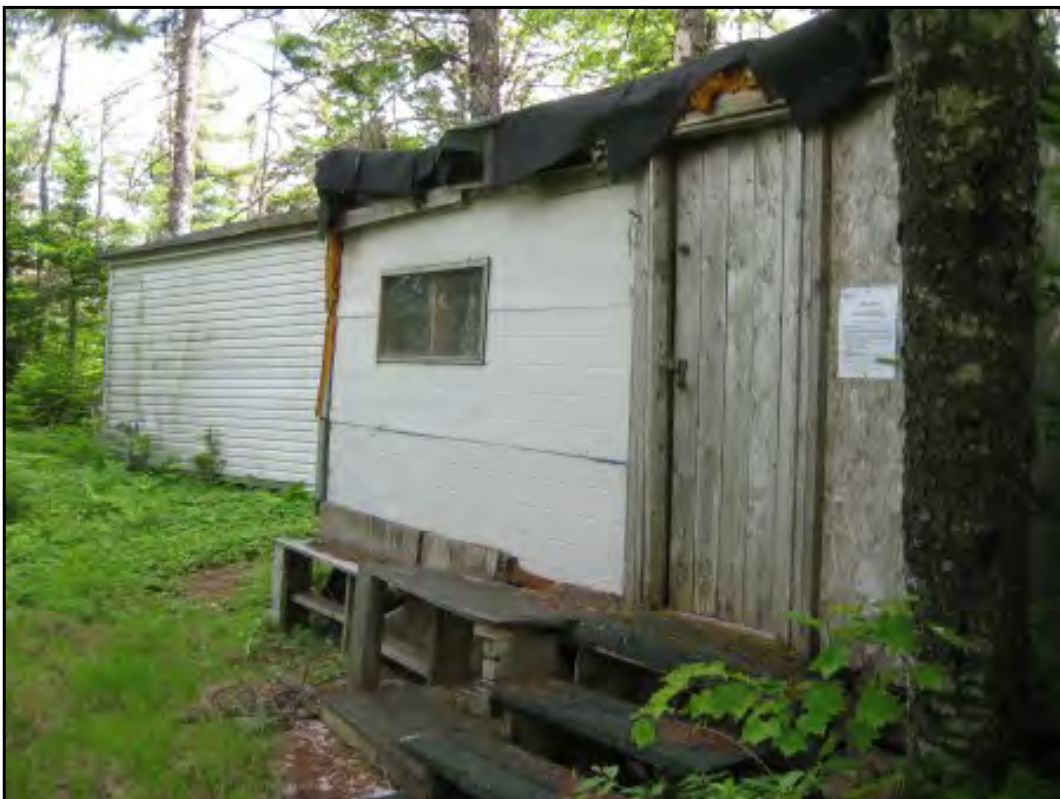
During the site visit a squatters camp was identified near the northeastern end of Crusher Lake. The camp consisted of four buildings; a "bunk house", a "cabin", a shed and an outhouse. Approximately 100 meters northwest of the camp accessed by following the brook from Crusher Lake and over several small wooden bridges, there was a tree-stand hunting blind. The foundation of a suspected former log cabin was discovered near the brook leading from Crusher Lake.

View of squatters camp looking southeast at the "Bunk house" with "Cabin" in the background

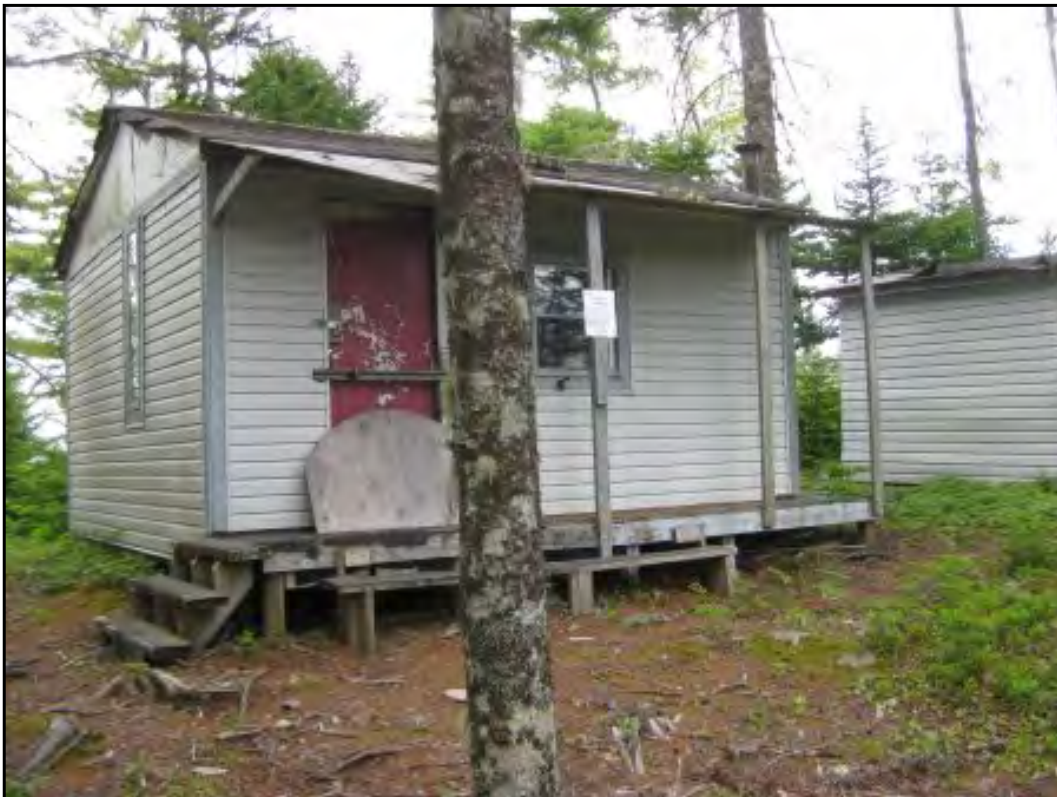
As the age of the squatters camp is unknown there is potentially asbestos-containing materials associated with these small buildings on the Site. During the site visit, the Cabin building was locked preventing an assessment of the interior. The Shed and Bunk House had limited finishes and no suspected friable asbestos materials in poor condition were noted.

As the age of the squatters camp is unknown there is a potential that painted surfaces contain lead paint. During the site visit there was a single exterior door on the Cabin that was in fair condition with flaking paint. Other painted surfaces were observed to be in good condition.

Looking northeast at the squatters camp "Cabin" building

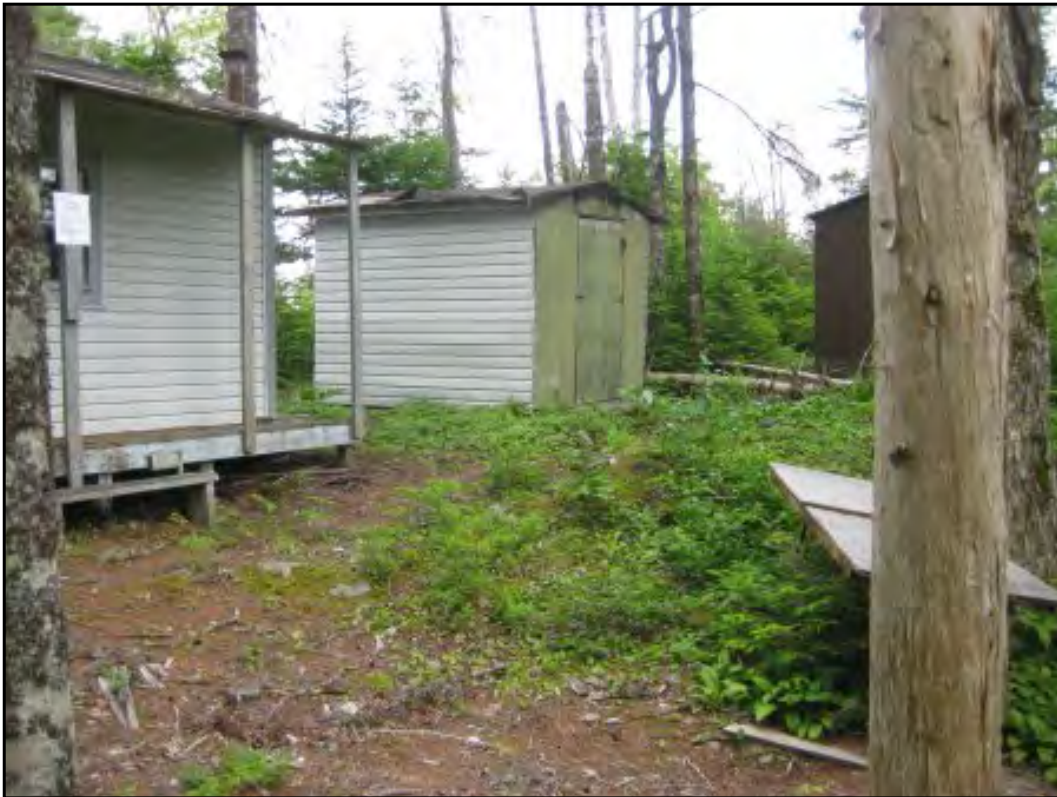
Looking east at the "Cabin", shed and outhouse buildings at the squatters camp

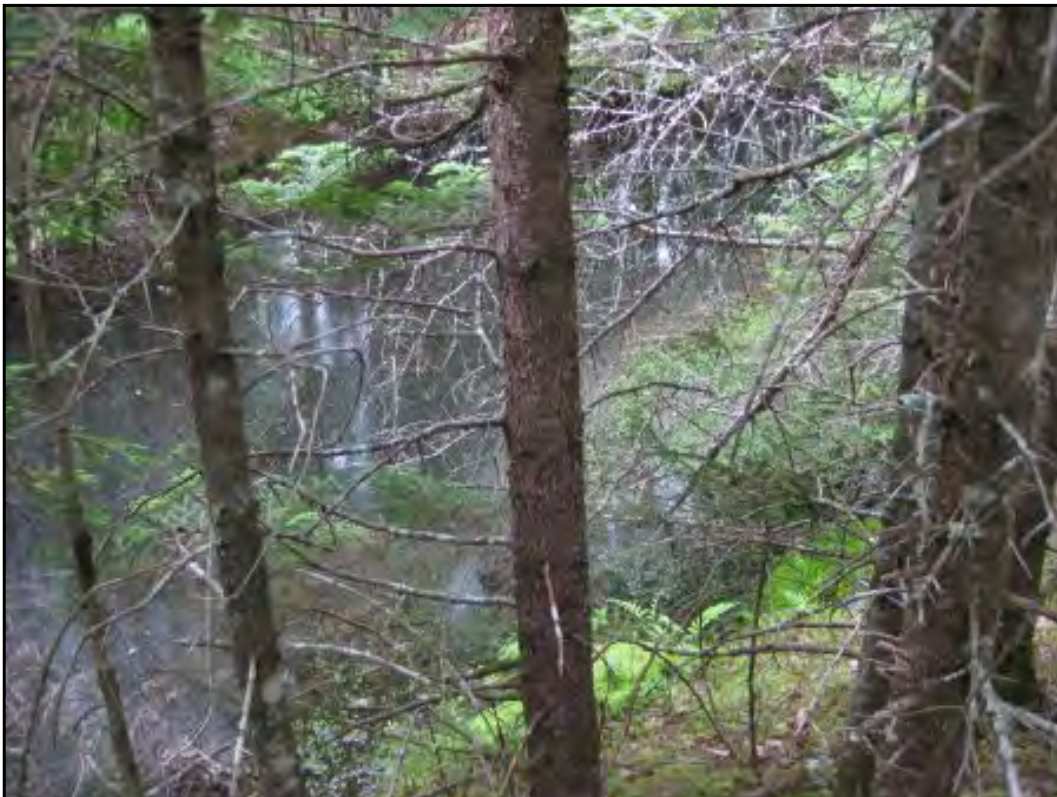
Water filled trench north of Crusher Lake

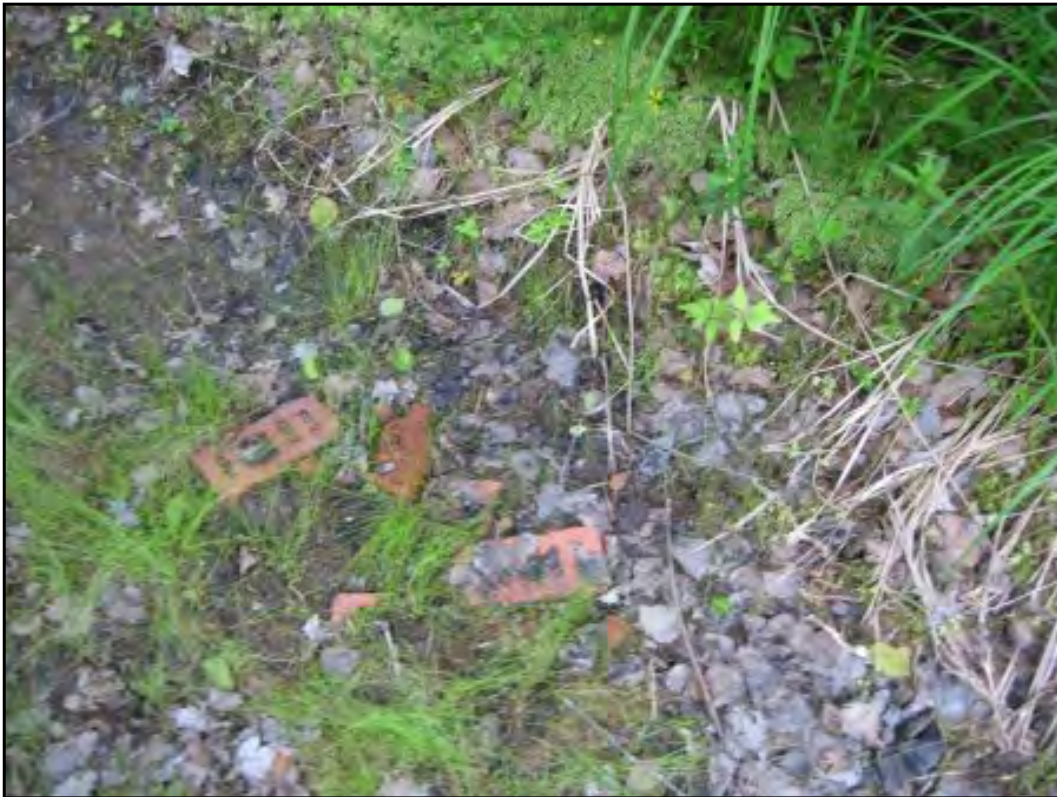
Brick debris along the access road toward the squatters camp

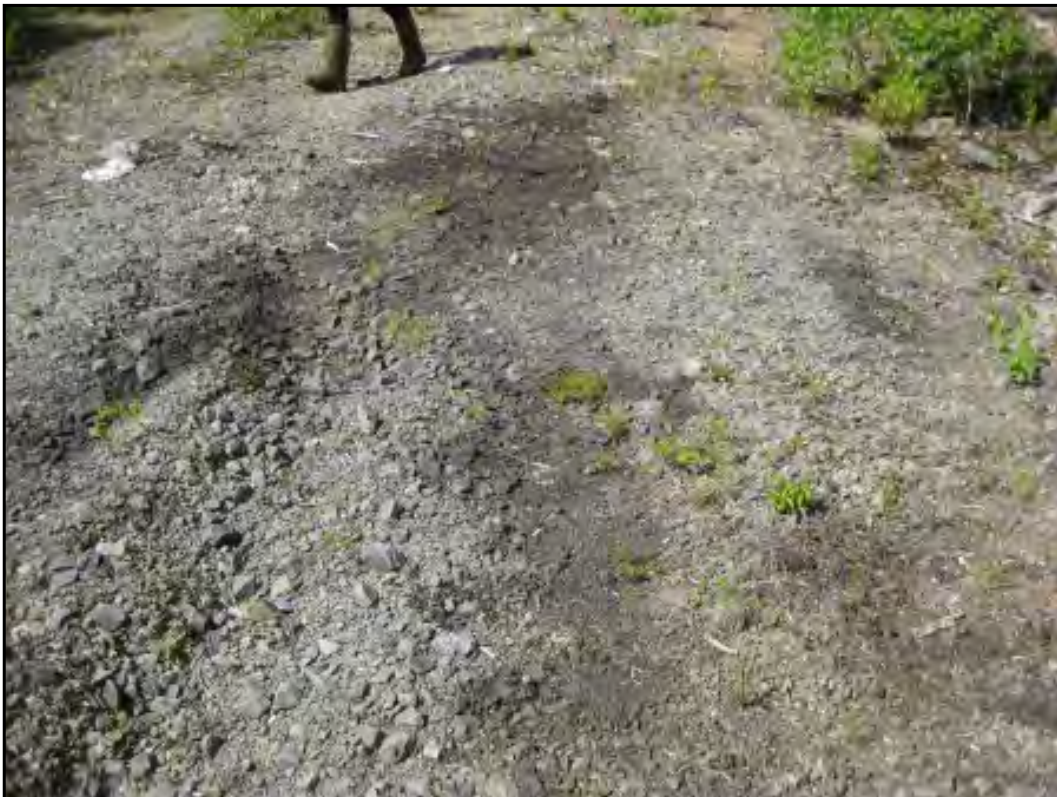
During the site visit several hydrocarbon stained gravel areas were observed along the southern access road, likely from the timber harvesting activities in the area. The presence of these stained areas are not considered to be a concern to the Site.

Typical example of small surface staining less than 2 sq.m. in various locations on the Site

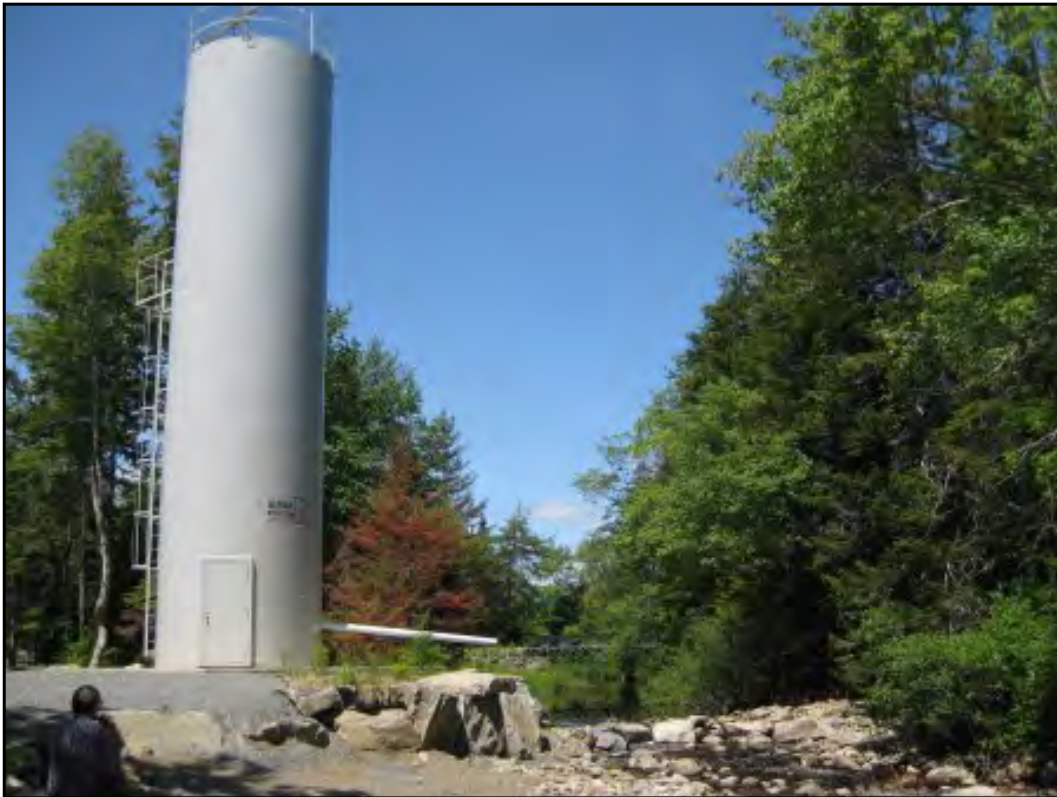
There were no concerns noted with the presence of the lime station or adjoining timber harvesting activities.

Looking northwest at the Killag River Lime dosing station located to the east of the Site

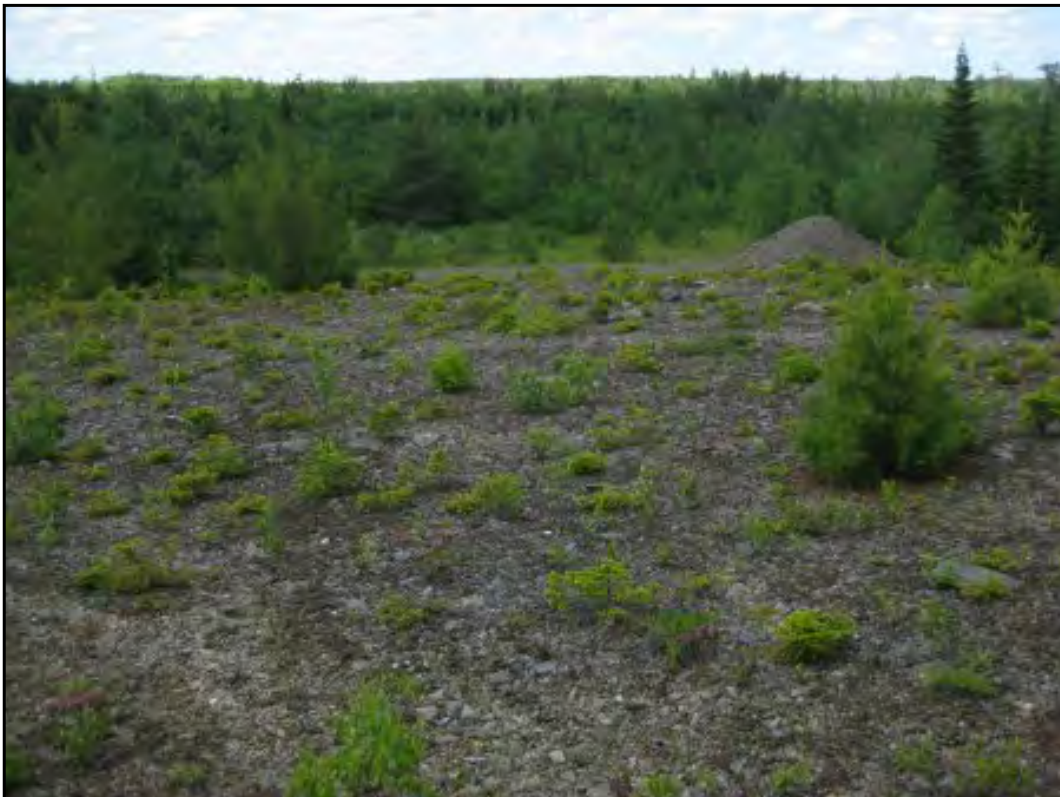
Suspected waste rock on the south side of the access road to Crusher Lake
