Emergency Reduction of Lake Manitoba & Lake St. Martin Water Levels Aquatic Environment Monitoring - Fall 2011

REPORT

Prepared for Manitoba Infrastructure and Transportation · August 2013
By North/South Consultants Inc. · 83 Scurfield Blvd. · Winnipeg, MB · R3Y 1G4

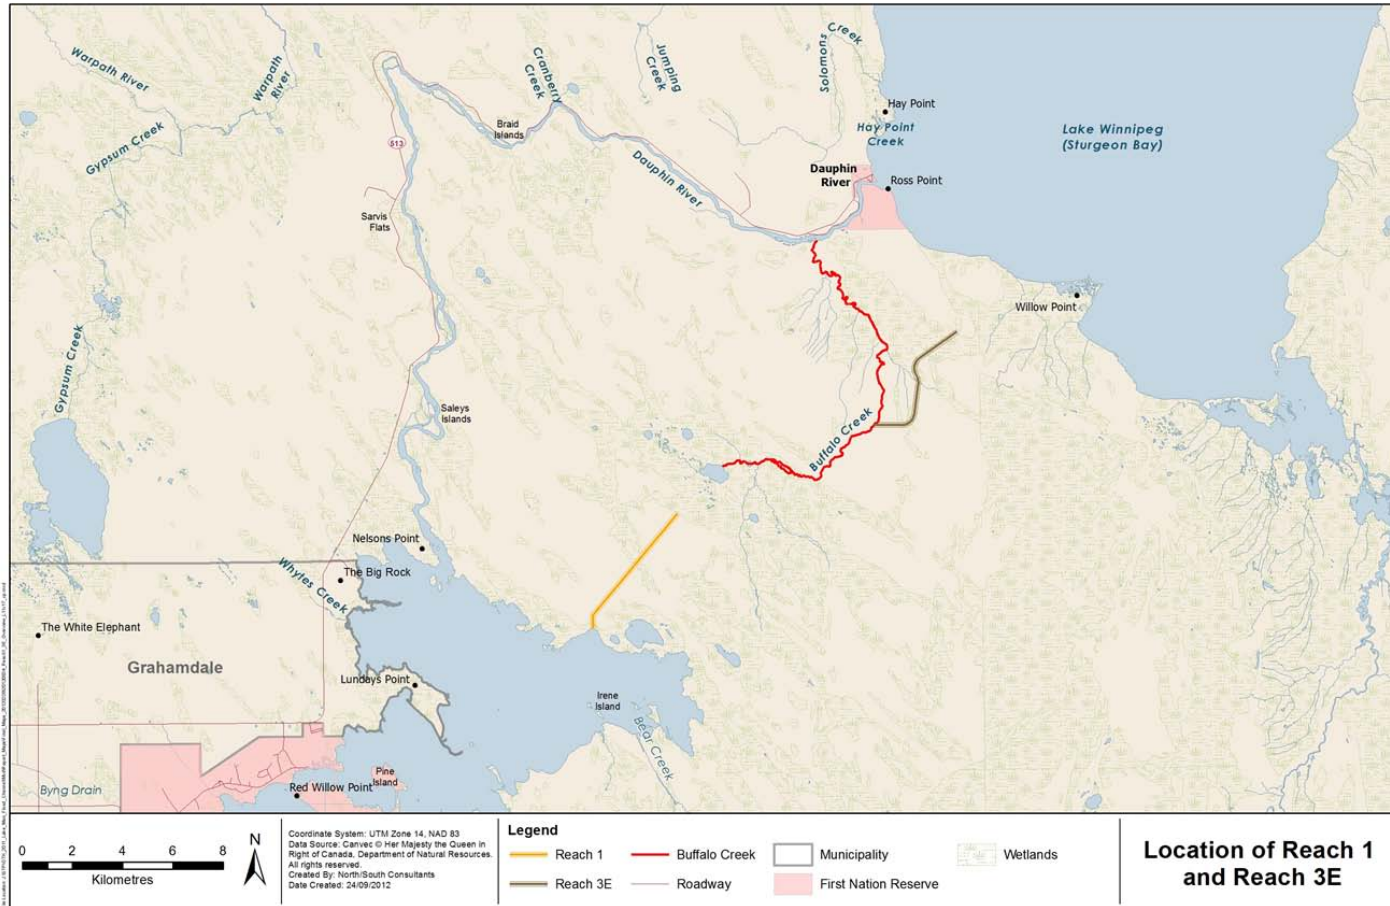
Figure 1-2. Location of the Reach 1 Emergency Outlet Channel and Reach 3 Emergency Channel and the Buffalo Creek Drainage System in relation to Lake St. Martin, the Dauphin River and Sturgeon Bay.

The proposed Reach 1 Emergency Outlet Channel (hereafter called Reach 1) included the excavation of a channel from Lake St. Martin to Big Buffalo Lake, a small lake located about 7 km northeast of Lake St. Martin (Figure 1-2). From Big Buffalo Lake, water would flow down Buffalo Creek and enter the Dauphin River about 4 km upstream of Sturgeon Bay on Lake Winnipeg. Construction of Reach 1 was initiated in late summer 2011 and water began flowing down the channel by 01 November 2011.

Buffalo Creek originates at Buffalo Lake and flows for approximately 17 km to its confluence with the Dauphin River. For approximately the first 4 km downstream of Big Buffalo Lake, the creek flows through a sparsely treed wetland/bog complex and is characterized by a narrow channel (< 5 m wide) that becomes indeterminate in some locations (Figures 1-2 and 5-5). Topography in the area is very flat.

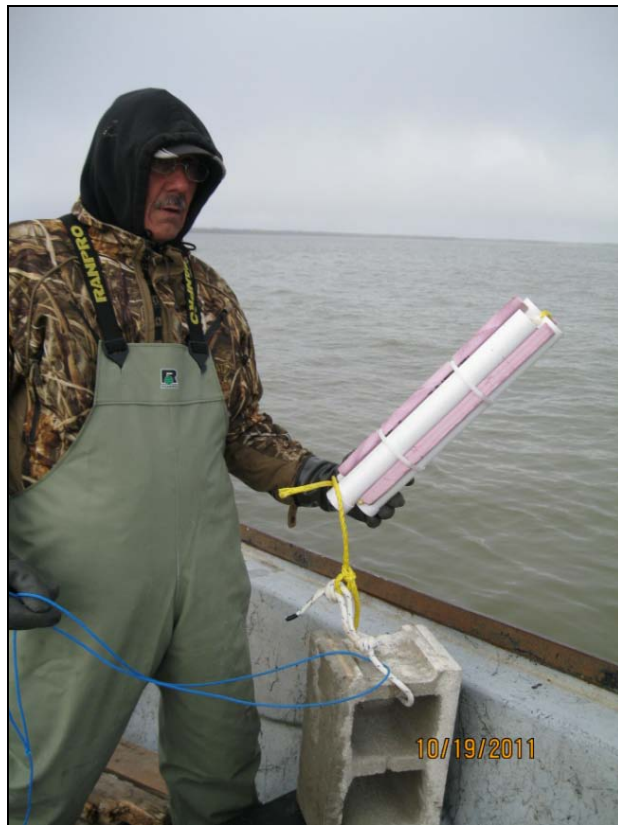
Figure 4-3. Example of sediment trap deployed in Sturgeon Bay.

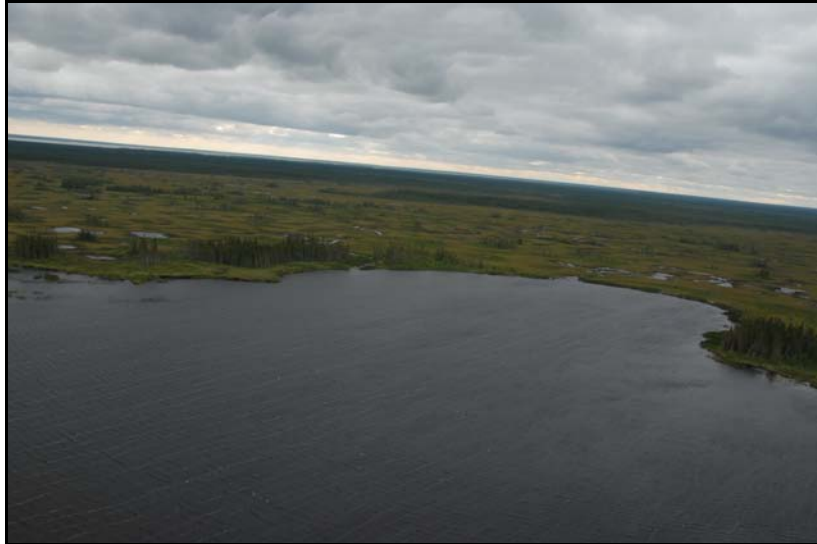
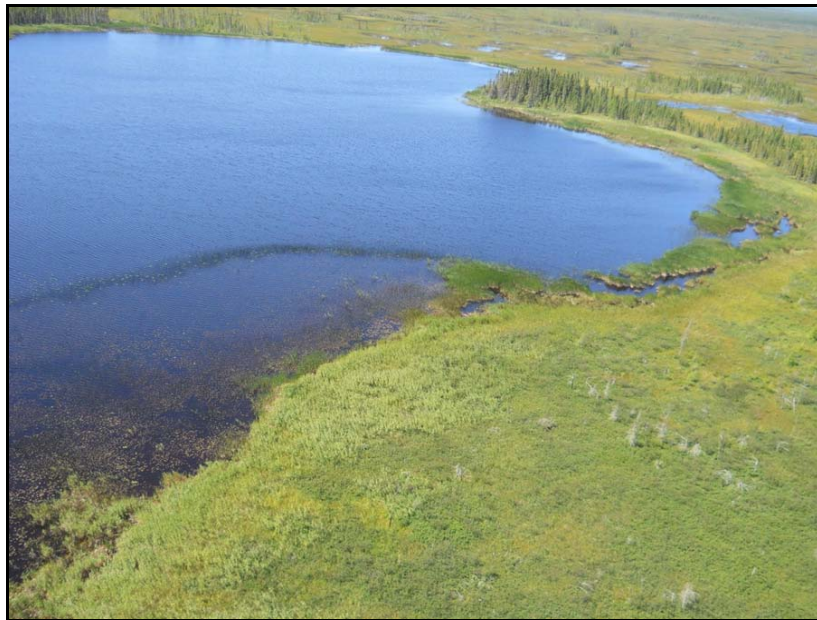
Figure 5-4. Big Buffalo Lake and associated shoreline, August, 2011.

Big Buffalo Lake is a small lake (surface area of 55 ha) from which Buffalo Creek originates. During the field program, maximum measured water depth was 2.2 m (Figure 5-2) and substrate was comprised of a deep layer of loosely compacted organic sediments. Aquatic vegetation (primarily *Potamogeton* sp.) occurred throughout much of the lake, although was considerably less dense in the central portion compared to nearshore areas. Lake shorelines were composed largely of shrub wetlands (Figure 5-3) comprised of cattails and bulrushes, as well floating bog in some areas. Few areas surrounding the lake support trees (Figure 5-4). Lake inflow is comprised of local run off from surrounding wetlands. Outflow is through Buffalo Creek (Figure 1-2).

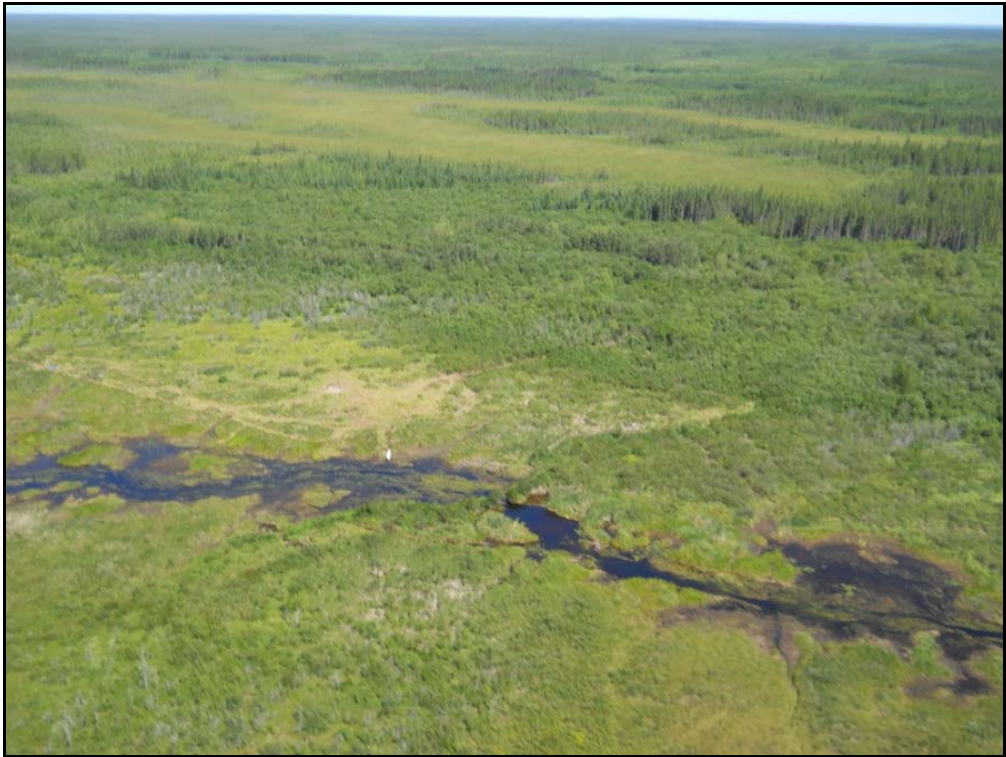
Figure 5-5. Buffalo Creek downstream of Big Buffalo Lake, illustrating wetland/bog complex through which the creek flows.

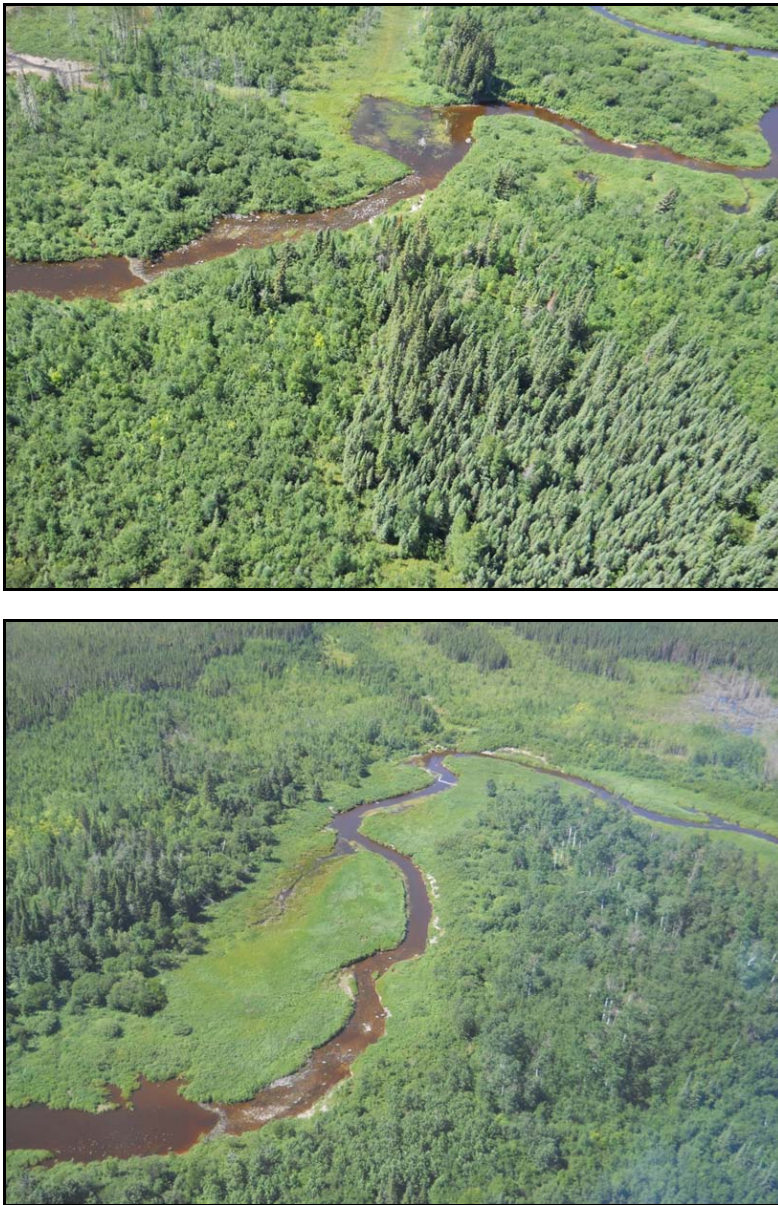
Figure 5-6. Buffalo Creek showing riffle/pool/run sequences and meandering pattern, August, 2011.

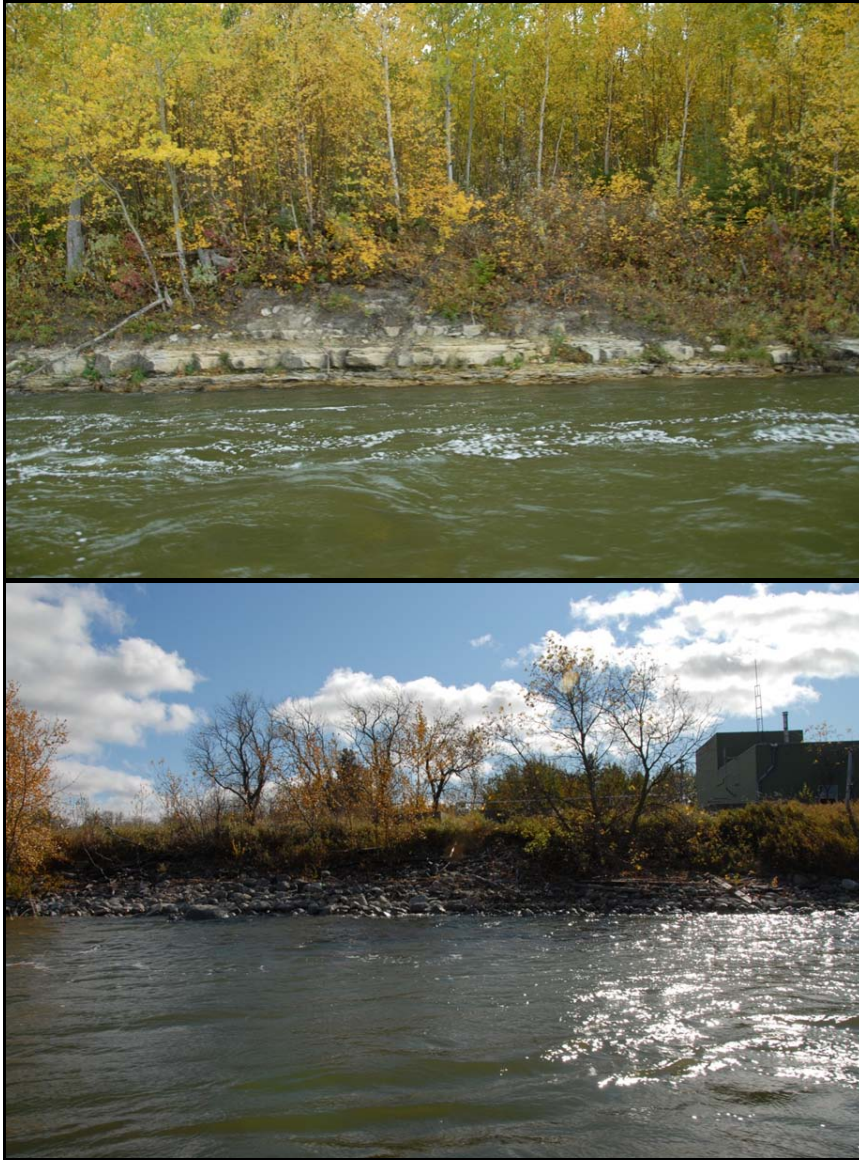
Figure 6-4. Limestone bedrock outcrop overlain by till materials in areas along the Dauphin River (top) and cobble/boulder shoreline extending into the water along the Dauphin River near Sturgeon Bay (bottom).

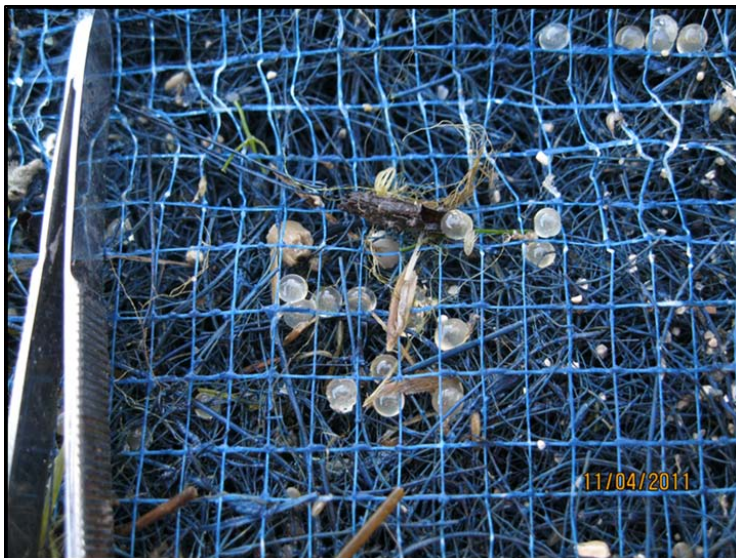
Figure 7-2. Lake Whitefish eggs collected on an egg mat set in the Dauphin River during fall, 2011.

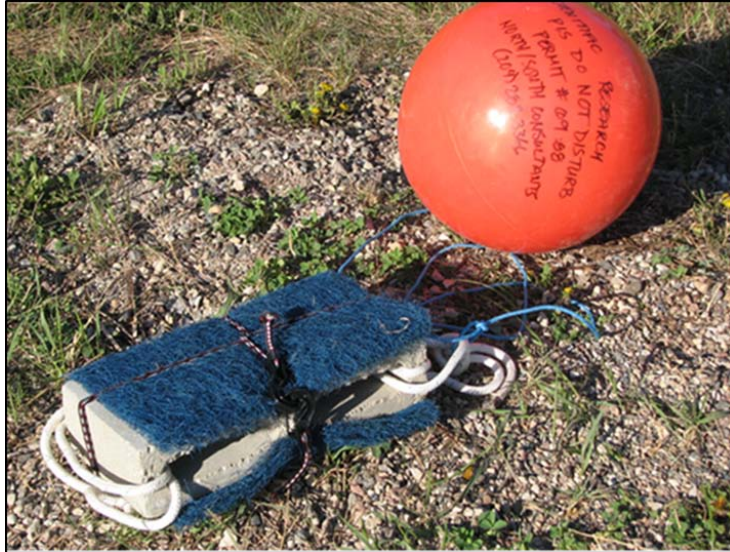
Figure 7-3. An egg mat ready for deployment.

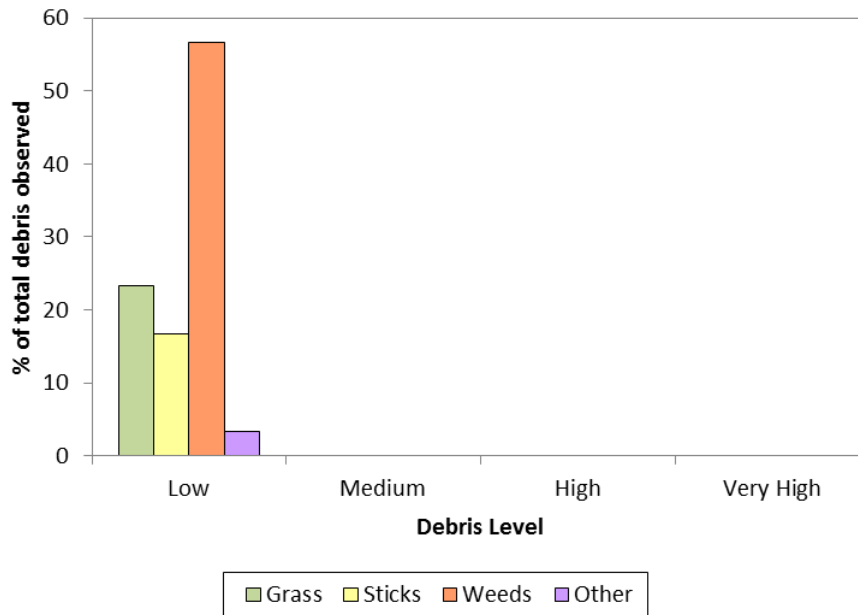
Figure 7-17. Relative composition of debris observed in three experimental gill nets set in Sturgeon Bay during fall, 2011. Note that one of four nets for which debris information was recorded had no debris in it.
