# Lake Manitoba & Lake St. Martin Outlet Channels Project

Aquatic Environment Monitoring, Fall 2020

Lake Whitefish Spawning Movements

A Data Report Prepared for  
Manitoba Transportation and Infrastructure

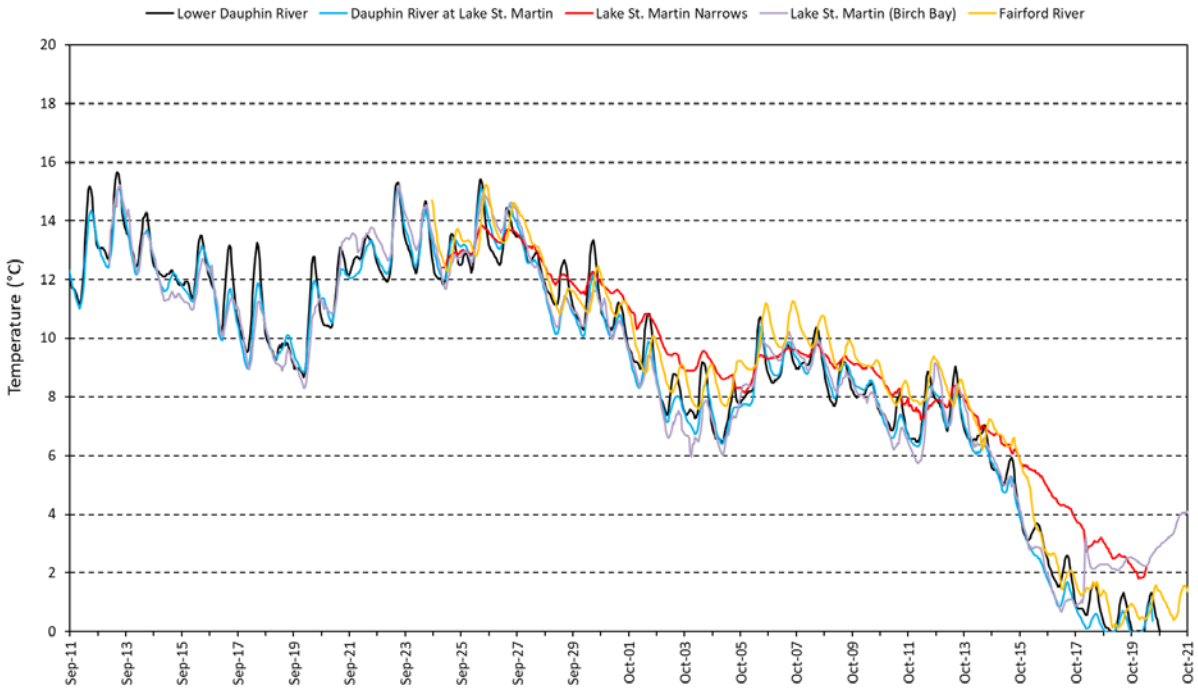
Figure 3. Water temperature data from the Lake St. Martin study area, fall 2020.

Water temperature data were collected throughout the duration of the fall field program. Logger deployment and retrieval dates are provided in Table 1. Monitoring start and end dates varied by location, but a general synchronicity among the water temperature trends observed at different locations is evident, as are pronounced day/night fluctuations presumably attributable to solar heating (Figure 3). In general, water temperature was 12-14°C at the onset of the monitoring program and decreased to approximately 8°C by October 13. Cold air temperature resulted in an abrupt decline to near 0°C water temperature by October 17 (Figure 3). Ice formation resulted in termination of the field program on October 21.

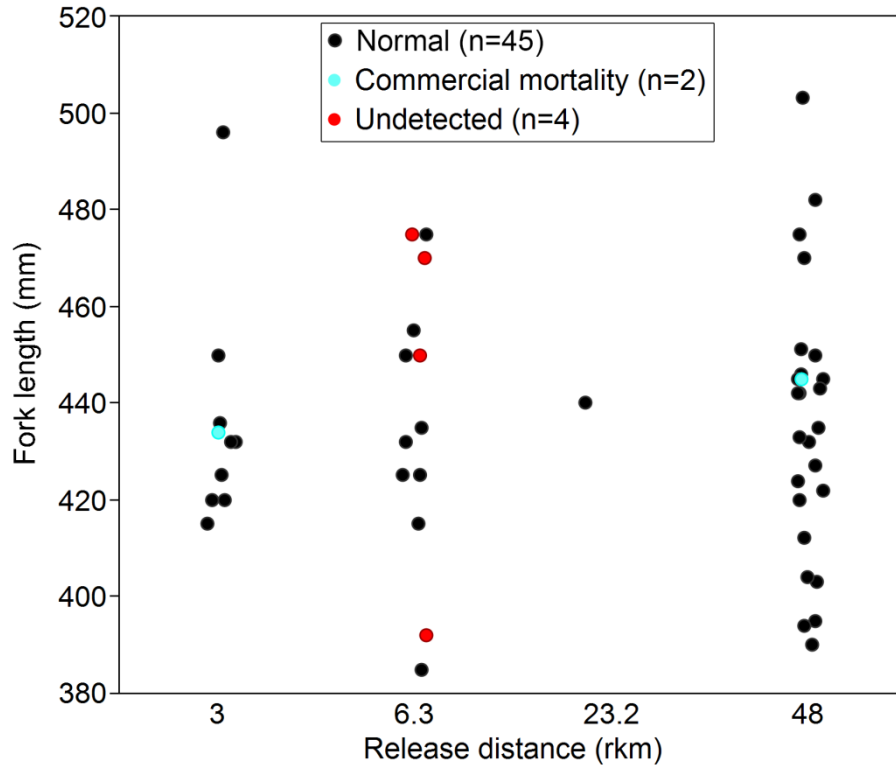
Figure 7. Summary of fork length of Lake Whitefish by release distance.

Biological and tag information for all tagged Lake Whitefish is provided in Table 4 and Figure 7.

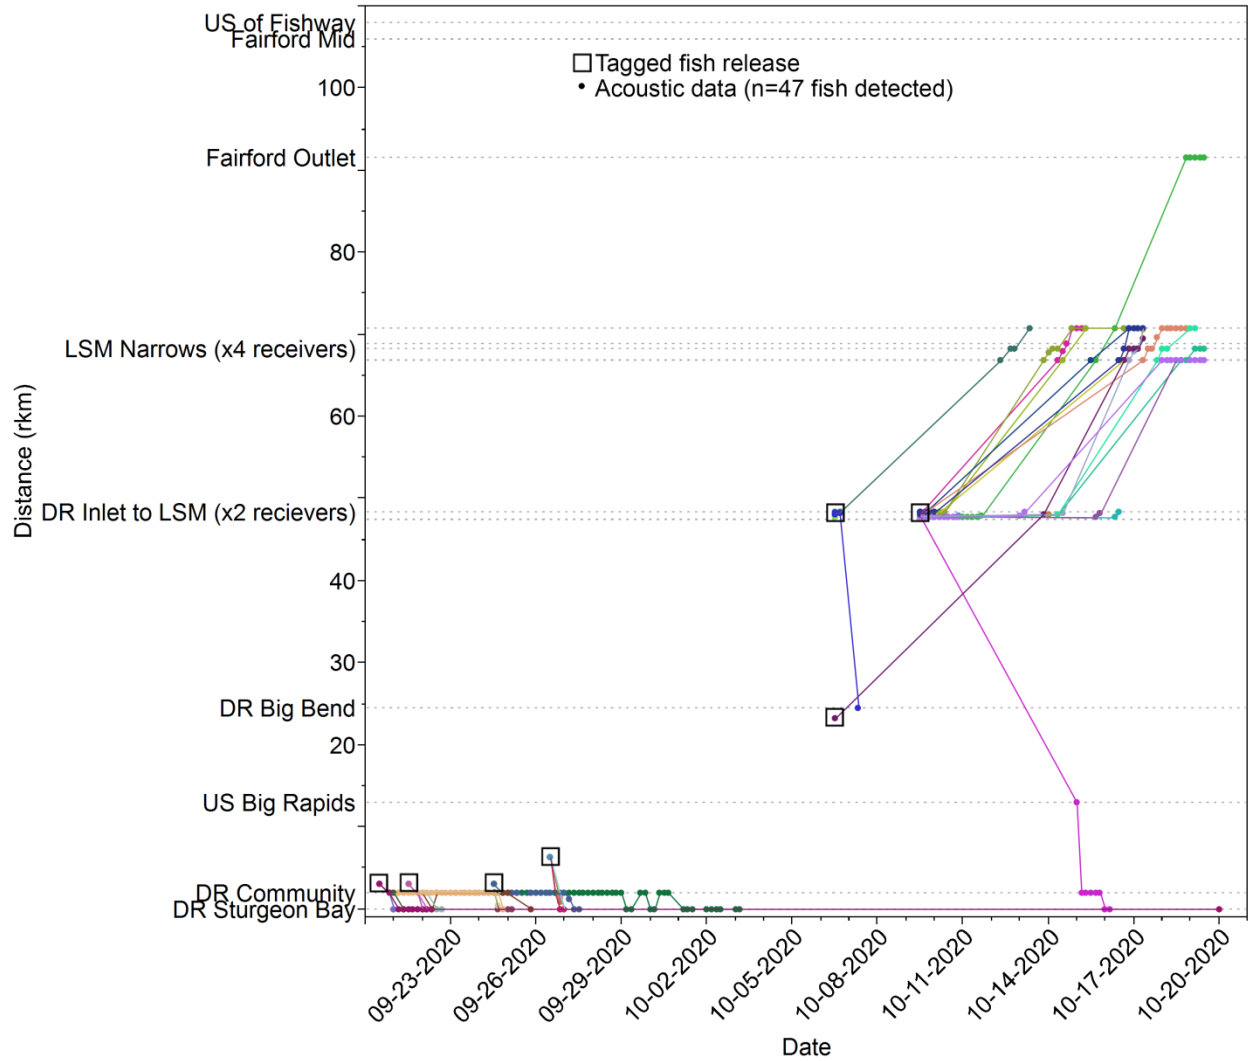
Figure 8. Graphical summary of Lake Whitefish movements based on a 4-hour algorithm output. Locations of receivers are shown using dotted lines, and reflect the river kilometer distances at which they were deployed. Date/times and locations of fish releases are also shown using black squares. In total, 47 of 51 Lake Whitefish tagged during the current study were detected during fall 2020 monitoring using acoustic receivers.

Graphical detection summaries of fish movements were generated using the 4-hour distance algorithm, with date/time plotted on the X-axis and detection distance (rkm) plotted on the Y-axis. For reference, tagging date/times and release locations are also included.

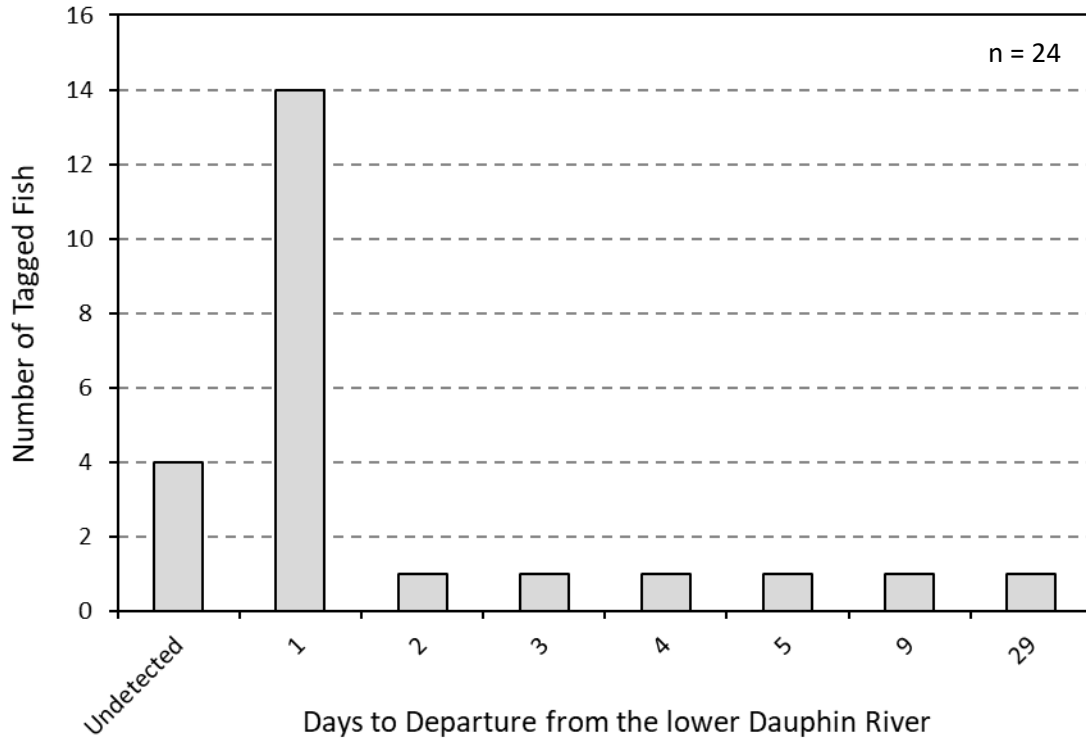
Figure 9. The number of days after transmitter implantation that tagged Lake Whitefish moved out of the lower Dauphin River and into Sturgeon Bay.
