Valentine Gold Project Baseline Study Appendix 4: Fish, Fish Habitat and Fisheries

**Valentine Gold Project
Environmental Impact Statement**

Baseline Study Appendix 4: Fish, Fish
Habitat and Fisheries (BSA.4)

September 25, 2020

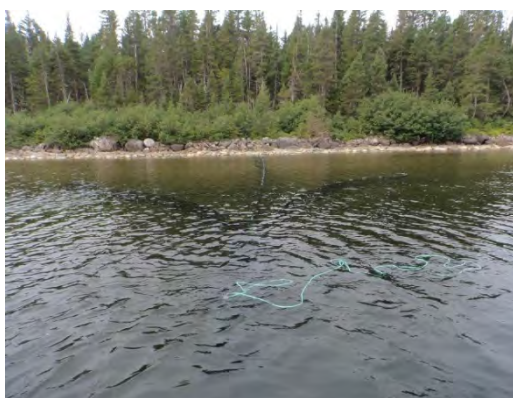
Photo 1 Fyke Net Set in Valentine Lake

Fish sampling in Victoria Lake and Valentine Lake was conducted by boat with fyke traps (Photo 1). A minimum of two fyke trap sets were fished for two consecutive nights resulting in four trap-nights of effort in each lake.

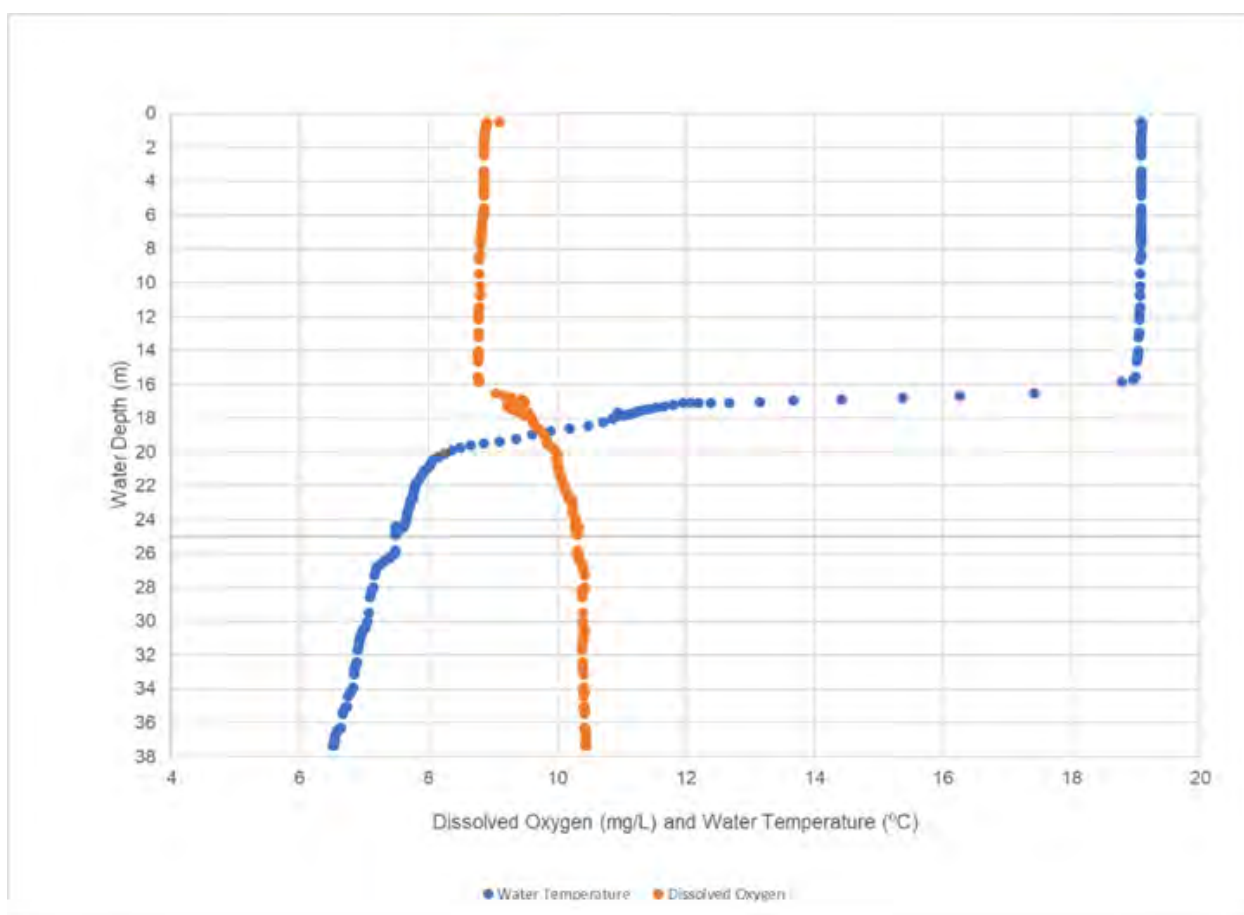
Figure 4.4 Dissolved Oxygen and Water Temperature Profiles at VIC01 in Victoria Lake, NL on August 3, 2019

A thermocline was apparent in Victoria Lake (VIC01) at a depth of 16 to 20 m from the water's surface on August 3, 2019 (Figure 4.6) and at 21 to 25 m on September 25, 2019, however the lake was no longer stratified on November 3, 2019 (Appendix D, Figures D.3 and D.4). When the thermocline was present on August 3, 2019, the water temperature in the epilimnion averaged 19.1 °C and dissolved oxygen concentrations averaged 8.8 mg/L. Below the thermocline in the hypolimnion, water temperatures averaged 7.2°C and dissolved oxygen concentrations averaged 10.3 mg/L (Figure 4.6). When the thermocline was present on Sept 25, 2019, the water temperature in the epilimnion averaged 11.3 °C and dissolved oxygen concentrations averaged 10.3 mg/L. Below the thermocline in the hypolimnion, water temperatures averaged 8.8 °C and dissolved oxygen concentrations averaged 9.8 mg/L (Appendix D, Figure D.3). On November 3, 2019, the water temperature averaged 8.3 °C and dissolved oxygen concentrations averaged 11.6 mg/L throughout the water column. (Appendix D, Figure D.4).

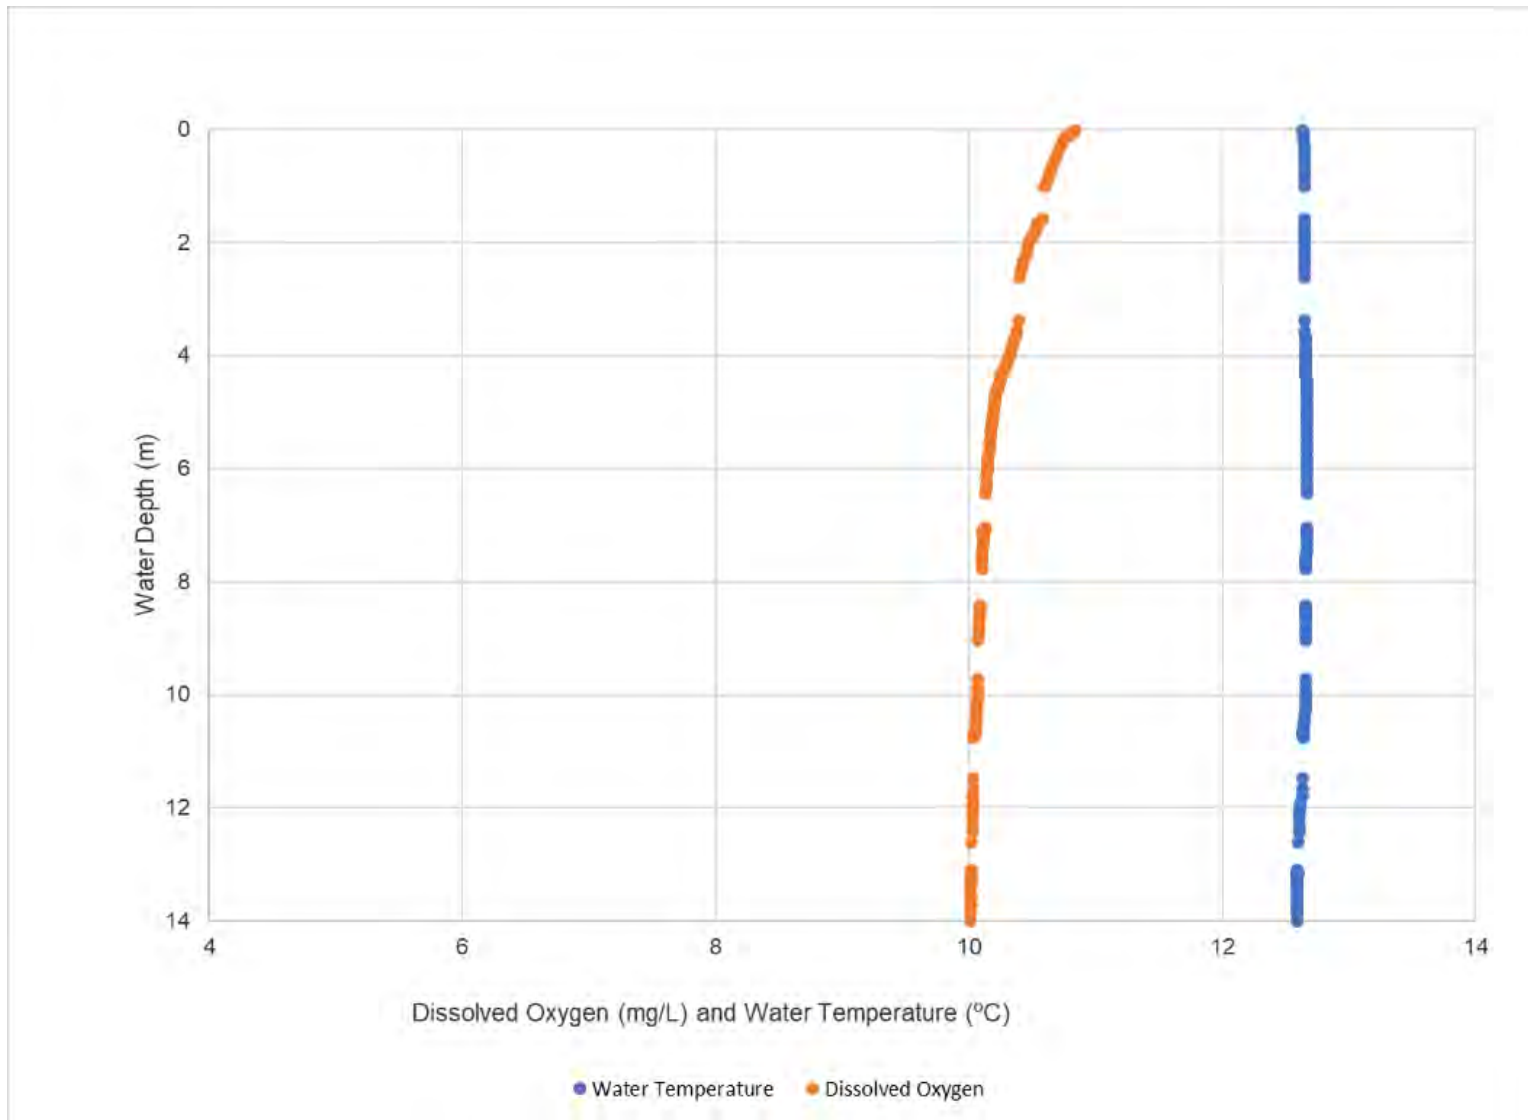
Figure D.1 Dissolved Oxygen and Water Temperature Profiles at VAL-01 in Valentine Lake, NL on September 25, 2019.
