Webequie Supply Road Project

APPENDIX D-2: WEBEQUIE AGGREGATE SITES

WEBEQUIE SUPPLY ROAD: JULY 2020 EXPLORATION OF POTENTIAL AGGREGATE DEVELOPMENT SITES

FINAL REPORT

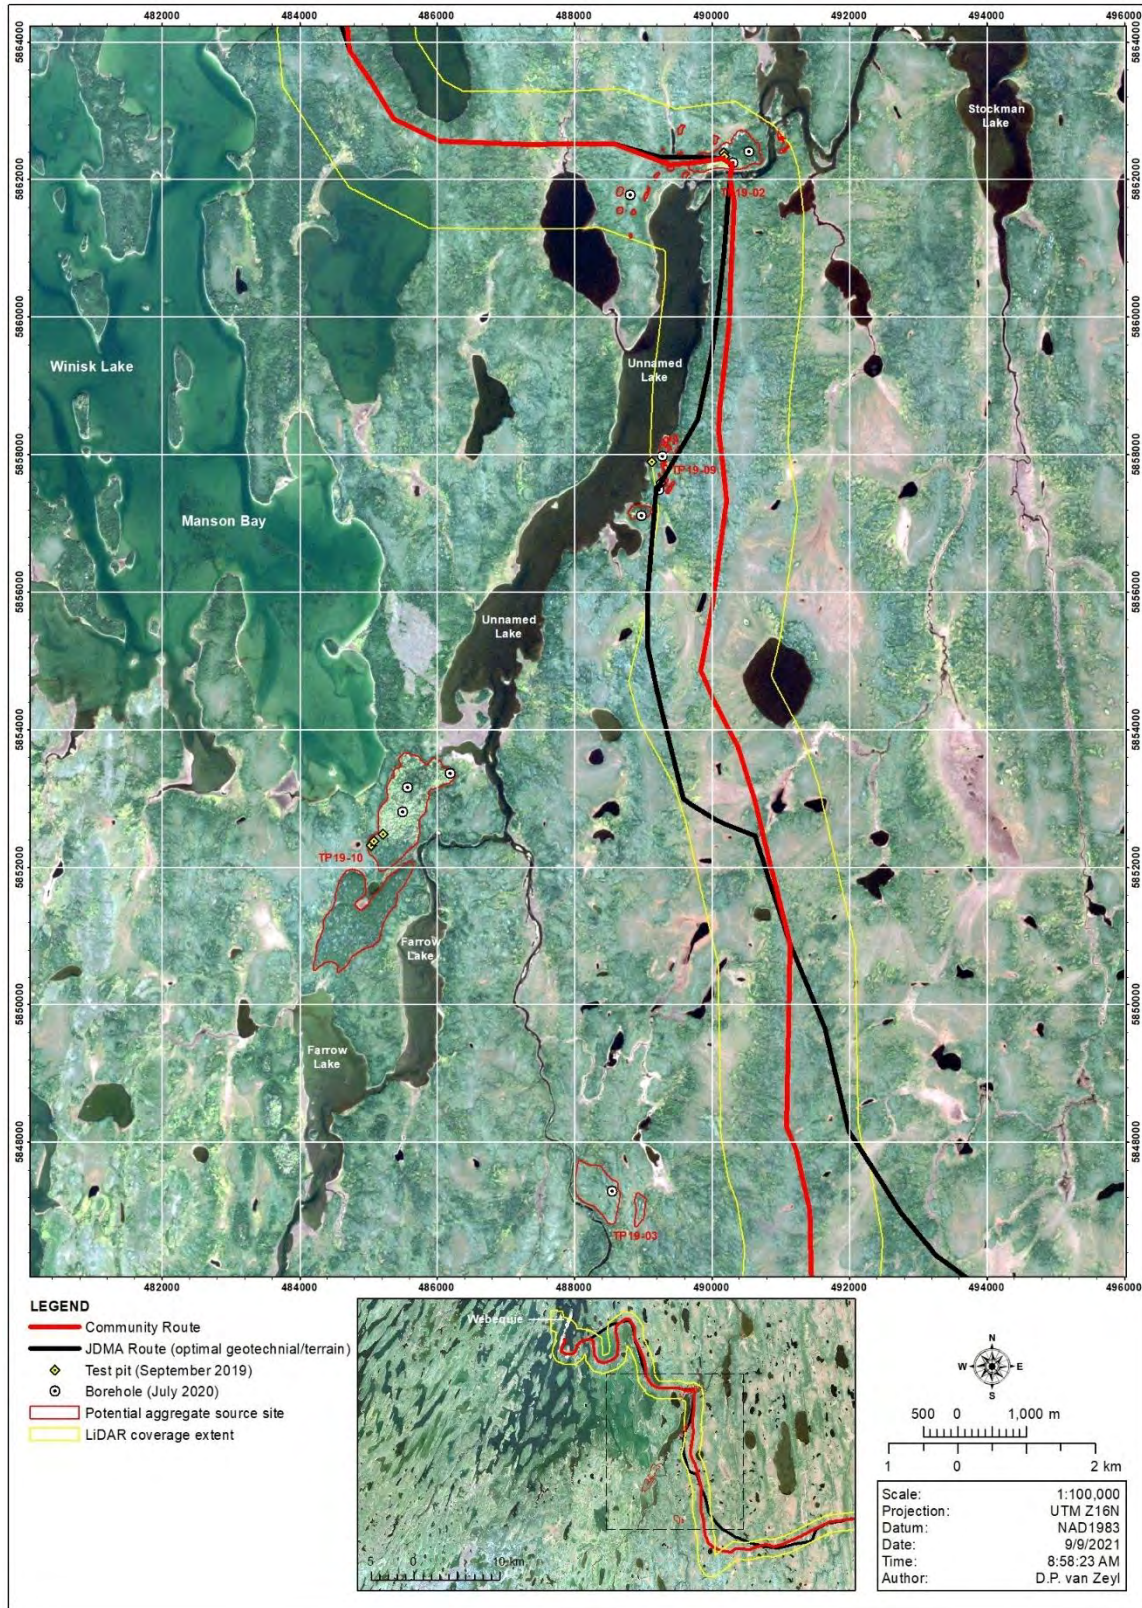
Figure 1 Satellite map showing sites explored in July 2020. Webequie Supply Road.

This site is situated at the north end of a north-northeast trending unnamed lake (Figs. 1,2). Results for this site are described in three separate areas respectively covered by cross sections A and B, C and D, and E through I (Figure 3). The main part of the site explored in 2019 is situated immediately north of the outlet channel at the north end of the unnamed lake (cross sections E through I). The two additional areas explored this year were identified prior to the fieldwork as being possible locations of shallow bedrock based on the presence of several localized hills and ridges shown hidden beneath the forest canopy by the LiDAR data.

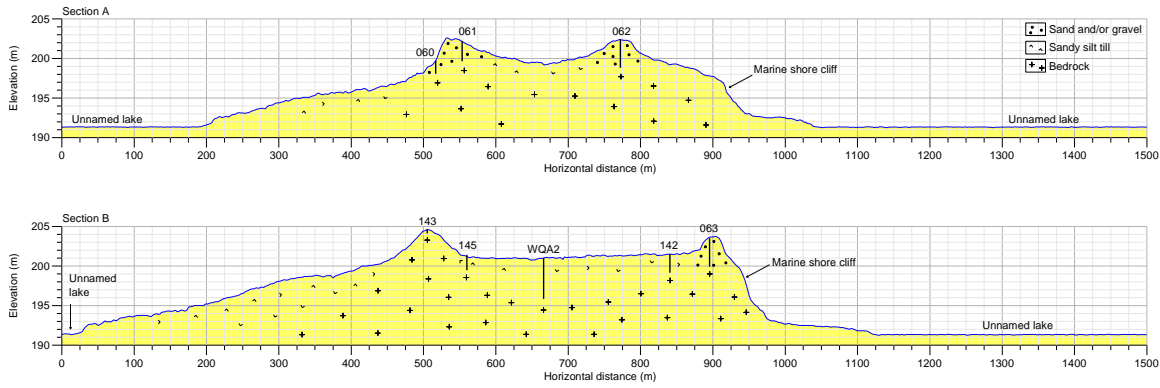
Figure 5 Borehole and hand auger observations plotted onto cross sections A and B.

Cross sections in Figure 5 are drawn to suggest that refusal in the hand auger holes was caused by impact with bedrock. However, no direct evidence was established to confirm whether refusal was in fact related to the top of bedrock. The main purpose of borehole WQA2 was to establish the depth of overburden in the location where overburden was expected to be thickest in the topographic low between hills in section B. Unfortunately, the borehole was terminated prematurely before hitting bedrock. As a result, it is uncertain whether bedrock is present beneath the hills in this area.

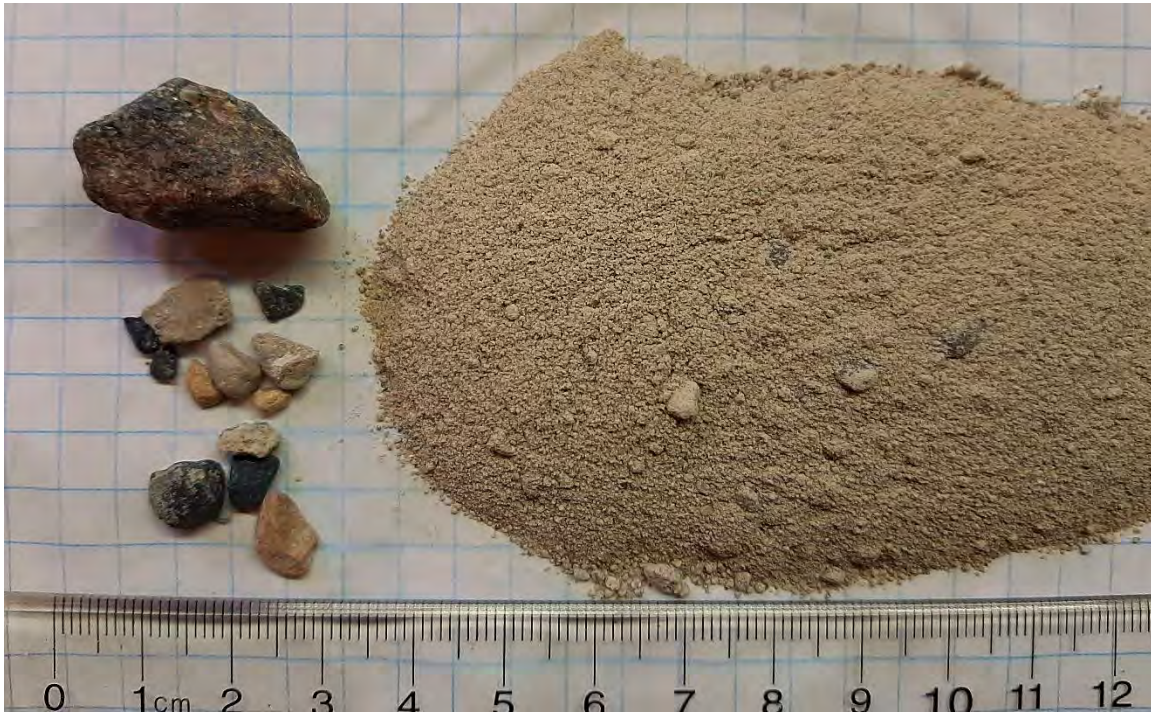
Figure 6 Sand and gravel from depth of 0.55 m in auger hole at waypoint 061.

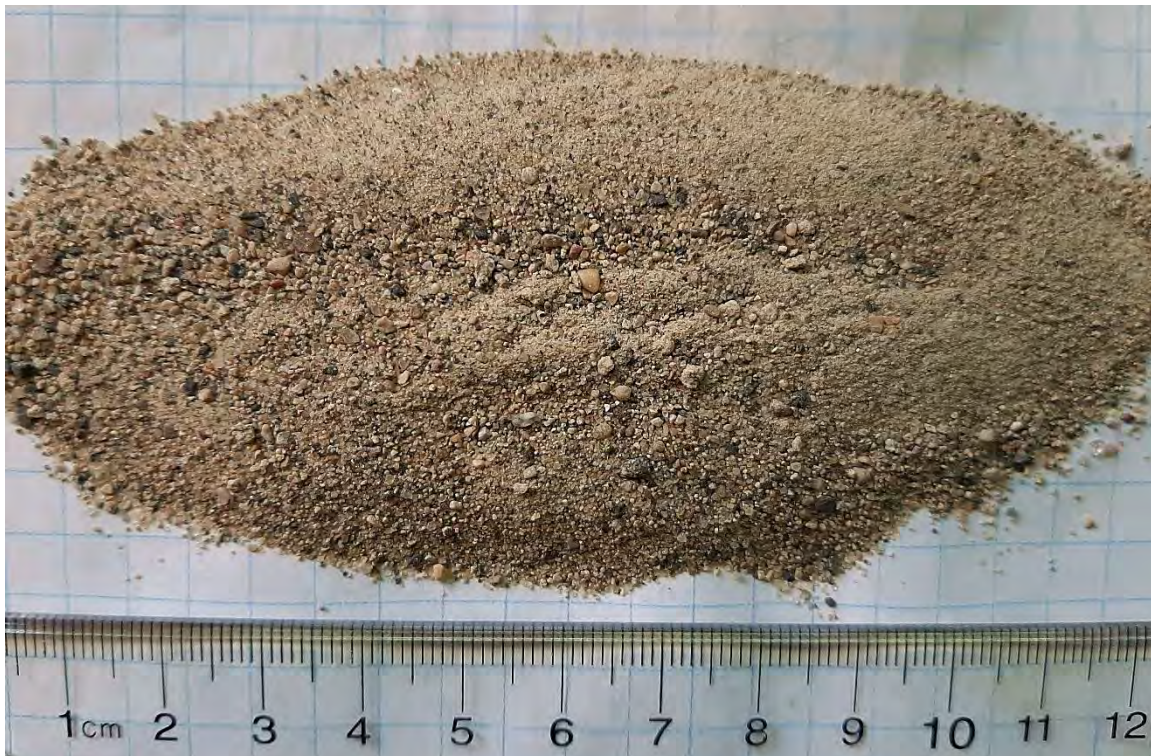
Figure 7 Very fine to very coarse sand from depth of 0.95 m in auger hole at waypoint 063.

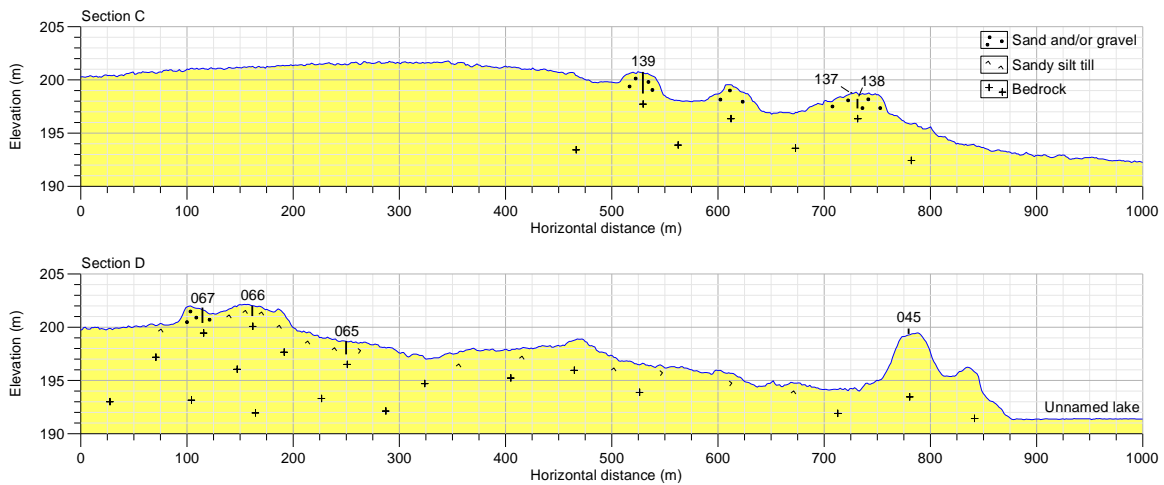
Figure 8 Hand auger observations plotted onto cross sections C and D.

The area covered by cross sections C and D (Figure 4) includes several isolated hill features that are suspected to be locations where bedrock is close to surface. Eight hand auger holes were drilled along and nearby these cross sections (Figure 8, Table 3).

Hand auger holes drilled along section C revealed very fine to very coarse sand to depths of 0.1 to 2.01 m with gravel present in one of the holes. It is suspected that auger refusal at these holes was caused by impact with the top of bedrock.

Hand auger holes in the hill at the top of section D (waypoints 066 through 068) revealed a silt drape covering variable amounts of sand and/or gravel. Auger hole 065 was drilled to determine the thickness of organics and depth to bedrock in a location marginal to the hilltop. The hill at the bottom of section D showed boulders at the surface throughout the hill.

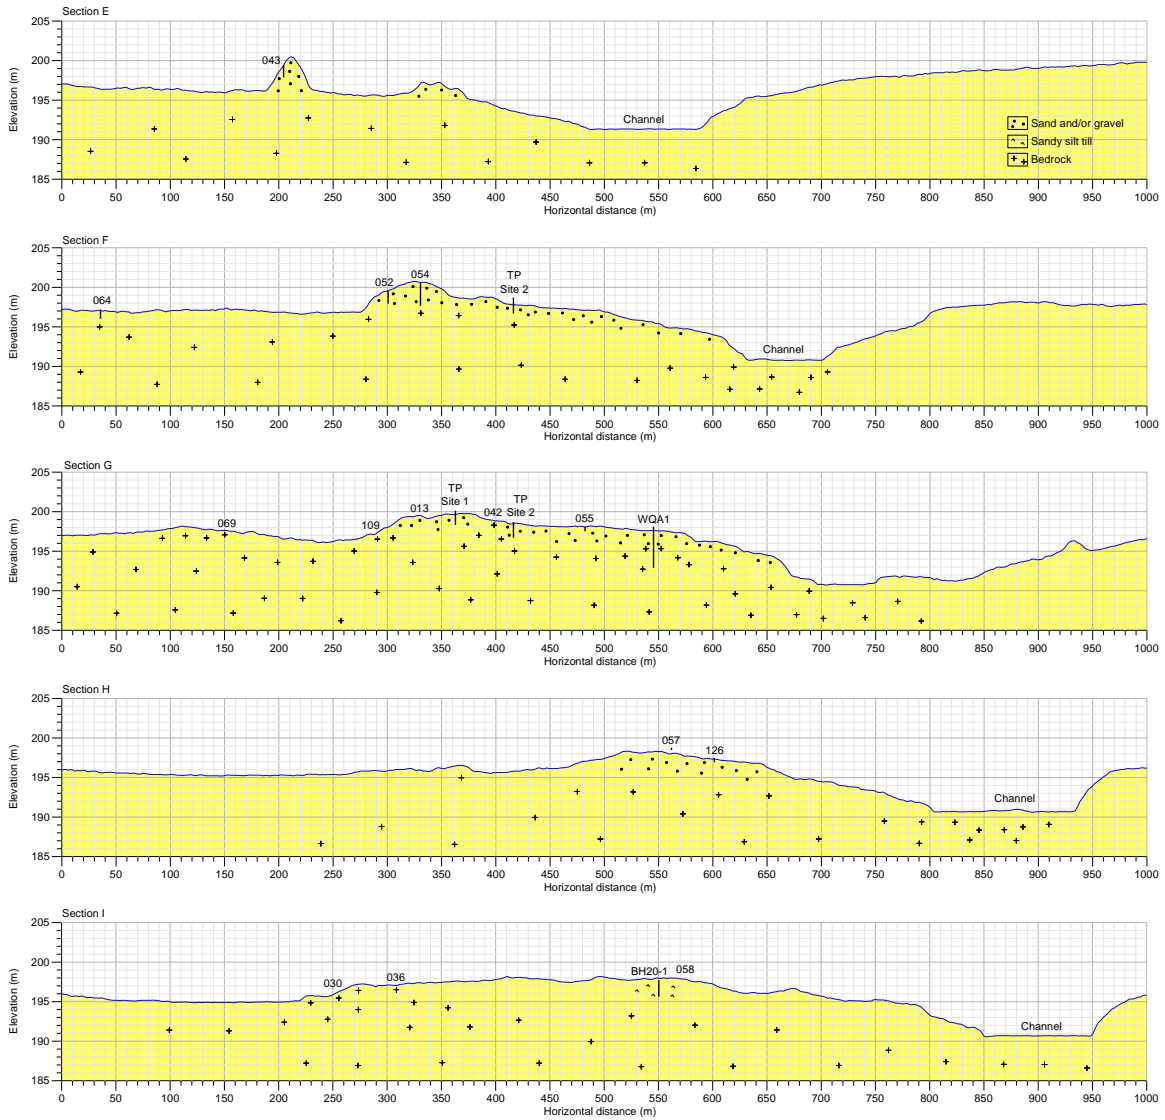
Figure 10 Borehole, hand auger and surface observations plotted onto cross sections E through I.

Section E (Figure 10) extends through a sand ridge standing up to 4.5 m above the surrounding terrain. Sand was observed in several locations along the length of this ridge. Hand auger hole 043 drilled in the centre of the ridge revealed fine to very coarse sand with trace fine gravel (Table 4).

Sections F and G (Figure 10) extend through the central part of this complex. Bedrock is exposed along the northwest edge of the complex as well as in a local topographic high northwest of the complex (e.g., waypoint 069). Auger refusal at waypoint 064 on Section F is taken as indicating depth to bedrock in that location. The hand auger hole at waypoint 054 was drilled in the highest part of the sand hill in this complex. The hole showed clayey silt and very fine sand grading down to fine to medium sand with some silt, with bedrock at a depth of 2.98 m. Many locations in the south half of the complex show boulders at the surface. Borehole WQA1 was drilled through a slight topographic high with boulders at the surface. The borehole intersected bedrock at a depth of 2.39 m beneath bouldery sand and gravel.

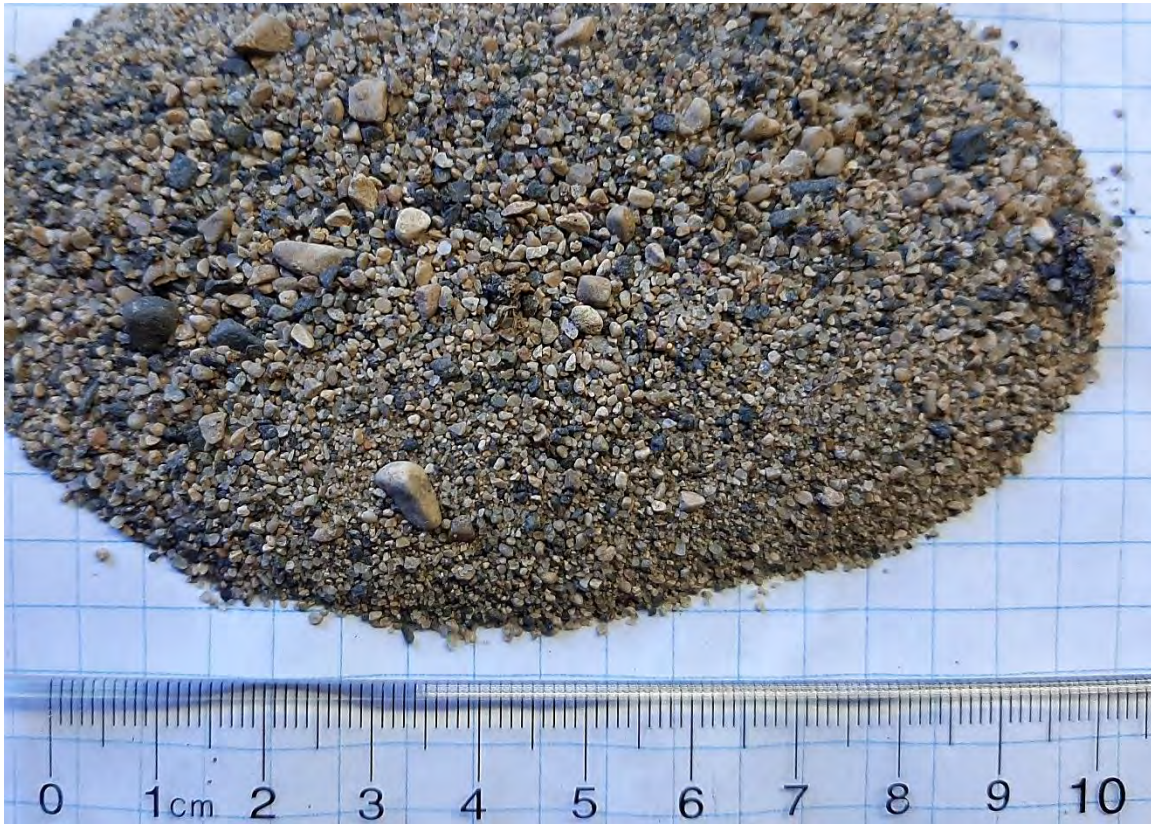
Figure 11 Med. to v.c. sand and fine gravel from depth of 0.50 m in auger hole at waypoint 043.

Visual examples of sand samples obtained from within this complex are shown for reference in Figure 11 and Figure 12.

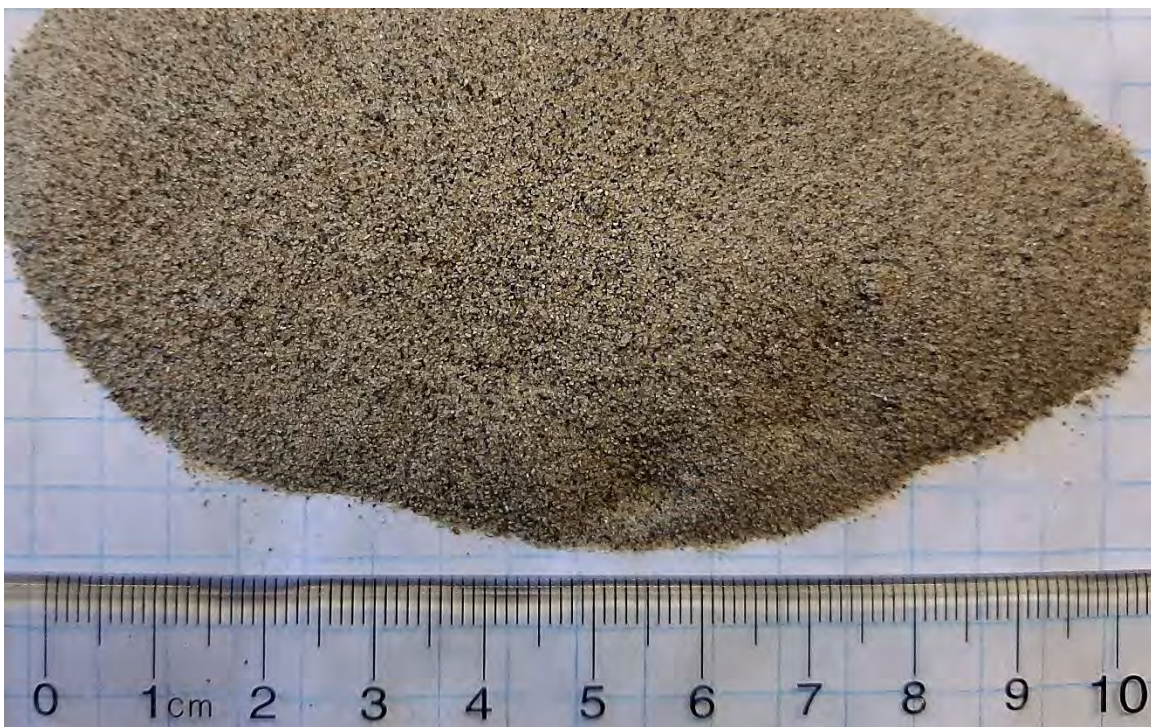
Figure 12 Fine to medium sand from depth of 2.60 m in auger hole at waypoint 054.

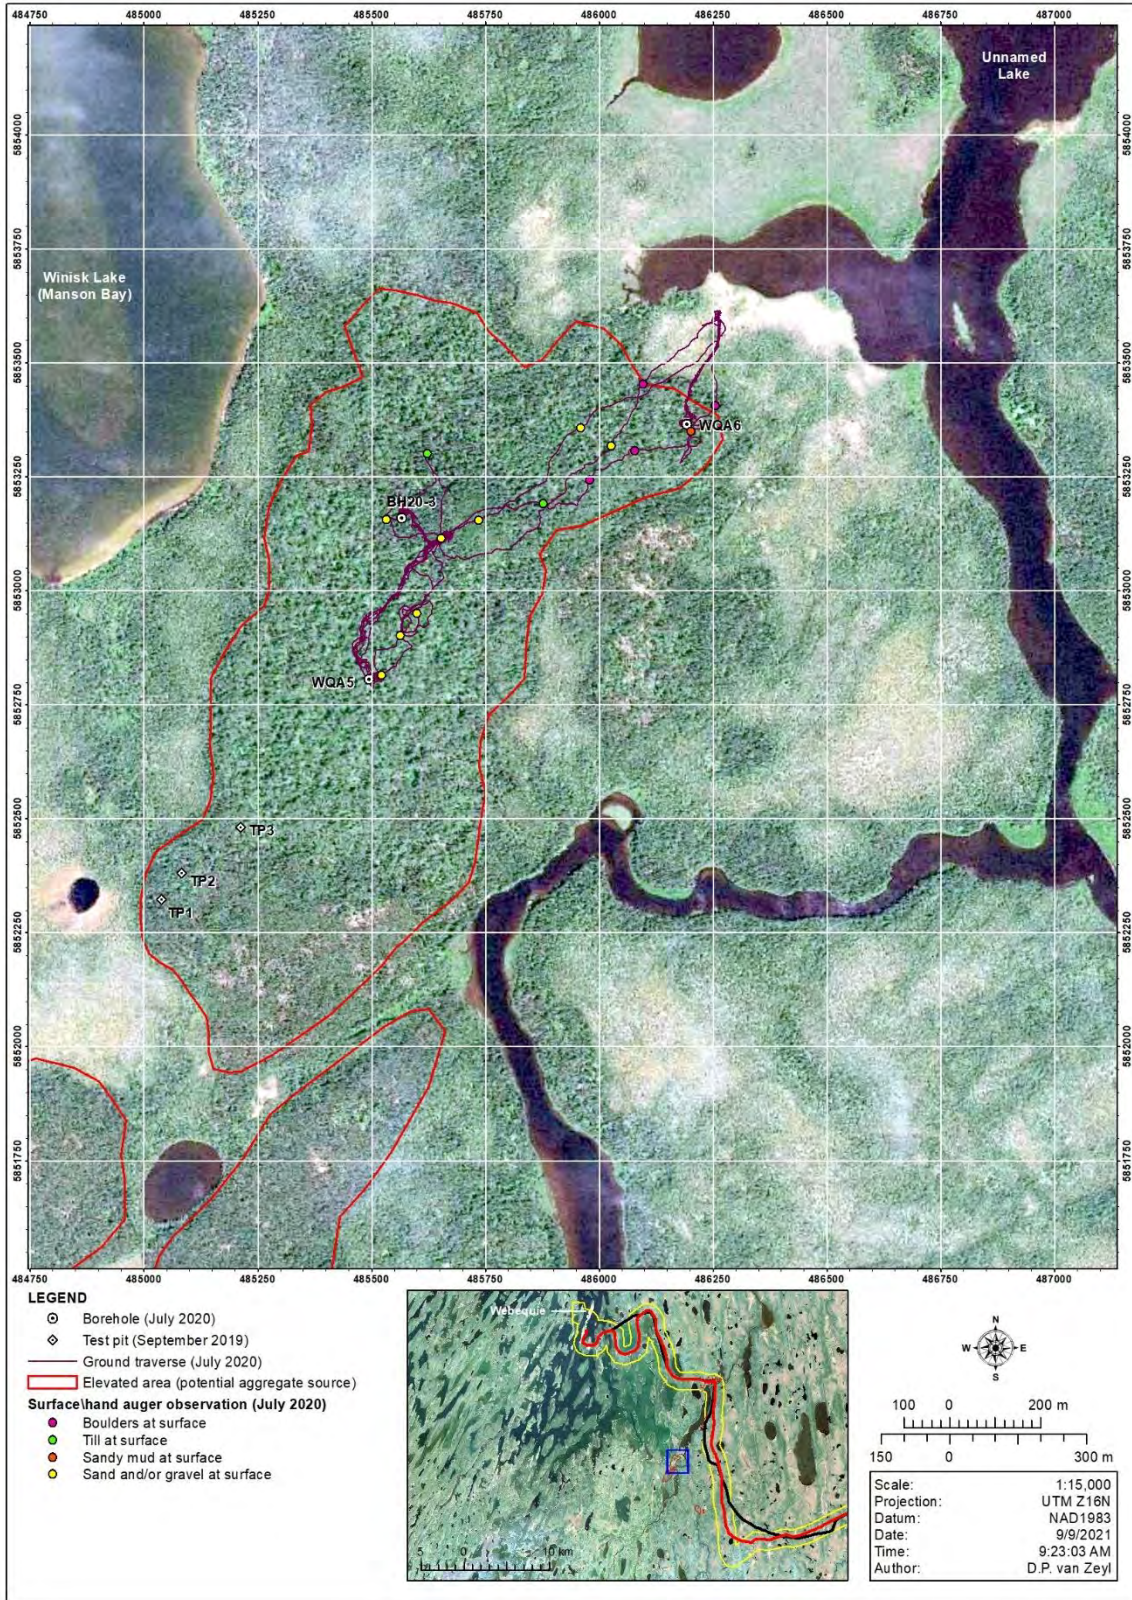
Figure 16 Satellite map showing overview of TP19-10.

TP19-10 is a large ridge containing significant sand and gravel resources located west of the corridor (Figure 16). The northeast tip of the ridge, as outlined in Figure 16, is located 3.2 km west of the proposed Webequie Supply Road and would require a river crossing with a bridge span of approximately 55 m. The landform extends toward the south, but no test pits or boreholes were completed outside of the area in Figure 16. LiDAR coverage, unfortunately, does not exist at this site.

The site was explored with three hand-dug test pits in September 2019 (Figure 16). The test pits are located at the south tip of the ridge. The first test pit was dug at the foot of the ridge, where silt with clay was found. The second and third test pits were dug at higher elevations and found medium sand with trace gravel.

Prior to drilling boreholes at this site, reconnaissance of the north and central parts of the ridge was performed. Cobbles and boulders were found at surface in many of the locations checked (Figure 16). Many attempts were made to drill with the hand auger, but auger refusal occurred within 0.25 m in all but one of the attempts. Sand with silt and clay and cobbles and boulders was observed at surface in many of these locations. Till or sandy silt was found at the surface in a few locations.

Three boreholes were drilled at this site in July 2020 (Figure 16). Boreholes WQA5 and BH20-3 were located so as to provide borehole coverage in widely spaced locations along the central part of the ridge. These two boreholes found silty sand and sandy gravel to depths of 6.6 and 5.8 m. The base of the sand and gravel deposit was not reached in either of these two boreholes. The third borehole (WQA6) was drilled at low elevation at the northeast tip of the ridge. This borehole found silt and clay as well as silty sand, but no appreciable sand or gravel.

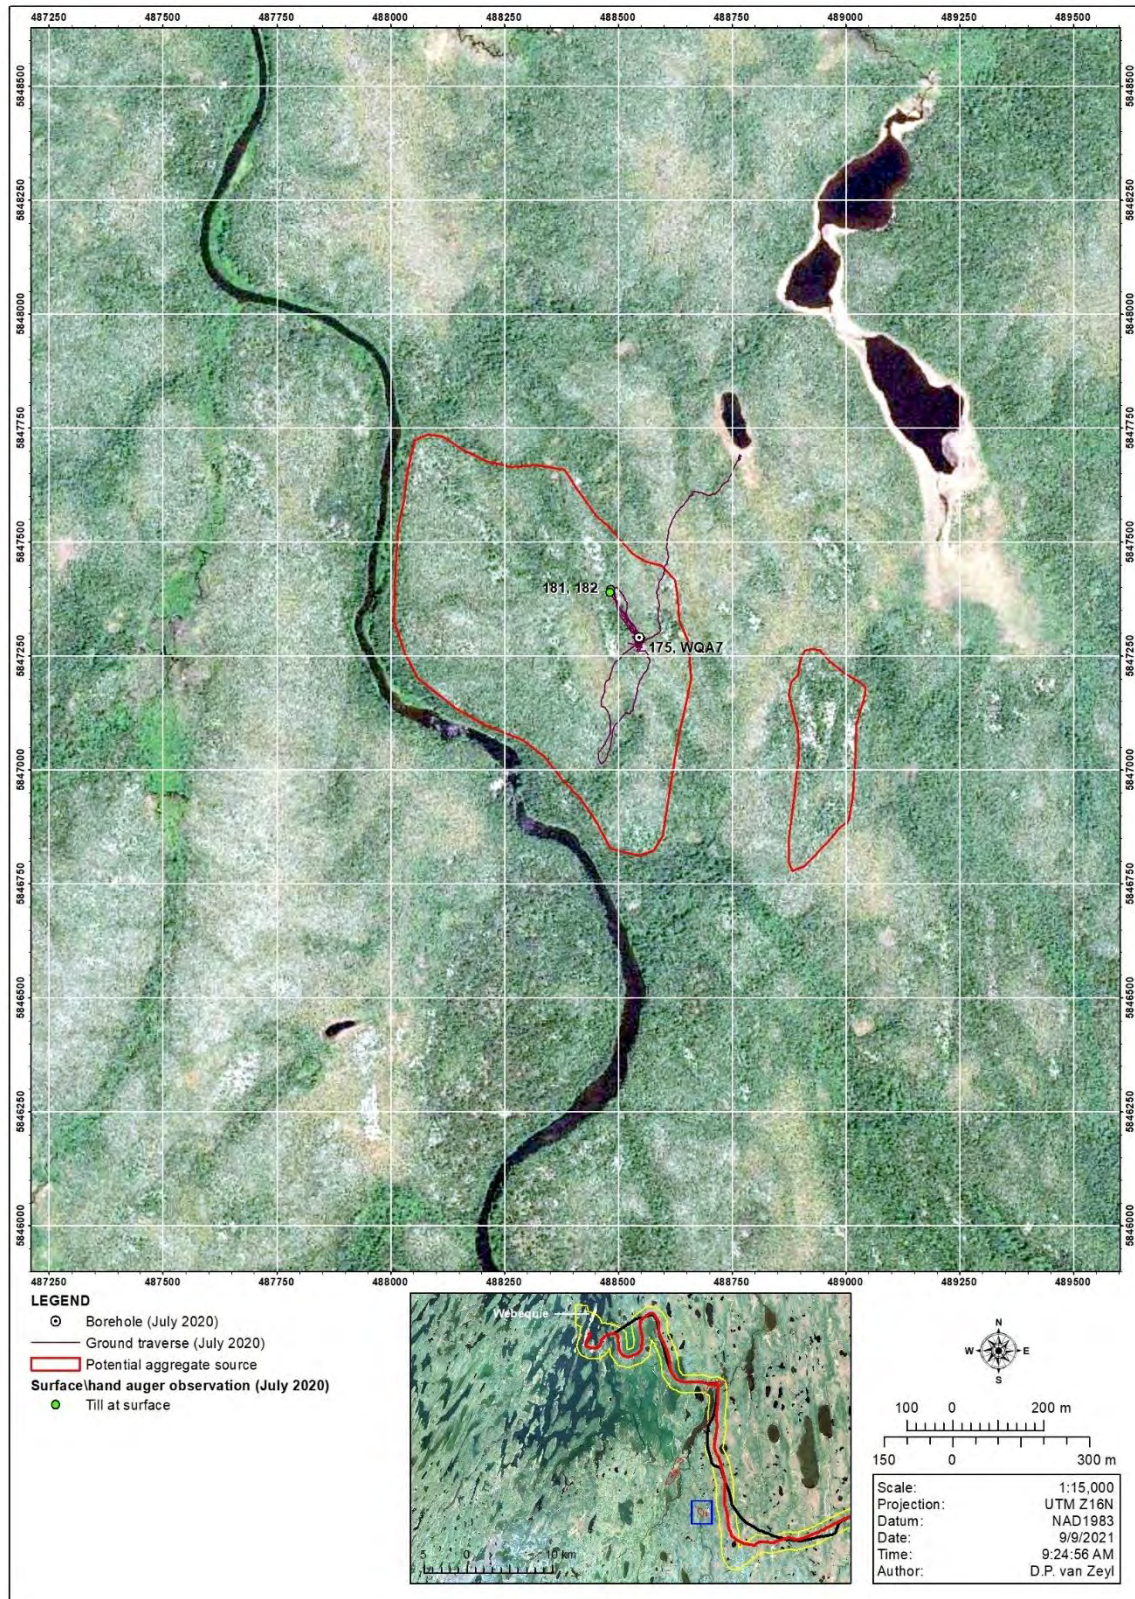
Figure 17 Satellite map showing overview of TP19-03.

Three hand auger holes were completed in two of areas of white moss (Figure 17). The first auger hole (at waypoint 175) was completed in the same location as the borehole that was later drilled at this site (WQA7). Silt and fine sand with some clay was found to a depth of 1.20 m. Below that, silt and clay with some gravel and some sand was found to a depth of 1.75 m, with auger refusal at a cobble/boulder. The borehole in this same location found sandy silt till to a depth of 5.0 m.

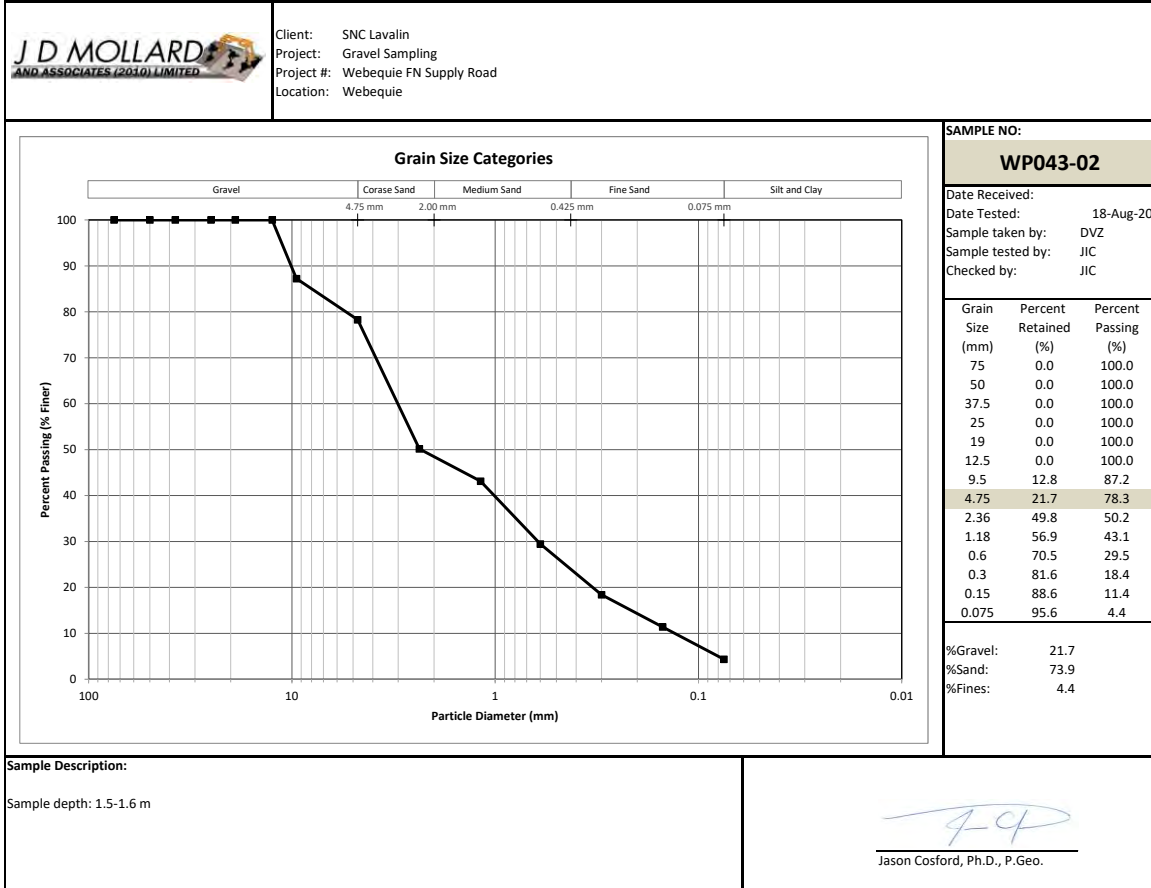
Figure C1 Grain size curve for sample WP043-02.

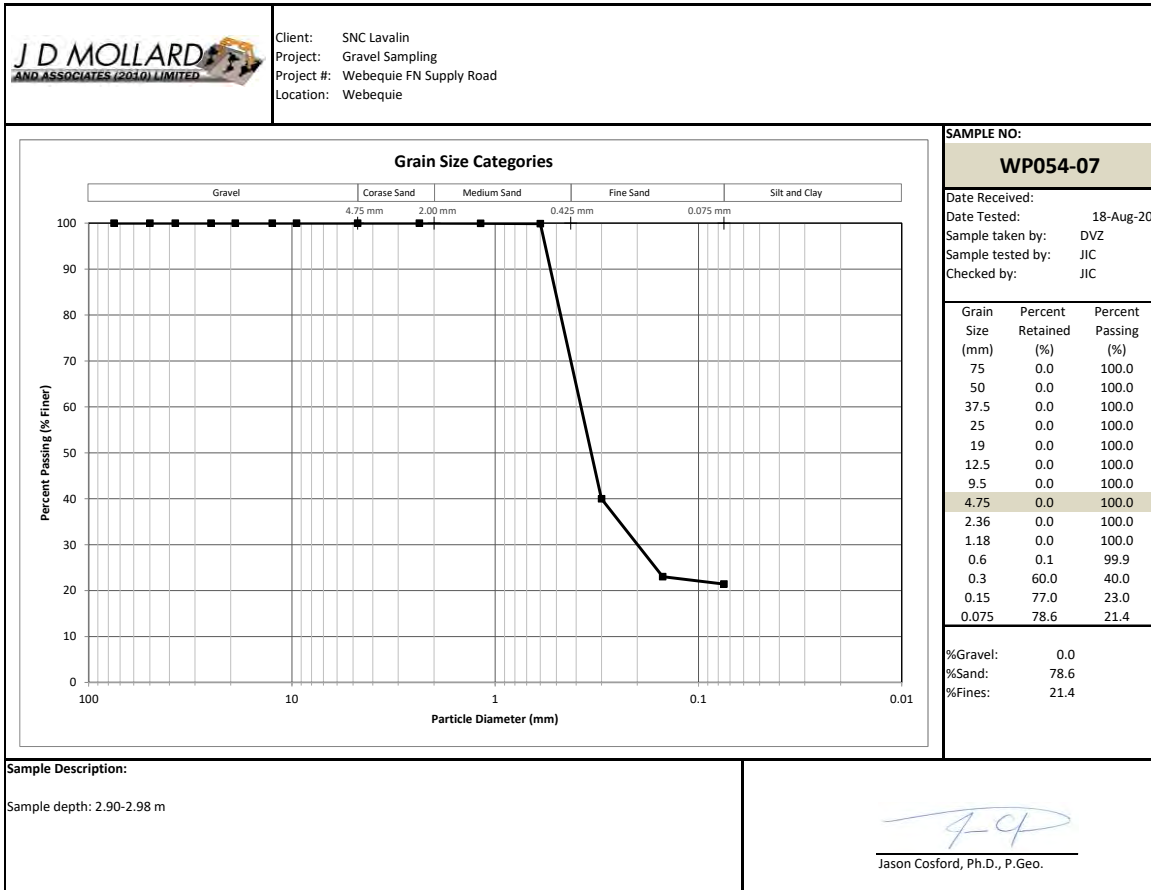
Figure C2 Grain size curve for sample WP054-07.

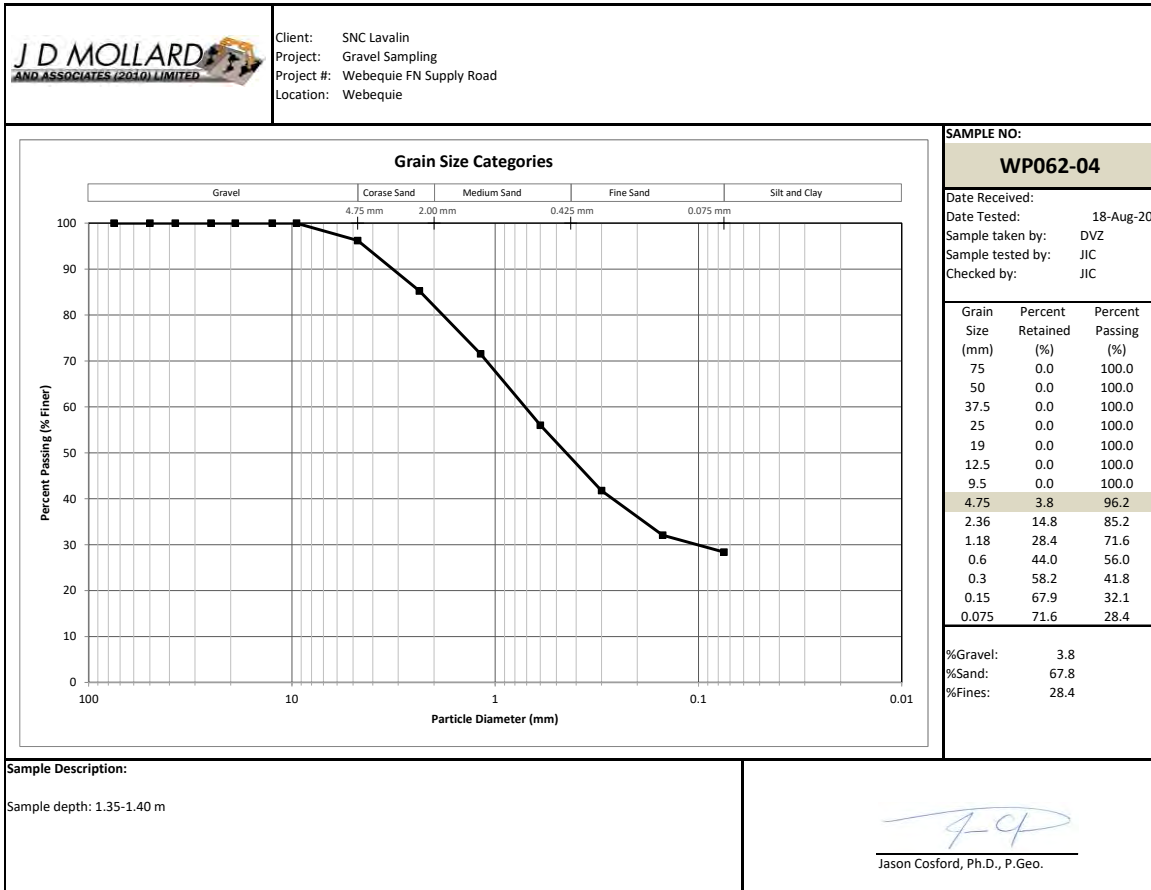
Figure C3 Grain size curve for sample WP062-04.

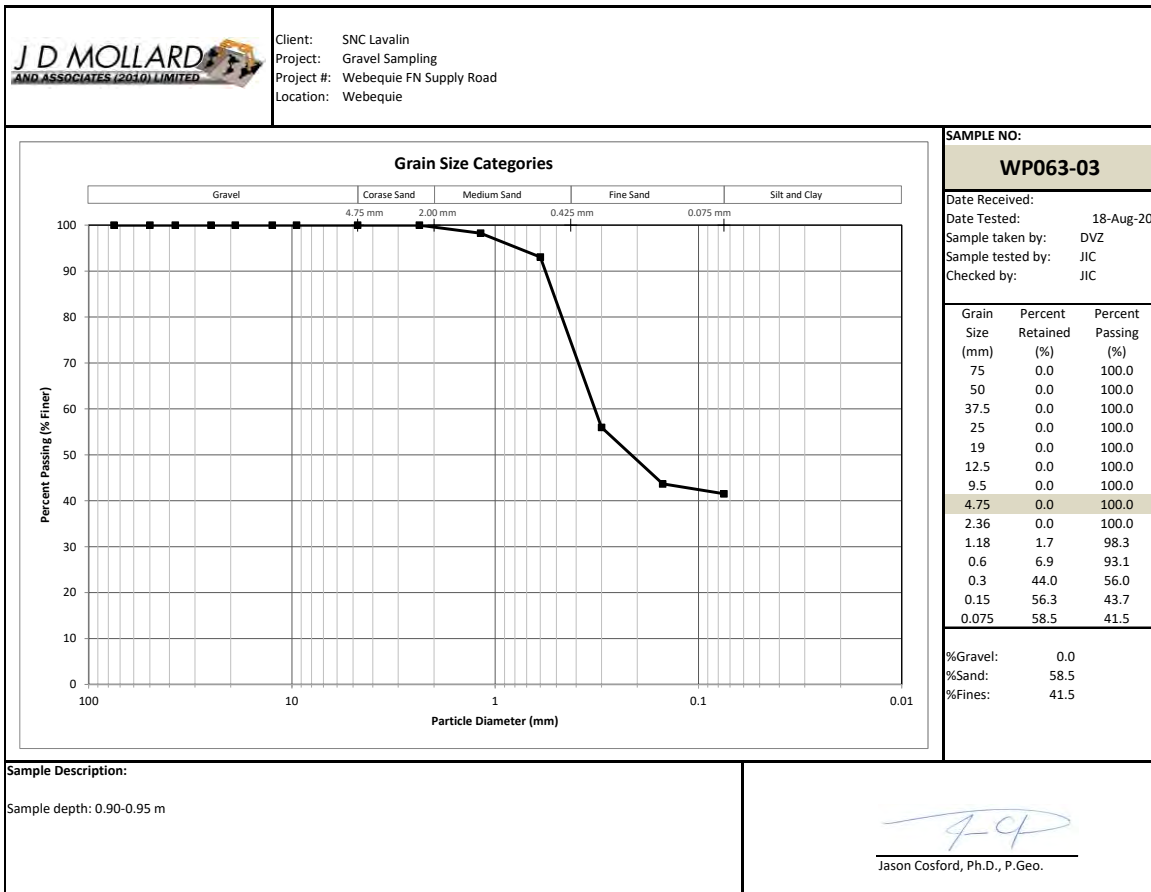
Figure C4 Grain size curve for sample WP063-03.

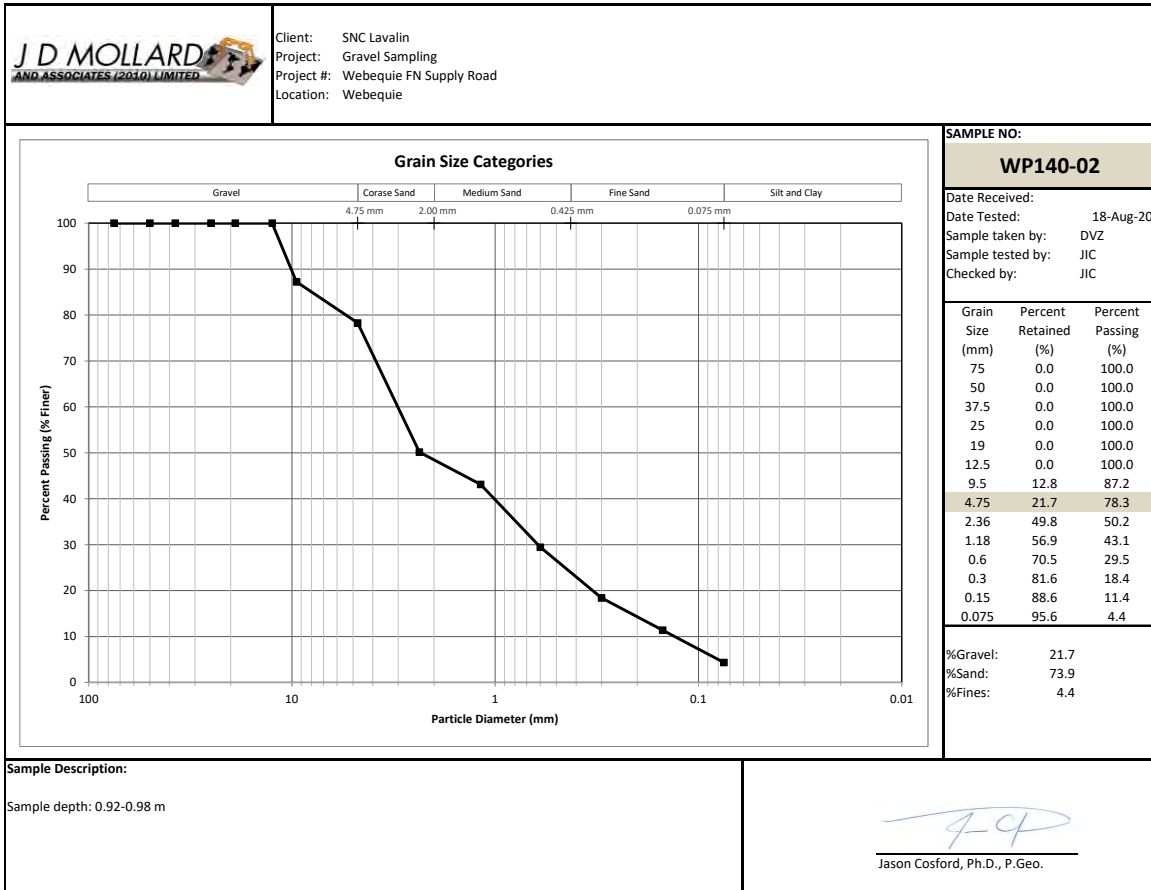
Figure C5 Grain size curve for sample WP140-02.
