Aquatic Environment Baseline Conditions

Aquatic Characterization – 2022 Field Campaigns

Patriot Battery Metals Inc.

Project 22-0095

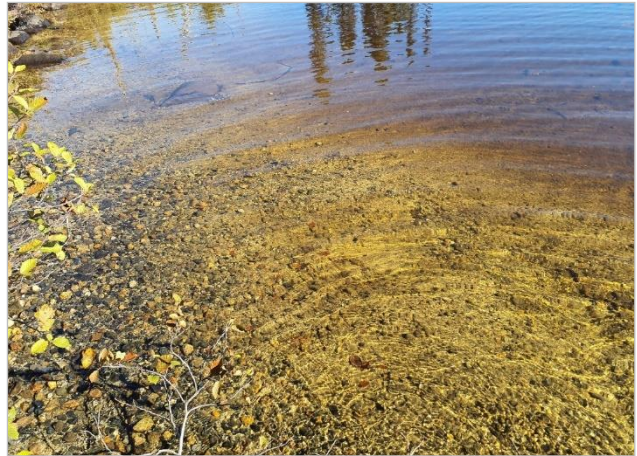
Photo 4. Fine substrate on shore of segment SH20 of Lake PE1

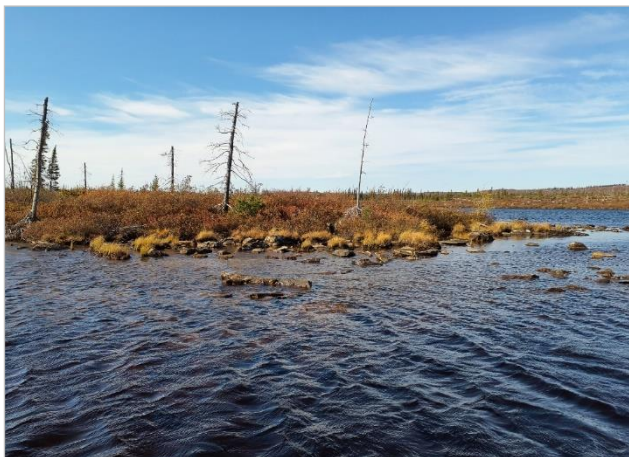
Photo 5. Coarse substrate on the shore of PE325 segment SH2

Photos 5 to 8 show respectively the main types of shorelines observed during the characterization lake PE325 and PE72.

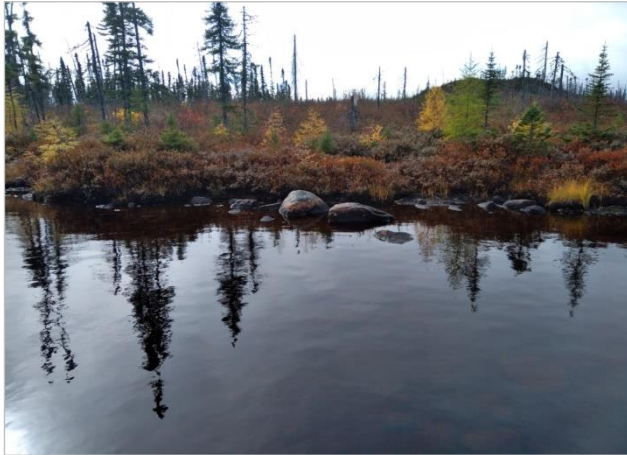
Photo 13. Coarse substrate on the shore of Lake PE18 segment SH1

Photos 13 and 14 show the main types of shorelines observed during the characterization of the lake PE18 and PE63.

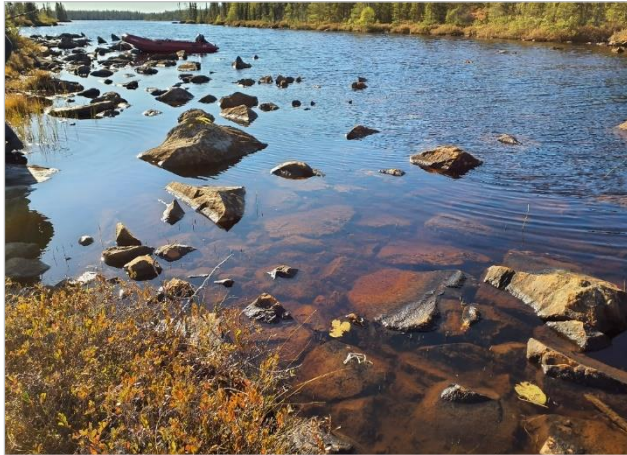
Photo 15. Coarse substrate on the shore of Lake PE2 segment SH1

Photos 15 to 18 show the main type of shorelines observed during the characterization of the lakes PE2 and PE61.

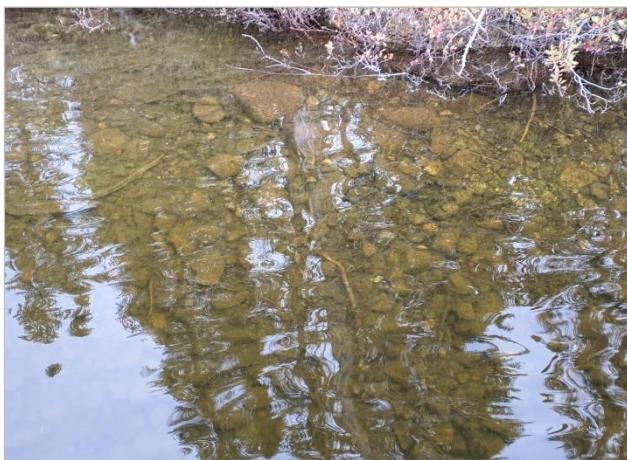
Photo 19. Coarse substrate on the shore of Lake PE3 segment SH2

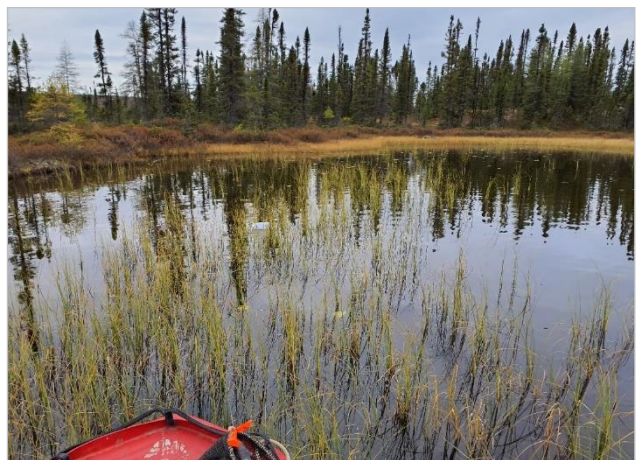
Photo 20. Aquatic grass bed of Lake PE3 segment SH5

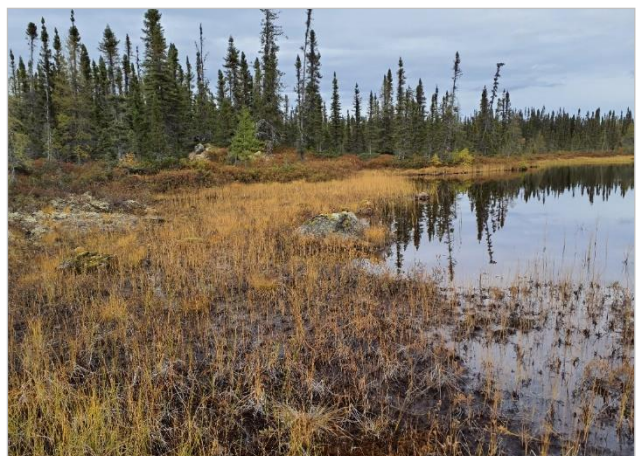
Photo 22. Aquatic grass bed of Lake PE4 segment SH2

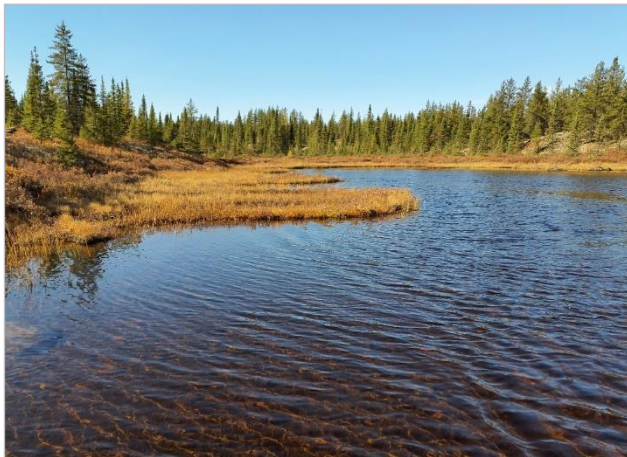
Photo 31. Grass bed on the shore of Lake PE9 segment SH4

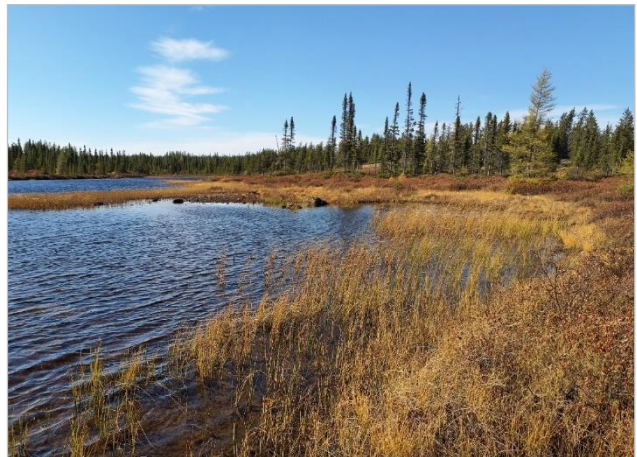
Photo 32. Aquatic grass bed of Lake PE9 segment SH1

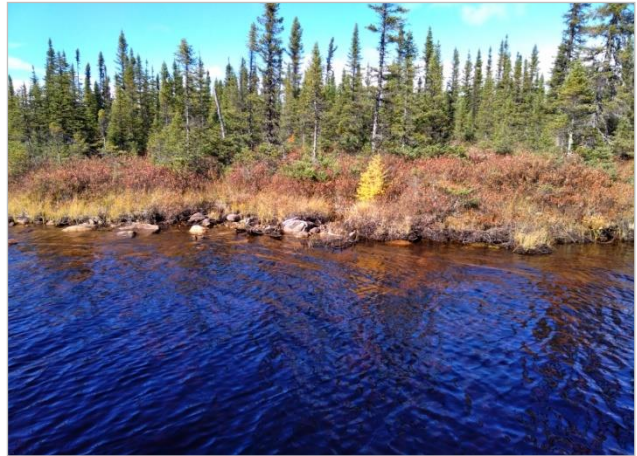
Photo 36. Coarse substrate on the shore of Lake PE12 segment SH3

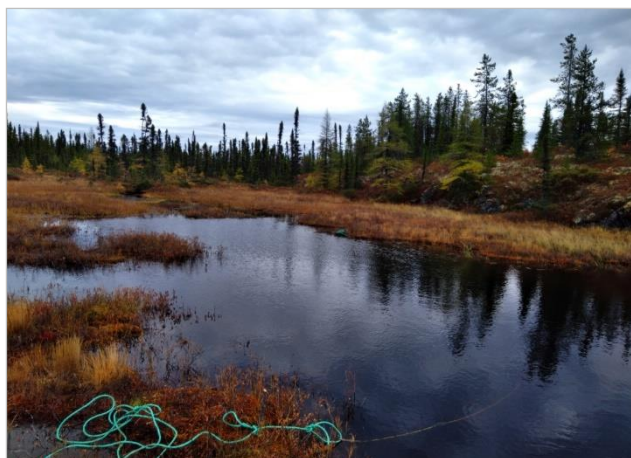
Photo 66. Grass bed on the shore of PE159 segment SH1

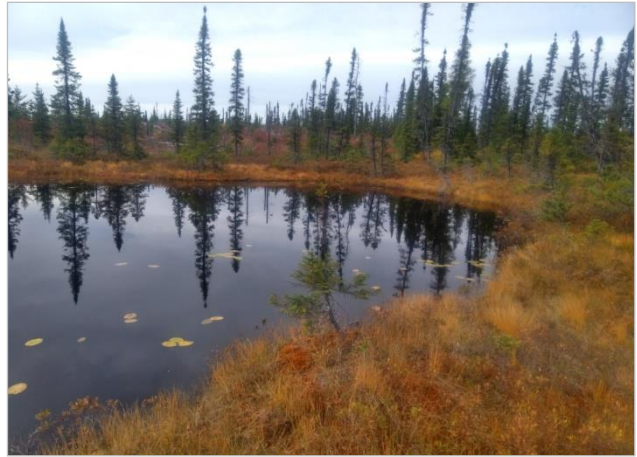
Photo 71. Grass bed on the shore of Lake PE188 segment SH1

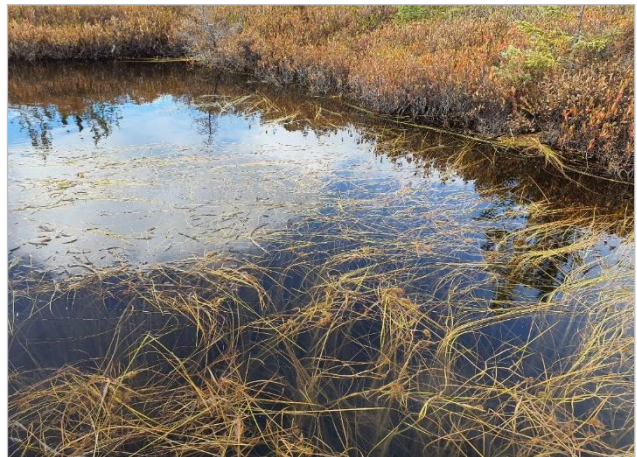
Photo 90. Aquatic grass bed of PE39

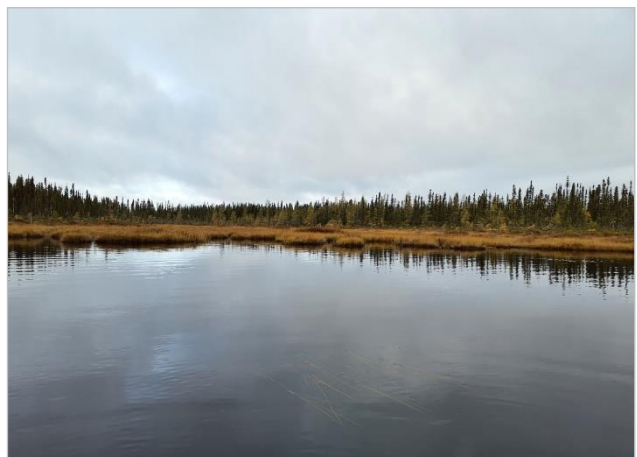
Photo 92. Aspect of PE46 segment SH1

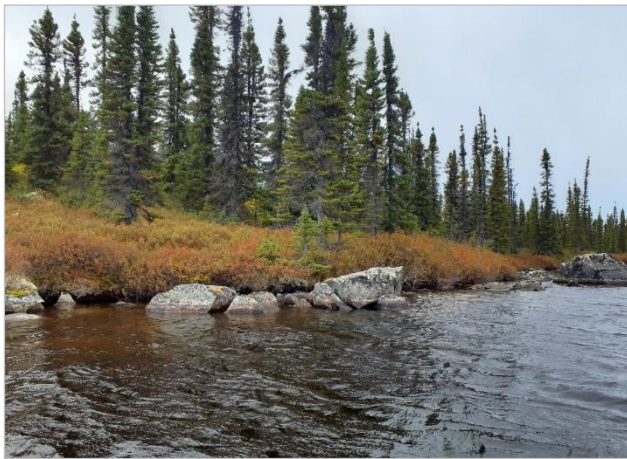
Photo 93. Coarse substrate on the shore of PE47 segment SH6

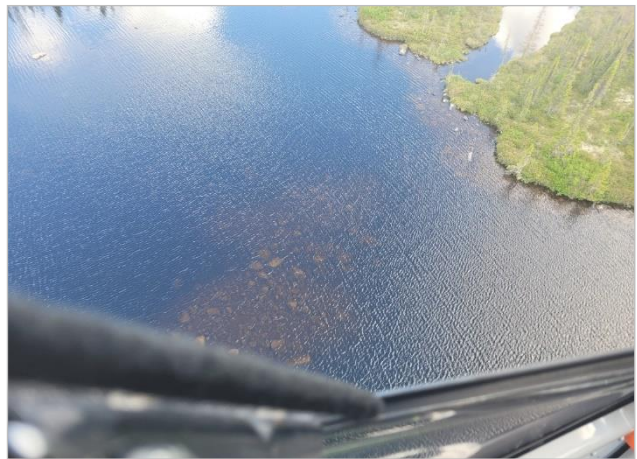
Photo 94. Shoal observed in PE47

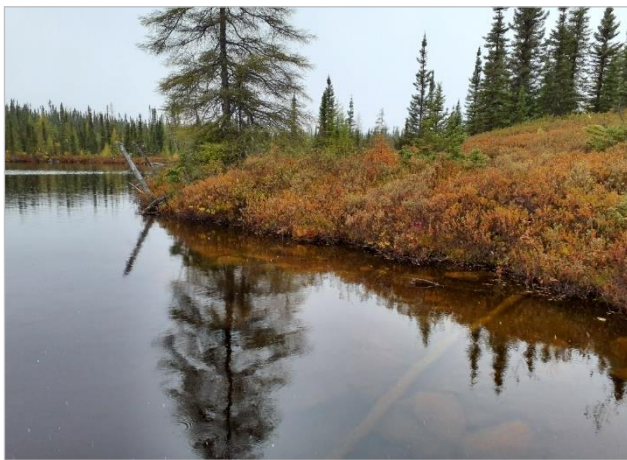
Photo 95. Coarse substrate on the shore of PE47 segment SH1
