May 14, 2010

**Kerr Sulphurets Mitchell Project
2009 Site Investigation Report**

KLOHN CRIPPEN BERGER LTD.

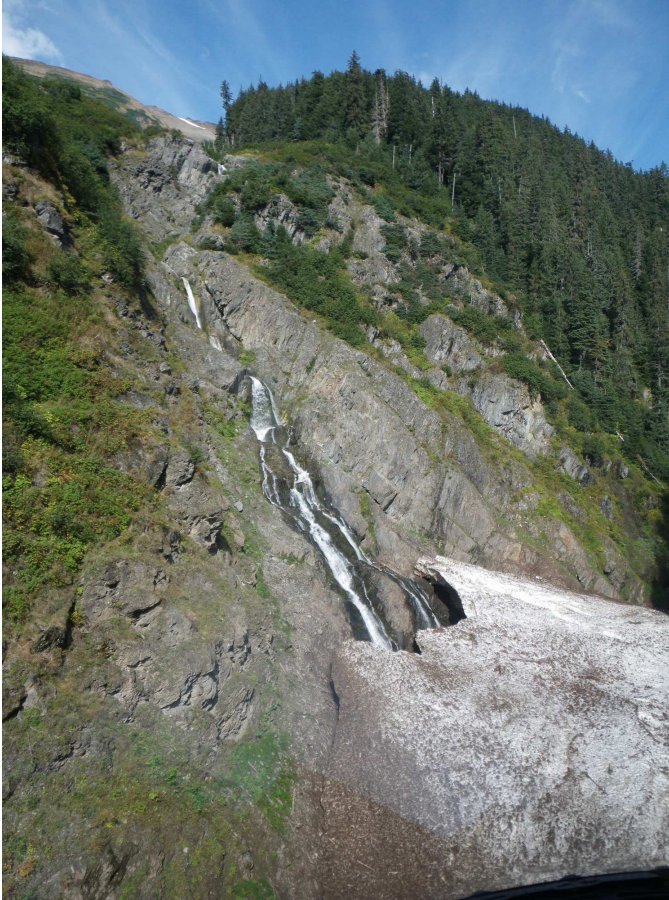
The major avalanche path terminates in a prominent blast zone with an area of tree knock down extending above the east bank of the creek. The location of the Water Storage Facility pond, dam and associated seepage collection pond were selected to be upstream and out of the major avalanche chute (Photo 2.2).

Photo 2.2 Major Avalanche Chute located 300 m to South of WSF Damsite (looking NW of rock canyon of lower Mitchell Creek).

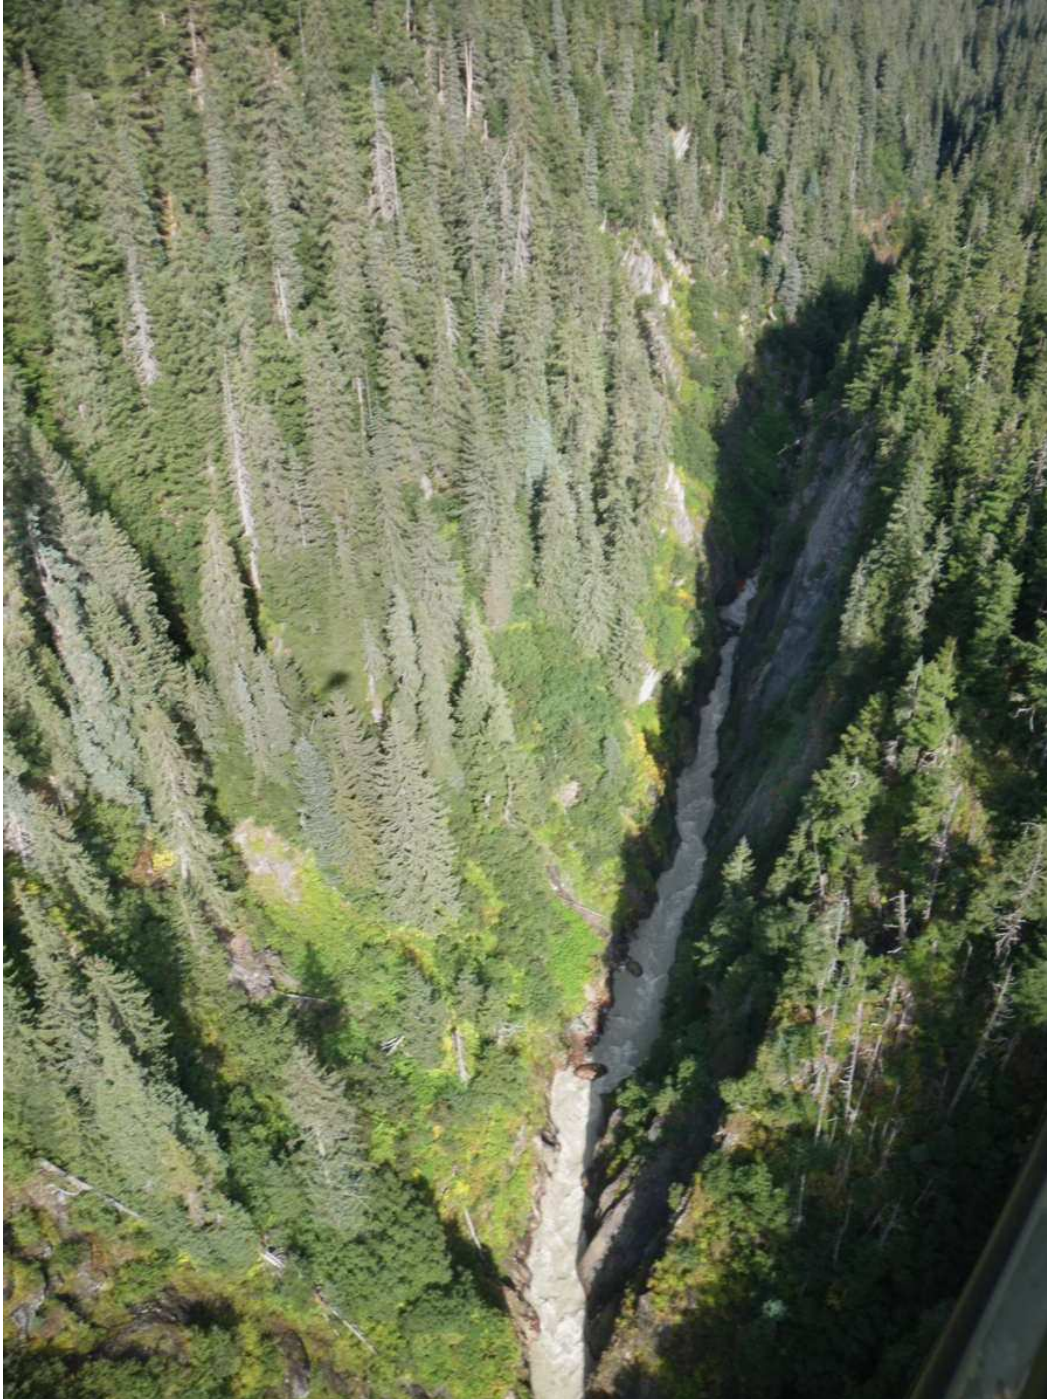
The in situ, unweathered rocks exposed by river erosion in the valley floor of Mitchell Creek immediately upstream of the Water Storage Damsite are generally hard (R4 to R5) and competent siltstones, sandstones and argillites.

Photo 2.3 Aerial View looking upstream along Lower Mitchell Creek bedrock canyon in area of WSP Dam Footprint.

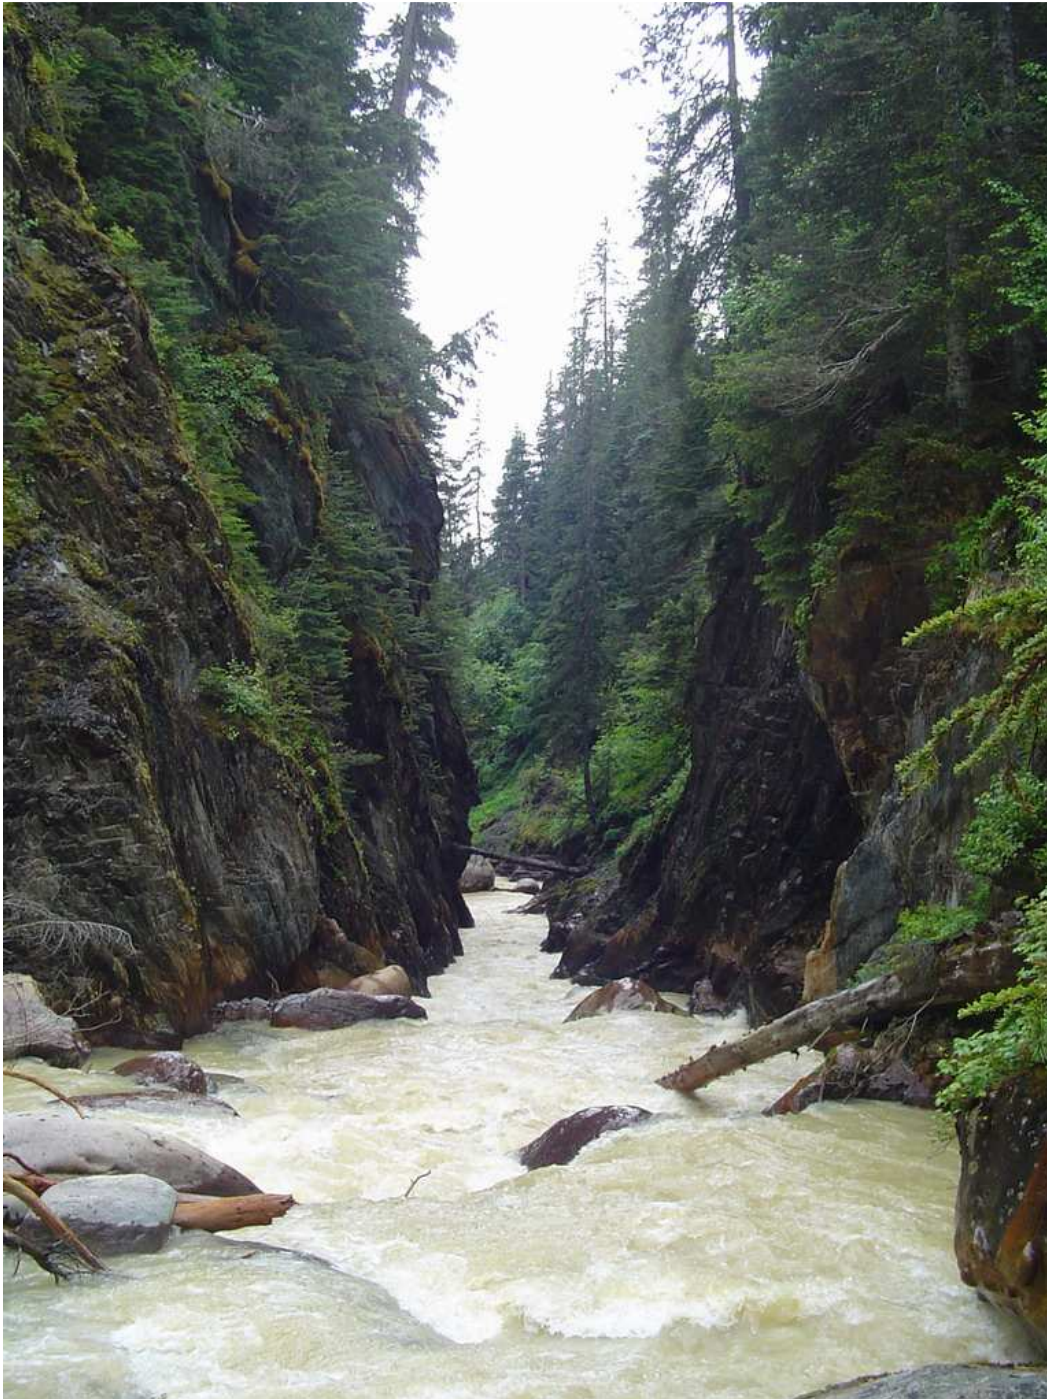
Photo 2.4 Gorge of Mitchell Creek in Area of Water Treatment Dam Upstream Toe Area (looking south).

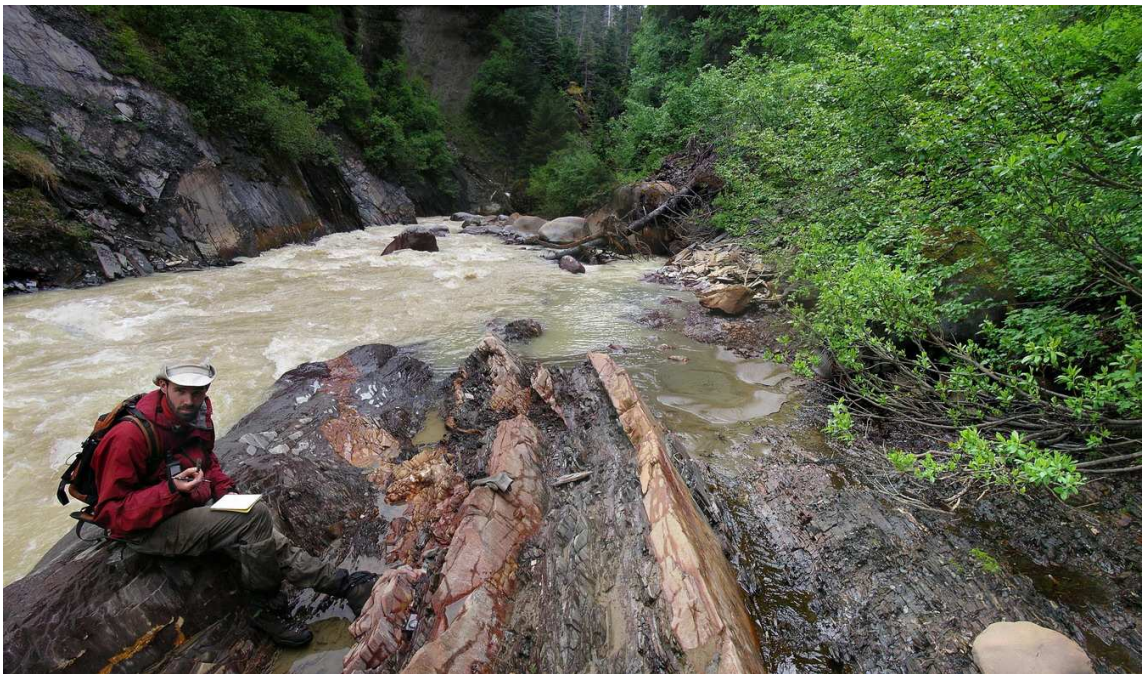
The base of the Lower Mitchell canyon contains little sediment due to the high water velocities and steep gradients. The bed of the creek is primarily exposed eroded rock, with edge on steeply dipping layers of siltstones, argillites, sandstones and intrusive dykes. Occasional fine grained intrusive dykes with thicknesses on the order of 20 cm to 50 cm were observed within the sediments of the stream channel (Photo 2.5).

Photo 2.5 Intrusive dykes and more resistant fine sandstone layers within finely bedded north-northwest dipping siltstone sediments (looking south).

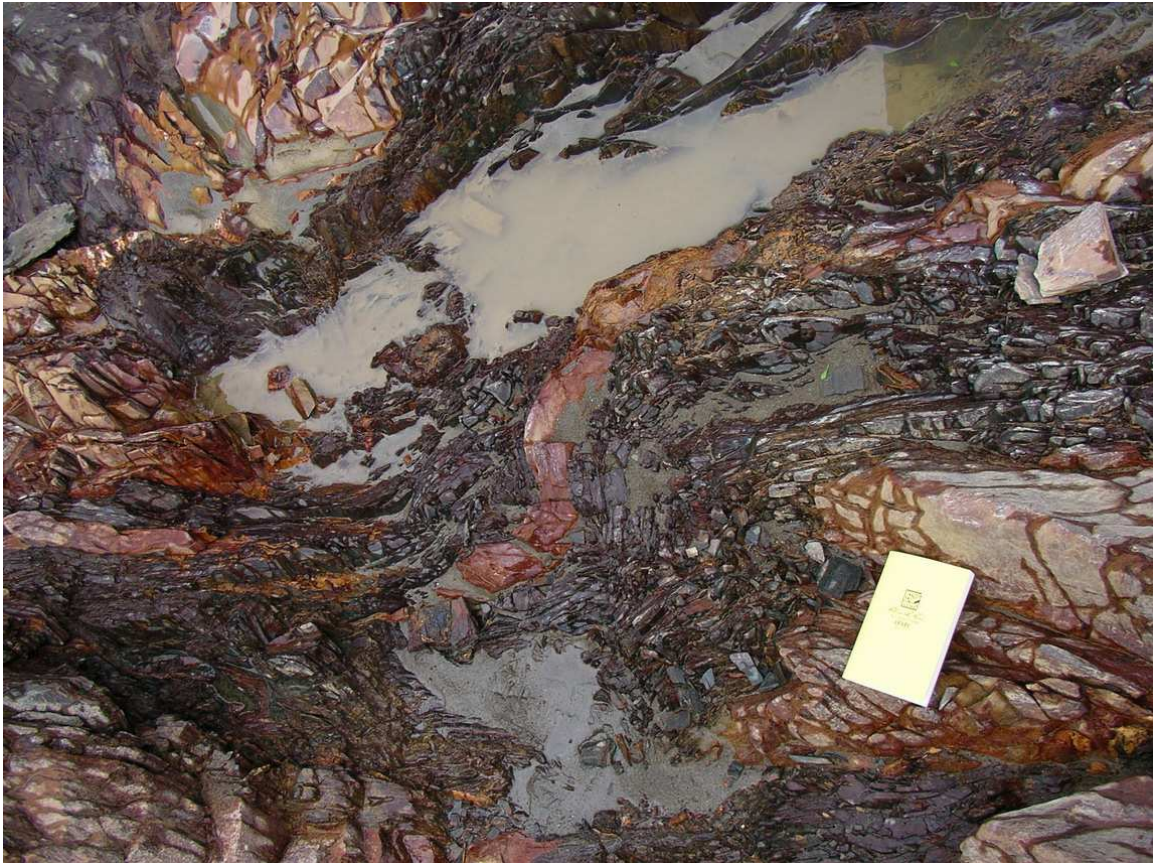
Within the valley floor, bedding planes of sediments are observed to be tight, with moderate fracturing. Sections of undisturbed sediments generally appear massive with some areas of heavier fracturing. Short wavelength folding, possibly soft sediment deformation was occasionally observed (Photo 2.6) within the sediments in some areas. It appears that this deformation had occurred during deposition or in some areas as a result of intrusive activities.

Photo 2.6 **Locally folded and deformed sediments.**

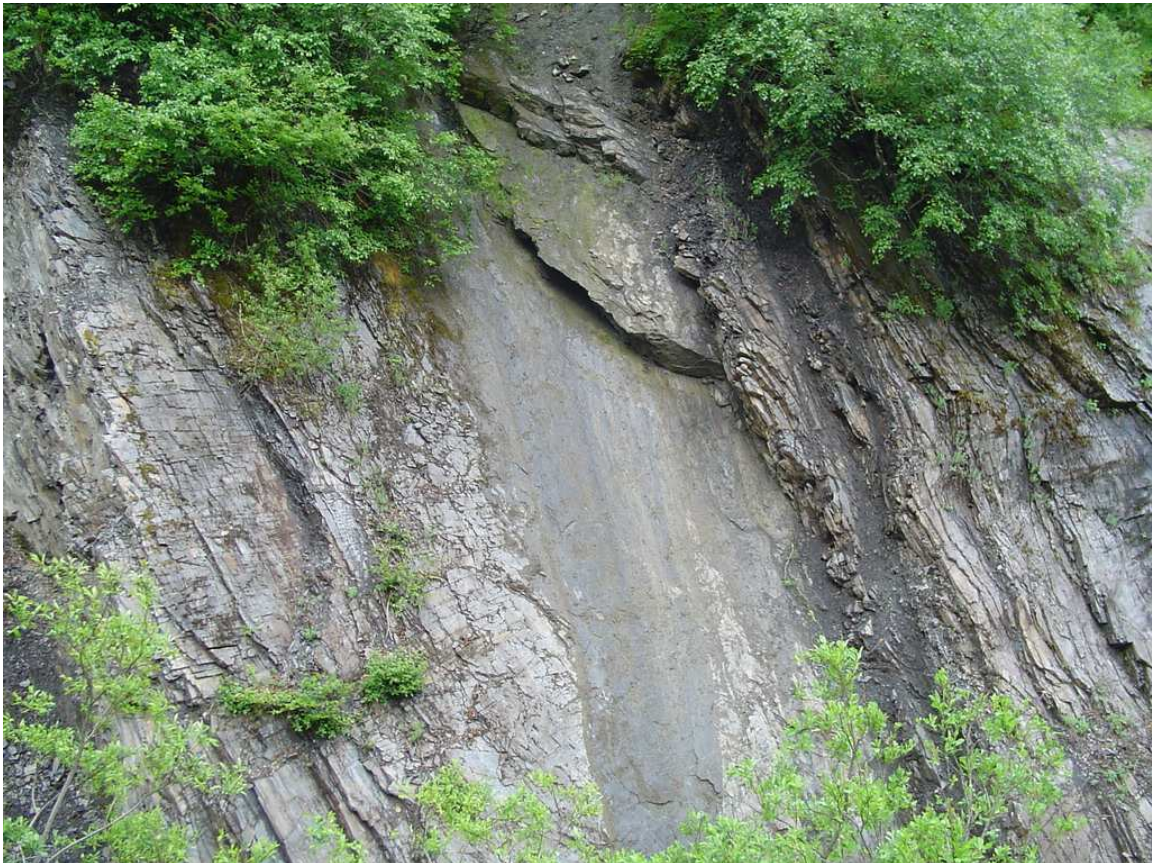
Generally the sedimentary formations are highly planar, with tight bedding planes observed in the exposed bedrock of valley floor area. Only slight undulations are visible on larger scales (Photo 2.7).

Lithology varies rhythmically between bedding layers on a scale of cm's to metres (Photo 2.7). Some layers appear to be lightly fractured (harder more brittle lithology)

whereas some layers are massive with little fracturing (softer, higher clay content, more ductile lithology). The alteration of layers of fractured and unfractured strata will result in significant anisotropy of permeability, with lowest permeability expected in the cross bedding direction.

Photo 2.7 Bedding planes exposed on east bank of Water Treatment Pond area.

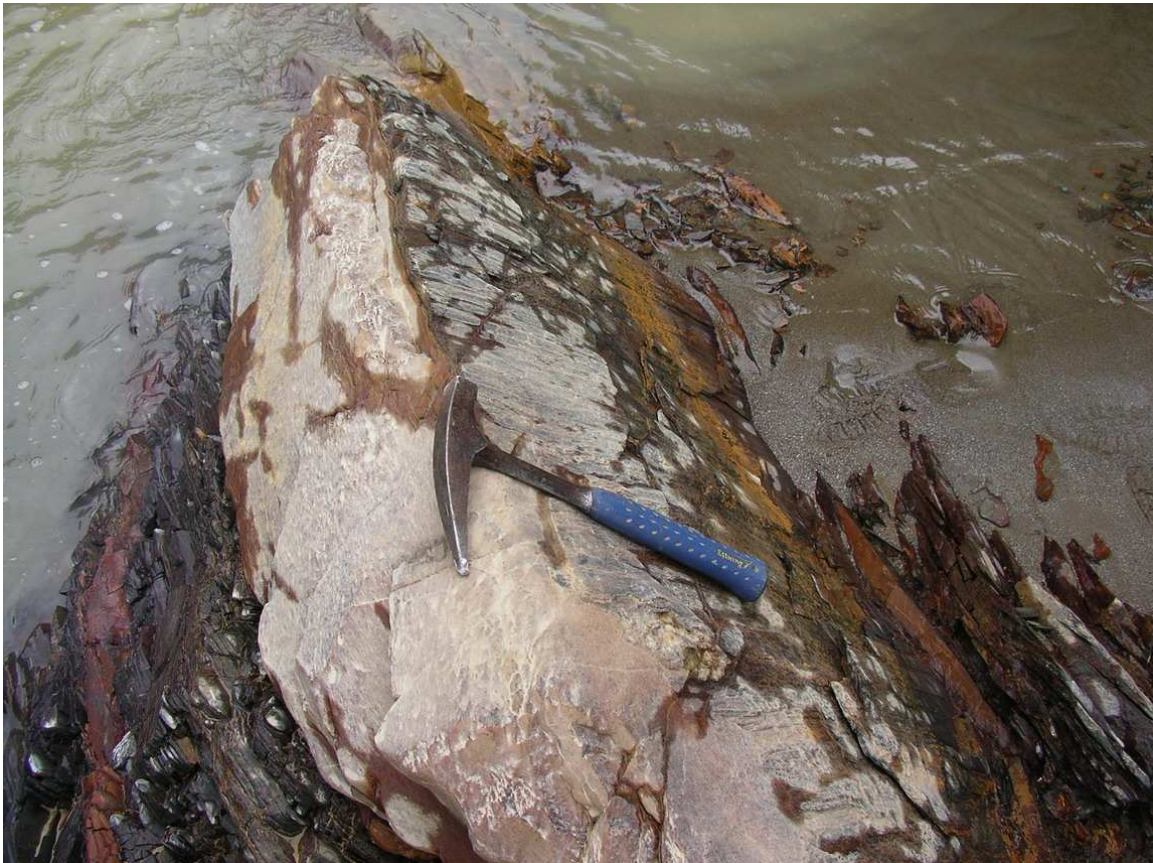
The variation in competency and brittleness between layers of rock with different clay content and grain sizes may have resulted in localized differential movement between bedding planes during folding leading to differences in fracture density between the layers. This movement may also have lead to the generation of the E-W orientated slickensides. These indicators of motion are visible on surfaces of the harder layers

(Photo 2.8). Fold induced movement on the bedding planes may have resulted in localized discontinuities or voids forming where sections of bedding were deformed, causing separation of the bedding planes in some areas.

Photo 2.8 Slickensides on bedding planes exposed in Mitchell Creek Canyon.

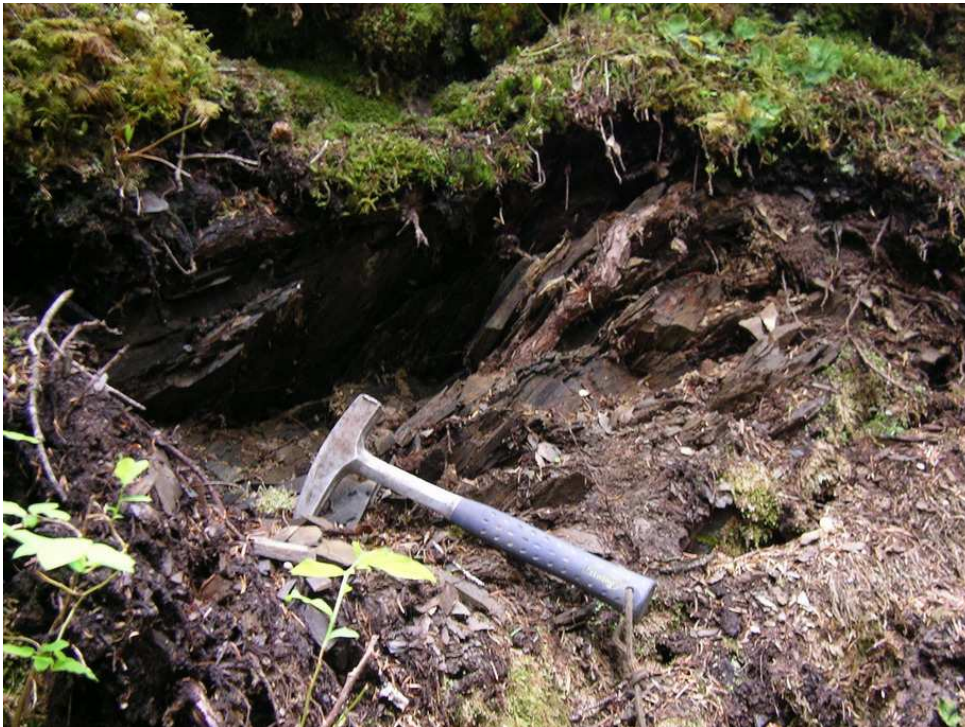
Photo 2.9 Finely Bedded, NW dipping Sediments in Sulphurets RSF Foundation.

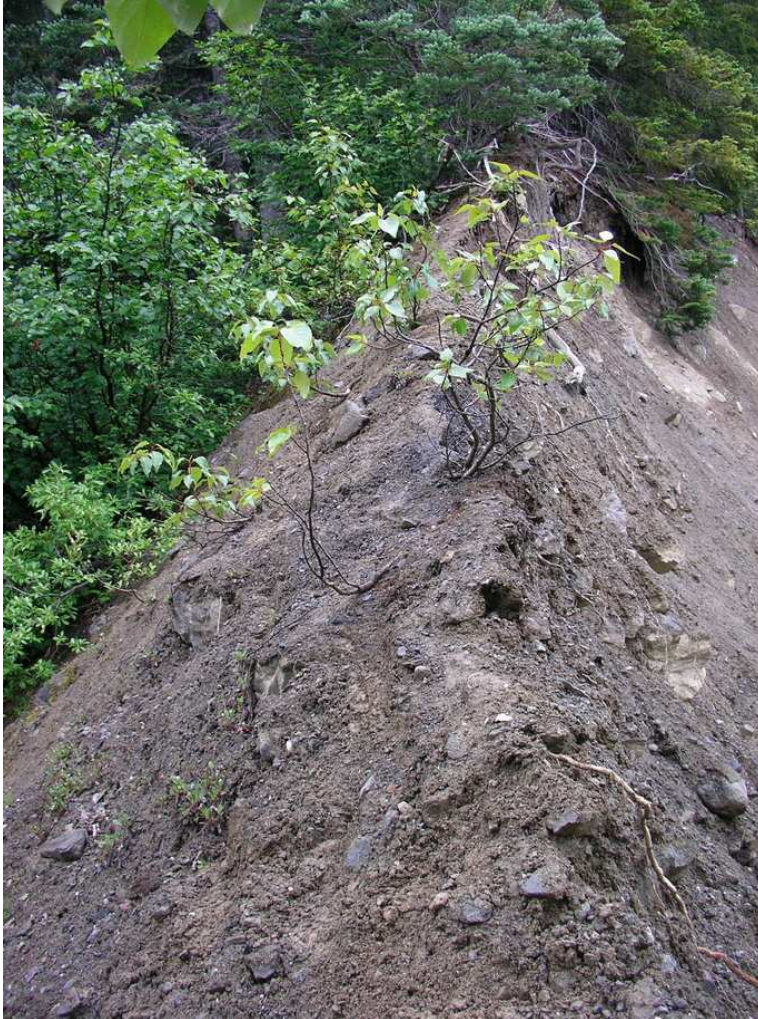
Photo 2.11 Eroded knife edge of 30 m high silty to sandy gravel. This is a moraine deposit situated over basal till and lacustrine silt layers at confluence of McTagg and Mitchell creeks.

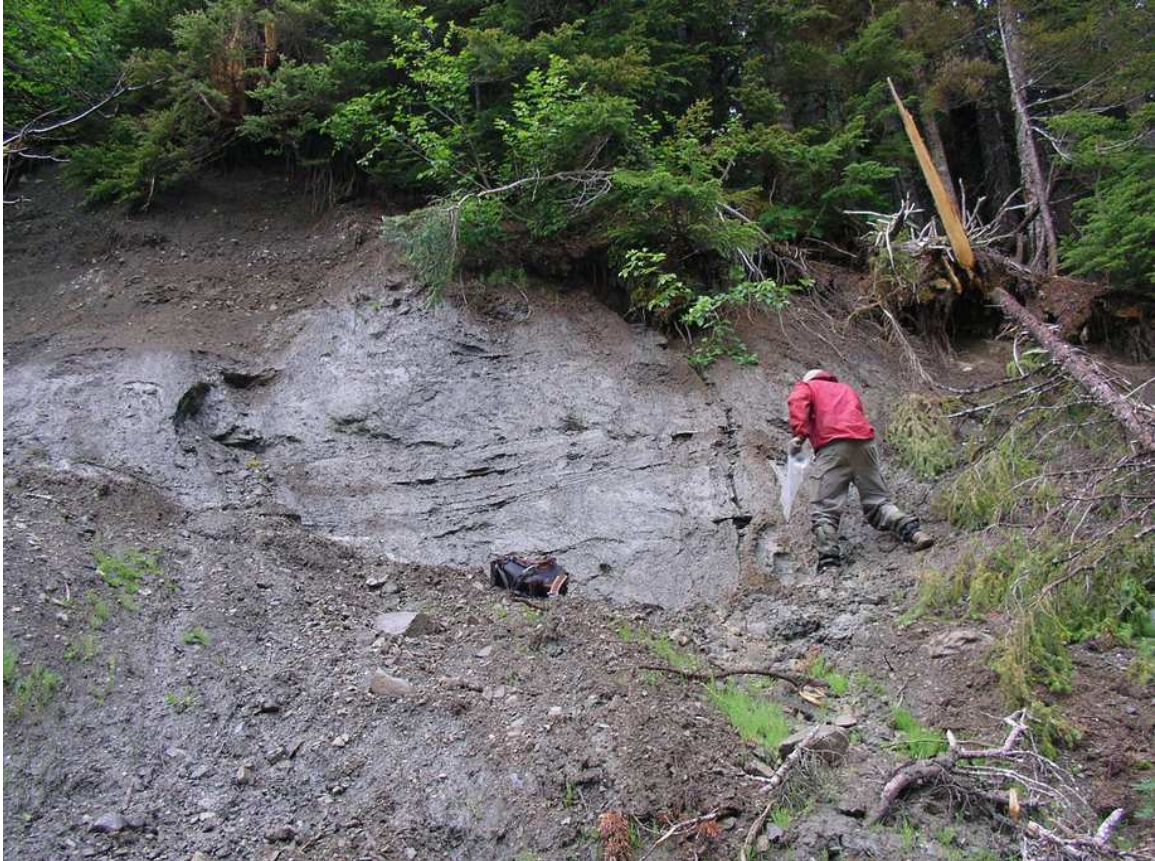
Photo 2.12 Dense, consolidated silty to clayey High Plasticity Lacustrine Deposit, Situated beneath Moraine Deposits, Valley Bottom at Mitchell-McTagg Confluence. Sample Site 37.

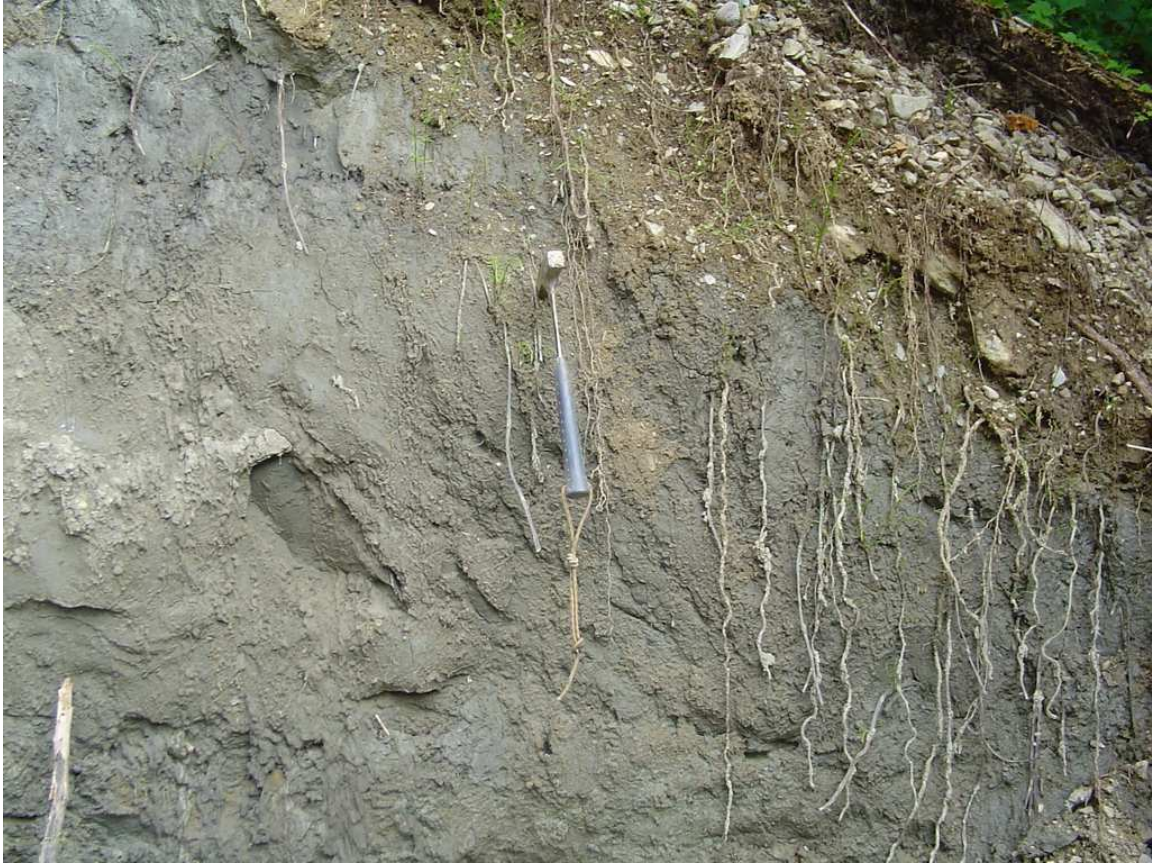
Photo 2.13 Fine grained, silty sand deposit located on west bank of Water Storage Pond – potential dam core material. 56.516368°N, -130.330842E.

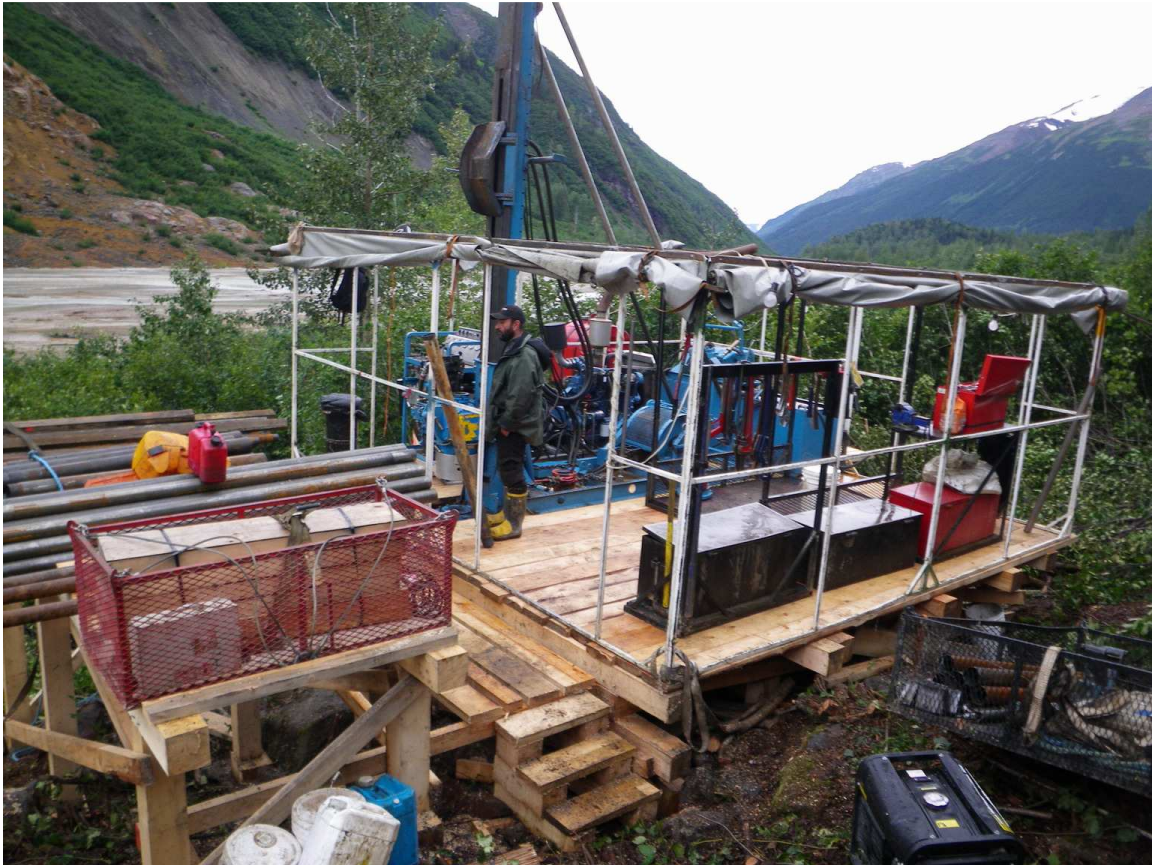
A heli-portable diamond drill rig was used to core triple tube HQ (61.1 mm ID, 96 mm OD) drill holes through the overburden and at least 20 m into bedrock. Adverse ground conditions at KC09-09 required the reduction to NQ (45.2 mm ID, 75.7 mm OD) triple tube coring below 36 m. To allow permeability testing and the possibility of future groundwater sampling, creek water with no additives was used as drilling fluid when possible. WDS drilling polymer was added to ease drilling in loose zones with high rod friction and for areas of poor core recovery. Holes were cased with HWT casing as required, generally keeping within 3 m of the bit.

Figure 2.7 Hy-Tech Geotechnical Drill Rig in Mitchell Valley at KC09-09

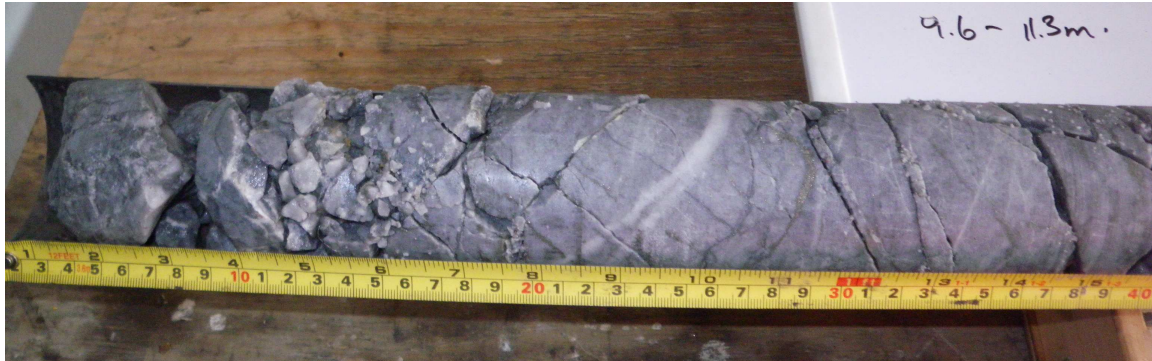
Photo 2.14 Volcanics from KC09-07 Depths of 9.6 m to 10.0 m.

The volcanics consisted of highly altered and weathered, moderately oxidized, fine-grained intermediate volcanic rock with subhorizontal to 45° dipping quartz veins throughout and significant pyrite mineralization. Most discontinuities dipped at 40° to core axis, joints were rough and undulating. RQD in the bedrock was typically lower than 30% down to 16.5m depth, indicating a near surface area of highly fractured rock.

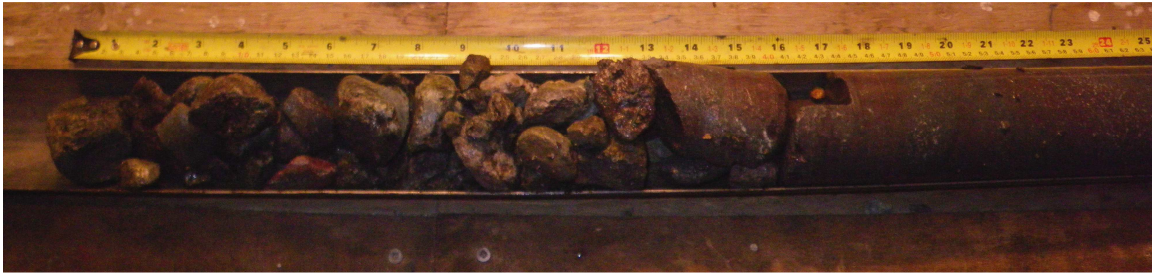
This drill hole was situated to test foundation conditions for the Mitchell Process Plant. 28.4 m of compact moraine material was present over bedrock. Moraine units (cobbles, some gravel, trace boulders, washed out matrix) were similar to those in KC09-07, which is 450 m to the southeast.

Photo 2.15 Moraine and Boulder Intersections in KC09-08 at Depth 3.0 m.

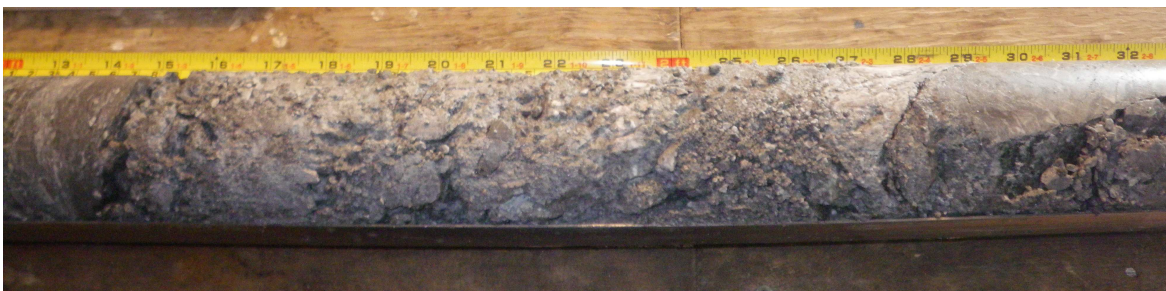
RQD varies and reduces at depth due to several fractured and faulted zones likely corresponding to the Sulphurets Thrust Fault at depth of 43.6 m to 44.8 m.

Photo 2.17 KC09-08 Fault Zone Consistent with Location of Sulphurets Thrust Trace. Depth 44 m.

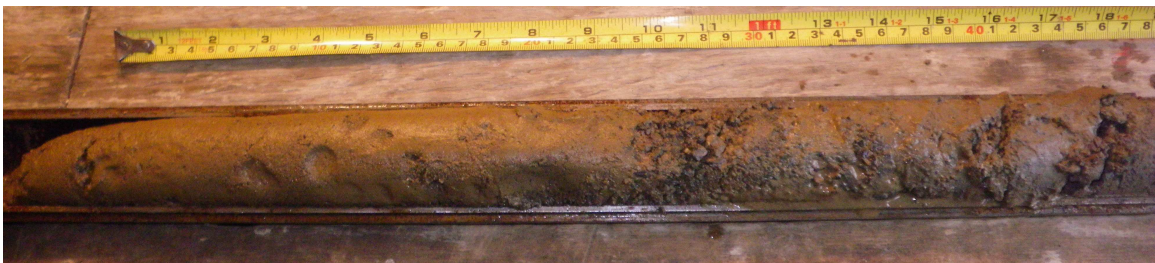
93.6 m of overburden was encountered in this drill hole. From surface, materials consisted of 9.5 m of boulder moraine, followed by gravels with some sand (27.3 m) and clay layers to 68.7 m where a thin (35 cm) sequence of clay and silt was present over a 2.7 m thick sand layer, another 1.5 m gravel layer and a 1.5 m sand layer. Gravel was then encountered to bedrock at 93.6 m.

Photo 2.18 KC09-09 50 cm thick Sand Layer at 27.3 m depth.

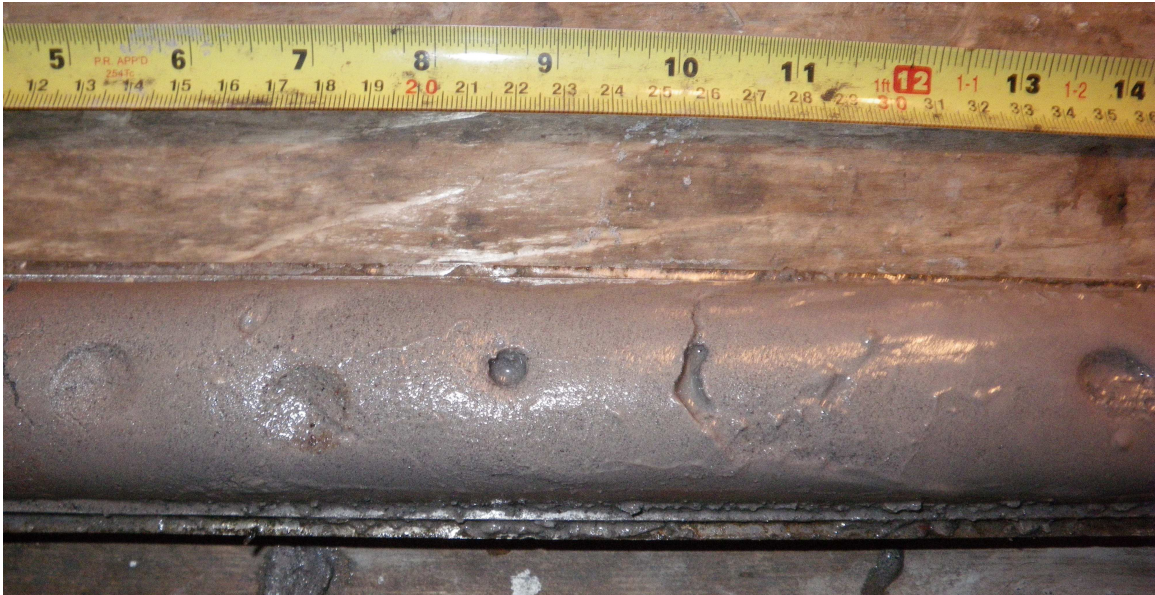
It is interpreted that these sands and clay layers corresponded to a thinning and pinching out layer of lacustrine deposits, corresponding to the thicker lacustrine layers seen to the east in KC08-03 at similar or deeper depths. These deposits likely formed due to valley damming landslides, possibly related to the knoll in Mitchell Valley.

Photo 2.19 KC09-09 2.5m thick layer of Silty Fine Sand at 73 m.

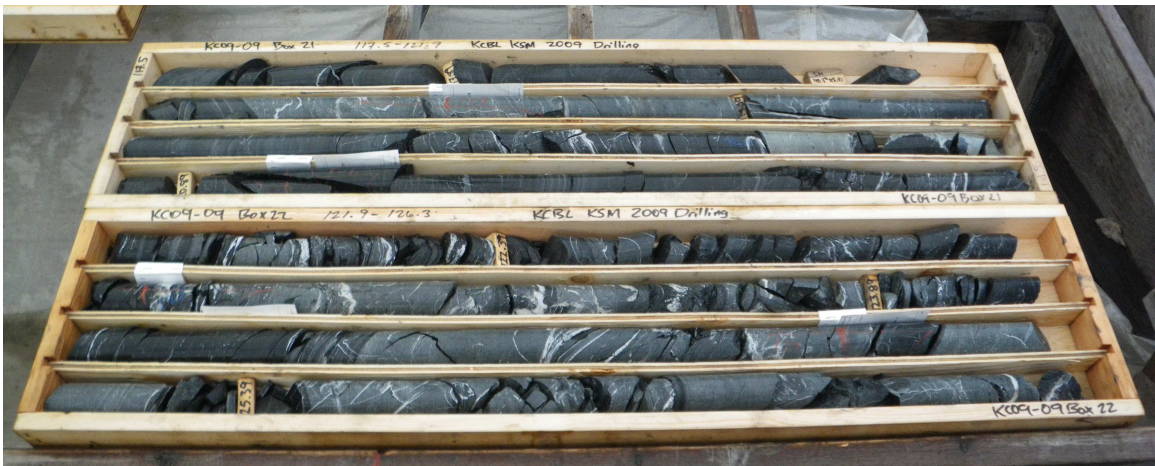
The bedrock encountered at 93.6 m is argillite, massive to finely laminated with interbedded light grey calcareous siltstone, medium strong, fresh rock mass, black with calcite and quartz veins throughout. Discontinuities are generally present along bedding planes dipping at 45° to 60° to core axis.

Photo 2.20 KC09-09 Argillites with quartz veining, Depth 117.5 m to 126.3 m.

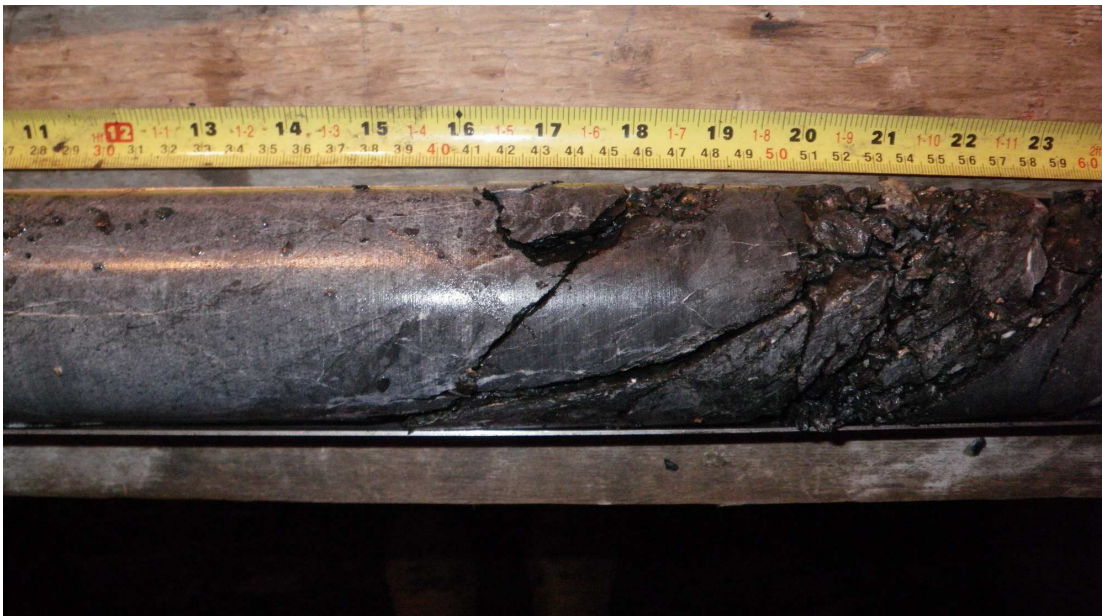
Photo 2.21 KC09-10 5.5 metres, Fine to Medium Grained Metasedimentary Units.

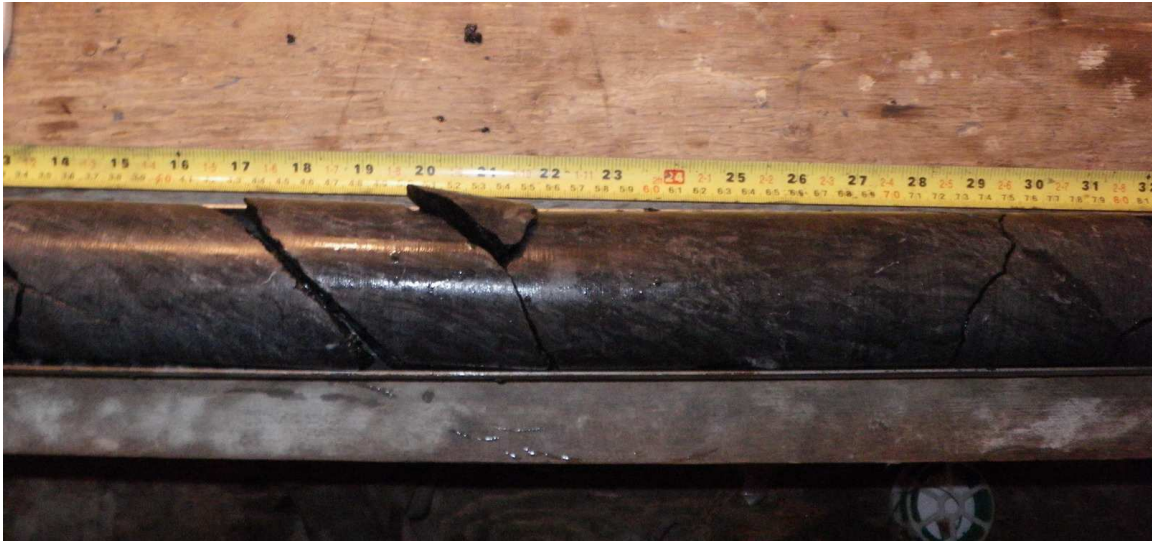
Photo 2.22 KC09-10 7.5 metres, Fine to Medium Grained Metasedimentary Units.

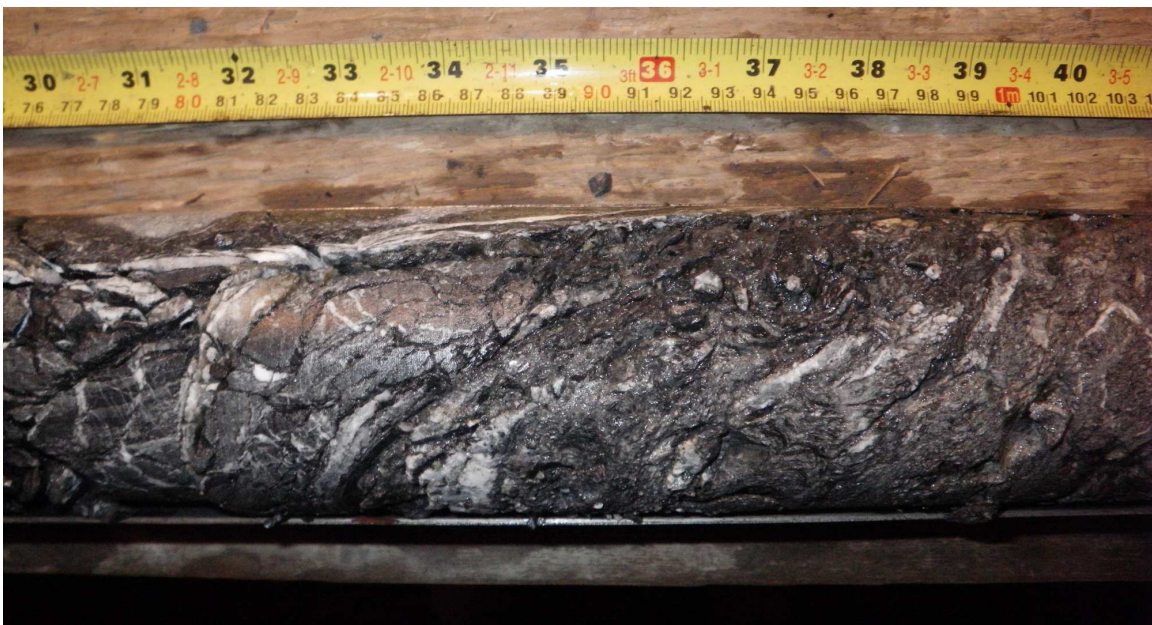
Photo 2.23 KC09-10 15.5 m Clay Gouge Layers in Weathered Fault Zone within Metasediments.

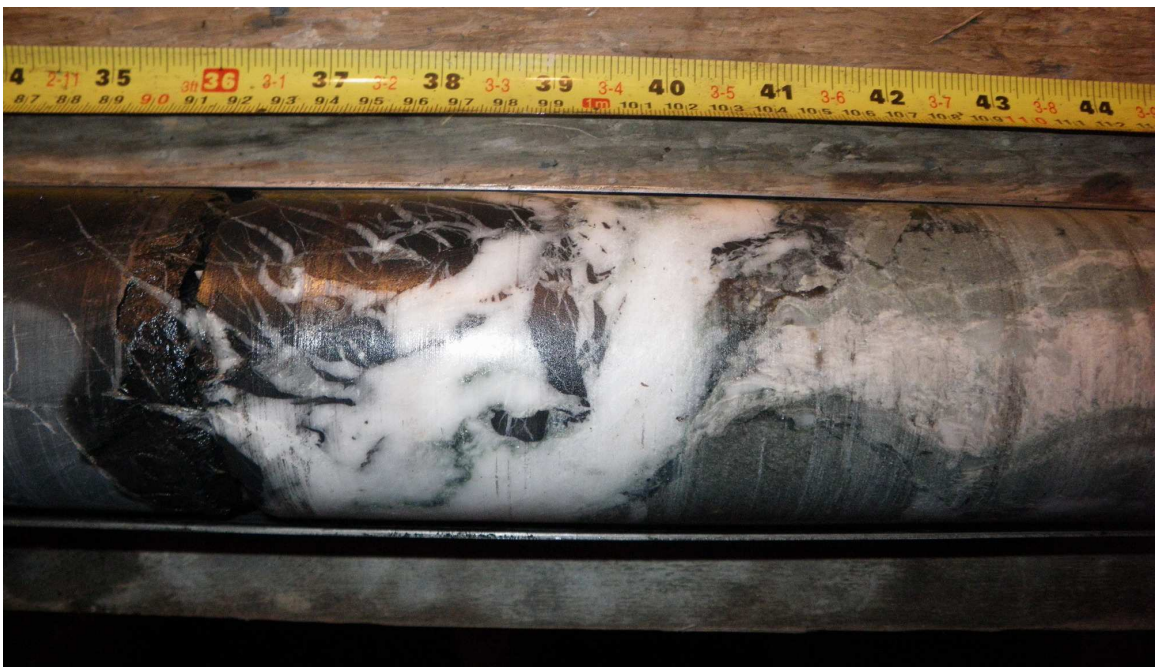
Drill hole KC09-11 was completed in the southwest toe of the Sulphurets RSF. A thin layer (1.2 m) of overburden was present over strong laminated argillites. Occasional 1 m to 2 m thick intrusive dykes of granodiorite were present in drill hole KC09-11 which was otherwise argillite, and metasandstone units. Quartz veining is abundant (Photo 2.24) along with pyrite mineralization. The argillitic sediments are typically strong to medium strong. Permeabilities ranged from 2 E-06 m/s in a fractured zone, to 8.4 E-08 m/s in a area of little fracturing.

Photo 2.24 KC09-11 8.5 m, Argillite with Quartz veins adjacent to Intrusives.

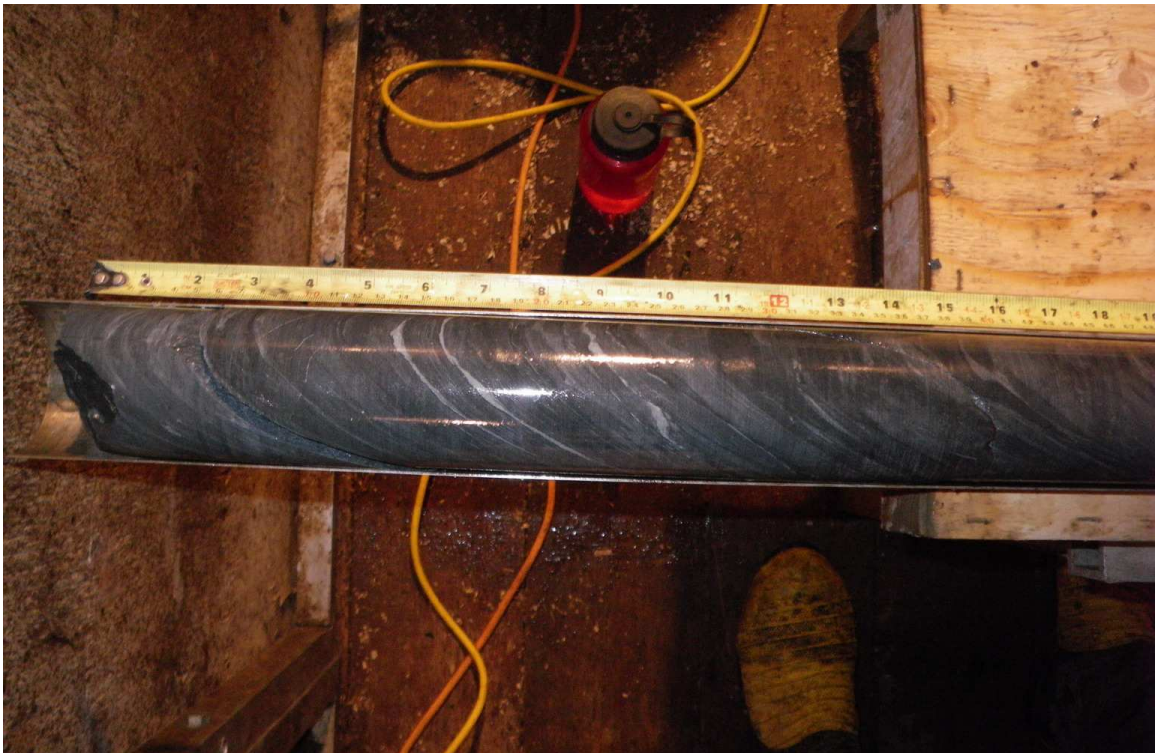
KC09-13 was located approximately 300 m downstream of the proposed dam centreline, on the west bank. This drill hole encountered a localized surficial pocket of 6 m of gravelly overburden over argillitic sediments and siltstones. Surficial weathering within bedding planes was noted to depths of approximately 7 m, below this the rock was relatively massive to 29 m where a 0.4 m fracture zone and quartz veining was intersected. Several intrusive dykes were intersected at 42 m to 53 m. A thick intrusive sequence is present between 55 m and 71 m. The presence of a one meter sequence of highly fractured argillite at 71.3 m resulted in the loss of circulation and difficult drilling conditions. With the use of gel, circulation was restored and relatively unfractured intrusives were drilled between 73 m and 76.5 m. Other than this 1 m fractured zone, unfractured regions of the rock mass are generally of low permeability (packer 8.7 E 8m/s at 14 m to 23.9 m, falling head 3.68 E-7 at 11.3 m, 6.3 E-7 m/s 36 m to 54 m). The finely bedded nature of the rock and the alteration of fractured and unfractured sequences visible on the surface suggests that the formation will have significant

Photo 2.26 Typical Core from KC09-13, bedded argillite with quartz veins (10.5 m to 11.0 m).
