**KEYYASK TRANSMISSION  
AQUATIC ENVIRONMENT  
TECHNICAL REPORT**

OCTOBER 2012

# KEYYASK TRANSMISSION

## Aquatic Environment Technical Report

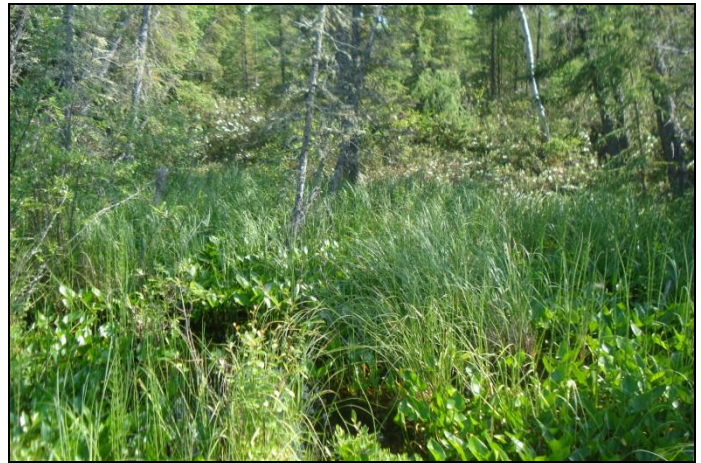
Photo 4. Downstream of dam.

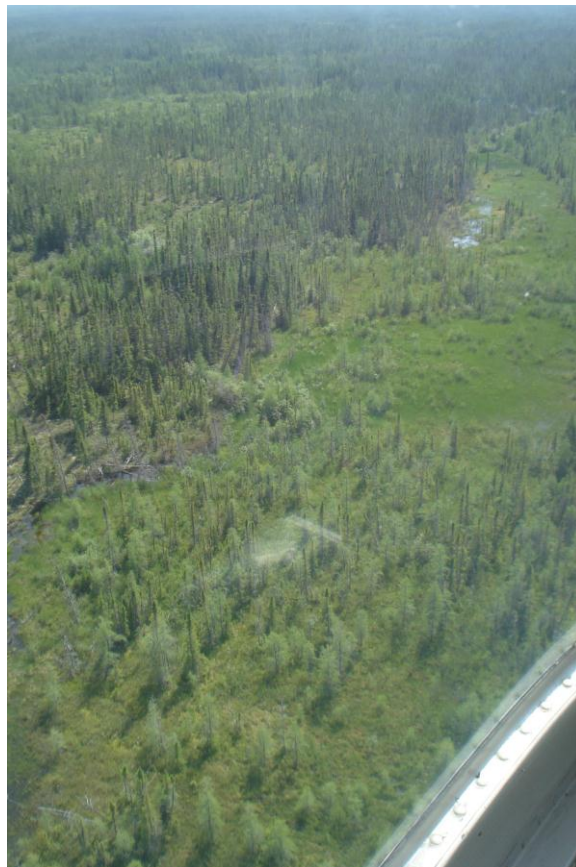
Photo 2. Large ponds located 800 m downstream of Site 43.
