**NEW GOLD RAINY RIVER MINE
APPENDIX K
EXCEEDANCE LETTERS
SUBMITTED TO MECP**

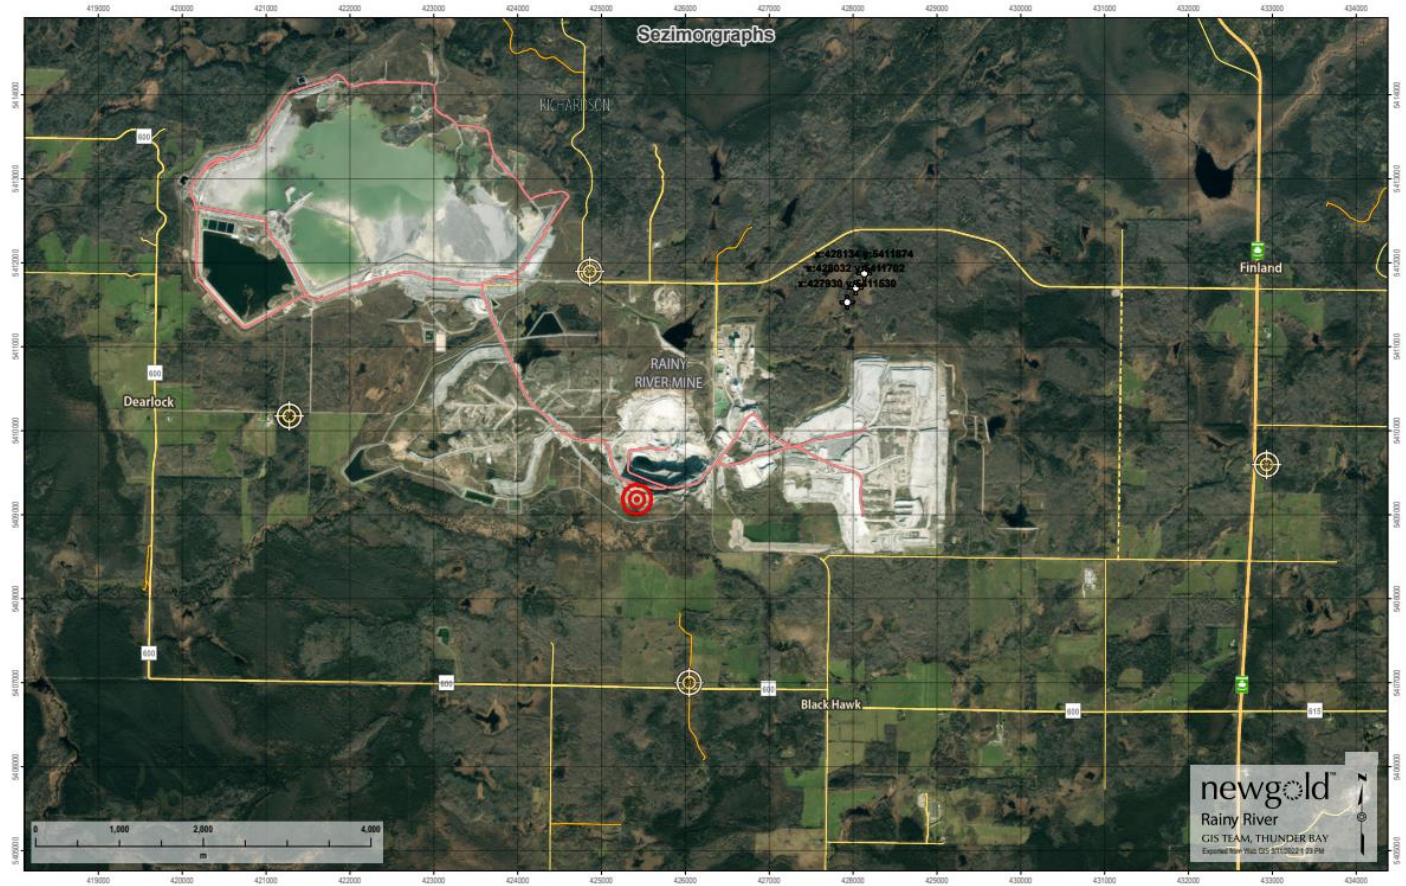
- 1- The blast was known as a frost shot, this term is used when frost has been driven into previously blasted material to the point that it cannot be handled and loaded. The holes for a frost shot are much shallower than a typical production shot.
- 2- The blast was at a higher elevation than any blast prior, except for the original ramp that dropped into the pit below the original Laydown 7 lookout.
- 3- The sky was overcast on Saturday March 5th, which amplified the effect of the sound of the blast.
- 4- The timing in a frost shot needs to be quite a bit faster than a production shot which also increase the vibration/sound of a blast.
- 5- There was a northerly wind the day of the blast which explains why the southern most instrument detected higher levels whereas the other 3 instruments did not read levels over the peak limit of 128.0 dB(L).

Figure 1. Plan view of RRM showing the location of Explotech sensors and blast location

Frost shots at this elevation are a very rare occurrence and are not likely to occur again in the near future. Should the need arise to do another frost shot, a smaller blast with a longer delay will be planned and communities will be notified. If possible, the blast will be delayed if there are overcast conditions at the time of the blast as well. No blasts since 2022-03-05 have triggered an exceedance.

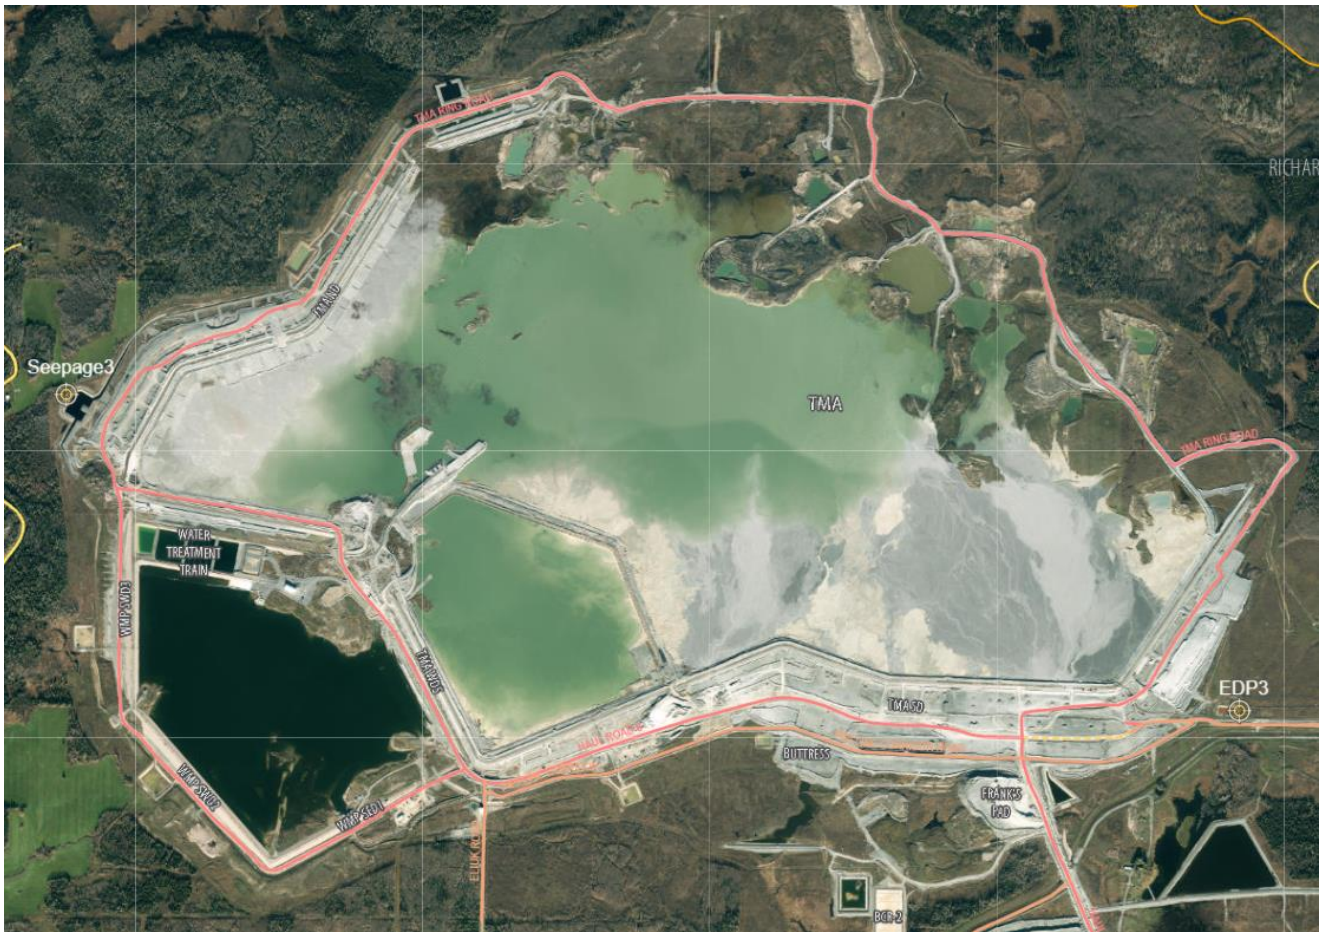
The quantities of the MDMER Section 3 prescribed deleterious substances, as calculated mass loadings utilizing the mass loading formula in MDMER Section 20(1), are provided in Table 2. The location of the deposit at EDP3 at zone 15U E424399.06, N5411825.73 and at Seepage3 at zone 15U E419979.45, N5412951.80.

Figure 2 Seepage3 and EDP3 locations around Tailings Management Area.

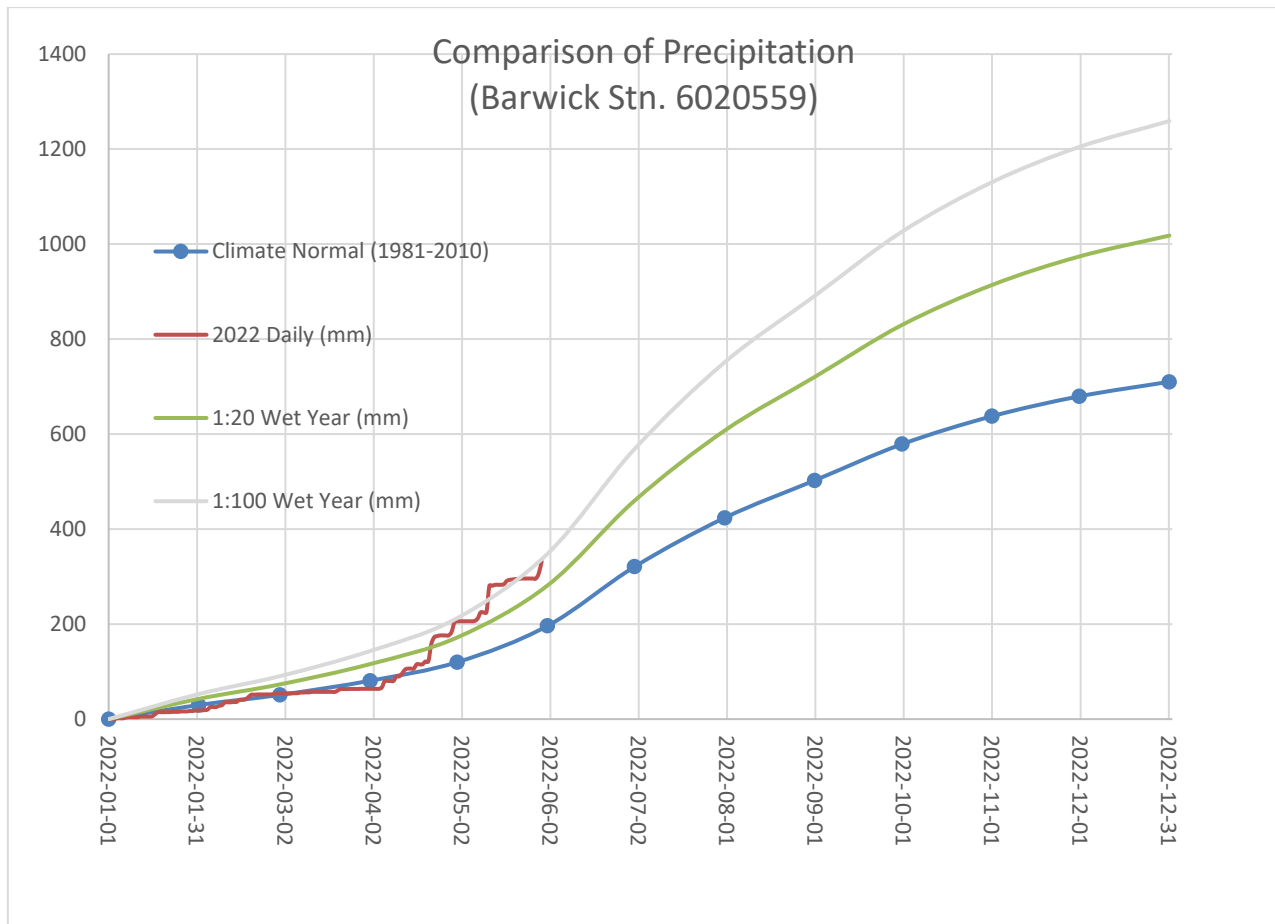
The region had been experiencing higher than average rainfall for the month of April which led to oversaturated ground conditions. On April 23 and 24, 2022, Rainy River Mine experienced a rain event of 81mm over 48 hours. Due to the saturated ground conditions, all water from this rain event reported directly to our infrastructure and overwhelmed the pumps at these sites.

Figure 3 Current precipitation compared to climate normal and Wet Year classifications.

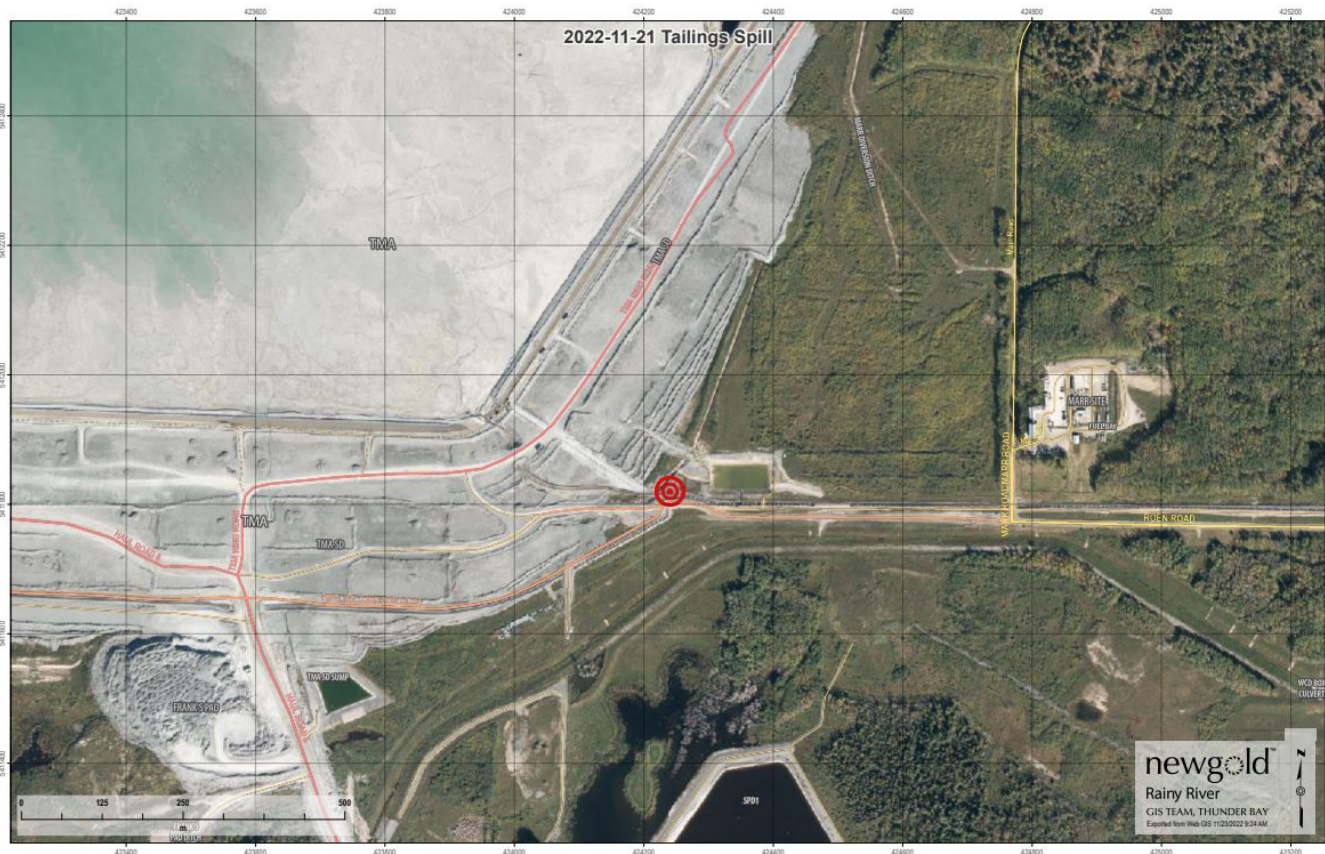
Figure 1: Location of Spill

No sampling was completed due to the consistency of the tailings outside of containment. All tailings that did not report to containment were collected with a HydroVac truck..

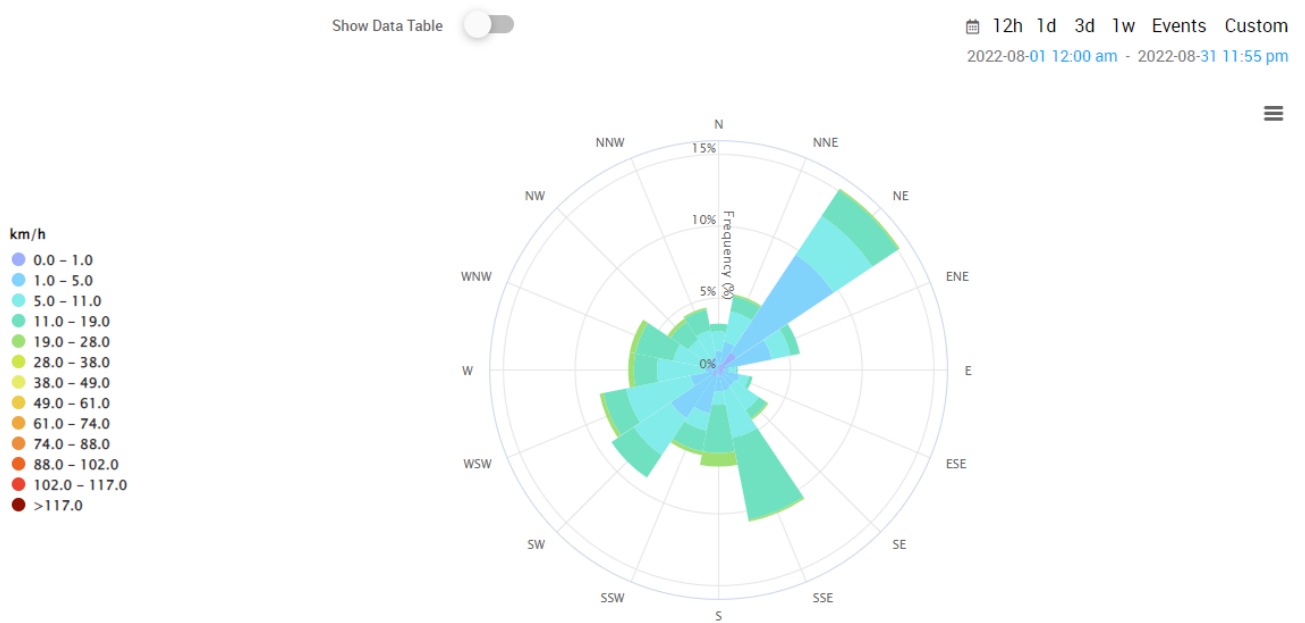
The sources of the August 2022 dustfall exceedance at South station are difficult to determine due to the mixed wind direction and velocity. Dust from the primary crusher to the North of the station could have been a factor, as well as dust created by the road material crusher or EMRS dumping to the Northeast. Public traffic also likely contributed. Dust suppression water trucks were available and in use on site during that time.

Figure 2: Barron Site weather station wind velocity and percentage for the month of August 2022.

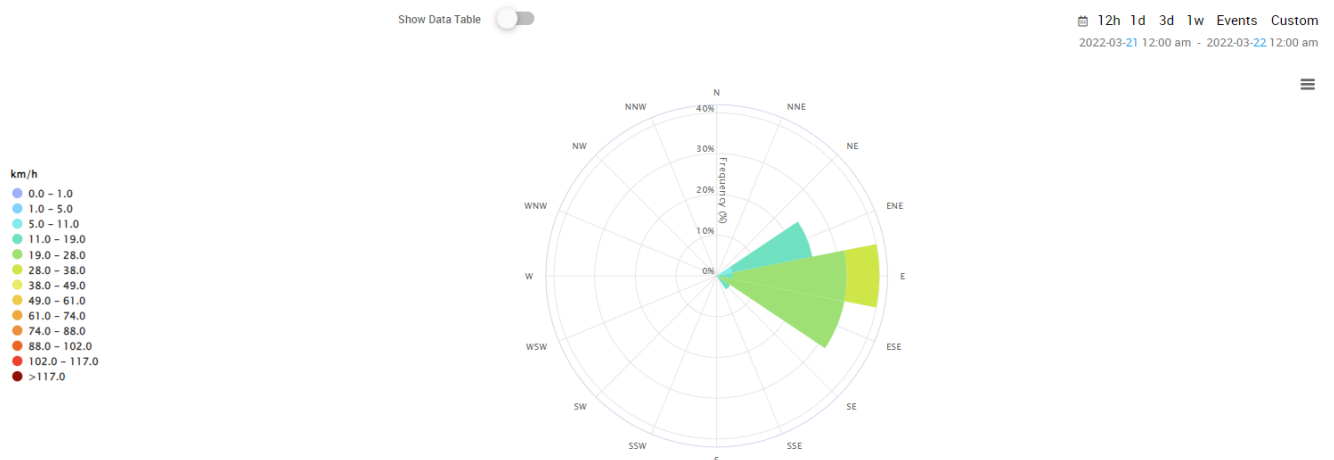
On March 21, 2022, the primary wind direction was from the East to Southeast so is expected to have come from public traffic on Tait Road/Highway 600 realignment.

Figure 1 shows Barron Site weather station wind velocity and percentage on March 21, 2022.

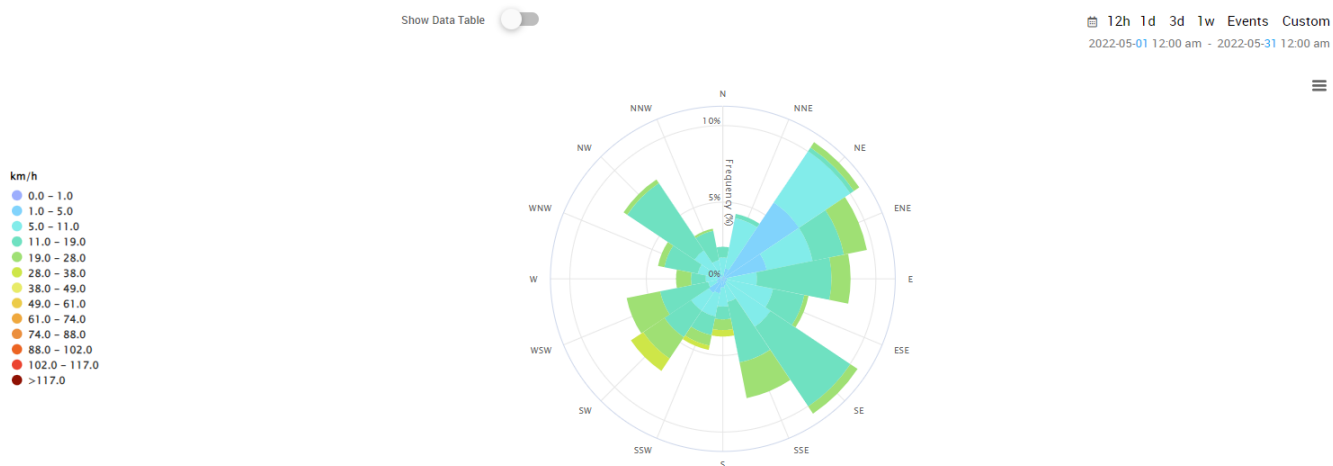
The sources of the May 2022 dustfall exceedance at Northwest station is difficult to determine due to the mixed wind speed velocity. The sources could be partially mine site related as well as public traffic related depending on size of plume and wind velocity. The elevated dust related activity happening within the Tailings Management Area at Rainy River Mine during that time was contractor mobilization and commencement of the Stage 4 TMA Dam Raise. Dust suppression water trucks were available and in use onsite during that time period.

Figure 2 shows Barron Site weather station wind velocity and percentage for the month of May 2022.
