**RE: COPPER SULFATE 40KG SPILL - SAC REFERENCE # 1661-B8VTYV**

New Gold Rainy River

RE: KOMATSU EXCAVATOR 450L HYDRAULIC FLUID SPILL - SAC REFERENCE #6704-B9C2VG

**RE: COPPER SULPHATE 30KG SPILL - SAC REFERENCE # 2828-B9SKZ5:**

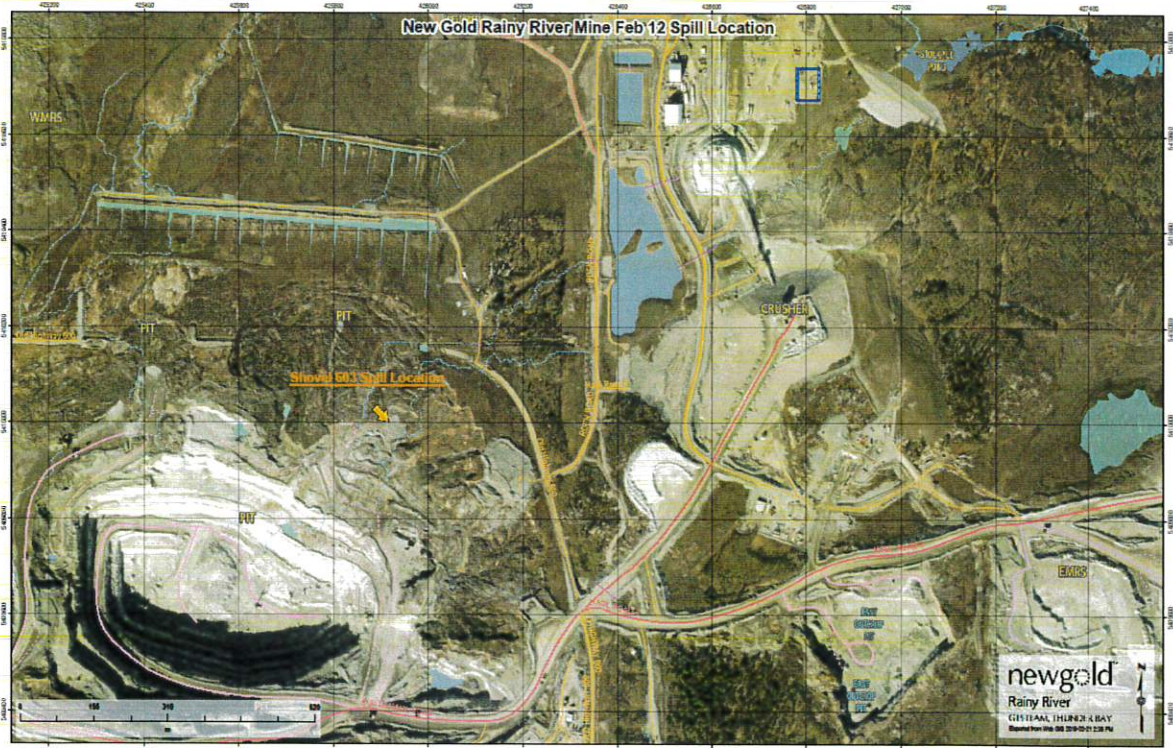
During the afternoon of February 12, while loading haul trucks on the 300 bench (photo 1) in phase 2 of the open pit, the Komatsu PC 8000 hydraulic shovel unit# 603 suffered a fracture of the main return line.

Photo 1. GIS image of Phase 2 of the Open Pit in relation to the plant and mine site. Yellow arrow indicates location of shovel and hydraulic fluid spill.

Leaking hydraulic fluid was noticed by the operator who immediately began to shut down the shovel. During the shutdown process approximately 450 L of hydraulic fluid escaped from the fractured hose line and spilled onto the pit floor. The leak was stopped, and cleanup of the spill began. (Photo 2).

Corrective actions include continuing with a regular preventative maintenance program, which is designed to identify and replace defective equipment before failures occur.

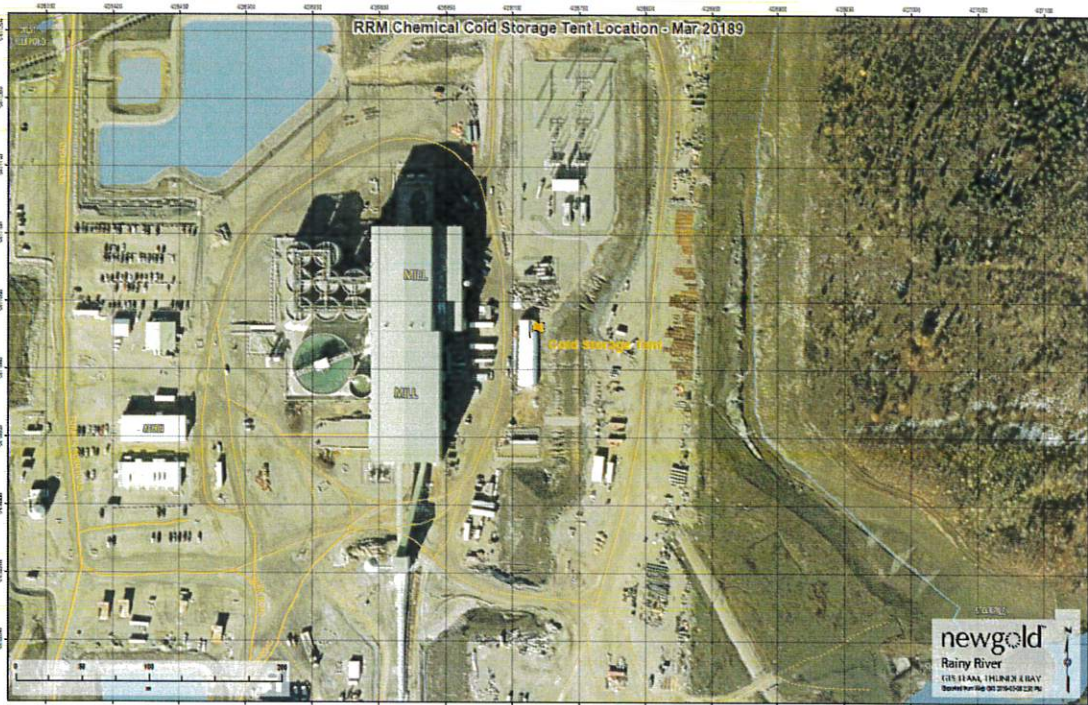
Further to the notification to the Spills Action Center (SAC) Reference #2828-B9SKZ5; on February 27, 2019 at 08:50 hours, a copper sulphate spill was noted on the gravel/clay floor of the covered chemical cold storage tent east of the Mill (Figure 1). The original volume was estimated at 200 kg, but it has since been corrected to approximately 30 kg.

Figure 1. Plan view of plant site showing location of Mill and covered chemical cold storage tent.

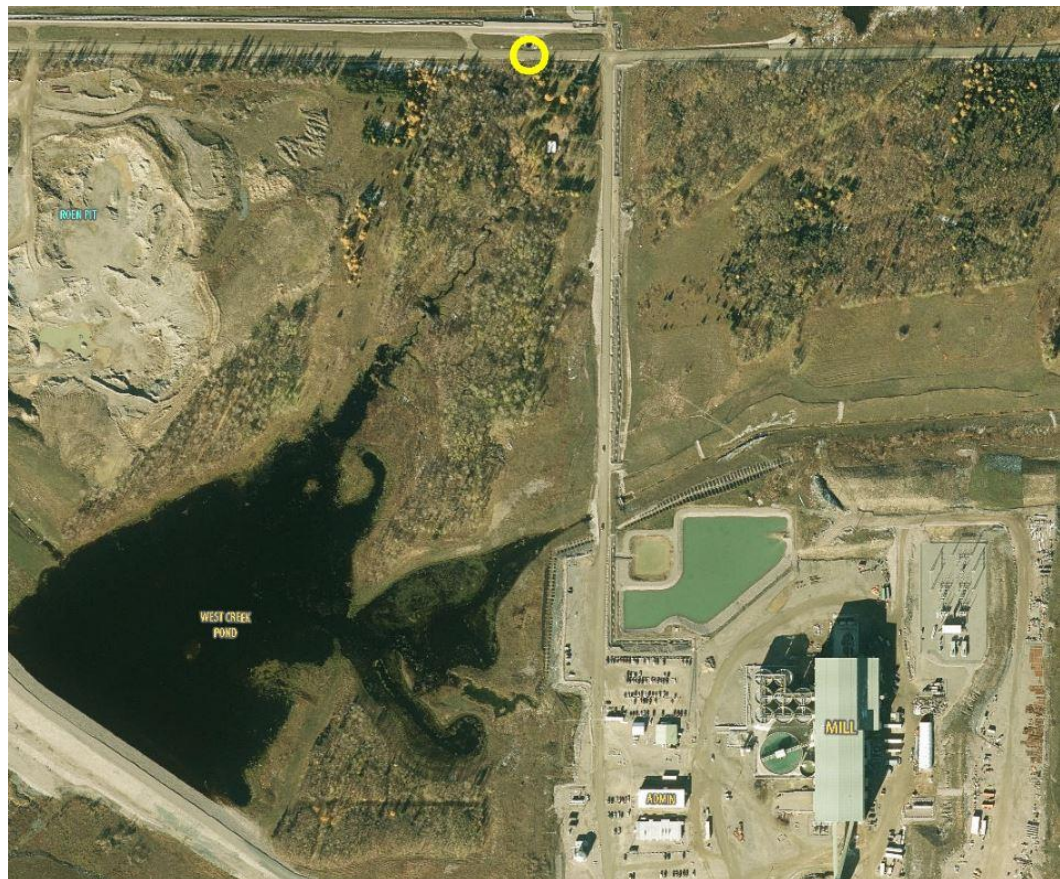
Further to the notification to the Spills Action Center (SAC) Reference #4364-BA7QQW; on March 12, 2019 at 12:00 hours, turbid water was sighted flowing through a culvert under Roen Road. Mitigation measures were installed, and the turbid water cleared up by 16:15 hours.

Figure 1. Plan view of plant site and West Creek Pond showing location of where the turbid water was spotted flowing under Roen Road.

The water flowing through the culvert appeared to be picking up sediment from road material that had thawed, eroded holes through the road bed and entered the watercourse at the upstream end of the culvert. Upon discovery of the turbid water, an in-field turbidity analyses was completed which determined the turbidity to be 77.9 NTU. Another sample was collected that was sent to a licensed external laboratory for total suspended solids and turbidity analyses which were determined to be 24.0 mg/L and 78.3 NTU, respectively.

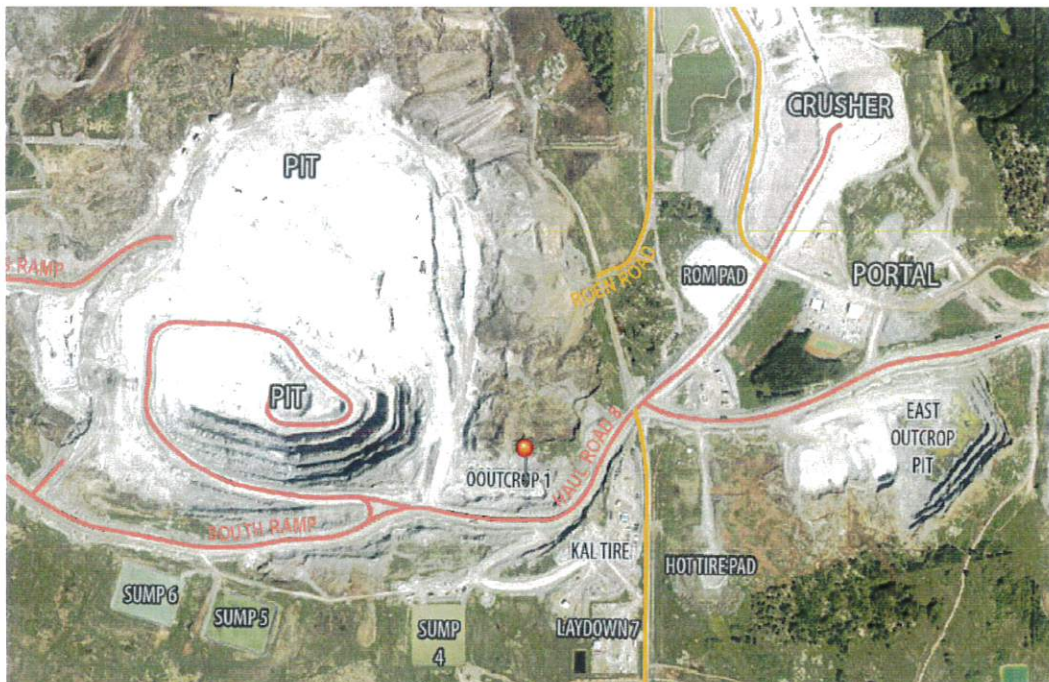
Further to the notification to the Spills Action Center (SAC) Reference #7470-BEK4MD: On July 29, 2019 at 00:30 hours, diesel fuel was sighted flowing out of a ruptured fuel line of an 830 Haul Truck at Outcrop 1 within the open pit. Mitigation measures were put in place and the spill was halted within 5 minutes. The cause of the spill was due to a rock hitting the fuel line of the haul truck. The haul truck has since been repaired.

Figure 1. Location of where spill occurred (Outcrop 1).

A 604 Shovel Operator noticed the diesel fuel spilling out of the fuel line of the haul truck as they were loading. Work stopped, and spill pads were laid down until spill containers could be put into place. Vacuum trucks were called to the scene to remove the fuel until the tank was empty. Approximately 120L of diesel fuel was spilled onto gravel. There are no nearby watercourses.

Approximately 5 yards of contaminated gravel was collected and placed in a contaminated soil bin for removal offsite by a certified hazardous waste hauler. See below photos of the spill area cleaned up. The area was returned to the original grade.
