Building Condition Assessment In-situ Decommissioning of Whiteshell Reactor 1 (WR-1)

WLDP-26000-REPT-011

Building Condition Assessment

In-situ Decommissioning of Whiteshell Reactor 1 (WR-1)

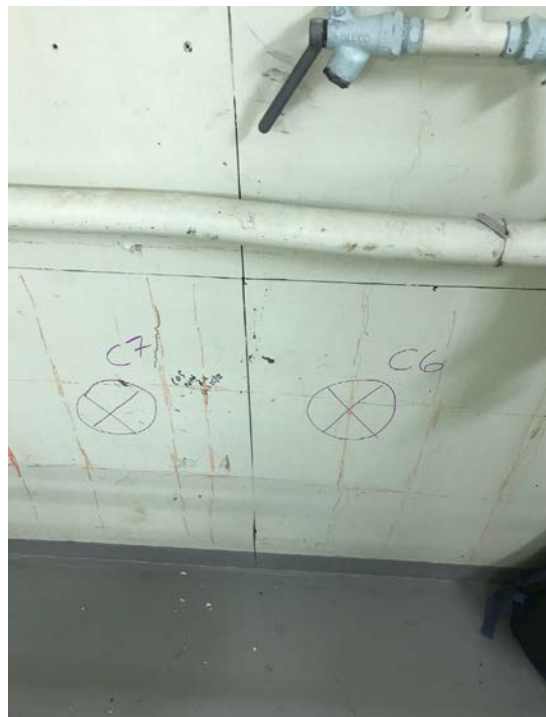
Location of Cores C6 and C7 after GPR scanning

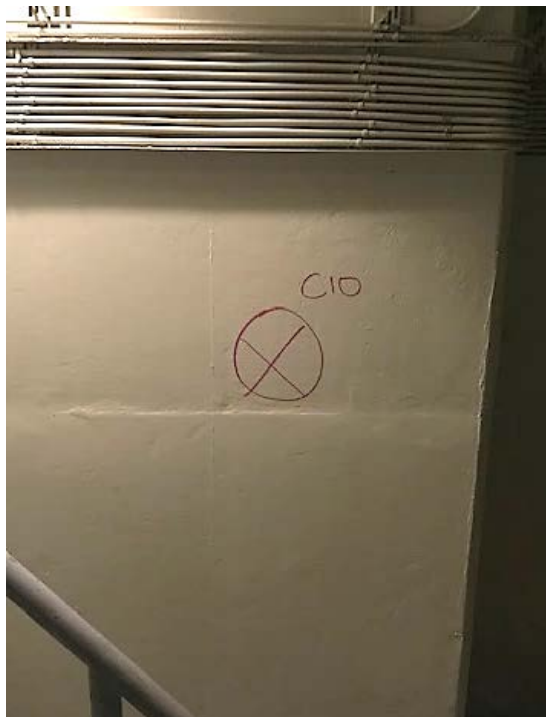
Location of Core C10 before GPR scanning

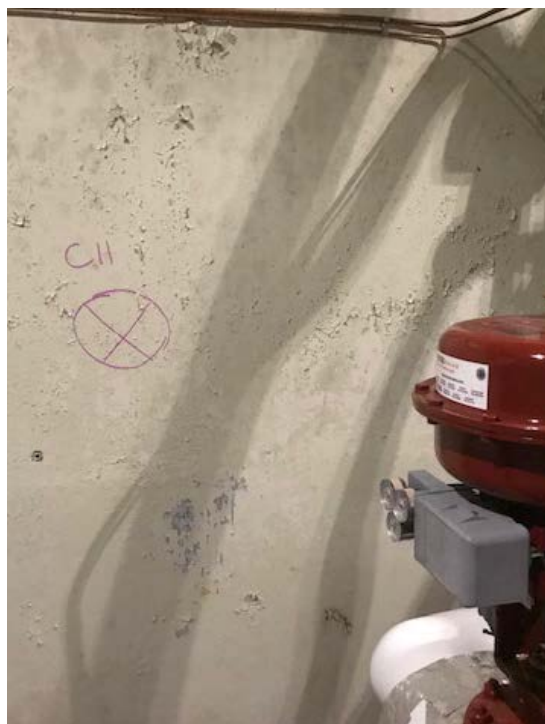
Figure A-5

Location of Core C11 before GPR scanning

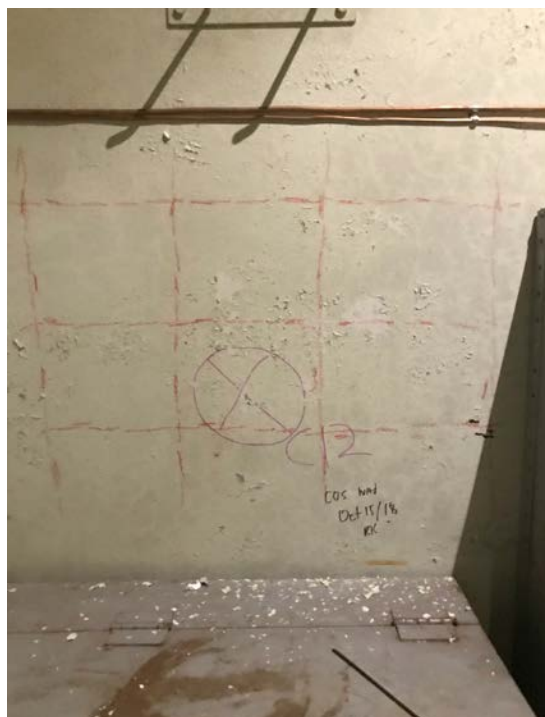
Location of Core C12 after GPR scanning

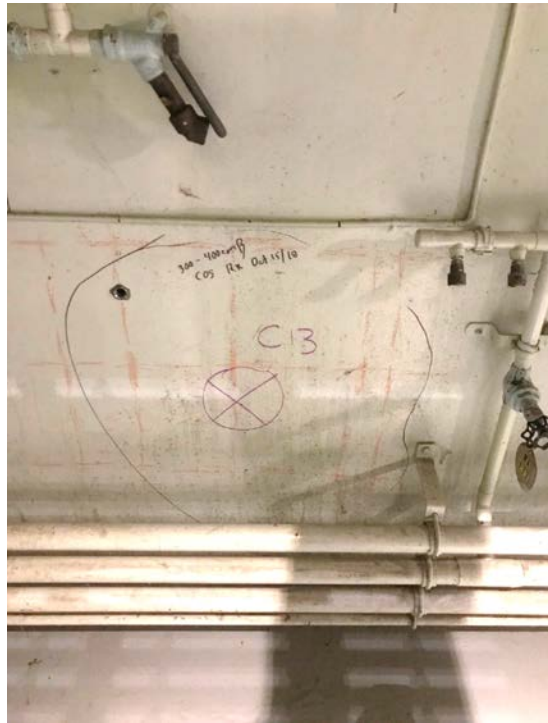
Figure A-6

Location of Core C13 after GPR scanning

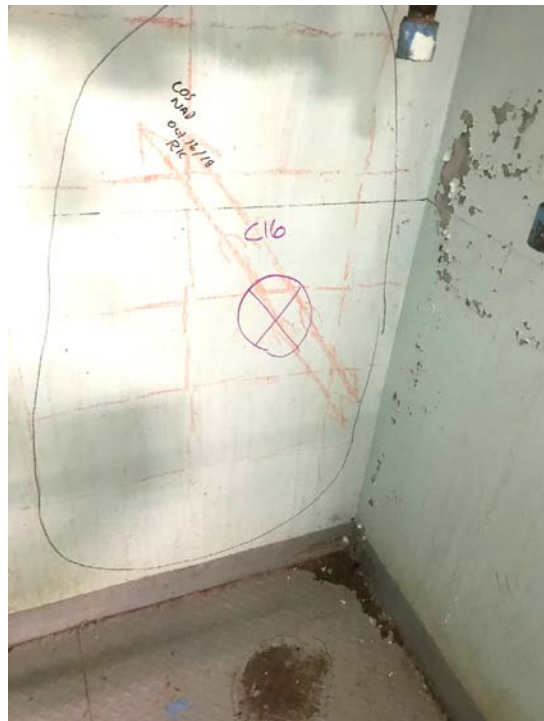
Figure A-7

Location of Core C16 after GPR scanning

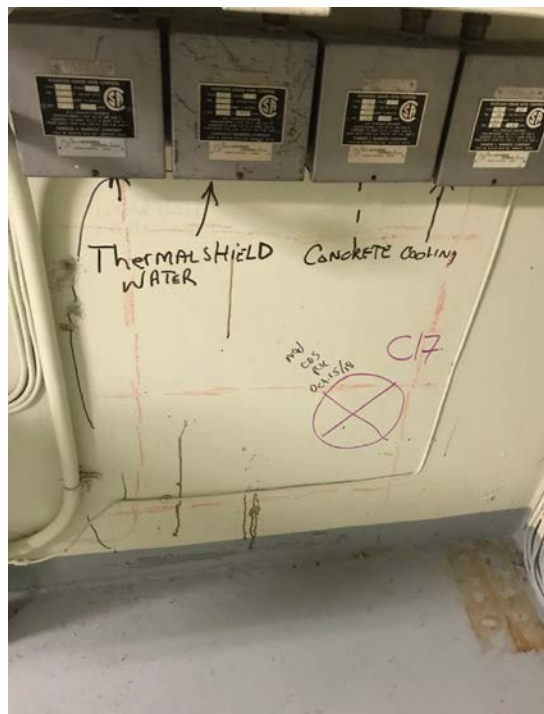
Location of Core C17 after GPR scanning

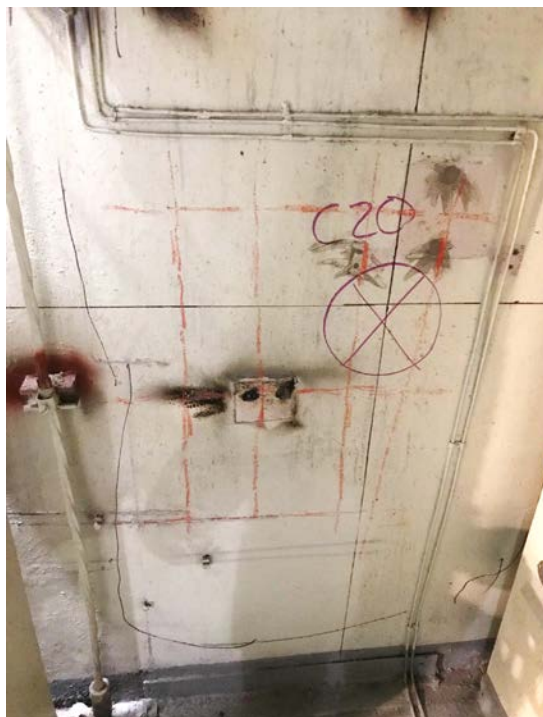
Location of Core C20 after GPR scanning

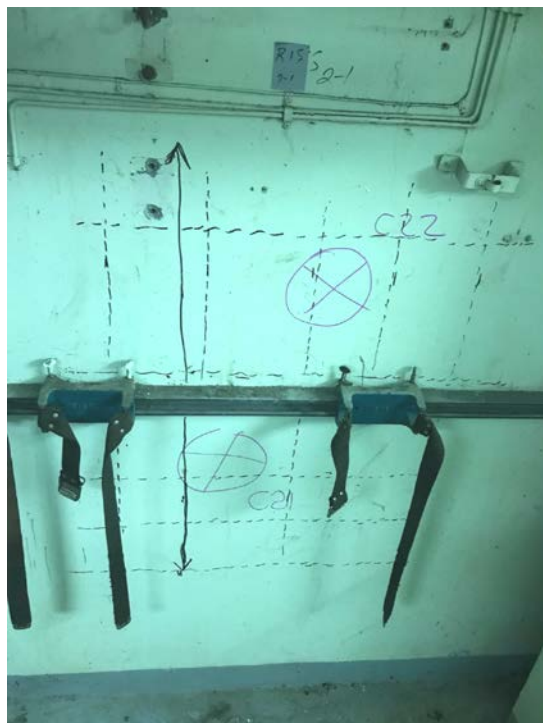
Figure A-9

Location of Cores C21 and C22 after GPR scanning

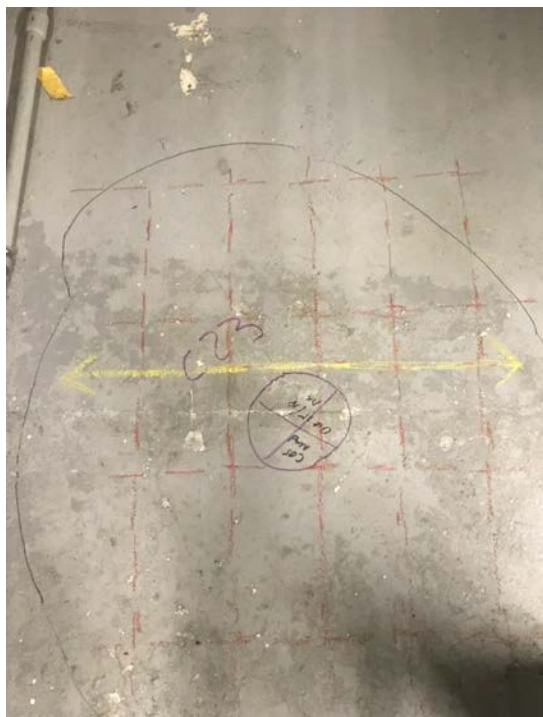
Location of Core C23 after GPR scanning

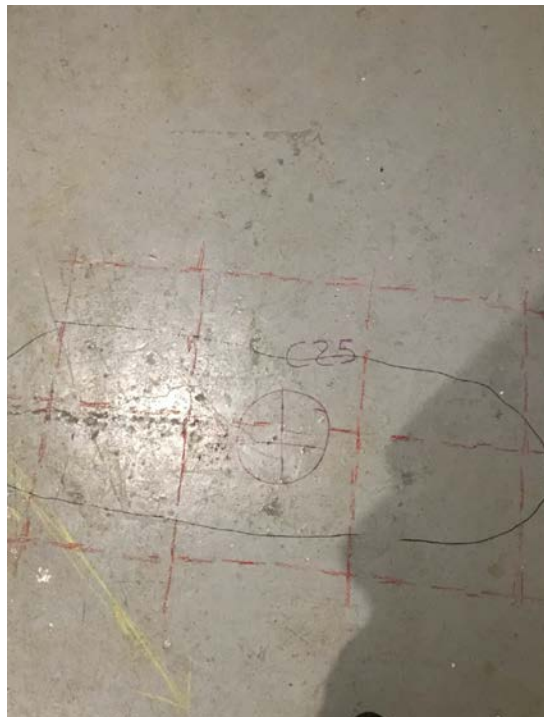
Location of Core C25 after GPR scanning

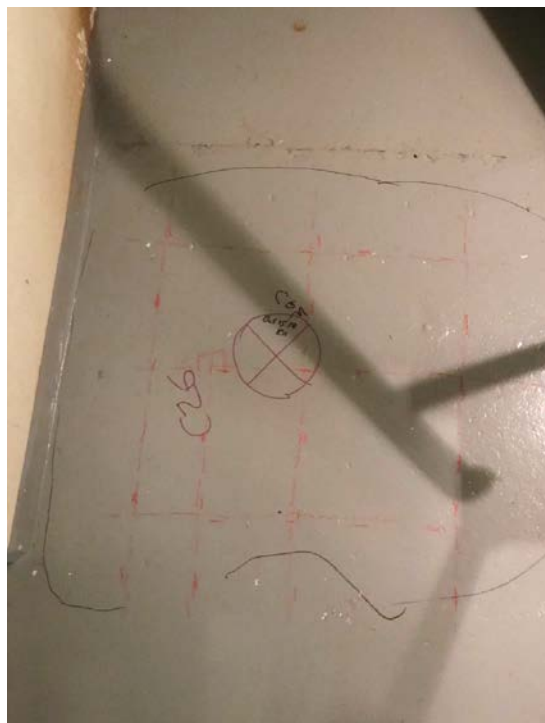
Figure A-11

Location of Core C26 after GPR scanning
