Lake St. Martin Emergency Outlet Channel
Assessment of Effects and Development of Offsetting

Physical Environment Supporting Volume (PESV)

May 2015

A report prepared for
Manitoba Infrastructure and Transportation
by
North/South Consultants Inc. and KGS Group

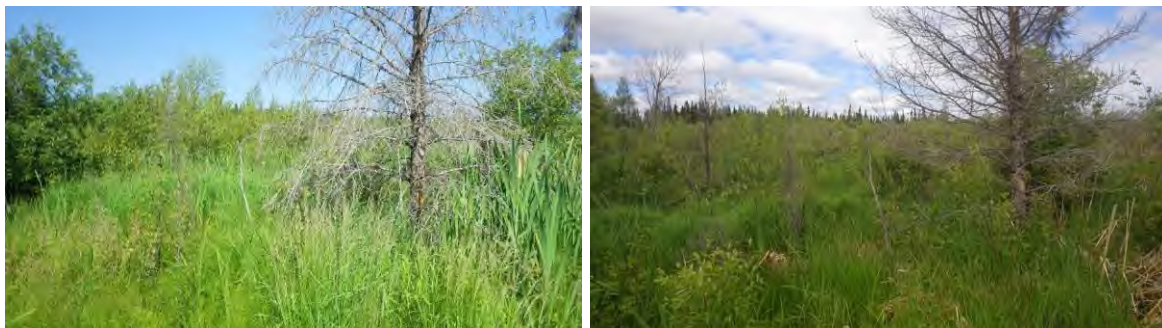
14+000-Left: Wet area above high water mark on left side in 2013 (left) and 2014 (right).

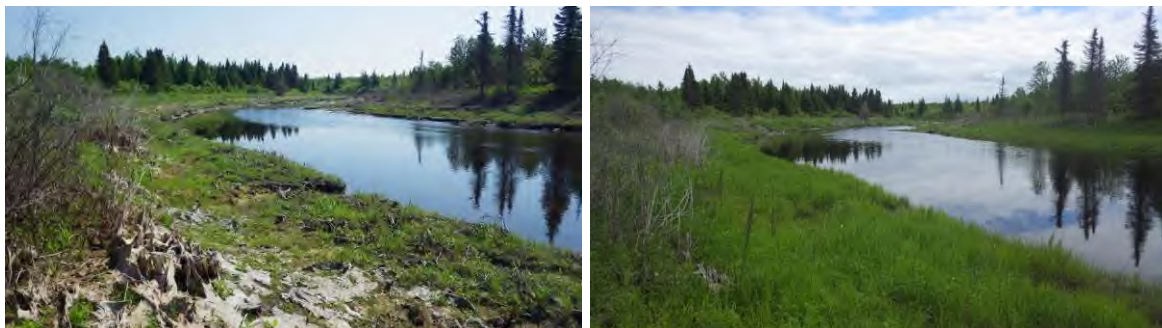
14+000: Looking downstream from left bank in 2013 (left) and 2014 (right).

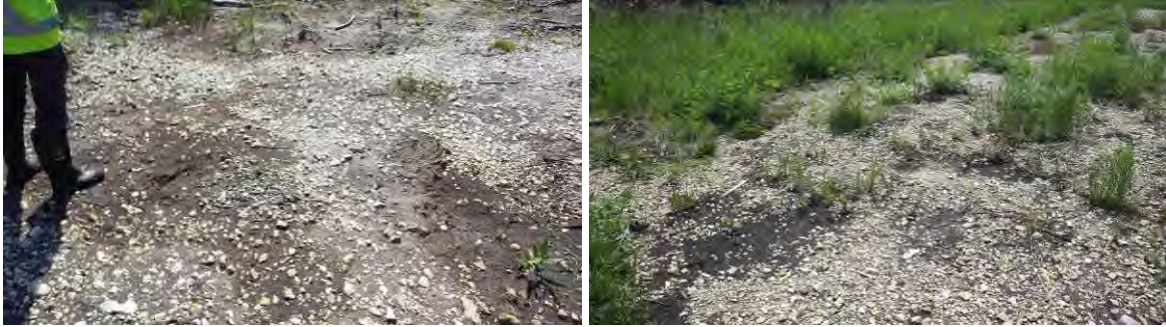
This transect runs in a northwest-southeast orientation. In 2013, the area nearest the channel was largely bare on both sides of the creek with exposed soil on the left side and exposed cobble on the right. Young grass species were starting to emerge. In 2014, much of this area was covered with grass and other herbaceous plants, but much of the exposed cobble on the right transect was still bare. Further away from the creek, there is a relatively thin strip of dead shrubs on both banks as the slope increases slightly. This was present both years, but grass was growing in the understory and through the dead shrubs in 2014. Beyond the slope and outside of the flooded area, both sides transitioned from largely shrubs to largely trees. Organic soils near the creek ranged from 0 (cobble) to 15 cm. Cobble appeared to be depositional. Some of the cobble was also overlain with depositional organic soils. Beneath the organic soils was silty clay and sand. At a creek bend upstream from 14+500, obvious signs of erosion and deposition were noted (photos below).

14+500: Bare area on right side of creek in 2013 (left) and 2014 (right).

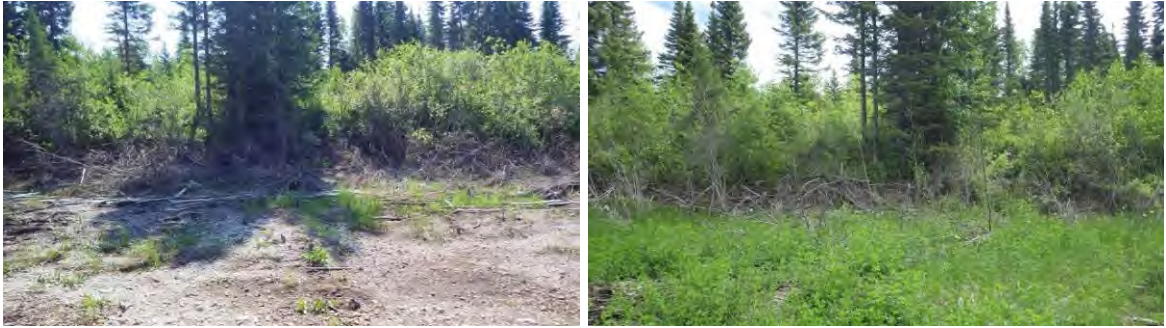
14+500: Right transect from creek bank in 2013 (left) and 2014 (right).

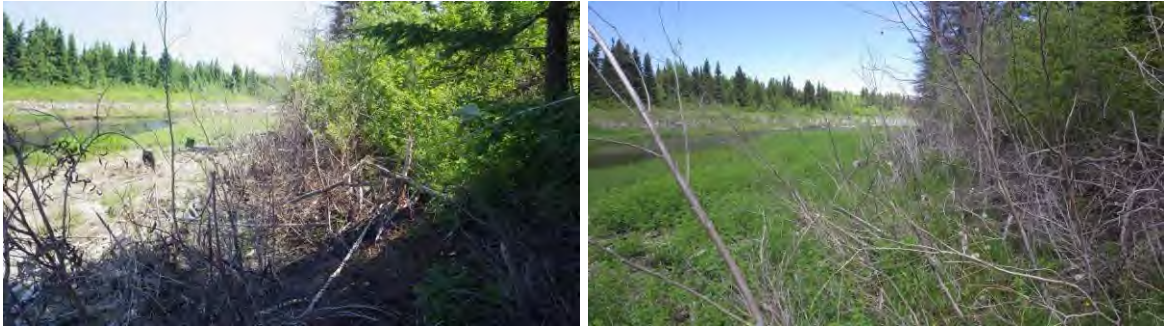
14+500: On right side of creek, looking downstream in 2013 (left) and 2014 (right).

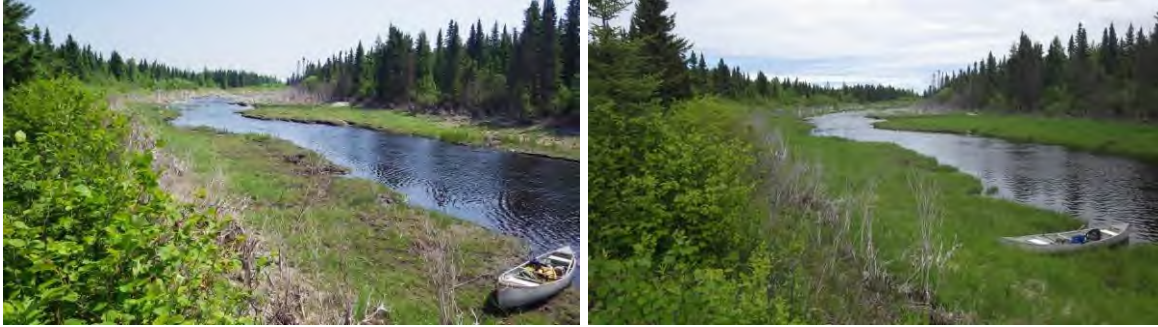
14+500: On left side of creek, looking downstream in 2013 (left) and 2014 (right).

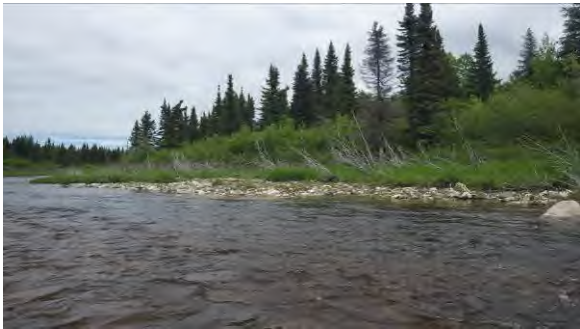
14+500: Erosion on right side approximately 175 m upstream from 14+500 (2014).

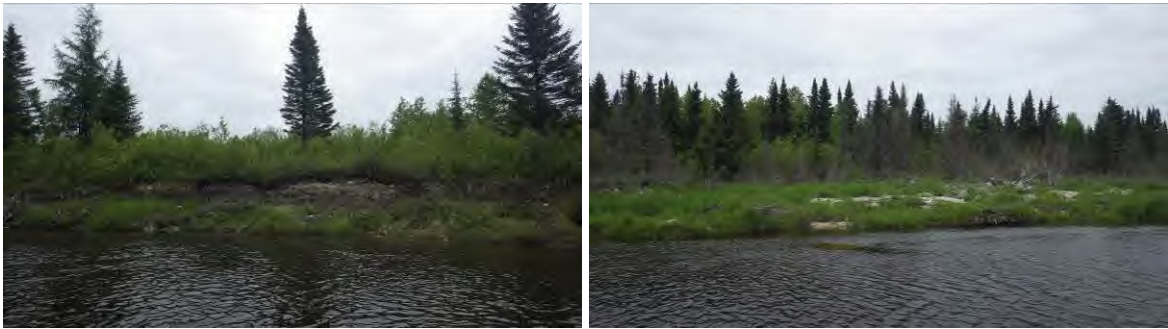
14+500: Erosion on left side (left) and deposition on right side (right) approximately 250 m upstream from 14+500 (2014).

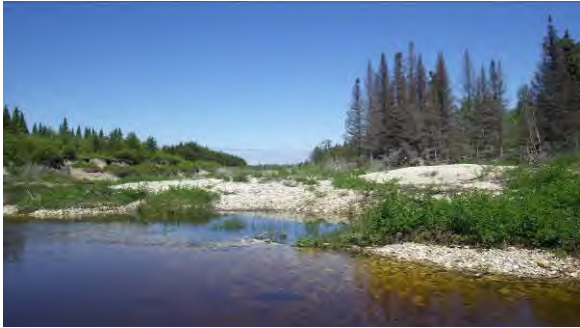
15+000: Deposition on right bank approximately 300 m downstream from 15+000 (2014).

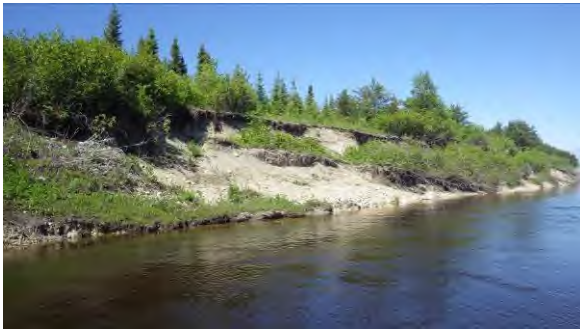
15+000: Erosion on left bank approximately 360 m downstream from 15+000 (2014).

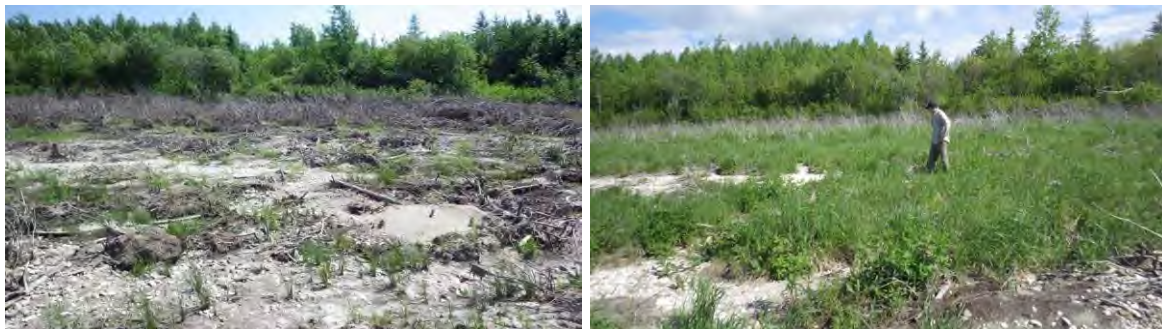
16+000: Right transect from creek bank in 2013 (left) and 2014 (right).

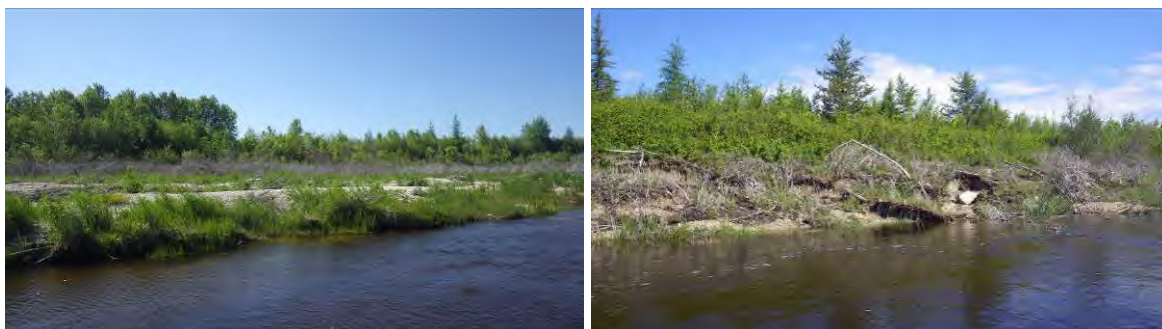
16+000: Deposition on left side (left) and erosion on right side (right) approximately 150 m upstream from 16+000.

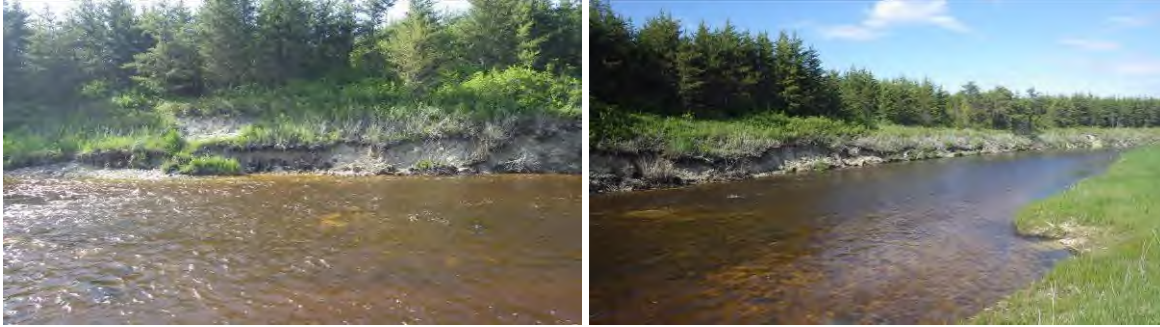
16+000: Erosion on left side approximately 50 m downstream from 16+000 (2014).

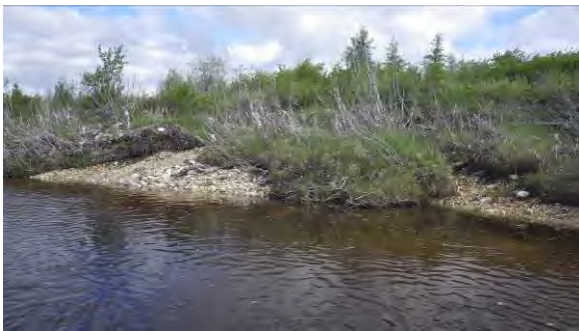
16+500: Erosion on right of creek 175 m downstream from transect (2014).

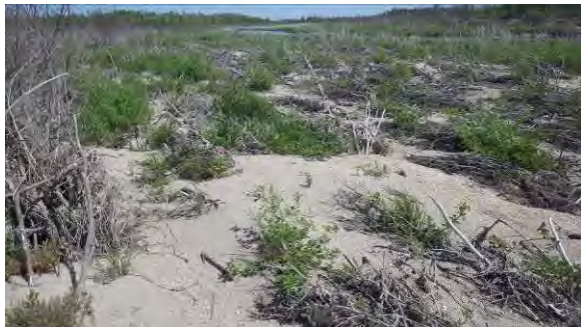
17+500: Inorganic deposition on left side of creek, looking downstream (2014).

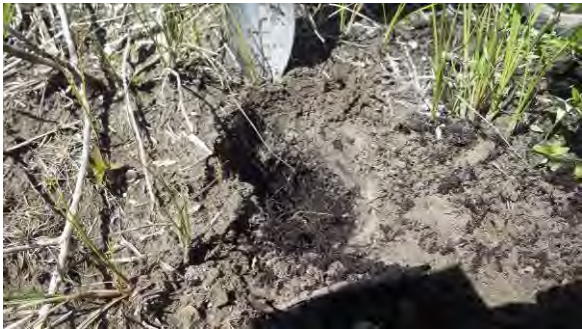
18+000: Silt overlaying organic soils on left side of creek (2014).

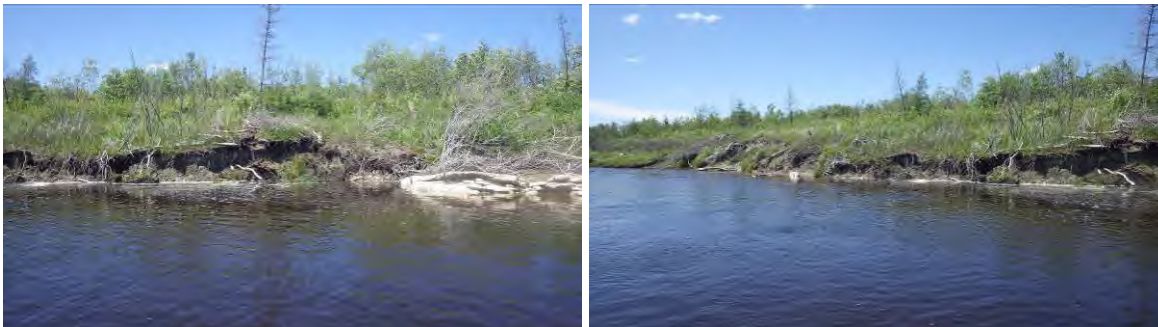
18+500: Erosion on left bank approximately 50 m upstream from transect.

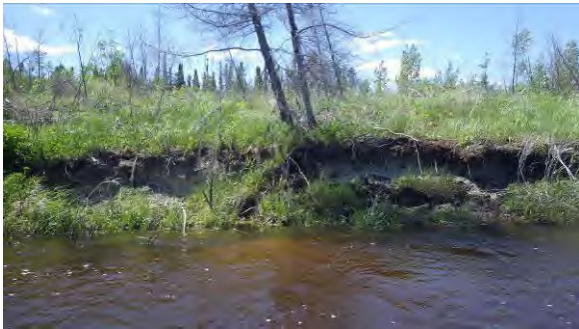
19+000: Erosion on left side of creek approximately 100 m upstream (2014).

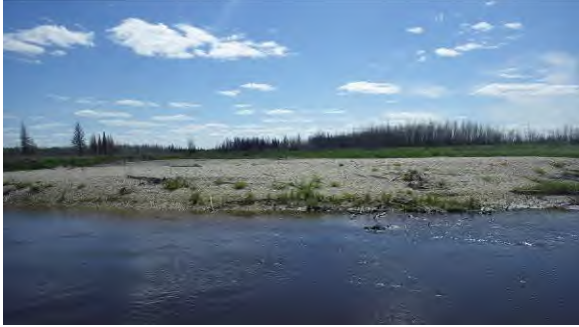
20+000: Bare area on left side of creek as seen from right bank (2014).

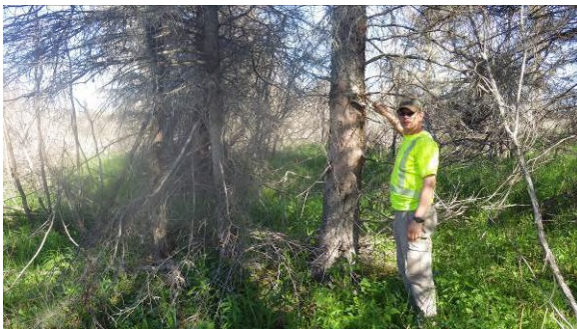
21+000: High water mark seen on dead spruce on left side of creek in 2014.

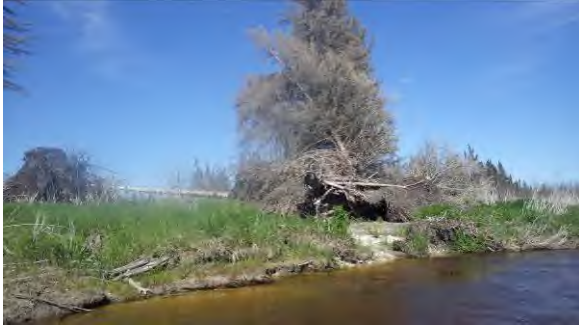
This transect runs in an east-west direction at a gentle left turn in the creek. In 2013, the left side of the creek was comprised largely of dead shrubs, with bare areas near the creek channel and some dead trees near the end of the transect. In 2014, this area was covered by a thick layer of grass, while dead trees and shrubs did not recover. The high water mark can be seen on many of the mature dead spruce (see photo below). In 2013, the right side had a mixture of dead shrubs, grass, and bare patches for the first approximately 30 m. Beyond this was live shrubs and grass layer underlain by sphagnum which transitioned to trees approximately halfway along the transect at the end of a small clearing up the slope. In 2014, this transect had lots of grass near the creek, and then transitioned to an area of shrubs (1/2 dead) and then to an area of trees (1/2 dead). These trees appear to have died between 2013 and 2014 as these trees were live in 2013. In 2013, deposited inorganic soils above the organic soils were 6-13 cm thick on the left side and 4 cm thick on the right side near the creek. Peat was observed above the slope on the right side. In 2014, inorganic fine sand and silt was present along most of the transect including all of the left side and the first half of the right side. On the right side, organic soils (peat) was present starting at approximately 50 m. Thicknesses of inorganic soils above the organic soils in 2014 varied from 5 to 15 cm. An area of erosion and fallen trees was observed on left side of creek approximately 200 m upstream from the transect (photo below).

21+000: Erosion and fallen trees on left side of creek approximately 200 m upstream from transect 21+000 (2014).

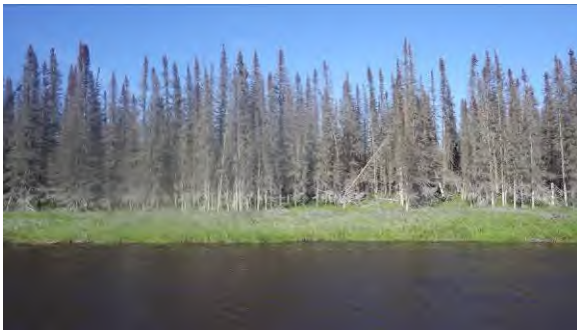
21+500: Right side of creek as seen from left side in 2014. Note high water mark on trees.

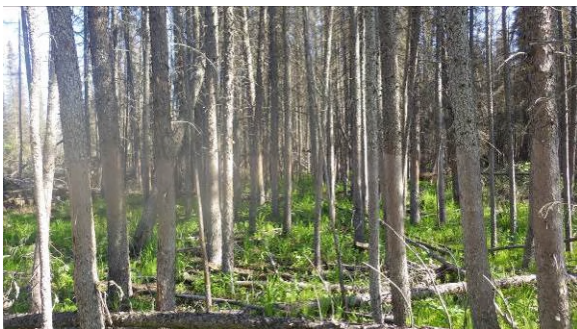
21+500: Dead spruce trees showing high water mark and a herbaceous understory on left transect in

2014.

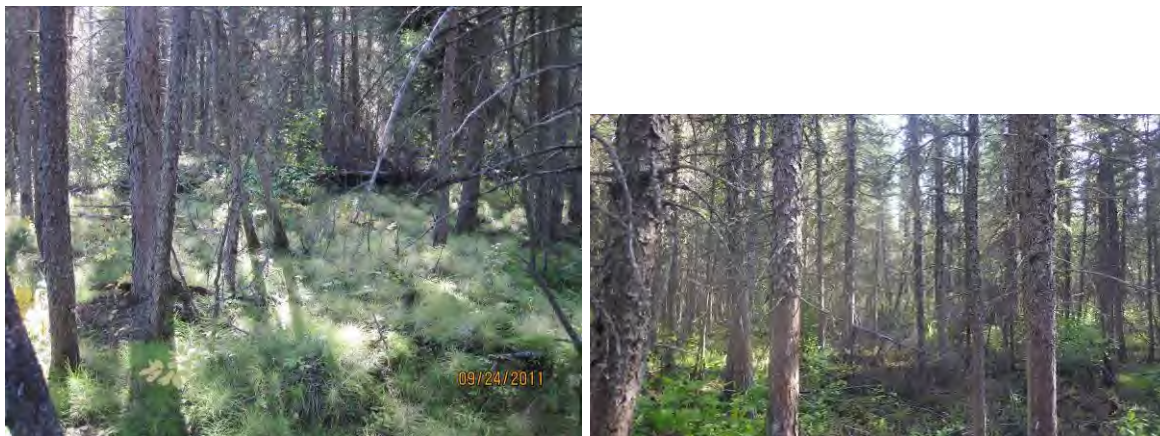
22+000: Mature spruce trees and herbaceous understory in 2011 (left) and 2014 (right). Note high water mark in 2014. (Photos not from exact same location)

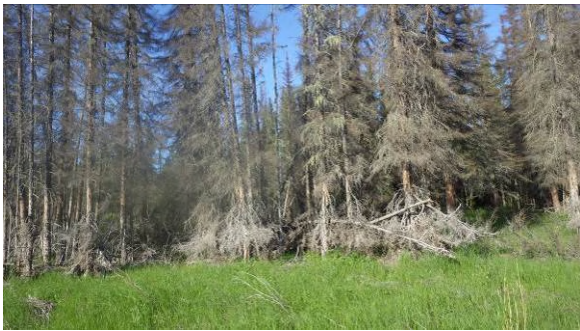
22+000: Dead trees on right side of creek, as seen from creek bank in 2014.

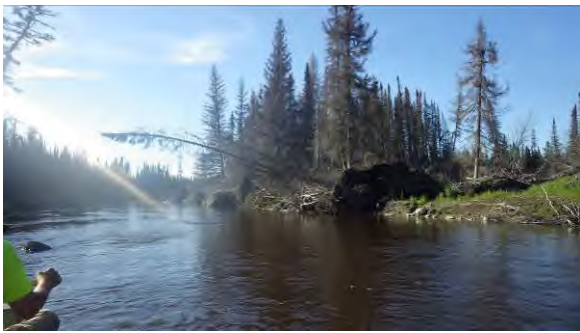
This transect runs in a southwest-northeast direction at a relatively treed stretch of the creek. In 2013, the first approximately 13-18 m on both sides of the creek were dominated by dead shrubs, but also had bare areas and grass. Beyond the dead shrubs were live mature trees on the left and a mixture of dead and live mature trees on the right. Both sides end in a forested area with sphagnum understory. In 2014, dead shrubs were still present along the creek, but were less visible as many had fallen to the ground and thick layer of grass now existed. Within the trees, the first 26-43 m were dead, followed by live trees transitioning into bog. High water marks were visible on the mature spruce well away from the creek. A small proportion of shrubs were also present on the left side. In 2013, inorganic soils overlaid organic soils along most of the transect with the exception of the sphagnum areas near the end on each side. Depths ranged from >13 cm near the creek to 5-6 cm in the trees. In 2014, 3-5 cm of silt overlaid most of the transect with a thick layer of sand (>13 cm) also found on the left side near the creek (beneath silt). Peat was again observed at the surface at the end of the transects. An area of erosion and fallen trees on the right bank approximately 230 m downstream from the transect.

22+000: Erosion and fallen trees on the right bank approximately 230 m downstream from 22+000 (2014).

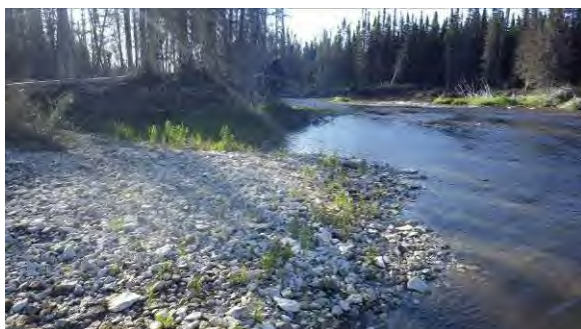
22+500: Bare area on left side, looking downstream in 2014.

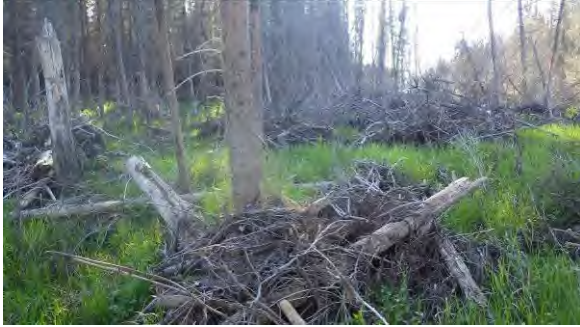
transect that were alive in 2013 appear to have died by 2014. The understory of this area was almost entirely grass. Large piles of debris (trees, sticks, etc.) were captured by trees on the left transect during high water (see photo below). The right side in 2013 had an area of dead trees with bare understory immediately adjacent to the creek for about 20 m, followed by live mature trees for the remainder of the transect. In 2014, a similar extent of dead trees was observed, although this time there was a 50% understory of herbaceous plants. The remainder of the transect was comprised of live trees. Organic soils in 2013 were beneath a 5-9 cm layer of inorganic soil deposition, with the exception of near the ends of transects. In 2014, 3-13 cm of silt was on the surface at most locations.

22+500: Dead trees, accumulated debris and grass on left transect in 2014.

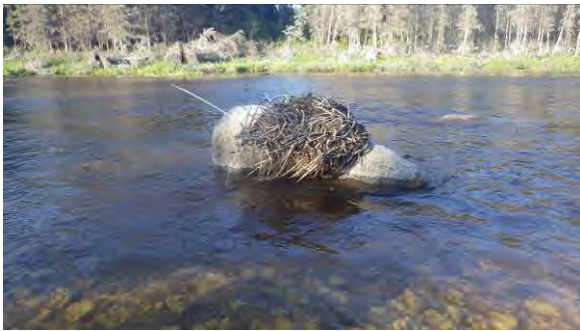
22+500: Debris on rock in creek, as seen from left bank in 2014 (flow going left).

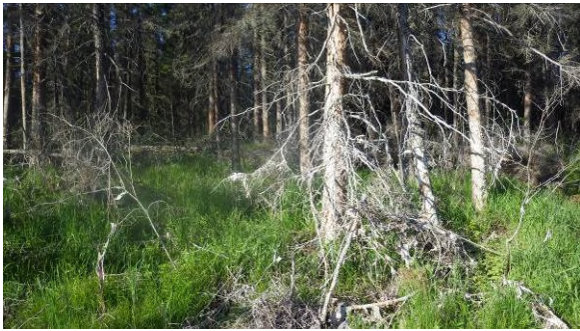
22+500: Dead trees and grass on right side, as seen from near creek bank in 2014.

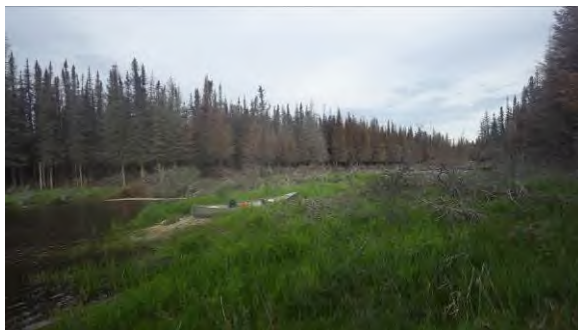
23+000: Grass and dead trees, looking downstream from right bank in 2014.

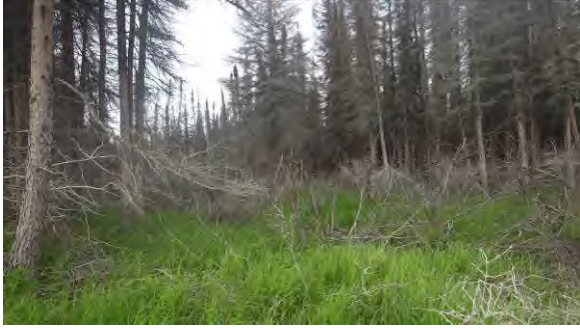
23+000: Dead trees and grass on left transect as seen from near creek bank in 2014.

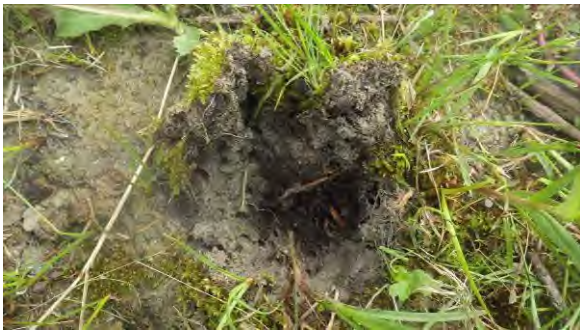
23+000: Silt deposition above organic soil on the left side of the creek in 2014.

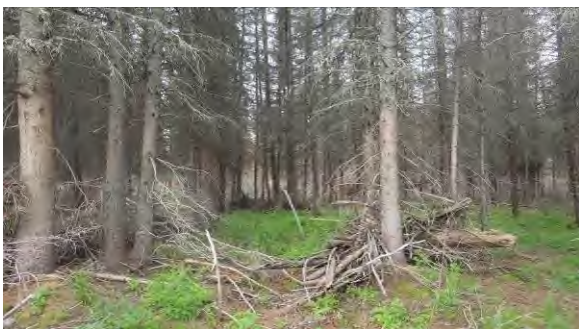
23+500: Dead trees on left transect, with herbaceous ground layer and accumulated debris on upstream side of trees. Note high water mark on tree trunks (2014).

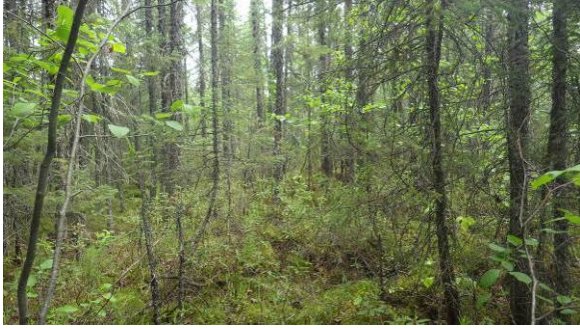
23+500: Bog at end of right transect. Typical of what was seen at the end of many transects (2014).

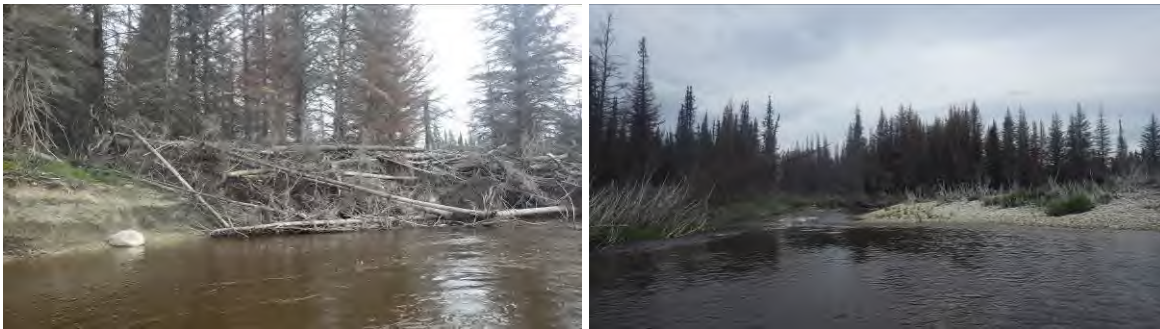
the transect. In 2014, 3 to >10 cm of silt was measured above organic soils near the creek, but silt was again observed along the full length of the left transect. An area of erosion and fallen trees on the left side of the creek and deposition on the right side of the creek was observed approximately 175 m upstream from the transect.

23+500: Erosion and fallen trees on left (left) and deposition on right (right) approximately 175 m upstream from transect (2014).

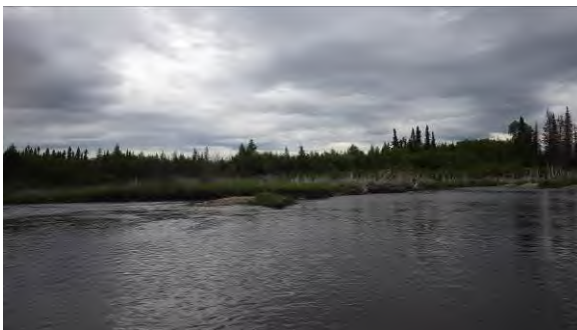
bank which appears to have slumped (see photo below). At the top of the slope were shrubs which were followed by deciduous trees and then coniferous trees. The right side in 2013 was less steep and had dead shrubs and a bare understory until 36 m. Much of the area consisted of exposed cobbles, gravel and sand. Beyond this was a mixture of live trees and shrubs. In 2014, the slumped bank was still present and had minimally more vegetation on it. Above the slope, a similar composition of shrubs and trees was observed. The right side in 2014 still had a bare cobble area adjacent to the creek although patches of grass had grown in a few locations. Beyond the cobble, thick grass was growing within the dead shrubs until near the end of the transect where the transect leaves the dead zone and live trees and shrubs are encountered. A fair bit of debris (logs, branches) was deposited within the dead shrub area. In 2013, 1 to 4 cm of inorganic soil overlaid organic soils near the creek, except for the large areas of cobble which were deeper. Organic soils were present on the surface further from the creek on both sides. In 2014, the bank slump on the left side was identified as being mainly silt. Above the bank, trace silt was present above organic soils. On the right side in 2014, 10 cm of silty organic soil was observed above silt within the grassy area with dead shrubs. Peat was present at the end of the right transect. An area with cobble and gravel deposition was observed approximately 200 m upstream from the transect at a sharp bend in the creek (photo below).

25+000: Areas with cobble and gravel deposition approximately 200 m upstream from transect (2014).

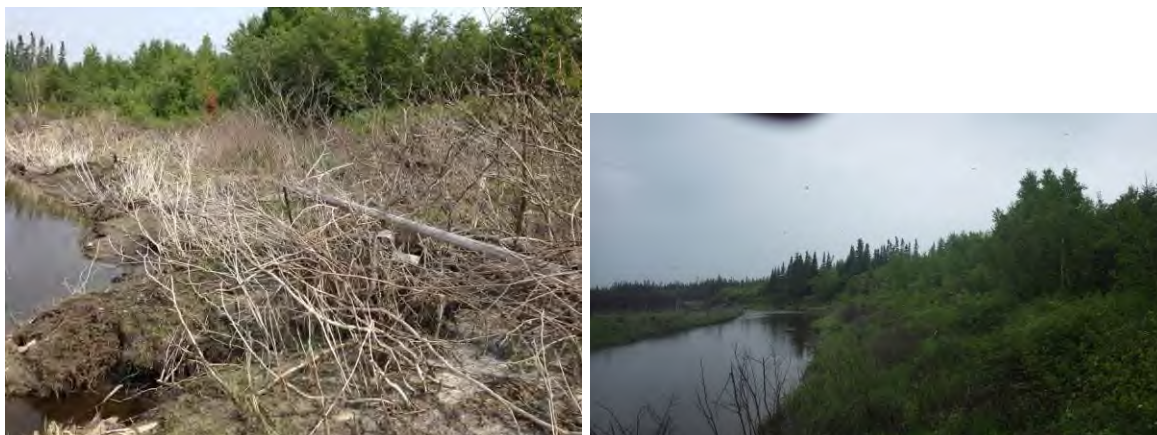
25+500: Right side of creek, looking downstream in 2013 (left) and 2014 (right).

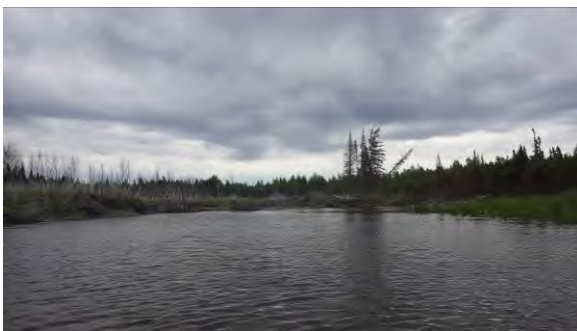
This transect was oriented in an east-west direction at a left turn in the creek. In 2013, the left side of the creek had a very gentle slope and consisted of dead shrubs and a largely bare understory for the entire left-side transect. The entire left transect had clearly been inundated during high water. The right side of the creek has a steeper bank. In 2013, it had a thin layer of dead shrubs with a bare understory, followed by a progression of live shrubs followed by trees with a sphagnum understory starting at 54 m. In 2014, the left side had been completely vegetated over with mainly grass, but also herbaceous species further from the creek. None of the dead shrubs recovered. On the right side in 2014, the thin strip with dead shrubs now had a thick layer of vegetation growing beneath it. Above the bank, a similar composition of shrubs, and trees was observed. Soils in 2013 had 1 to 4 cm of inorganics above organic soils near the creek and along the left transect. In 2014, 5 to 8 cm of silt was observed at the surface on the left side. At one location, beneath the silt was 3 cm of organic soil followed by further silt. On the right bank, 10 cm of organic soil was measured above a layer of silt. An area of erosion was observed at an outside bend in the creek approximately 175 m upstream from the transect (photo below).

25+500: Area of erosion on left side of creek approximately 175 m upstream from transect (2014).

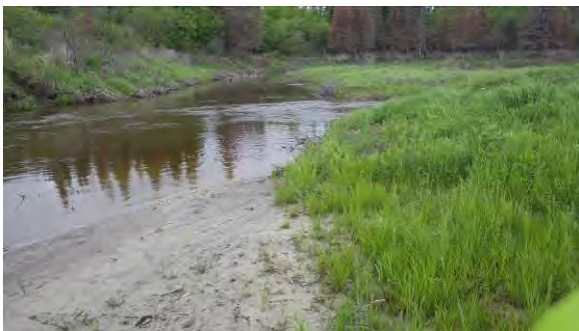
26+000: Bare area adjacent to creek on left side, looking upstream.

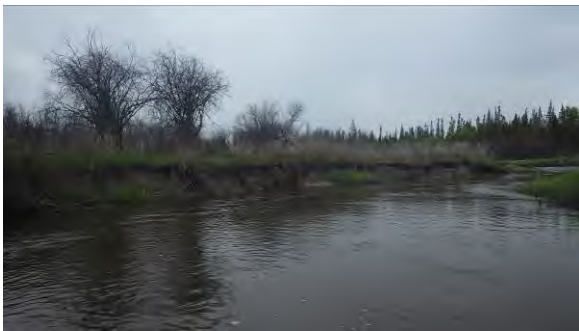
comprised of dead shrubs and bare understory, with a small percentage of grass. The right side of the creek in 2013 had a similar area of dead shrub and bare understory adjacent to the creek until the transect went up the slope and a dense shrub coverage was encountered seemingly above the high water mark. Due to the winding nature of the creek at this point, this transect approaches the creek again near its end. In this area, dead shrubs and trees and a bare understory were again encountered. In 2014, there was a 3 m area adjacent to the creek on the left side which was still bare, but otherwise the remainder of the left transect was 100% covered by grass. None of the dead shrubs recovered. On the right side in 2014, areas near the creek both at the beginning and end of the transect (which were previously bare) were largely covered by grass. In 2013, a thin inorganic soil layer was observed above organic soils on the left side. On the right side, 4-13 cm of inorganic soils were present above the organic soils. In 2014, the small bare area adjacent to the creek was composed of 5 cm of silt above gravel. On the right bank in 2014 a silty organic soil was noted. An area of erosion on the left bank approximately 250 m upstream from transect was observed (photo below).

26+000: Area of erosion on left bank approximately 250 m upstream from transect.

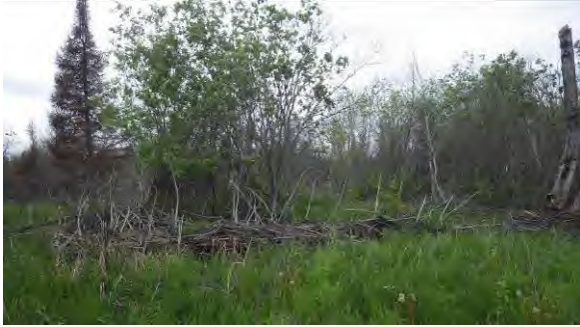
26+500: Accumulated debris on right transect (2014).

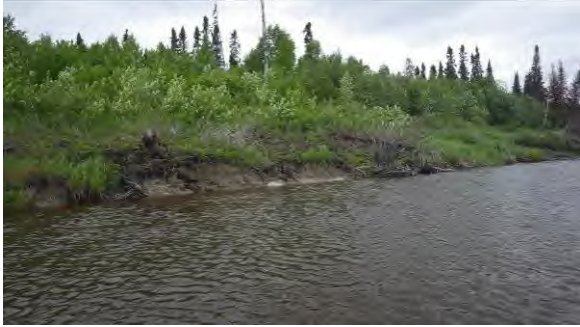
26+500: Erosion on right side of creek approximately 175 m downstream from transect (2014).

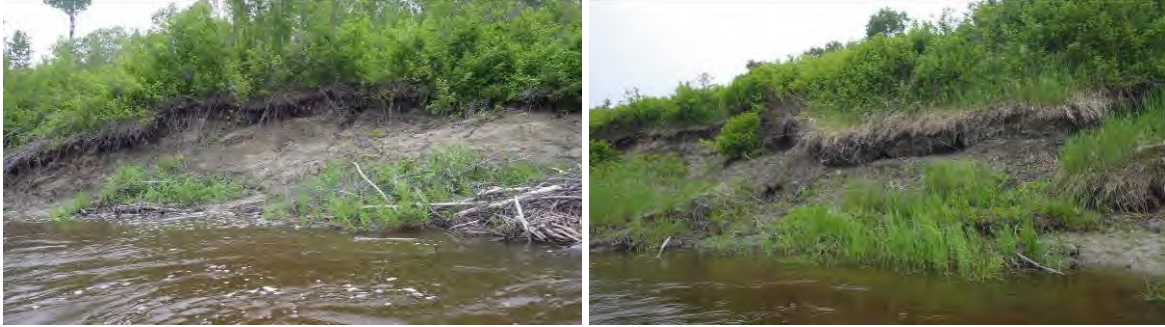
This transect runs in an east-west direction at a left turn in the creek. The inside bend (left side) is low in elevation, while a distinct bank was present on the right side at approximately 20 m from the creek bank. In 2013, the left side of the river was composed of mainly dead shrubs with a smaller portion of grass and a largely bare understory. At 77 m the transect entered live mature trees. On the right side in 2013, a similar composition of dead shrubs, grass and bare understory was encountered adjacent to the creek. At 42 m (base of slope), the transect transitioned to shrubs and at 58 m, there was a mixture of shrubs and trees. In 2014, the lower lying areas which were largely bare were now covered with a thick layer of grass. Dead shrubs did not recover. Organic soils near the creek in 2013 were overlain with 2-3 cm of inorganic deposition at the low areas near the creek, while organic soils were observed on the surface up the bank on the right side. In 2014, 1 cm of silt was measured above >13 cm of fine gravel near the creek on the left side, while 1 cm of silt was measured above organic soils on the right side (near the creek). Erosion was noted at locations 100 m to 200 m downstream from the transect along the outside bend of the creek (photos below).

27+000: Eroded right bank approximately 100 m downstream (left) and 200 m downstream (right) from transect (2014 photos).

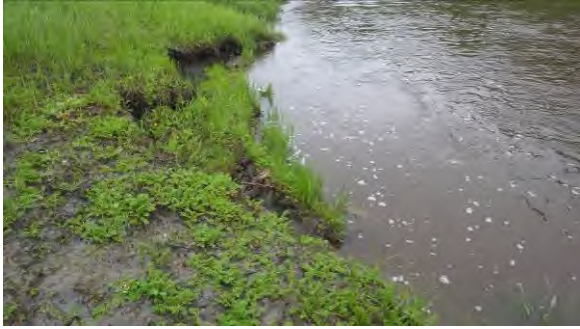
28+000: Erosion on left bank, looking downstream (2014).

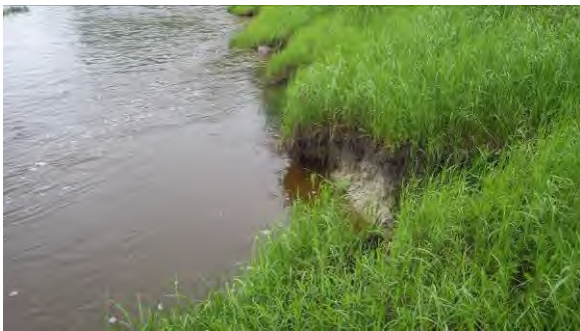
28+000: Erosion on left bank, looking upstream (2014).

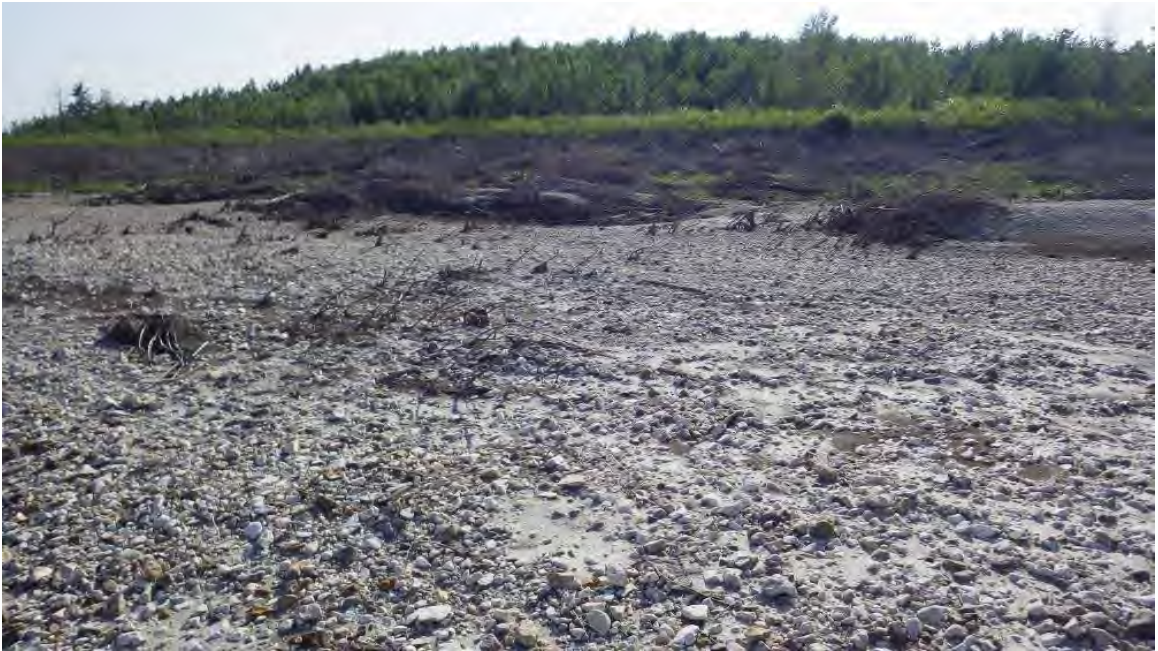
Photo 1. "Bare" substrate observed at 18+000.

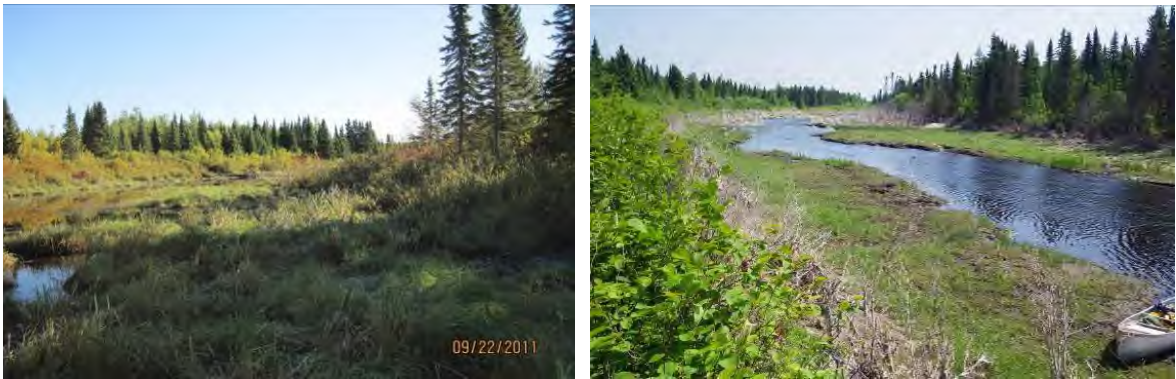
soils ranged from <1 to 5 cm. The 2011 survey described very similar vegetation composition, but with grass near the channel, and no mention of any dead vegetation (Photo 6 compares 2011 and 2013 photos). The 2011 survey also observed deeper organic soils (14-15 cm) in the grassy creek bed area.

Photo 6. Looking downstream from 14+500 (left photo: 2011 ; right photo: 2013)

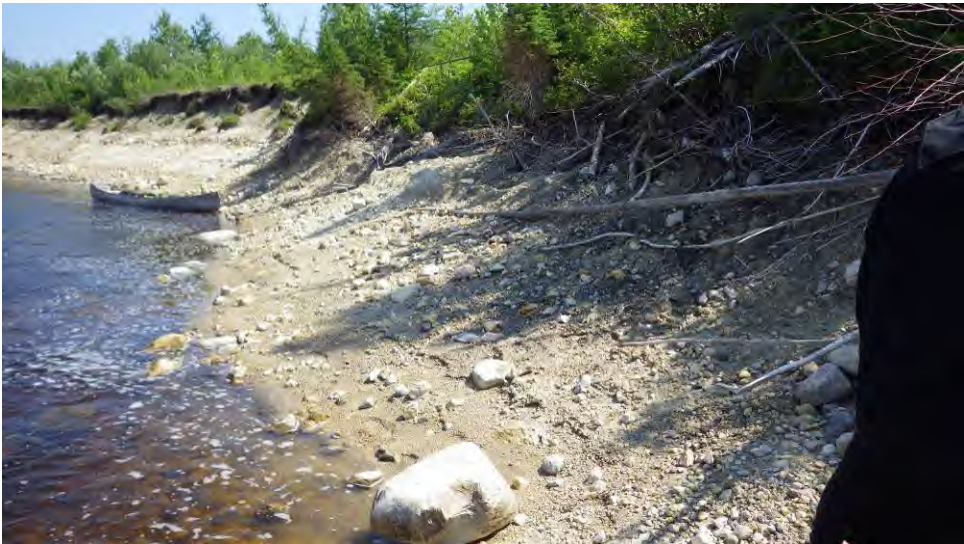
This transect runs in a northwest-southeast orientation. Bare areas of cobble and gravel were observed adjacent to the channel. Exposed roots along the steep slope on the right side suggest recent erosion activity (Photo 7). Above the slope, trees transition to shrubs as the transect enters a sphagnum bog at 52 m. The slope on the left side of the river is much more gradual (inside bend of river) and is bare (cobble, gravel) with dead shrubs for the first 42 m before it transitions to shrubs and then to trees. The organic layer of soils ranged from 0 (adjacent to creek channel) to 9 cm (in sphagnum bog). The 2011 description of this transect described grass and shrubs adjacent to the channel, no bare areas, and slightly higher measurements of organic soil in that area (2-4 cm).

Photo 7. Steep bank along Buffalo Creek at 15+000.

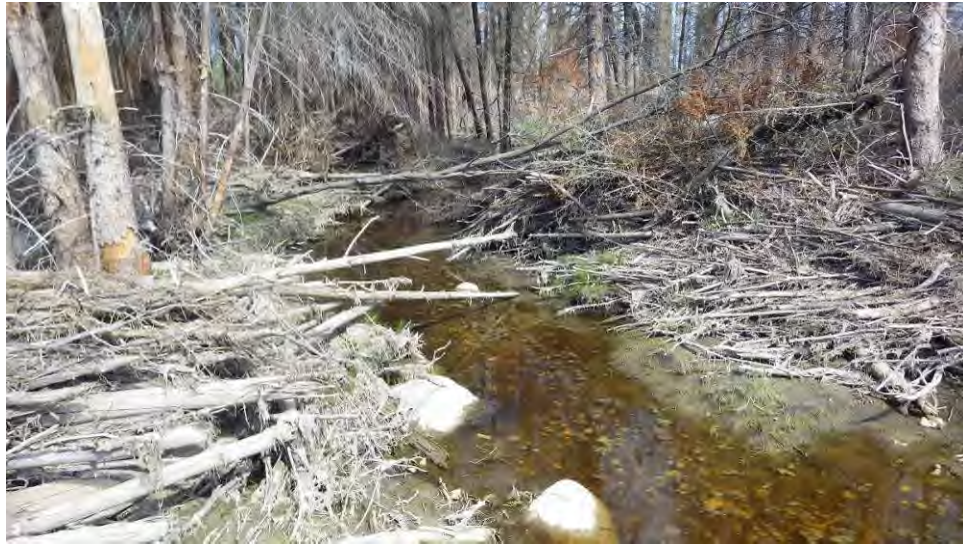
This transect followed an east-west alignment. The left side was bare along the creek, followed by a large area of mature dead trees which were largely bare beneath. Many trees were on the ground, as it appeared the mature trees acted as a catch/dam/strainer for dead vegetation moving down the creek from upstream (see Photo 11). Live trees were encountered at 96 m of the left transect. The terrain on the right side of the creek was much flatter. Bare areas were observed near the creek channel, with a combination of dead shrubs and trees for the entire transect distance. Aquatic emergent vegetation was found at several locations on this side. Organic soil depths varied from 0 to 7 cm with several locations being overlain by 1 to 5 cm of inorganic soils (see Photo 12). In 2011, the right side was inundated by beaver activity with a combination of grass and shrub transitioning to largely trees at 21 m, while the left side showed a grass and bare area along the creek, then trees at 21 m which transitioned to shrubs at 91 m. Organic soil depths in 2011 were similar in range (1-12 cm) as those observed in 2013 with >30 cm measured deep along the left transect. No sample was taken from the same area in 2013. There was no mention of inorganic soils overtop of organic soils in 2011.

Photo 11. Left side of river at 19+500 showing large amount of dead trees.

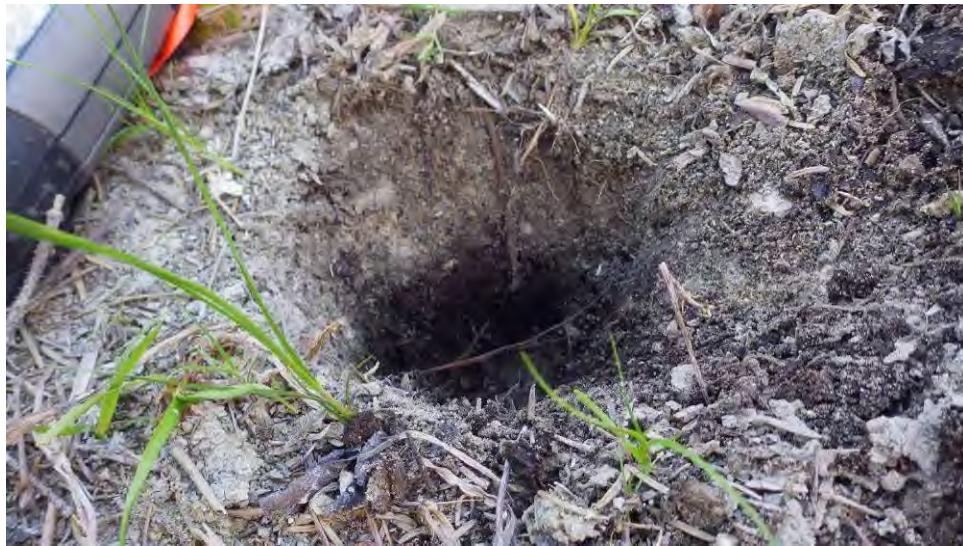
Photo 12. Soil sampling hole at 19+500 showing organic soils (black) overlain by inorganic soils (grey).

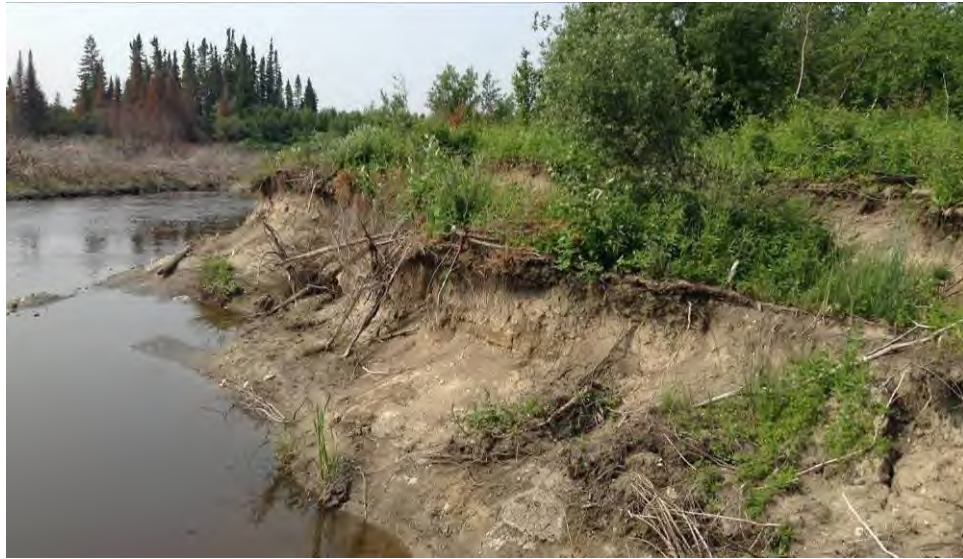
This transect is oriented in a northwest-southeast direction. The left side of the creek had a steeper bank and the presence of slump suggested recent erosion (see Photo 13). At the top of the slope were shrubs which were followed by deciduous trees and then coniferous trees. The right side was less steep and had dead shrubs and a bare understory until 36 m. Much of the area consisted of cobbles, gravel and sand. Beyond this was a mixture of live trees and shrubs. The organic soil depths varied from 0 (cobble, gravel, sand) to >13 cm with some areas having 1-4 cm of inorganic soils on top. In 2011, a similar shrub and tree mixture was described. Organic soils depths were between 7 and >30 cm. There was no mention of bare ground or dead vegetation during the 2011 survey.

Photo 13. Slump on left side of creek at 25+000 (looking upstream).
