Taseko Prosperity Gold-Copper Project

Appendix 3-8-C

**AN ASSESSMENT OF THE HANCEVILLE HATCHERY AS A RAINBOW
TROUT FRY PRODUCTION FACILITY**

June 20, 2008

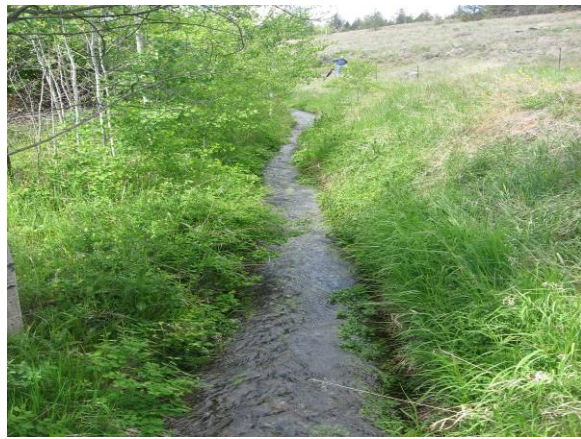
Photo 6. Upstream water supply ditch

- Livestock can also access the ditch and waterline potentially resulting in bank erosion and/or damage to the waterline.
- Spring water collection box damaged and unsuitable for future use.
- Hatchery waterline is broken in at least one location and may be subject to further breakages.
- Exposed access to spring pond and water in ditch and hatchery settling pond poses significant risk of contamination and disease from all forms of wildlife.
- Several mature rainbow trout were observed in ditch and settling pond adjacent to and upstream of hatchery. Potential vector for fish disease.
- At least 2 other waterlines are connected to the spring water supply and ditch so presumably neighbours are accessing some of this water for their needs.

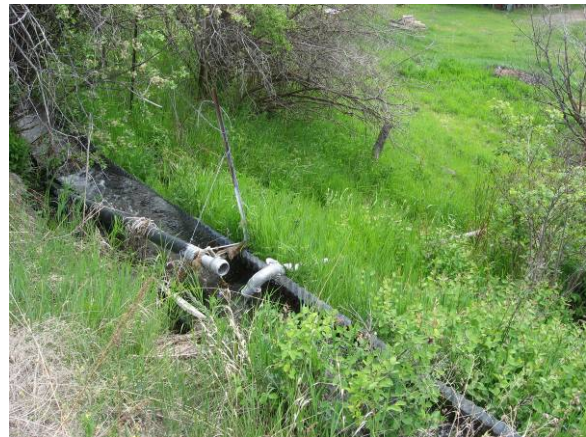
Photo 8. Irrigation pipe in upstream water supply ditch

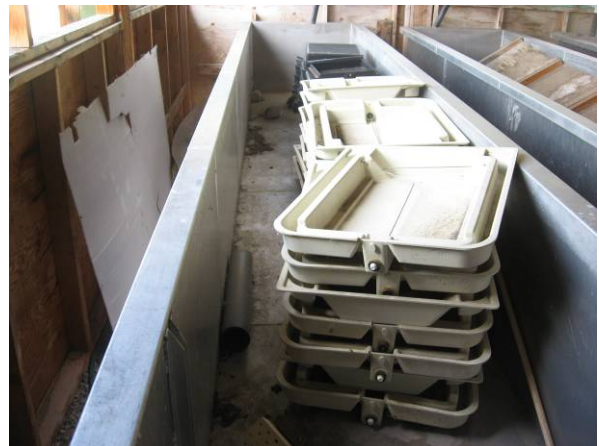
Photo 20. Vertical tray incubator trays

- Three vertical tray (Heath brand) incubation systems are located in the hatchery. Trays appear to be in satisfactory condition and suitable for future use.
- Six – 16' X 2.5' X 2' aluminum jumbo flat-bottomed rearing troughs are located at the hatchery. They are all in satisfactory condition and suitable for future use.
- One 16' X 2' X 2' plastic trough is located at the hatchery. It too is in satisfactory condition and suitable for future use.
- An aged EWOS fish feeding system is installed at the hatchery. It is unsuitable for present fish culture needs.

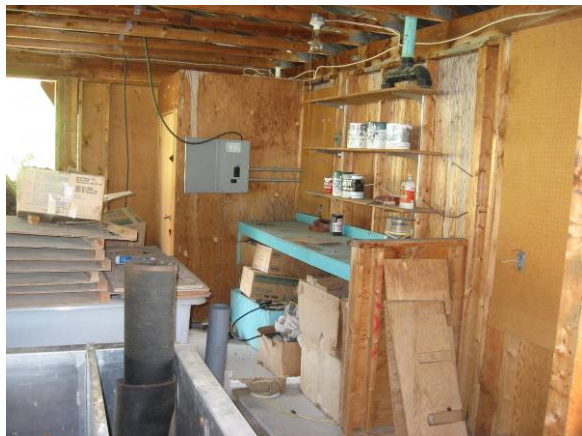
Photo 33. Workbench and electrical service panel

- Rats and mice have infested all areas of the hatchery.
- Hatchery floor is gravel and unsuitable for biosecurity needs of cultured fish.
- Tin roof on wood trusses appears in satisfactory condition although it may leak during certain weather conditions.
- The electrical service does not appear to be consistent with present day electrical standards. The electrical supply has been disconnected at the hatchery power pole. The inside electrical service appears to be a 60 amp 120 volt 1-phase service. This is inadequate for most modern small electrical needs. No 3-phase electrical power was observed in the immediate area although it is not required for this small hatchery facility.
- Environmental controls and alarms systems are aged and inadequate for safe culturing of fish.
