**APPENDIX 9-D**  
**KSM PROJECT GEOHAZARD RISK ASSESSMENT OF**  
**UPDATED FACILITY LOCATIONS**

## **SEABRIDGE GOLD INC.**

### **KSM PROJECT**

# **GEOHAZARD RISK ASSESSMENT OF UPDATED FACILITY LOCATIONS**

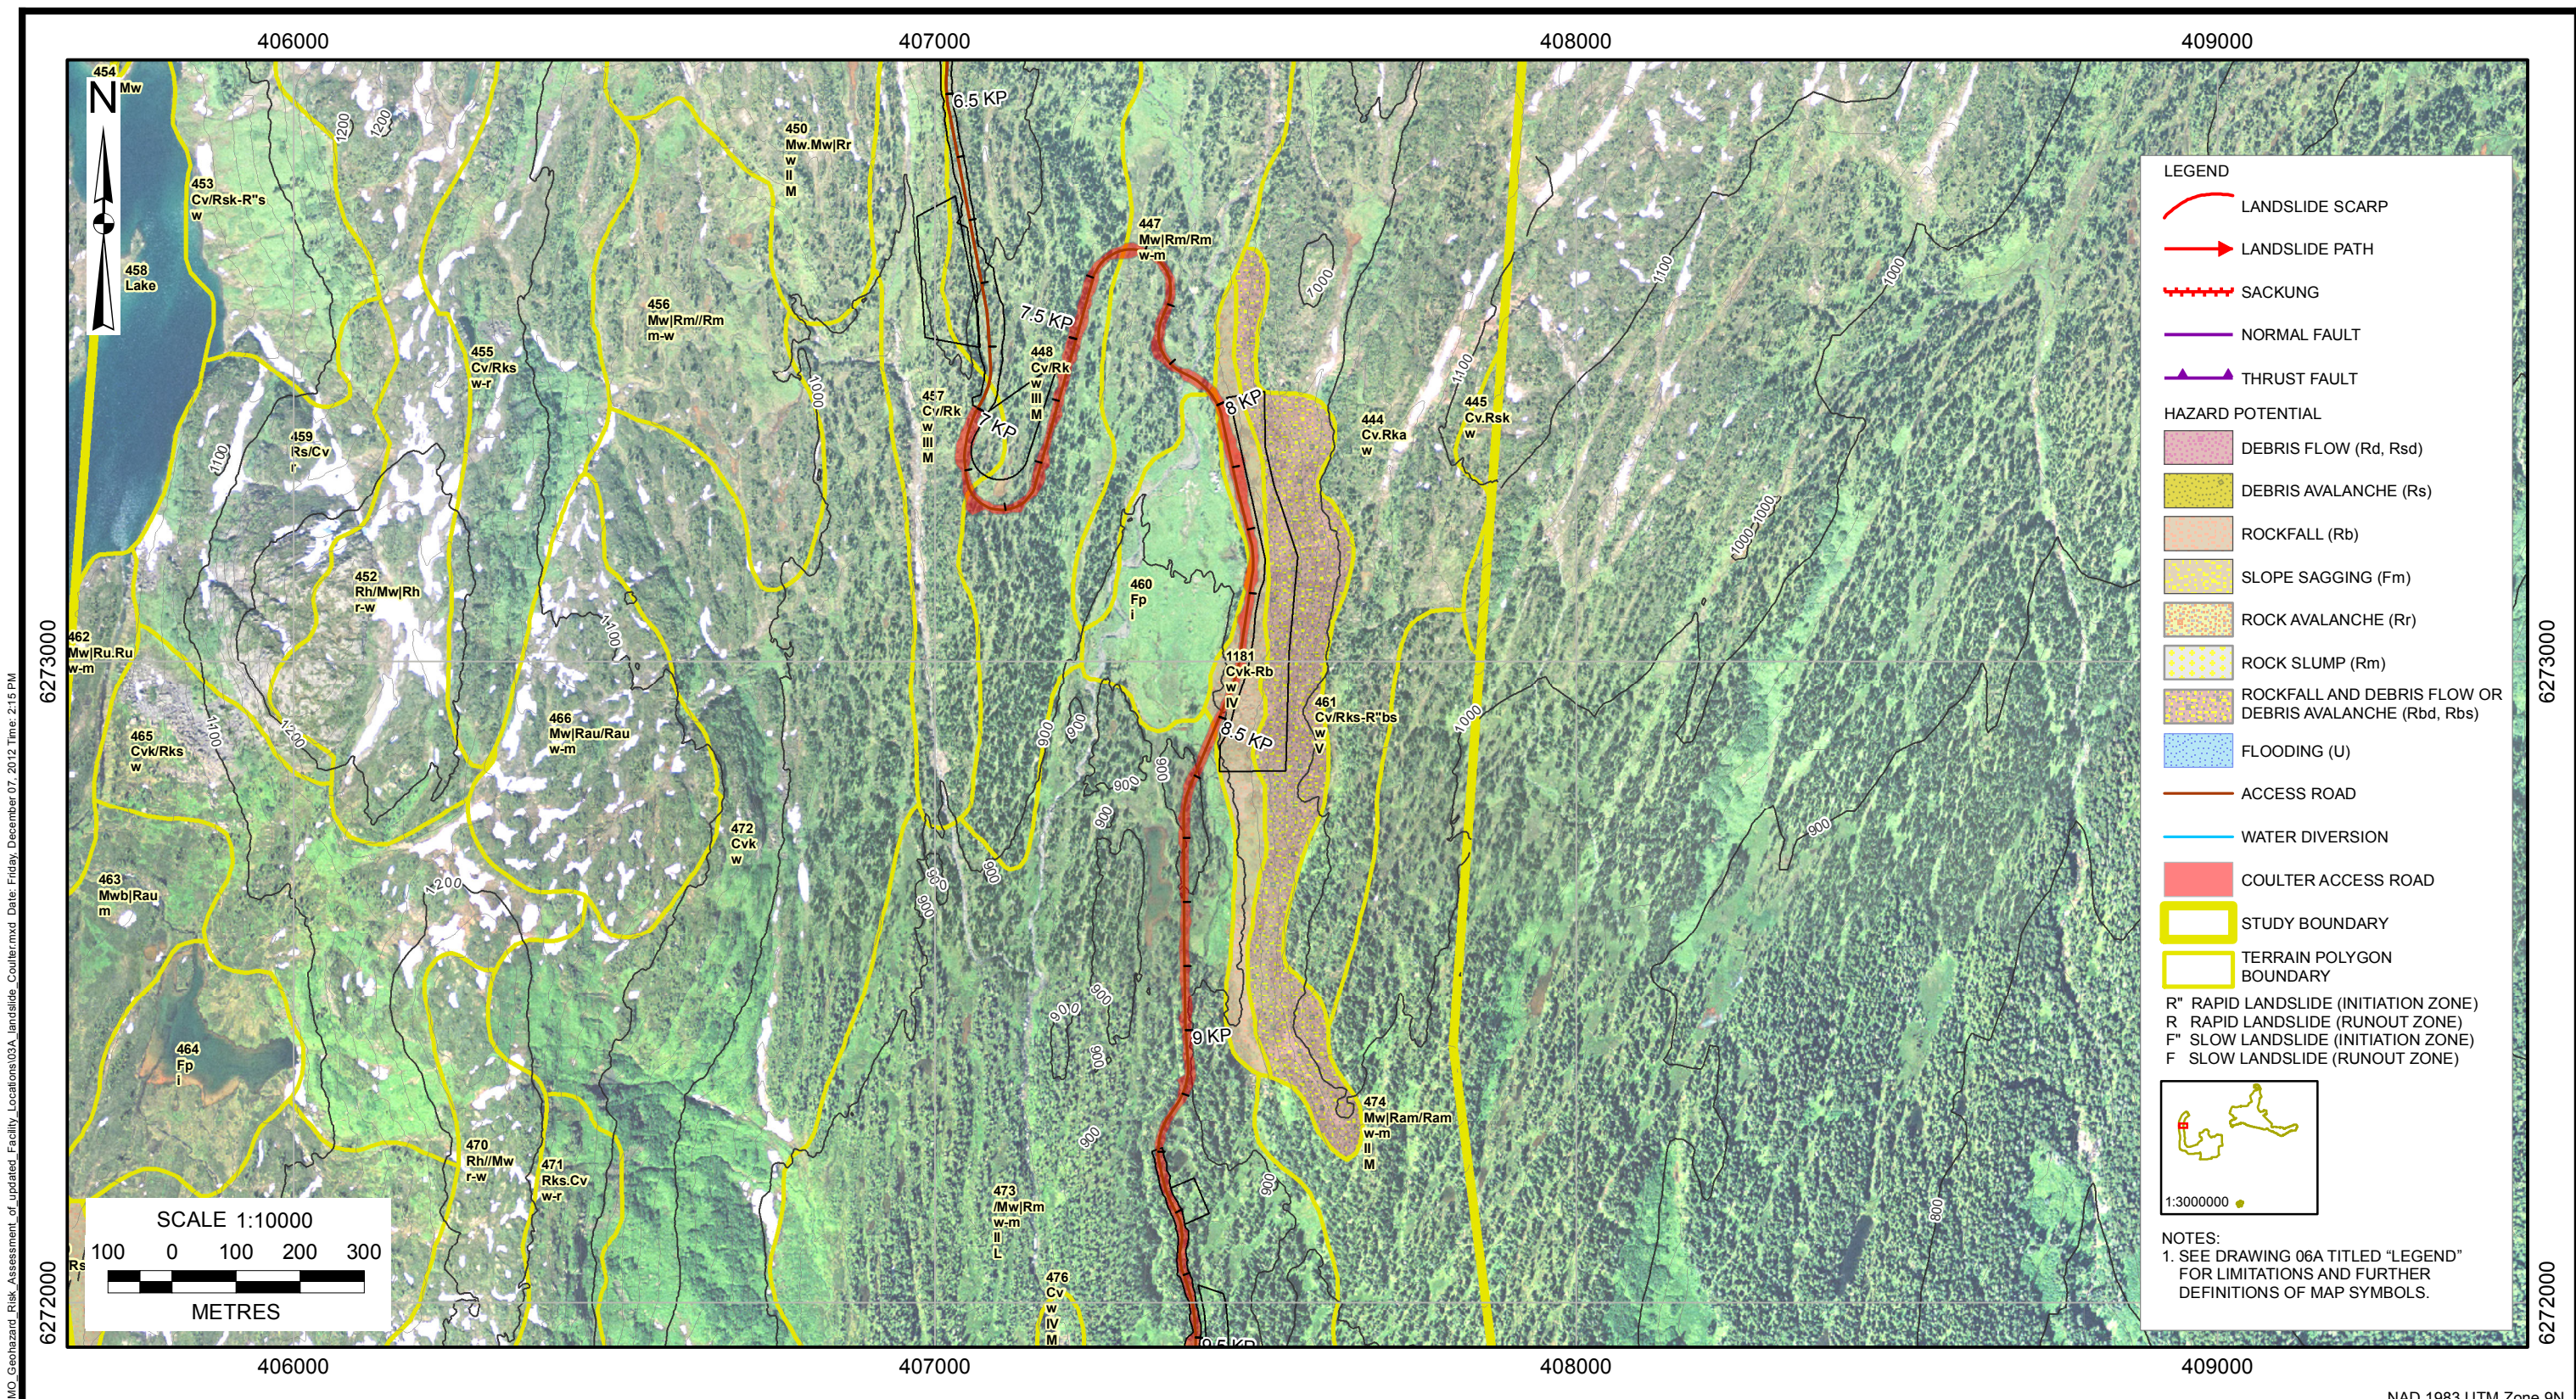
PROJECT: GEOHAZARD RISK ASSESSMENT OF UPDATED FACILITY LOCATIONS		
TITLE: AVALANCHE GEOHAZARDS: SOUTH SEEPAGE POND AND DISCHARGE PIPELINE TO TREATY CREEK		
PROJECT No.: 0638013	DWG No.: 02B	REV.:

The Southeast Seepage Dam has been moved 500 m south to a position 2.0 km downstream of the South Dam (Drawings 2a and 2b). The southwest boundary of the dam footprint is immediately adjacent to the runout of an avalanche path to the west. Avalanches are not expected to be a hazard to the collection dam or the pond. There is potential for hazard to personnel during construction and serving, depending on the location of worksites. No other avalanche or landslide geohazards have been identified at this location.

The TMF discharge pipe runs from the north cell of the TMF to Treaty Creek. From the north cell to the Southeast Dam the pipe replaces the South Diversion Channel. From the Southeast Dam the pipe parallels the North Treaty road and North Treaty Creek to Treaty Creek (Drawings 2a and 2b). The pipe crosses avalanche paths between the Southeast Dam and Treaty Creek. These could be a hazard during construction or servicing. No geohazards were identified that could impact a buried pipe.
