# Preliminary Hazard Identification for the Mark II Conceptual Design

**NWMO-TR-2016-02**

**January 2016**

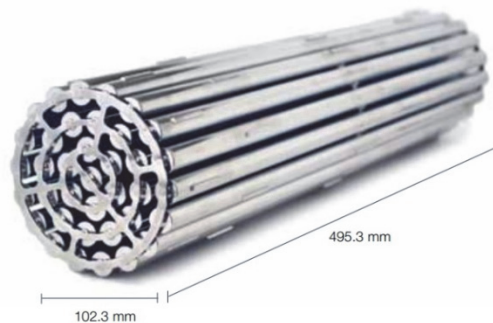
**Figure 4: A CANDU Fuel Bundle**

Used fuel to be disposed in the planned DGR is CANada Deuterium Uranium- **CANDU fuel** (Figure 4) that uses natural uranium. Canadian used fuel consists primarily of used CANDU fuel, which is generated at commercial nuclear power reactors in Ontario, Québec and New Brunswick. In addition, there are very small quantities of used fuel from research and isotope-producing reactors in Canada.

A CANDU **fuel bundle** consists of 28 to 37 elements containing uranium pellets. The fuel sheath is manufactured from Zircaloy 4, a zirconium metal alloy. Once filled with uranium pellets, the sheathing material is sealed at both ends with zircaloy plugs and welded together into a cylindrical matrix with plates at each end. A typical CANDU fuel bundle is shown in Figure 4. Each fuel bundle is approximately 500 mm long, 102 mm in diameter and weighs about 24 kg.

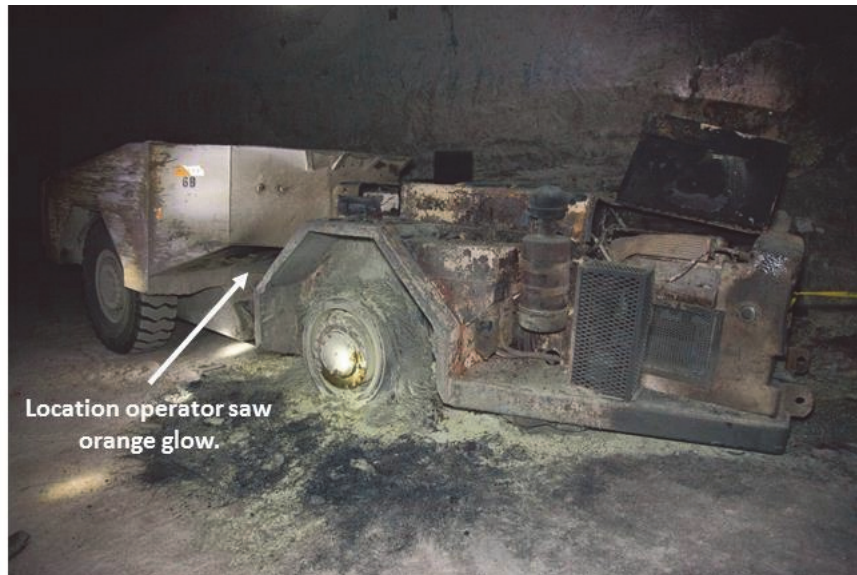
**Figure 27: Burned Salt Hauler Involved in the WIPP Fire**

been removed in maintenance. Most significantly it was found that the safety culture of the mined section of the facility is not that of a nuclear facility, but resembles normal mining culture. The vehicle fluids were flammable; there were maintenance deficiencies and additional deficiencies in emergency and rescue training, fire extinguishing and evacuation. The burned salt hauler is shown in Figure 27.
