Tailings Management Facility Preparation Plan

Re: Kami Project Tailings Management Facility Preparation Plan

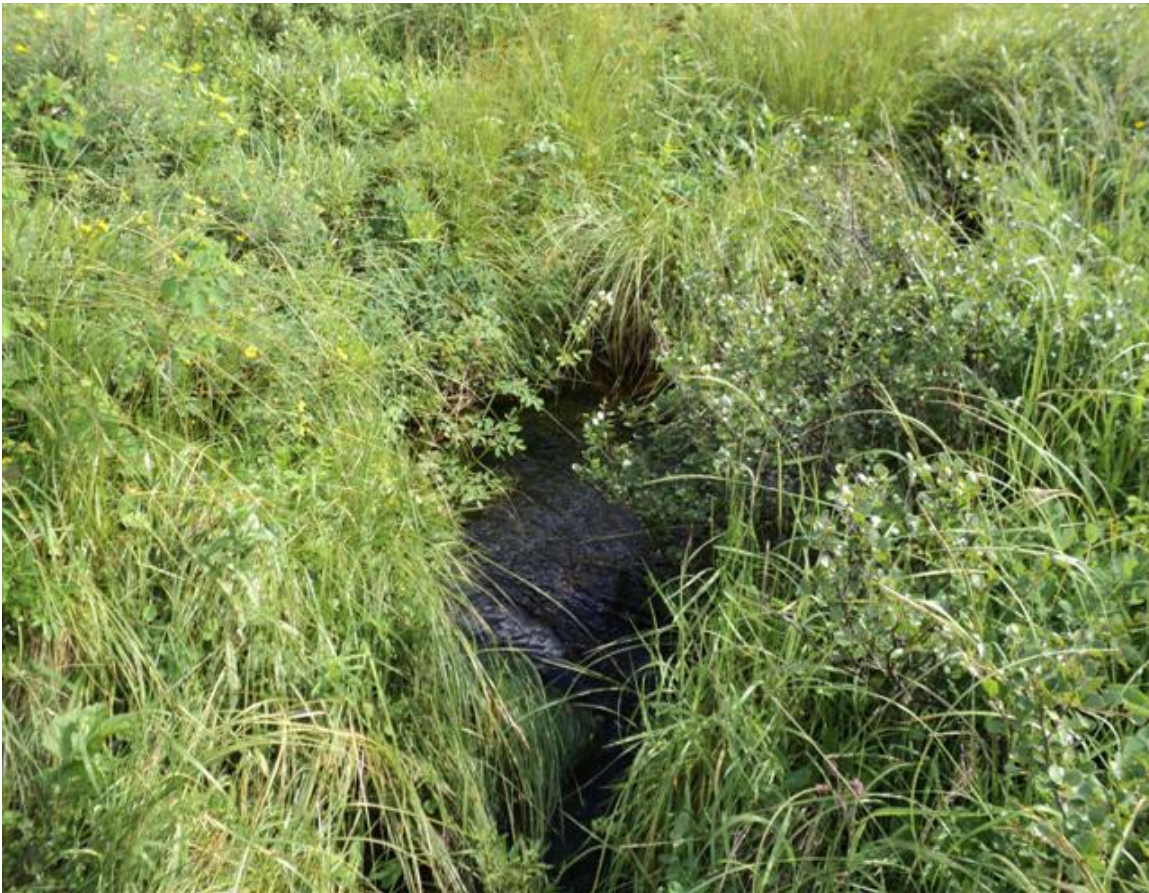
Photo 1-1 Typical Stream Habitat, TDA01

TDA01 begins as a series of slow flats, seepages, and frequent areas of underground flows for the uppermost 500 m (Photo 1-1). It then transitions into sections of pools, flats, and a few riffles segregated by numerous underground flow areas for the next 1,000 m. Continuous stream habitat extends downstream from this point, with flats and riffles prominent for the next 300 m, followed by deep runs, deep flats and riffle for another 350 m until the stream flows into a bog. The bog extends for approximately 450 m at which point stream habitat is evident (200 m upstream of Long Lake) and flows as a series of shallow runs and riffles followed by a deep flat, deep run, and chute at the inflow to Long Lake.

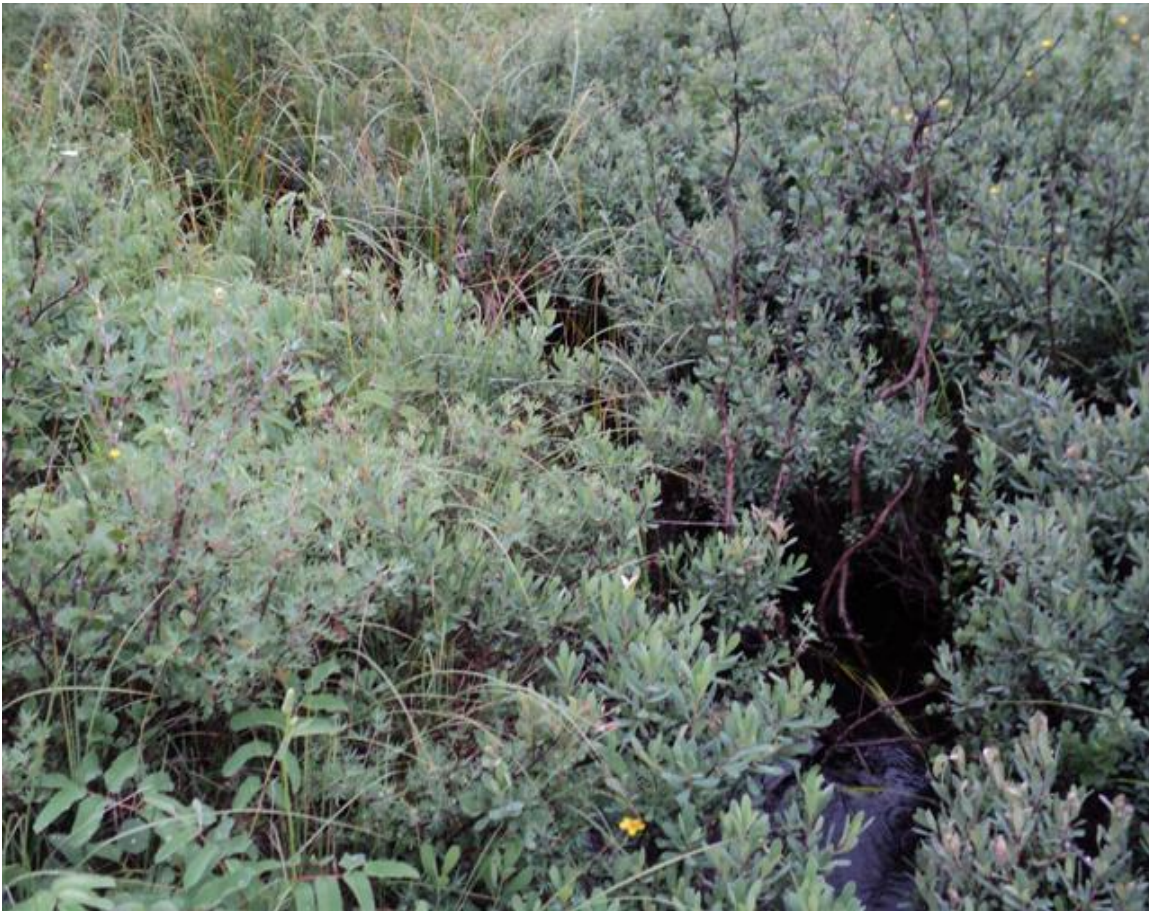
Photo 1-2 Typical Stream Habitat, Upper Portions of TDA02

Stream TDA02 originates at a small standing waterbody (SW1 on Figure 1-3). A narrow stream flows from SW1 to a second small waterbody (SW2), a distance of 272 m. This stream section is less than 1 m wide, with a substrate consisting of fines and organics (Photo 1-2).

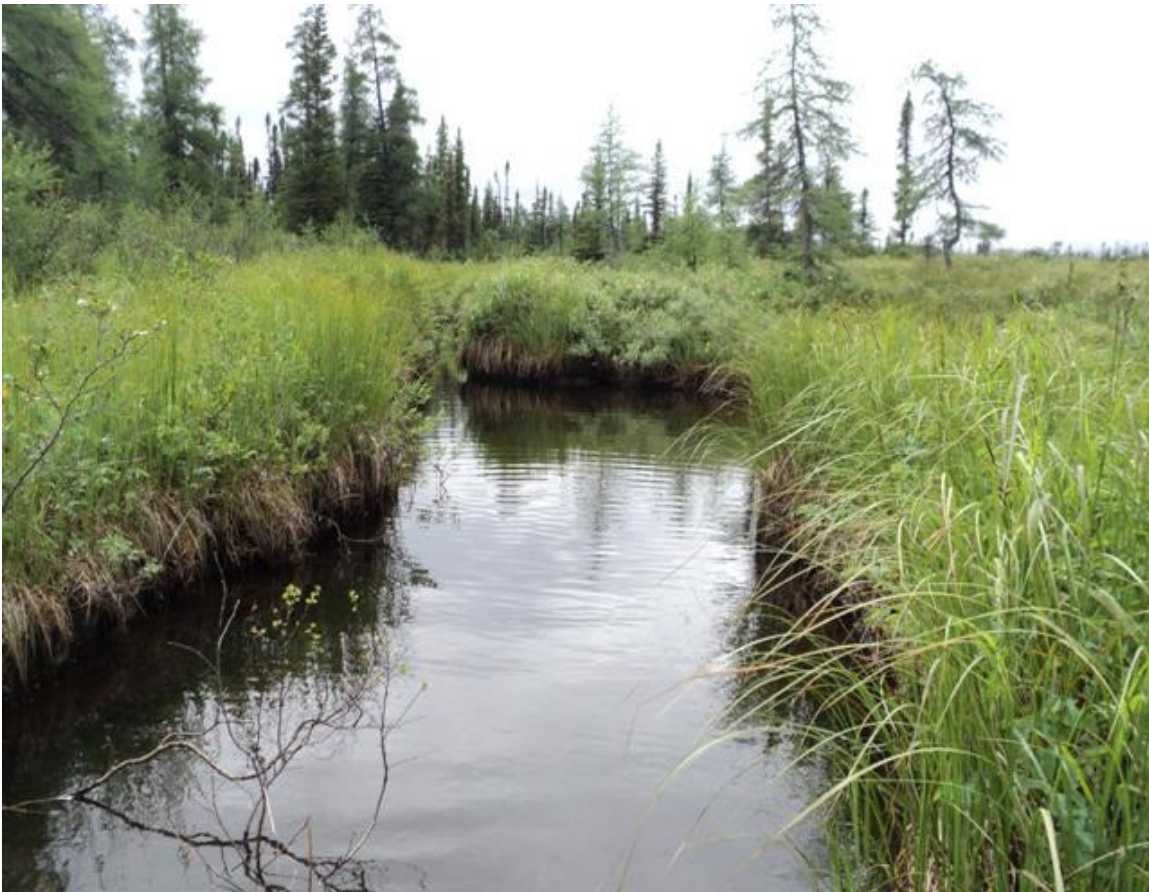
Photo 1-3 Typical Habitat, Near Northern Extent of TMF Phase 2

pools, the stream transitions back into predominately flats of varying depths, interspersed with riffles for 750 m. In the next 750 m, stream character is mainly riffle and run habitat with a few flats (Photo 1-3). This location is approximately the most northern extent of the TMF – Phase 2. At 3,900 m downstream of SW2, the stream widens out into a flat with deep pools prior to entering another boggy area extending for the next 150 m. Downstream of this boggy area, the stream is comprised mainly of a series of riffles and runs until it becomes an extended flat just upstream of a beaver dam located 5,250 m from the start of the survey. Below the beaver dam, the stream becomes a series of rapid and run sections interspersed with riffles for 600 m, transitioning into a 500 m section of deep flats interspersed with riffles, and then a 300 m series of rapids and fast runs with chutes as it nears Long Lake (Photo 1-4).
