RAINY RIVER MINE

OPERATION, MAINTENANCE AND SURVEILLANCE MANUAL

PART II - TAILINGS MANAGEMENT AREA

September 2022

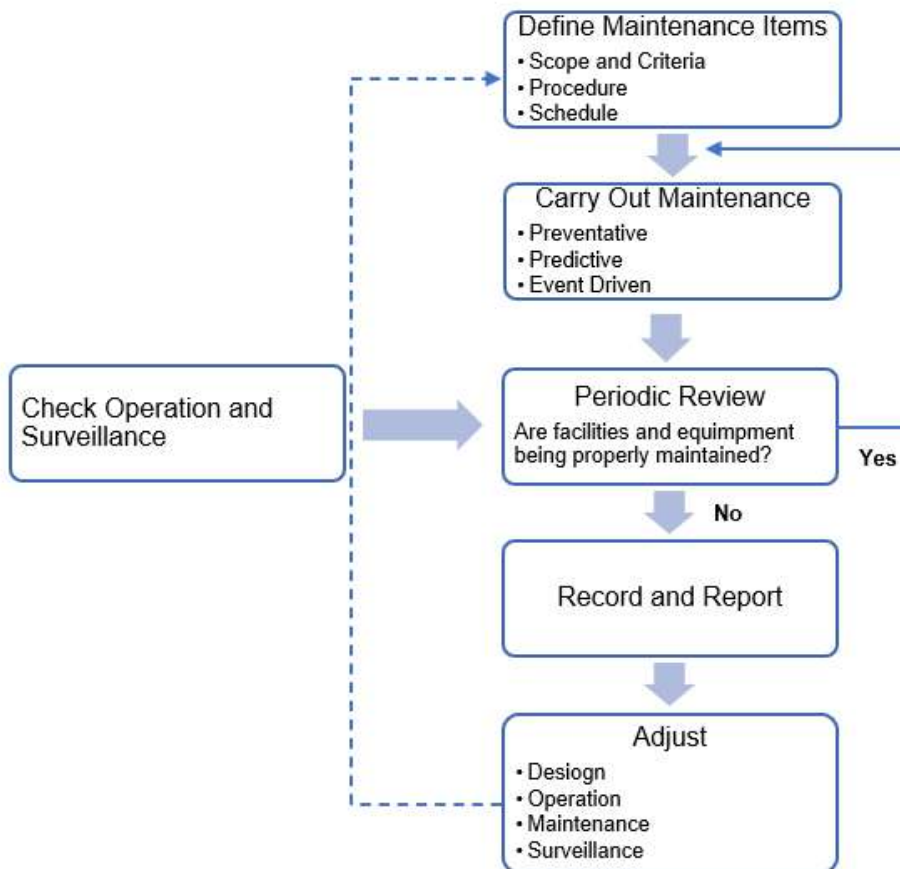
Figure 4- 1: Maintenance Flow Chart

Maintenance records are retained by NGI teams who perform the work in accordance with the procedures described in this document. The teams are Site Service, Mill, Environment and Capital Projects. The maintenance flowchart is illustrated in Figure 4- 1.

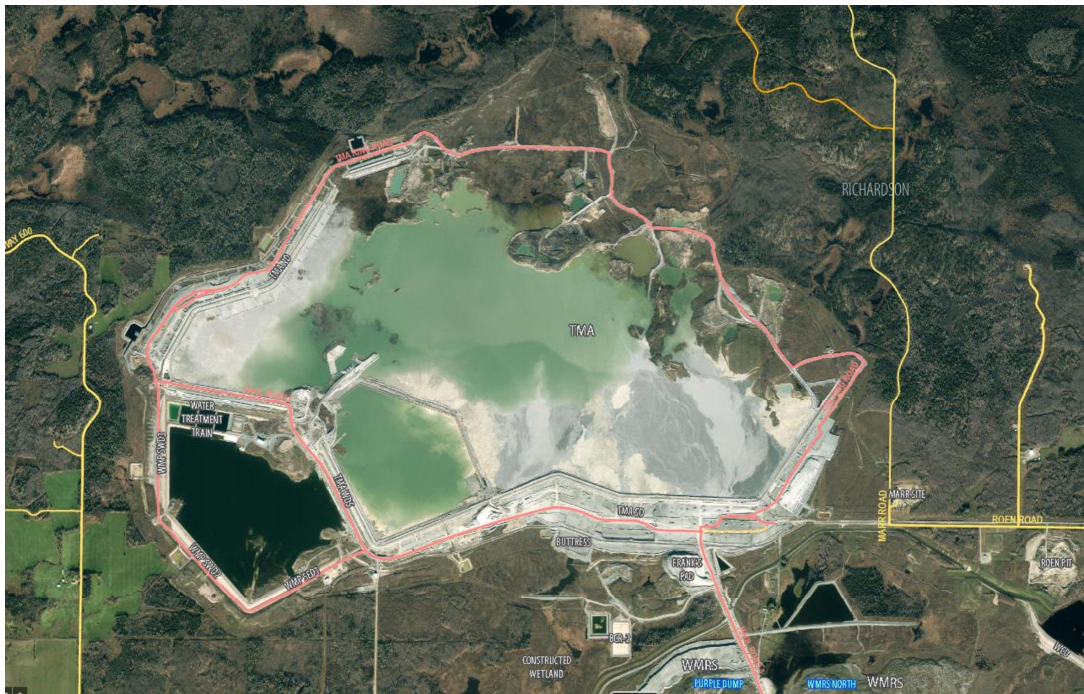
Fig 1. Plan View of TMA

1. From a safe vantage point check that it is safe to approach the dam. Call the Capital Project Manager if the dam is not considered safe to approach.
2. Record weather conditions: _____
3. Record Pond level _____
4. Is there any sign of new deformation such as: cracking, slumping, change of alignment and depressions? YES NO
 - a. If yes use deformation checklist to record details of the observations.
5. Is there any sign of new or increased seepage? YES NO
 - a. If yes use seepage checklist to record the details of the observations.
6. Is there damage to the spillway? YES NO
 - a. If yes use seepage checklist to record the details of the observations
7. Estimate the length of tailings beach. SD: ___m, WD: ___m, ND: ___m

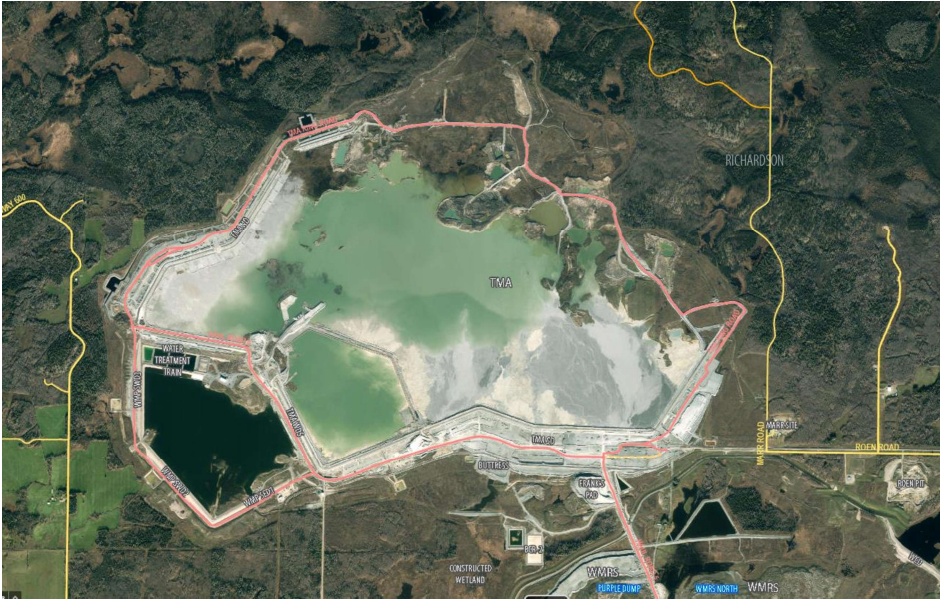
Fig 1. Plan View of TMA

Inspect the condition of the Spillway:

6. Is there damage to the Sill? YES NO
7. Is there damaged to the toe? YES NO
8. Is there damaged to the side walls? YES NO

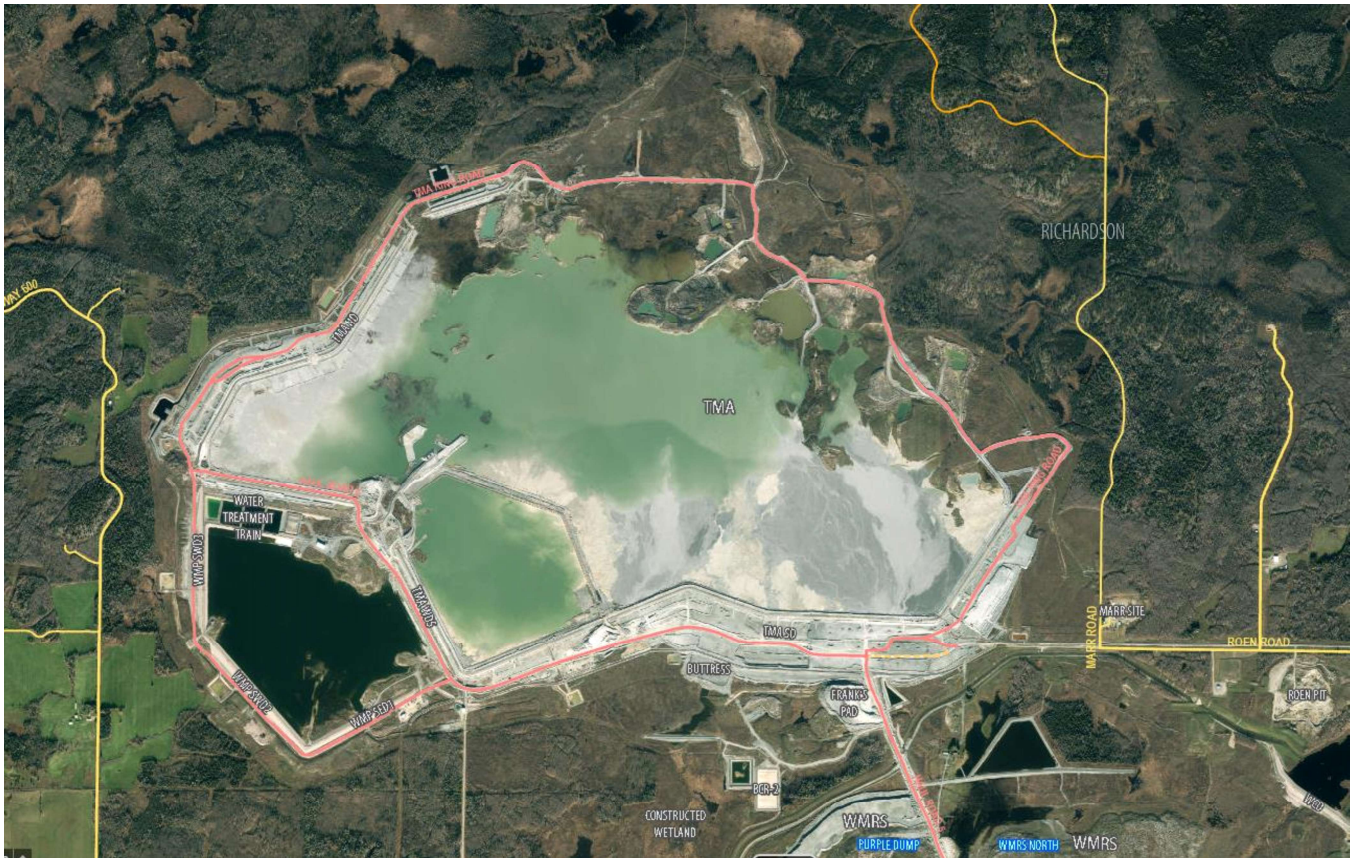
Fig 1. Plan View of TMA

Record of Seepage

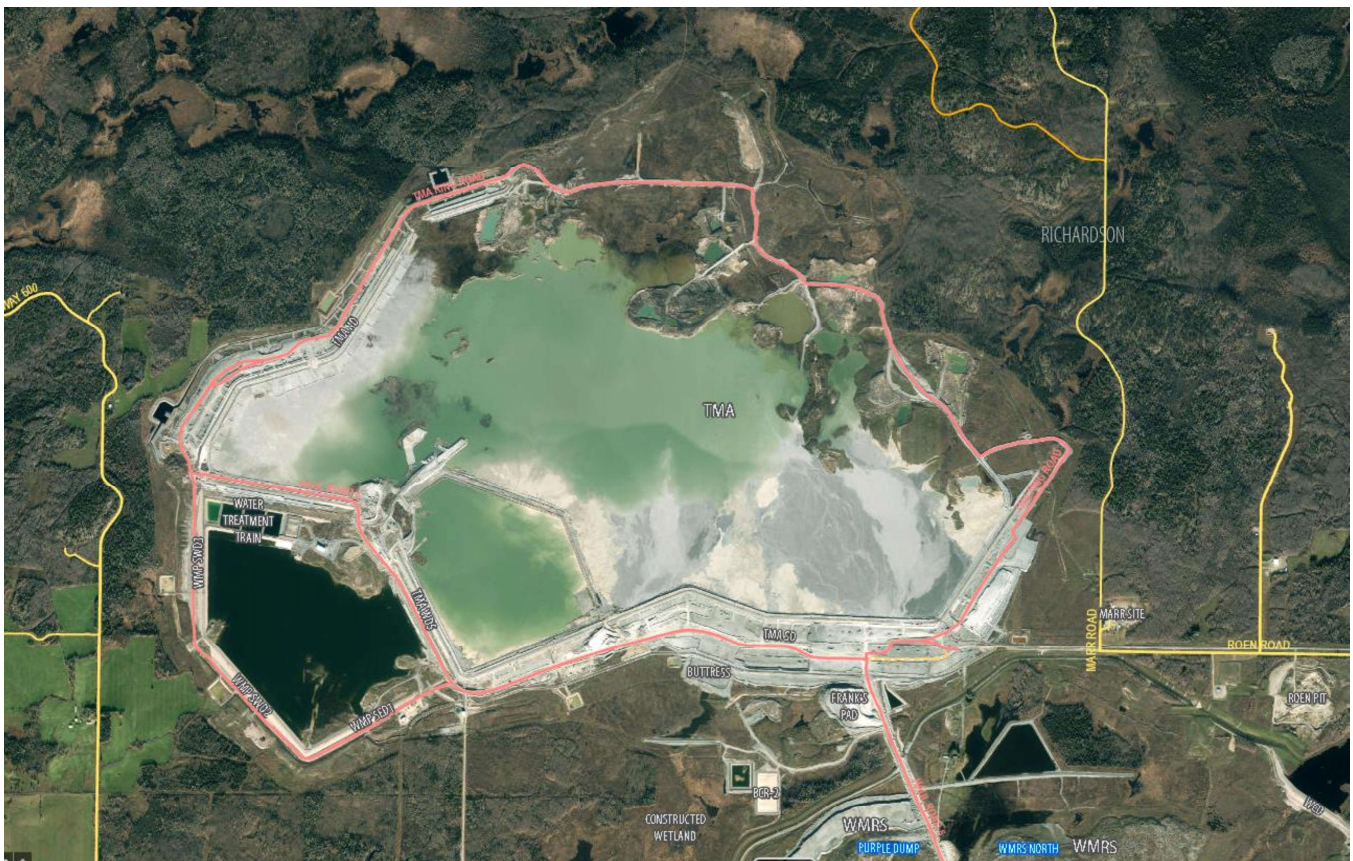
Fig. 1. Plan View of TMA

9. Inspect the rest of the dam using the Routine Weekly Inspection Checklist. Look for signs of deformation such as:
 - New or increased seepage (If observed go to the Increased Seepage SRP)
 - Other areas of deformation
10. If anything looks unusual report back to Capital Project Manager immediately.
11. Continue to measure and record the Length, Width etc. every hour and check that there are no changes. Report any changes in the measurements to the Capital Project Manager immediately.
12. Continue to inspect the entire dam every two hours following the Routine Weekly Inspection Checklist.
13. Do not leave site until manager instructs you to do so.
