Assessment of Potential Open Pit Groundwater Inflows Beaver Dam Gold
Project Nova Scotia - April 2015
Completed for the Updated 2021 Beaver Dam Mine EIS

**ASSESSMENT OF POTENTIAL OPEN PIT GROUNDWATER INFLOWS
BEAVER DAM GOLD PROJECT
NOVA SCOTIA**

Report No: 1501_R01

April 2015

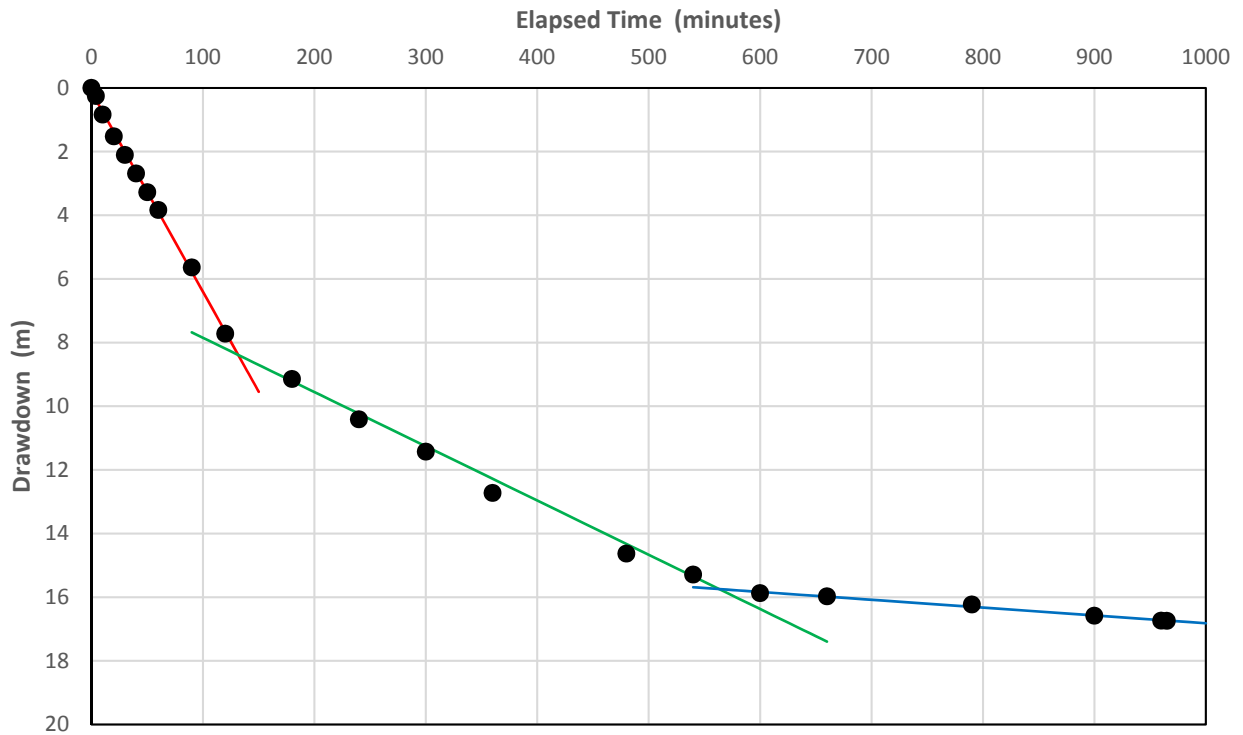
Austen Shaft pumping test, 18 June 1986

Rate of pumping: 2,275 kL/day (26.3 L/sec)

Rate of drawdown in each linear segment:

Time (minutes)	Rate of drawdown (m/minute)	Drawdown (m)
0 - 120	6.28×10^{-2}	0 - 7.7
120 - 600	1.70×10^{-2}	7.7 - 15.9
600 - 965	2.46×10^{-3}	15.9 - 16.7
