# Rainy River PAG Cover Trial - Annual Monitoring Report

1003-16-005

January 2020

New Gold Inc.

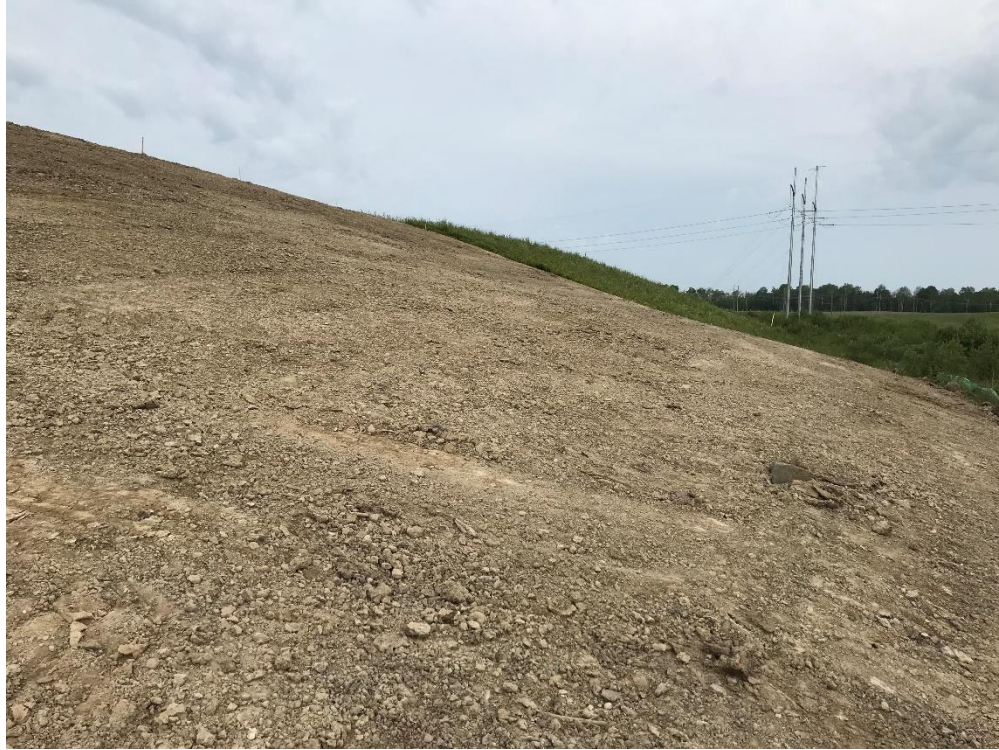
Figure 2.1: Completed modified north slope construction. July 17, 2019.

During site visits, large erosional rills were observed on the northern and eastern slopes of Trial #2. The erosional rills were attributed to the steep (3H:1V), non-vegetated slope. Okane identified the potential for advective air movement into the underlying mine rock and deeper frost penetration due to the loss of material and recommended repairing and modifying Trial #2 slopes. Approximately 2,200 m<sup>3</sup> of overburden material was placed on the north, east, and south slopes of Trial #2 to reduce the overall slope to approximated 4H:1V (Figure 2.1). Once extended, the new slopes were hand-seeded with appropriate seed mix to promote vegetation development and reduce erosion potential. Drawing 1003/16-001 outlines design details of the modifications.

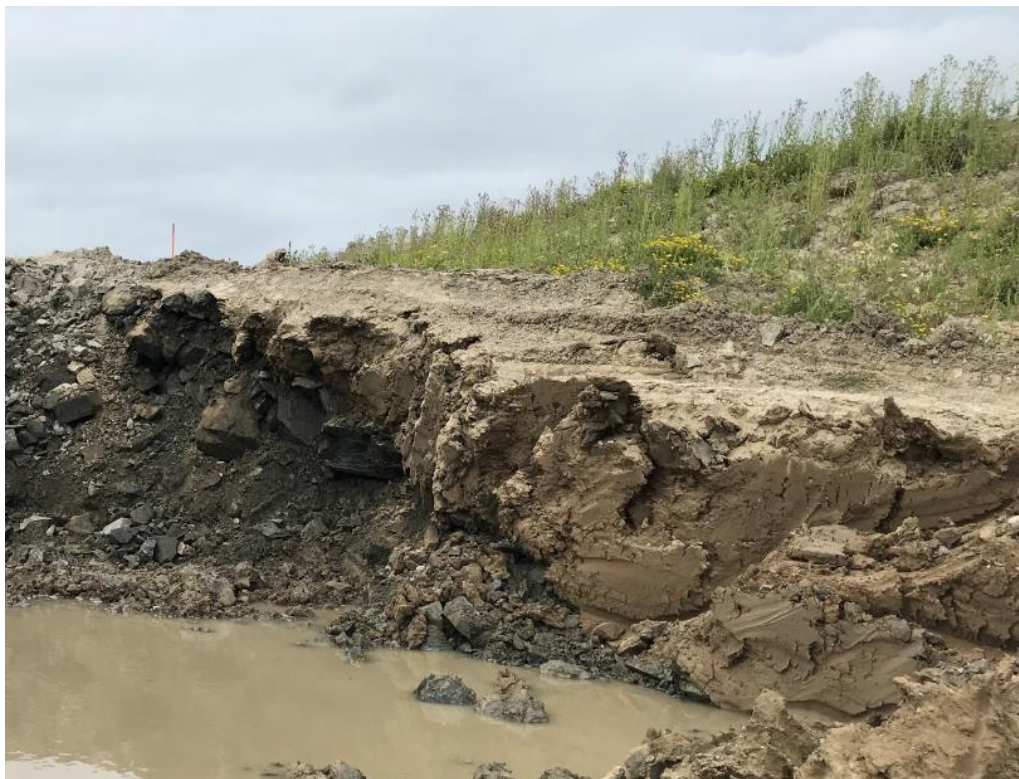
During material placement, a small borrow investigation of the clay key surrounding the cover trials was completed on the south-east corner. It was observed that the thickness of the key at this location pinched out and is less than the minimum design thickness (Figure 2.2). It should be noted that a thin clay key could be an additional potential pathway if oxygen ingress is observed in the future.

Figure 2.2: Borrow investigation of clay key layer on southeast corner of Trial #2. July 15, 2019.

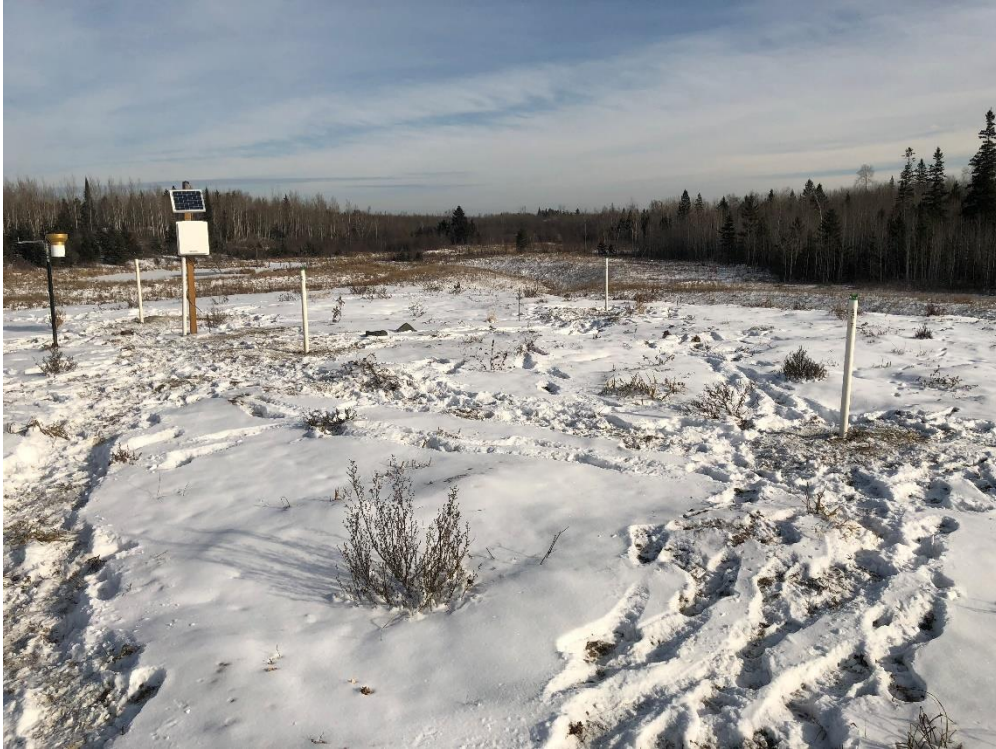
Photograph A.1: Overview of manual gas sampling stations on Trial #2. November 14, 2018.

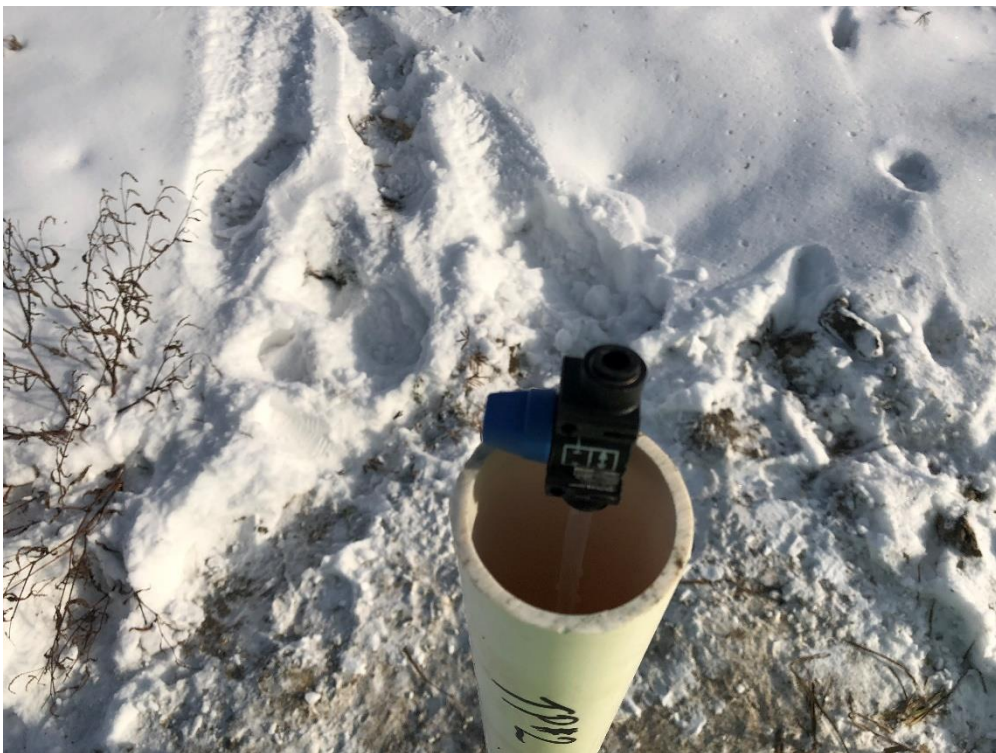
Photograph A.2: Manual gas sampling shut-off valve. November 14, 2018.

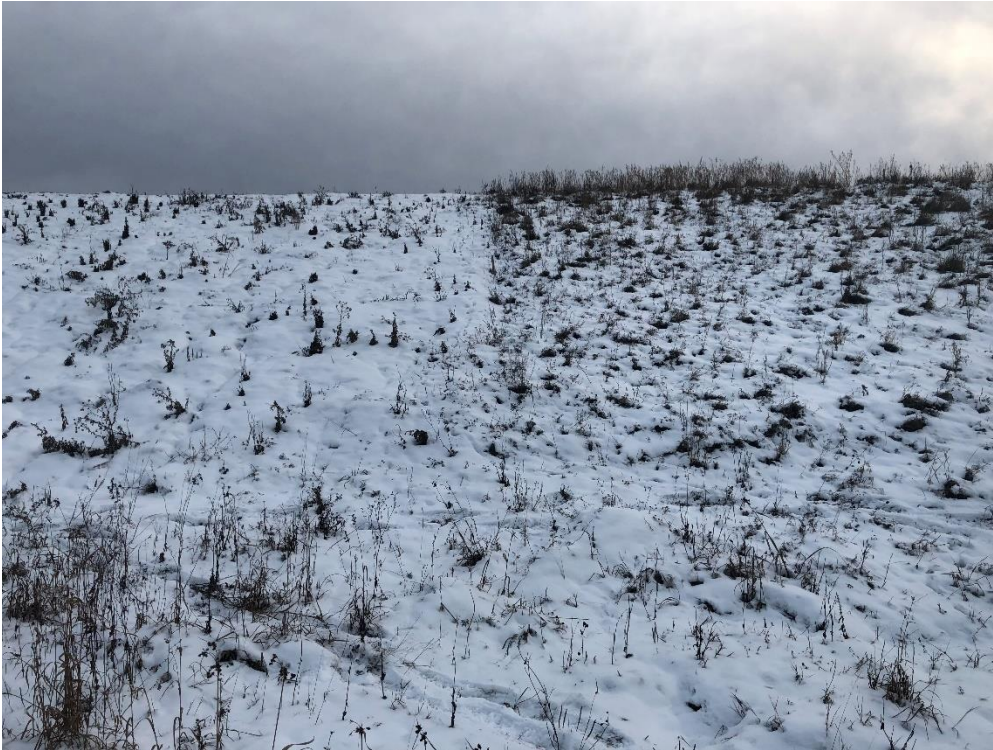
Photograph A.3: Trial #1 vs. Trial #2 vegetation comparison. November 14, 2018.

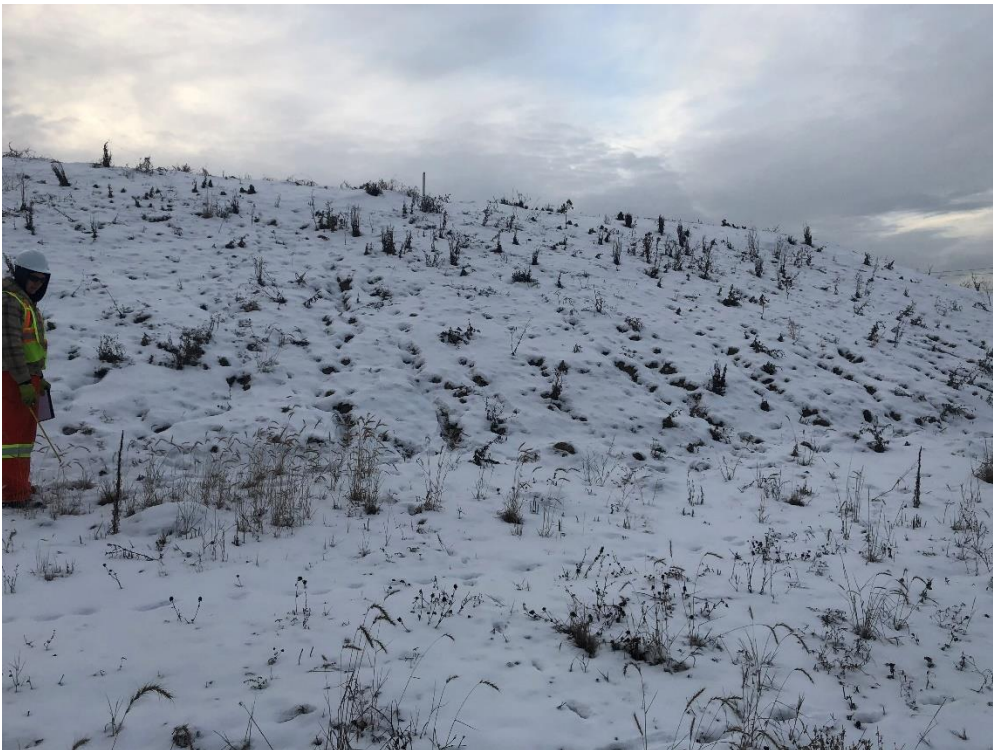
Photograph A.4: Erosional rill on east slope. November 14, 2018.

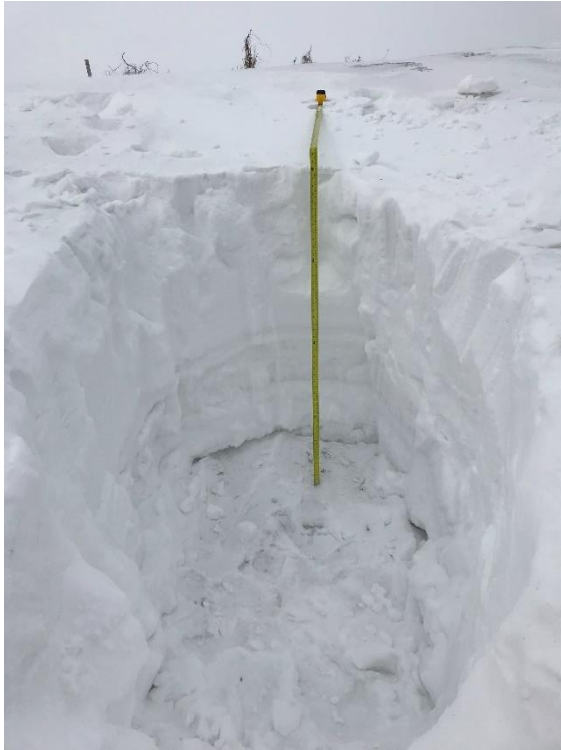
Photograph A.5: Snowpack on south slope on Trial #2. March 4, 2018.

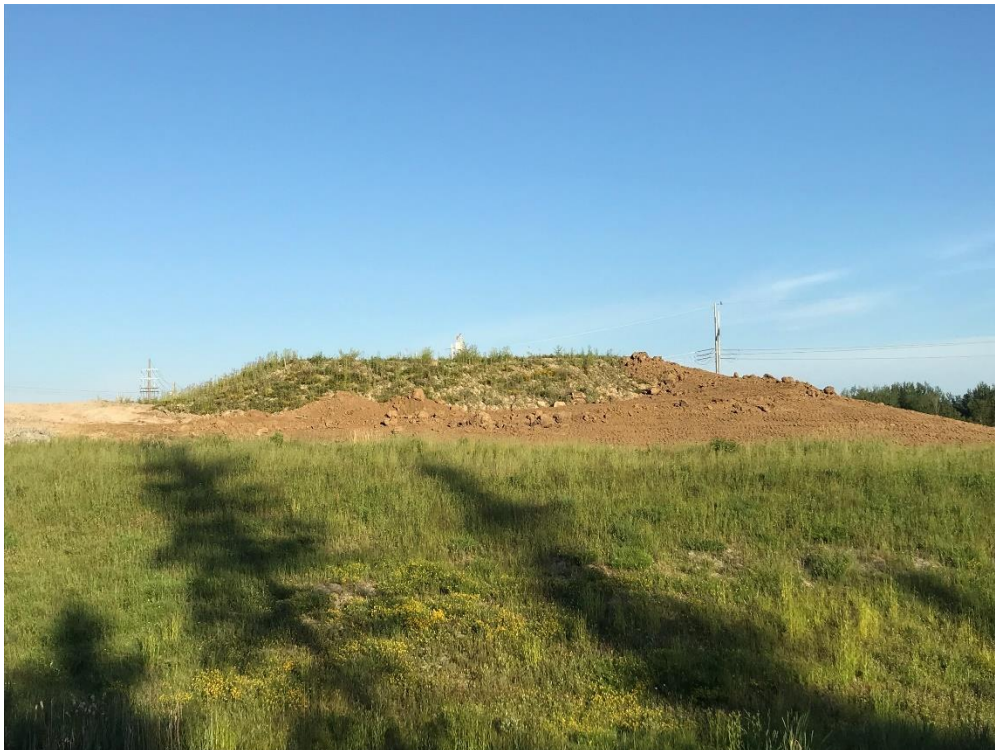
Photograph A.6: Material being added to east slope. July 15, 2019

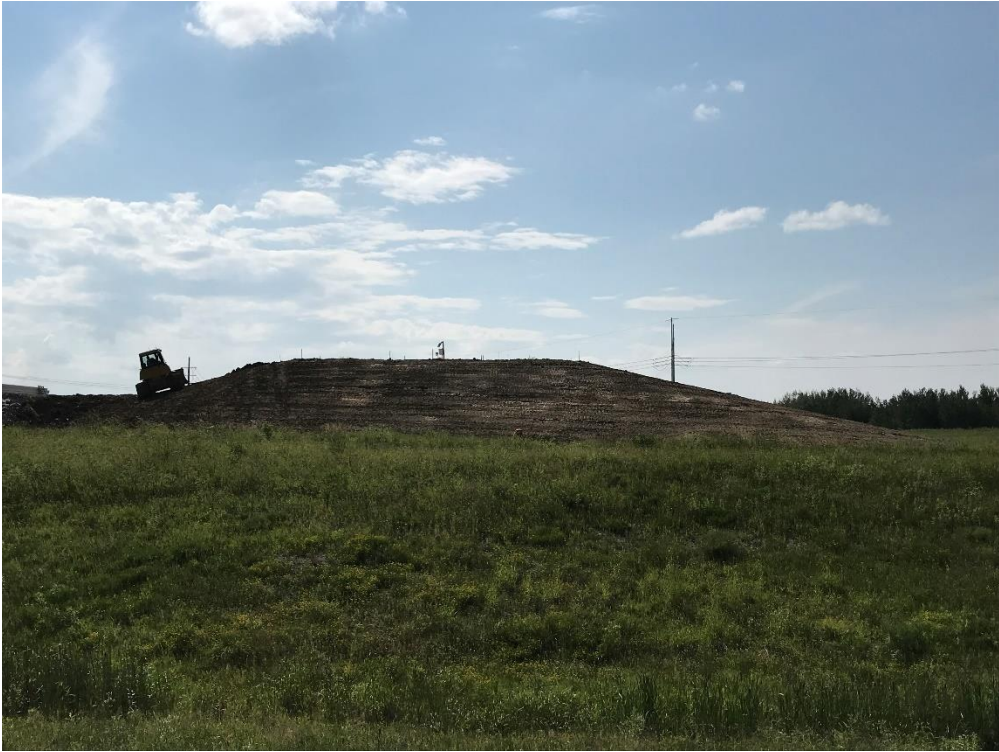
Photograph A.7: Completed east slope construction. July 16, 2019.

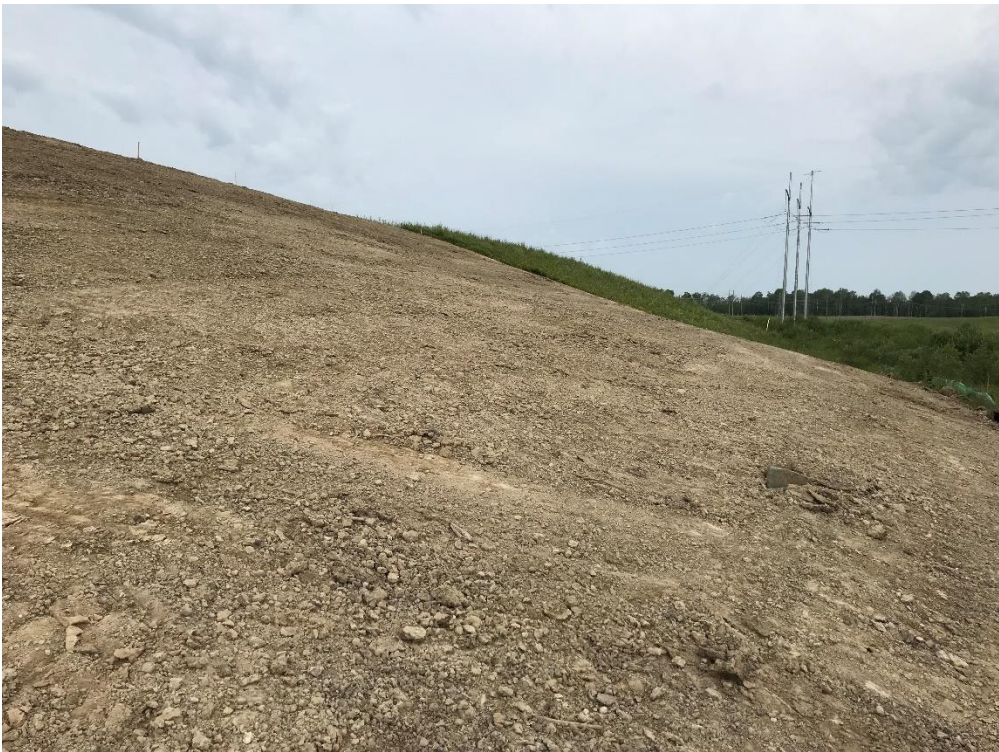
Photograph A.8: Completed north slope construction. July 17, 2019.

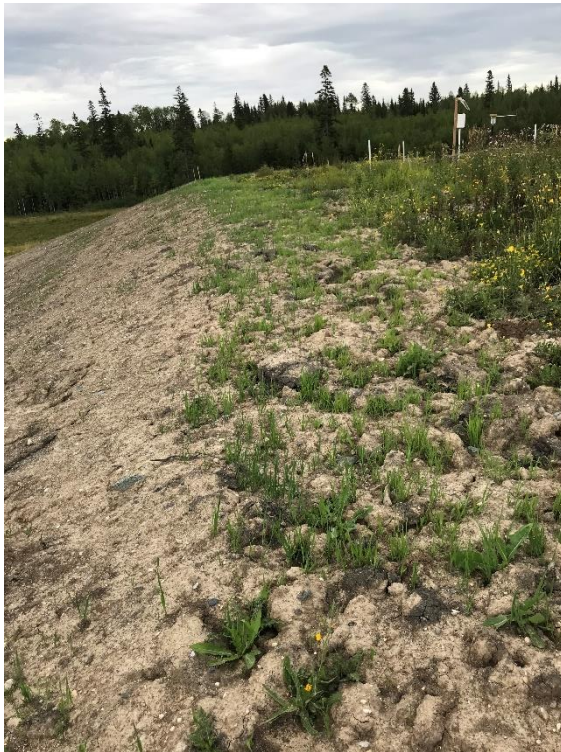
Photograph A.10: Fresh vegetation on north slope of Trial #2 from hand seeding. August 13, 2019.

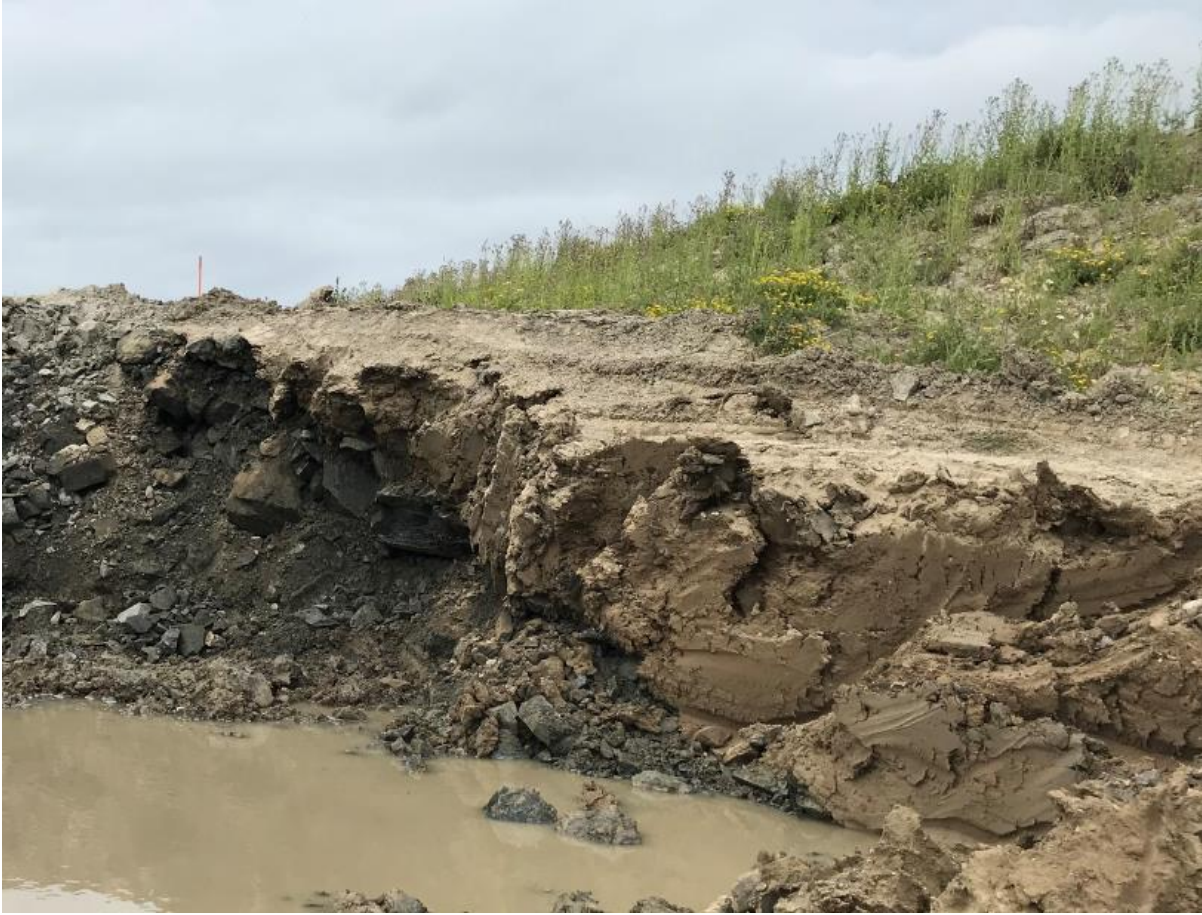
Photograph A.11: Borrow investigation of clay key layer on southeast corner of Trial #2.  
July 15, 2019.
