**APPENDIX 4-AI
EVALUATION OF ALTERNATE GLACIER
ACCESS ROUTES, KSM PROJECT 2012**

ISSUED FOR USE
EBA FILE: EI4101069

Subject: Evaluation of Alternate Glacier Access Routes
Kerr Sulphurets Mitchell Project

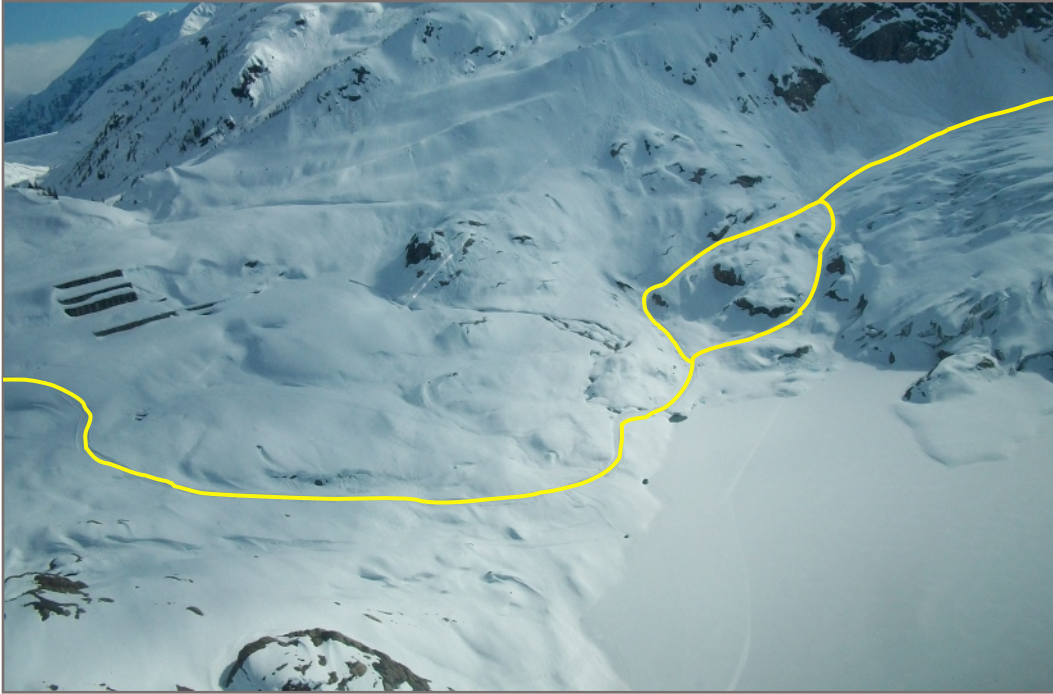
1. Station 0+200 to 1+000 – This section is quite steep and as shown on Photo 1 (winter) and Photo 2 (summer) the access route used by Pretium follows one of two narrow valleys between outcropping rock. The width of the two small narrow valleys and the steepness of the route will be a challenge. Some of the loads may have to be moved by winching up this section.

Photo 1: Looking west up the toe of the Berendon Glacier in the winter of 2011. The routes used by Pretium to haul equipment into their Brucejack Lake site are highlighted in the photo. The abandoned Granduc mill building foundations are visible on the left side of the photo.

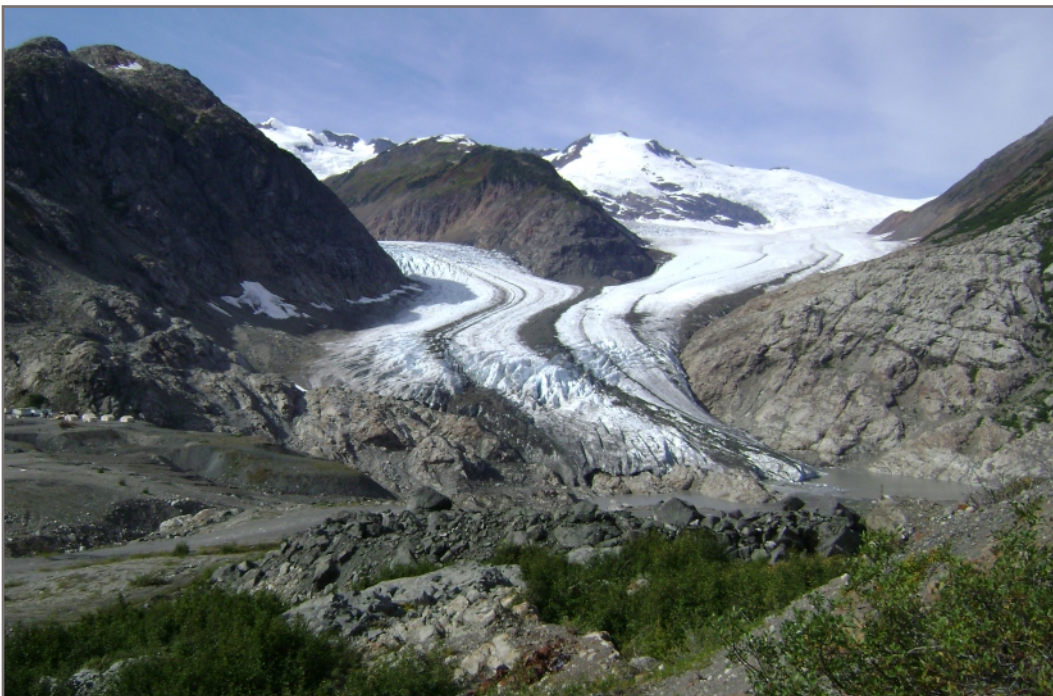
Photo 2: Looking west at the toe of the Berendon Glacier in the summer. The tents on the left side of the photo are located near the old Granduc Mine facilities.

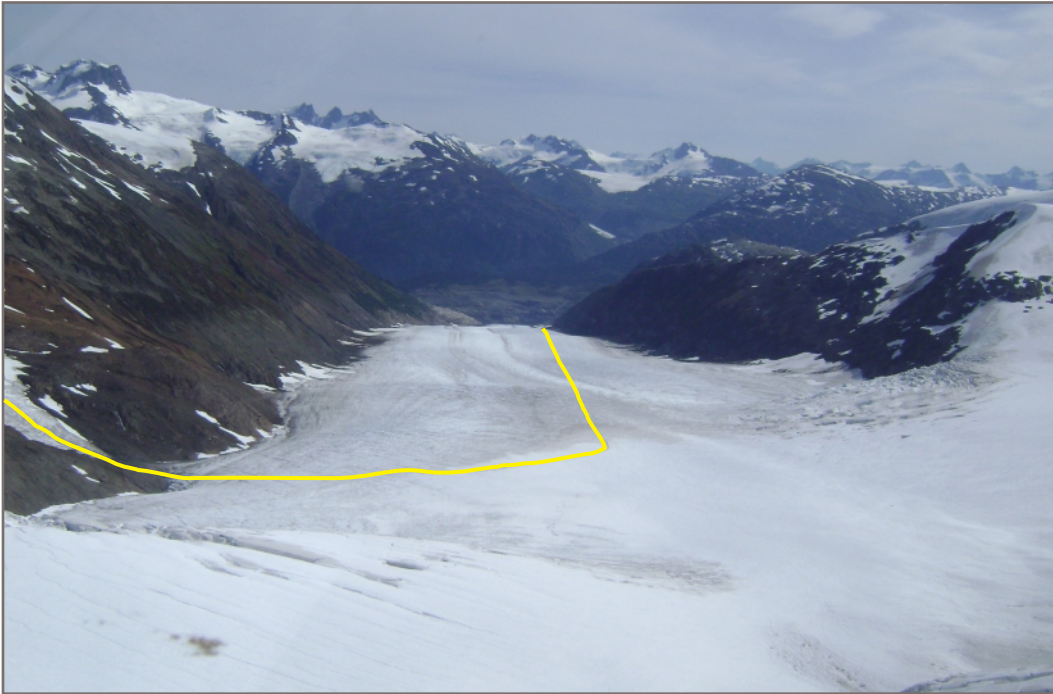
2. Station 6+800 to 7+100 – This is the steepest section of the entire route, being an approximately 30% upwards grade on the haul leg (see Photos 3, 4, and 5). Pretium appeared to have moved directly up this slope with the equipment that they mobilized, but the actual method that they used is not known. The loads may have been winched up the slope. Switchbacks may have to be constructed in this area to be able to haul the types of loads expected for the Seabridge haul. The empty returning tractors and sleighs will likely have to be held back with a winch from the top of the slope to ensure that they do not get into a runaway situation.

Photo 3: Looking east down the Berendon Glacier. The trail used by Pretium is highlighted. The small tongue of the narrow and steep glacier that was used to gain access to the Frank Mackie Glacier is just visible in the middle of the photo on the left side.

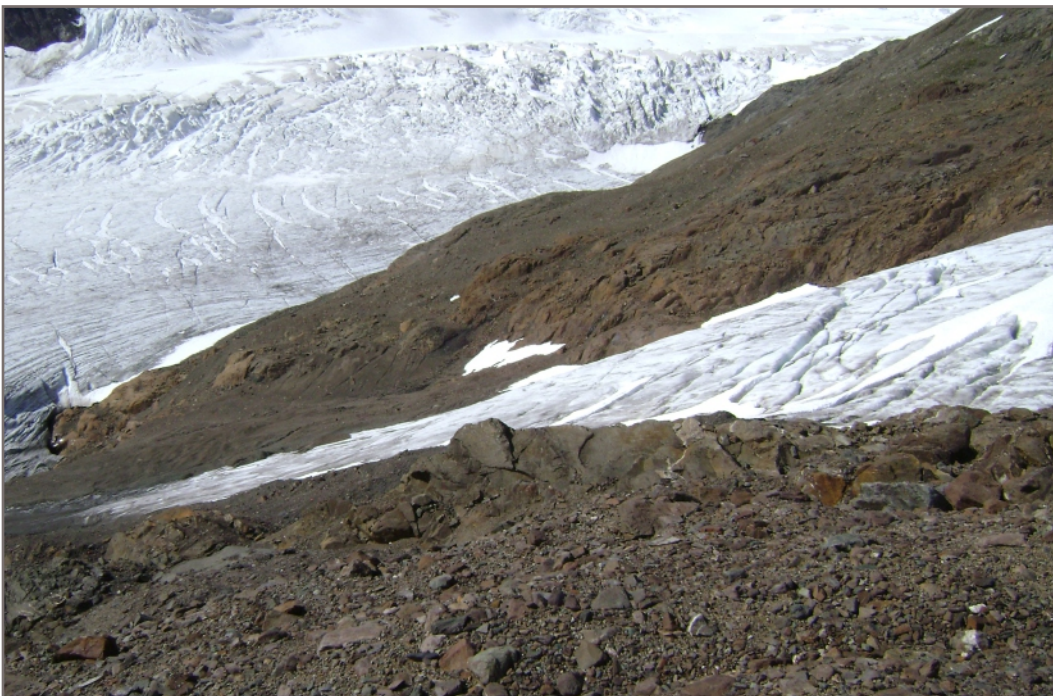
Photo 4: Looking to the southwest from near the top of the narrow and steep side glacier at approximately Sta. 7 +000 on Figure 2. The Berendon Glacier is in the background.

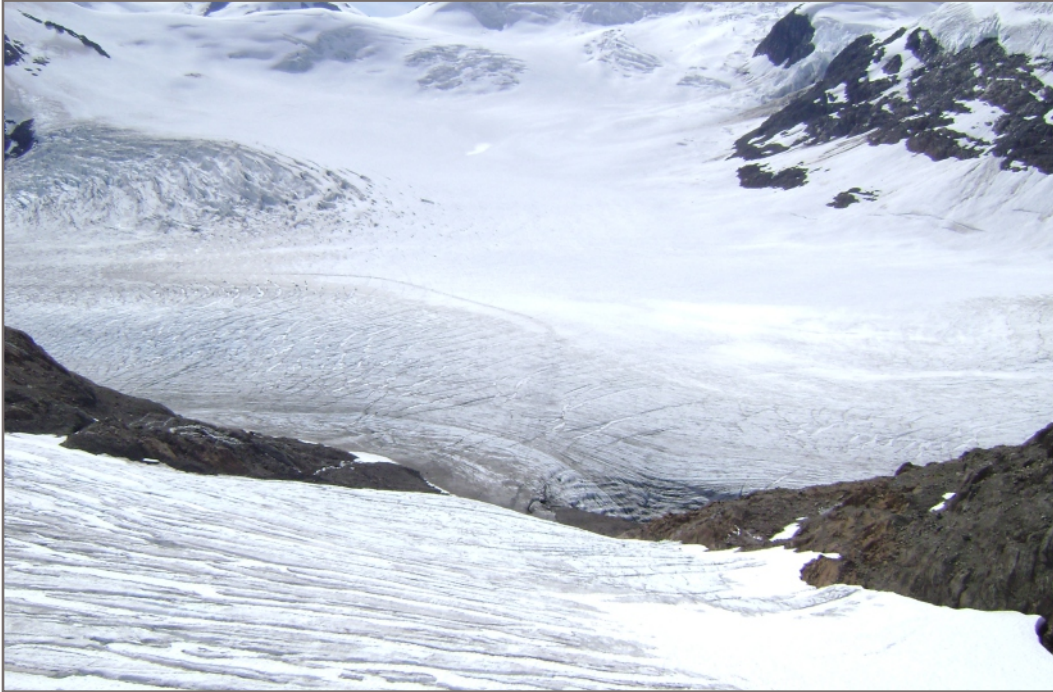
Photo 5: Looking to the south at the narrow and steep side glacier (approximately Sta. 7 +000 on Figure 2. The Berendon Glacier is in the background.

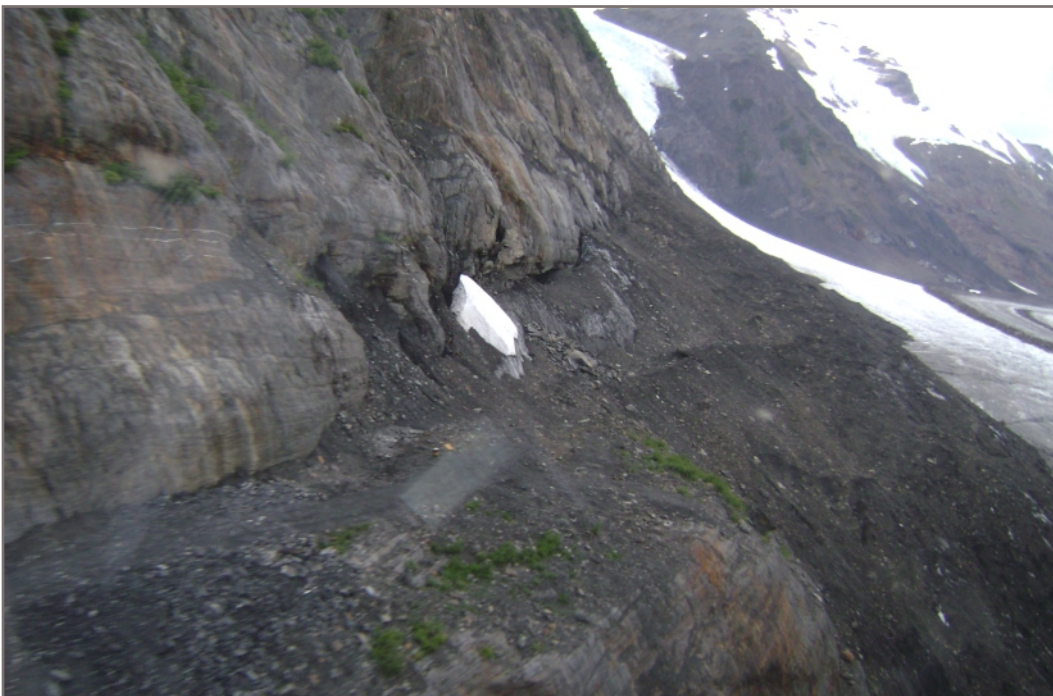
In addition to the above routes, the access road currently being constructed to gain access onto the Knipple Glacier was examined. It was found to be a very narrow and potentially unstable road and is not likely going to be suitable for hauling equipment of the size required by Seabridge. Therefore, a glacier haul route using the Knipple Glacier to gain access to the Mitchell Glacier or into the Sulphurets valley is not likely feasible.

Photo 6: Looking to the northwest at a portion of the access road being constructed/ rehabilitated by Pretium to gain access onto the Knipple Glacier. The Knipple Glacier is visible in the distance on the right side of the picture.

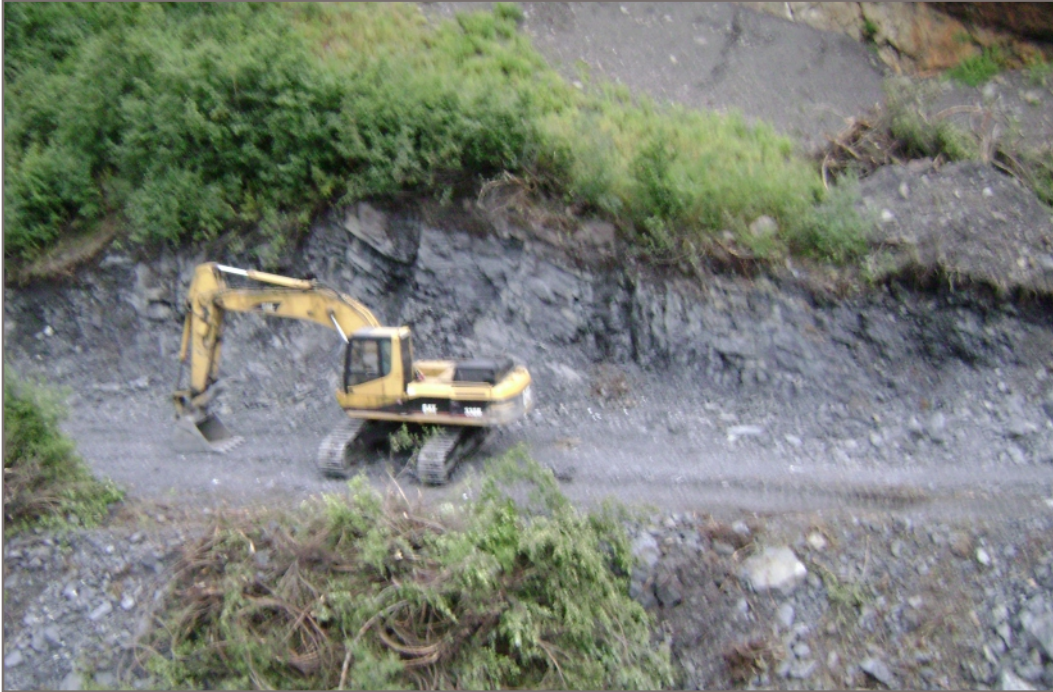
Photo 7: The backhoe on a portion of Pretium's newly constructed access road near the Knipple Glacier. It is believed that this machine was walked into site on the Berendon/Frank Mackie Glacier in the winter of 2010/11.

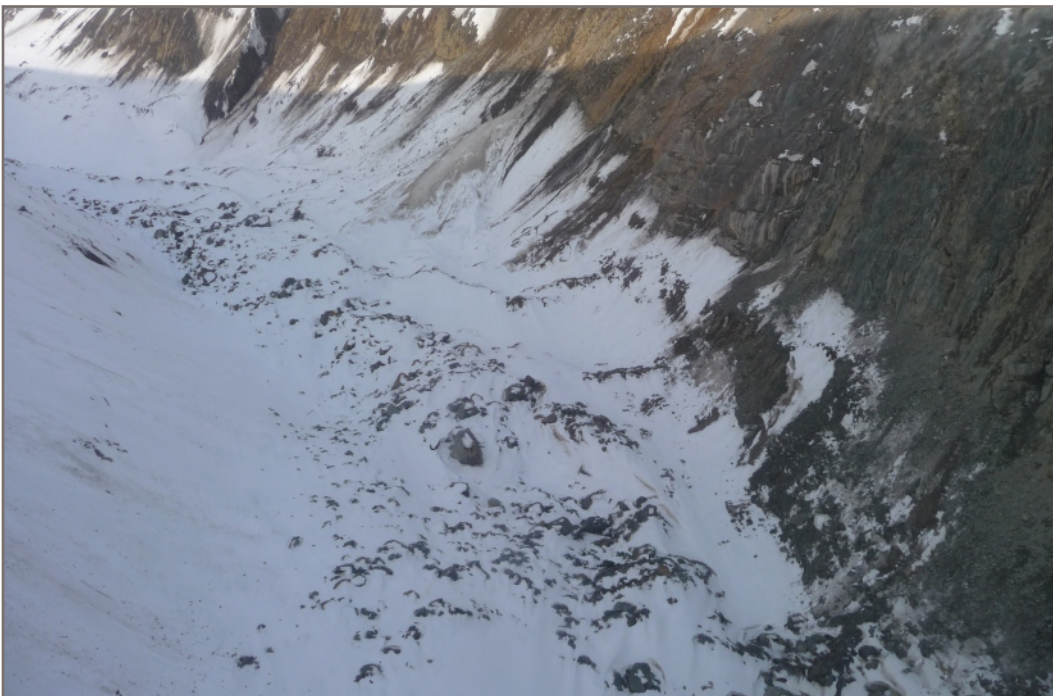
- The rest of the Frank Mackie route was good, but in the Ted Morris Creek valley it was observed that there was less snow in this area (see Photo 8). Due to the snow conditions, it would take longer to push snow along a route over the boulder field coming down off the glacier. There was little snow in the valley, north of the glacier in the Ted Morris Creek valley and all the way over to the camp in the Sulphurets valley.
- At the Sulphurets camp, the helicopter pilot noted that the snow cover was perhaps 0.5 m less than normal.
- To the north of the KSM area, near the Eskay Creek Mine, there was more snow.

Photo 8: Looking south up the Ted Morris Creek valley at approximately Sta. 33+500, April 15, 2010. Note the relative lack of snow in this area at this time of year and the lack of avalanche and rockfall evidence.

There remains some concern regarding the amount of snow in the Ted Morris Creek valley. This should be further evaluated during the coming winter.

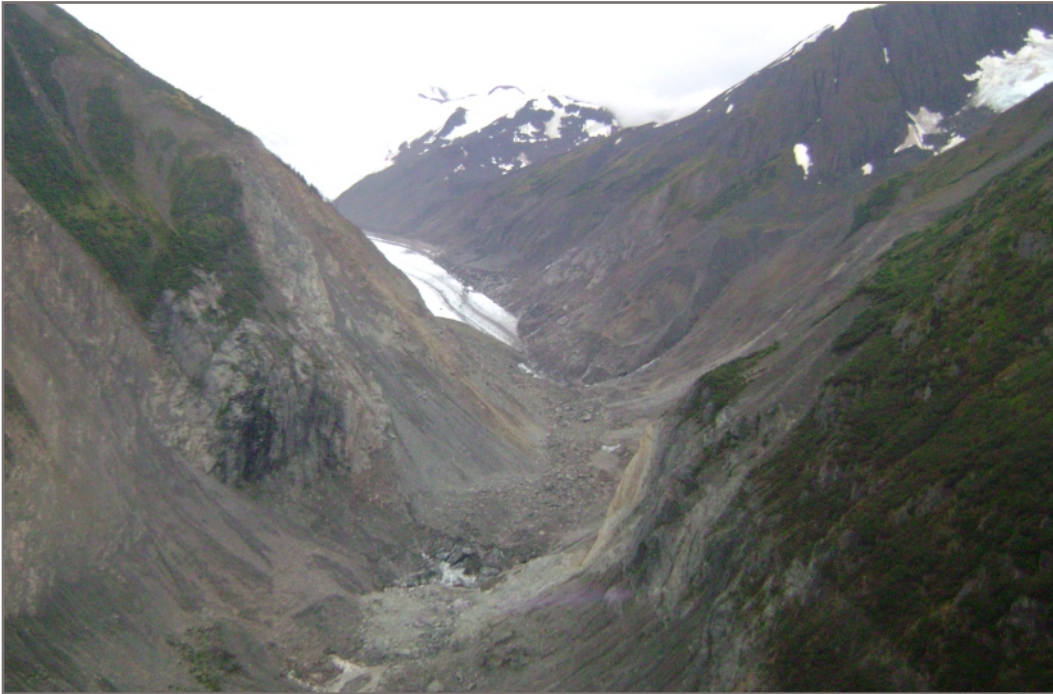
Photo 9: Looking south up the Ted Morris Creek valley at approximately Sta. 34+200. Note the creek emerging from a melt water tunnel in the glacier and rock fall debris on the glacier surface and in the bottom of the valley.

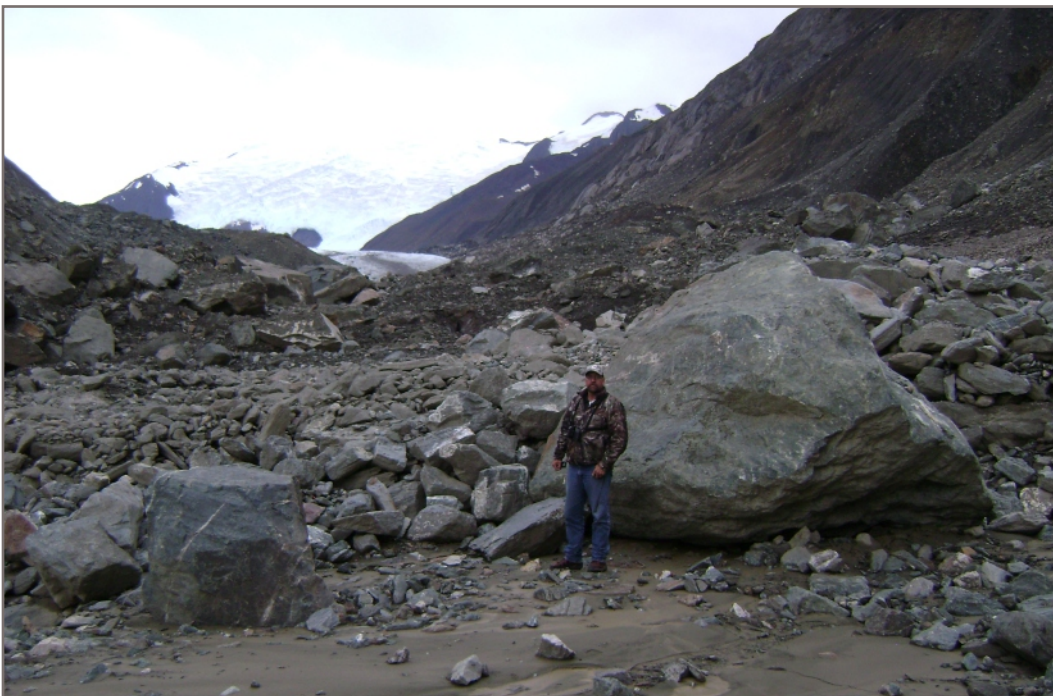
Photo 10: Looking south up the Ted Morris Creek valley at approximately Sta. 33+400. Note the size of some of the boulders that exist above the underlying glacier ice.

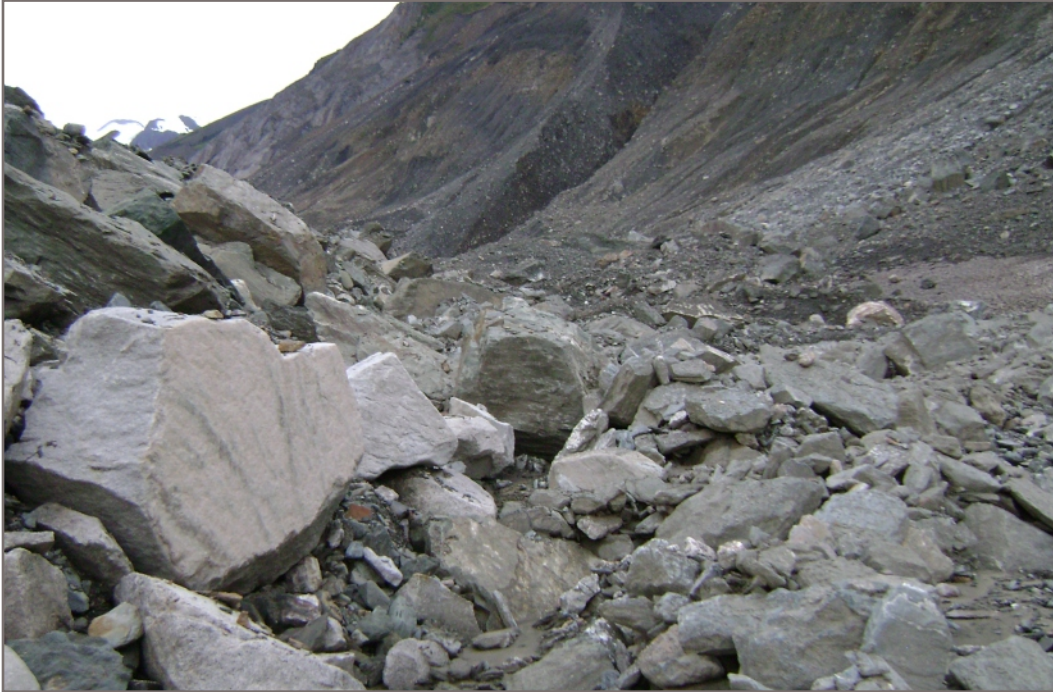
Photo 11: Looking to the south-southwest up the Ted Morris Creek valley at approximately Sta. 33+400, again showing the size of the rock rubble that exists in the valley.

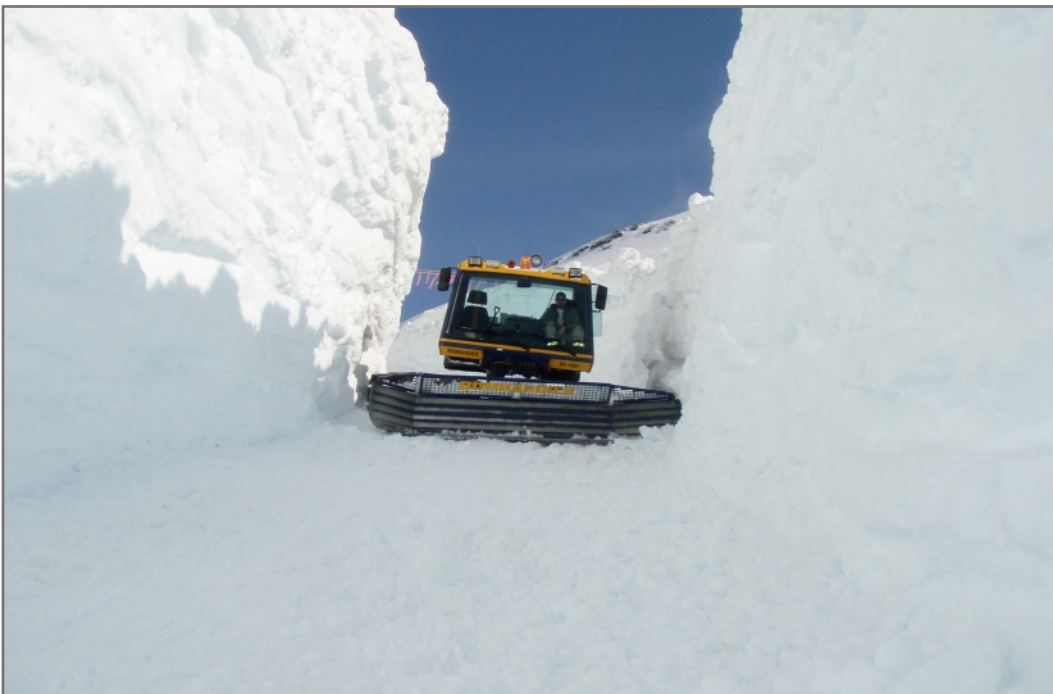
Photo 12: Photo from Brett Wildman of Nuna taken in the winter of 2009 showing a snowcat creating access trails in the area immediately south of the Eskay Creek Mine.

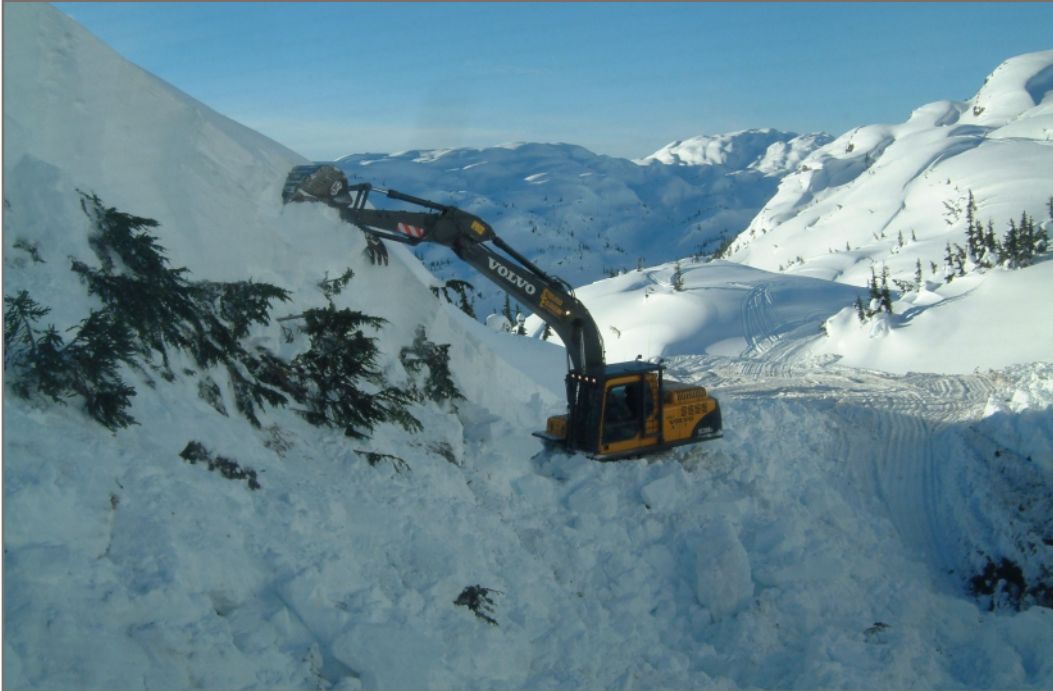
Photo 13: Photo from Brett Wildman of Nuna taken in the winter of 2009 showing a backhoe creating a drilling pad in the area immediately south of the Eskay Creek Mine.
