Date:	July 12, 2022	Owner/Client:	New Gold Inc.
Day:	Tuesday	Okane Project #:	1003-223
Prepared by:	Brady Hay	Project Location:	Ontario

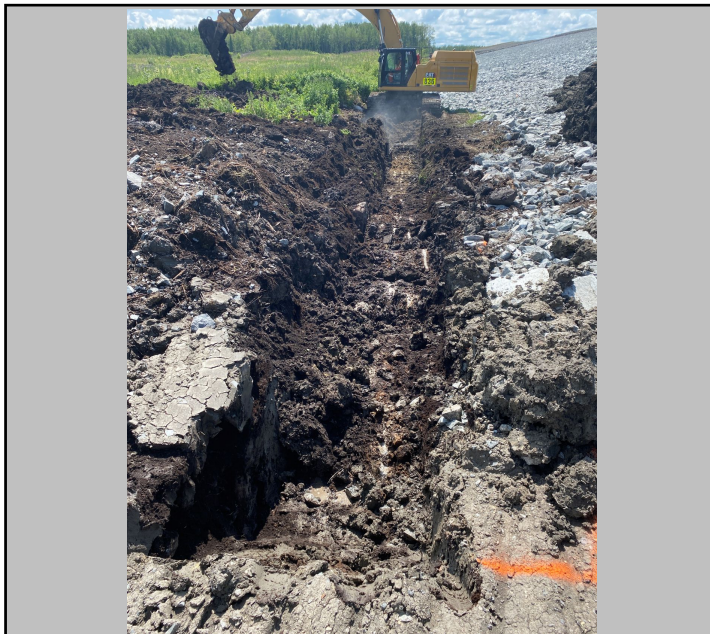
Photo #: 2

P32, L1 tied into P31

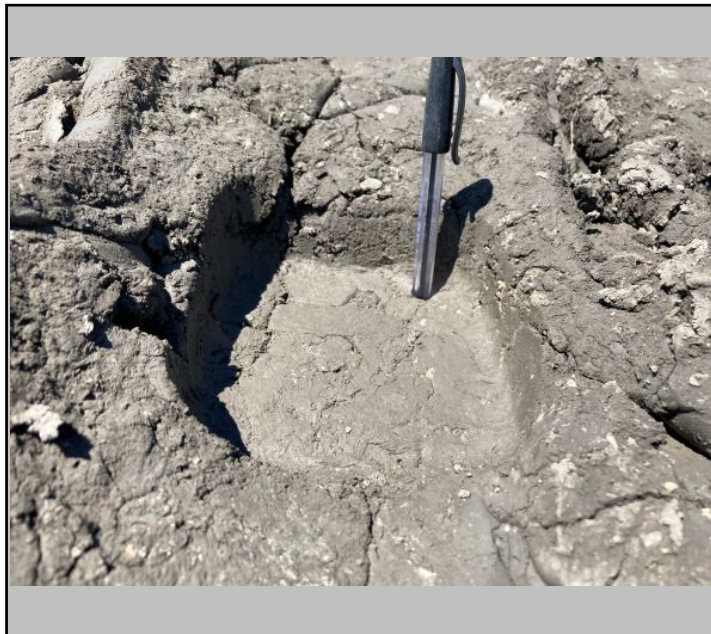
Photo #: 2

P32, L2, post-compaction

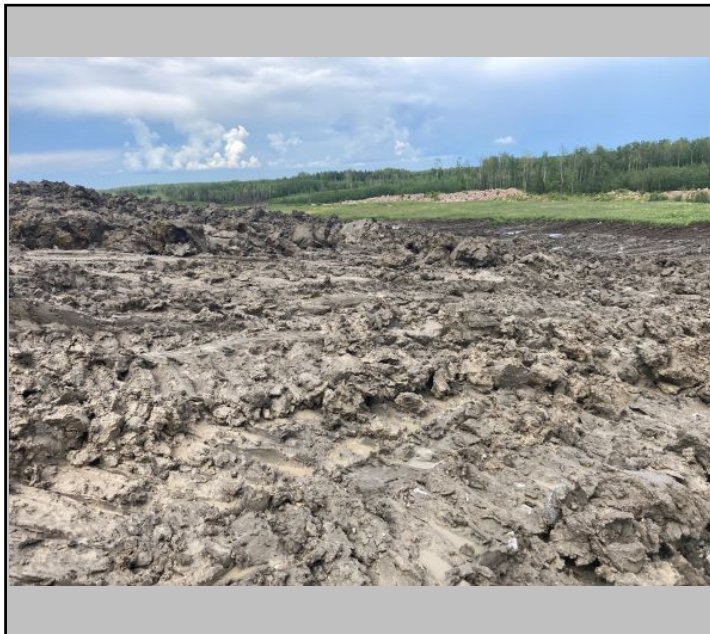
Photo #: 2

Central Stockpile material used for part of P32,
L3 and all of P33, L1

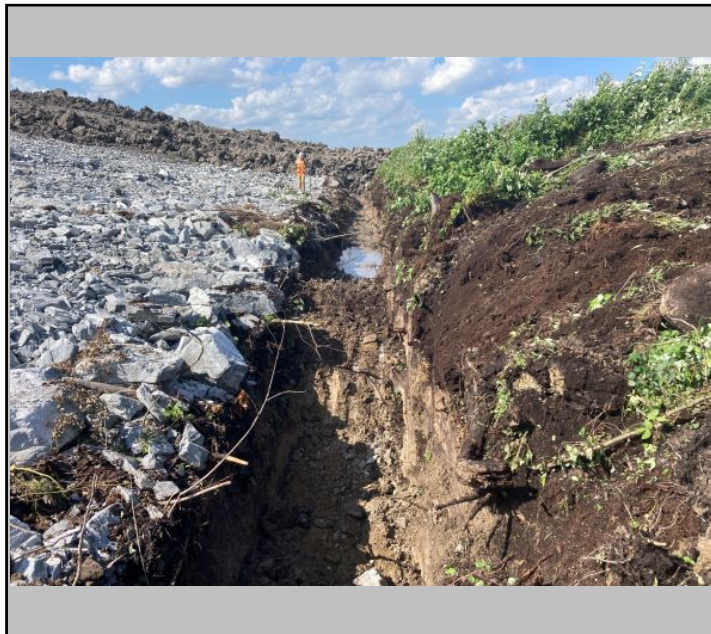
Photo #: 2

Standing water at toe of P32, L3

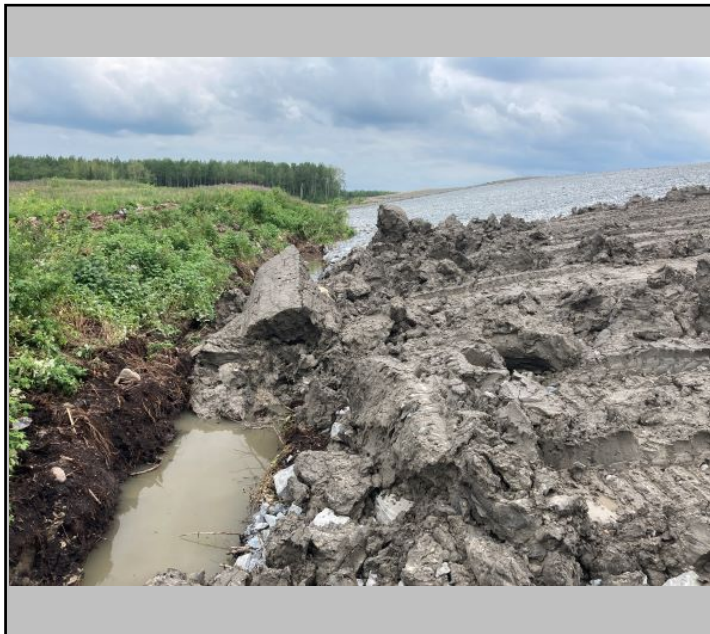
Photo #: 2

P32, L3 material very wet

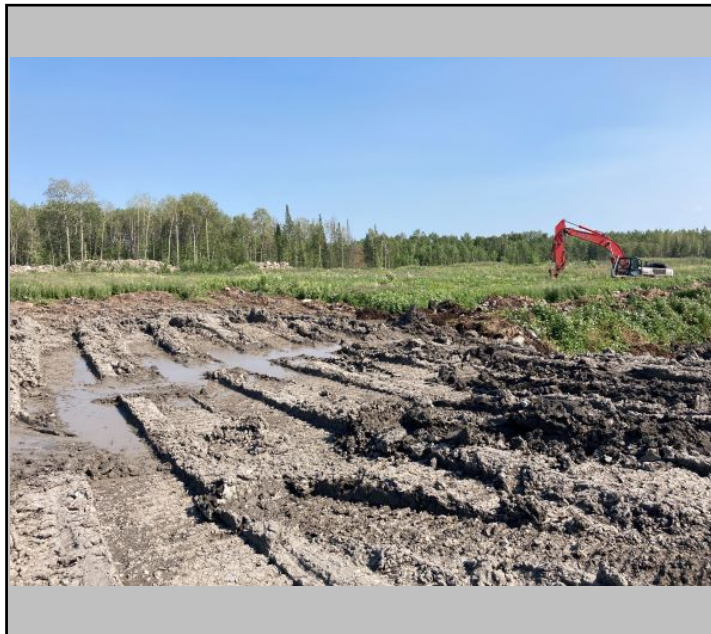
Photo #: 2

P33, L1 material.

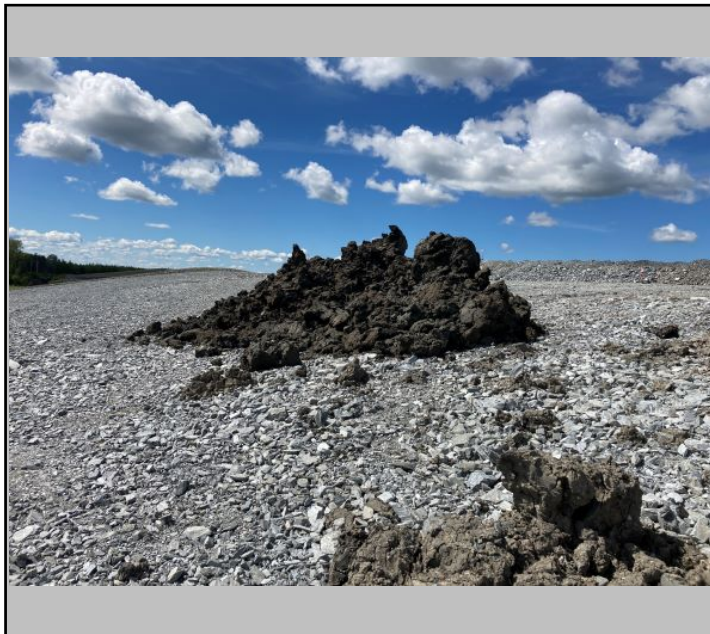
Photo #: 2

P33, L2 placement
