Building Condition Assessment In-situ Decommissioning of Whiteshell Reactor 1 (WR-1)

WLDP-26000-REPT-011

Building Condition Assessment

In-situ Decommissioning of Whiteshell Reactor 1 (WR-1)

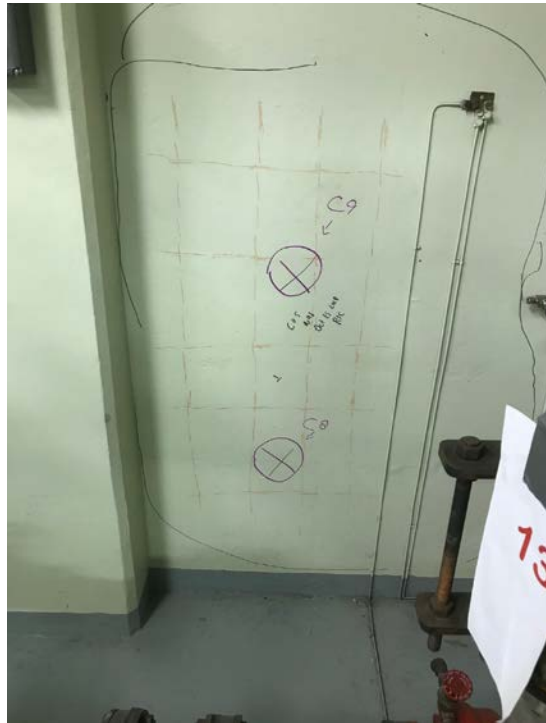
Figure A-4

Location of Cores C8 and 9 after GPR scanning

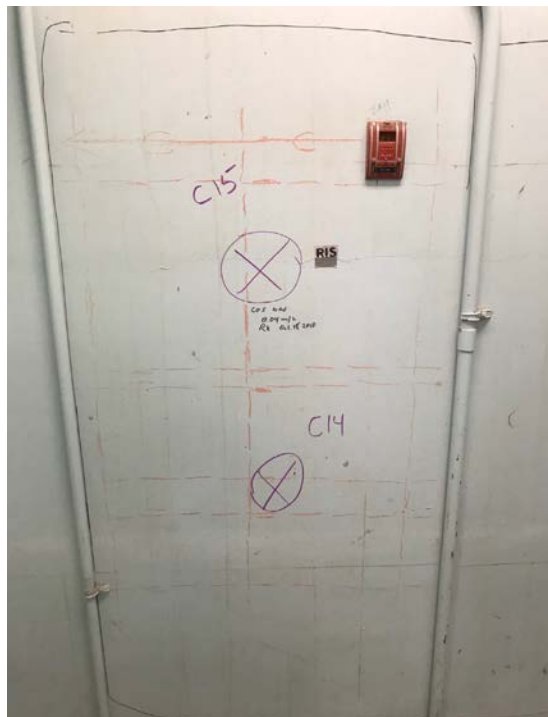
Location of Cores C14 and 15 after GPR scanning

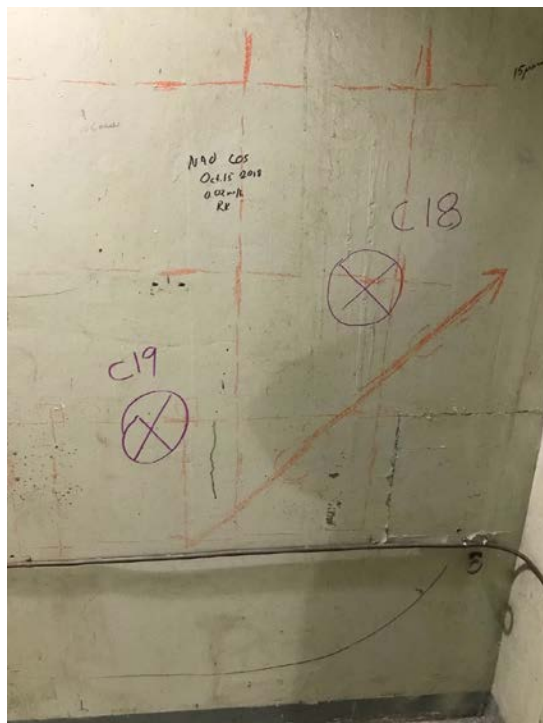
Figure A-8

Location of Cores C18 and 19 after GPR scanning

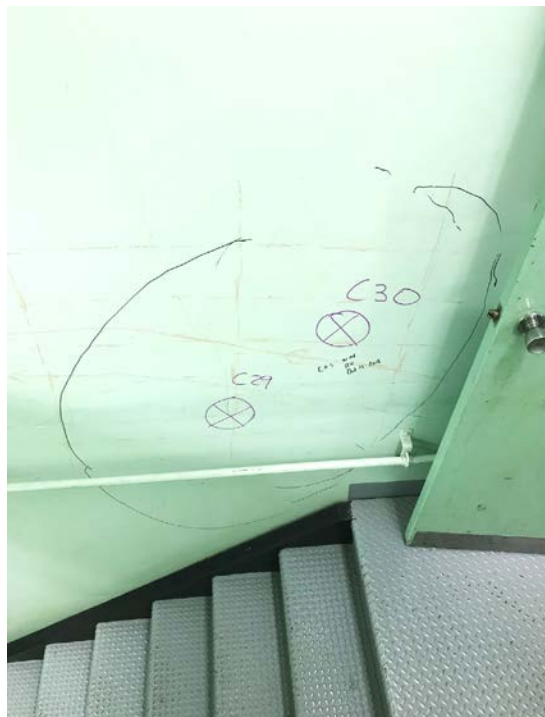
Location of Cores C29 and 30 after GPR scanning

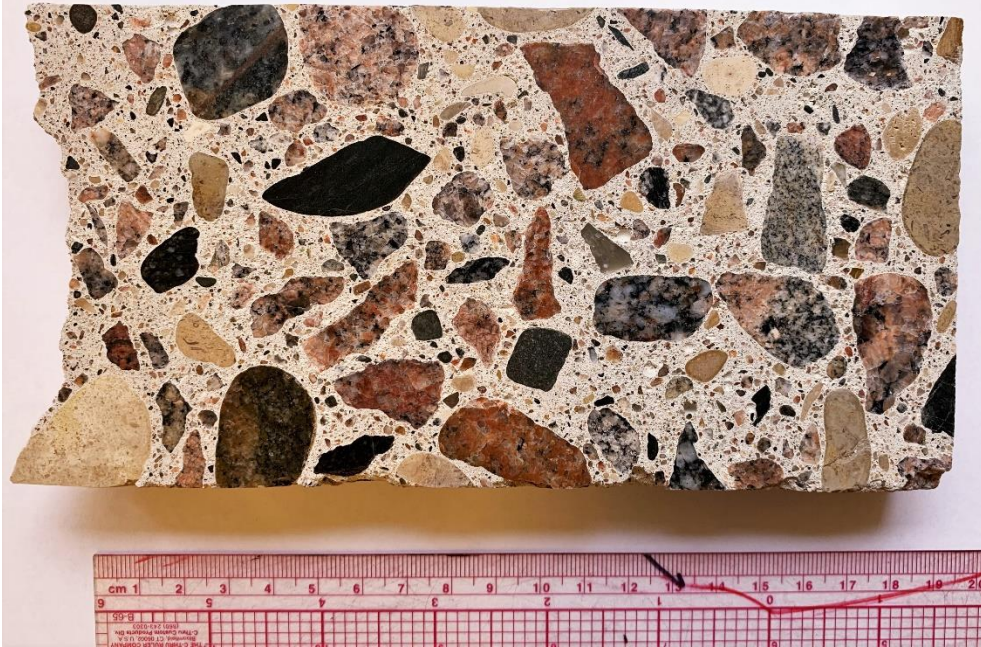
1. View of the core, after sawcutting and polishing. Surface is at far right.
