Lake St. Martin Emergency Outlet Channel
Assessment of Effects and Development of Offsetting

Physical Environment Supporting Volume (PESV)

May 2015

A report prepared for
Manitoba Infrastructure and Transportation
by
North/South Consultants Inc. and KGS Group

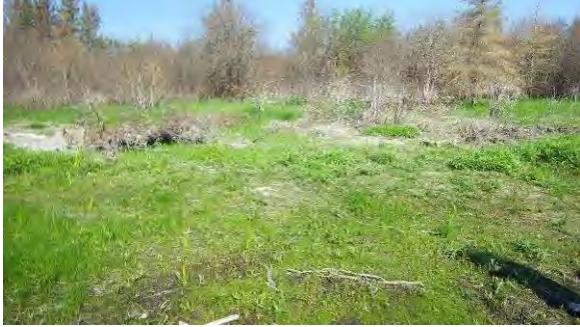
Photo 2. “Grass” vegetation observed at 13+500.

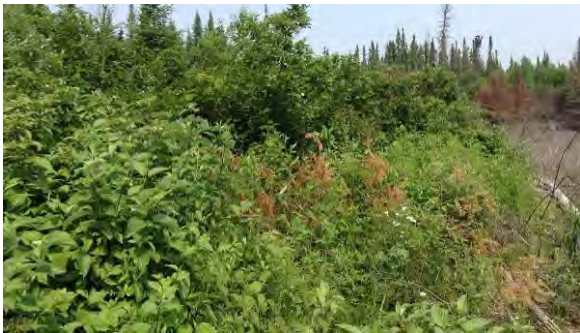
Photo 3. “Shrub” vegetation observed at 26+000.

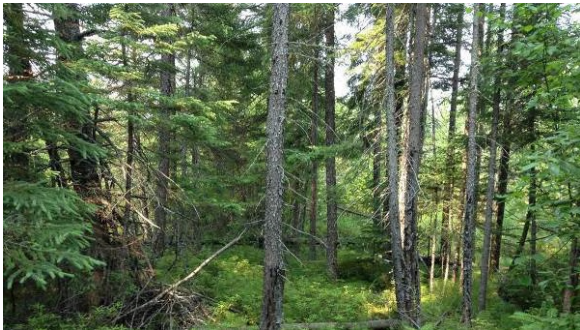
Photo 4. “Treeed” vegetation observed at 25+000.

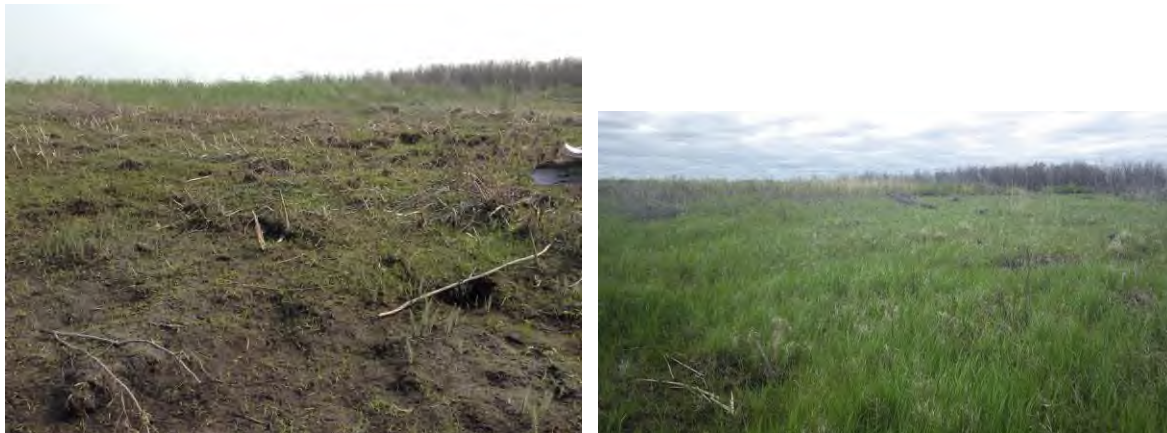
This transect runs in a northeast-southwest orientation. This section is within the vast open bog area surrounding Buffalo Lake that was widely flooded during operation of the emergency channel. During the 2013 survey, both sides had dead shrubs and approximately 50% bare and 50% grass. A dense patch of dead willows was present near end of the right transect. In 2014, some bare areas were present in the first 2 m adjacent to the creek, but otherwise the grass was much thicker (90%-100% coverage) and taller. Also, some of the shrubs which appeared dead in 2013 had begun regrowth, particularly on the right transect. Most shrubs did not recover however. Organic soil depths were similar during both surveys and were fairly deep (>12 cm). There was no sign of deposition.

13+000 – Left. Transect from creek bank in 2013 (left) and 2014 (right)

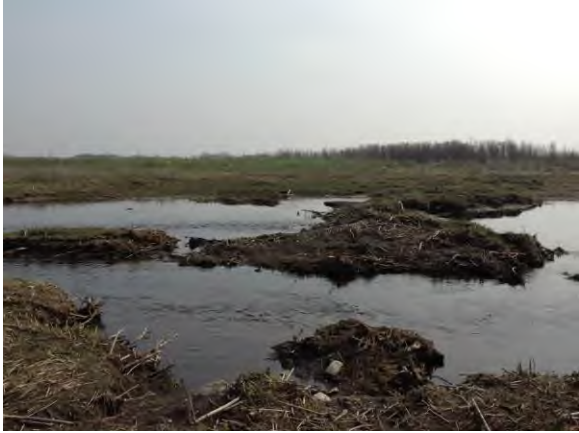
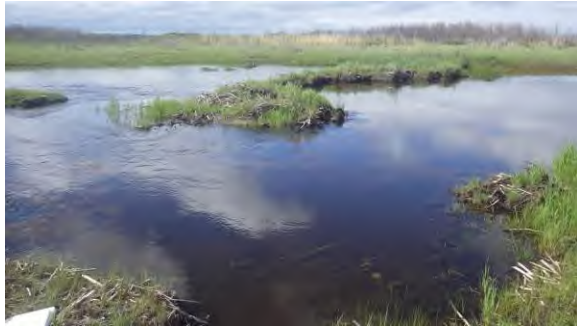
13+000 – Left. Looking across creek from left bank in 2013 (left) and 2014 (right)

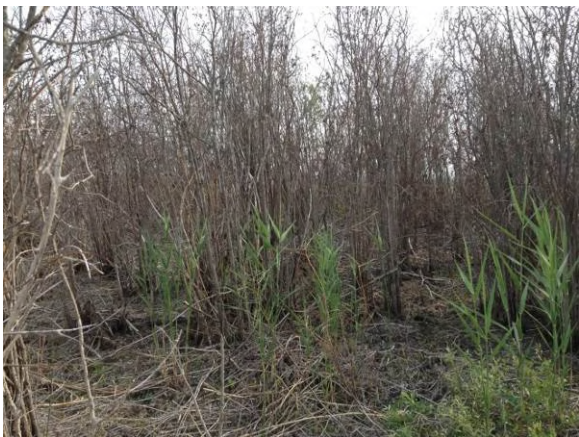
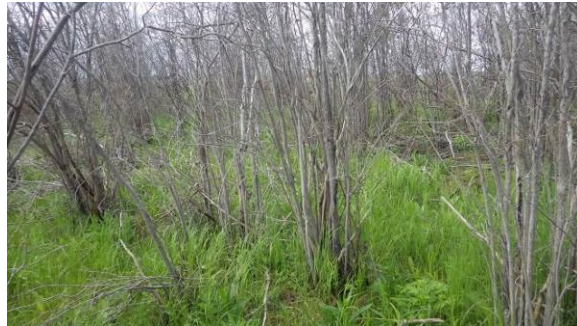
13+000-Right: Willows at end of right transect in 2013 (left) and 2014 (right).

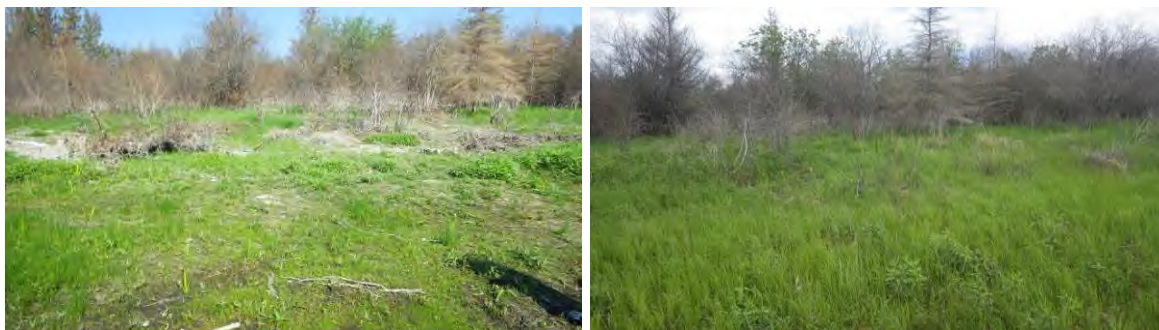
13+500-Left: Transect from creek in 2013 (left) and 2014 (right).

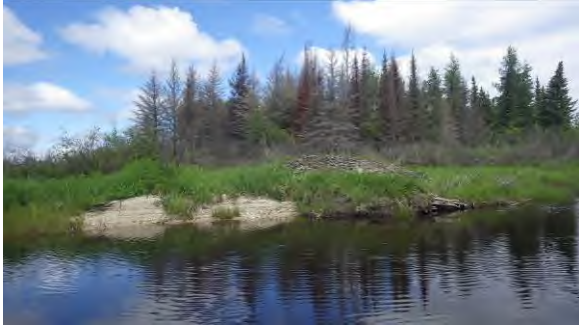
14+000: Deposition on left side of creek 100 m upstream from 14+000 (2014).

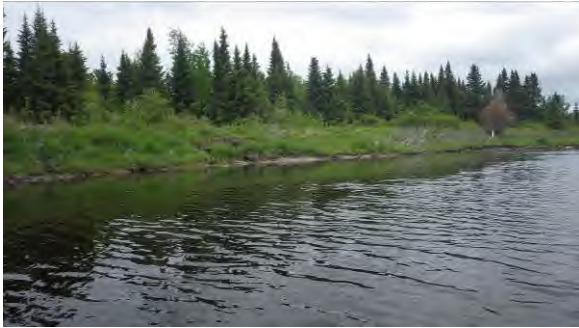
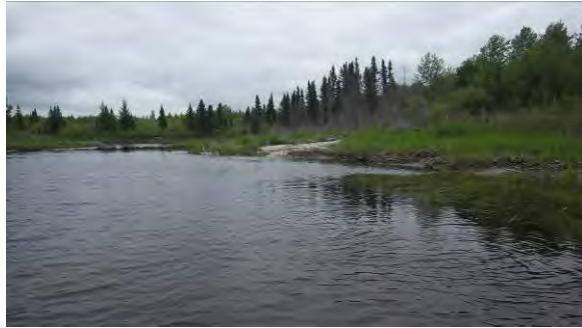
14+000: Erosion on left side and deposition on right approximately 75 m downstream from 14+000 (2014).

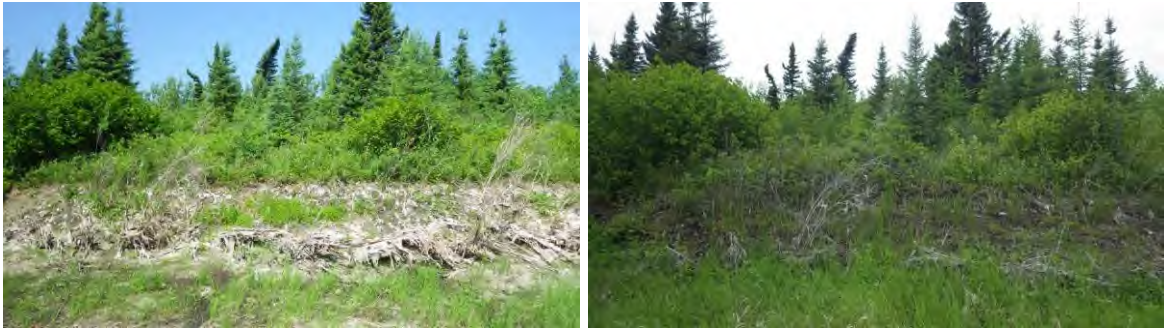
14+500: Left transect from creek bank in 2013 (left) and 2014 (right).

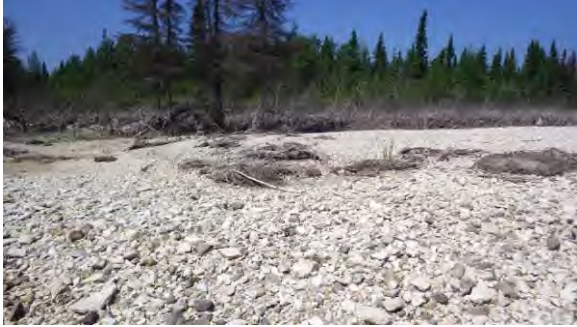
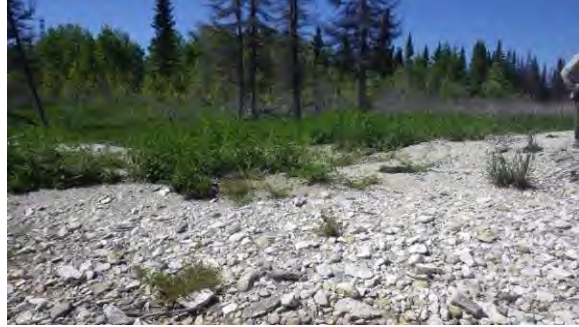
15+000: On left side of creek. Looking at transect from near creek bank in 2013 (left) and 2014 (right).

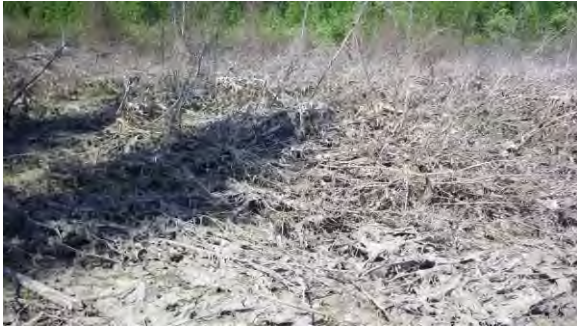
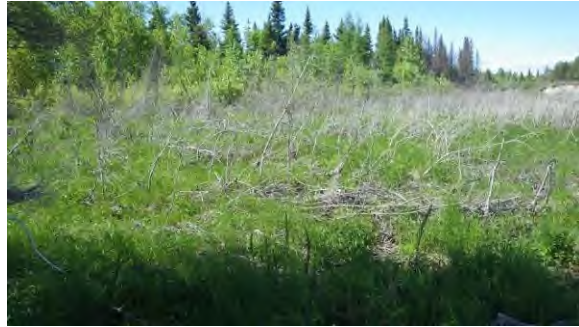
15+000: On left side of creek in 2013 (left) and 2014 (right).

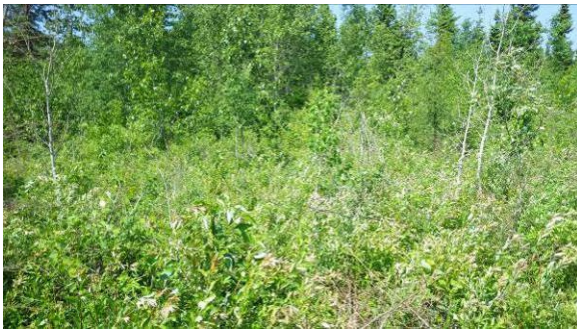
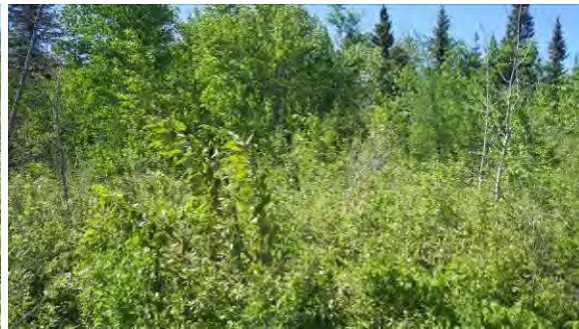
15+000: On left side of creek above slope in 2013 (left) and 2014 (right).

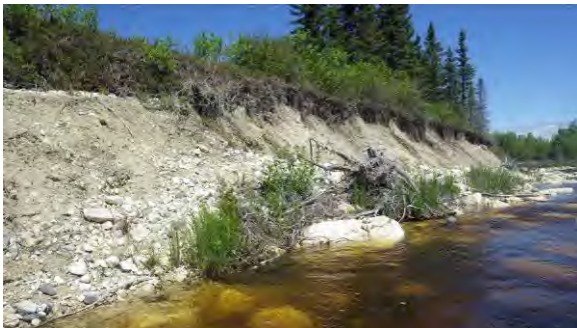
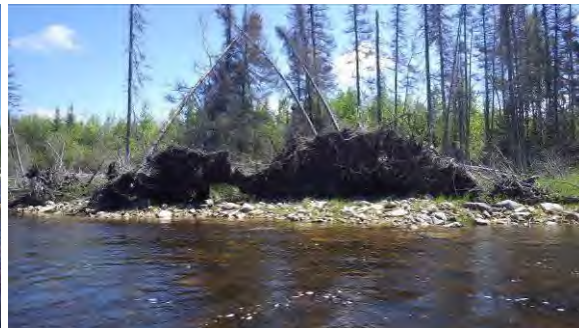
15+000: Erosion approximately 150 m upstream from 15+000 (2014).

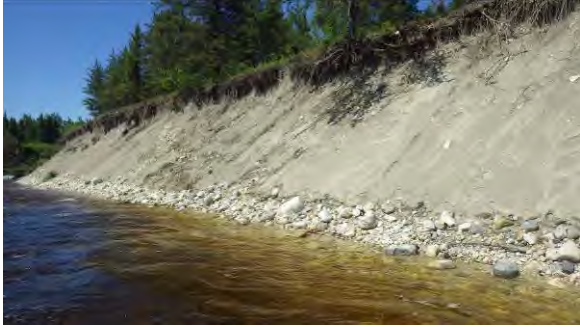
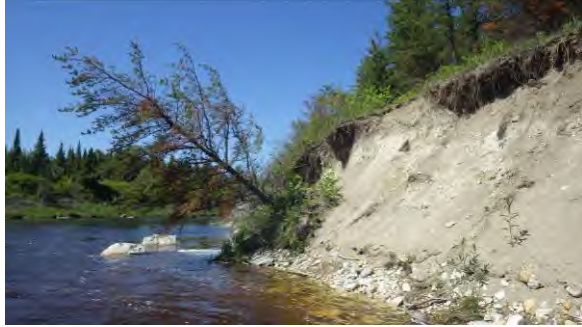
15+000: Erosion on right bank approximately 200 m downstream from 15+000 (2014).

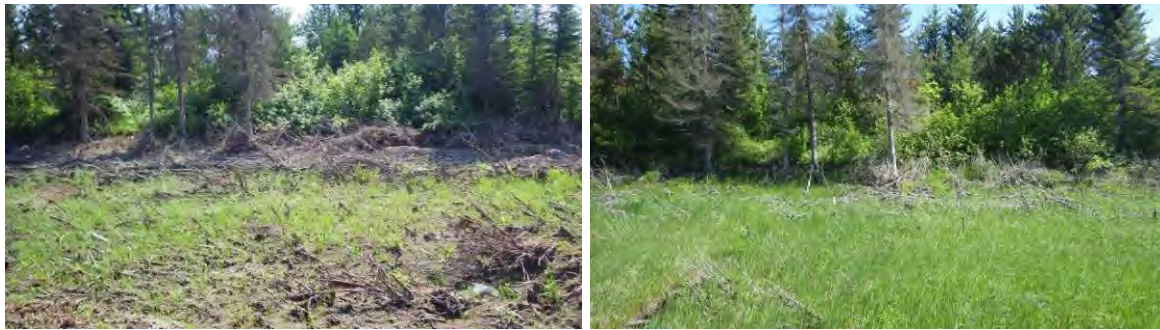
15+500: Right transect from near creek bank in 2013 (left) and 2014 (right).

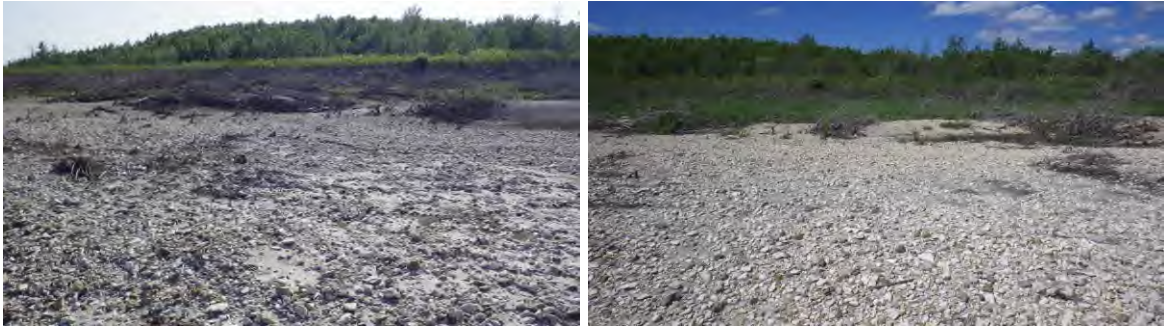
This transect runs in a northeast-southwest direction at a relatively strait section of the creek. A large bare area (20 m) of cobble and gravel was observed on the left side of the creek in 2013. In 2014, this area looked very similar as only a small area was revegetated. Beyond the bare exposed area on the left side in 2013 was a band of dead shrubs (17 m) which was also bare beneath. When visited in 2014, much of this area was now covered by grass, but up to 40% of some areas remained bare. The dead shrubs and trees did not recover. Beyond this, as the slope increased, an area of short shrubs (herbaceous and young poplar) transitioned to taller shrubs (alder) and then to trees. This area appears to be outside of the impacts of high water and was unchanged between years. On the right side of the river, the first 18 m were largely bare soil with grass and some dead shrubs in 2013. In 2014, this area was entirely covered by grass, but dead shrubs still protruded above. Up the slope and beyond the impact area of high water, shrubs transitioned to trees with a largely sphagnum understory which was unchanged between years. Depositional inorganic soils were noted at most sites along this transect, but particularly on the left side. On the left side, large areas of sand, gravel and cobble were observed closer to the creek, while further from creek, organic soils are overlain with 0.5 to 5 cm of silt. On the right side of the creek, a thin layer of organic soil overlaid silt which was above the organic soil.

18+000: Bare area on left transect in 2013 (left) and 2014 (right).

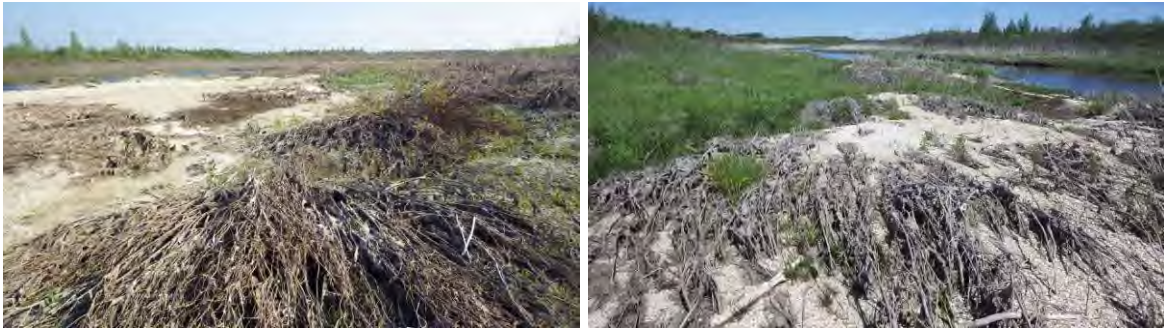
18+000: Left transect looking upstream in 2013 (left) and looking downstream in 2014 (right).

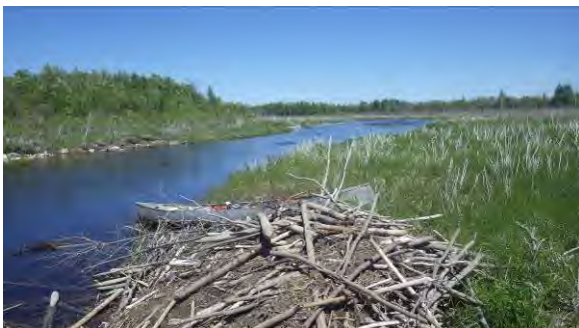
18+500: Beaver lodge on right side of river, looking downstream (2014).

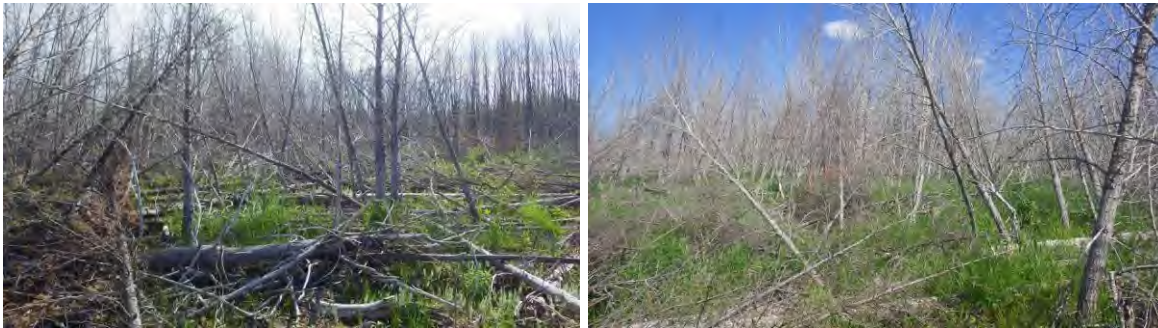
19+500: Dead trees along right transect in 2013 (left) and 2014 (right).

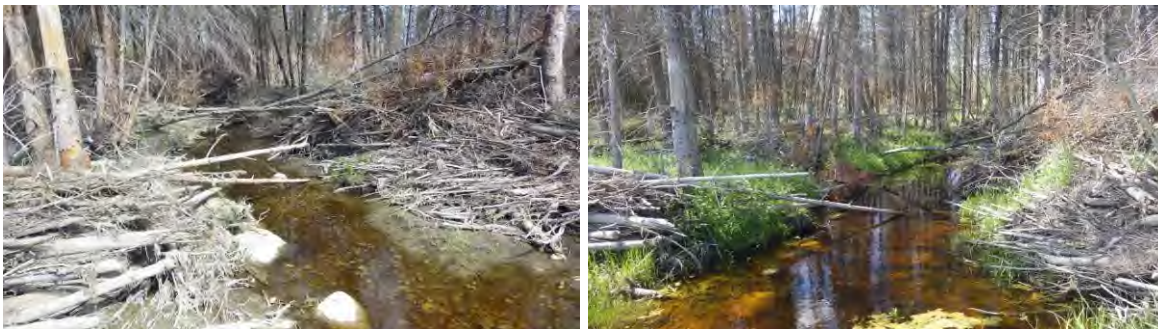
19+500: Small channel on left transect in 2013 (left) and 2014 (right).

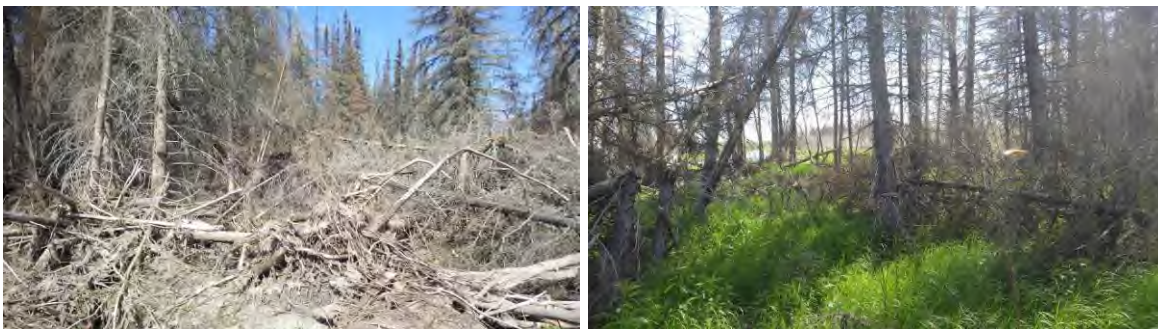
19+500: Dead trees along left transect in 2013 (left) and 2014 (right) (photos not from exactly same location).

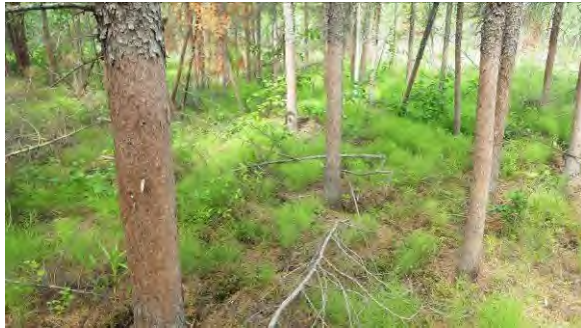
19+500: High water mark on spruce trees on left transect in 2013.

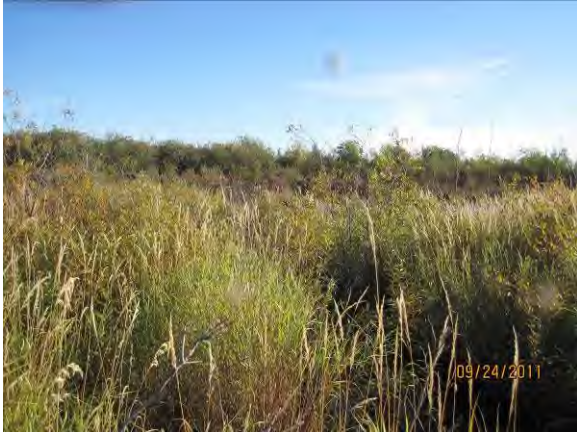
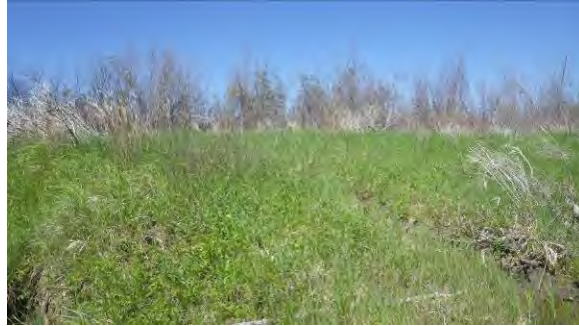
20+000: Grass on right transect in 2011 (left) and 2014 (right). (Photos not from exact same location)

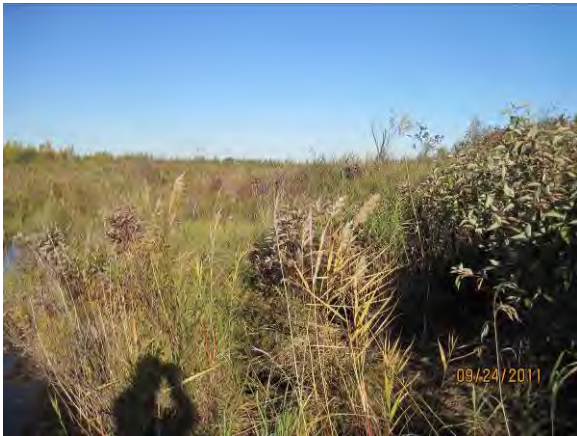
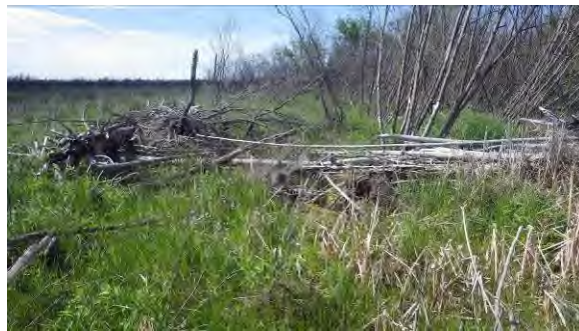
20+000: Looking downstream from right side of creek in 2011 (left) and 2014 (right). (Photos not from exact same location)

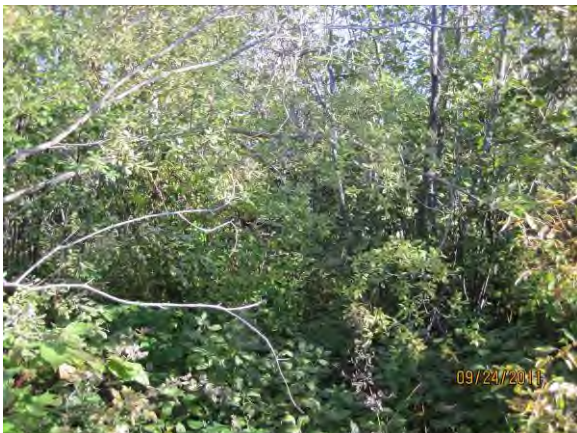
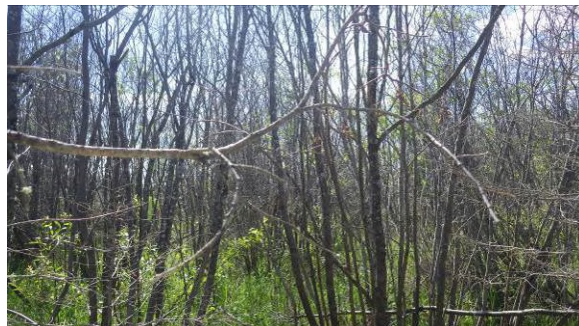
20+000: Trees along right transect seen in 2011 (left) and 2014 (right). (Photos not from exact same location)

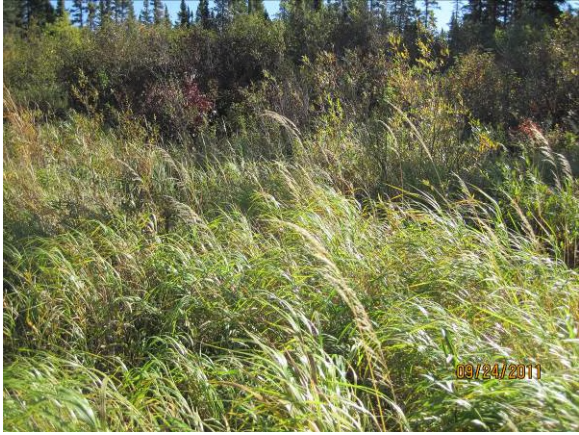
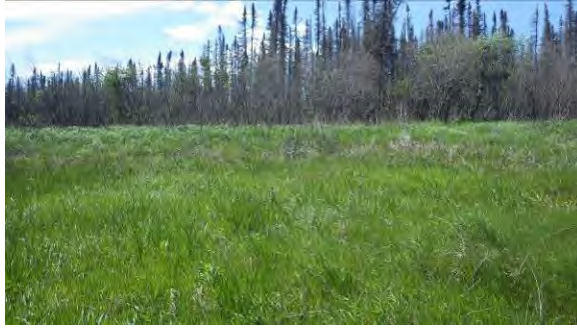
20+500: Left transect from near creek bank in 2011 (left) and 2014 (right). (Photos not from exact same location)

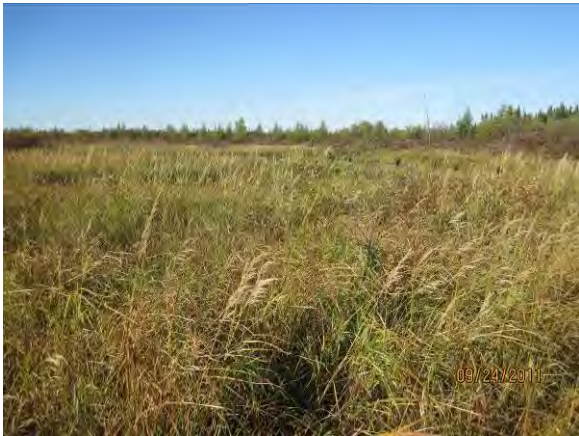
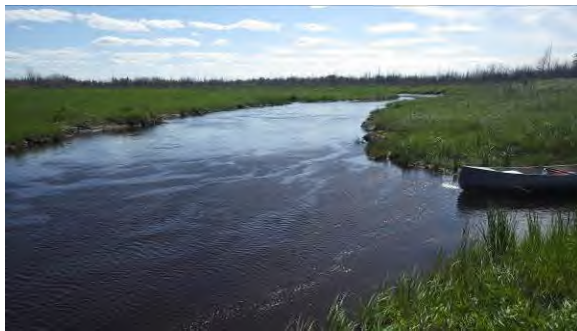
20+500: Looking upstream from left bank in 2011 (left) and 2014 (right). (Photos not from exact same location)

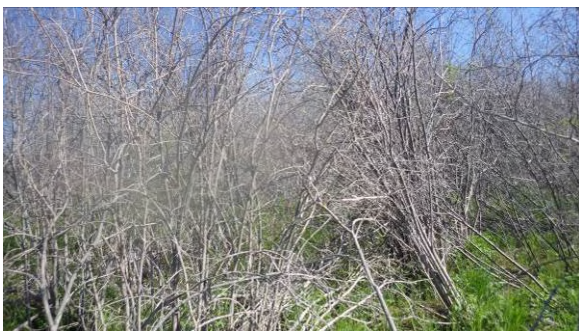
20+500: Dead shrubs and grass along left transect (2014).

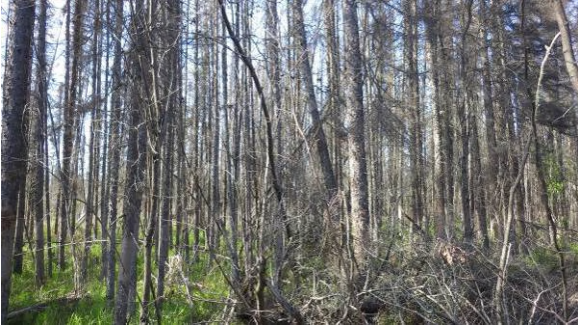
20+500: Dead trees and grass along left transect (2014).

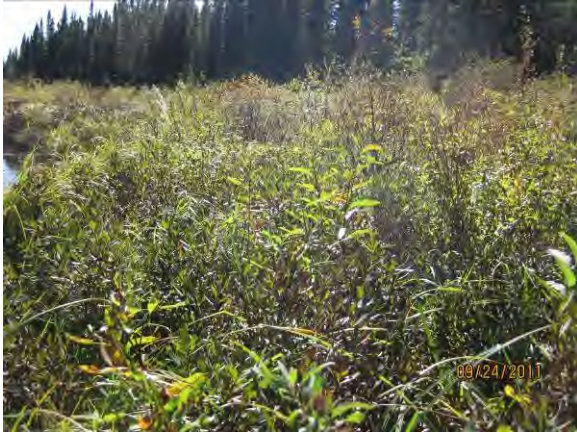
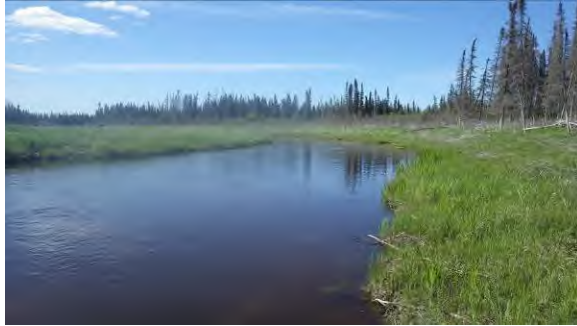
21+000: Right side of creek looking downstream in 2011 (left) and 2014 (right).

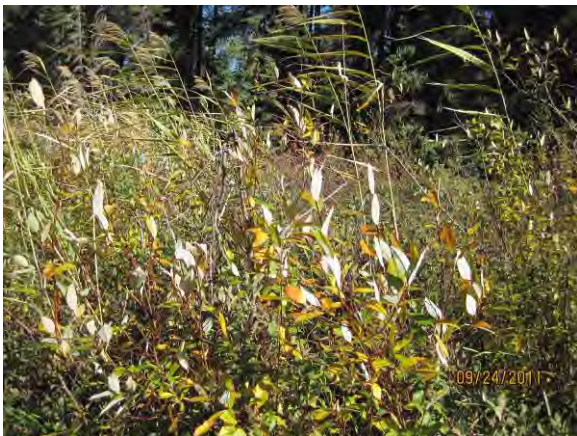
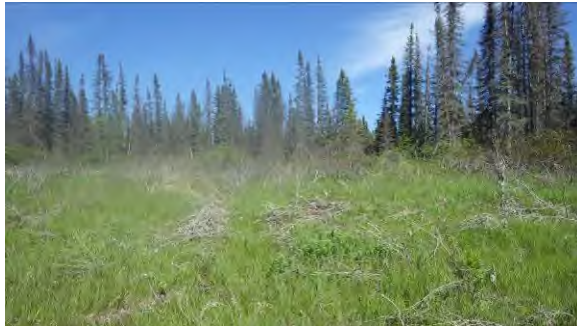
21+000: Right transect from near creek bank in 2011 (left) and 2014 (right). (Photos not from exact same location)

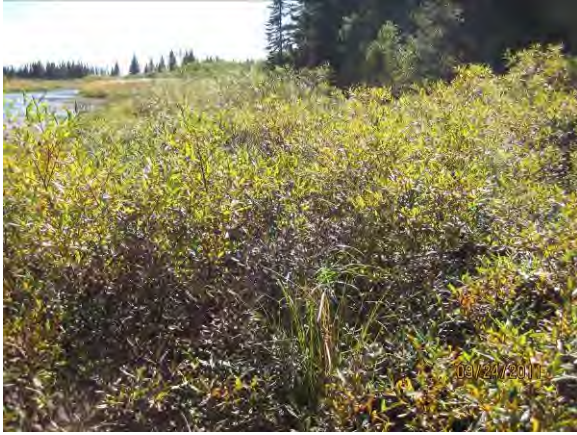
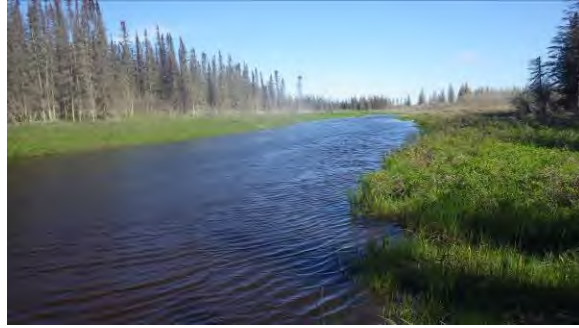
21+500: Left side of creek looking upstream in 2011 (left) and 2014 (right).

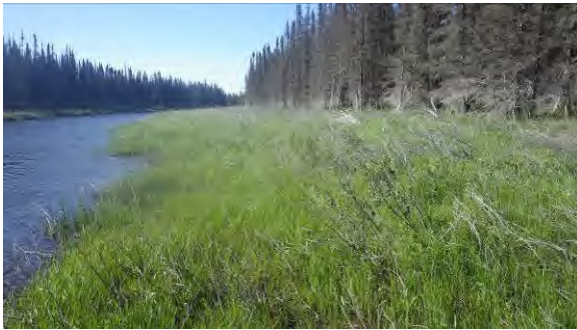
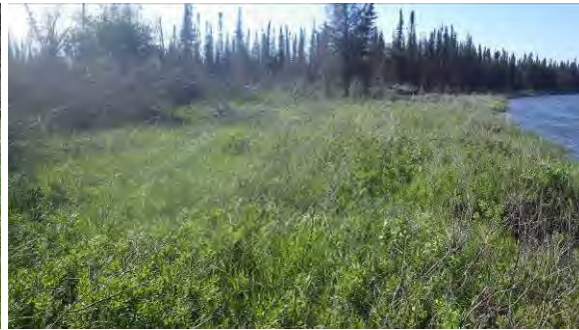
21+500: Right side of creek in 2014 looking upstream (left) and downstream (right).

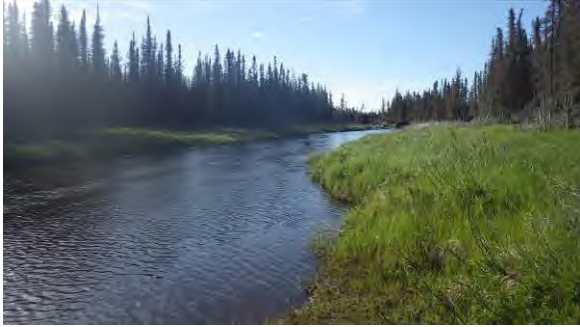
22+000: Right side of creek, looking downstream in 2014.

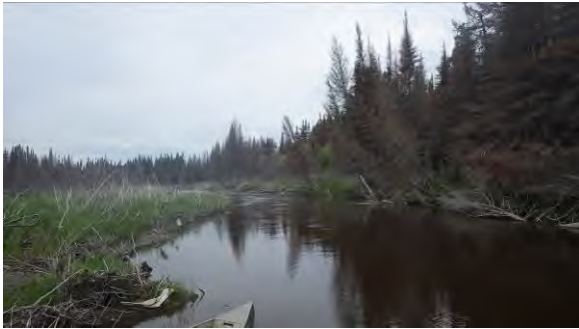
23+500: Looking downstream from left bank (2014).

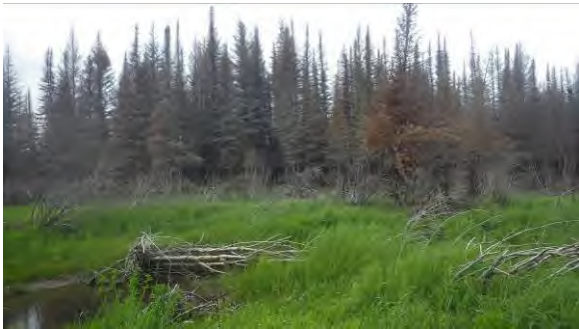
23+500: Grass and dead trees on left transect, as seen from shore (2014).

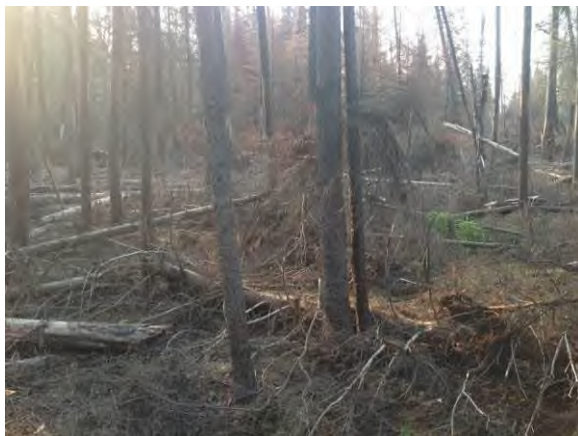
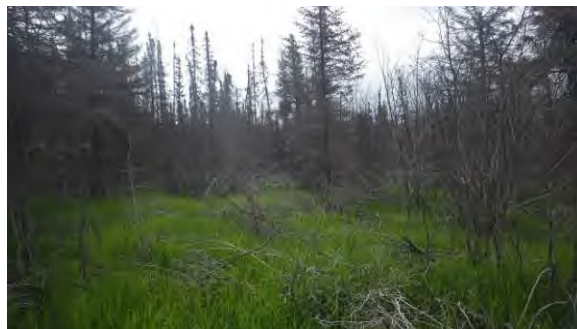
24+000: Dead trees on right transect in 2013 (left) and 2014 (right) (photos not from exactly the same location).

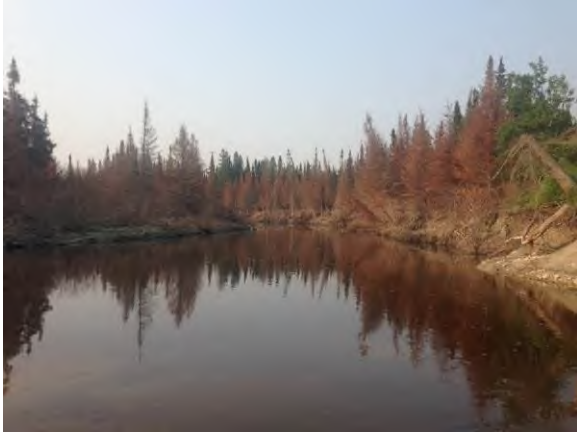
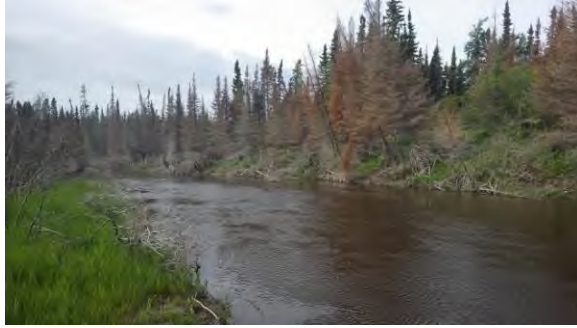
24+000: Looking upstream from left bank in 2013 (left) and 2014 (right).

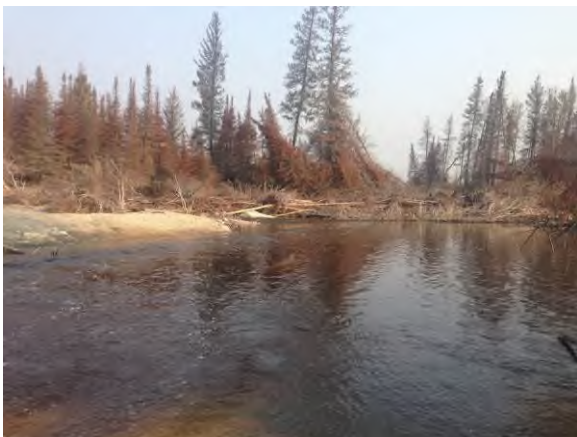
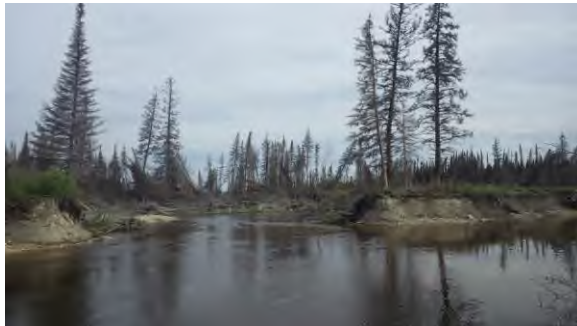
High water levels forged new creek channels immediately downstream from the transect, essentially short-cutting the previous meandering route. While water continues to pass through the previous channel, it appears the majority of water now goes through the new channels, particularly during low water conditions.

24+000: Looking downstream from left bank in 2013 (left) and 2014 (right). Original channel is to the right, while new channel is on left (2014 photo).

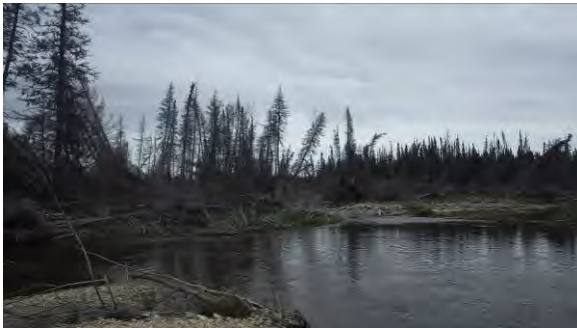
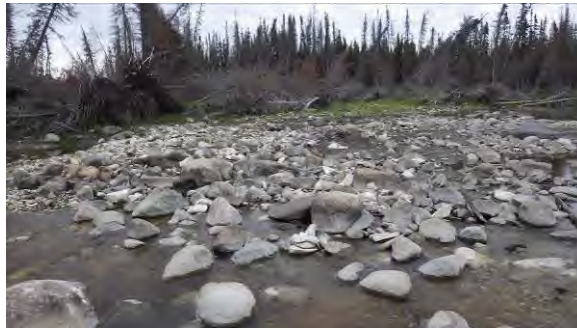
24+000: Erosion immediately downstream from transect where near channels were created (2104)

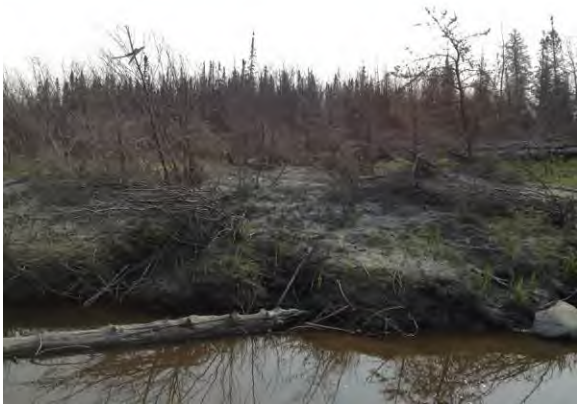
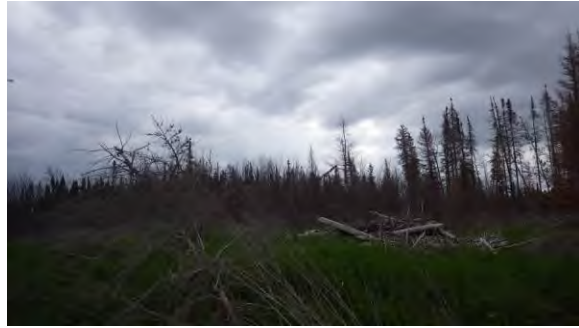
24+500: Right transect seen from near creek bank in 2013 (left) and 2014 (right).

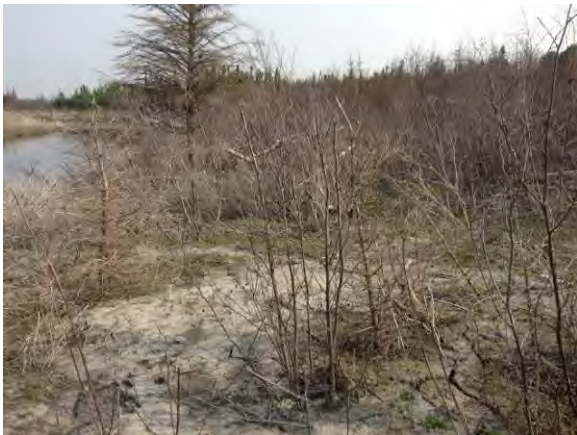
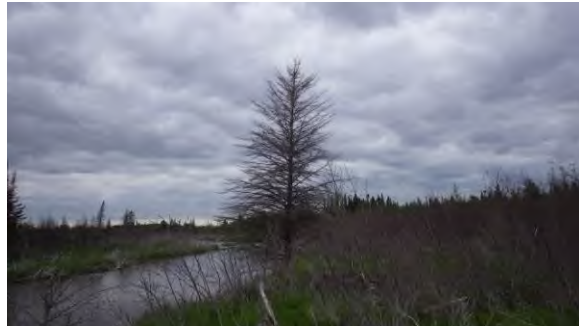
24+500: Along right transect, looking downstream in 2013 (left) and 2014 (right).

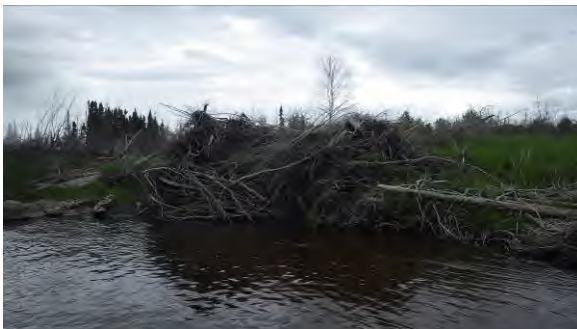
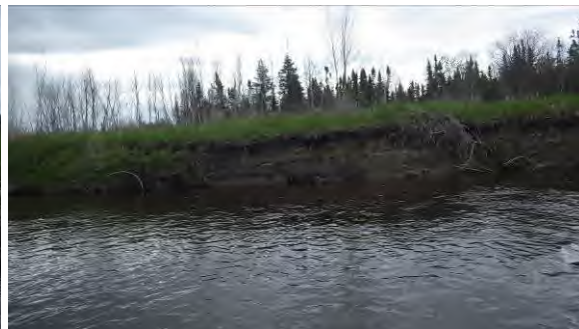
shrubs with a bare understory until 34 m where a layer of live shrubs began. Beyond this, the vegetation became largely treed with a sphagnum understory. Effects from high water appear to end approximately 20 m from the creek bank. On the right side, bare areas with dead shrubs and trees span the entire transect in 2013. This side of the creek is lower and was clearly immersed by high water for its entire length. In 2014, the left side was unchanged other than the 90% grass cover near the creek where it was previously bare. The right side in 2014 showed a similar pattern. Dead shrubs and trees did not recover, but the understory was largely covered by grass near the creek and more herbaceous species within the dead trees further away from the creek. Soils in 2013 showed thick layers of inorganic deposition near the creek. 14-15 cm deep inorganics were measured above organics on the left side while >19 cm of inorganics were measure on the left side near the creek. Thinner inorganic layers were noted further from the creek on both sides. In 2014, 5 cm of silt was measured near the creek on both sides, while >15 cm of silt was present further along the right transect. Peat was observed at the end of the left transect which was unchanged between 2013 and 2014. An area of erosion and deadfall was observed approximately 190 m downstream from the transect (see photos below).

24+500: Erosion and deadfall on left (left) and right (right) of creek approximately 190 m downstream from transect.

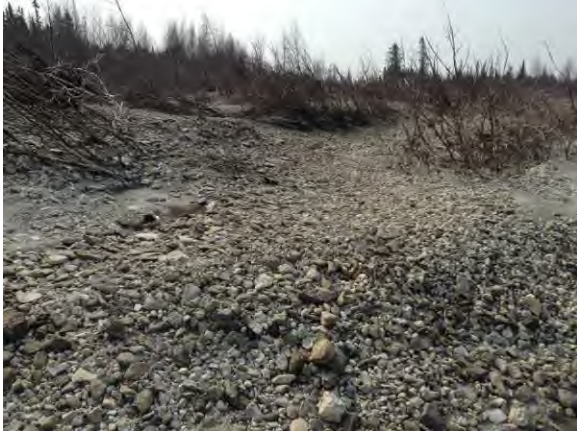
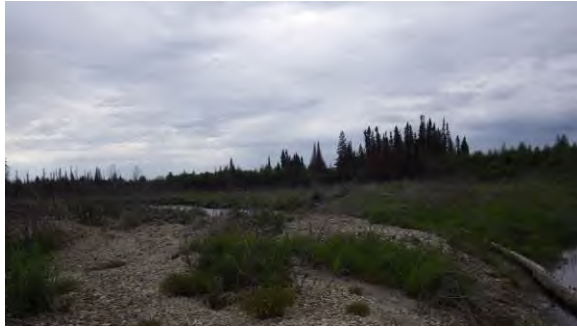
25+000: Cobble area on right side of creek in 2013 (left) and 2014 (right) (photos not from exact same location).

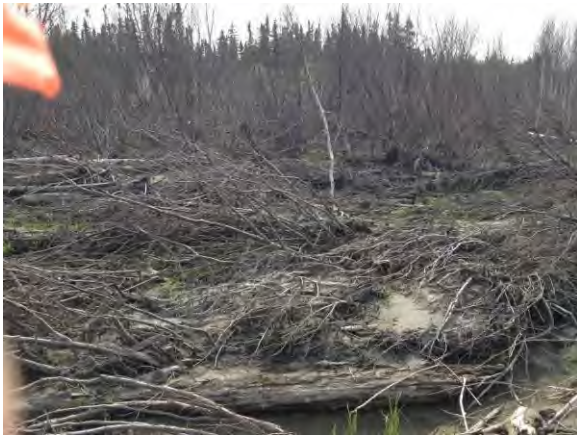
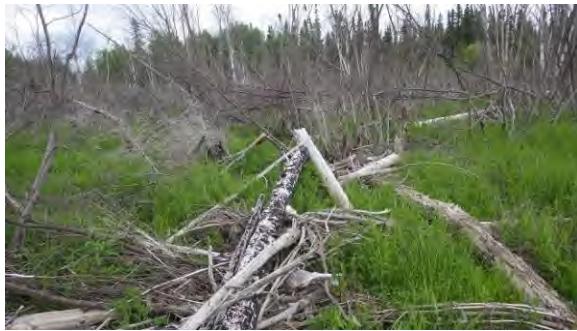
25+000: Dead trees along right transect in 2013 (left) and 2014 (right) (photos not from exact same location).

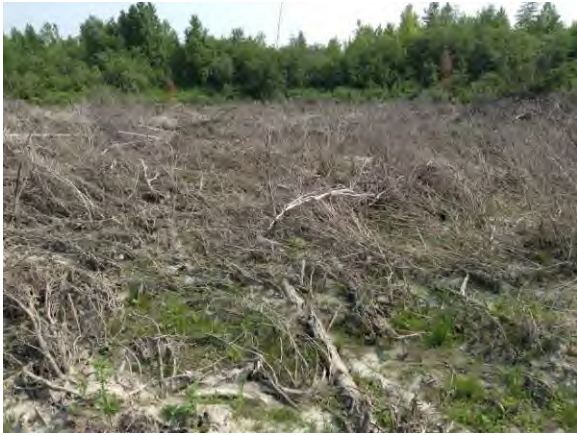
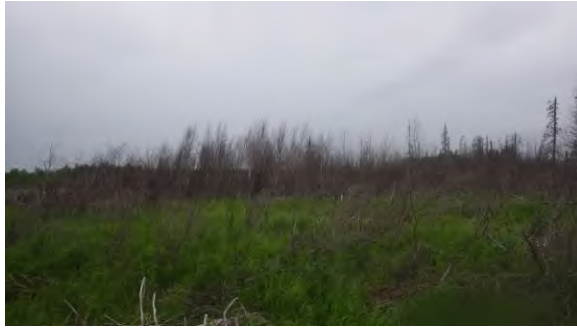
25+500: Left transect in 2013 (left) and 2014 (right).

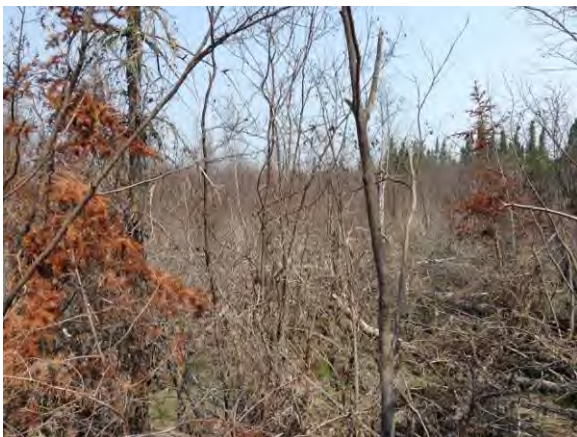
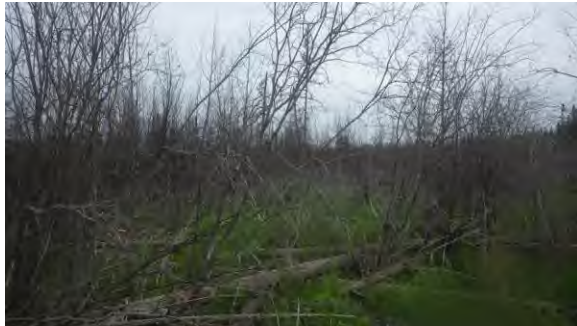
25+500: Left transect in 2013 (left) and 2014 (right).

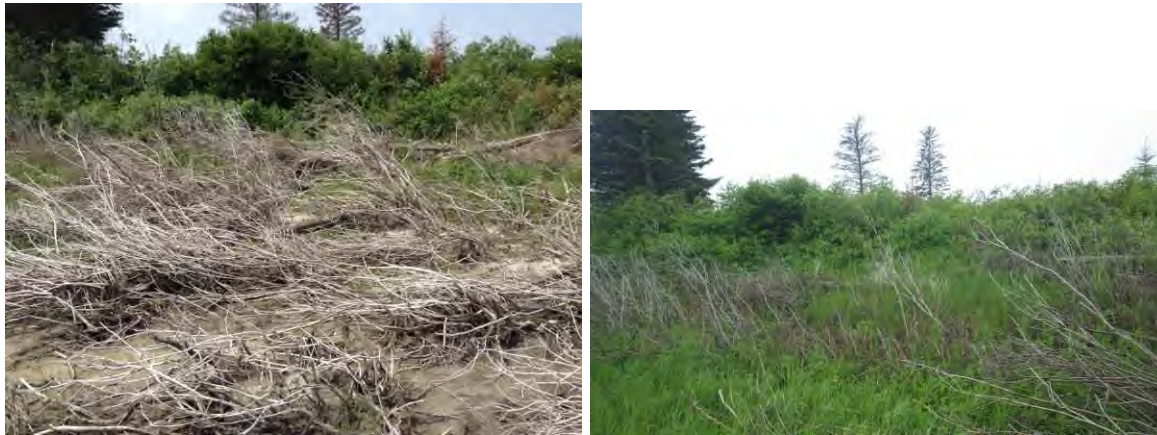
26+000: Right transect in 2013 (left) and 2014 (right).

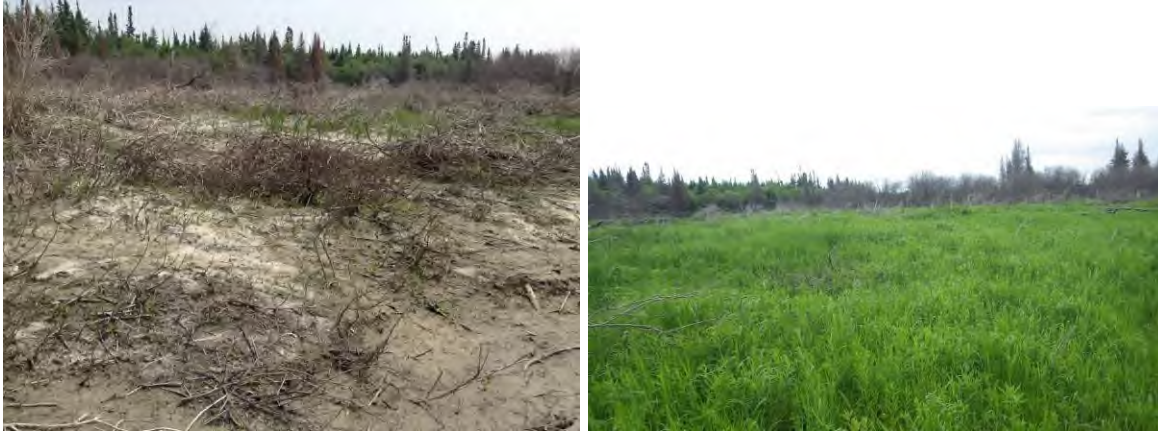
26+000: Left transect in 2013 (left) and 2014 (right).

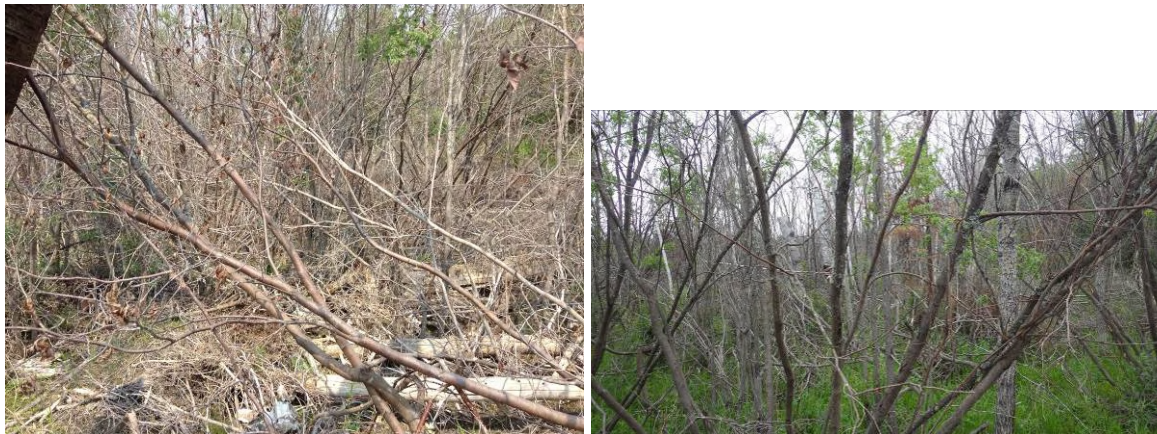
26+500: Within dead shrubs on right transect in 2013 (left) and 2014 (right).

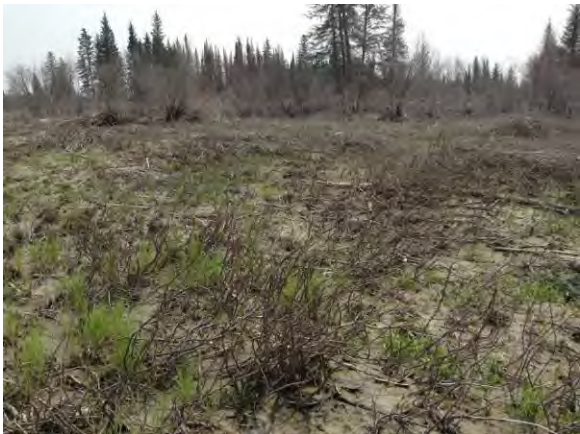
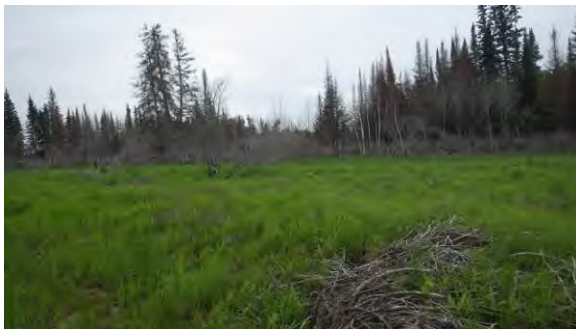
26+500: Left transect in 2013 (left) and 2014 (right).

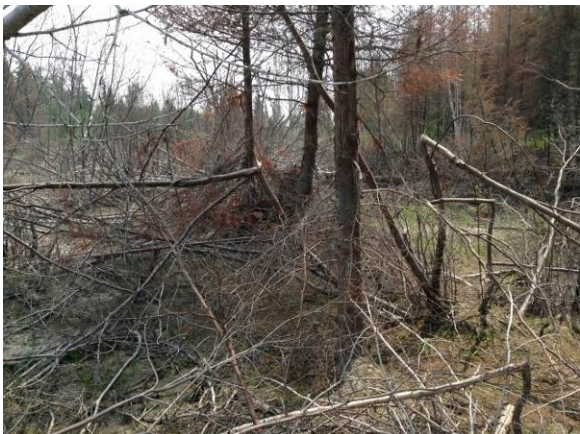
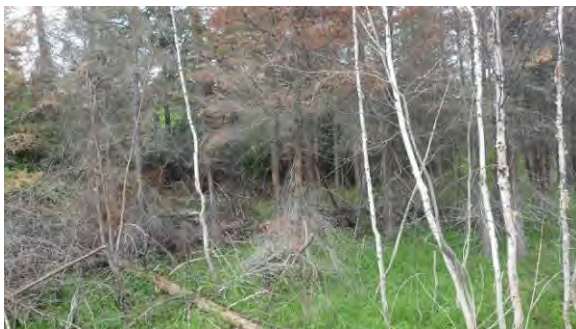
26+500: Trees near end of left transect in 2013 (left) and 2014 (right).

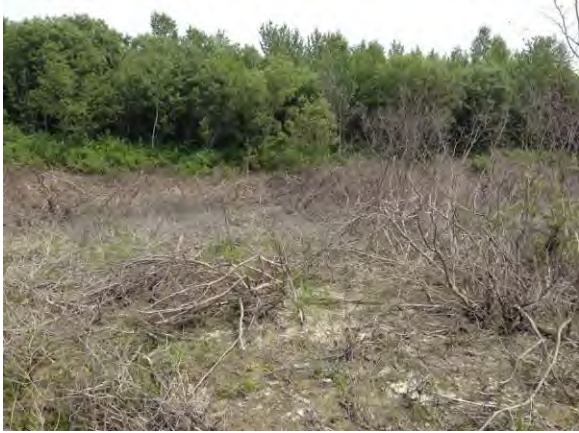
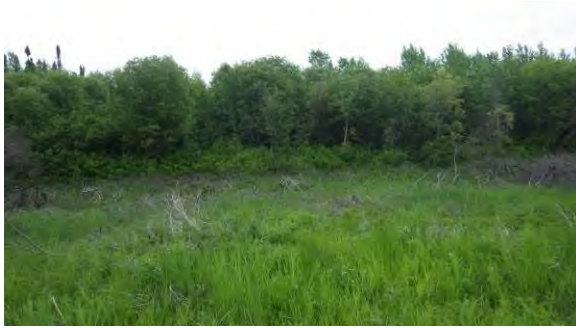
27+000: Right transect in 2013 (left) and 2014 (right).

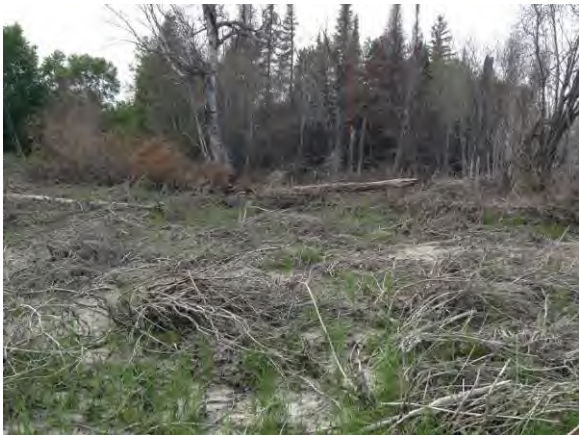
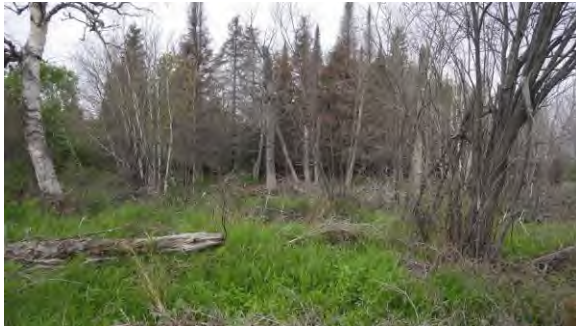
27+000: Left transect in 2013 (left) and 2014 (right).
