Lake St. Martin Emergency Outlet Channel
Assessment of Effects and Development of Offsetting

Physical Environment Supporting Volume (PESV)

May 2015

A report prepared for
Manitoba Infrastructure and Transportation
by
North/South Consultants Inc. and KGS Group

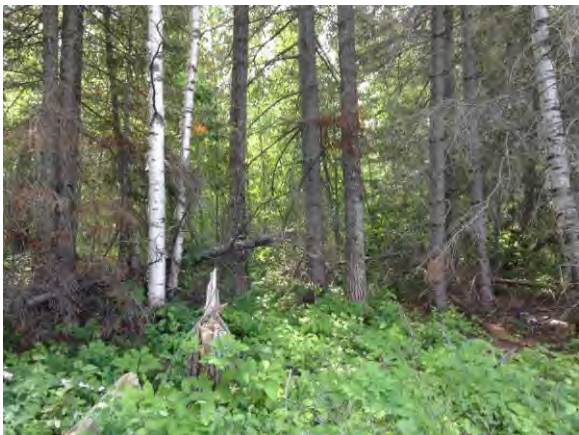
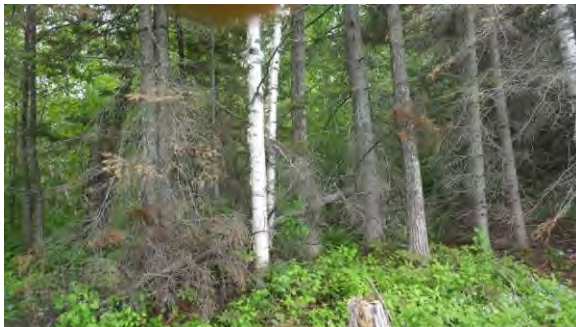
27+000: Near end of left transect in 2013 (left) and 2014 (right).

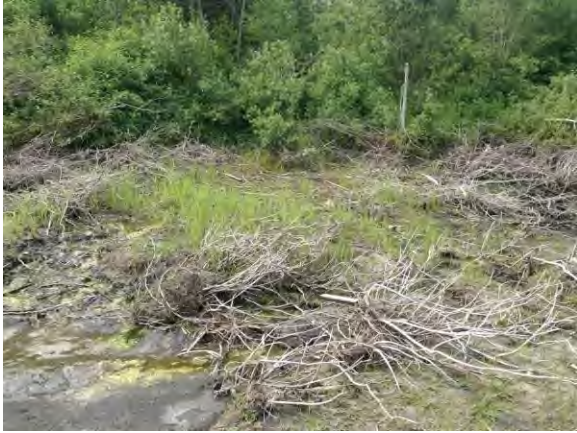
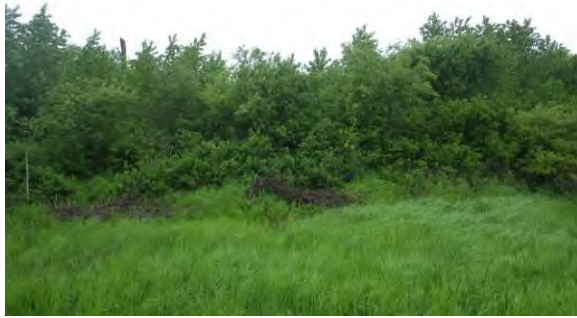
27+500: Left transect in 2013 (left) and 2014 (right).

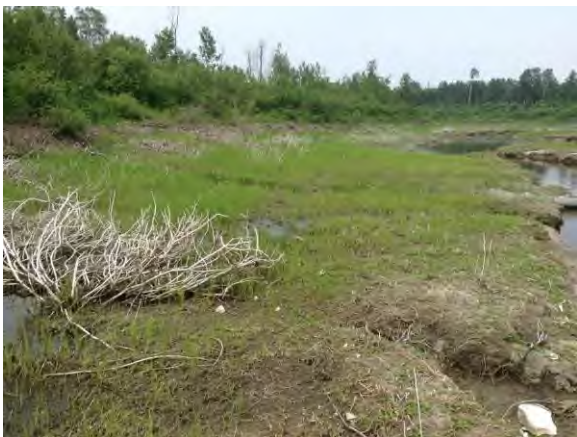
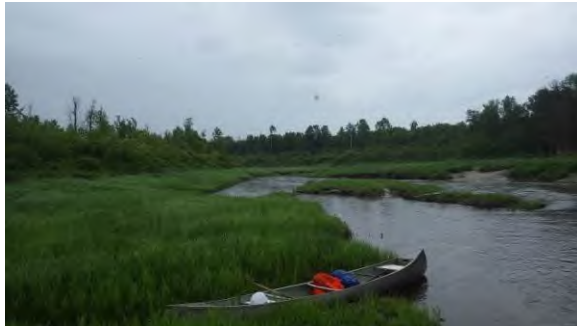
27+500: Left transect, looking downstream in 2013 (left) and 2014 (right).

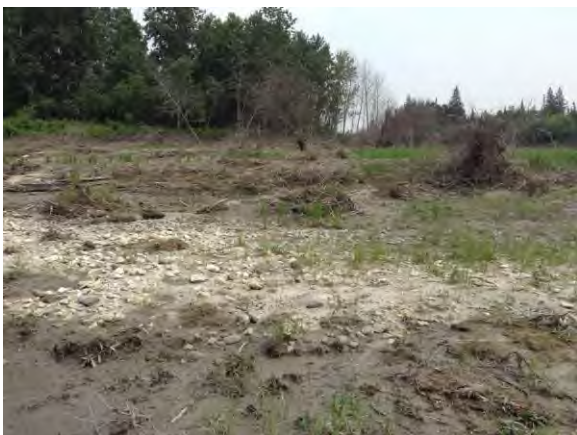
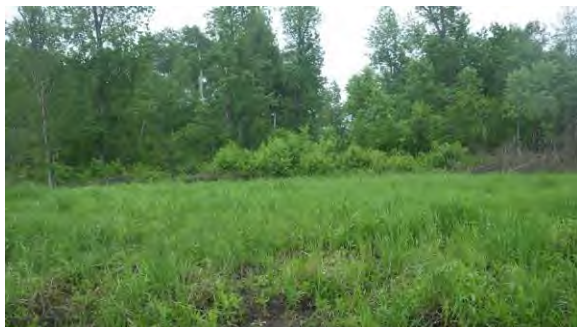
27+500: Right transect in 2013 (left) and 2014 (right) (photo not from exactly same location).

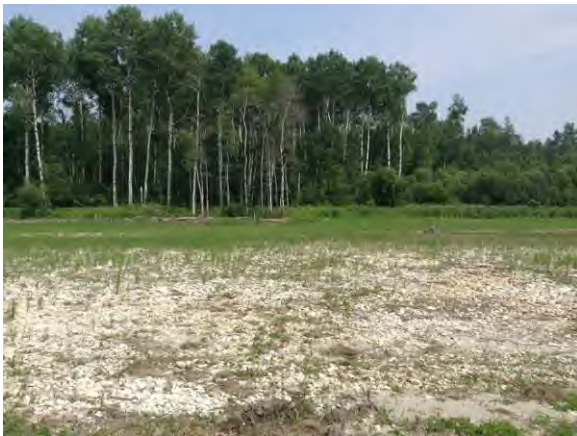
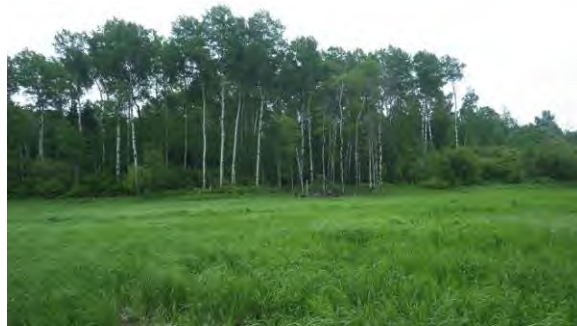
28+000: Right transect from near creek bank in 2013 (left) and 2014 (right).

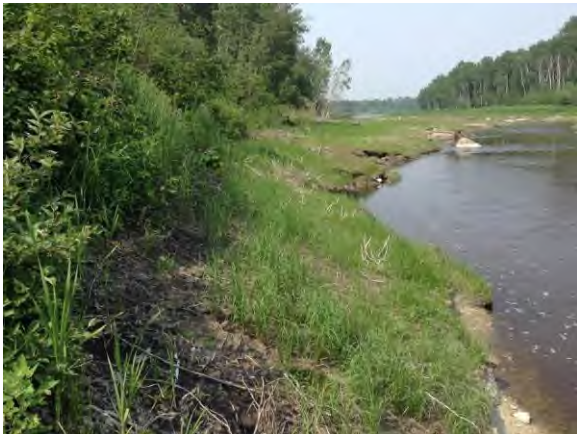
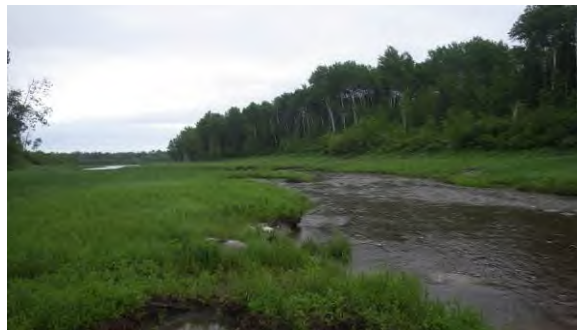
28+000: Looking downstream from left bank in 2013 (left) and 2014 (right) (photos not from exact same location).

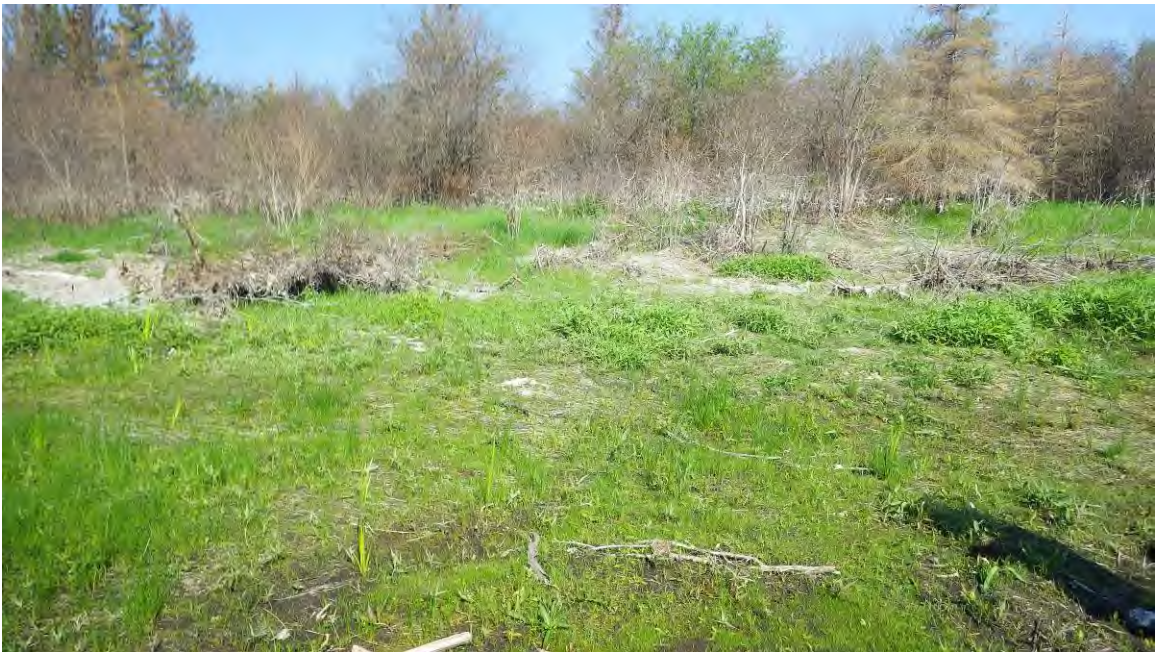
Photo 2. "Grass" vegetation observed at 13+500.

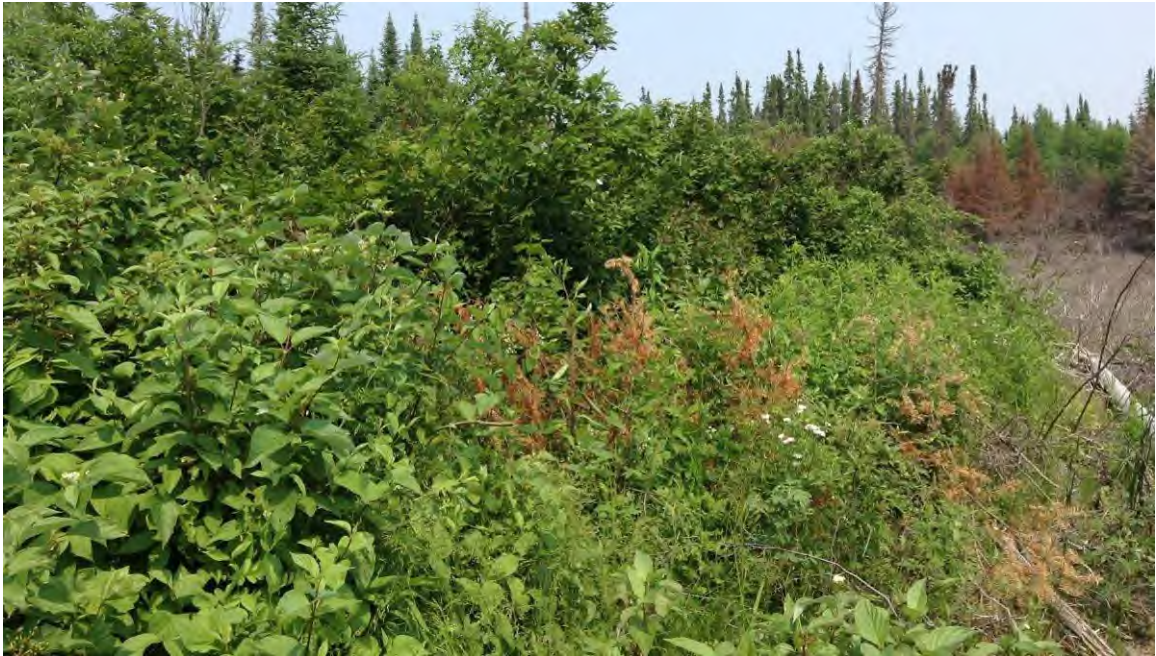
Photo 3. "Shrub" vegetation observed at 26+000.

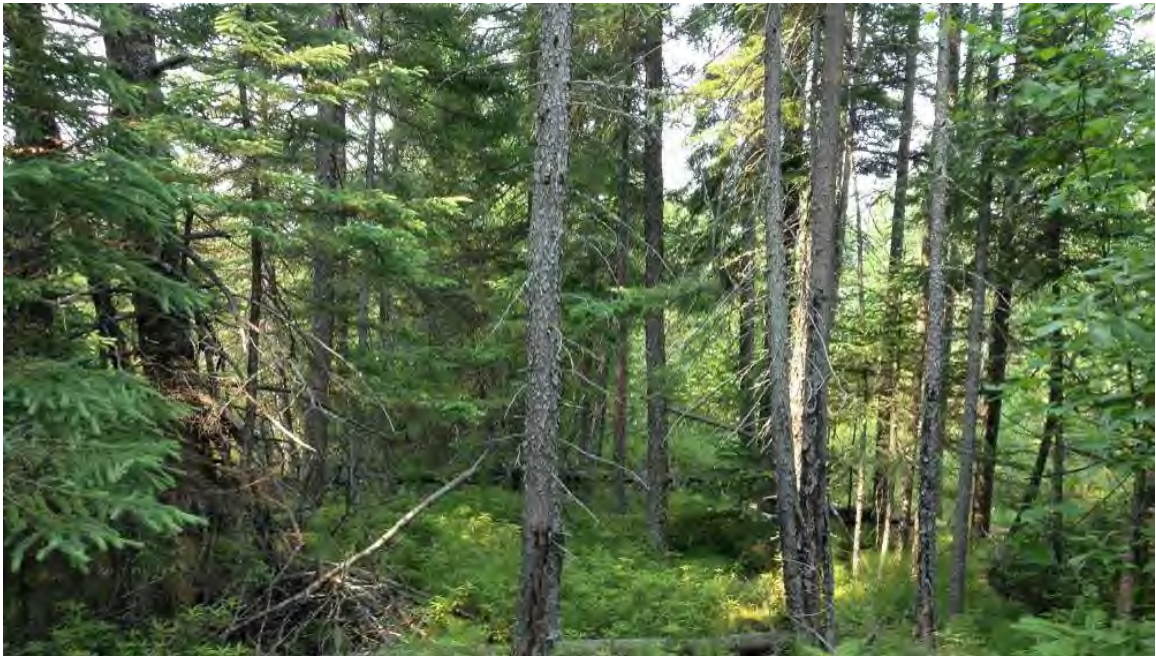
Photo 4. "Treed" vegetation observed at 25+000.

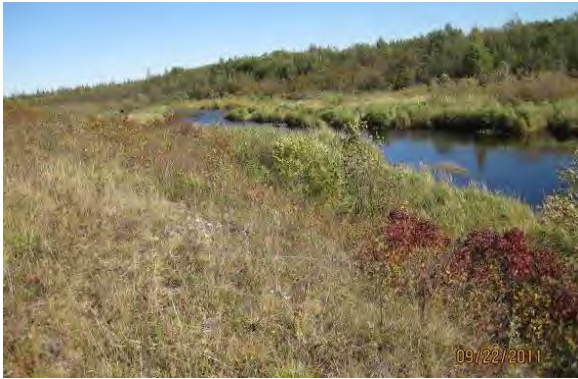
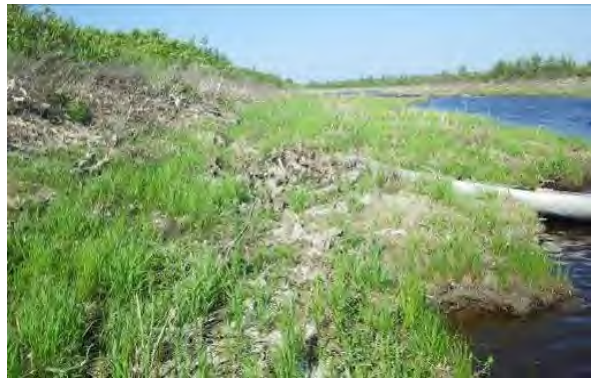
This transect runs in a northwest-southeast orientation. Both sides of the creek show a mix of bare cover, grass and dead shrubs extending 20 to 35 m from the creek centerline. Up the slope on the left side of the river is an area of herbaceous plants and very young poplar trees which transitions into a mixture of trees and shrubs comprised of poplar, willow and alder. A similar mixture of taller shrubs was observed on the right side of the river. The depth of organic soil varied from 0 along the creek's edge to 7 cm in the shrub area. Observations made in 2011 noted a mixture of grass and shrubs along the transect line, but made no mention of bare areas or dead vegetation. Photo 8 compares 2011 and 2013 photos.

Photo 8. Looking downstream from 17+000 (left photo: 2011; right photo: 2013)

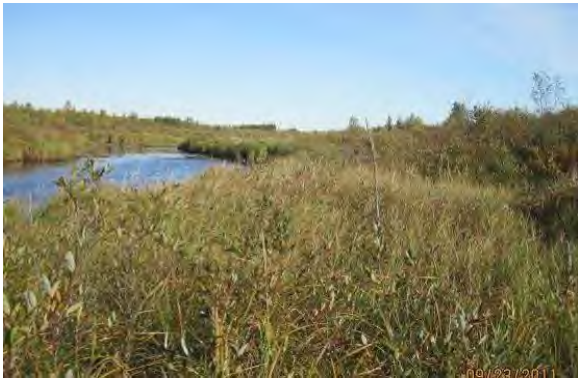
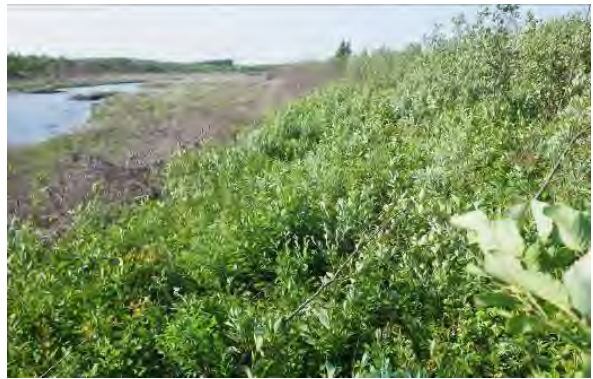
This transect runs in a northeast-southwest direction. A large bare area (20 m) of cobble and gravel was observed on the left side of the creek which had a band of dead shrubs beyond it (17 m) which was also bare beneath. Beyond this, as the slope increased, an area of short shrubs (herbaceous and young poplar) transitioned to taller shrubs (alder) and then to trees. On the right side of the river the first 18 m were largely bare soil with grass and some dead shrubs. Up the slope, shrubs transitioned to trees with a largely sphagnum understory. The depth of organic soil varied from 0 cm (cobble, gravel) to >10 cm (sphagnum). Observations made in 2011 noted high concentrations of grass adjacent to the creek as well as deep layers of organic soil (>25 cm) in the same area. Photo 9 compares 2011 and 2013 photos.

Photo 9. Looking downstream from 18+000 (left photo: 2011; right photo: 2013)

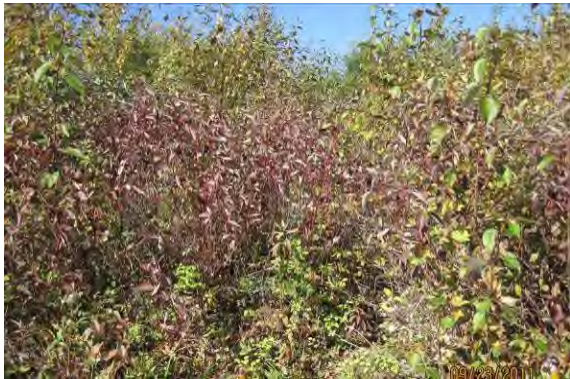
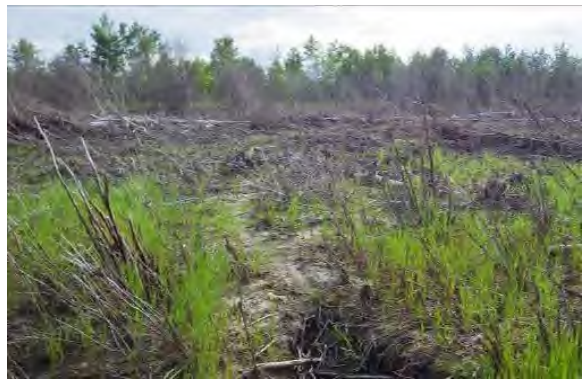
This transect runs in a northeast-southeast orientation. Both sides of the channel had large areas of bare soil, dead shrubs and young grass for the first 37-57 m. The left side transitions to short shrubs followed by tall shrubs with a high percentage of grass before becoming largely trees. Standing water was present at the end of the transect. The right side has a small area of short shrubs before entering a tree/shrub mixture. At 94 m, the understory became sphagnum-dominated. The organic soil depths varied from 0 to >12 cm. In 2011, the first 12-20 m on either side of the channel was inundated as a result of a beaver dam downstream. Similar compositions of grass/shrubs/trees were noted, as was the sphagnum terrain at the end of the transect on the left side. Organic soil depths measured in 2011 were slightly deeper, particularly close the creek channel. Photo 10 contrasts a shrub area in 2011 with a dead shrub area seen in 2013 at the same transect (we cannot confirm if the photos are from exactly the same locations, but they were both taken at 19+000).

Photo 10. Shrub area adjacent to creek channel at 19+000 (left: 2011; right: 2013)
